TECHNICAL REPORT HL-92-1

BRUSH CREEK, KANSAS CITY, MISSOURI

Hydraulic Model Investigation

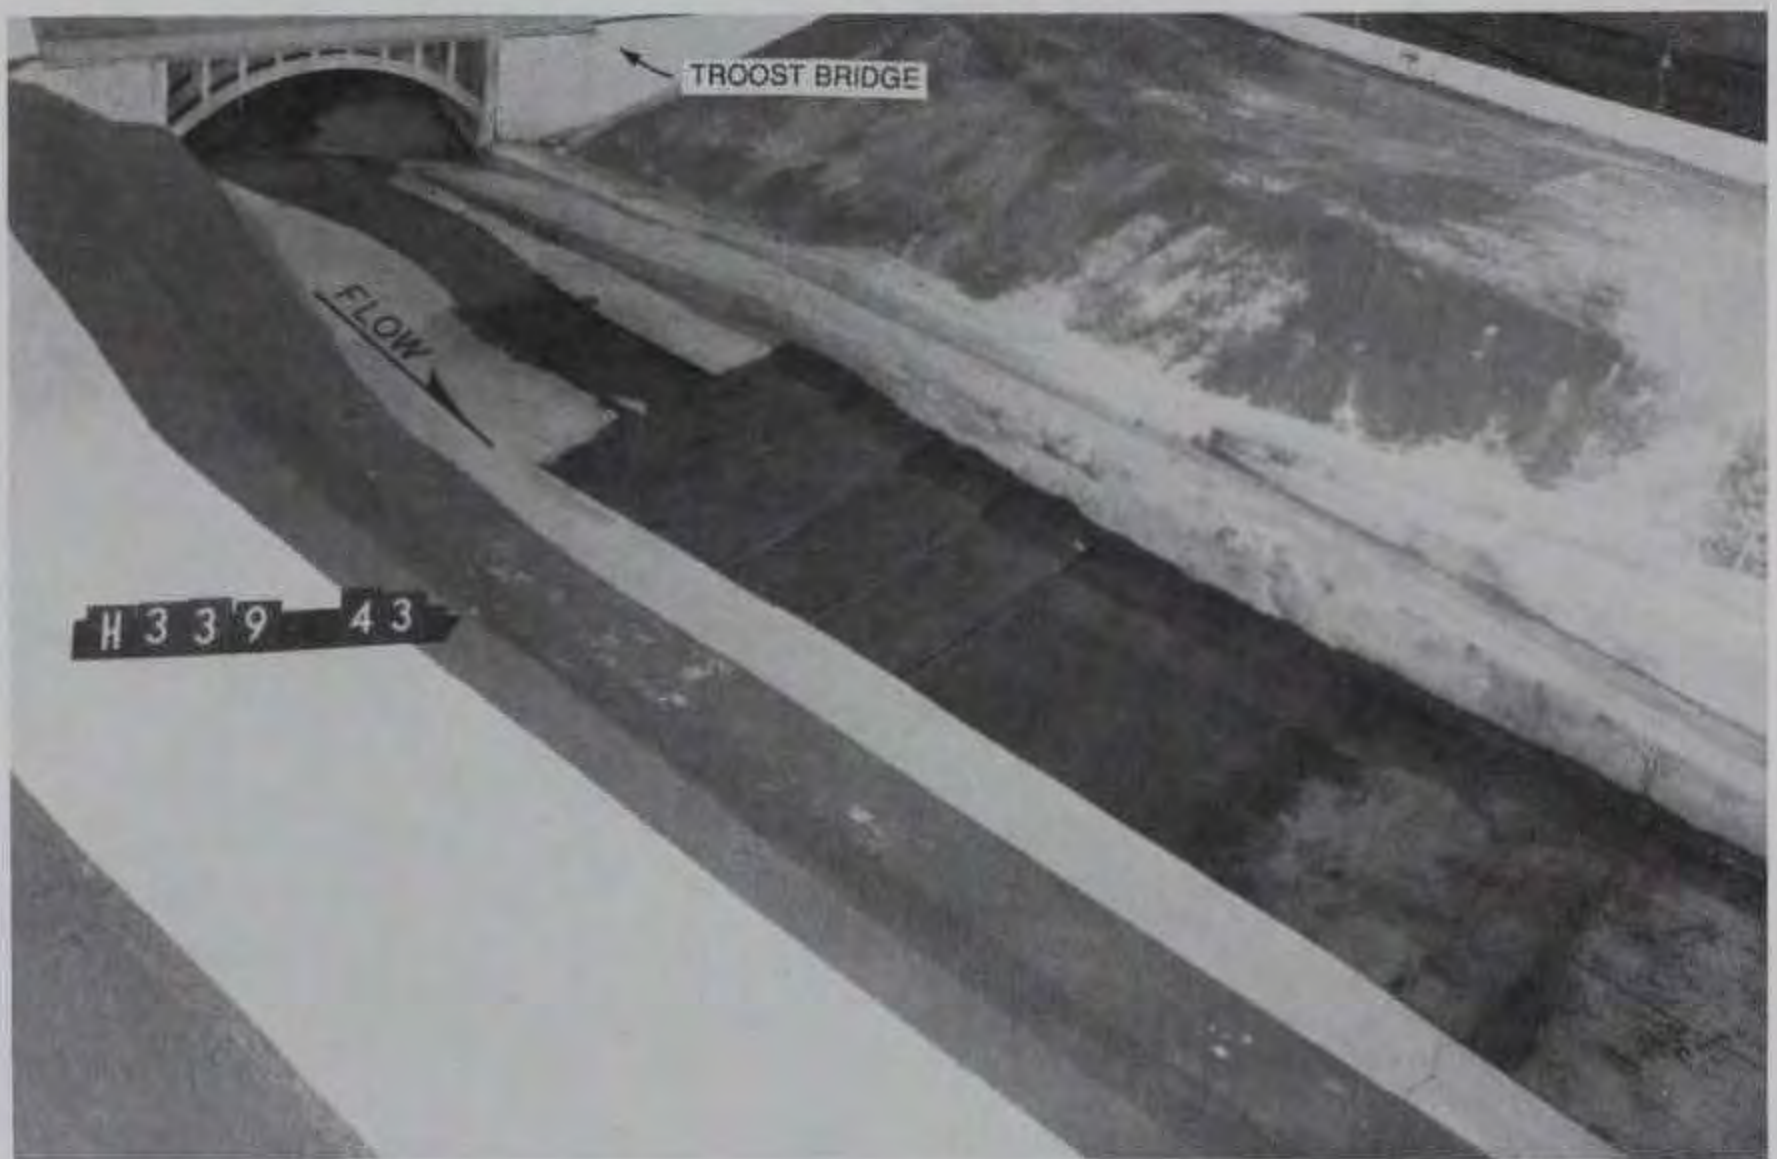
Photo 56. Drop 2, type 3 design stilling basin

75. Type 3 design. Safety considerations, as explained previously (paragraph 72), required that the Troost drop structure also be modified to prevent the formation of any strong reverse roller in the stilling basin. The type 3 design (Photo 56) had five steps approximately 2 ft high for a total drop of 10.7 ft. The steps were 20 ft long. Dimensions and elevations are shown in Plate 21. Flow conditions are shown in Photo 57 for the 10-, 100-, and 500-year floods. Flow was directed to the center of the structure by the Troost Avenue Bridge and sidewall blocks were not required. Although there was little energy dissipation, smooth flow conditions were observed for all discharges. The type 3 design is therefore recommended based on safety considerations.

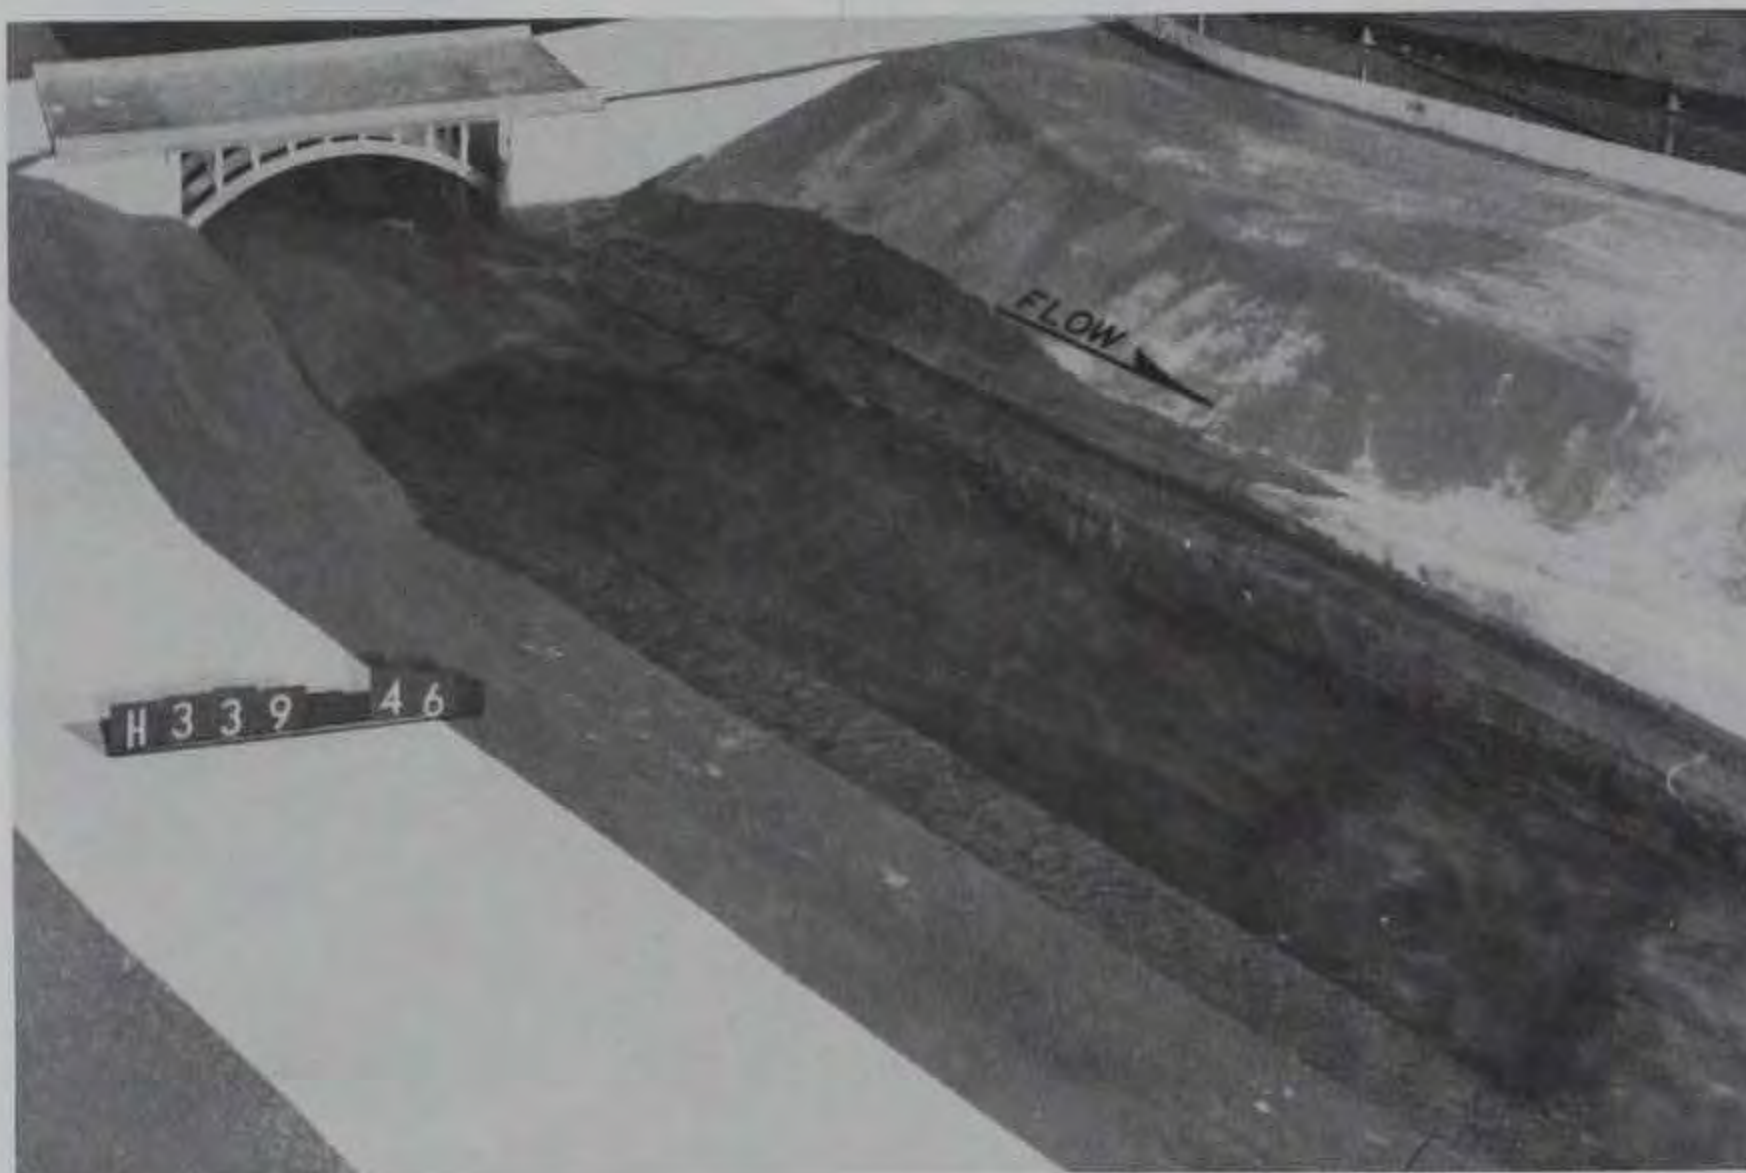
a. 10-year flood

b. 100-year flood

Photo 57. Flow conditions at drop 2, type 3 design stilling basin (Continued)

c. 500-year flood

Photo 57. (Concluded)

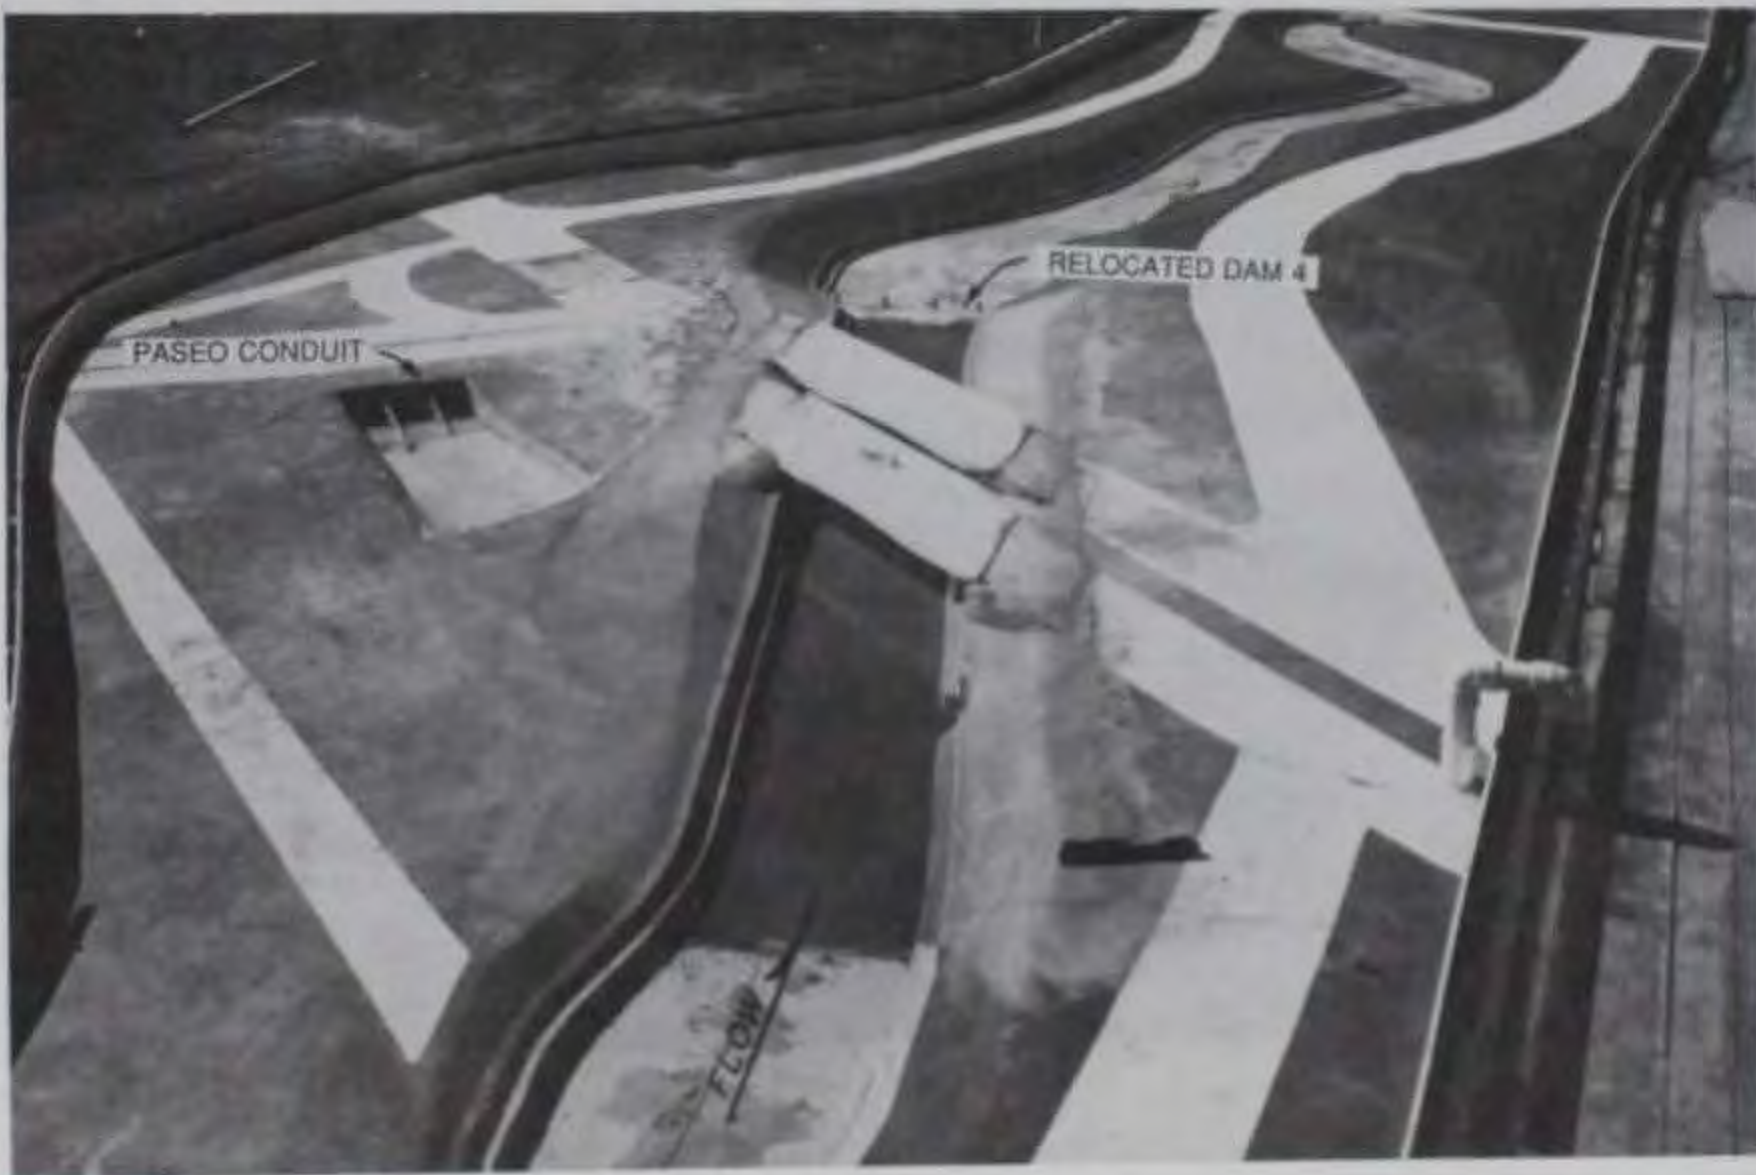
Photo 59. Paseo realignment, sta 123+00 to sta 147+00

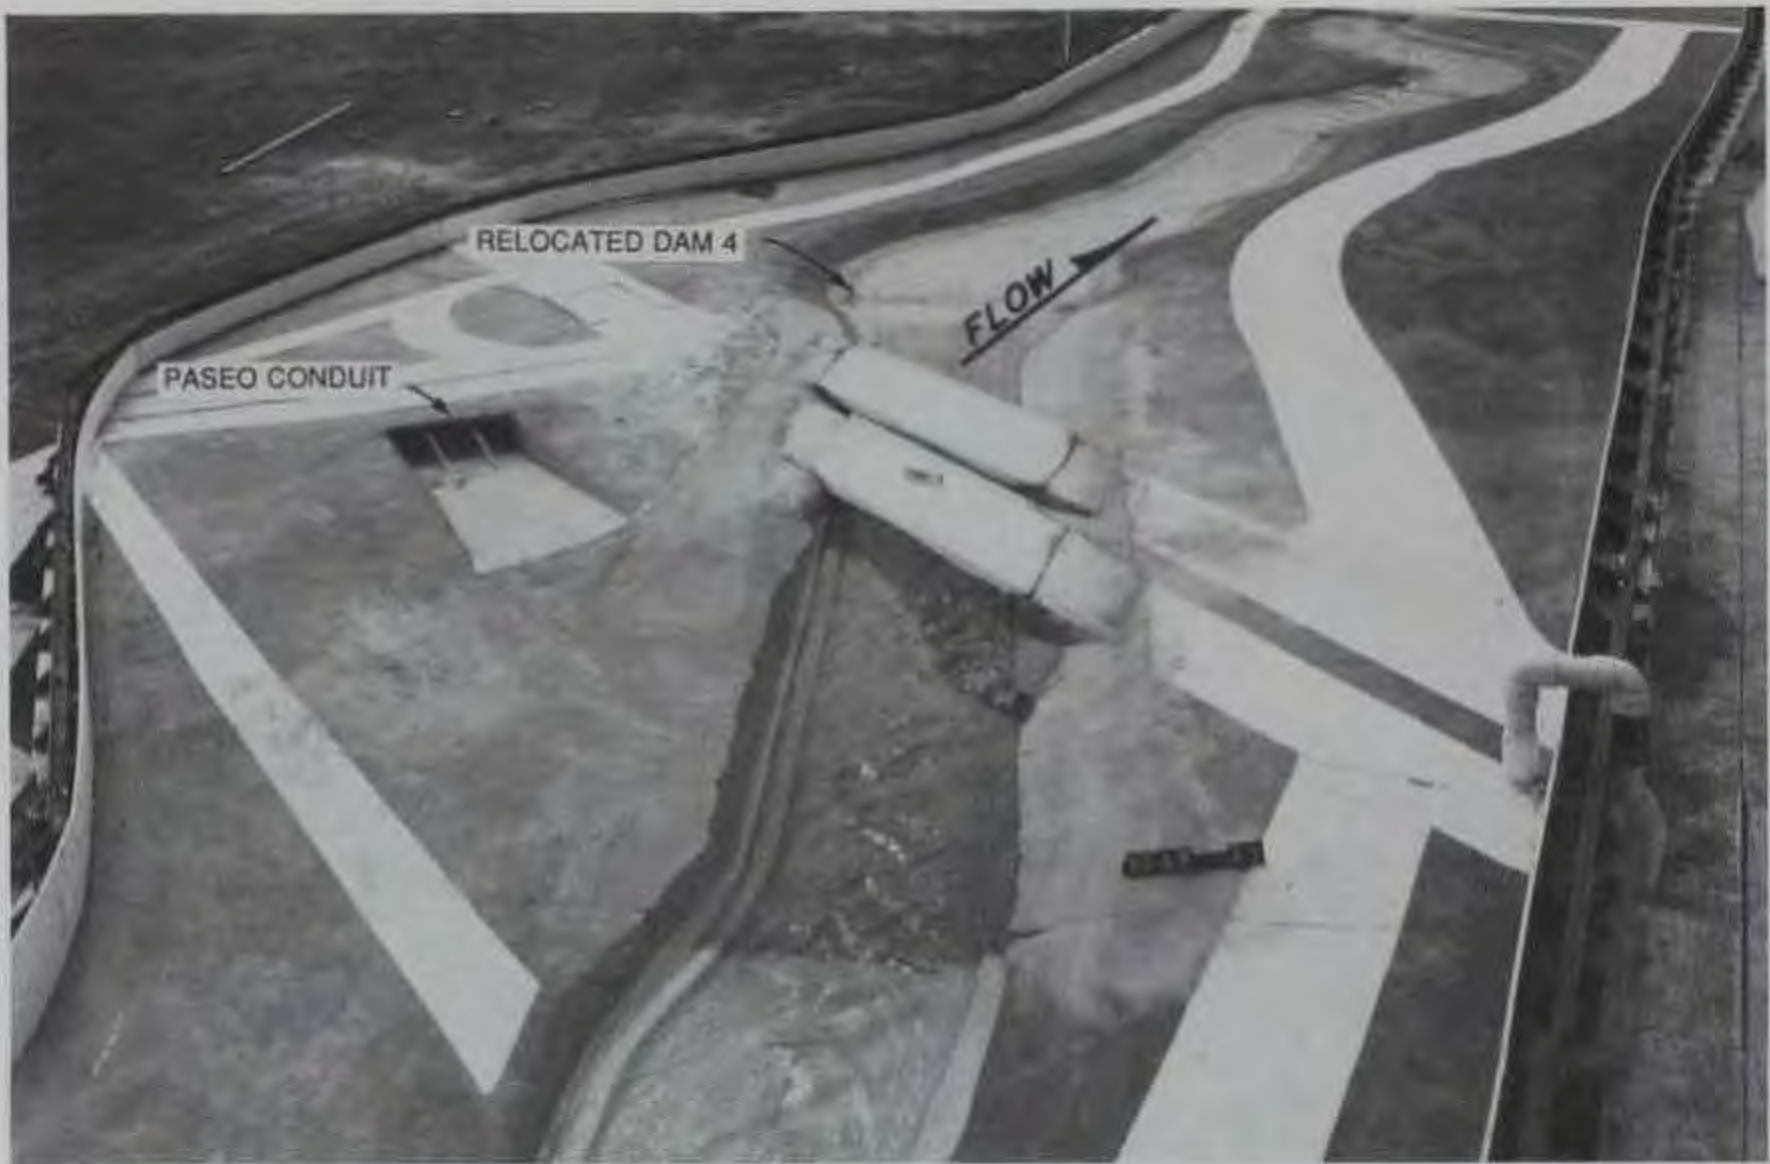
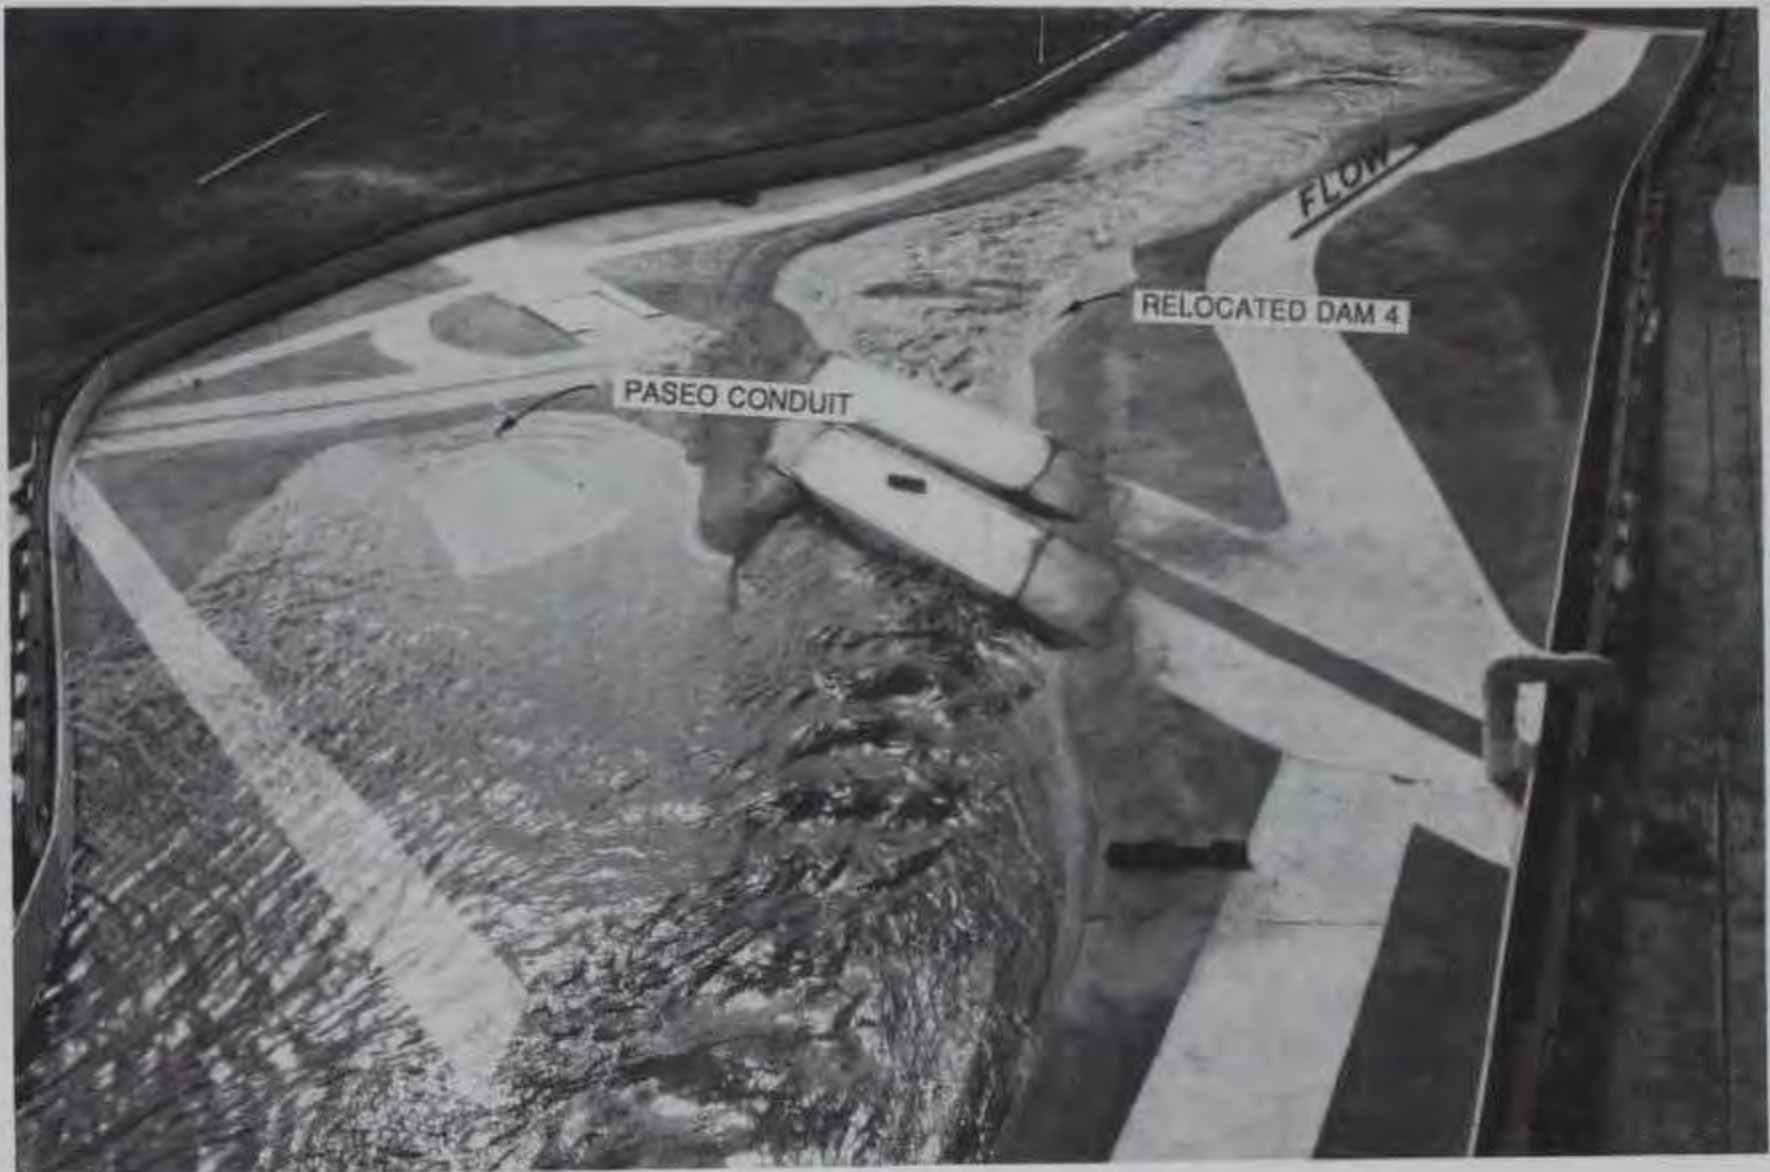
a. 10-year flood

b. 100-year flood

Photo 60. Flow conditions at Paseo realignment with new Paseo bridges, sta 123+00 to sta 147+00 (Continued)

c. 500-year flood

Photo 60. (Concluded)

77. Although flow conditions were improved, the 500-year flood still overtopped the left bank and flooded the low area in the vicinity of the Brush Creek Boulevard-Paseo intersection. This flooding was due to the location of dam 4, which restricted the flow underneath the bridges. Also, the curved alignment of the channel upstream of the Paseo bridges contributed to the problem. Relocation of dam 4 downstream to sta 131+50 improved the situation, but additional refinement was needed. The channel upstream of the Paseo bridges was straightened to remove any curvature. The combination of these modifications, shown in Photo 59, greatly improved the flow conditions in the Paseo area. Flow conditions for the 10-, 100-, and 500-year floods, shown in Photo 60, reveal that the flood impact in this area was greatly reduced when compared with previous conditions.

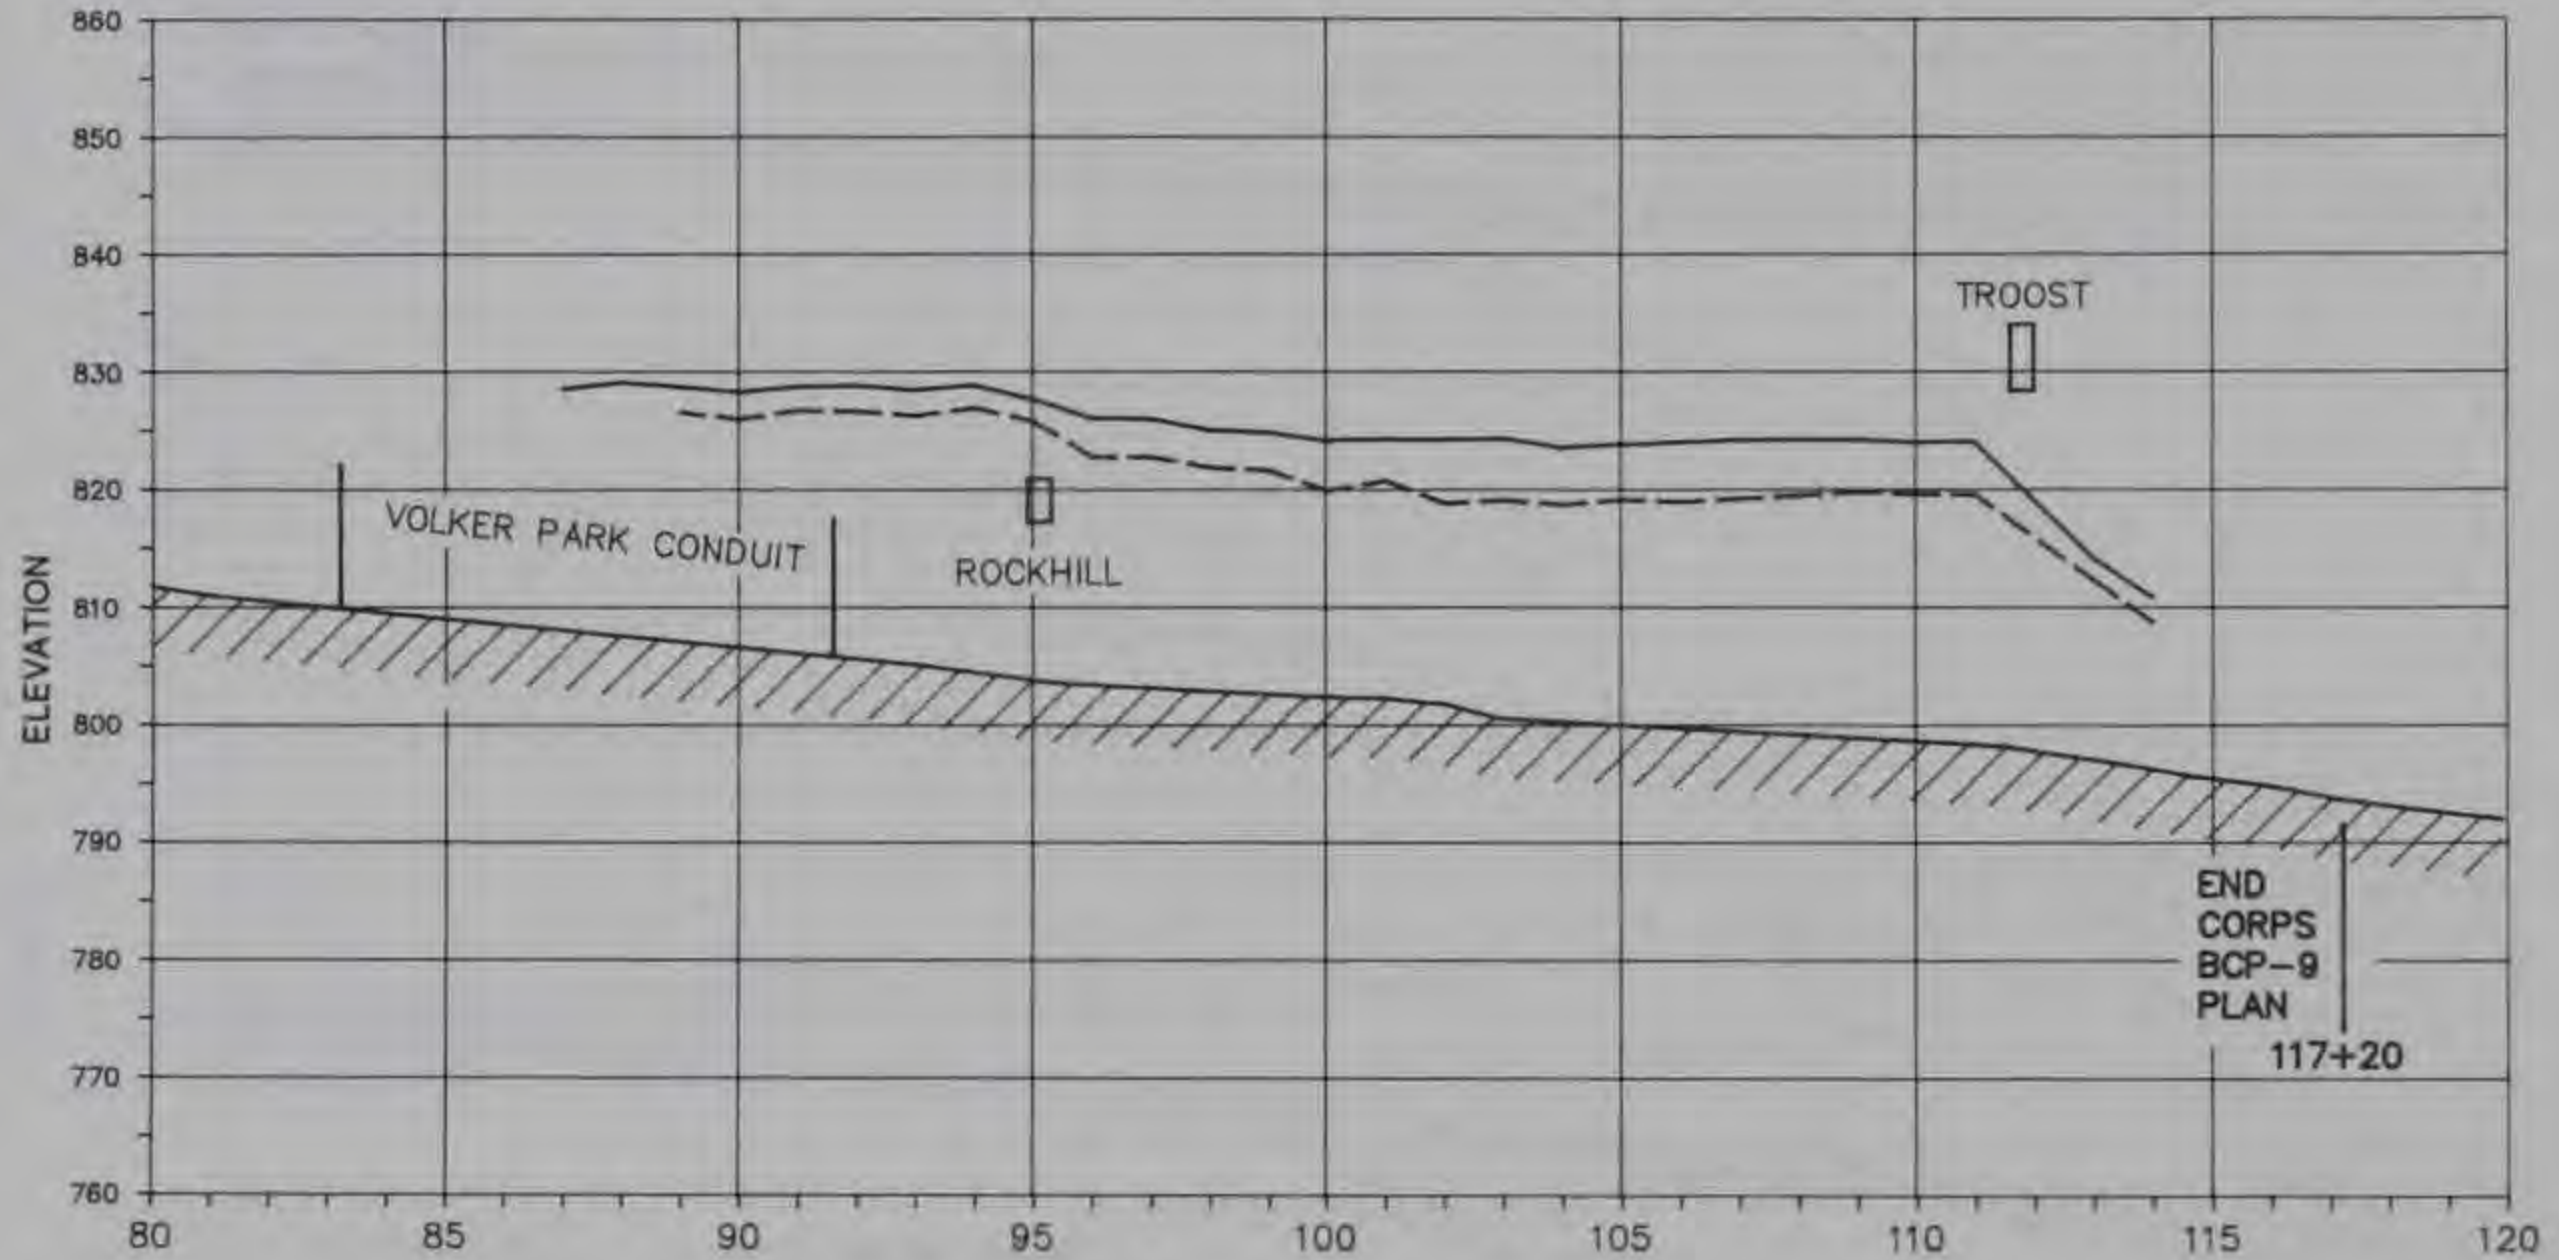
- 100-YEAR FLOOD
- 500-YEAR FLOOD
- BRIDGES

WATER-SURFACE PROFILES
 EXISTING CONDITIONS
 SAILORS DEVELOPMENT WITH FLOODWALL
 100-YEAR AND 500-YEAR FLOODS

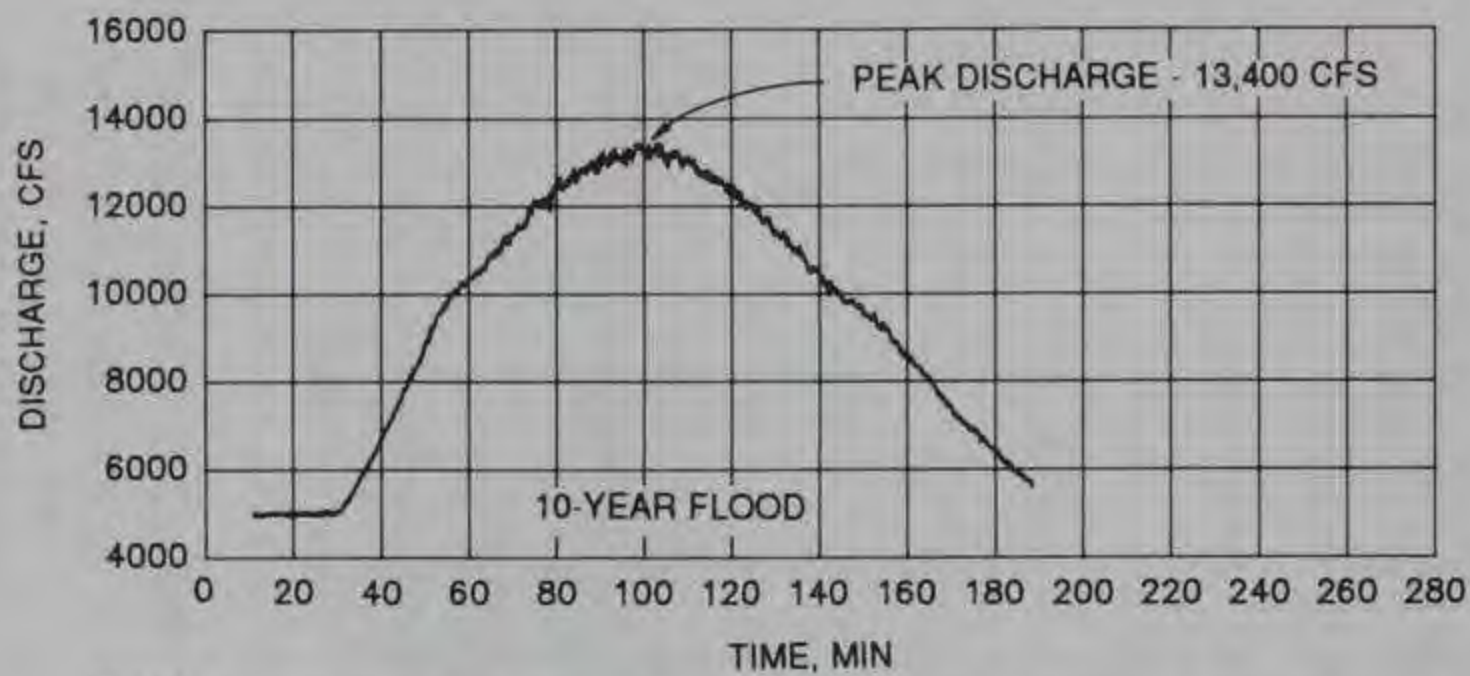
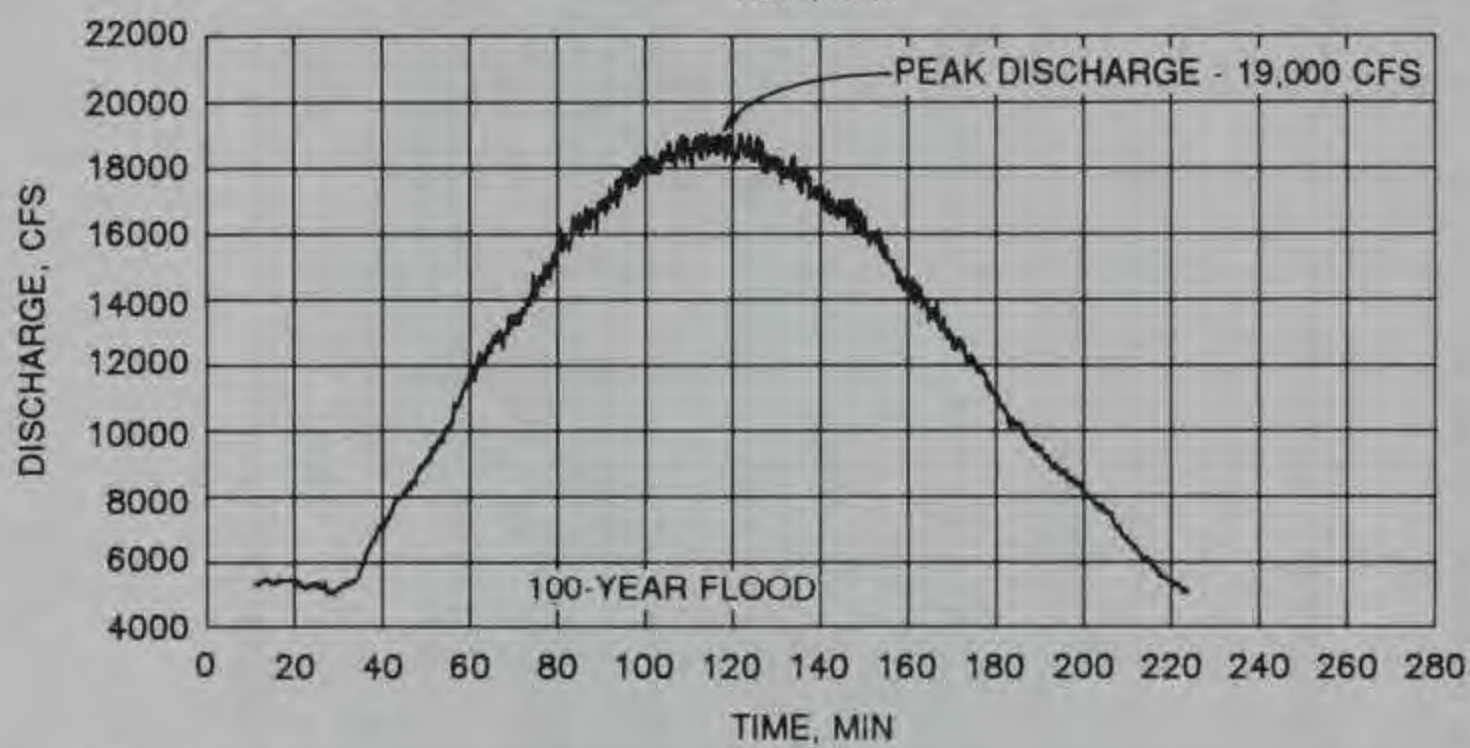
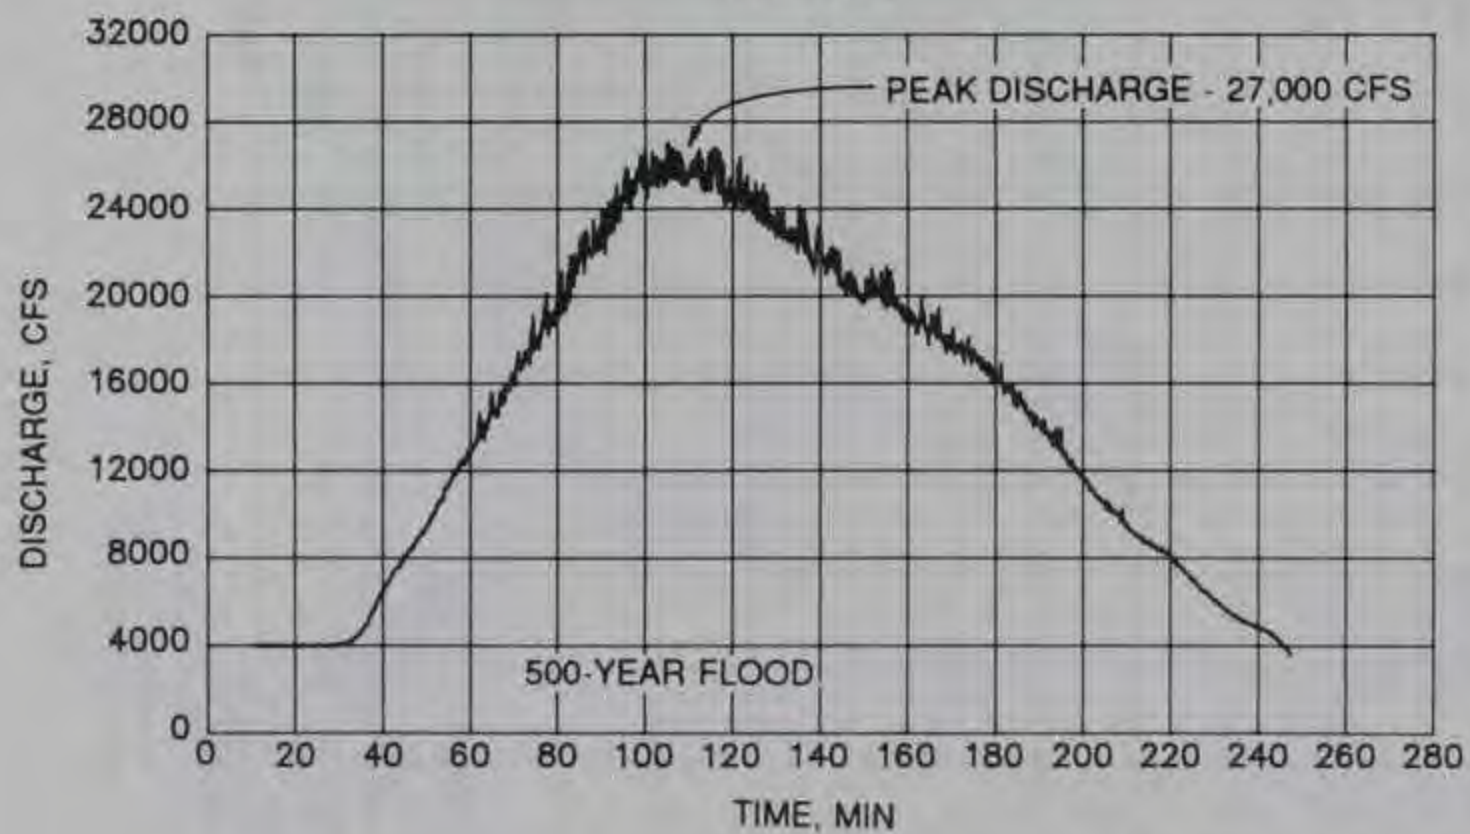
- 10-YEAR FLOOD
- - - 100-YEAR FLOOD
- 500-YEAR FLOOD

INFLOW HYDROGRAPHS
EXISTING CONDITIONS
10-YEAR, 100-YEAR
AND 500-YEAR FLOODS

82. Hydrograph tests were conducted with the existing conditions and BCP-9 Plan. These tests show that any proposed modifications would not increase the downstream discharge or the downstream flooding potential.
