TECHNICAL REPORT H-68-8

NAVIGATION CONDITIONS AT LOCK AND DAM NO. 3, ARKANSAS RIVER ARKANSAS AND OKLAHOMA

Hydraulic Model Investigation

U. S. Army Engineer District
Little Rock

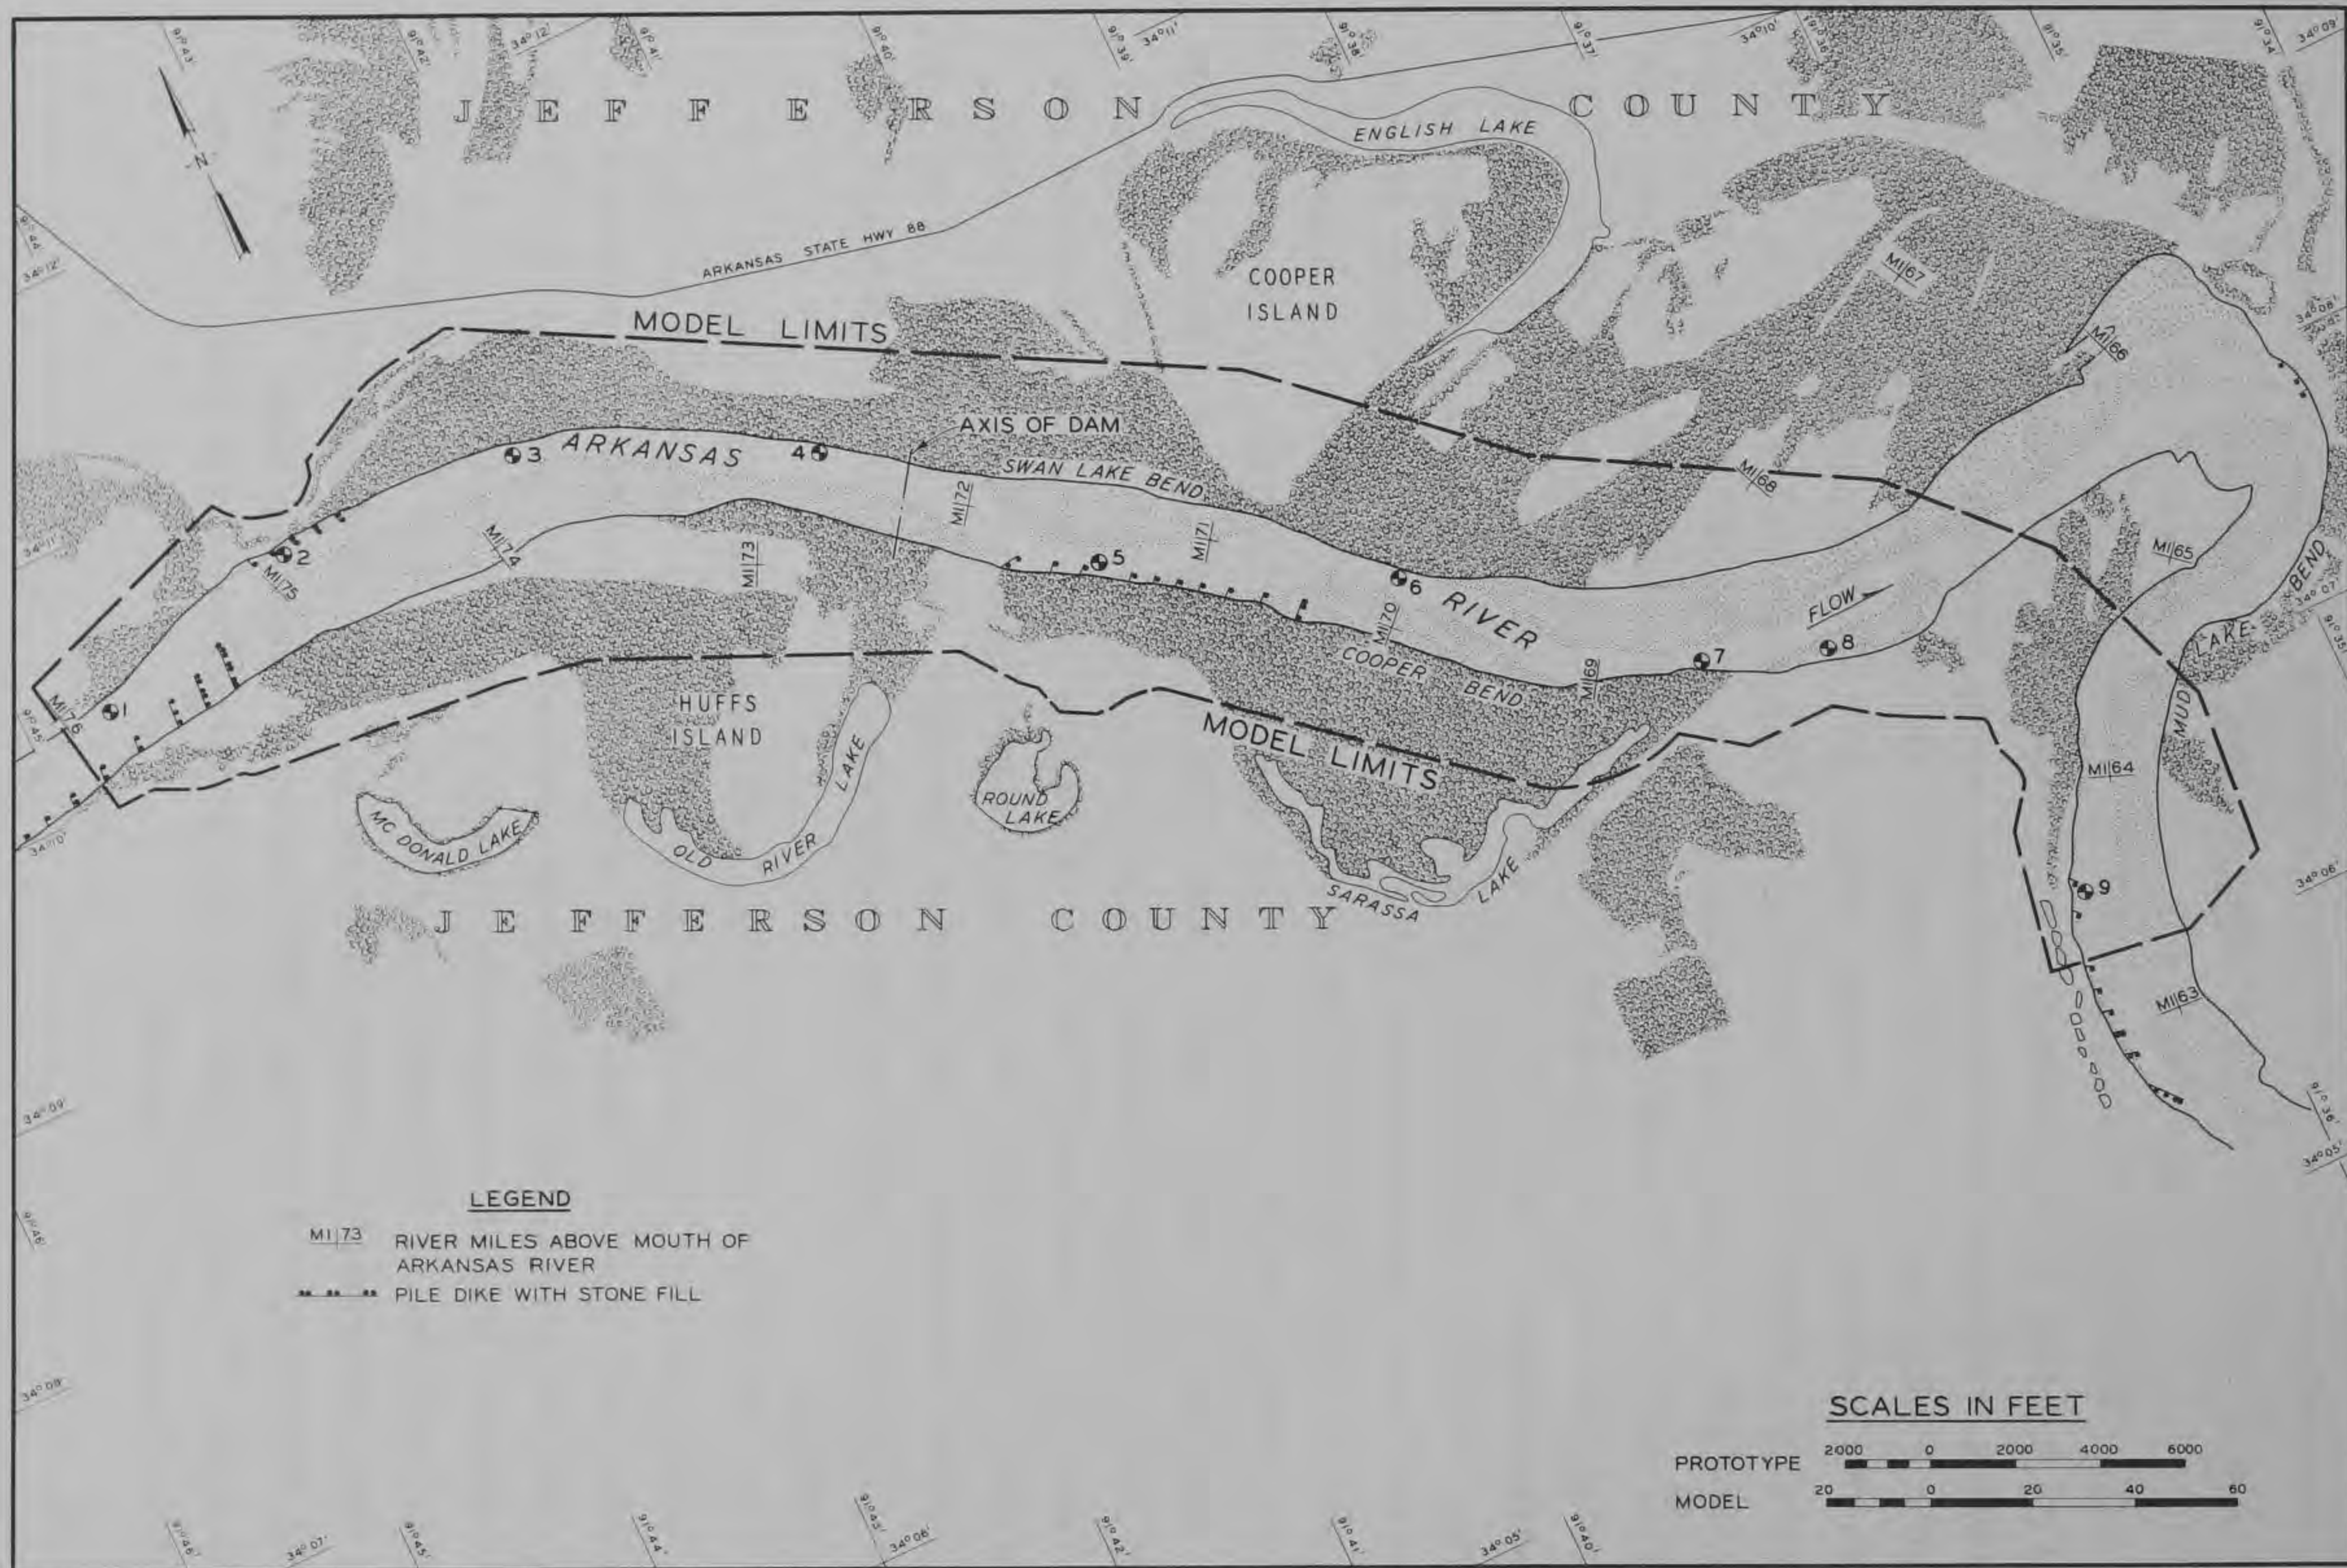
Fig. 3. Model layout and locations of gages

8. The model of Lock and Dam No. 3 (fig. 3) was a scale reproduction of a reach of the Arkansas River extending from mile 76.0 to mile 63.2, including sufficient overbank area to permit overbank flow across bends on both banks, but not to the limits of the floodway at all points. The model was built to linear scale ratios of 1:120 horizontally and 1:80 vertically, producing geometrically a slope scale ratio of 1.5 to 1, model to prototype. A small supplementary slope of 0.00007 (equivalent to about 0.37 ft per mile prototype), which was needed to provide satisfactory bed movement, was also incorporated in the model. The model was of the movable-bed type with fixed banks and overbank areas molded in sand-cement mortar. Folded strips of mesh wire were used to simulate the roughness effect of trees and underbrush on the overbank areas, as shown in fig. 4. The bed material was coal which had a median grain diameter of about 4 mm and a specific gravity of 1.30. The permeable pile dikes in the model were made of two rows of metal rods. The lock and dam were fabricated of sheet metal to prevent change in elevation which might have been caused by expansion or warping after the structures were set. The upstream and downstream dimensions of the dam were constructed to the vertical scale to produce the required jump within the basin. Each bay of the model dam was constructed to reproduce two prototype bays with the piers modified accordingly.

9. The fixed portions of the model were molded from the edge of the movable bed to the top bank in accordance with data shown in the Richland Bend to Round Lake survey dated 11-16 May 1960 and the Round Lake-Cummins Bend survey dated 17-18 February 1959. The remainder of the fixed bed was molded to 1940 data shown on chart 5 dated 1942. The initial contours of the movable bed of the model were in accordance with the configurations shown in plate 1. This configuration was based on the February 1959 and May 1960 surveys referred to above, except for a short reach of about 0.7 mile at the upstream end of the model which was based on the April 1961 survey.

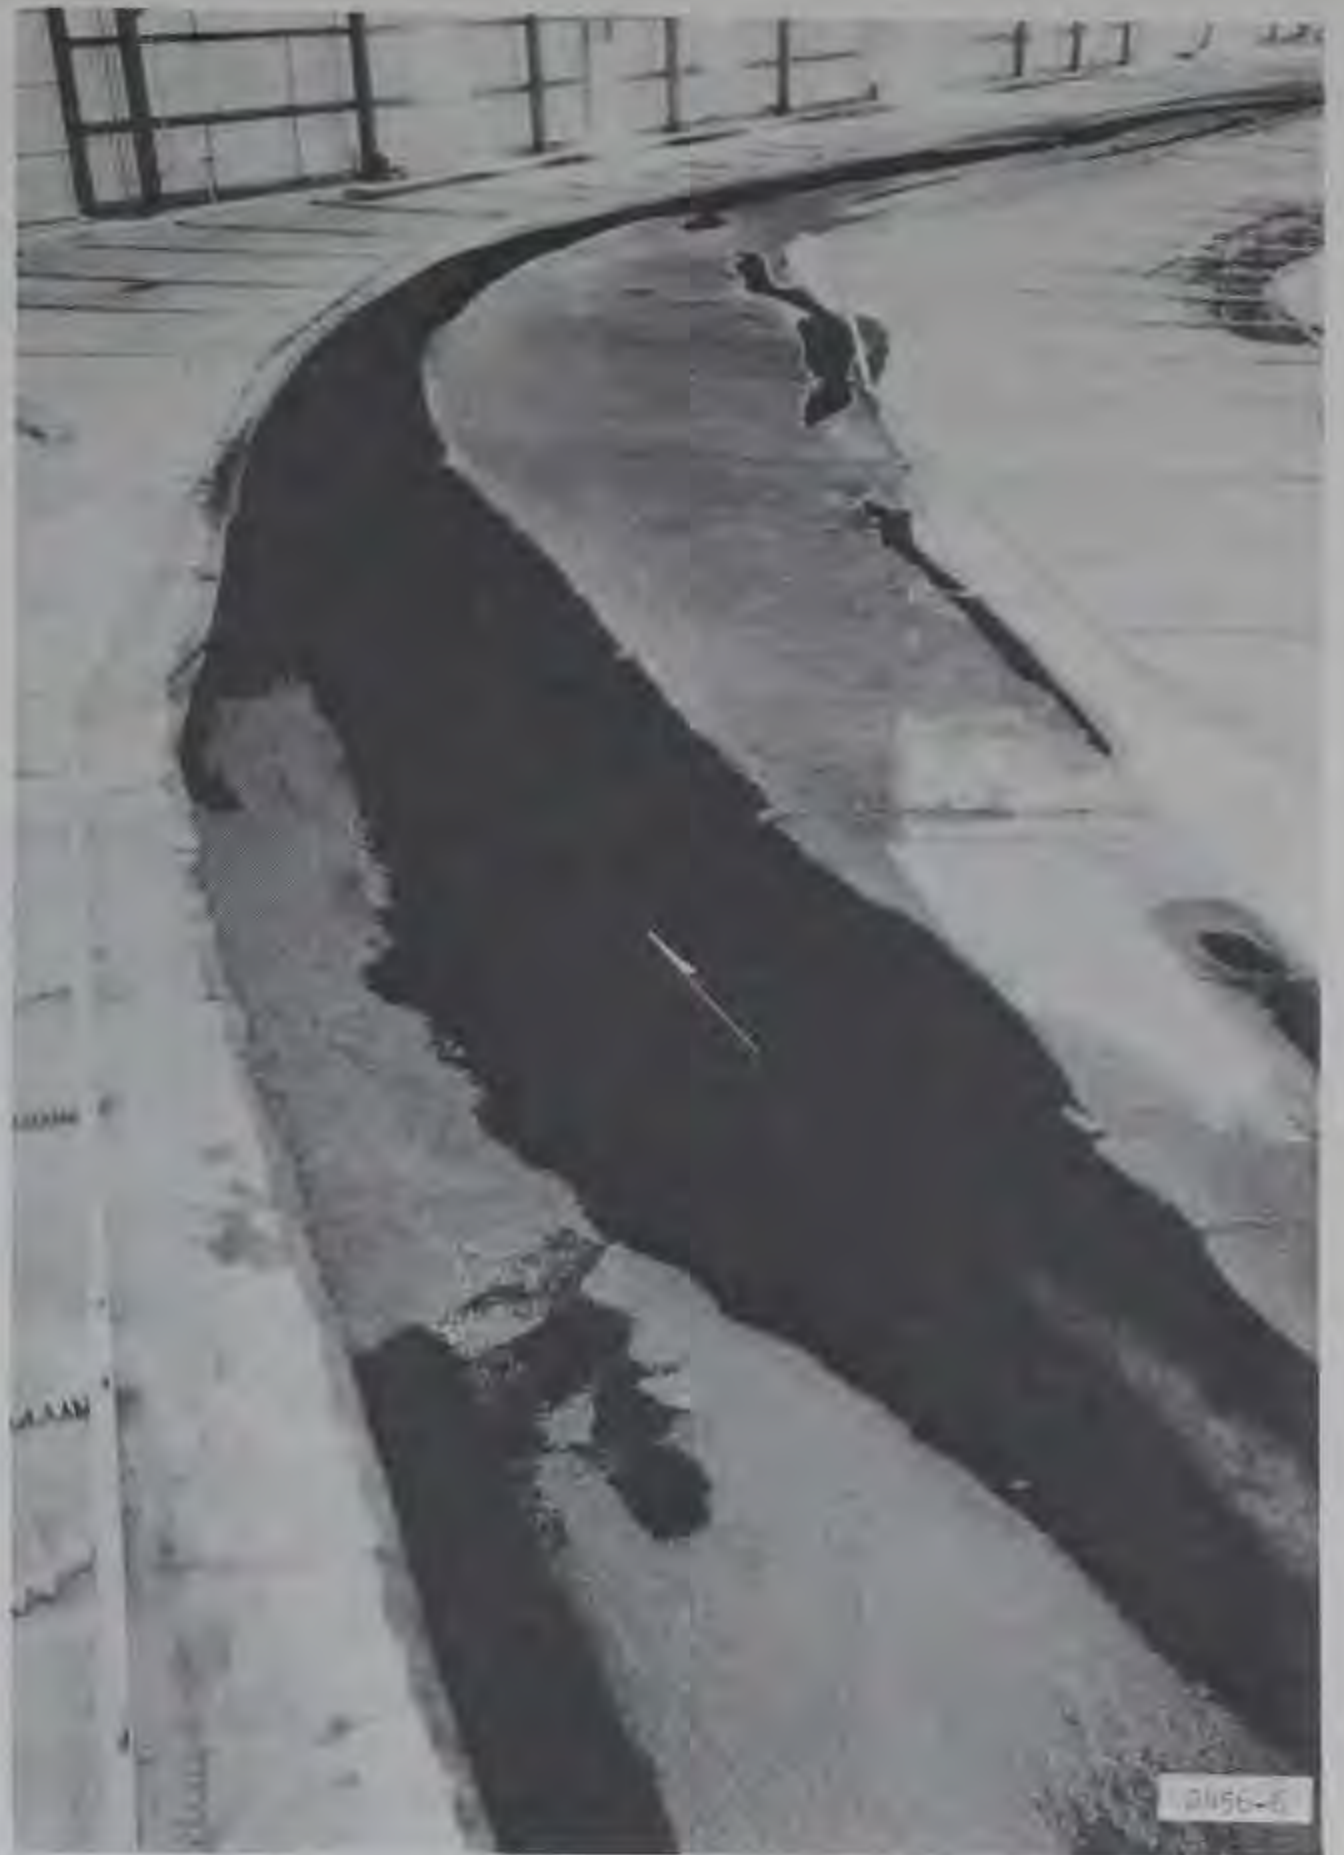
Fig. 4. The model

10. Water was supplied to the model by a 10-cfs axial flow pump operating in a circulating system and was measured at the upper end of the model by means of two venturi meters of different sizes required to handle the range of discharge. Water-surface elevations throughout the model reach were measured with nine piezometer and two point gages. Tailwater elevations at the lower end of the model were controlled with an adjustable tailgate. Soundings in the model were obtained by use of a sounding rail and special sounding rod which permitted the reading of elevations in prototype feet.

Bed material to be introduced into the model was measured in a graduated container and introduced by hand at the upper end of the model. A sediment trap was provided at the lower end of the model where extruded material could accumulate and be measured to determine the amount discharged for any period. Sheet metal templates were used for molding the model bed prior to initiation of certain tests. A row of carefully graded, threaded iron rods was provided along each concrete bank of the channel to support templates at correct elevations and the rails from which the model bed was surveyed, and to control the grade of dredged cuts and structures during installation. Current directions were determined by plotting the paths of wooden floats with respect to ranges established for that purpose; floats were submerged to a depth of 8 ft, equivalent to the draft of a loaded barge. Velocities for current directions were

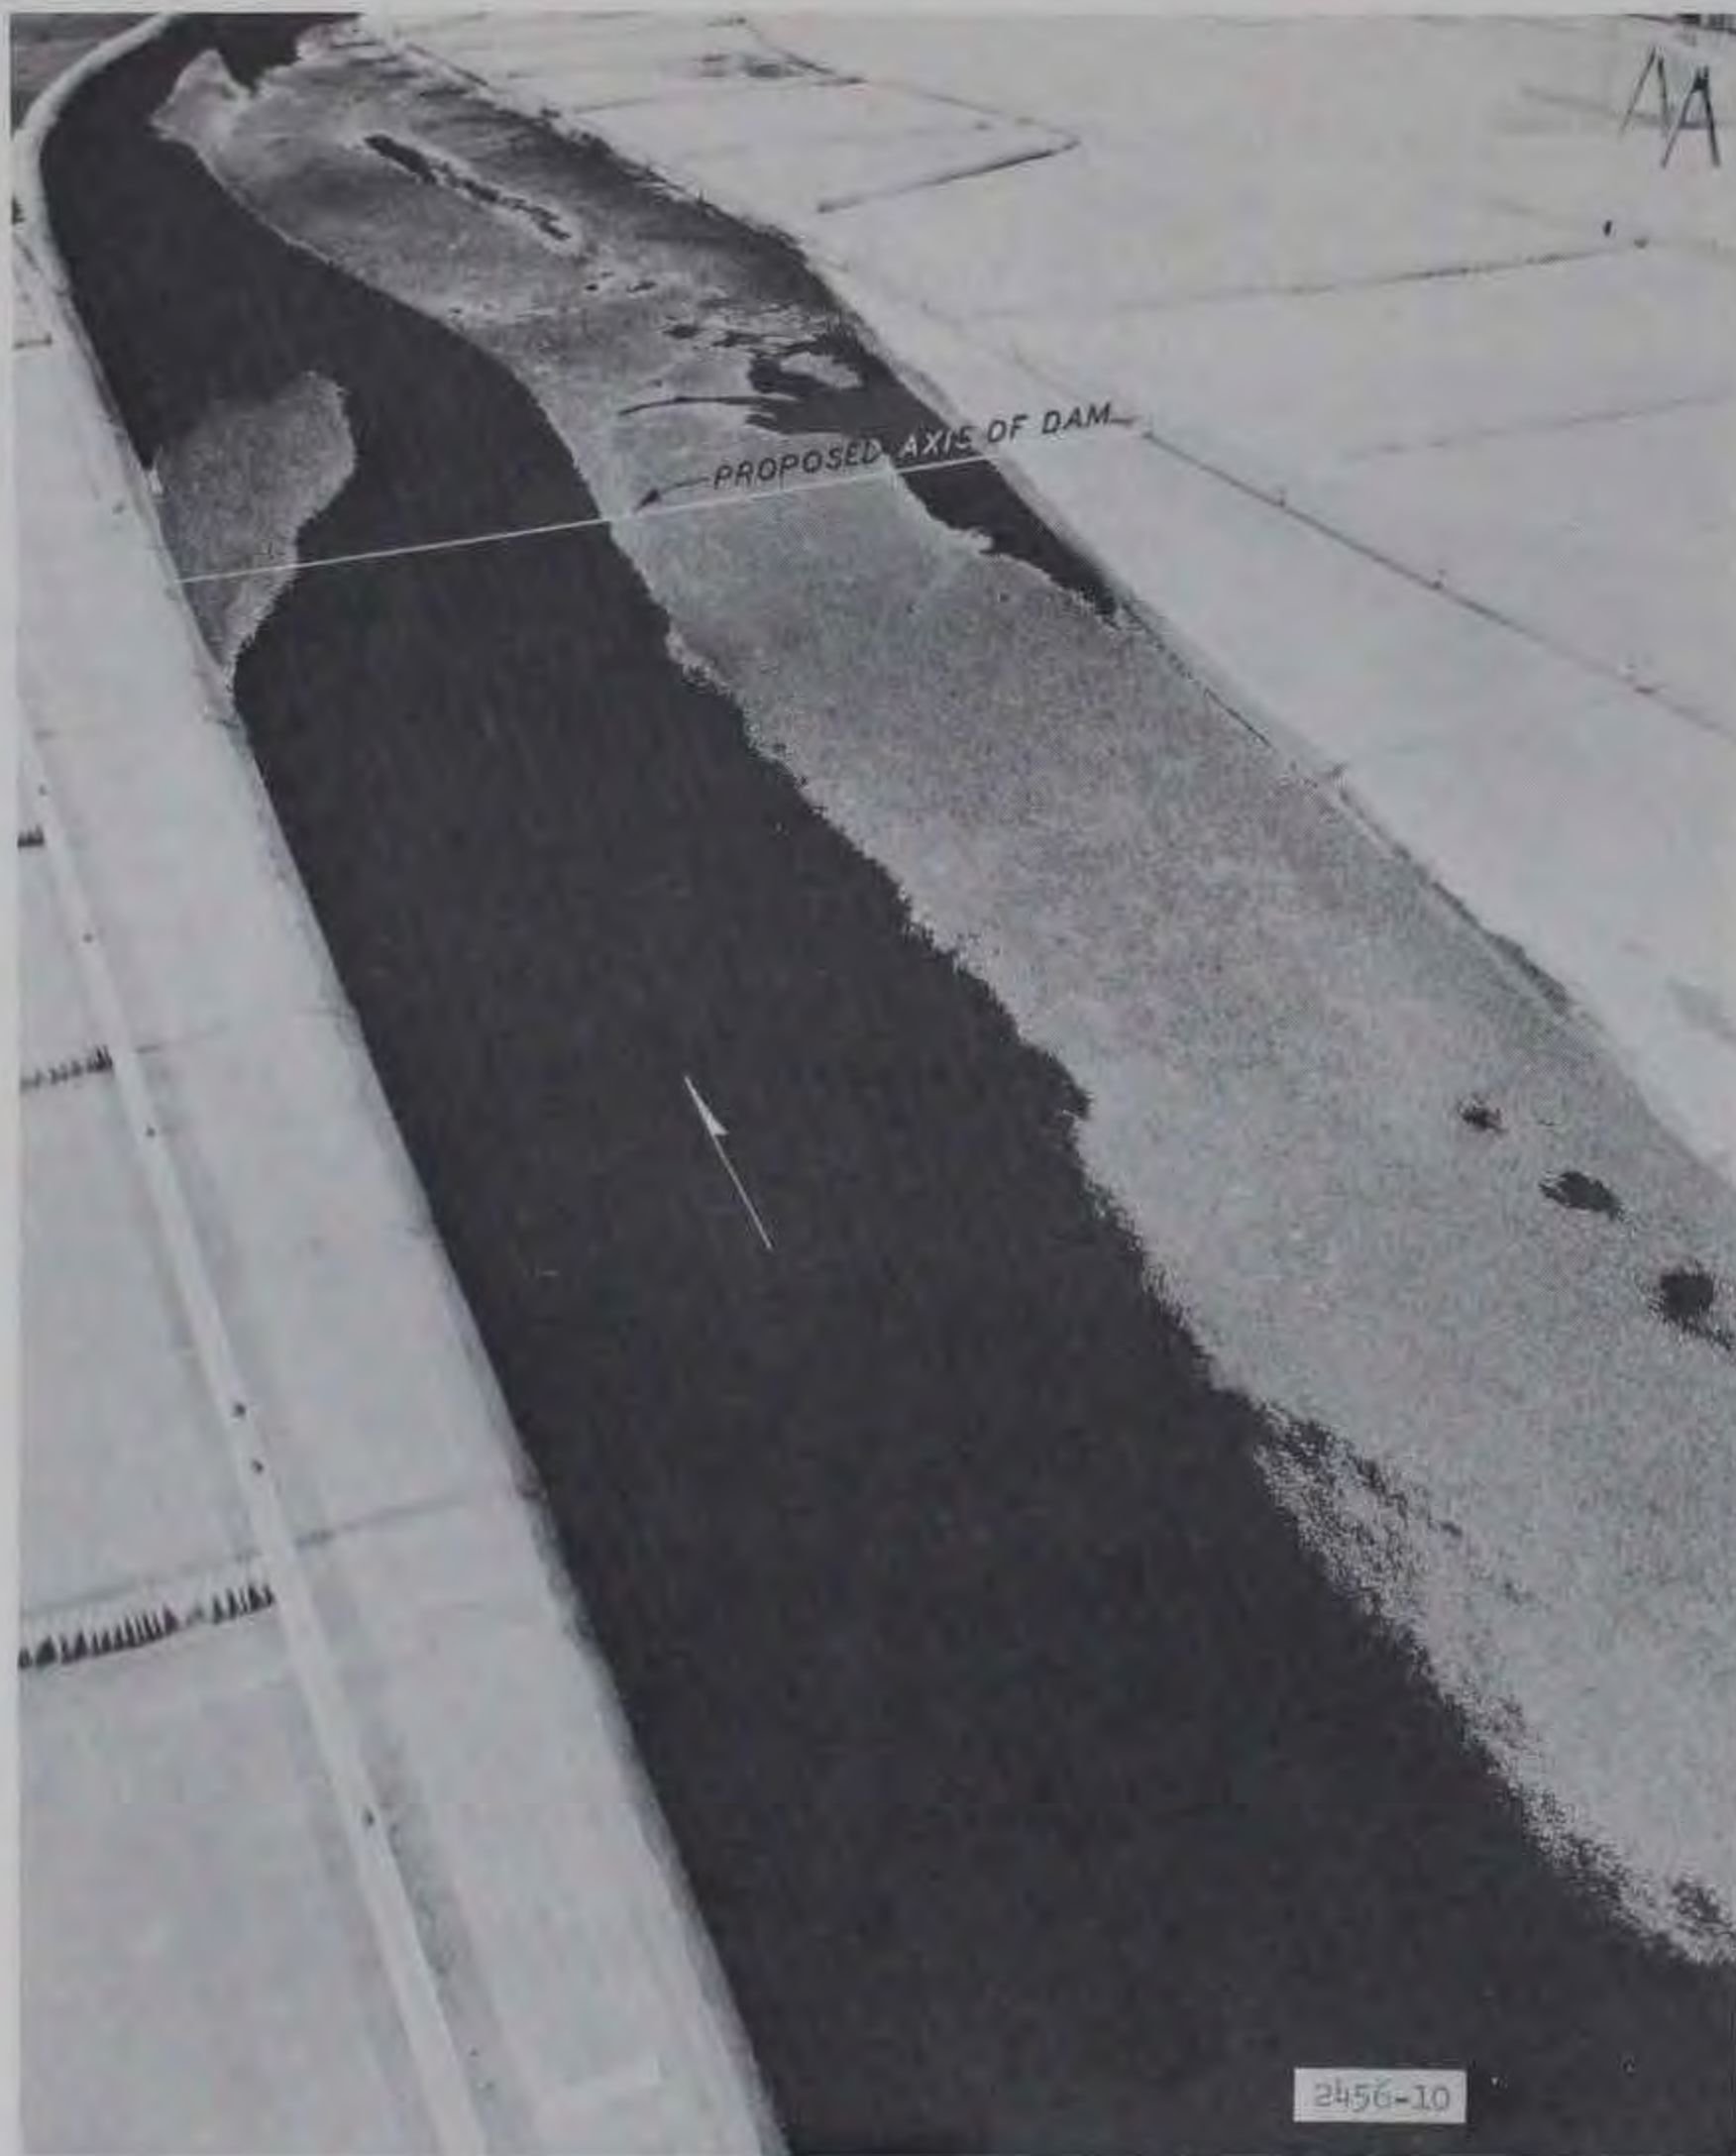
Photograph 1. Base test, run 1, 0-ft stage. View from about mile 73.0, showing bar formation along left bank near proposed damsite, indicating tendency for channel to meander

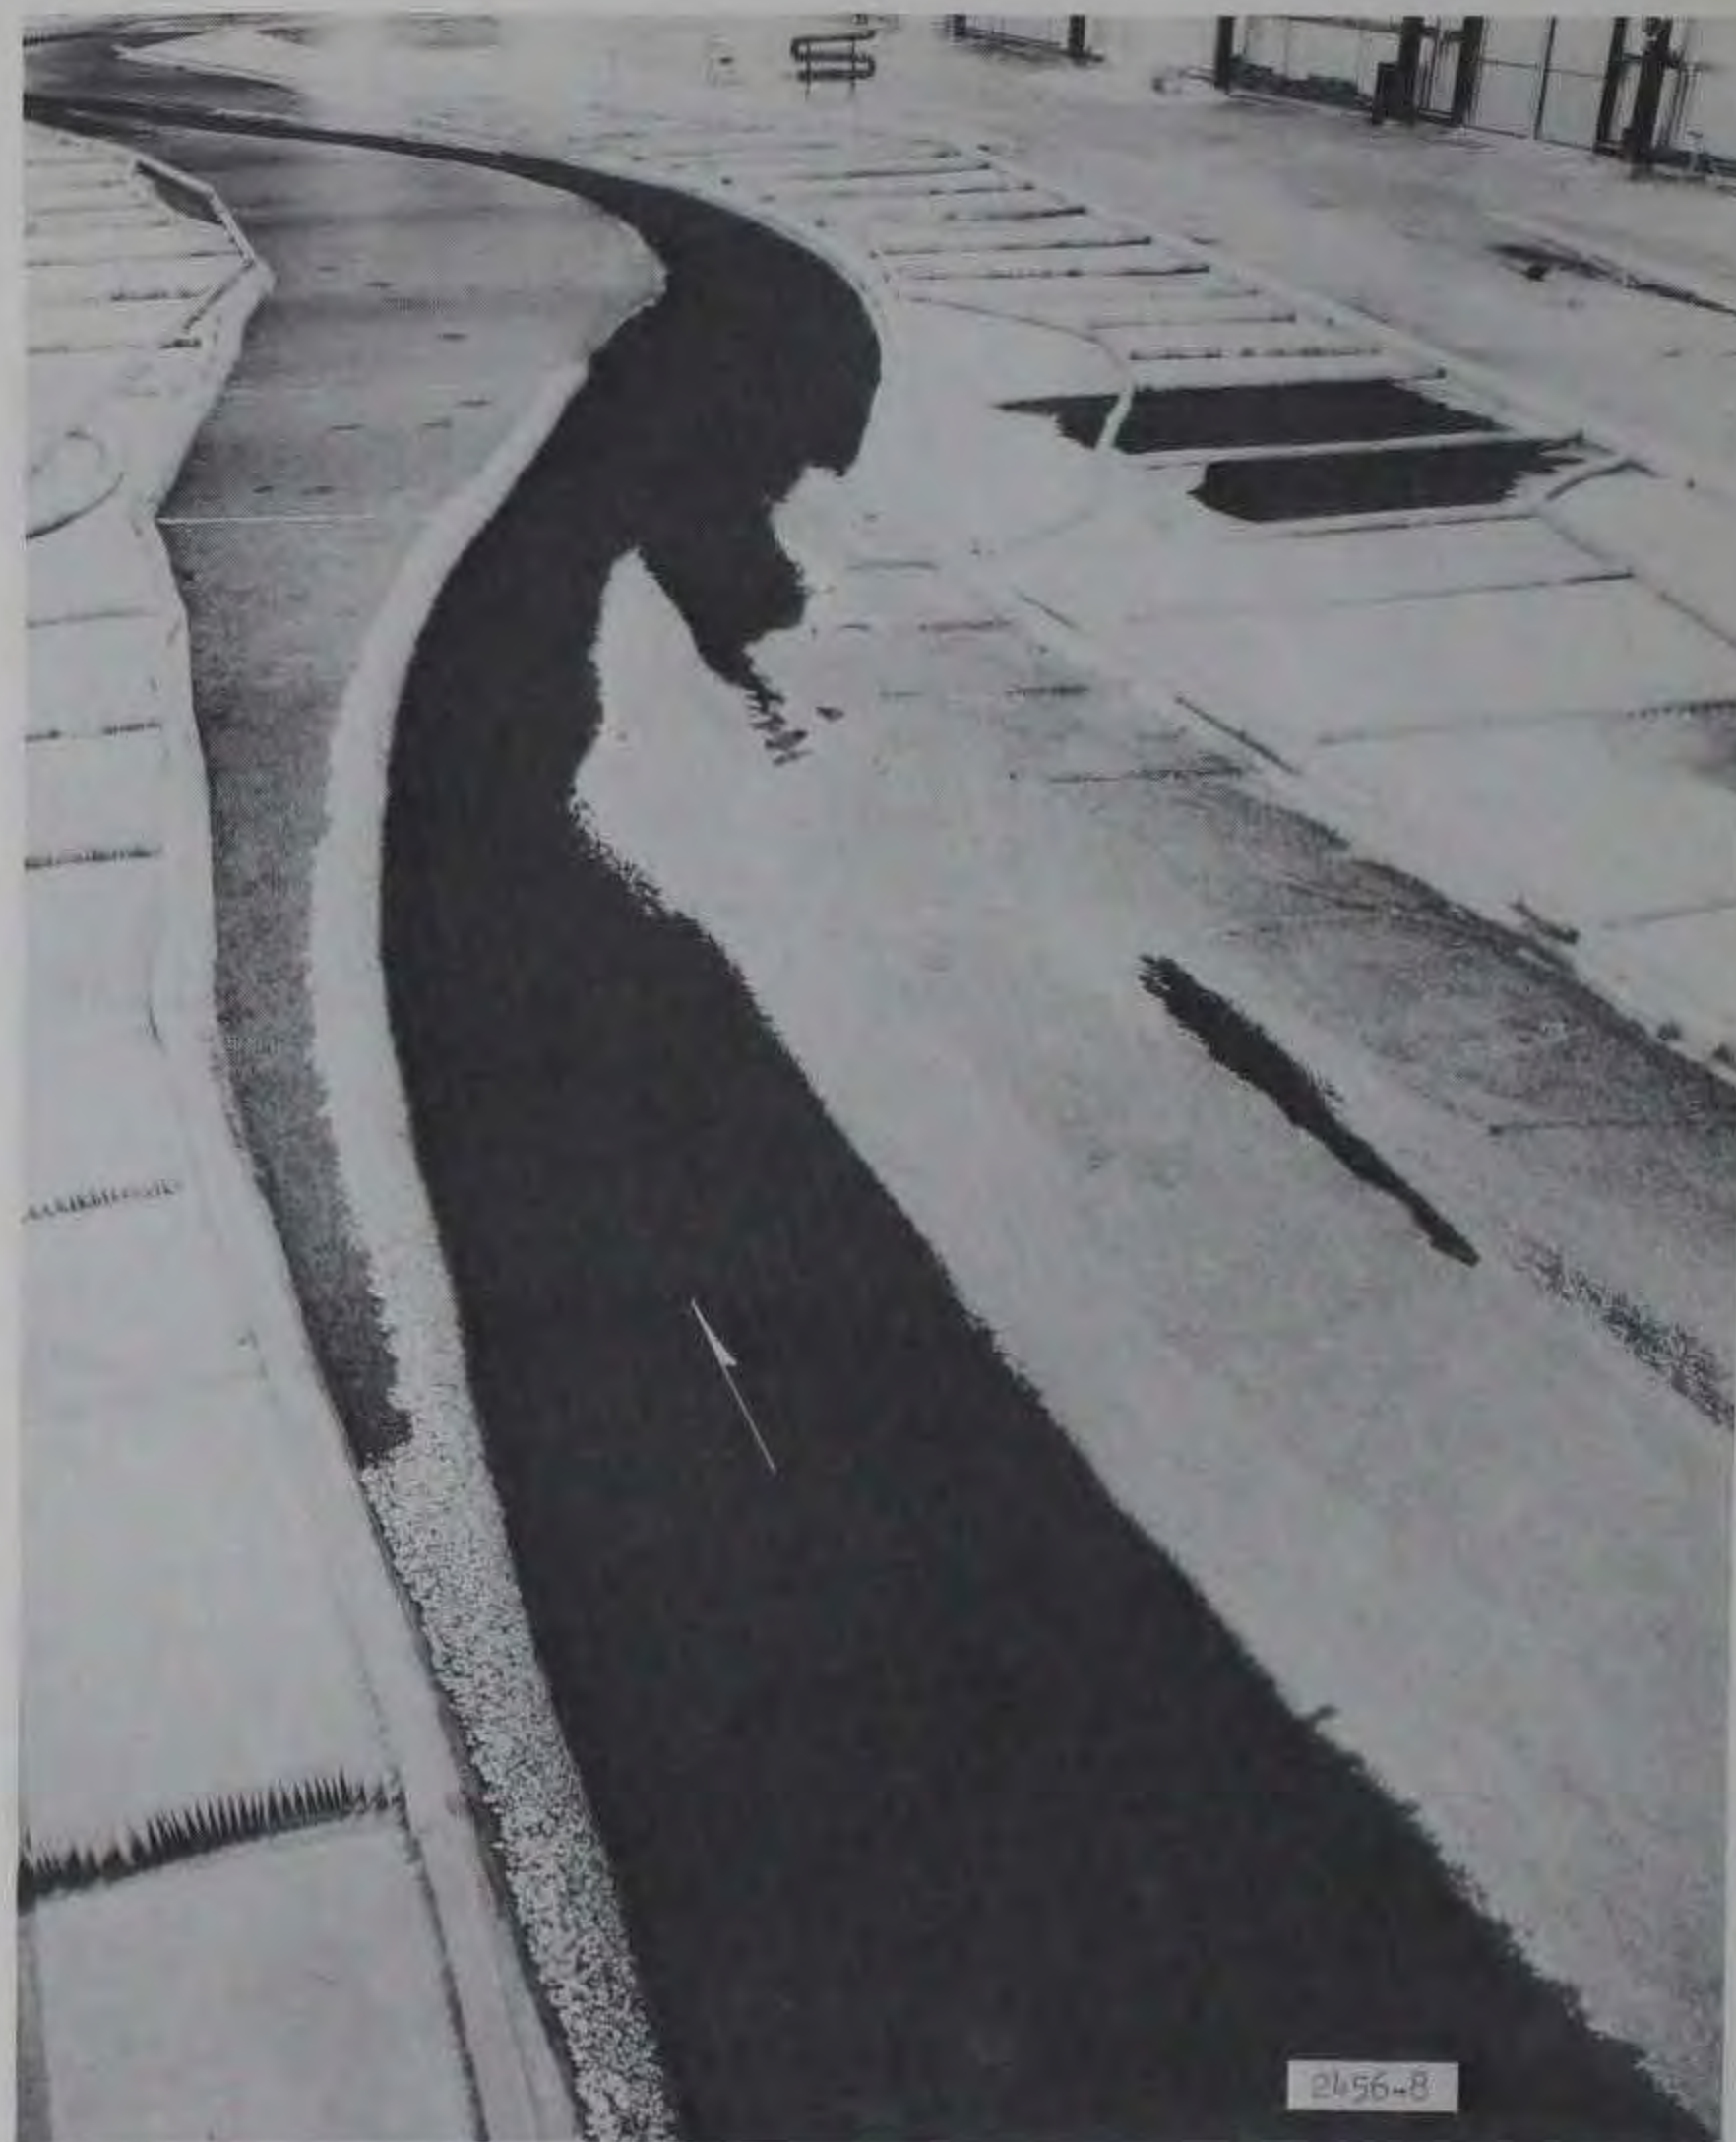
Photograph 2. Base test, run 1, 0-ft stage. View from about mile 72.2 showing channel along pile revetment downstream of proposed damsite

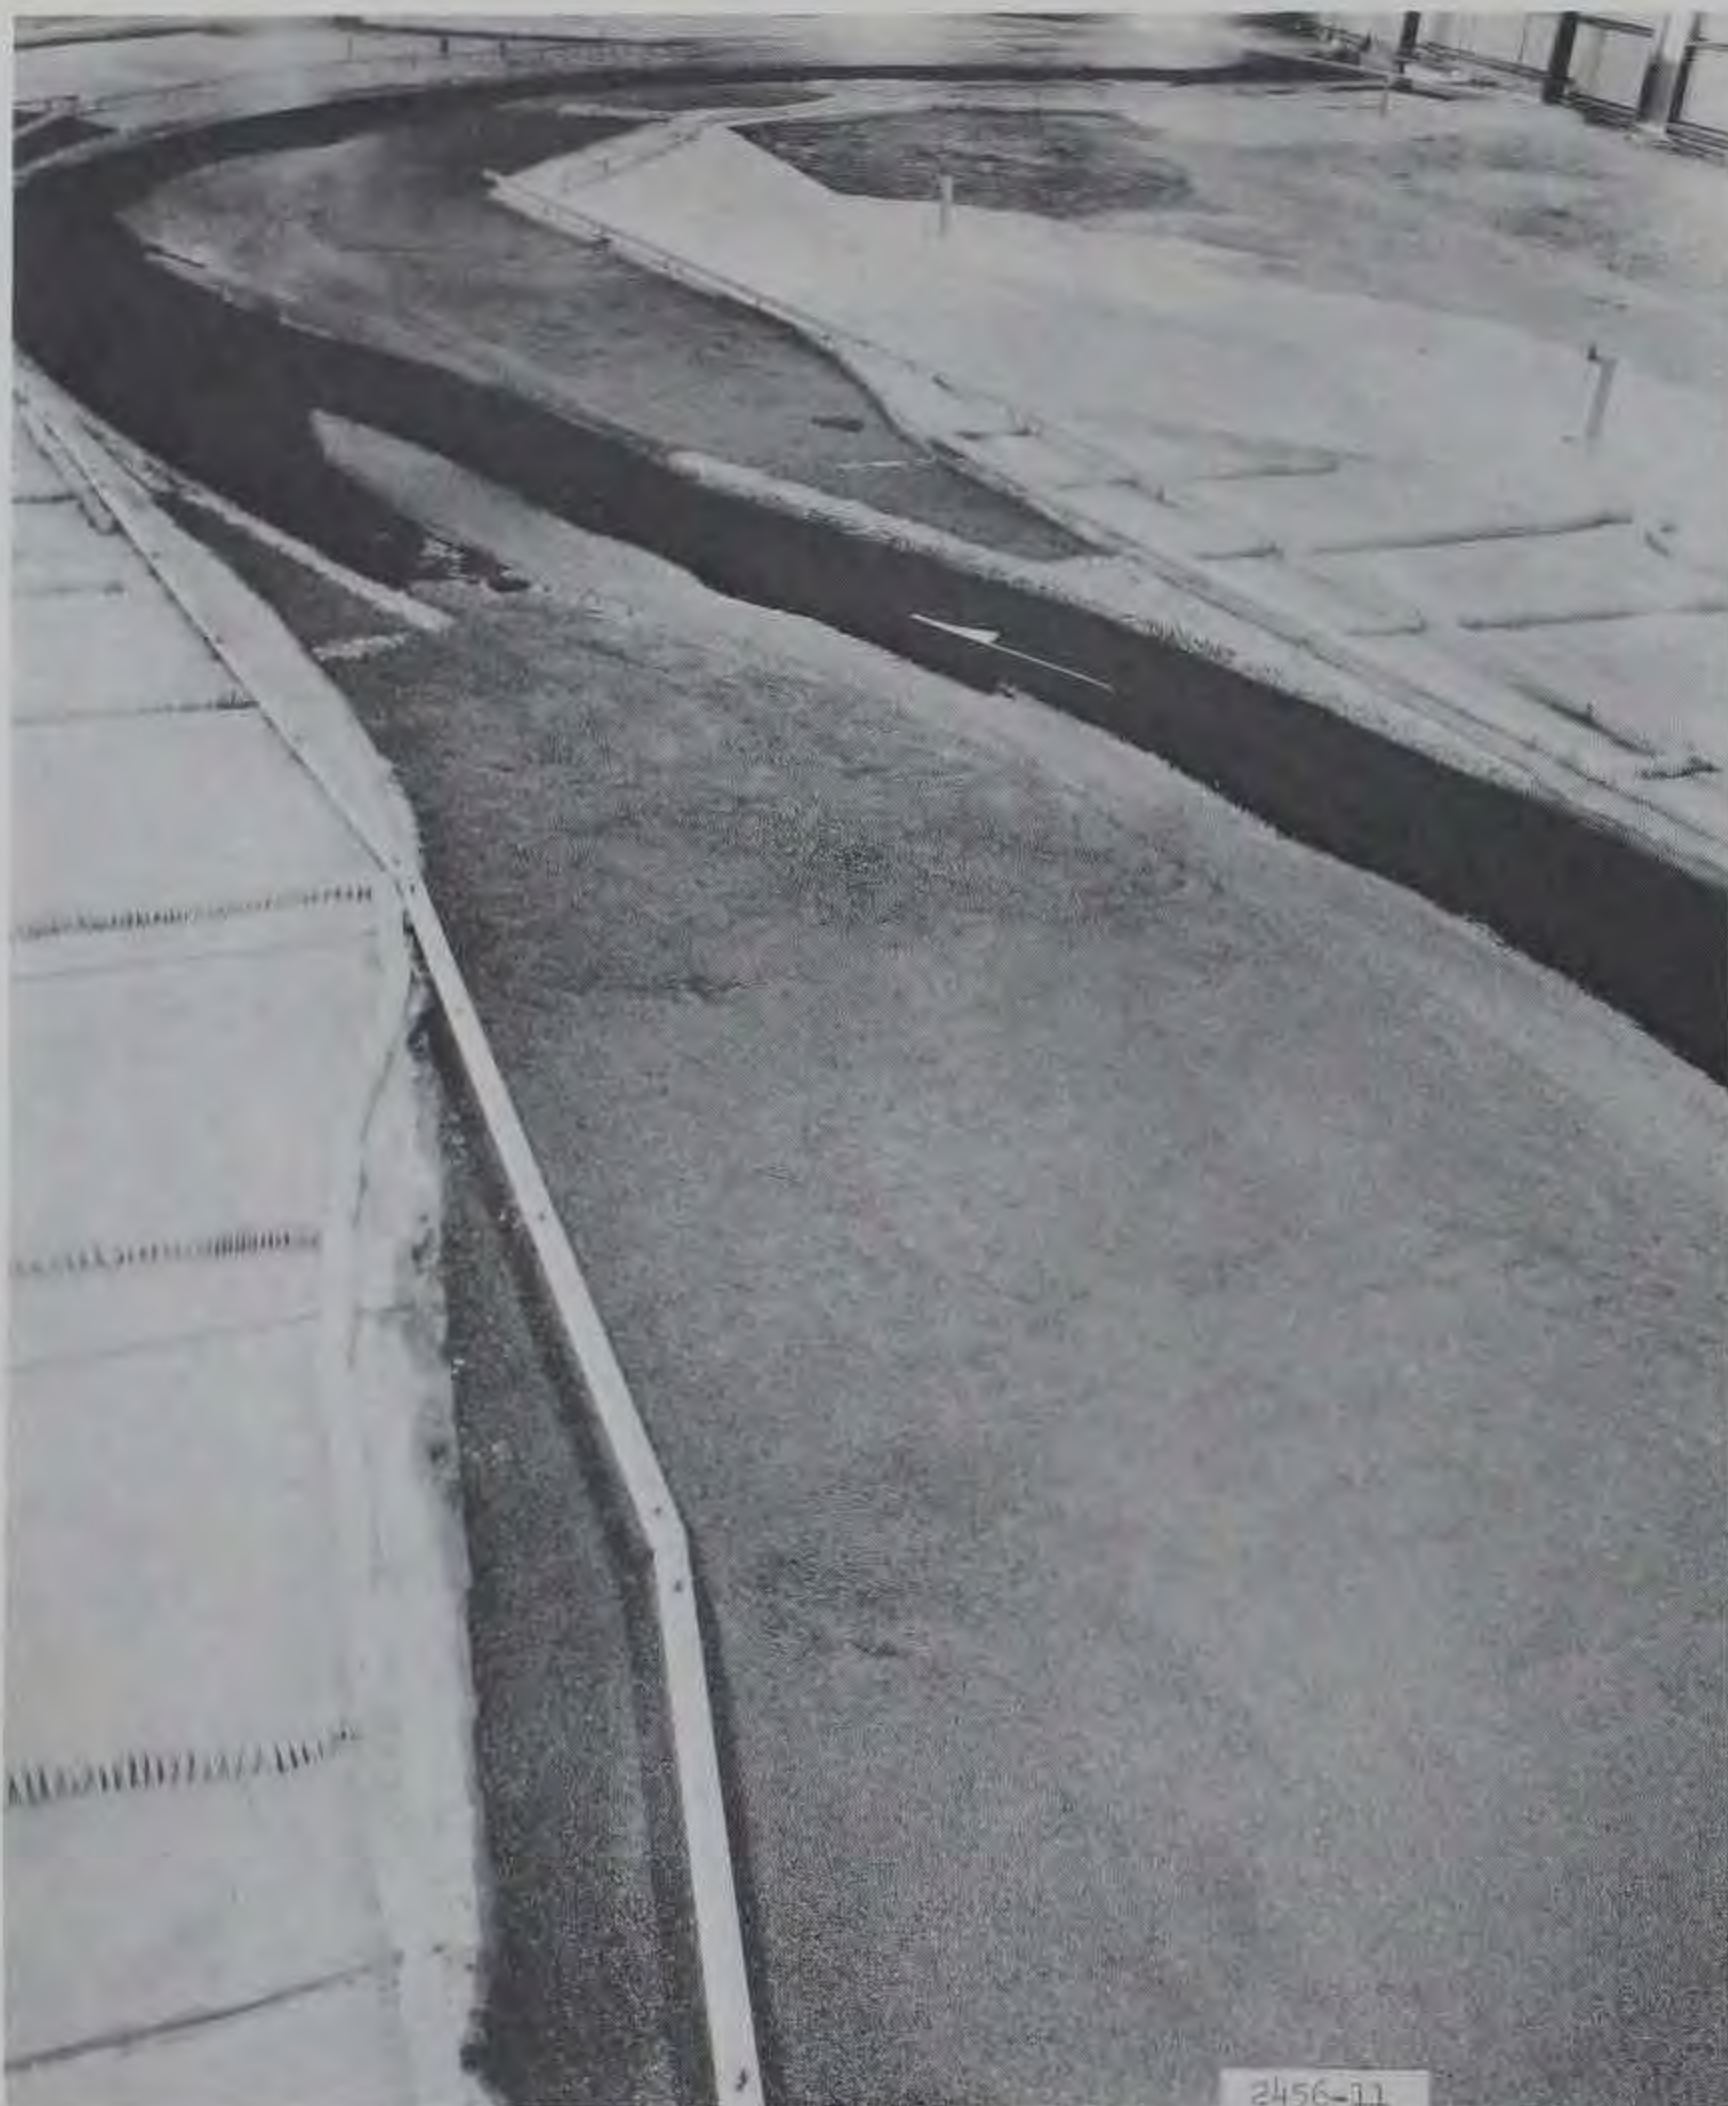
Photograph 3. Base test, run 1, 0-ft stage. View from about mile 69.4 showing crossing at mile 68.5 and channel into and through cutoff

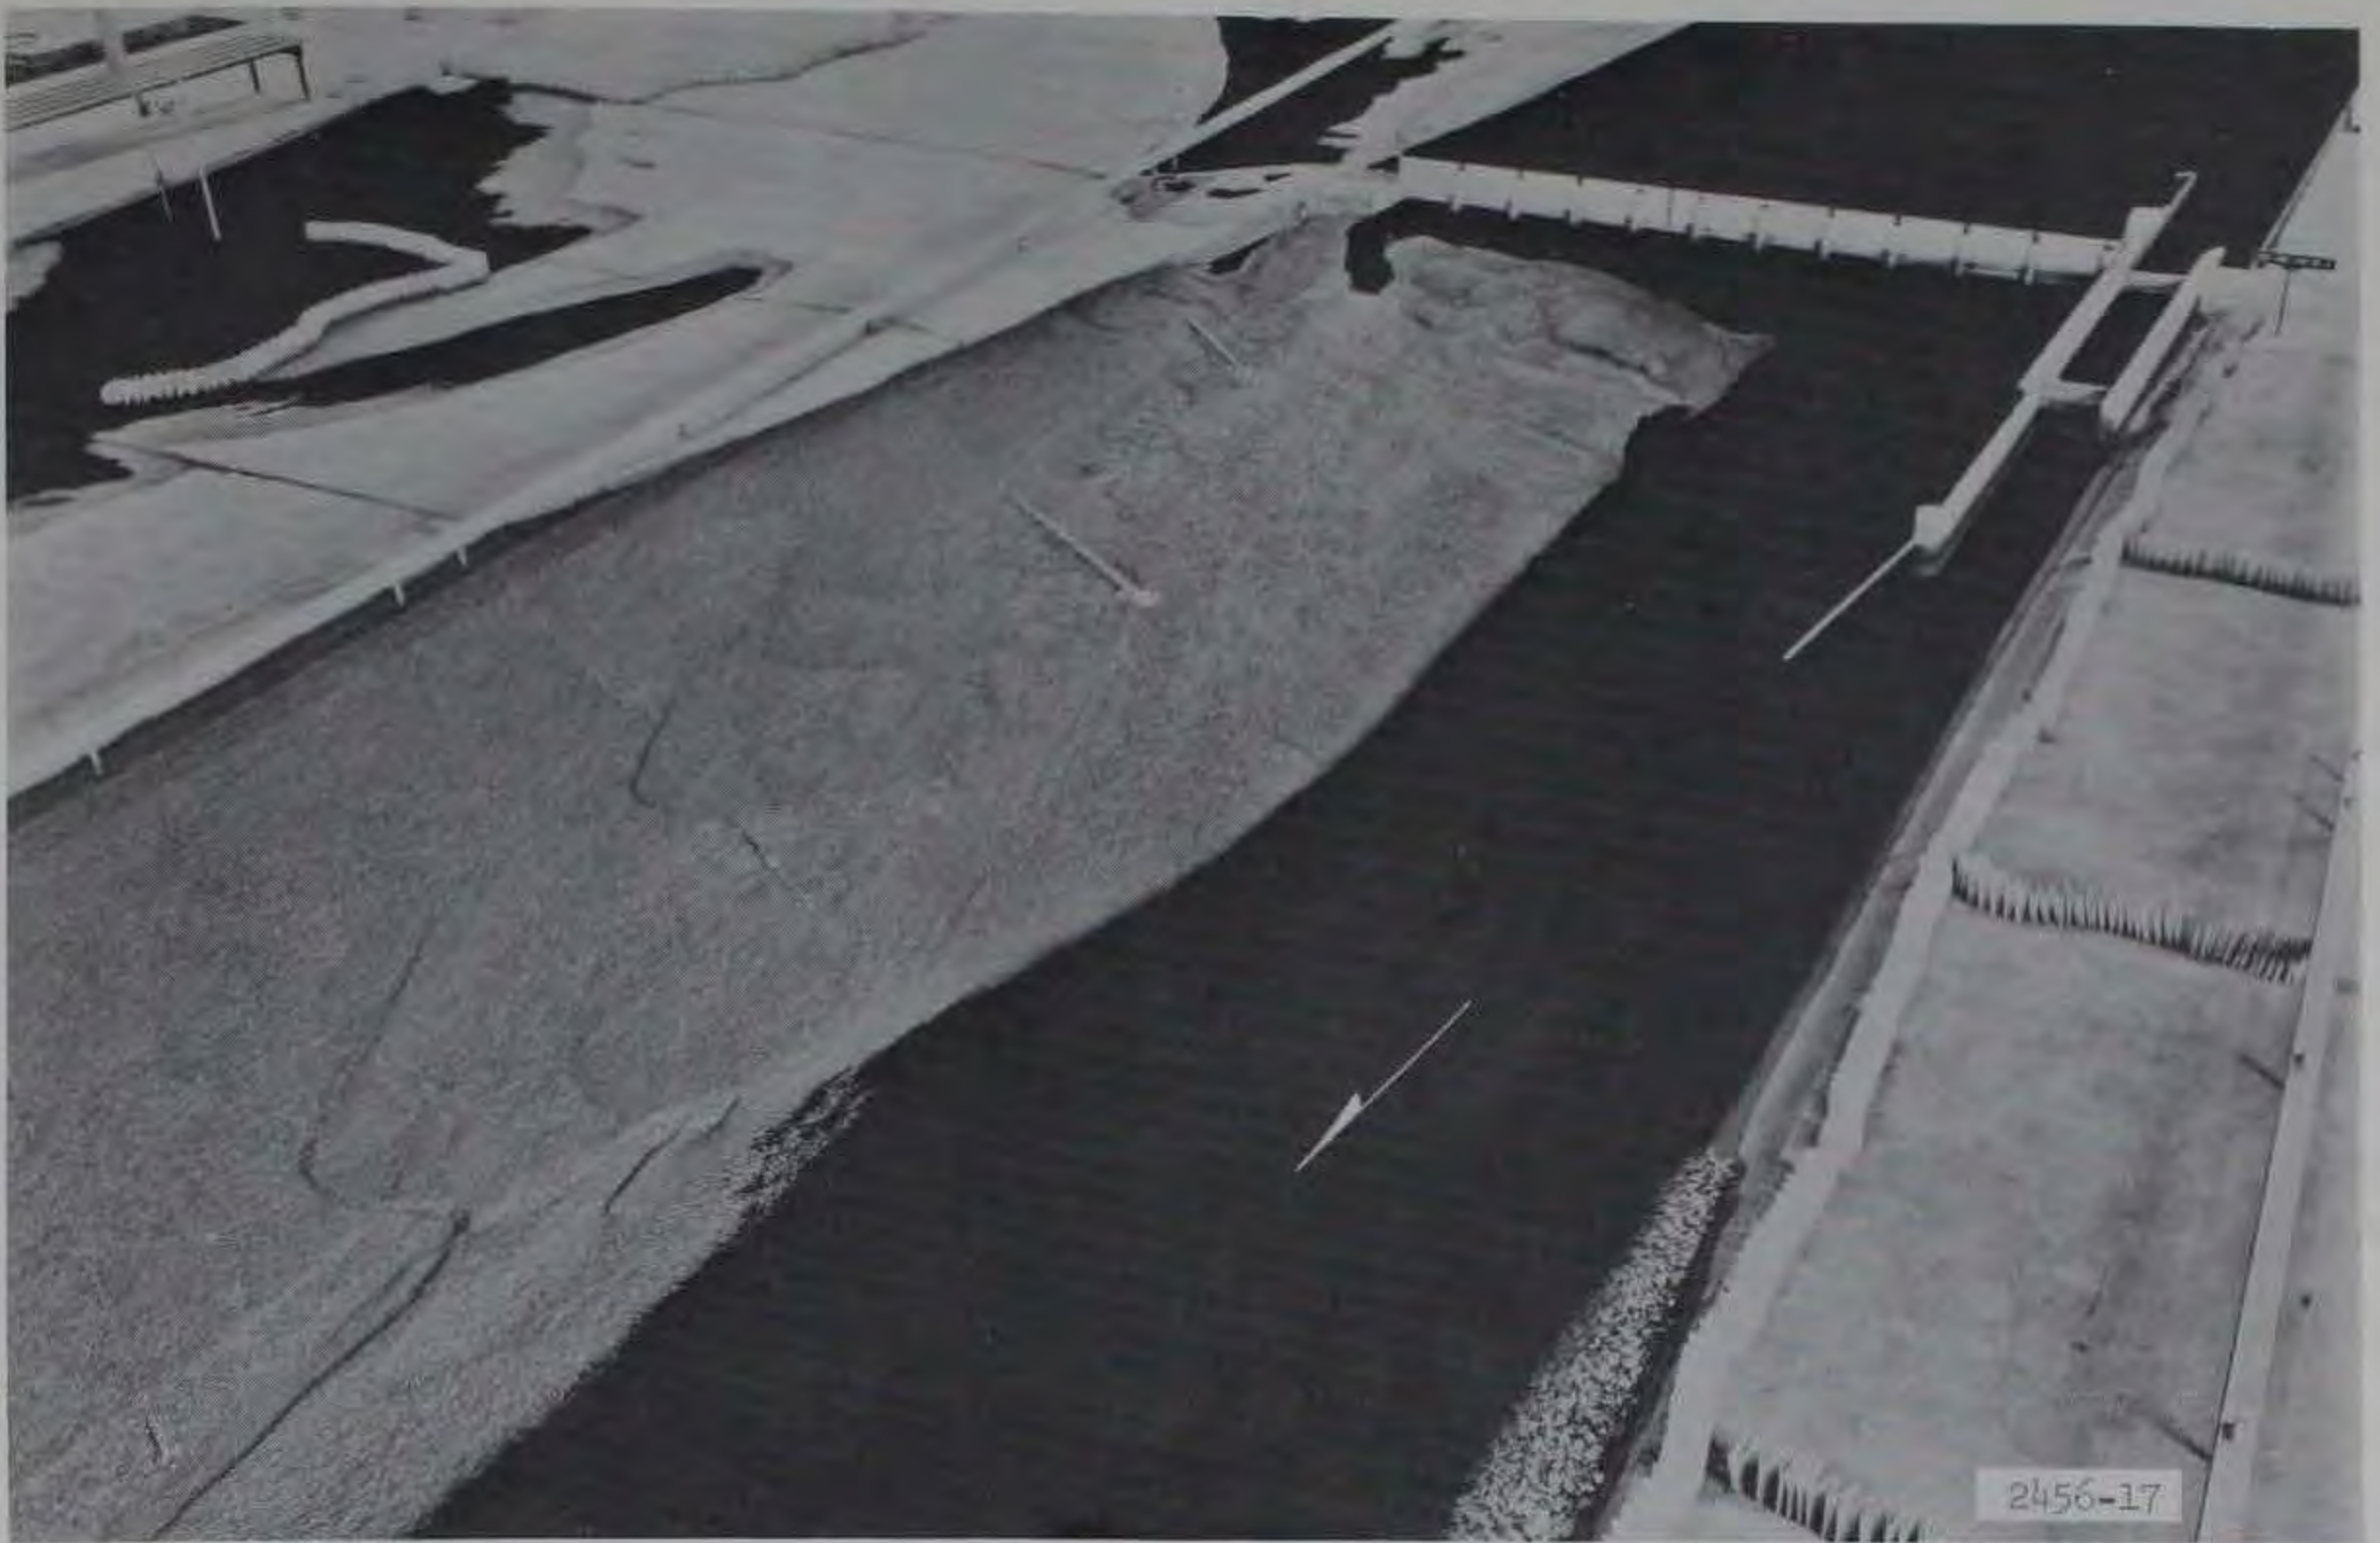
Photograph 5. Plan A-3, run 1, -1.0-ft stage. Bed configuration downstream of dam. Note bar in front of right bank dikes
