TECHNICAL REPORT H-68-8

NAVIGATION CONDITIONS AT LOCK AND DAM NO. 3, ARKANSAS RIVER ARKANSAS AND OKLAHOMA

Hydraulic Model Investigation

U. S. Army Engineer District
Little Rock

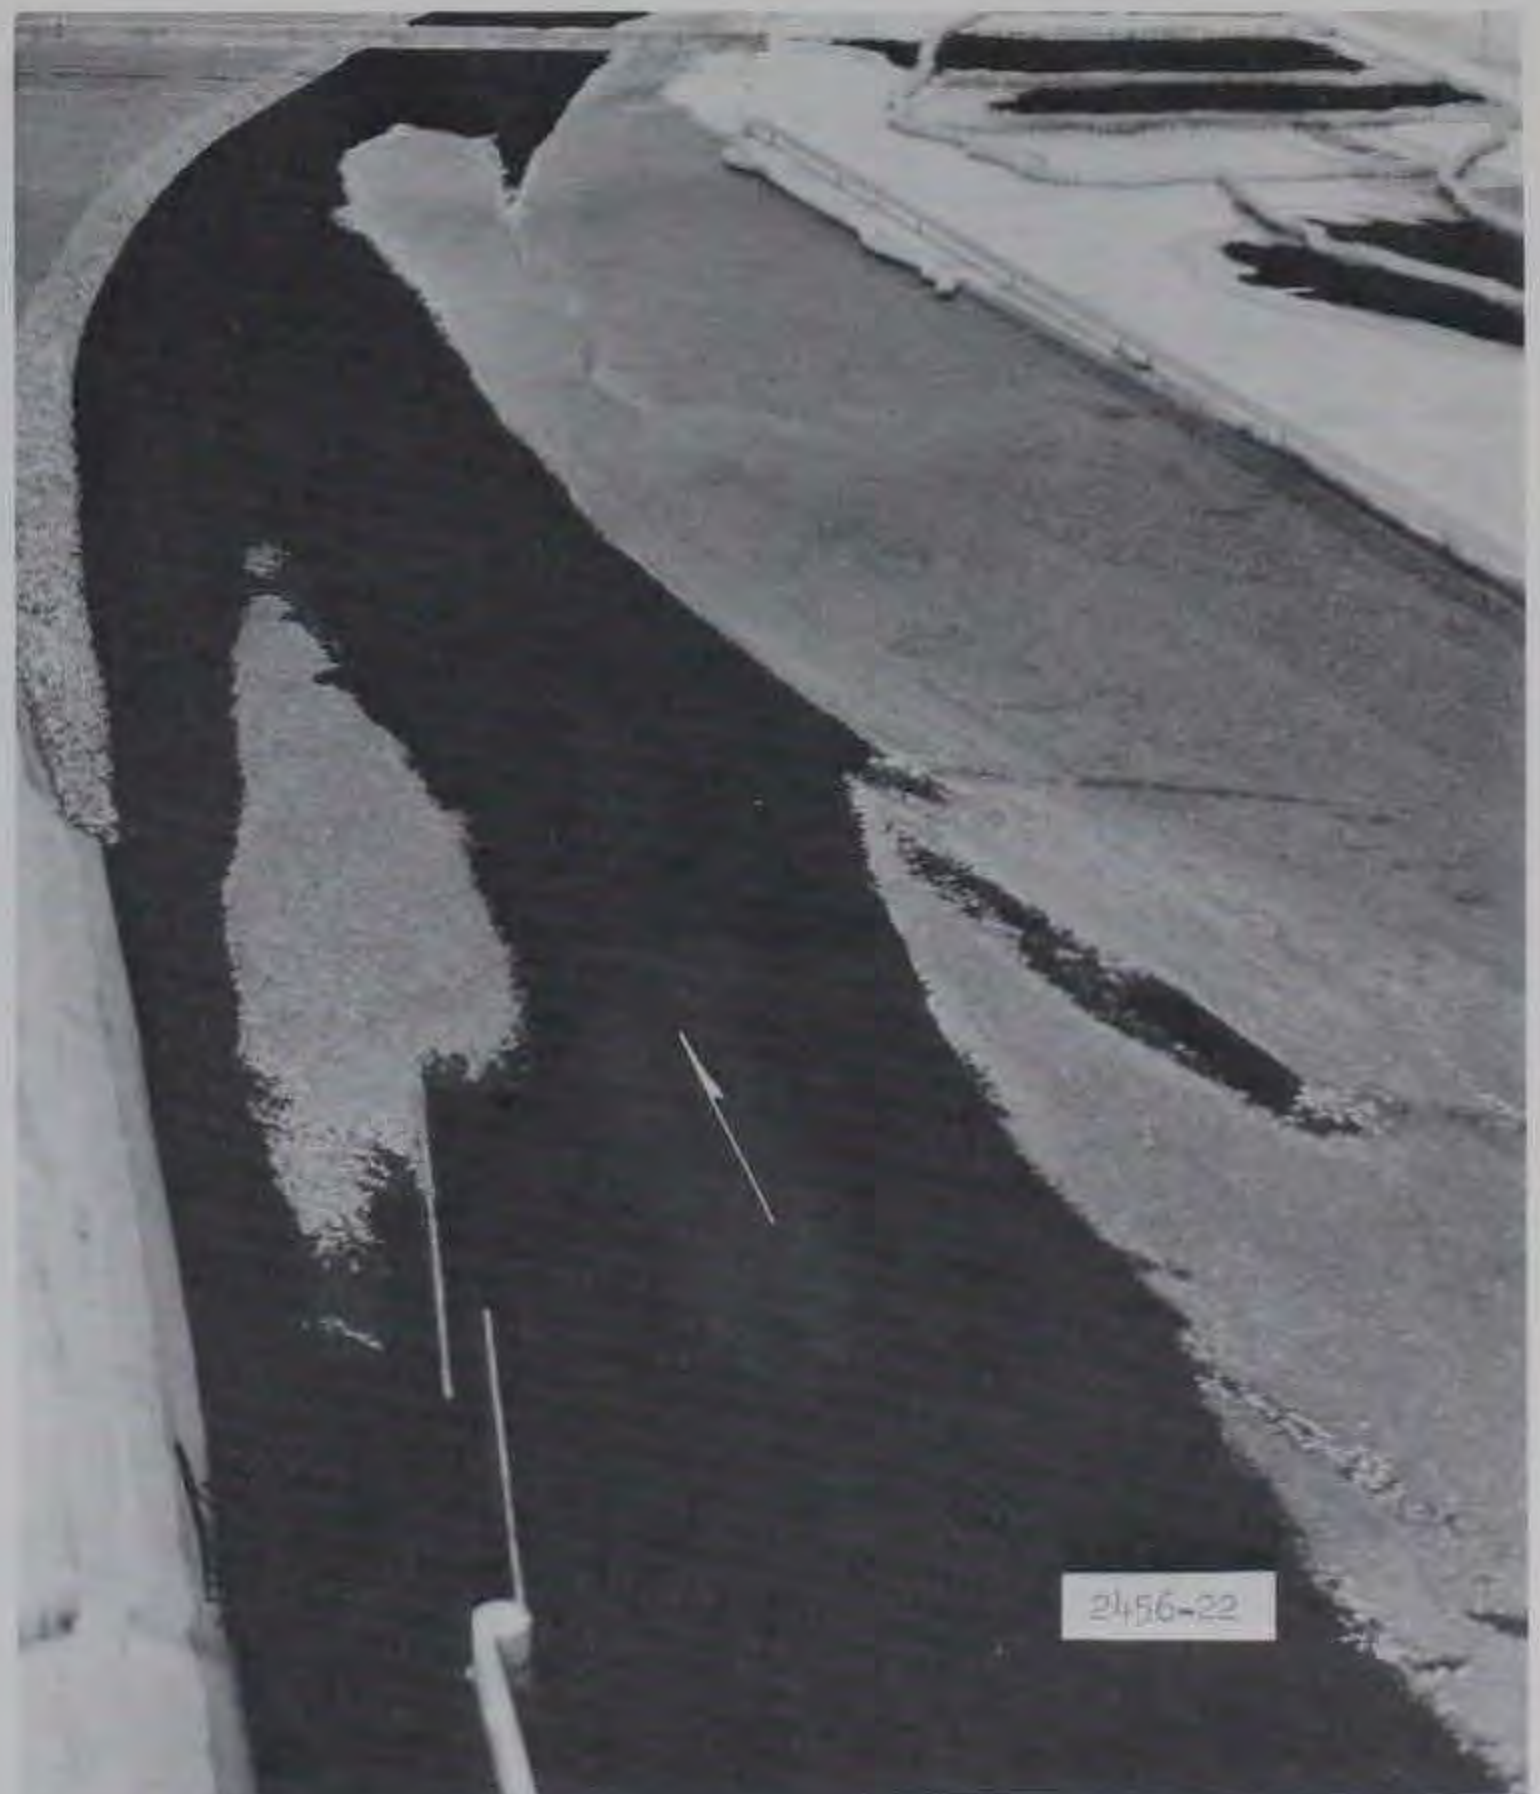
Photograph 6. Plan A-3, run 4, -1.0-ft stage, pool el 165.2. Bar formation in lower lock approach; lower end of guard wall in foreground

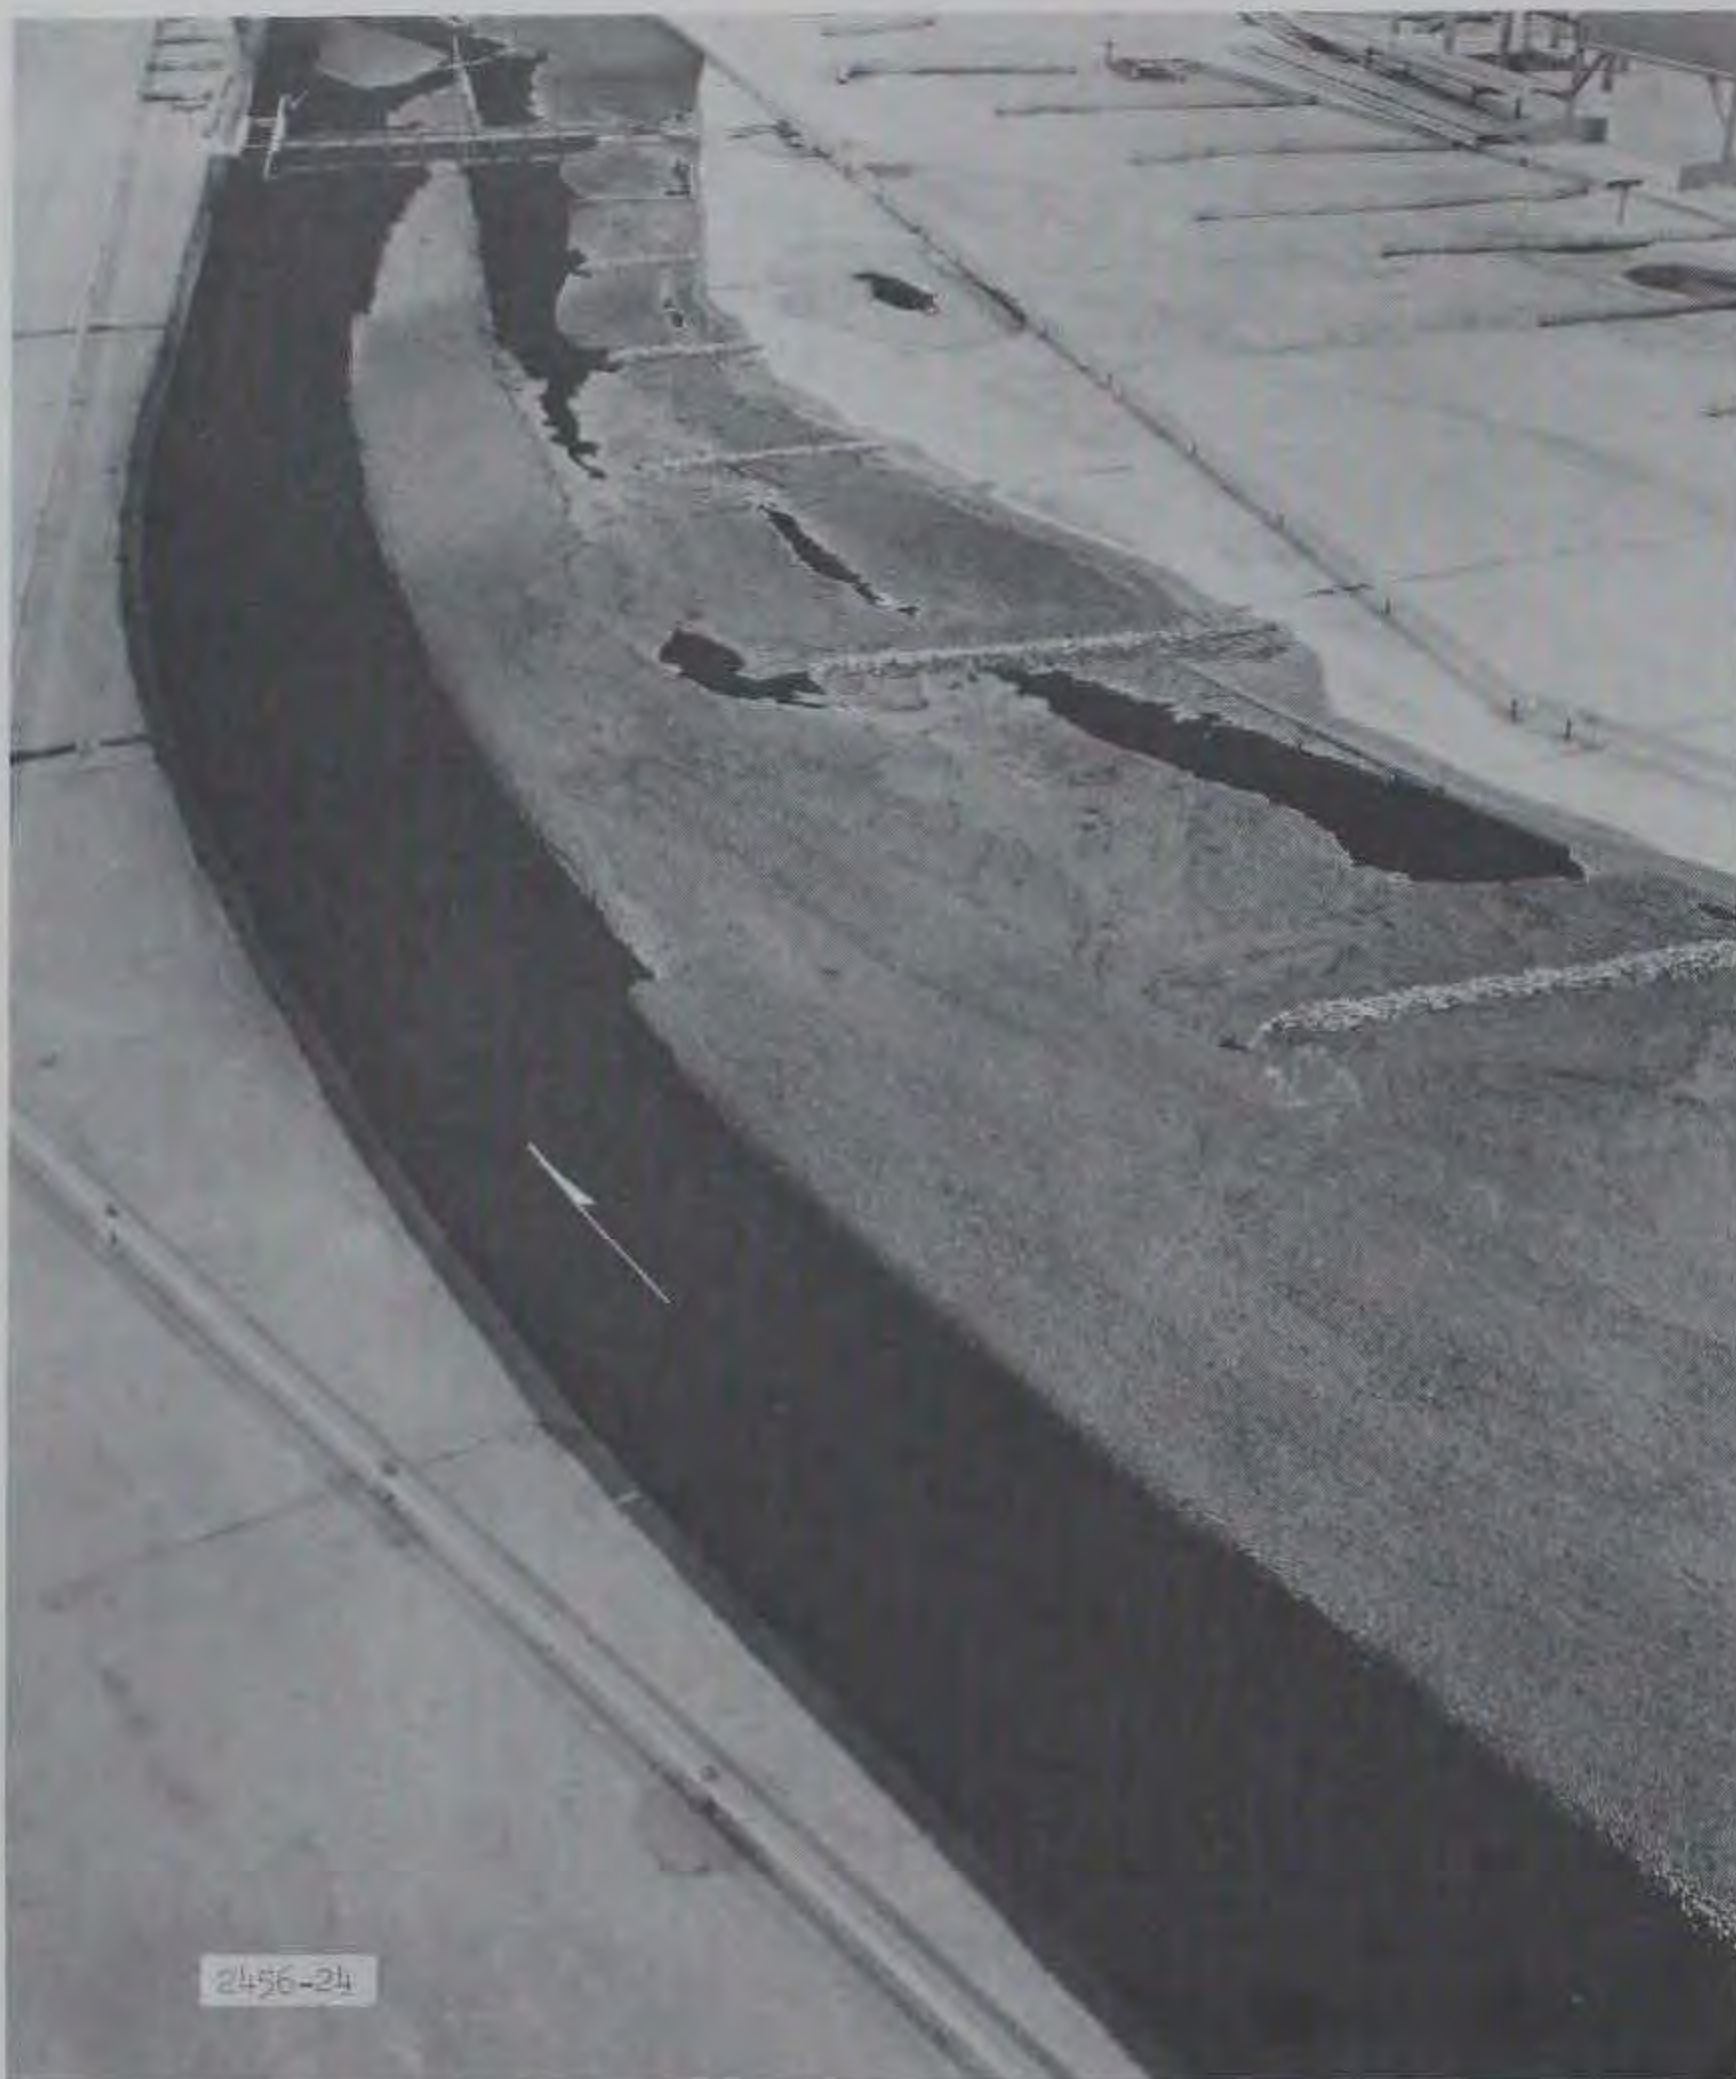
Photograph 7. Plan A-5, run 4, water surface lowered to el 168.0. Note bar formation opposite ends of right bank dikes

40. Results. The results of tests of plan A-5 are shown in plates 25 and 26 and photographs 7 and 8. These results indicate that shoaling along the ends of the dikes just upstream of the dam continued to increase with a corresponding increase in the depth of the channel approaching the lock (photograph 7). Downstream of the dam the shoal area had extended upstream toward the center of the channel and caused divided flow (photograph 8). Although depths in the lower lock approach channel were greater, the shoal area extended farther downstream than with plan A-4, and there was little difference in the amount of maintenance dredging required. By the end of run 2, controlling depths in the crossing at mile 70.5 were only 8 ft below normal lower pool. Extending the left bank revetment increased depths over the crossing about 3 ft. Shoaling also occurred in the crossing approaching the cutoff channel (mile 68.4). Although project depths were obtained over the crossing, the alignment of the channel was not entirely satisfactory for navigation.

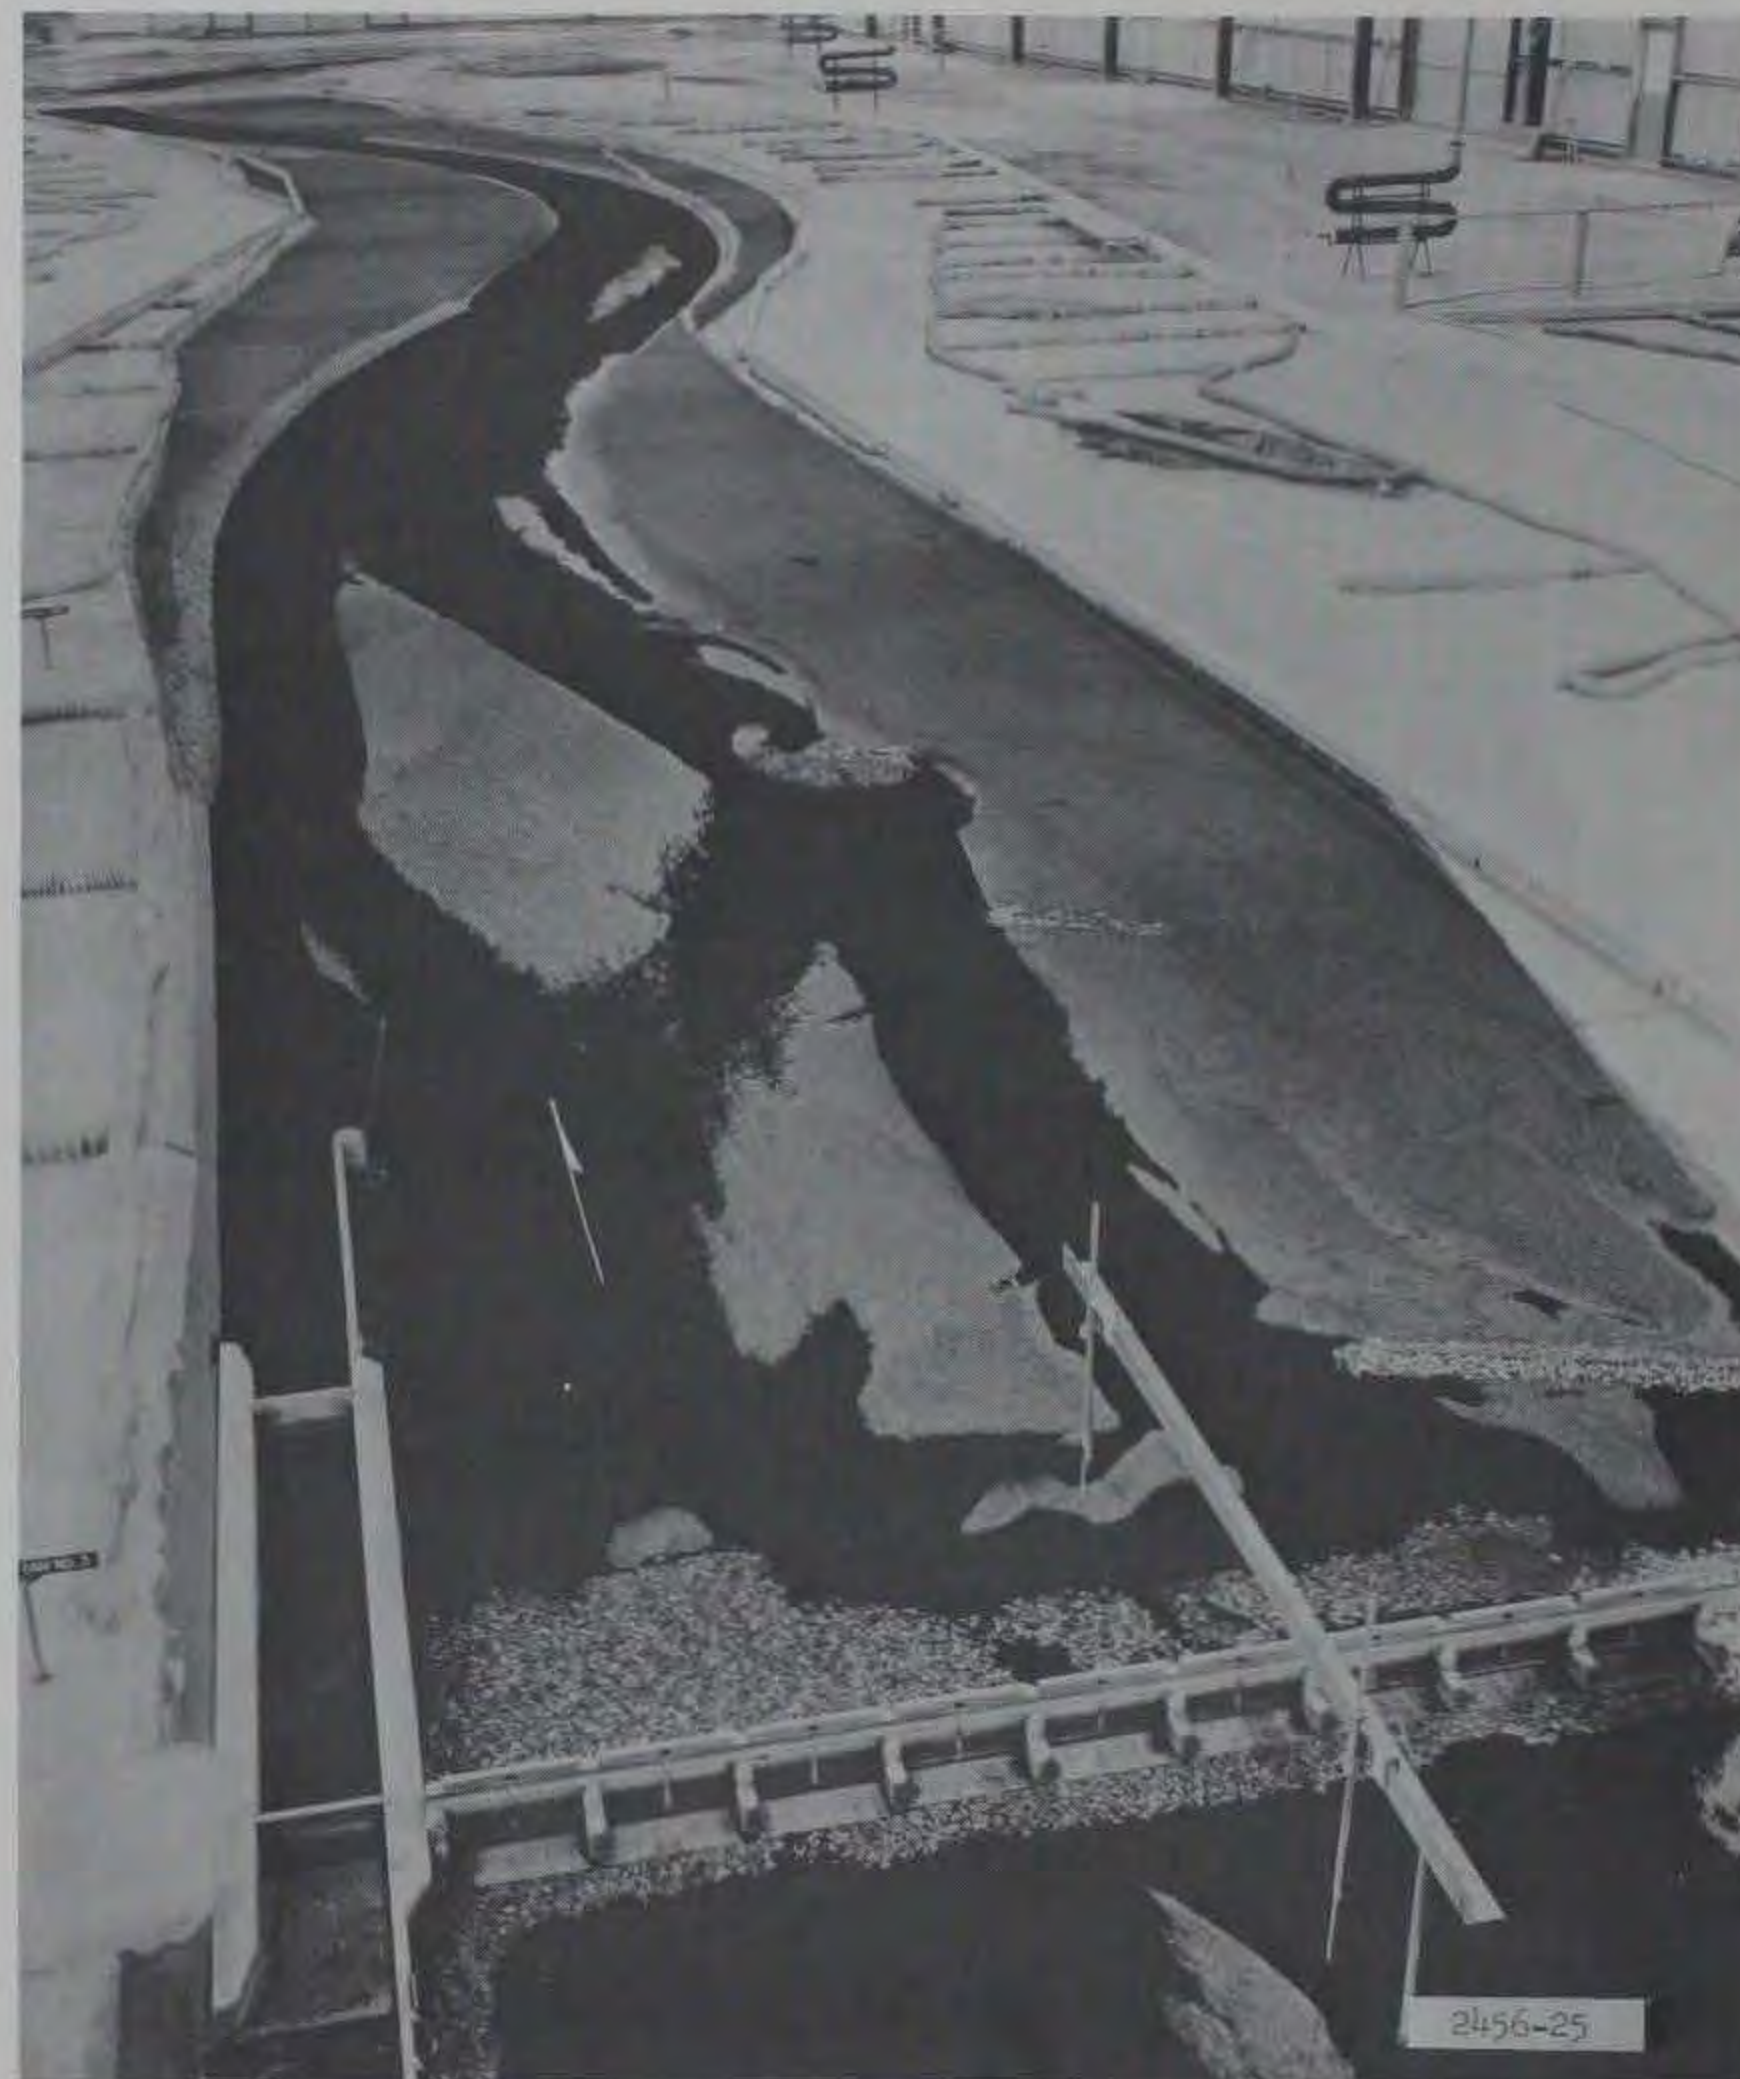
Photograph 8. Plan A-5, run 4, water-surface el 164.0. Note bar formation and division of channels below the dam

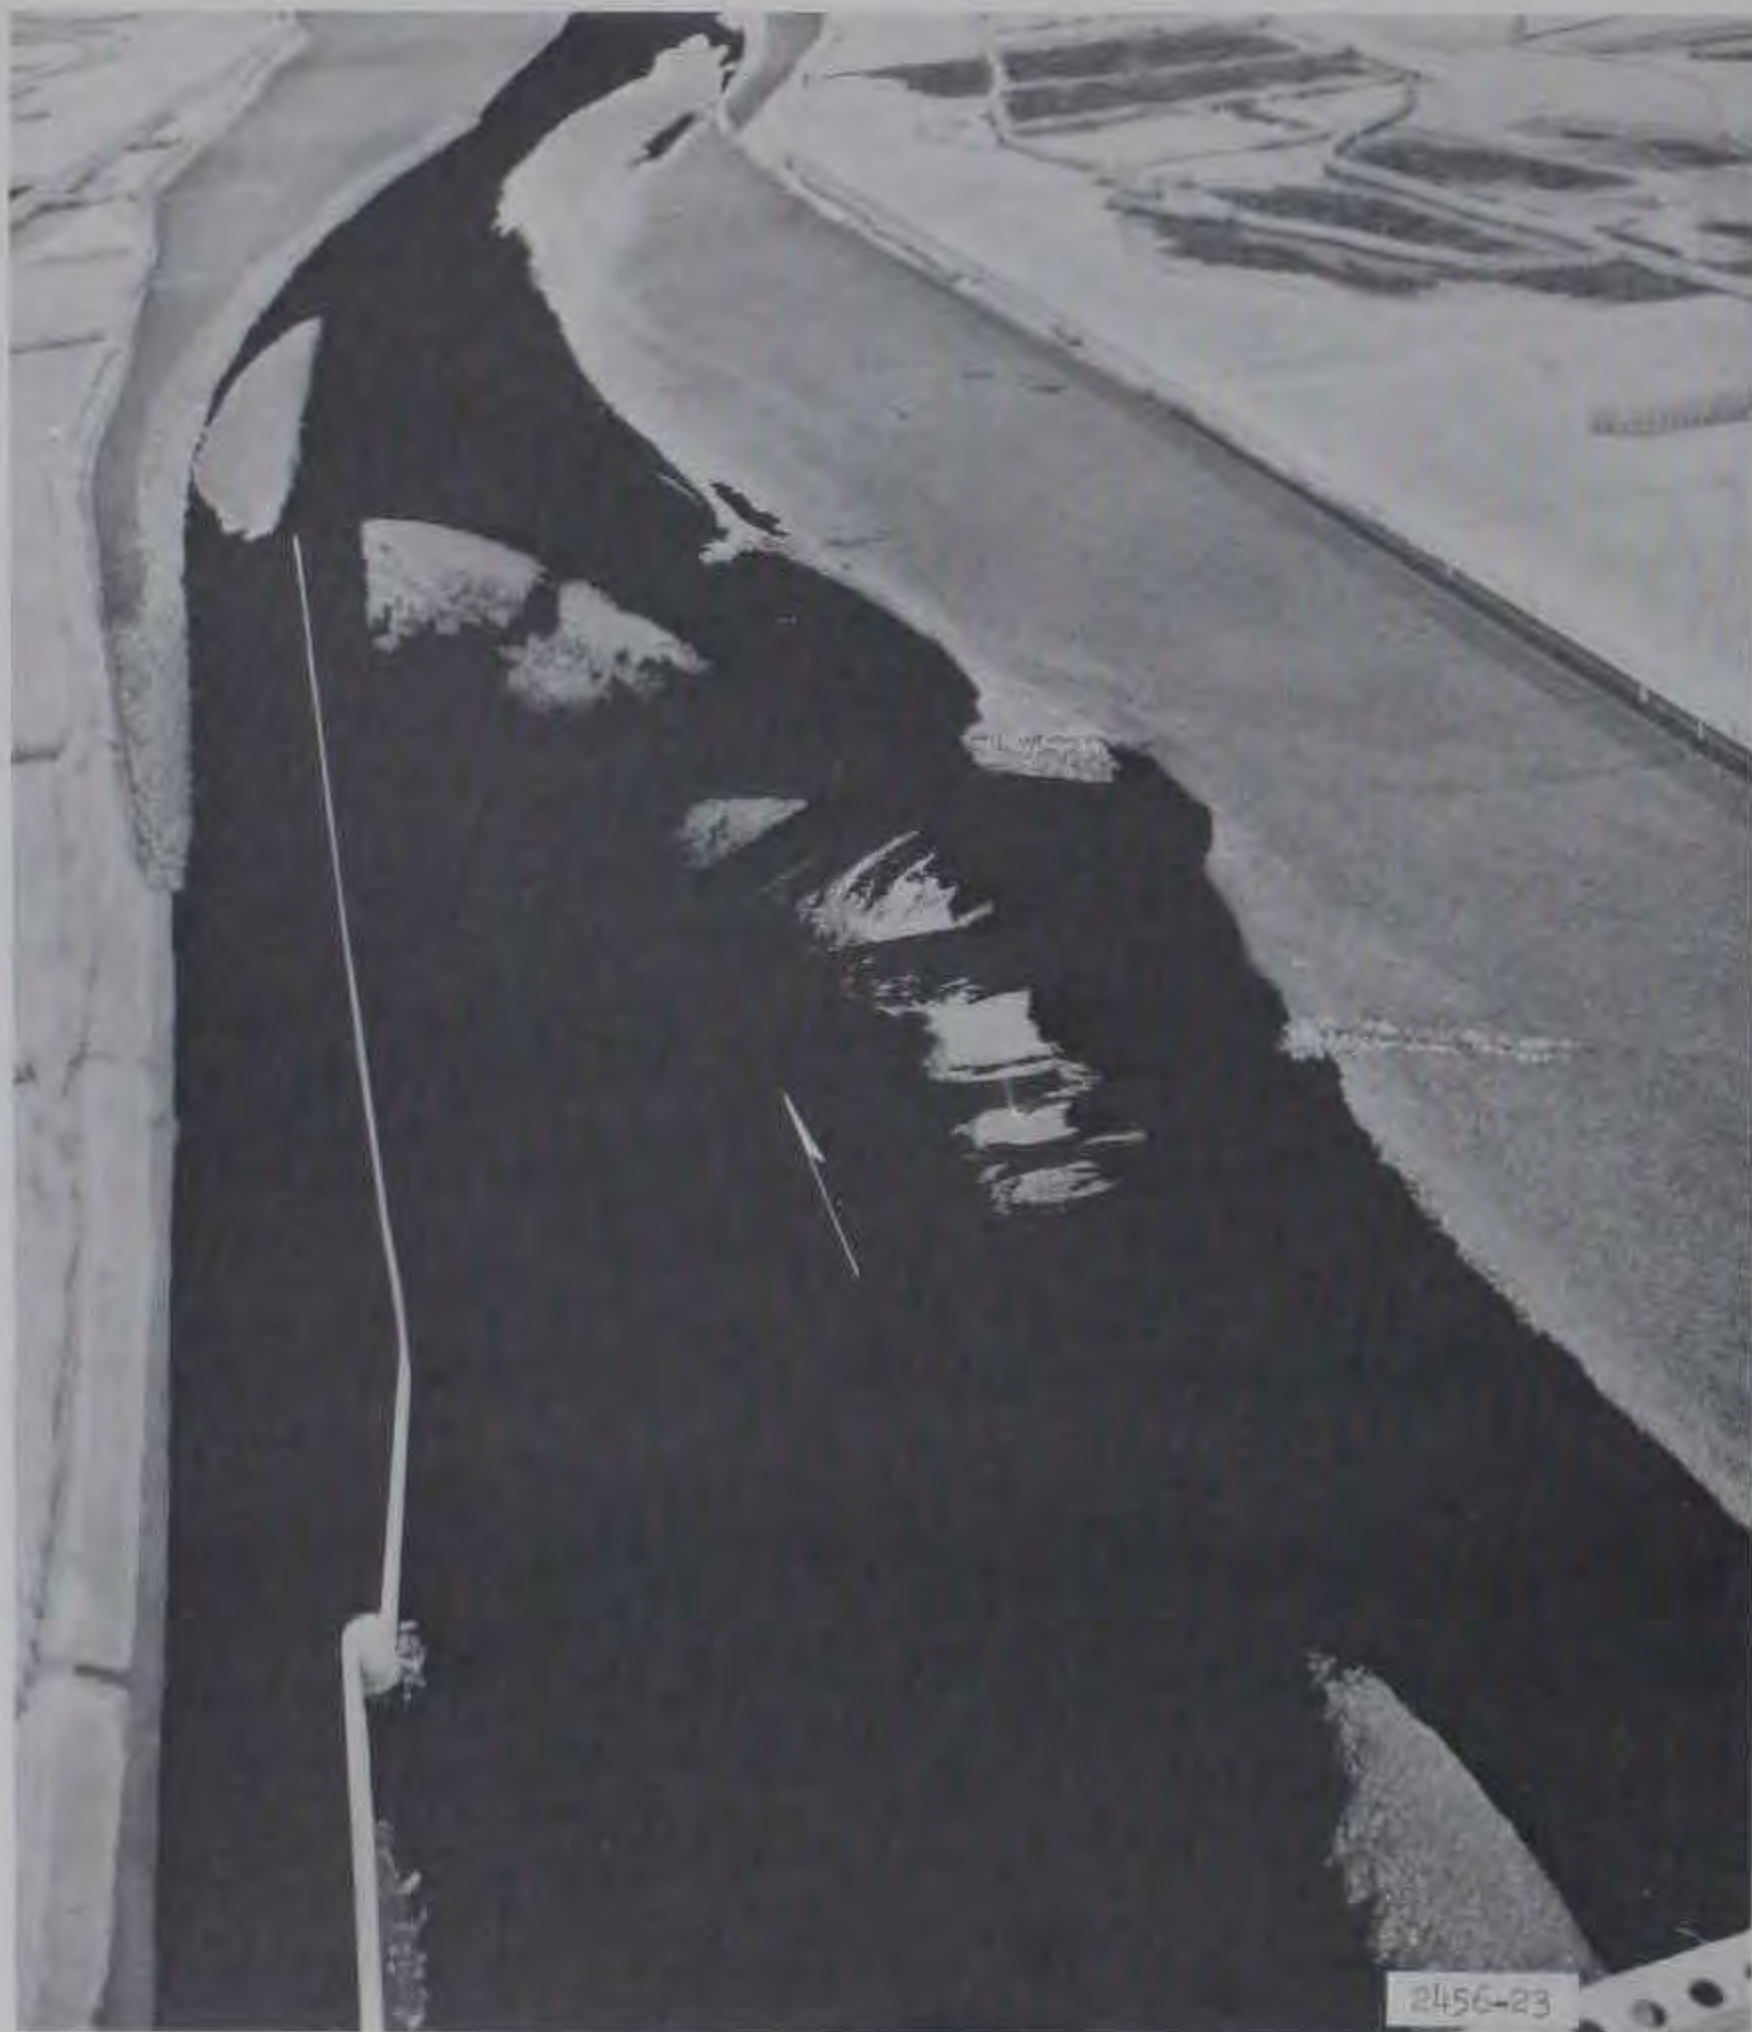
Photograph 9. Plan A-6, run 1, pool el 166.1. Note shoal area in the approach channel downstream of the end of the guard wall extension

43. Results. Results obtained at the end of run 1 indicated that the long guard wall would tend to move the location of the shoal area downstream without any material effect on the amount of maintenance dredging required (photograph 9). Testing of this plan was discontinued when modifications of the lengths of the dikes mentioned above did not produce any

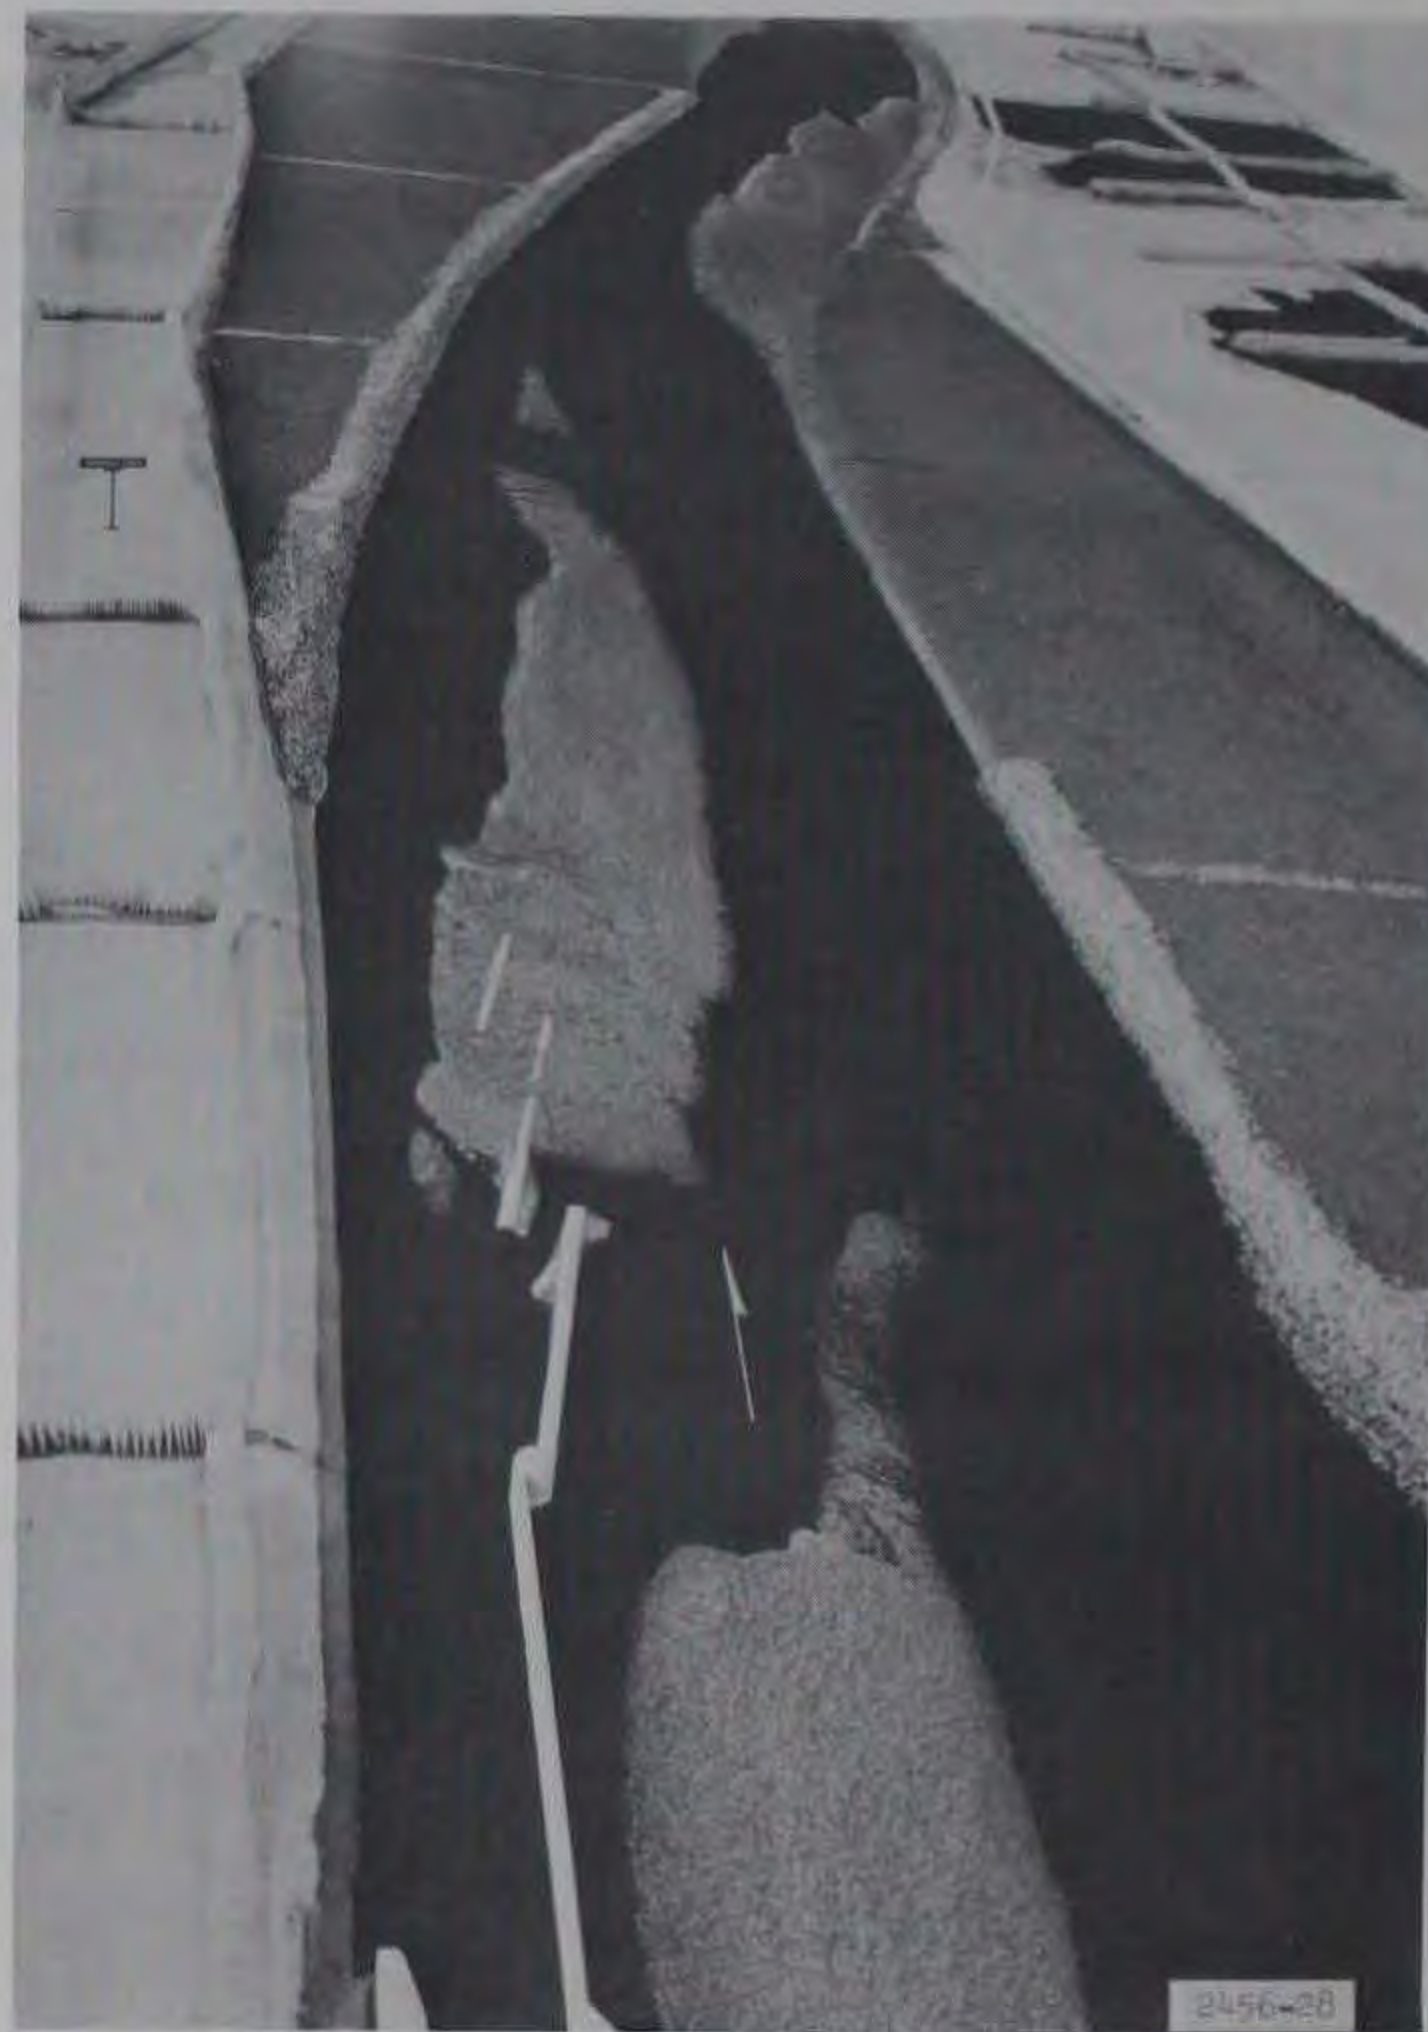
Photograph 10. Plan A-10, run 1, -1.0-ft stage. End of lower guard wall and wing dikes downstream. Note deposition over and downstream of lower two wing dikes and in lock approach channel

52. Results. Results of tests of this plan at the end of one run are shown in plate 34. Material from the left side of the channel moved over the lower two wing dikes and into the downstream approach channel during high flows. By the end of the high stages, the lower two dikes were practically covered with sediment, and some material moved into the approach through the opening between the first and second wing dike (photograph 10).

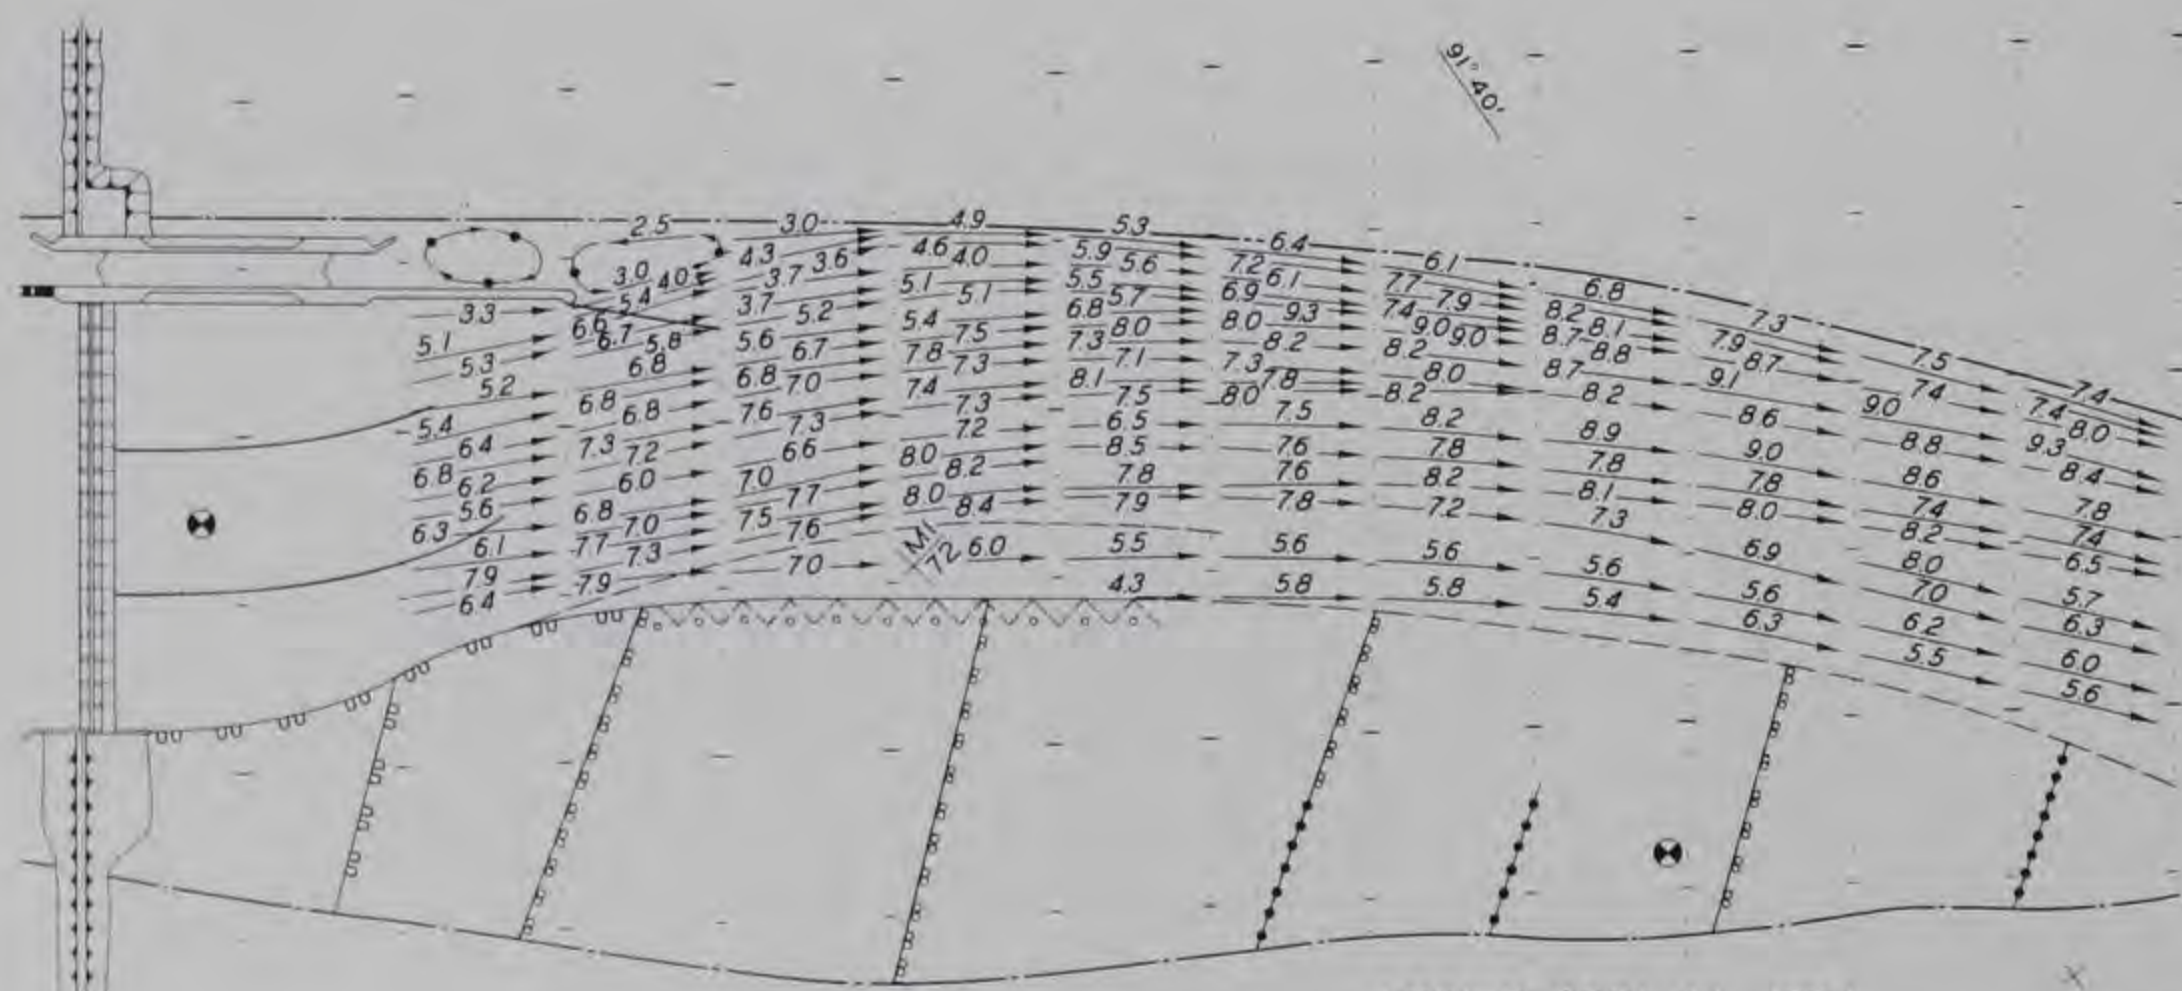
UPPER POOL EL 182.0 FT MSL

PLAN A-14

NOTE: VELOCITIES AND CURRENT DIRECTIONS TAKEN WITH FLOATS SUBMERGED TO DRAFT OF LOADED BARGES (8 FT)

LOWER POOL EL 180.1

PLAN A-14 MODIFIED

158. Current directions and velocities obtained during these tests are shown in plates 81-86. These results indicated that velocities would tend to be high in the upper approach (about 10 or 11 fps) with the 150,000-cfs flow and decrease with increase in discharge. The alignment of currents was generally straight and no serious difficulties were indicated. The differences in conditions between plans A-9 and A-14 upstream of the lock were not sufficient to have any significant effect on navigation conditions. Current directions and velocities in the lower lock approach and observations with the model towboat indicated that conditions for navigation would be better with the 480-ft wing dike of these plans during the 150,000- and 230,000-cfs flows. With the 350,000-cfs flow, conditions would be somewhat better without the dike because of the directions of the currents over the dike that would tend to move upbound tows landward (plate 86). Although this tendency increased with an increase in flow, tows should not encounter any serious difficulty in approaching the guard wall even with the maximum navigable flow. Flow from the spillway toward the left bank tended to resist the movement of the head of a downbound tow away from the left bank and some difficulty was experienced in making the turn downstream of the lock. To overcome this difficulty, it was necessary to position the towboat stern as far to the left as possible so that the entire tow was angled to the right with respect to the left bank. This condition could be improved considerably by excavation of the left bank downstream of the lock at least 50 ft landward to permit the stern of downbound tows to be moved landward before the head passes the end of the guard wall extension (wing dike).

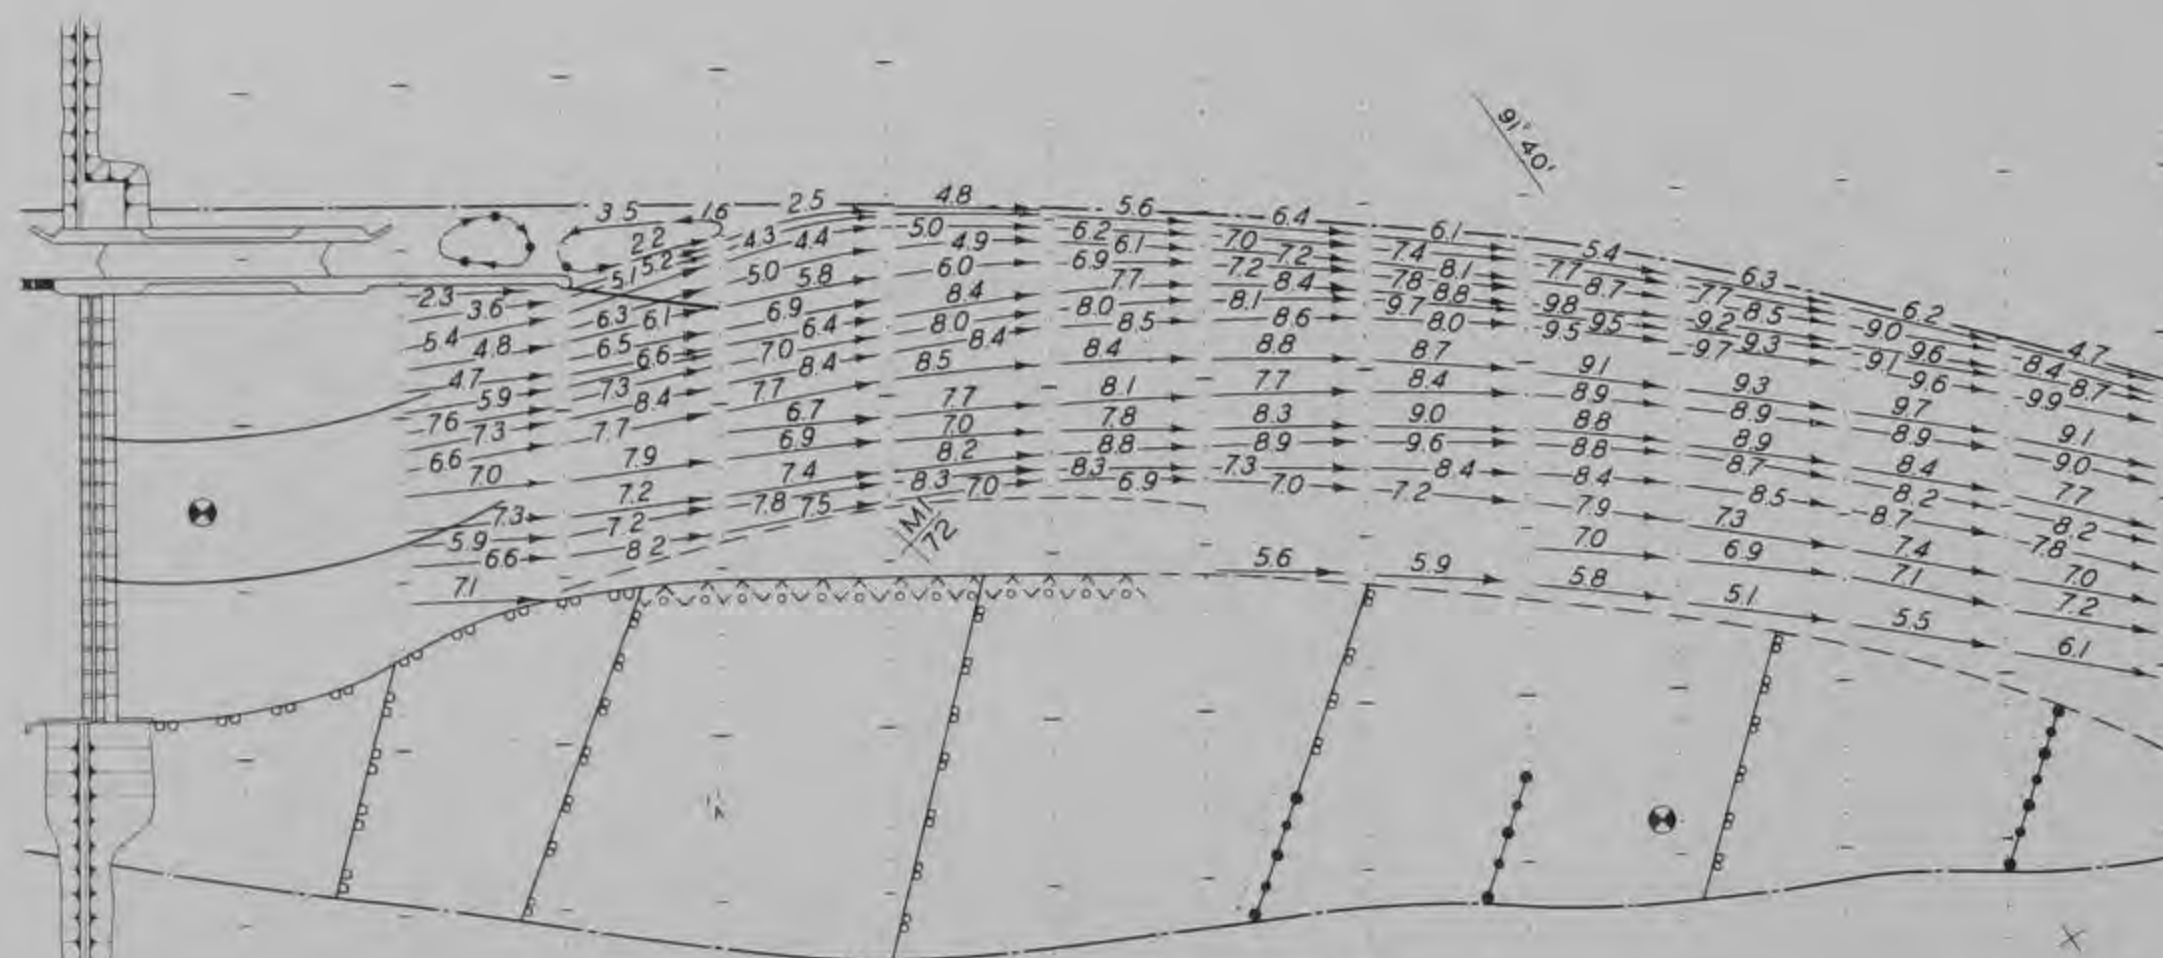
PLAN A-14

LOWER POOL EL 1847

NOTE: VELOCITIES AND CURRENT DIRECTIONS TAKEN WITH FLOATS SUBMERGED TO DRAFT OF LOADED BARGES (8 FT)

LOWER POOL EL 184.7
PLAN A-14 MODIFIED

VELOCITIES AND
CURRENT DIRECTIONS
PLANS A-14 AND A-14 MODIFIED
DISCHARGE 230,000 CFS
