TECHNICAL REPORT H-68-8

NAVIGATION CONDITIONS AT LOCK AND DAM NO. 3, ARKANSAS RIVER ARKANSAS AND OKLAHOMA

Hydraulic Model Investigation

U. S. Army Engineer District
Little Rock

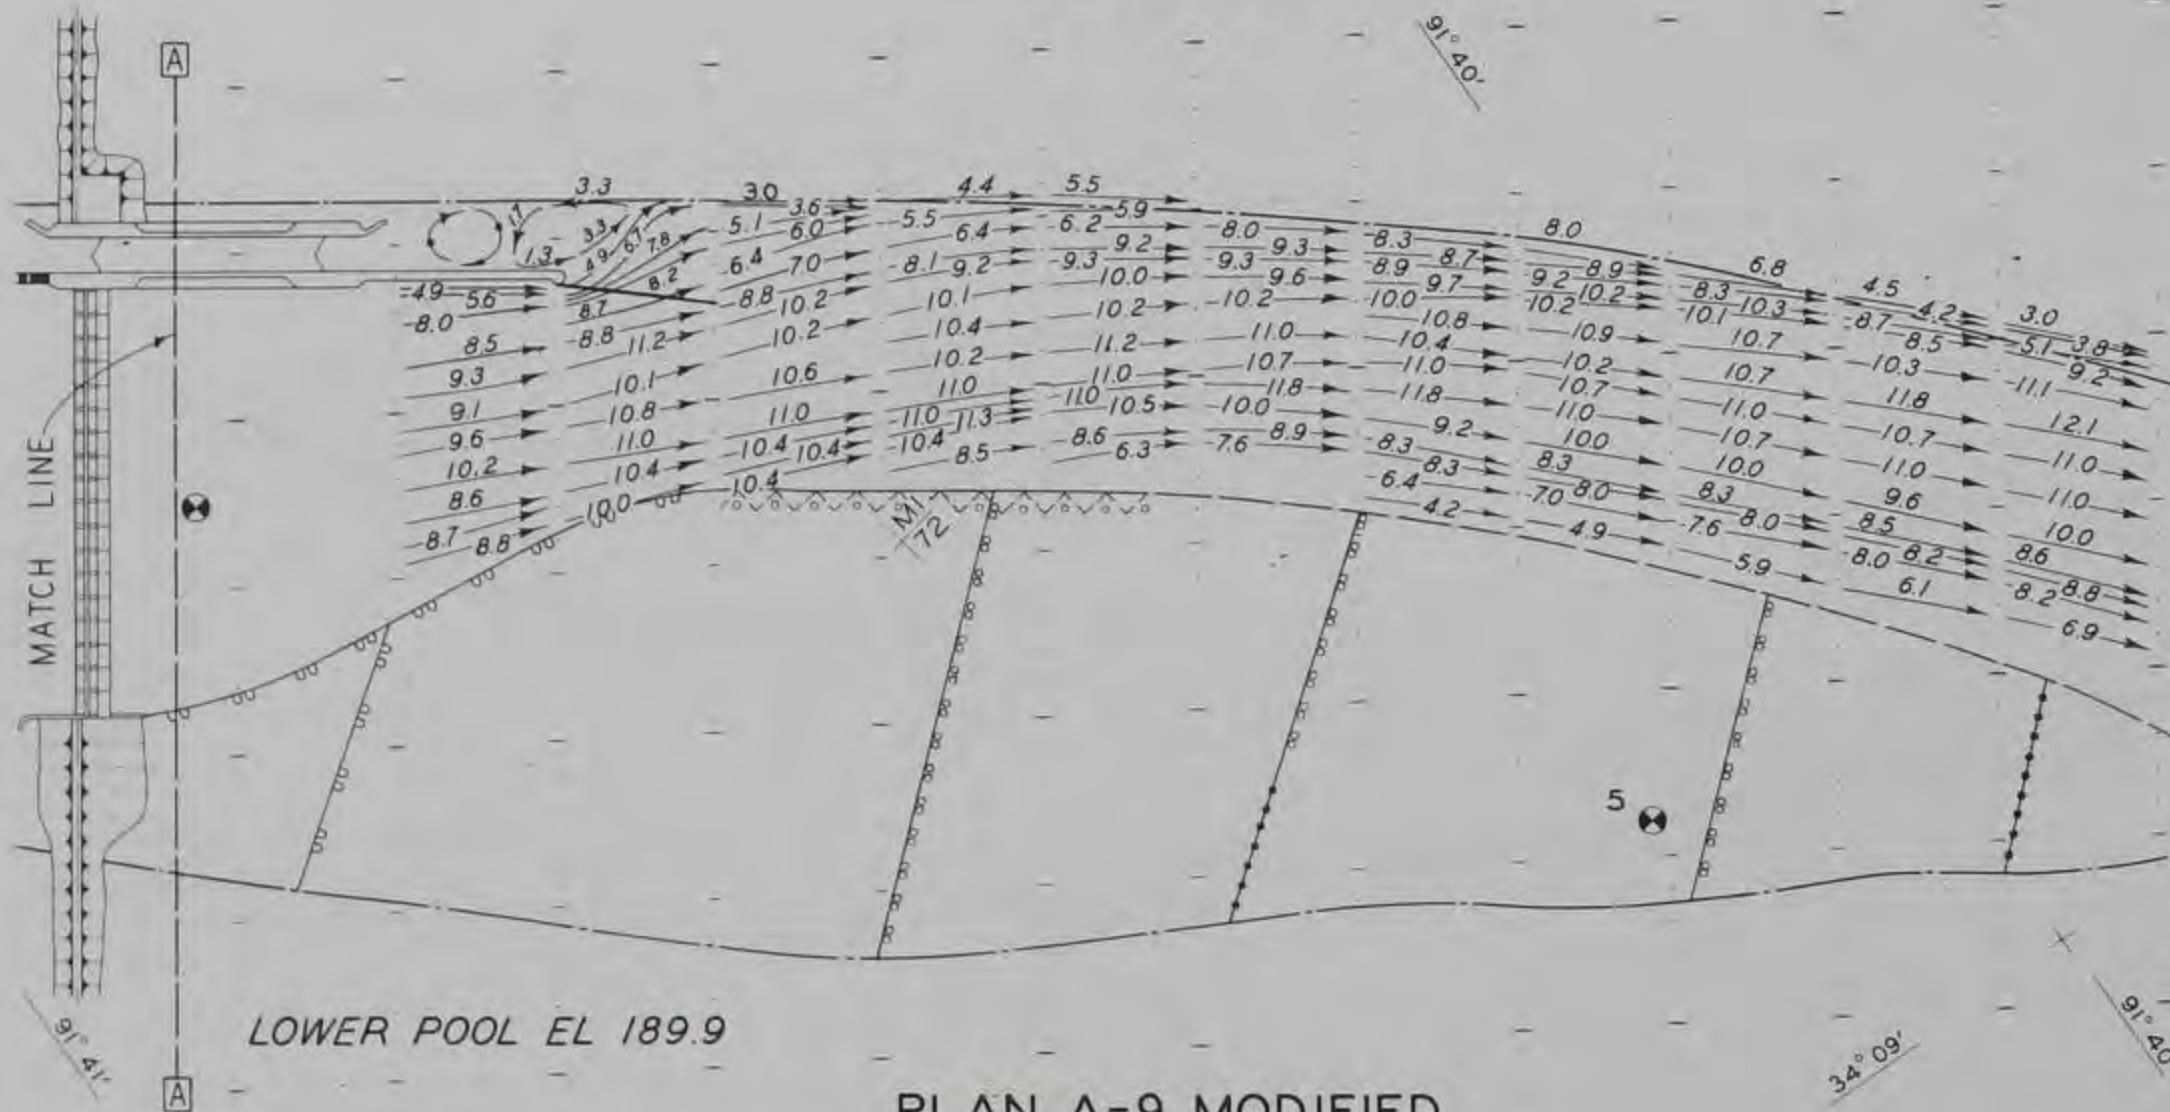
PLAN A-9

PLAN A-9 MODIFIED

158. Current directions and velocities obtained during these tests are shown in plates 81-86. These results indicated that velocities would tend to be high in the upper approach (about 10 or 11 fps) with the 150,000-cfs flow and decrease with increase in discharge. The alignment of currents was generally straight and no serious difficulties were indicated. The differences in conditions between plans A-9 and A-14 upstream of the lock were not sufficient to have any significant effect on navigation conditions. Current directions and velocities in the lower lock approach and observations with the model towboat indicated that conditions for navigation would be better with the 480-ft wing dike of these plans during the 150,000- and 230,000-cfs flows. With the 350,000-cfs flow, conditions would be somewhat better without the dike because of the directions of the currents over the dike that would tend to move upbound tows landward (plate 86). Although this tendency increased with an increase in flow, tows should not encounter any serious difficulty in approaching the guard wall even with the maximum navigable flow. Flow from the spillway toward the left bank tended to resist the movement of the head of a downbound tow away from the left bank and some difficulty was experienced in making the turn downstream of the lock. To overcome this difficulty, it was necessary to position the towboat stern as far to the left as possible so that the entire tow was angled to the right with respect to the left bank. This condition could be improved considerably by excavation of the left bank downstream of the lock at least 50 ft landward to permit the stern of downbound tows to be moved landward before the head passes the end of the guard wall extension (wing dike).
