TECHNICAL REPORT HL-79-17

NAVIGATION CONDITIONS AT THE UPSTREAM APPROACH TO LOCK AND DAM NO. 3 MISSISSIPPI RIVER

Hydraulic Model Investigation

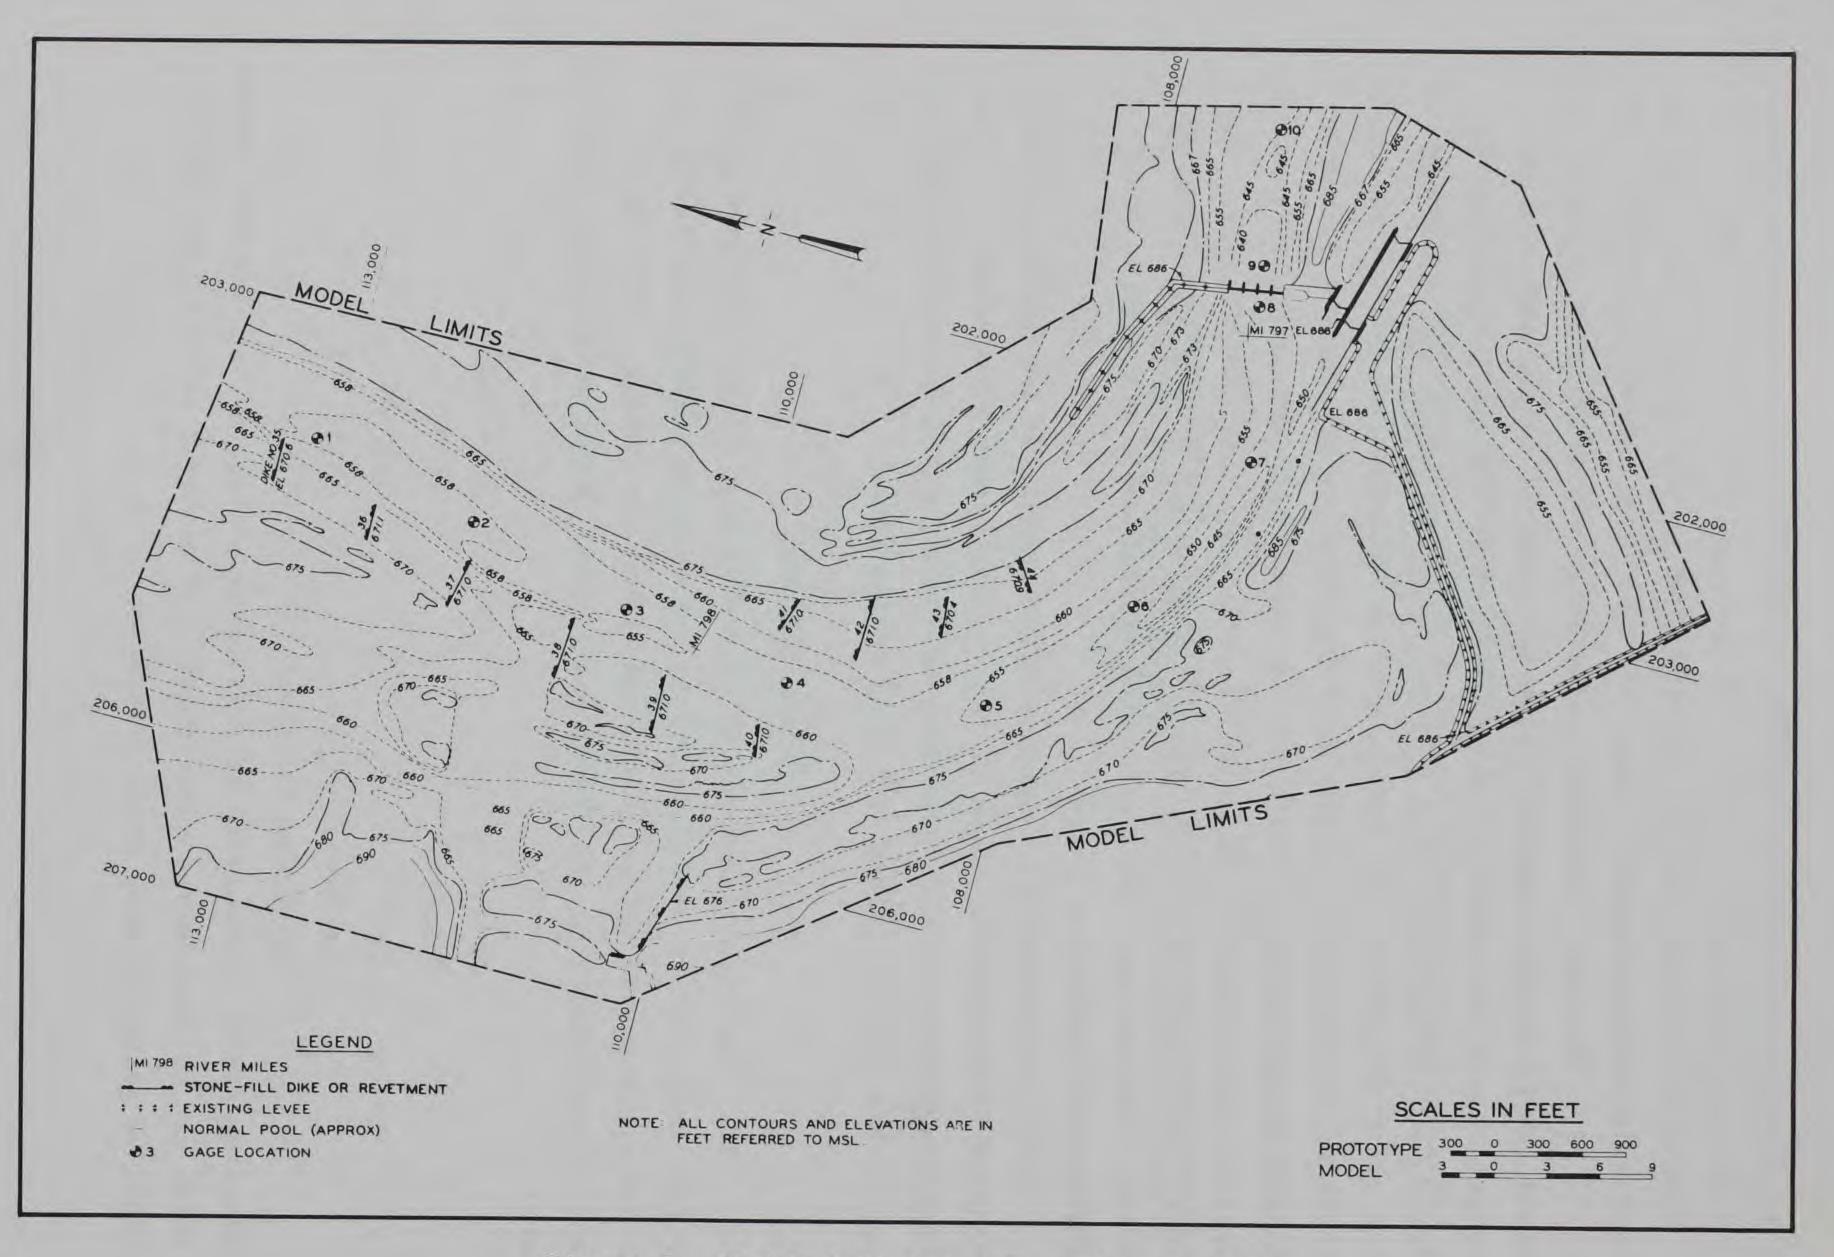
Figure 2. Model layout and location of gages

10. The model (Figure 2) was a scale reproduction of a short reach (about 2 miles) of the Mississippi River channel, and adjacent overbank area from about 9,000 ft upstream of the dam (mile 798.8) to 1,200 ft below the dam (mile 796.7). The model was of the fixed-bed type with the channel and overbank areas molded in sand-cement mortar to sheet-metal templates. Portions of the model, where changes in bank alignments and channel configurations were considered or could be anticipated, were molded in pea gravel to allow for easy modification. The lock, dam, crest, piers, and guard and guide walls were built from sheet metal. The dam gates were simulated schematically with simple vertical sheet-metal slide-type gates.

13. Water was supplied to the model by a circulating comprehensive water supply system. Inflow was controlled and measured at the upper end of the model by means of valves and venturi meters. Watersurface elevations were measured by means of 10 piezometer gages located in the model channel and connected to a centrally located gage pit (Figure 2). For controlled riverflows, upper pool stages were controlled at the dam by opening and closing the dam slide gates; for open riverflows, tailwater elevations were controlled by means of a tailgate located at the lower end of the model.

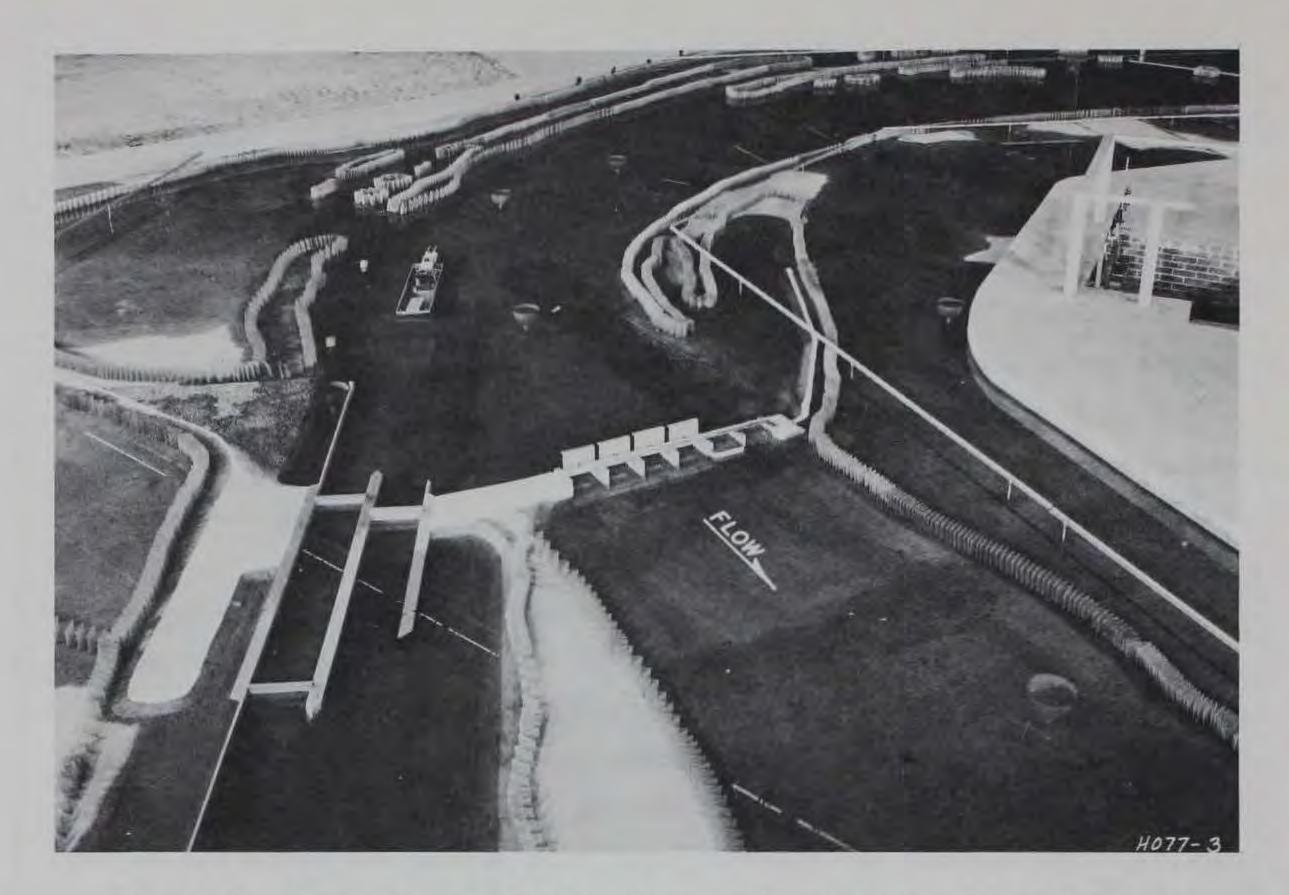
Figure 3. Remote-controlled towboat and tow approaching the lock

14. Velocities and current directions in the model were determined by cylindrical wooden floats weighted on one end to simulate the maximum draft for loaded barges using the waterway (9 ft prototype). A model towboat and tow were used to determine and demonstrate the effects of currents on tows approaching and leaving the lock in the upper pool (Figure 3). The towboat was equipped with twin screws and propelled by two small electric motors operating from batteries in the tow. The rudders and speed of the tow were remote-controlled, and the tow could be operated in forward or reverse with the power adjusted by means of a rheostat to a maximum speed comparable to that of towboats using the upper Mississippi River waterway.

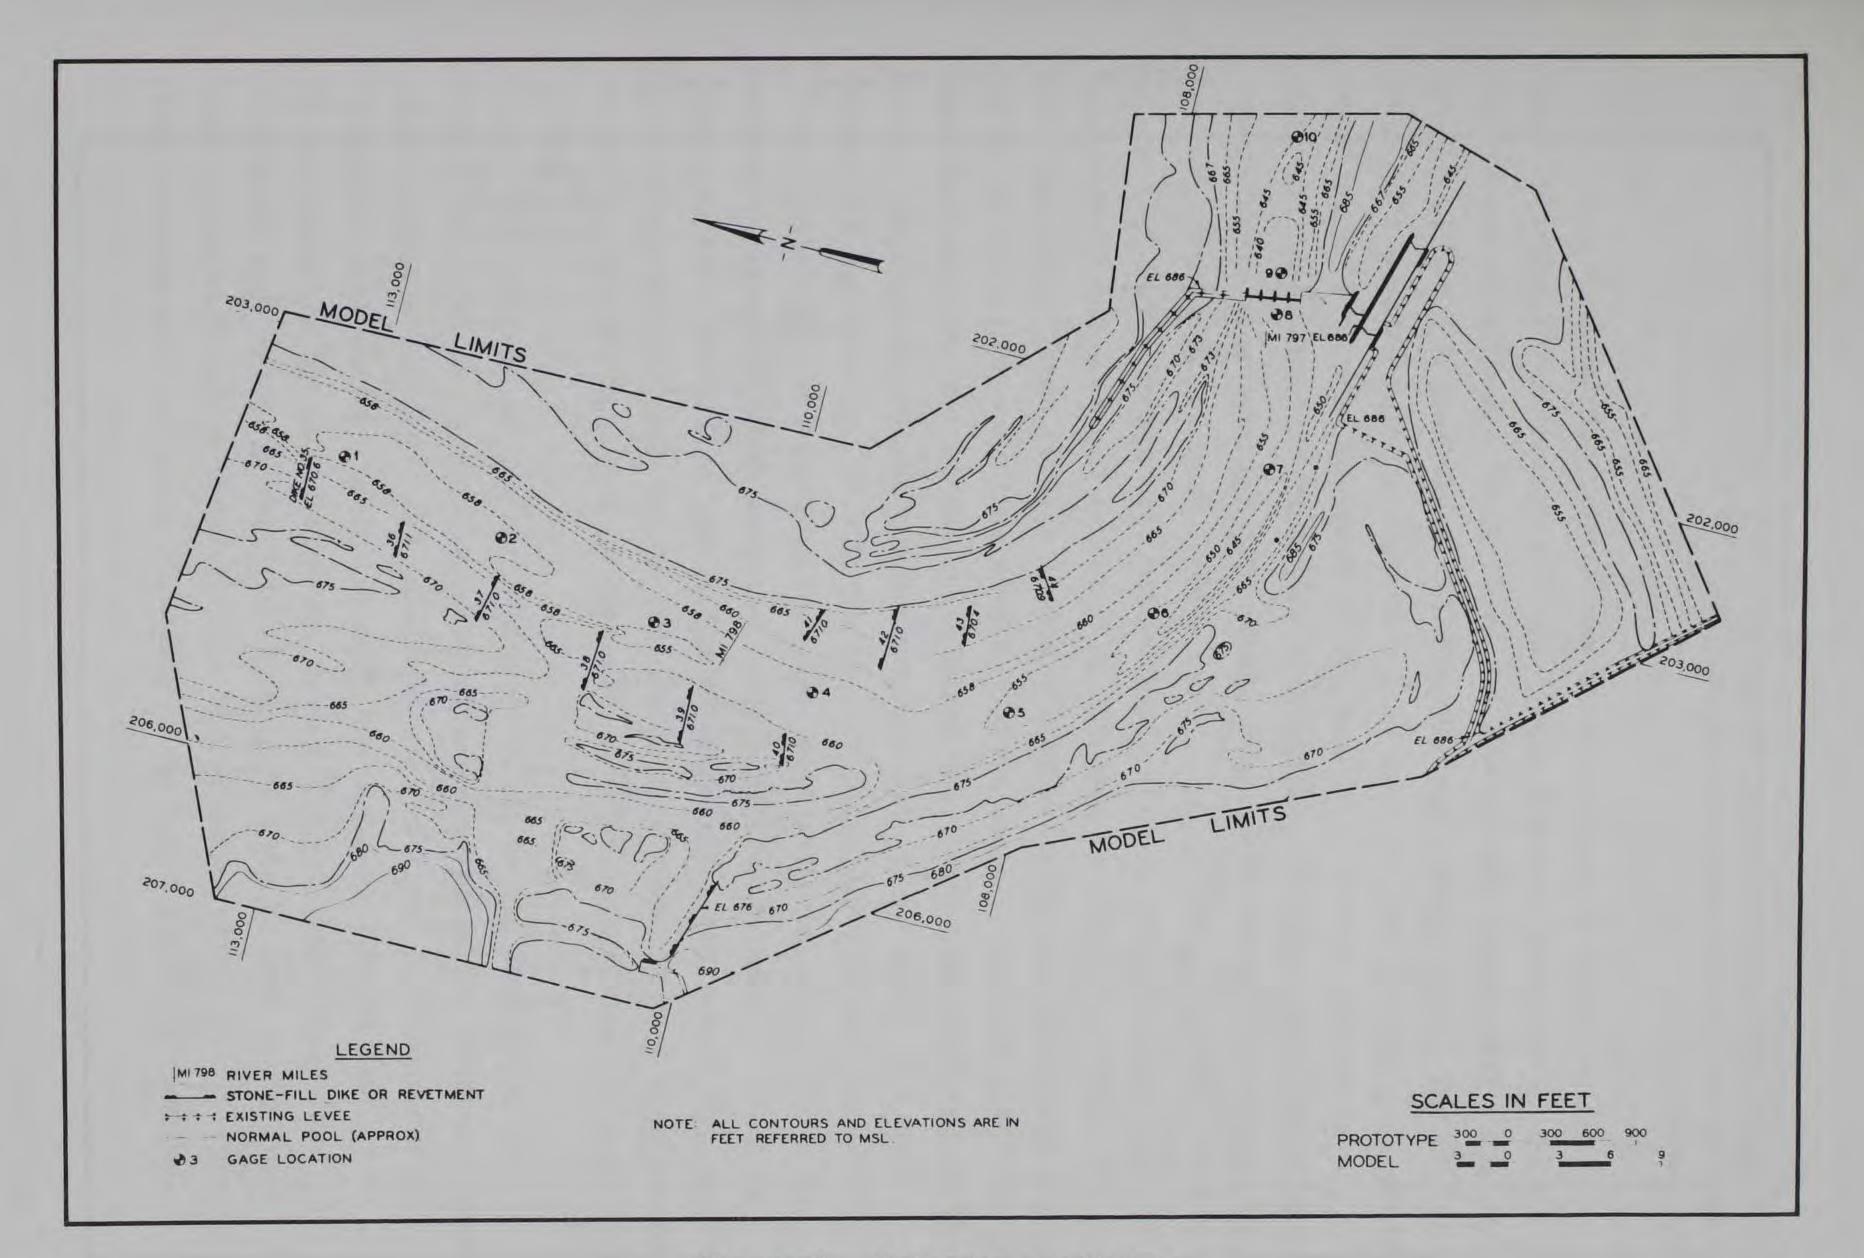
Figure 4. Existing conditions

21. The base test was conducted with the model reproducing existing conditions as shown in Figures 4 and 5. The purposes of this test were to establish and record the conditions existing in the prototype with the flows selected for testing and to provide a basis for determining the effectiveness of proposed modifications. The principal features of the prototype that were reproduced or simulated in the model for this test included the following:

- <u>a</u>. The lock located in a canal along the right bank with clear chamber dimensions of 110 ft wide by 600 ft long, a 576-ft-long upper guide wall, and a 570-ft-long lower guide wall and provisions for a second lock on the riverward side. Tops of lock walls were at el 686.0.
- b. A nonnavigable gated spillway including four 80- by 20-ft roller gates located in the river channel. The dam was connected to high ground on the left overbank with an earth dike, top el 686.0.

<u>c</u>. Two cells located along the right bank upstream of the guide wall and a system of submerged dikes (wing dams) with crest el 671.0 located upstream of the lock on each side of the channel.

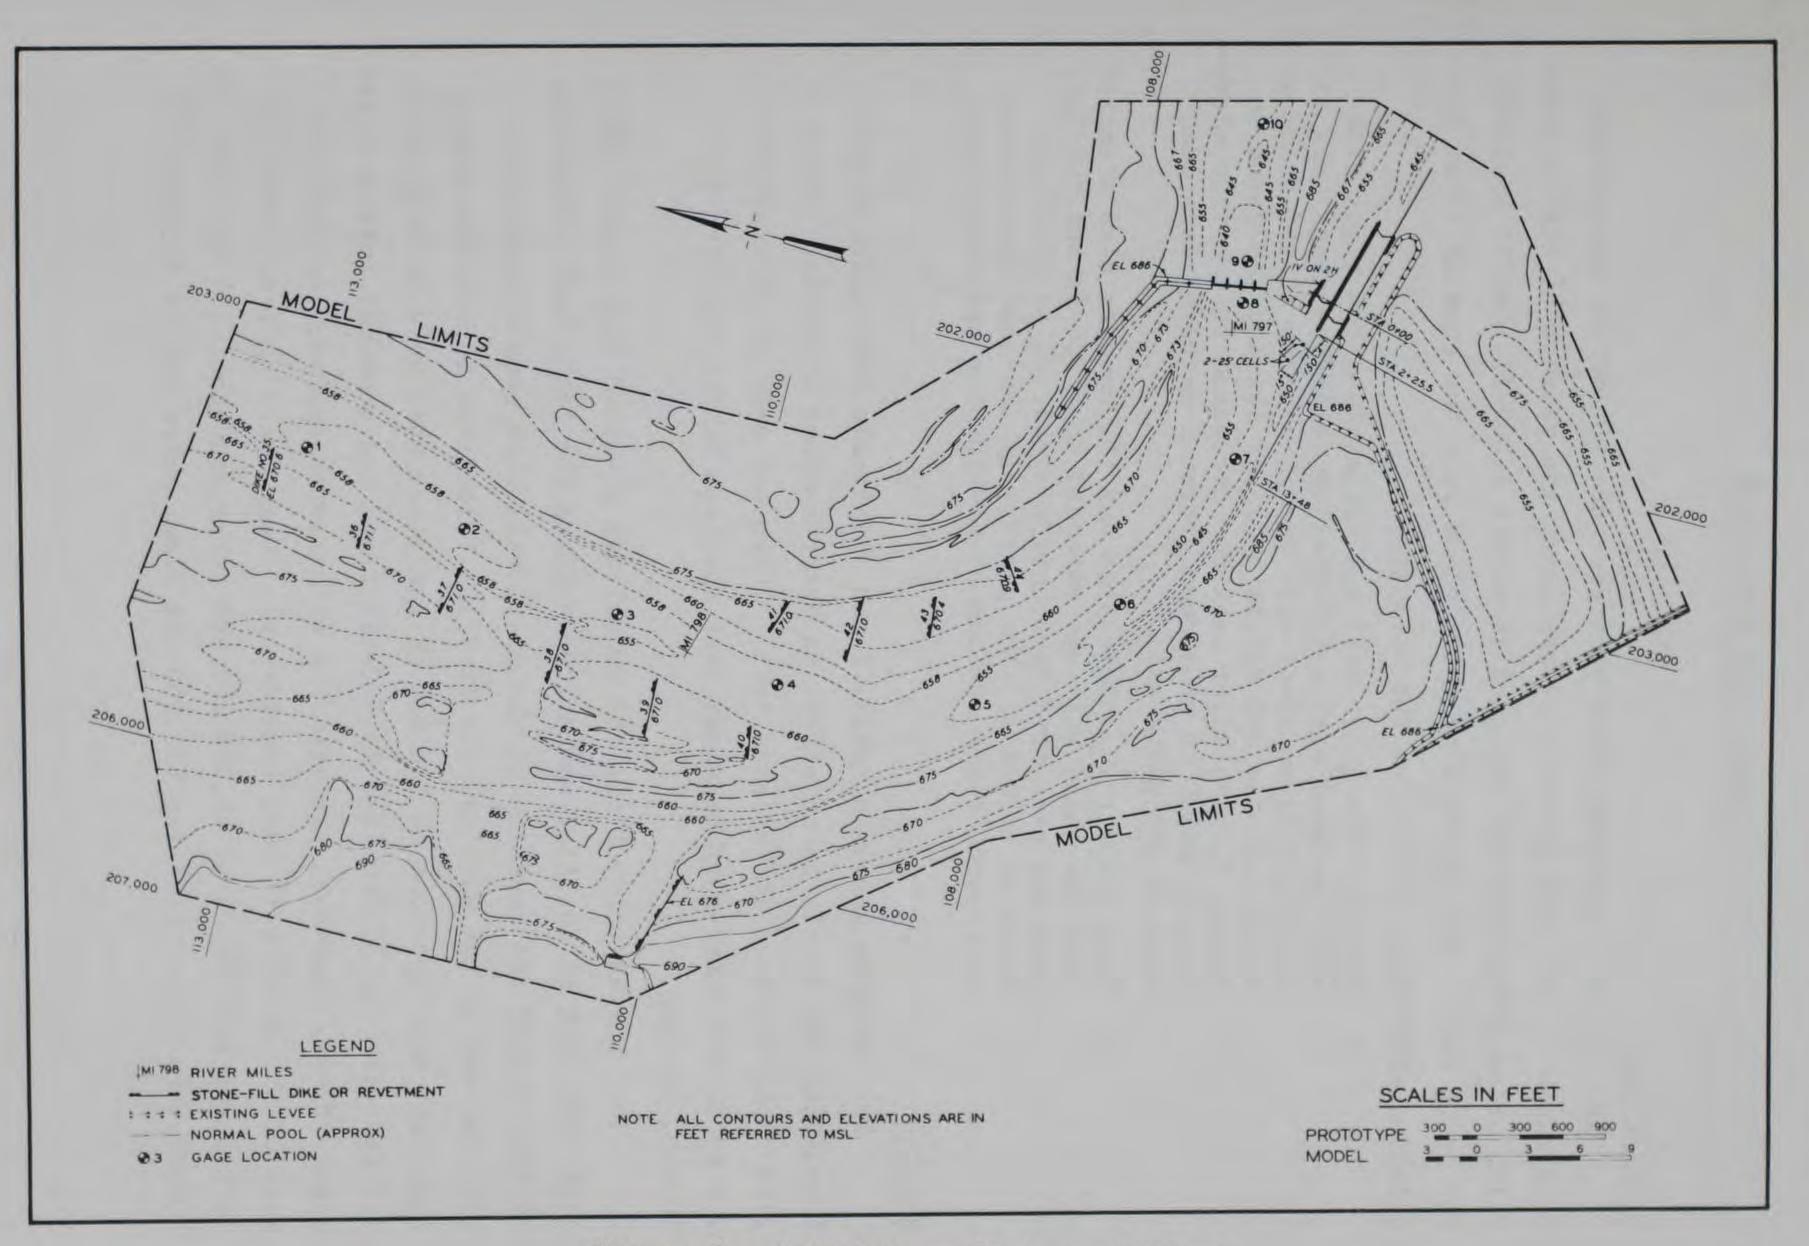
Figure 6. Existing conditions-modified

25. This plan was the same as that for existing conditions (base test) except for modifications designed to assist tows in approaching the guide wall for passage through the lock. The modifications involved the following (Figure 6):

26. Extension of the upper guide wall and the cells included in this plan had little or no effect on water-surface elevations. There was also little change in the alignment of currents and velocities in the lock approach, as shown in Plates 9-11. Velocities along the guide wall were slightly higher than those along the shorter wall with little change in the crosscurrents compared with those obtained during the base test. Currents were generally straight along the guide wall extension before moving to the left toward the spillway.

27. Because of the alignment of the currents along the guide wall extension, downbound tows could approach the guide wall with less difficulty than with the existing wall. However, the head of the tow would tend to be moved riverward by the crosscurrents a short distance downstream of the end of the wall (Photo 2a). Although navigation conditions for downbound tows would be somewhat better than those with existing conditions, the attachment of mooring lines would be required to maintain the position of the tow along the wall and to control its movement along the wall for entrance into the lock (Photo 2b). The modifications had little effect on navigation conditions for upbound tows leaving the lock (Photo 2c).

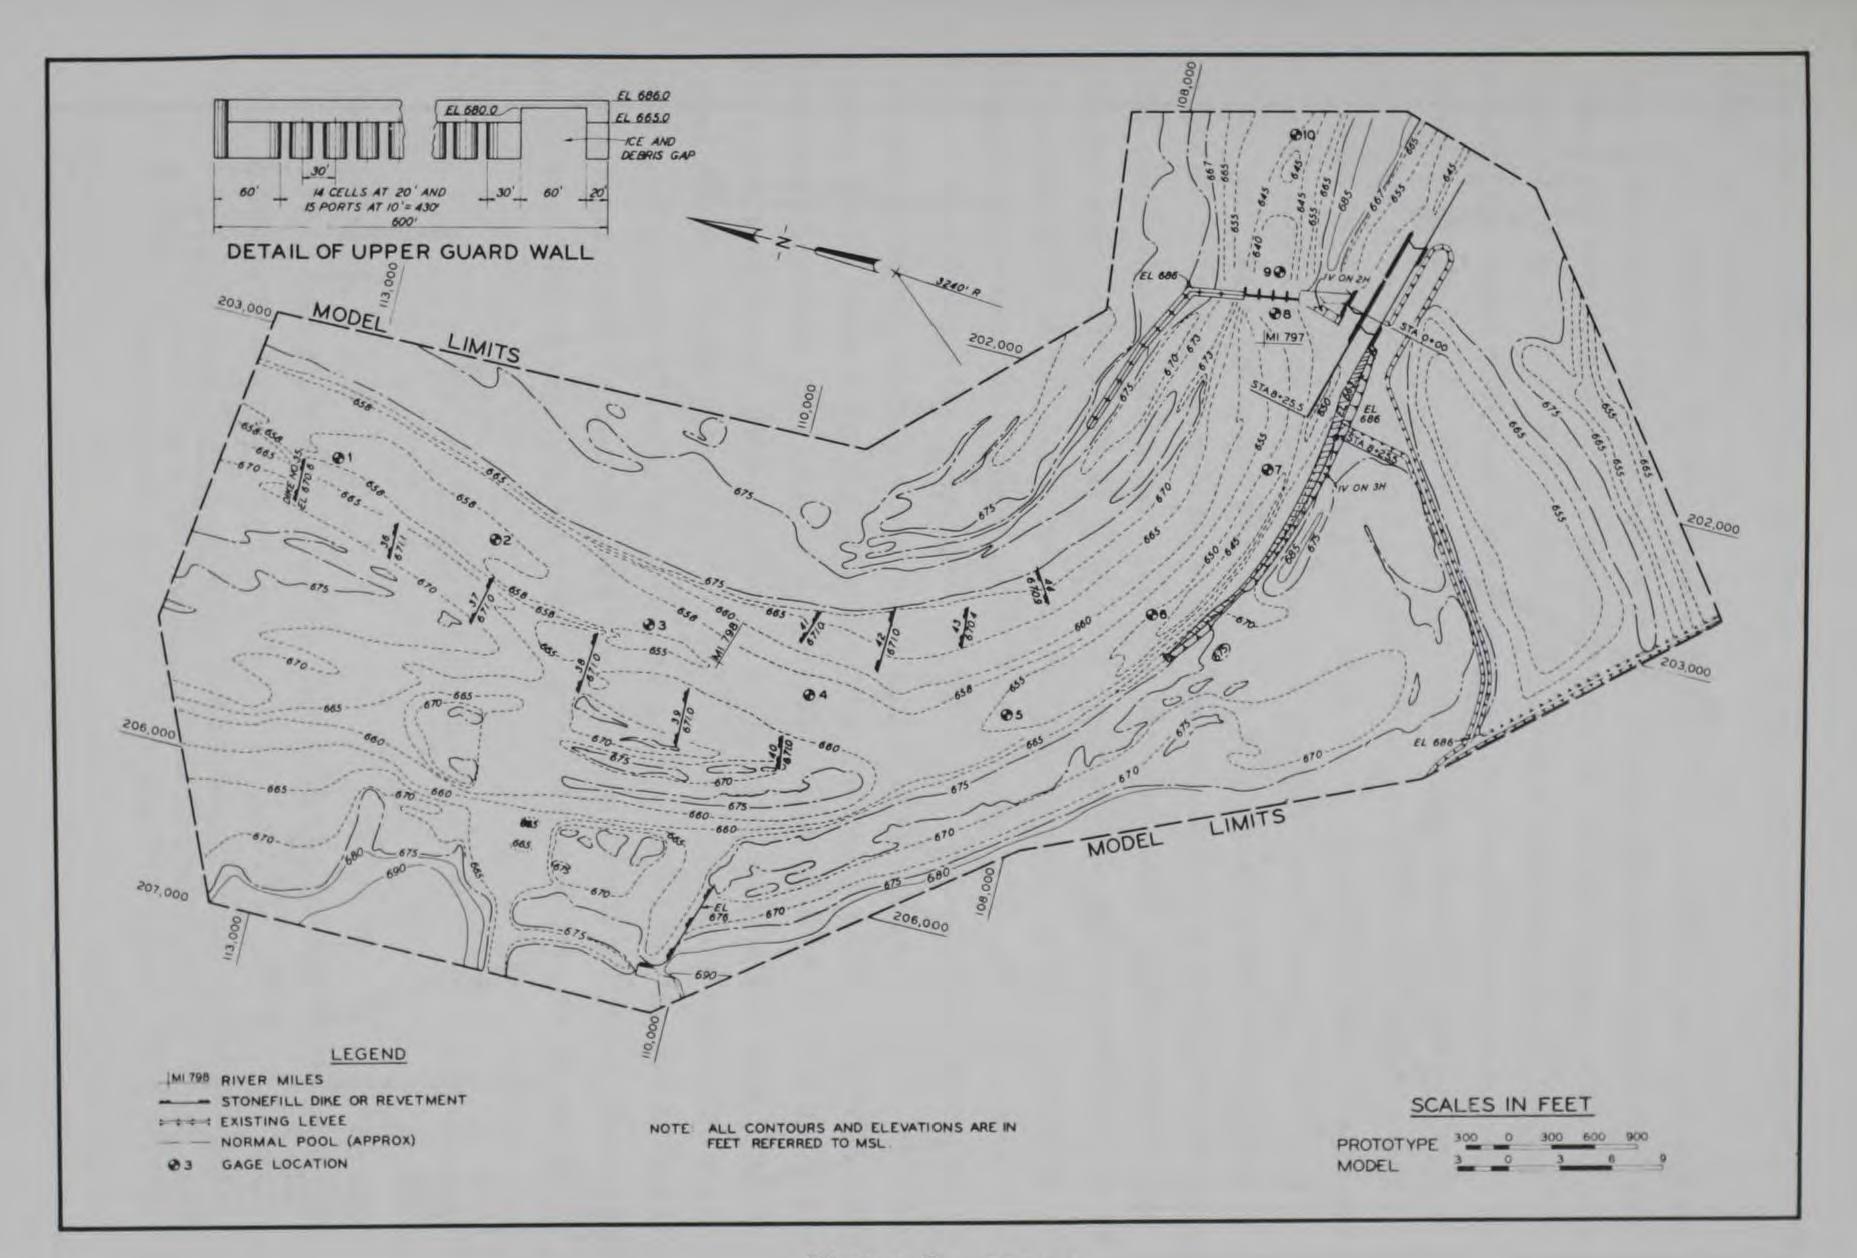
Figure 7. Plan A

- <u>a.</u> <u>Plan A.</u> The guide wall and cells along the right bank were replaced with a 600-ft-long cell-type guard wall including fifteen 10-ft-wide ports with top el 665.0 and a 60-ft-wide ice and debris gap near the lock as shown in Figure 7. The right bank was excavated to a bottom elevation of 663.0 to provide additional maneuver area landward of the guard wall.
- b. Plan A-modified. This plan was the same as plan A except that the guard wall was extended to 1,200 ft and the left bank was excavated to a bottom elevation of 660.0 as shown in Figure 8. The guard wall included thirty-five 10-ft-wide ports and the 60-ft-wide ice and debris gap.

30. Current directions and velocities obtained with plan A indicate that most of the flow moving close along the right bank would tend to move toward the landside of the guard wall with some crosscurrents near the end of the wall (Plates 12-17). Velocities of currents along the right bank upstream of the end of the guard wall were as much as 3.3 fps with the 30,000- and 36,000-cfs flows and somewhat less with the higher flows. However, the velocity of currents approaching and landward of the guard wall were considerably lower, varying from about 1.0 to 1.5 fps with flows of 70,000 cfs and lower and about 2.4 fps with the 100,000-cfs flow. With the 134,000-cfs flow, there was an increase in

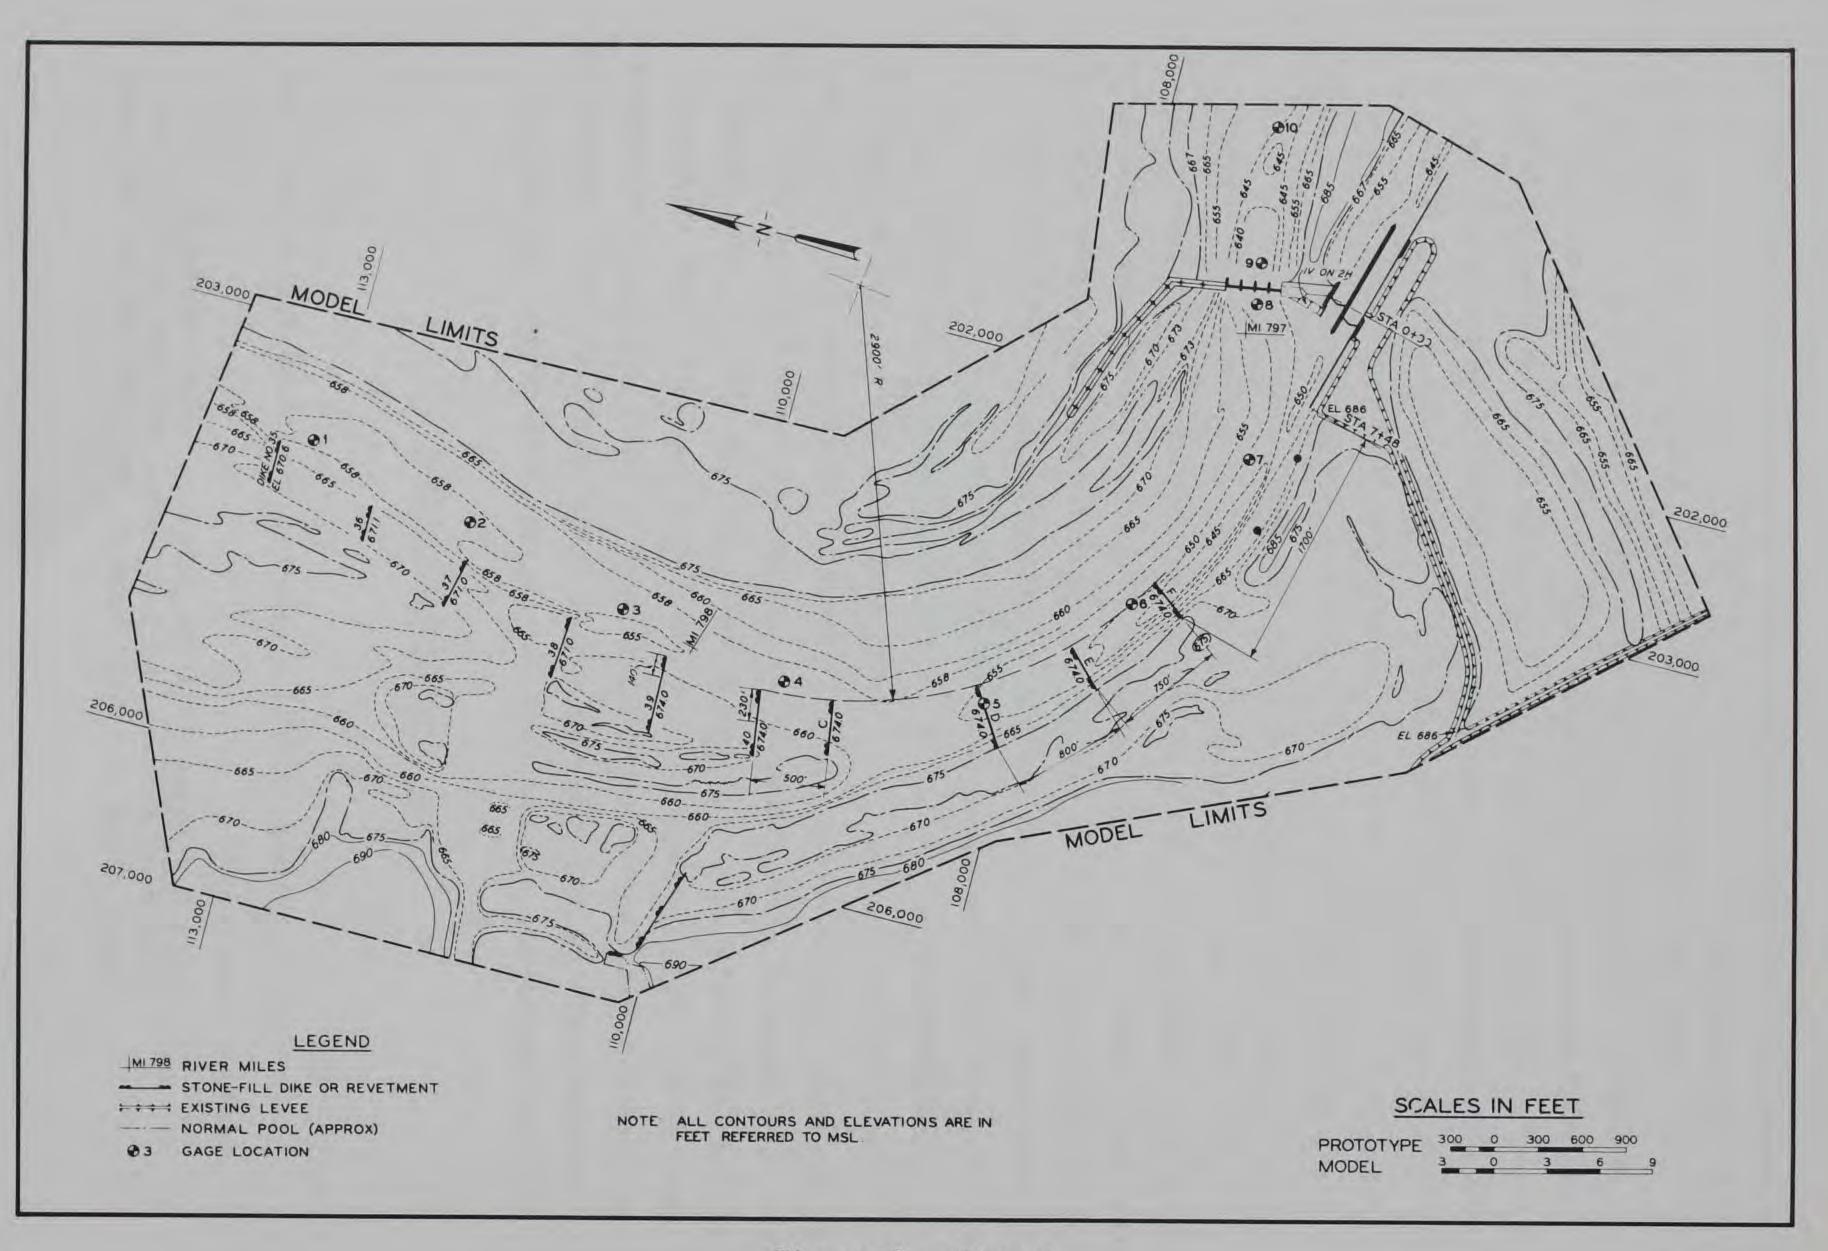
<u>a.</u> <u>Plan B (Figure 9).</u> The submerged dikes along the left bank were removed and four dikes with top el 674.0 were added along the right bank upstream of the lock approach.

Dikes 39 and 40 were raised to el 674.0 and lengthened 140 ft and 230 ft, respectively.

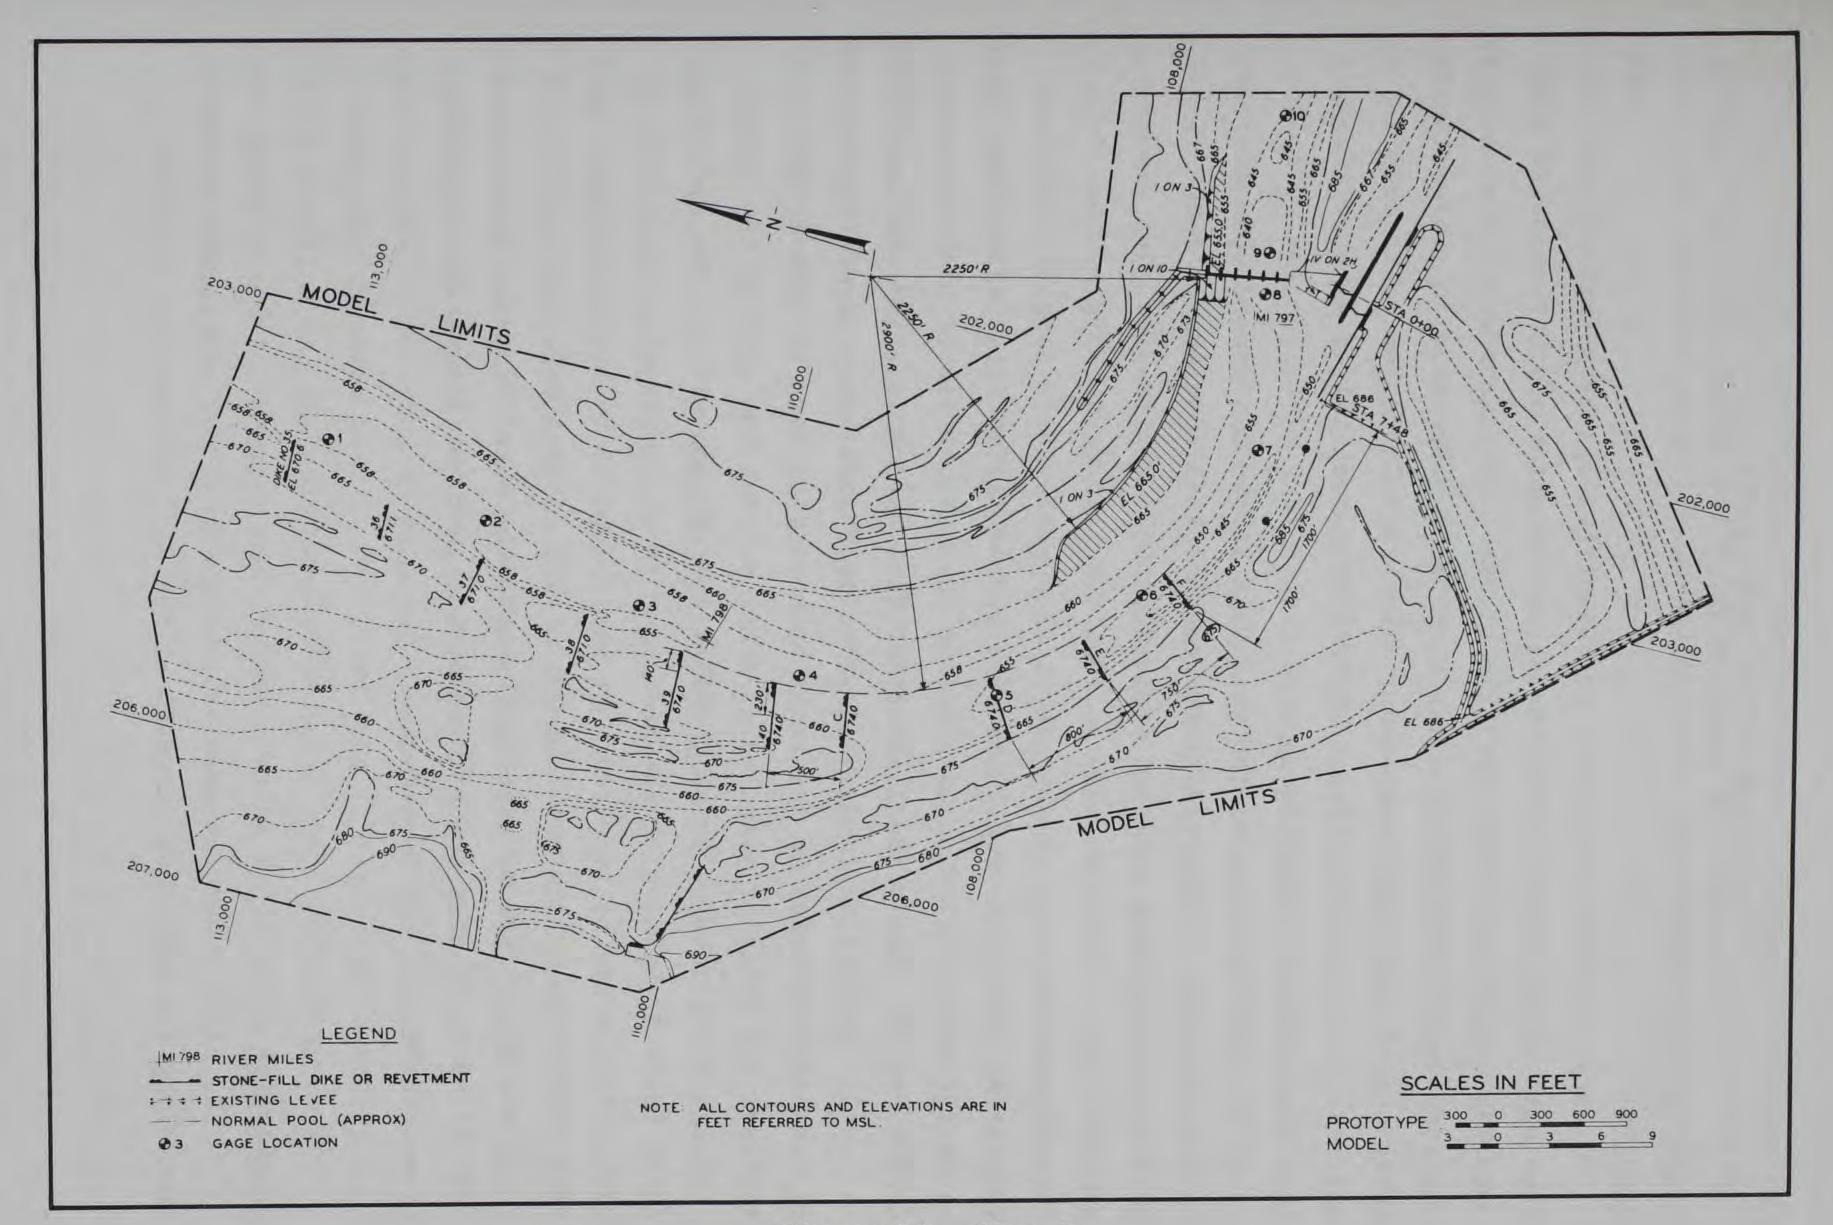
Figure 10. Plan C

- <u>a.</u> <u>Plan C (Figure 10).</u> Two additional gate bays were installed on the left end of the dam and the left bank downstream of the dam was excavated to el 665.0 extending from the new left abutment to about 800 ft downstream. The left bank was excavated to el 665.0 starting at the left dam abutment and extending upstream about 2,400 ft on a 2,250-ft radius to provide a 650-ft-wide channel approaching the dam.
- b. Plan C-modified. Same as plan C except that the upper guide wall was extended upstream 600 ft and the two mooring cells along the right bank were removed.
- <u>Plan C-1.</u> Same as plan C except that the upper guide wall was replaced with a 600-ft-long ported guard wall and the right bank was excavated to el 663.0, same as in plan A (Figure 7). The two mooring cells were removed.

41. The addition of two gate bays in the dam caused some increase in the velocity of currents in the channel just upstream of the lock with open riverflows compared with plan B (Plates 24-27). There was a tendency for a clockwise eddy to form downstream of the proposed right bank dikes that extended into the lock approach with some of the plans. Velocities along the guide wall of plan C-modified were higher than those along the guide wall of plan C. With the guard walls of plans C-1 and C-2, there was only a small amount of flow moving into the lock approach.

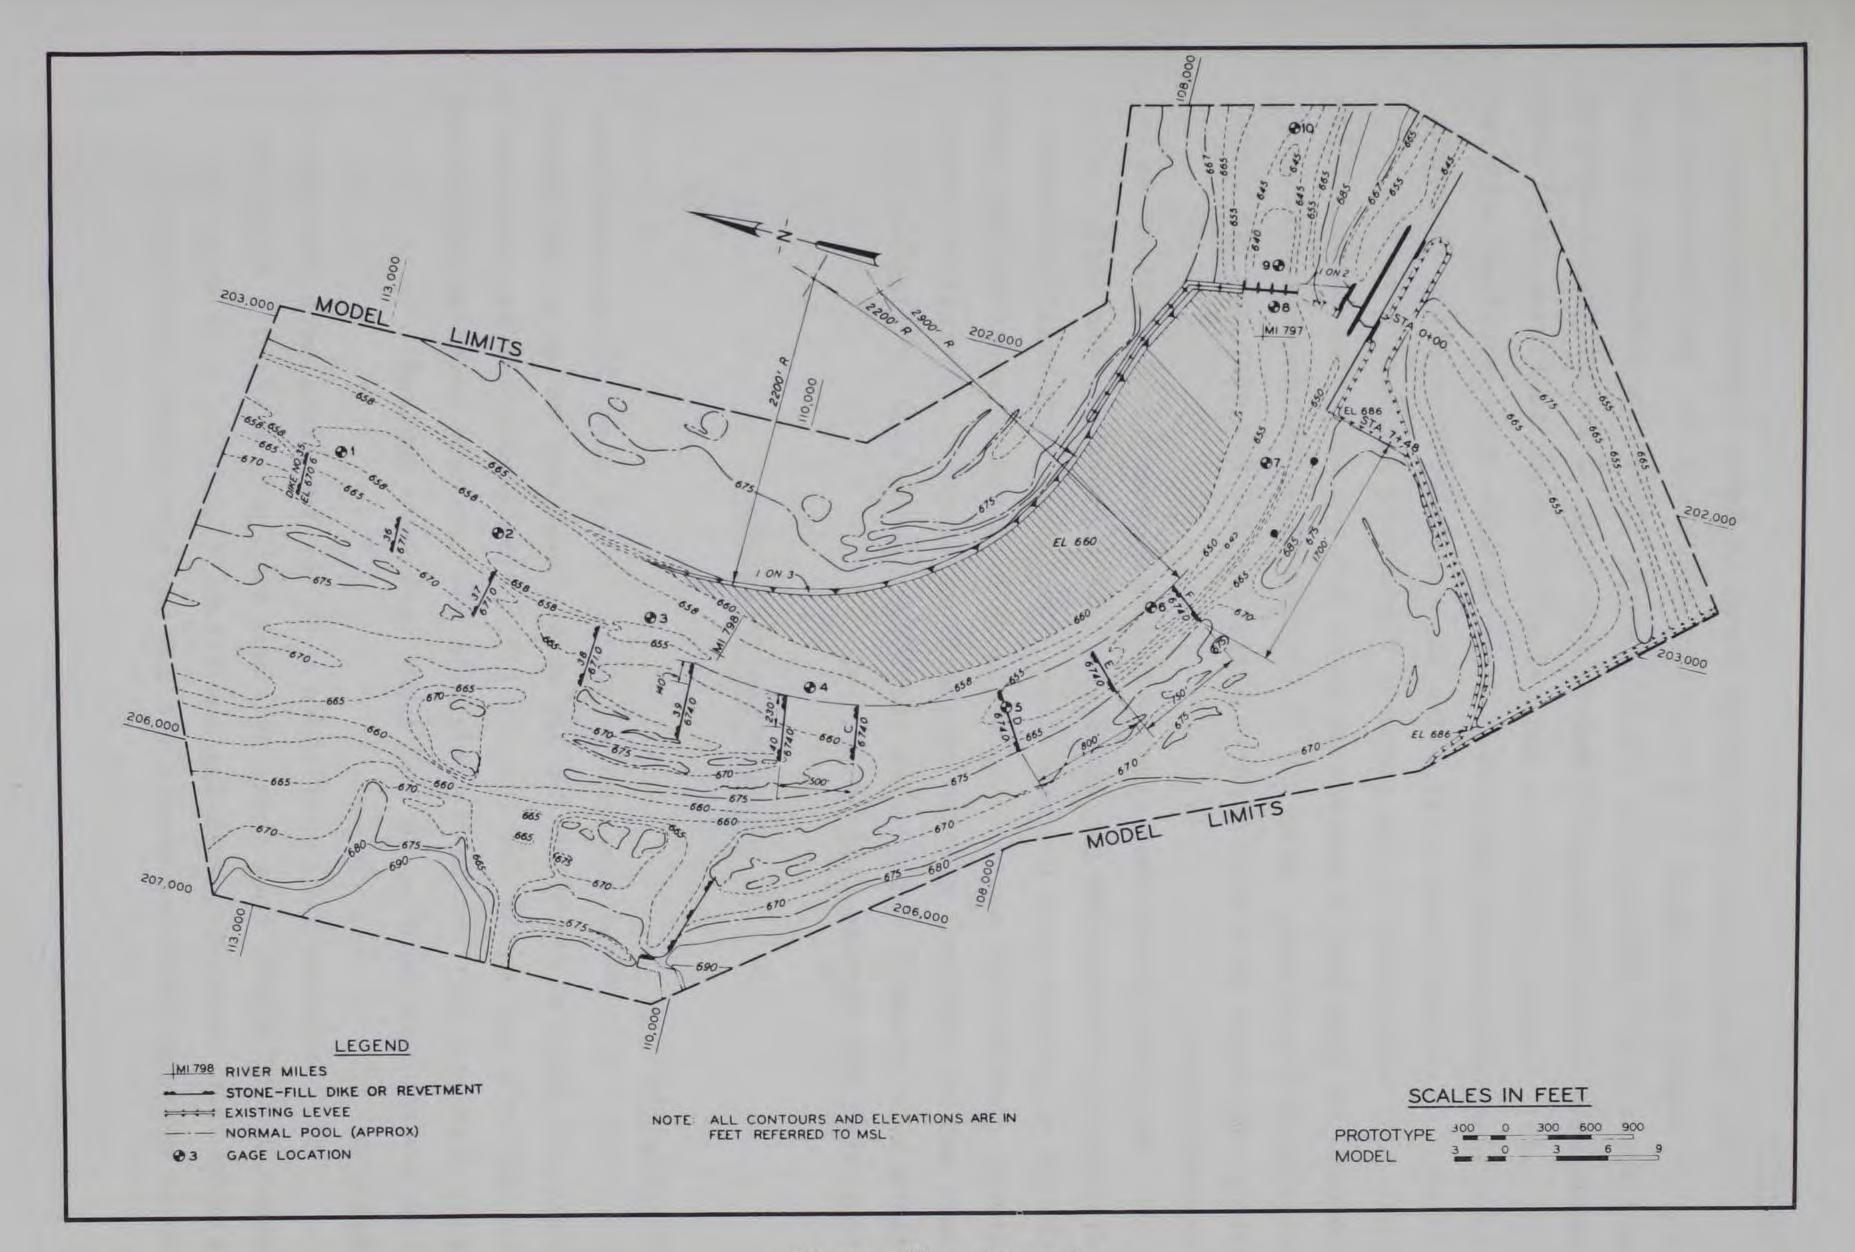
Figure 12. Plan E

47. These plans were designed to reduce water-surface elevations in the upper reach with the proposed right bank dikes. Plan E was the same as plan D except that the proposed additional gate bays in the dam were eliminated and excavation along the left bank was lowered to el 660.0 and extended upstream to river mile 798 as shown in Figure 12. Plan E-modified was the same as plan E except that the lock guide wall was extended 600 ft upstream and the two mooring cells along the right bank were removed.

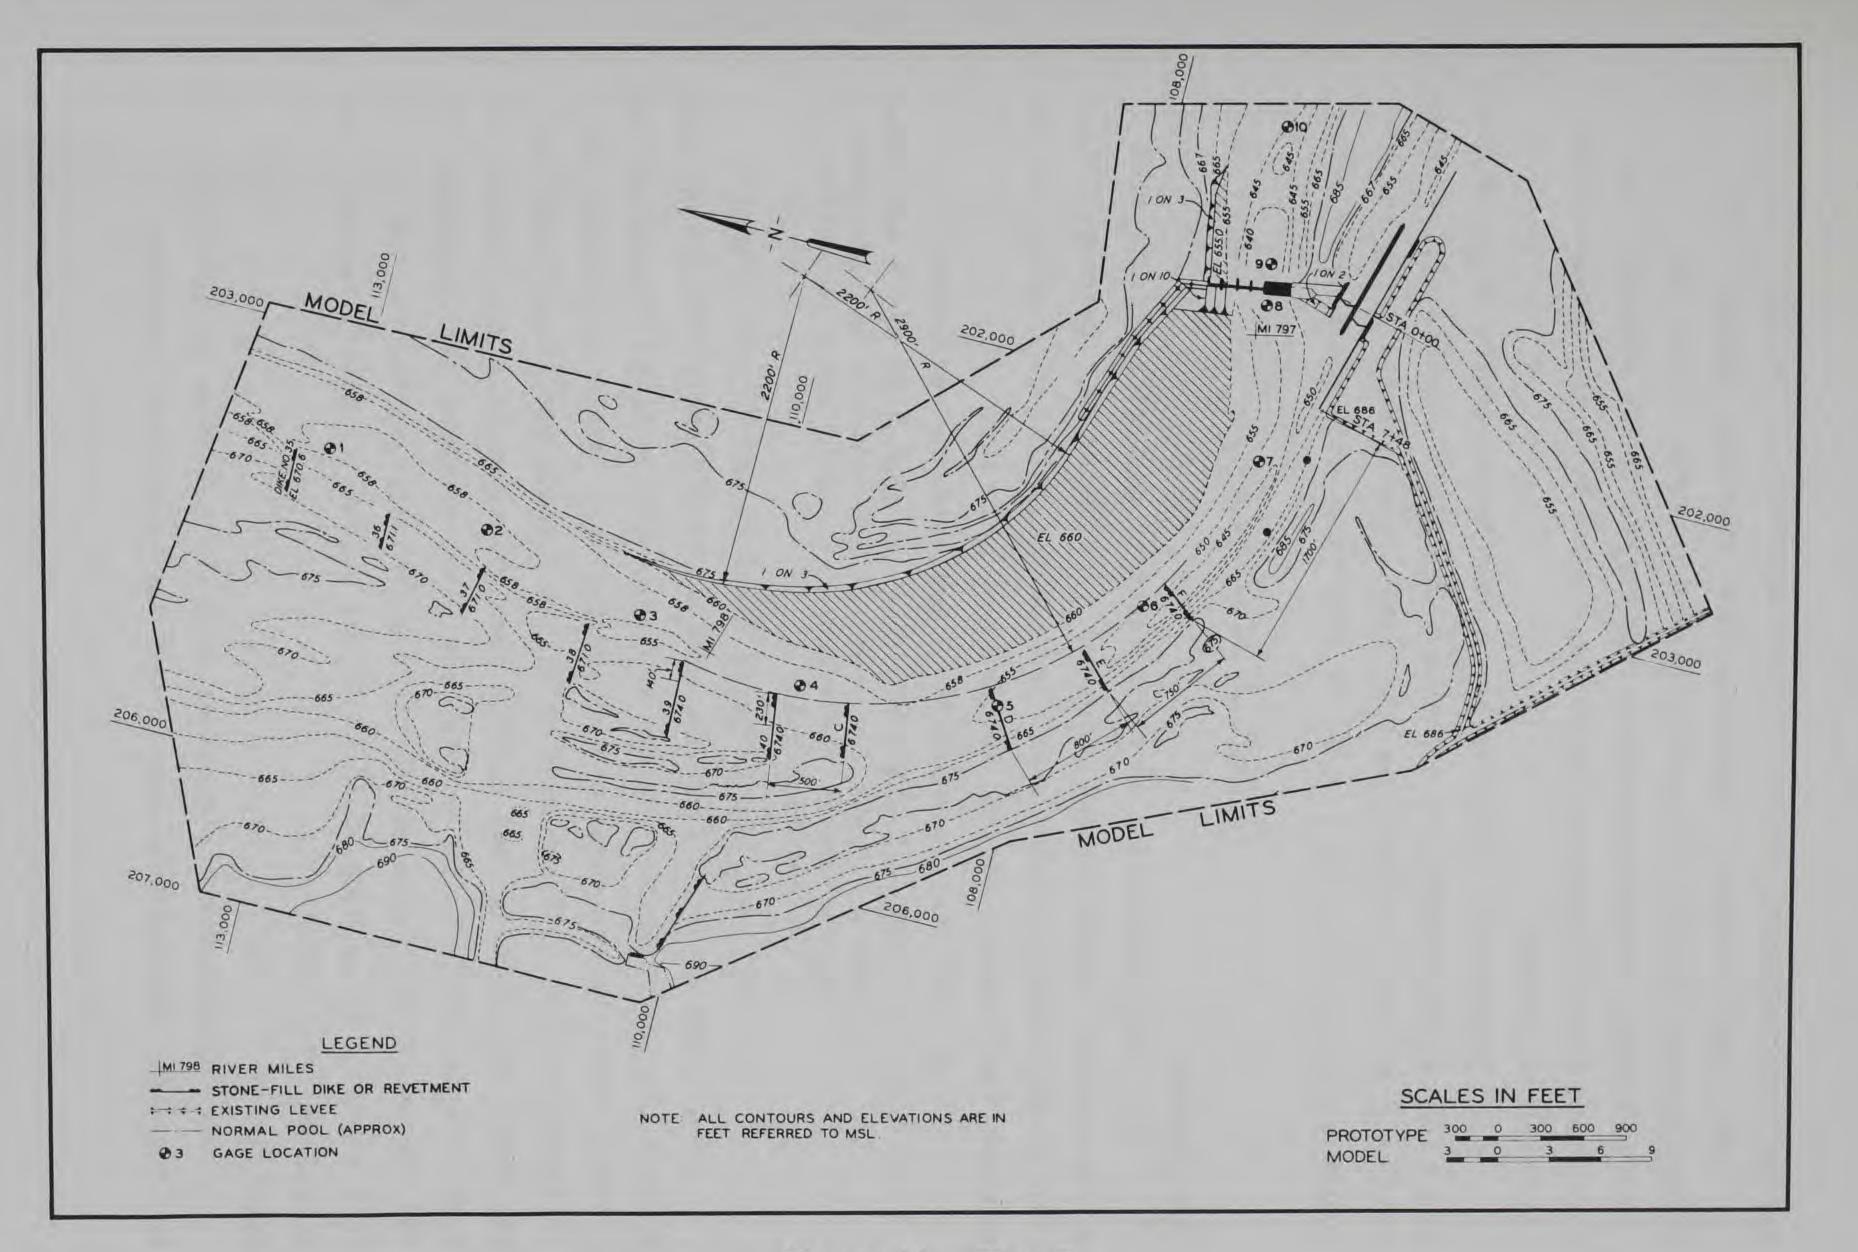
Figure 13. Plan F

51. Plan F was the same as plan E except that the two gate bays near the right abutment of the dam were closed and two gate bays added to the left end of the dam (Figure 13). Plan F-modified was the same as plan F except that the lock guide wall was extended upstream 600 ft and the two mooring cells along the right bank were removed. Results

52. Water-surface elevations with the two plans were the same and about 0.2 ft higher than those obtained with plan E and 0.3 to 0.4 ft higher than those with existing conditions (Table 7). The drop in water-surface elevation across the dam was also higher, attributed
