TECHNICAL REPORT HL-79-17

NAVIGATION CONDITIONS AT THE UPSTREAM APPROACH TO LOCK AND DAM NO. 3 MISSISSIPPI RIVER

Hydraulic Model Investigation

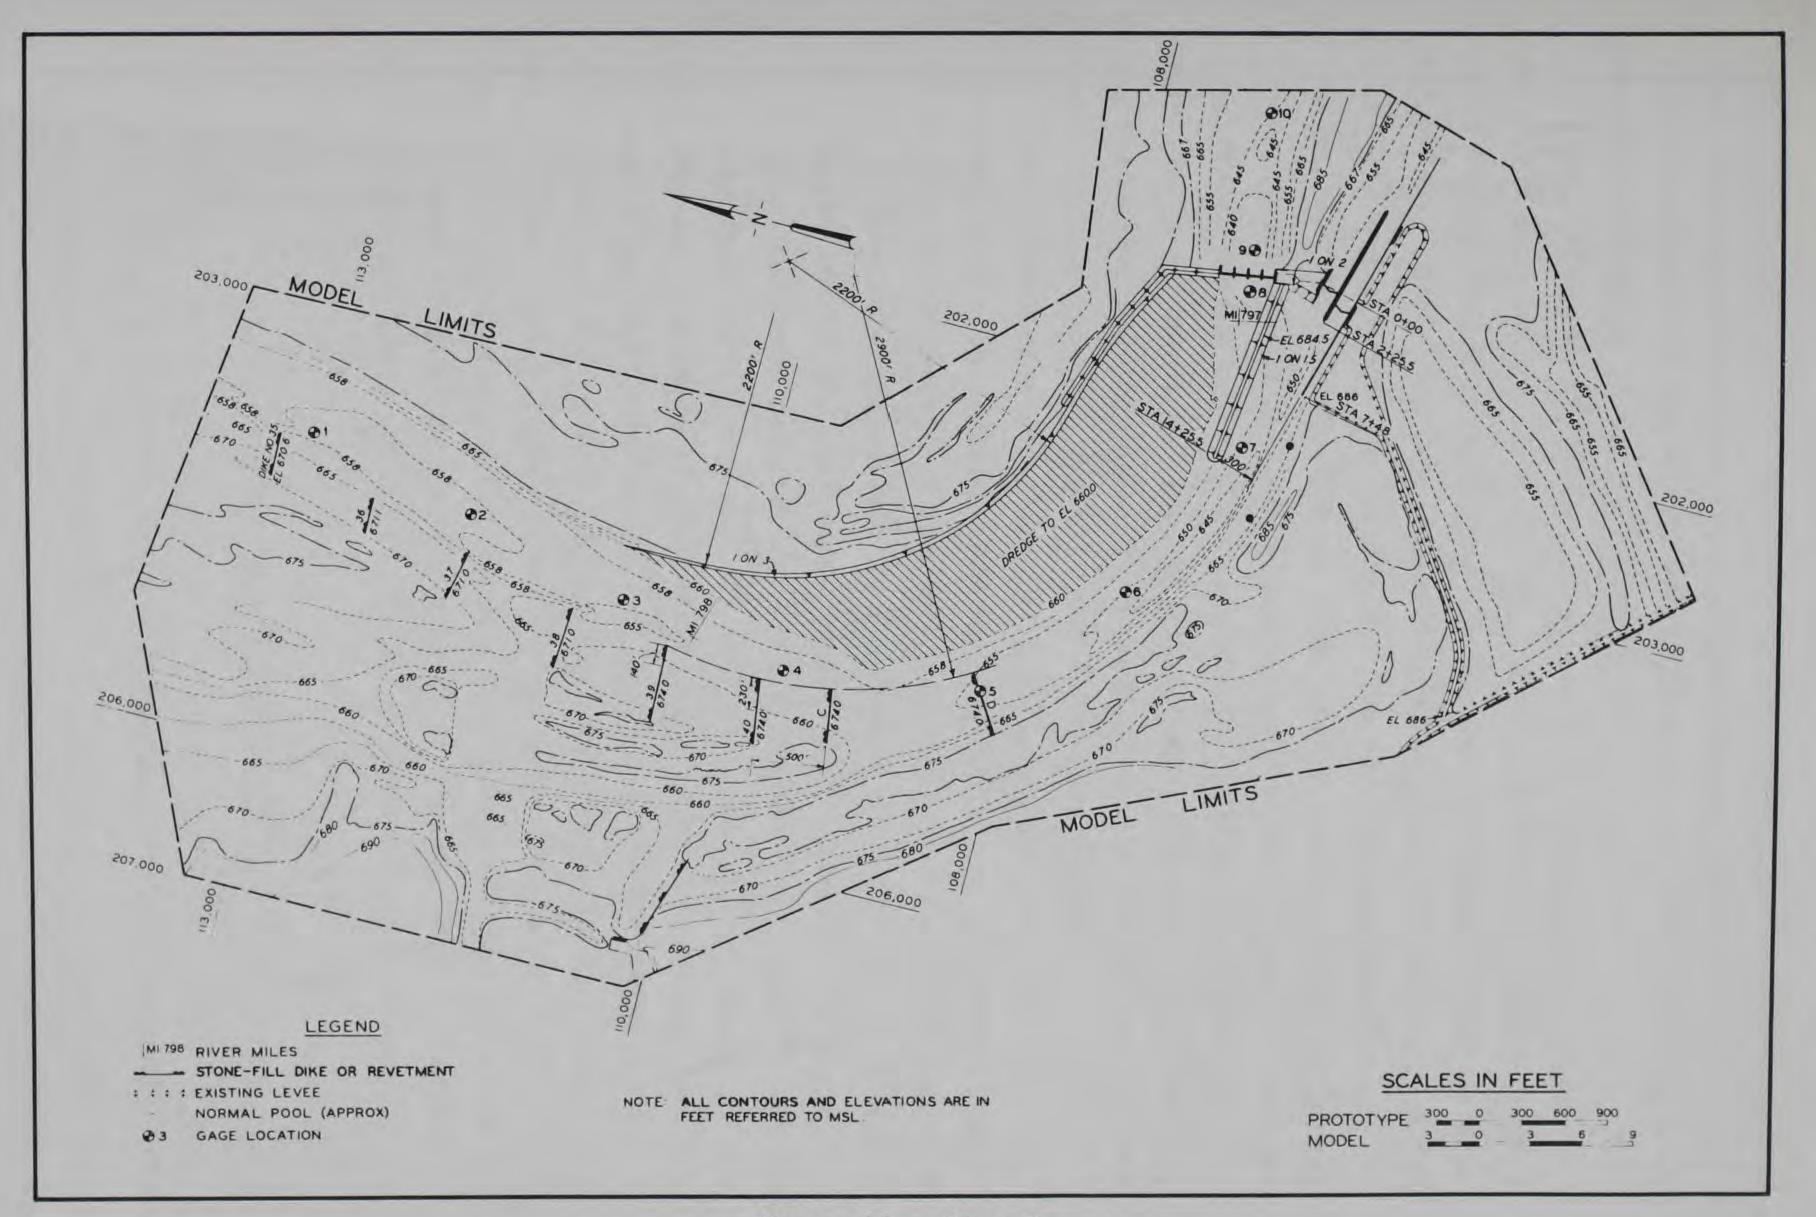
Figure 14. Plan G

55. Plan G was based on the results of preliminary tests with various types, locations, and alignment of structures. The most effective of these modifications were incorporated in the plan which was the same as plan E except for the following (Figure 14):

58. With the 36,000-cfs flow, currents were generally parallel to the right bank line (Plates 37-39). With plan G, a slow eddy formed in the lock approach extending from the lock to the proposed dike on the right bank. With plan G-modified, there was some flow landward of the rock dike and through the opening and the eddy did not extend as far downstream. With the 70,000-cfs flow, some crosscurrents occurred near the upper end of the rock dike, particularly with plan G. The velocity of currents moving toward the upper end of the dike was about 1.6 fps with plan G and about 2.1 fps with plan G-modified. The velocity of currents along the lock side of the rock dike with plan G-modified was generally less than 1.0 fps with the 70,000-cfs flow.

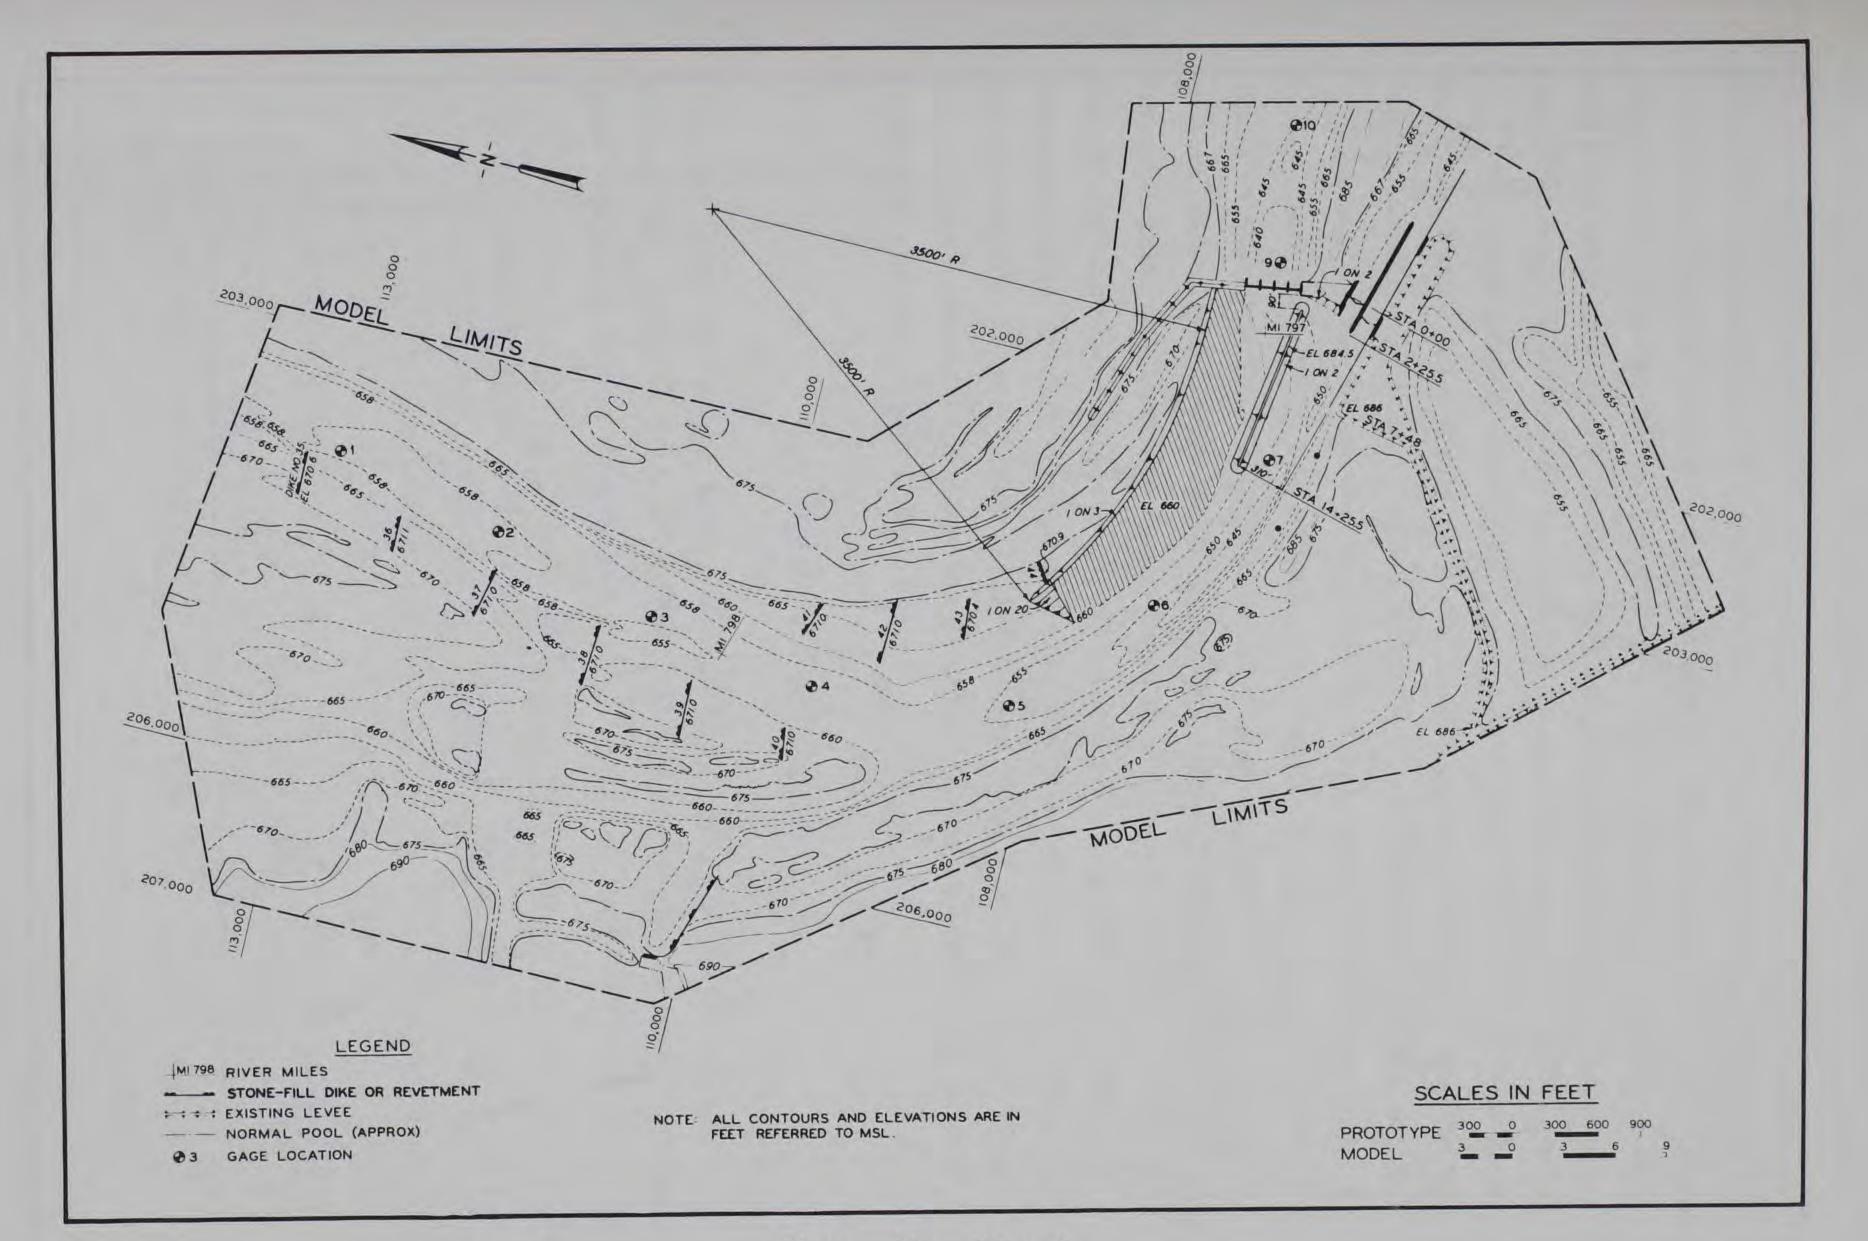
Figure 16. Plan H

61. Plan H was the same as existing conditions (base test) except

for the following modifications (Figure 16):

64. Current directions and velocities shown in Plates 40-47 indicate that because of the alignment of the channel, the higher velocity currents tend to move toward and along the right bank upstream of the lock. Since only a small portion of the total flow intercepted by the rock dike can pass through the opening between the dike and dam abutment wall, there will be some flow moving riverward of the upper end of the dike creating some crosscurrents that increase with an increase in discharge. Maximum velocities along the right bank upstream of the upper end of the dike were about 3.6 fps with the 36,000-cfs flow and decreased with lower and higher discharges. There was little difference in currents and velocities between plans H and H-modified.

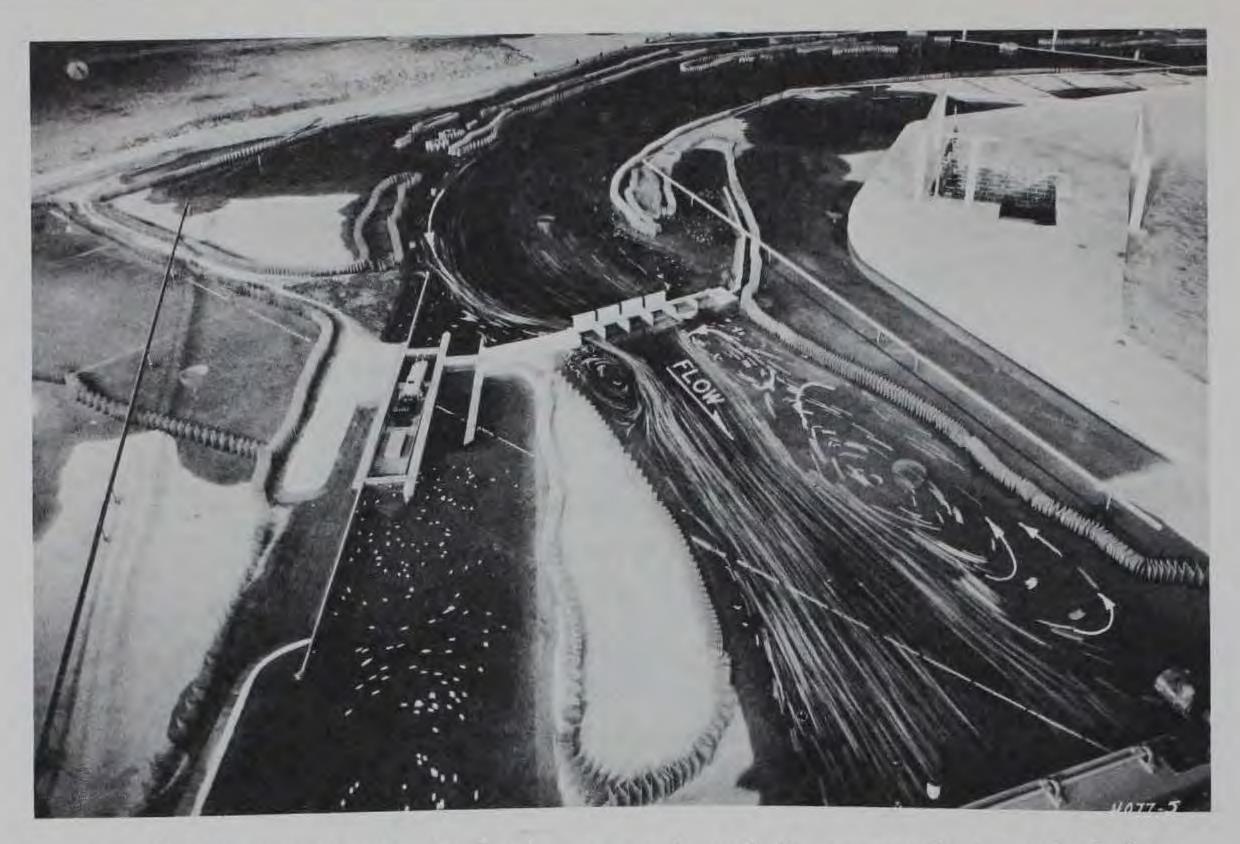
a. Surface currents in lock approach and in approach to gated dam

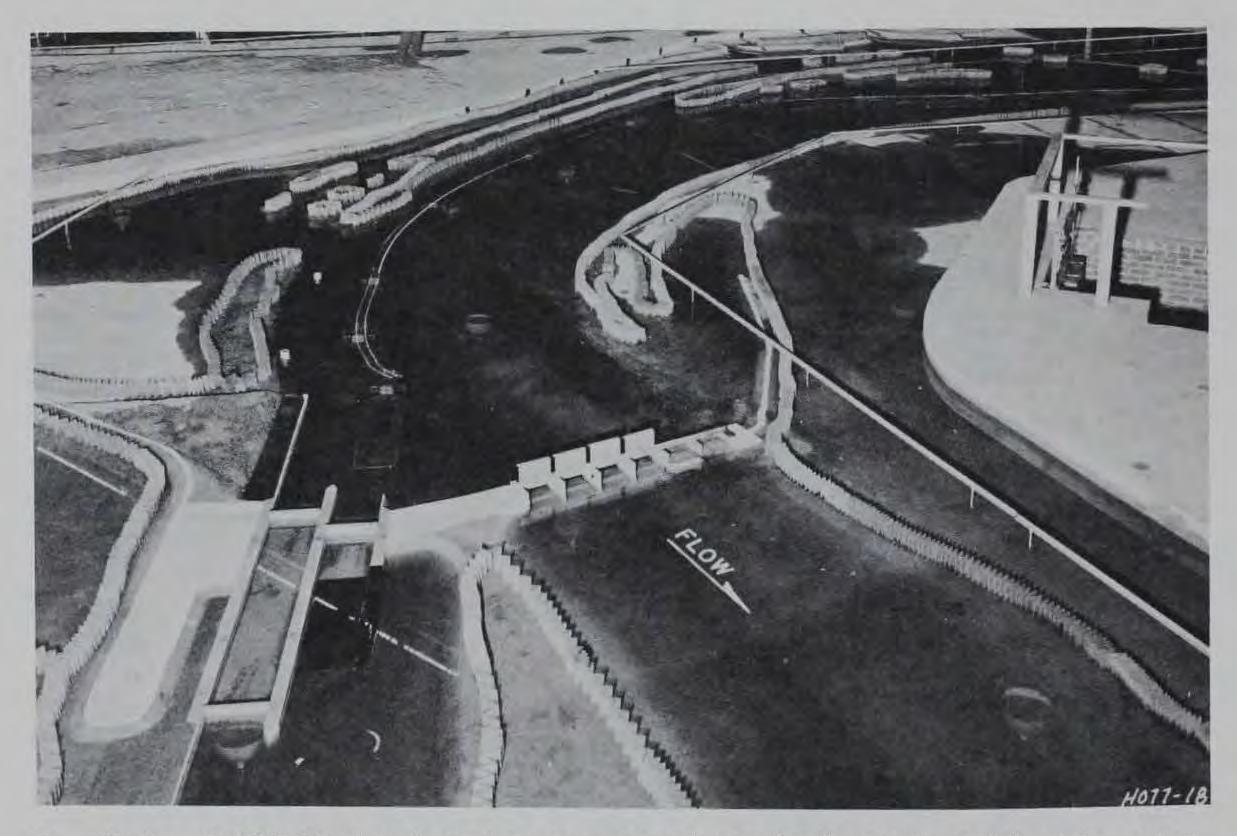
b. Path of 600-ft downbound tow approaching lock guide wall with existing conditions. Note tendency for tow to be moved away from guide wall Photo 1. Base test; discharge 36,000 cfs, upper pool el 674.0 (Sheet 1 of 2)

24. Because of the set of the currents moving from along the right bank toward the spillway, navigation conditions for downbound tows were extremely difficult and hazardous even with the low flows tested. Downbound tows attempting to approach the guide wall would tend to be moved riverward by currents moving toward the spillway (Photo 1b). Downbound tows reaching the guide wall would tend to have their stern moved riverward unless mooring lines are attached to the wall. Upbound tows leaving the lock would also tend to be moved riverward, but no

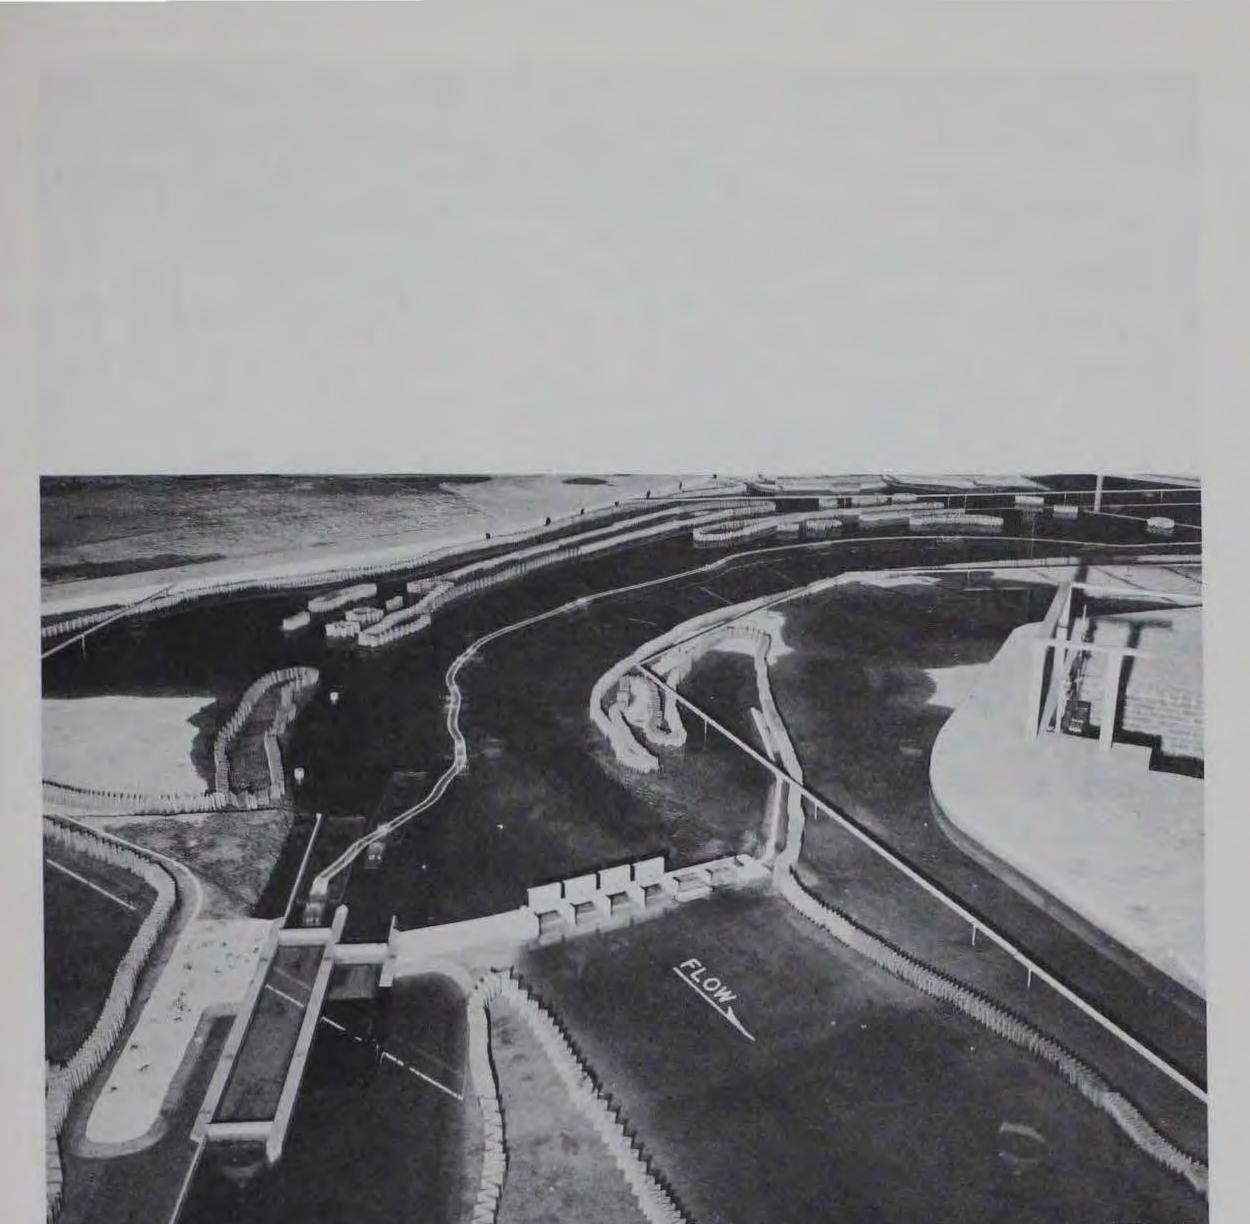
Photo 1 (Sheet 2 of 2)

c. Path of 600-ft upbound tow leaving lock showing effects of crosscurrents on head of tow

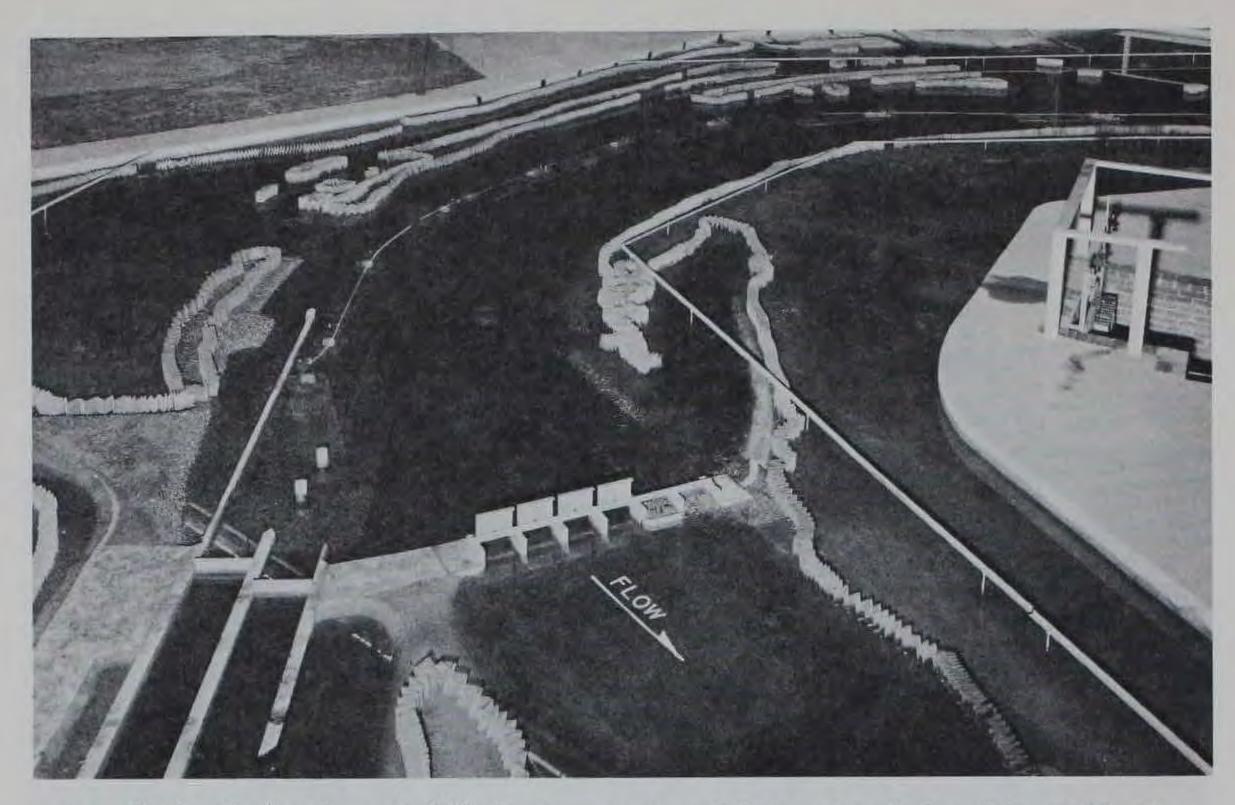
a. Path of downbound 600-ft tow approaching extended guide wall at a slight angle to wall. Note tendency for tow to be moved riverward after passing end of wall

Photo 2. Existing conditions-modified; discharge 36,000 cfs, upper pool el 674.0 (Sheet 1 of 2)

27. Because of the alignment of the currents along the guide wall extension, downbound tows could approach the guide wall with less difficulty than with the existing wall. However, the head of the tow would tend to be moved riverward by the crosscurrents a short distance downstream of the end of the wall (Photo 2a). Although navigation conditions for downbound tows would be somewhat better than those with existing conditions, the attachment of mooring lines would be required to maintain the position of the tow along the wall and to control its movement along the wall for entrance into the lock (Photo 2b). The modifications had little effect on navigation conditions for upbound tows leaving the lock (Photo 2c).

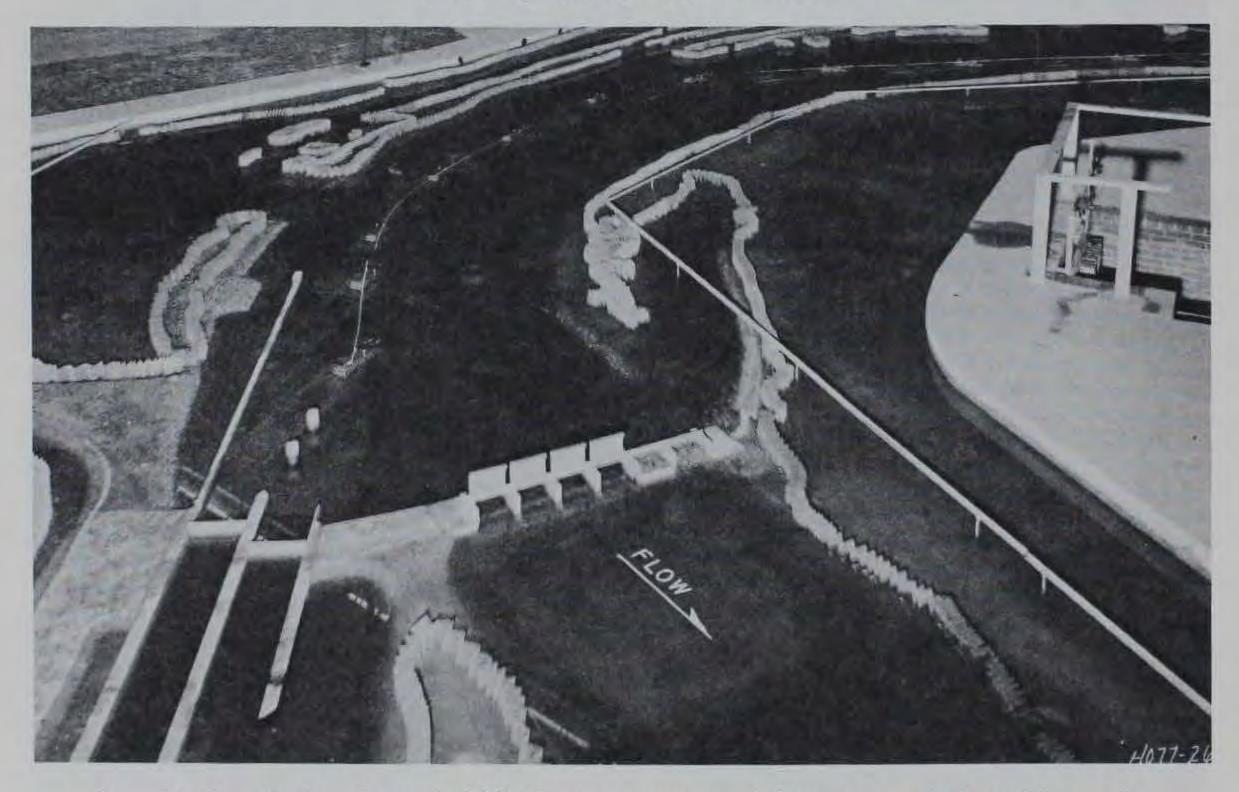
b. Path of downbound 600-ft tow approaching extended guide wall at a slight angle to wall. Note tendency for tow to be rotated clockwise

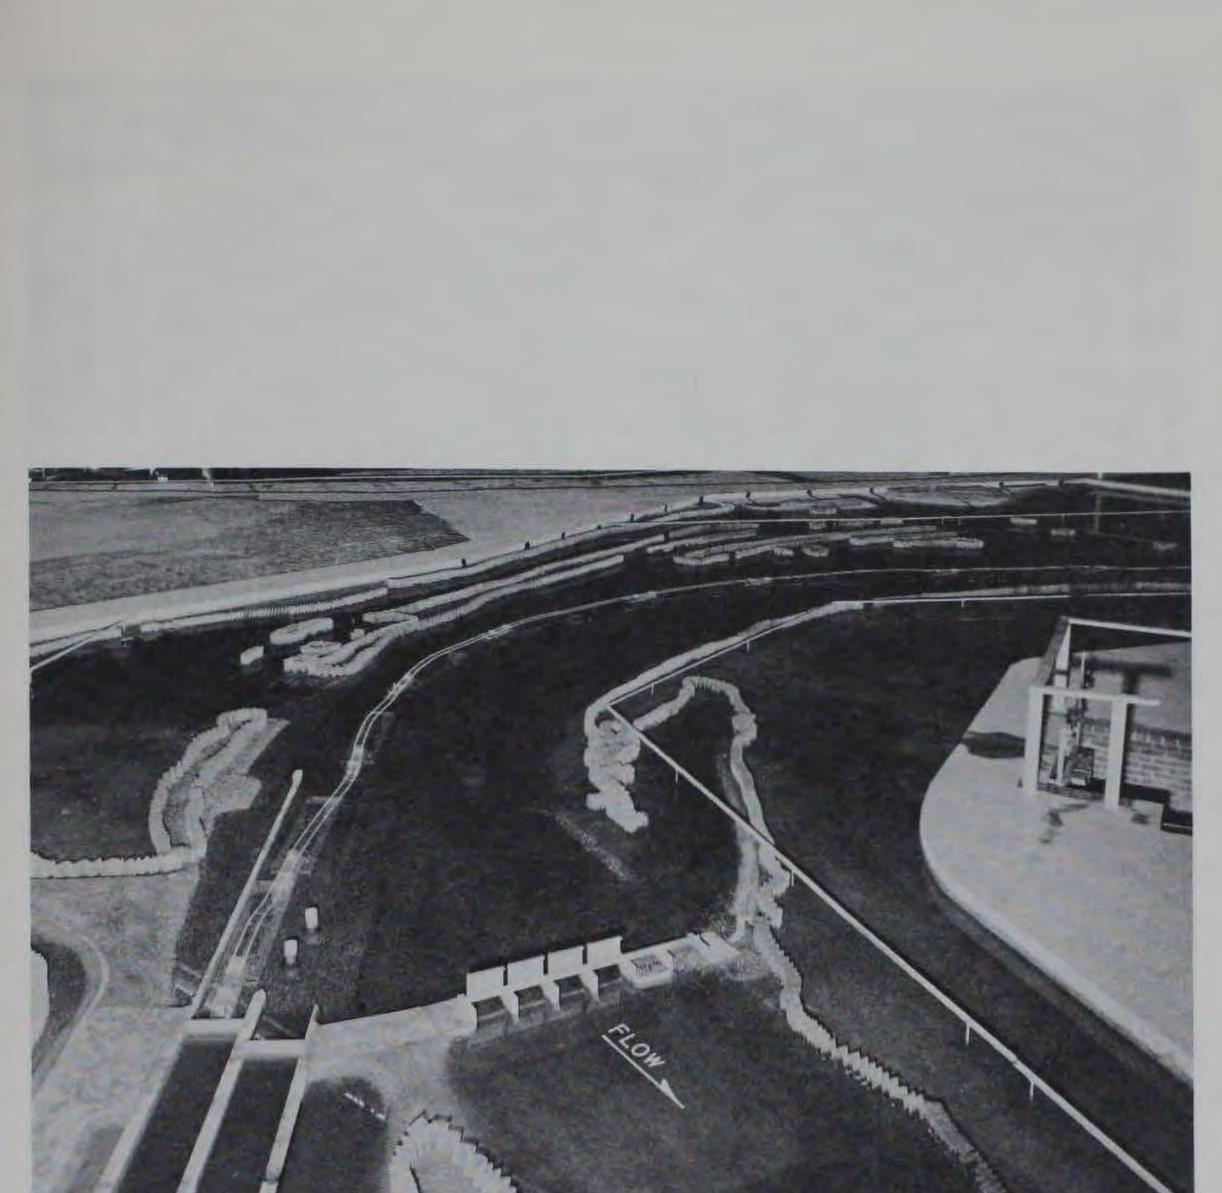
Photo 2 (Sheet 2 of 2)

c. Path of upbound 600-ft tow leaving lock. Conditions for upbound tows were somewhat better than with shorter existing guide wall

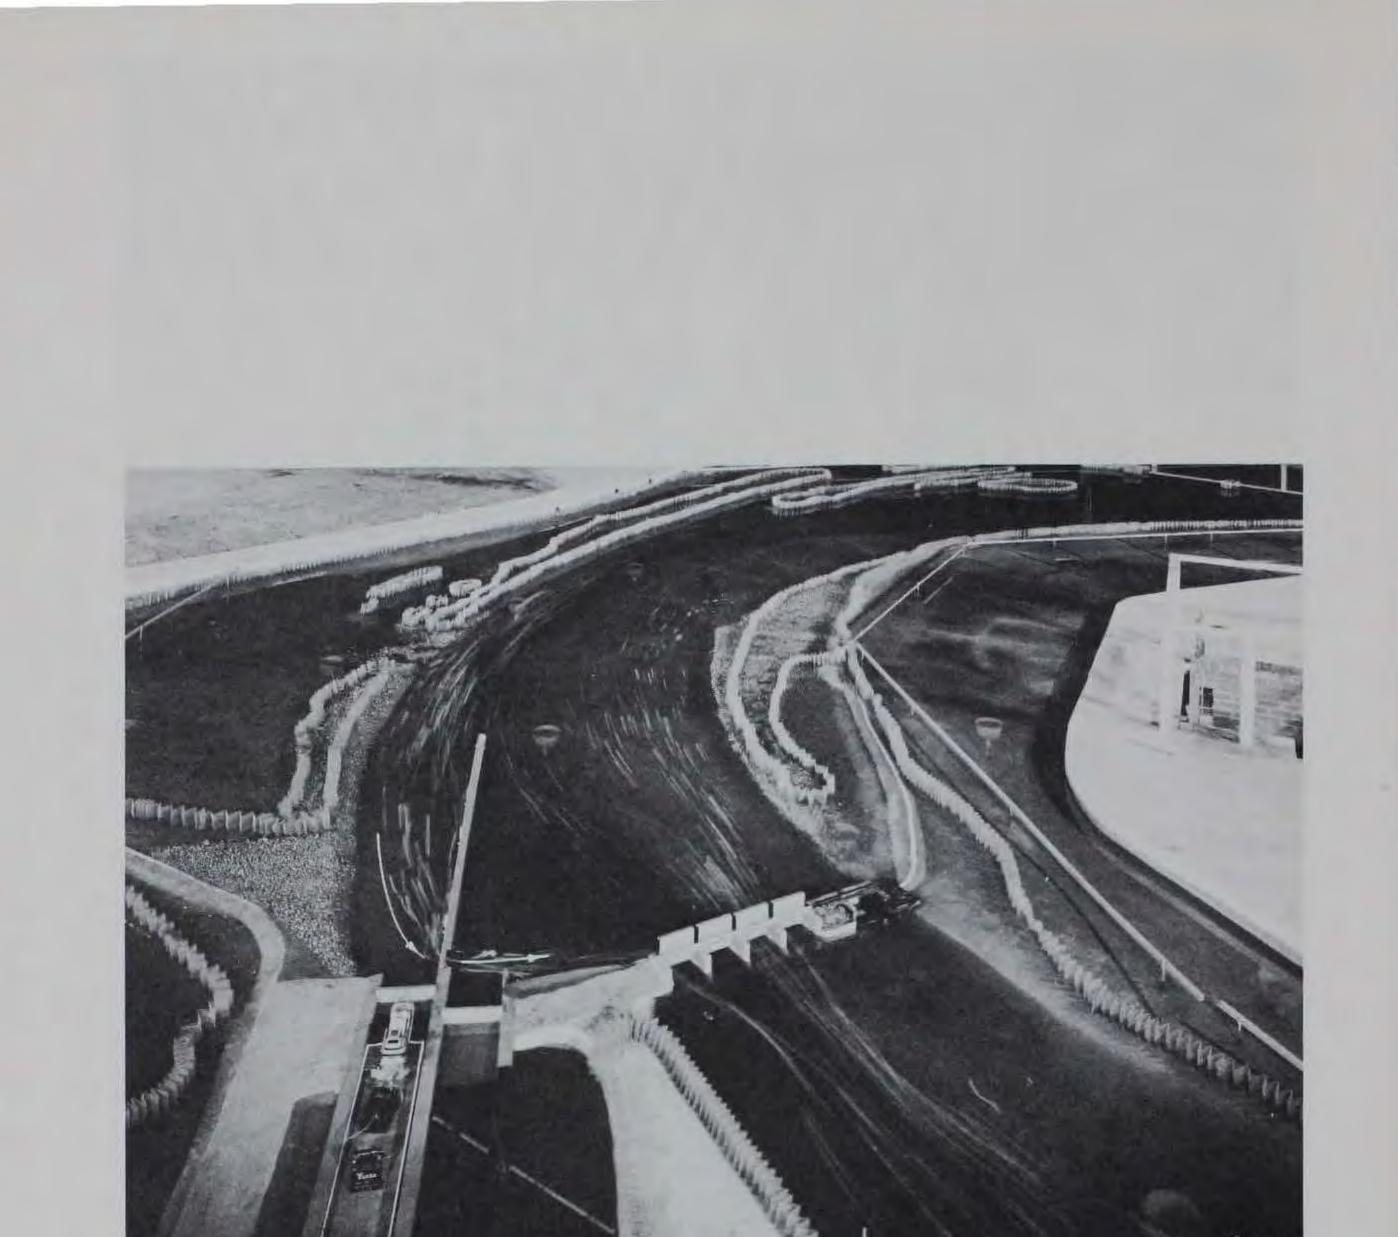
Photo 3. Plan A-modified; discharge 36,000 cfs, upper pool el 674.0. Surface currents in approaches to lock and dam. Note flow through the ice gap in upper guard wall

32. With the guard walls of plan A and plan A-modified, there would be a tendency for most of the floating debris and ice moving along the right bank to drift into the lock approach. The ice and debris gap in the guard wall would be effective in passing a considerable amount of flow and most of the loose ice and debris entering the lock approach, particularly with the longer wall (Photo 3).

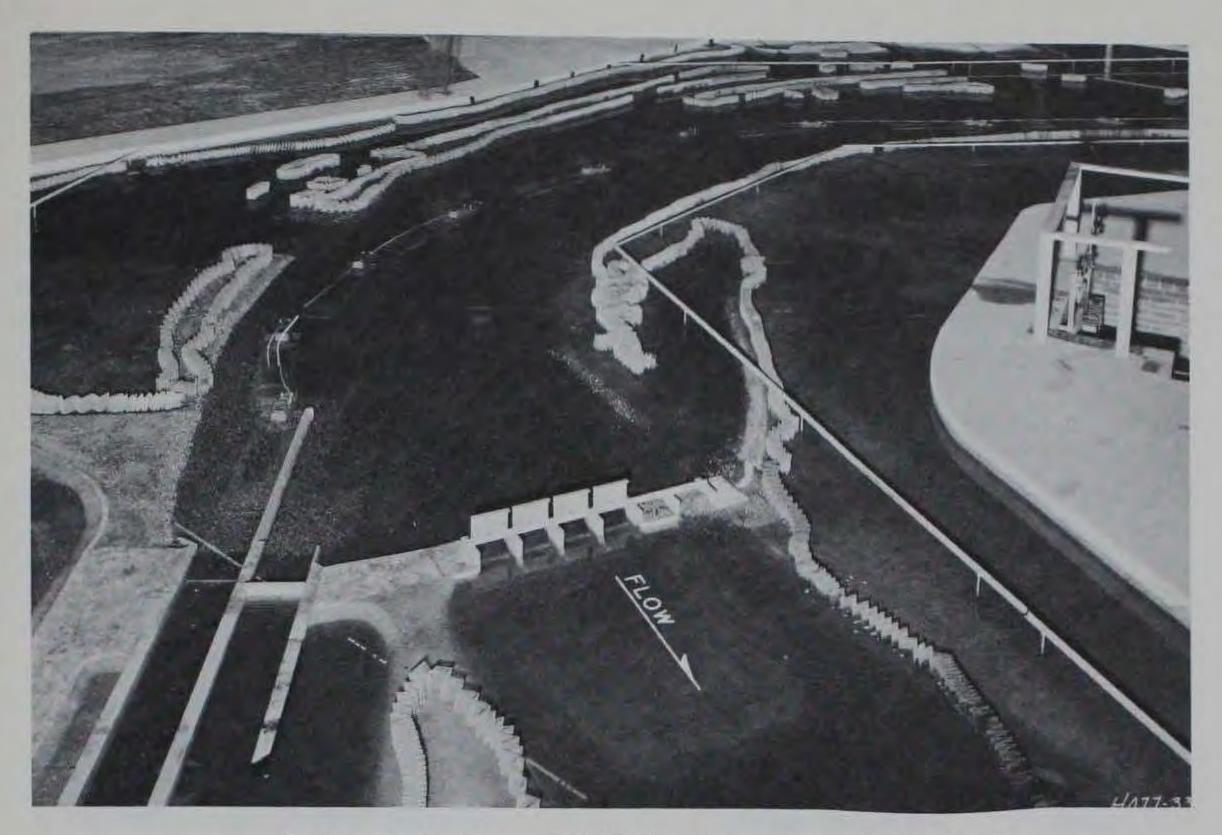
a. Path of downbound 600-ft tow approaching lock

33. Navigation conditions in the upper lock approach were considerably better with the guard walls than with the existing or modified guide wall. Tows properly aligned along the right bank could drift into the lock approach with little or no maneuvering (Photos 4a and 5a). Conditions were better with the longer wall, particularly for tows longer

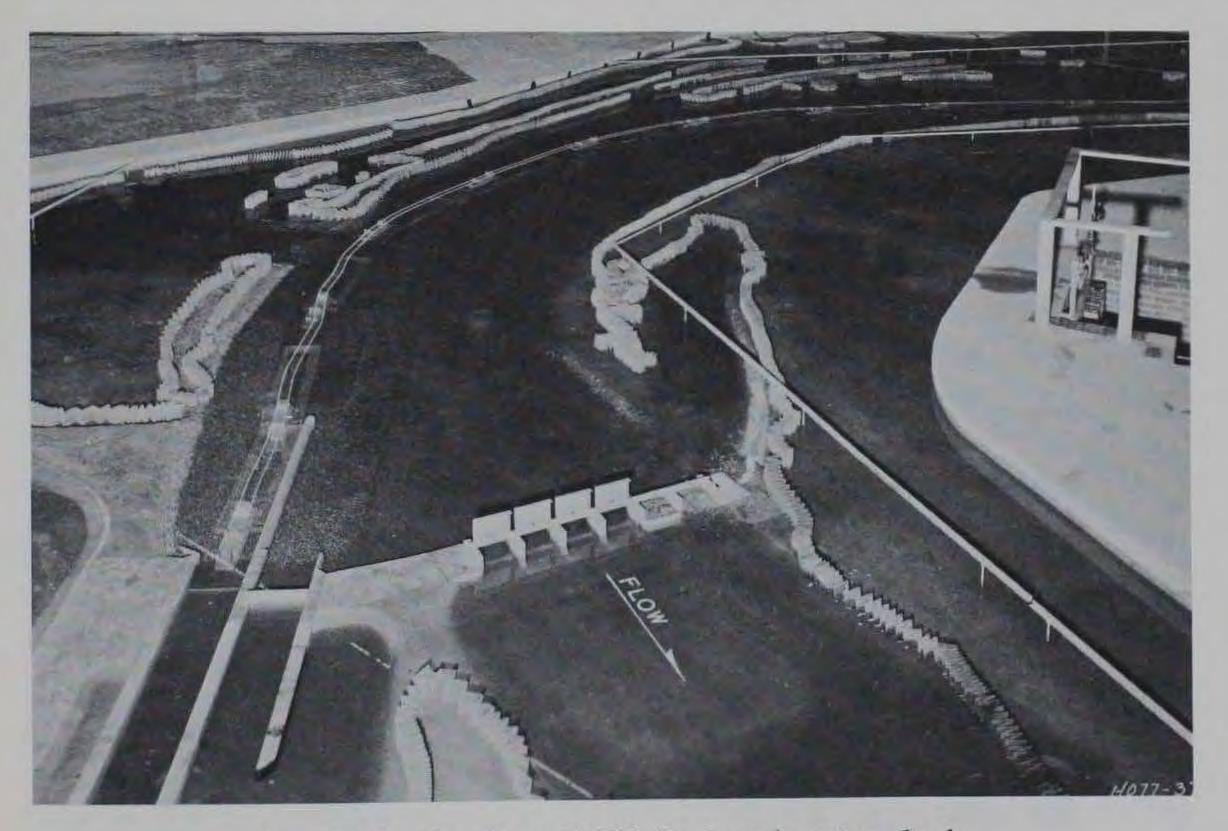
b. Path of upbound 600-ft tow leaving lock
Photo 4. Plan A; discharge 36,000 cfs, upper pool el 674.0

than 600 ft. Flow through the ice and debris gap would have little effect on large tows but could be hazardous for small boats, and a closure or barrier might be required when not passing debris and ice. Conditions were also better for upbound tows leaving the lock (Photos 4b and 5b).

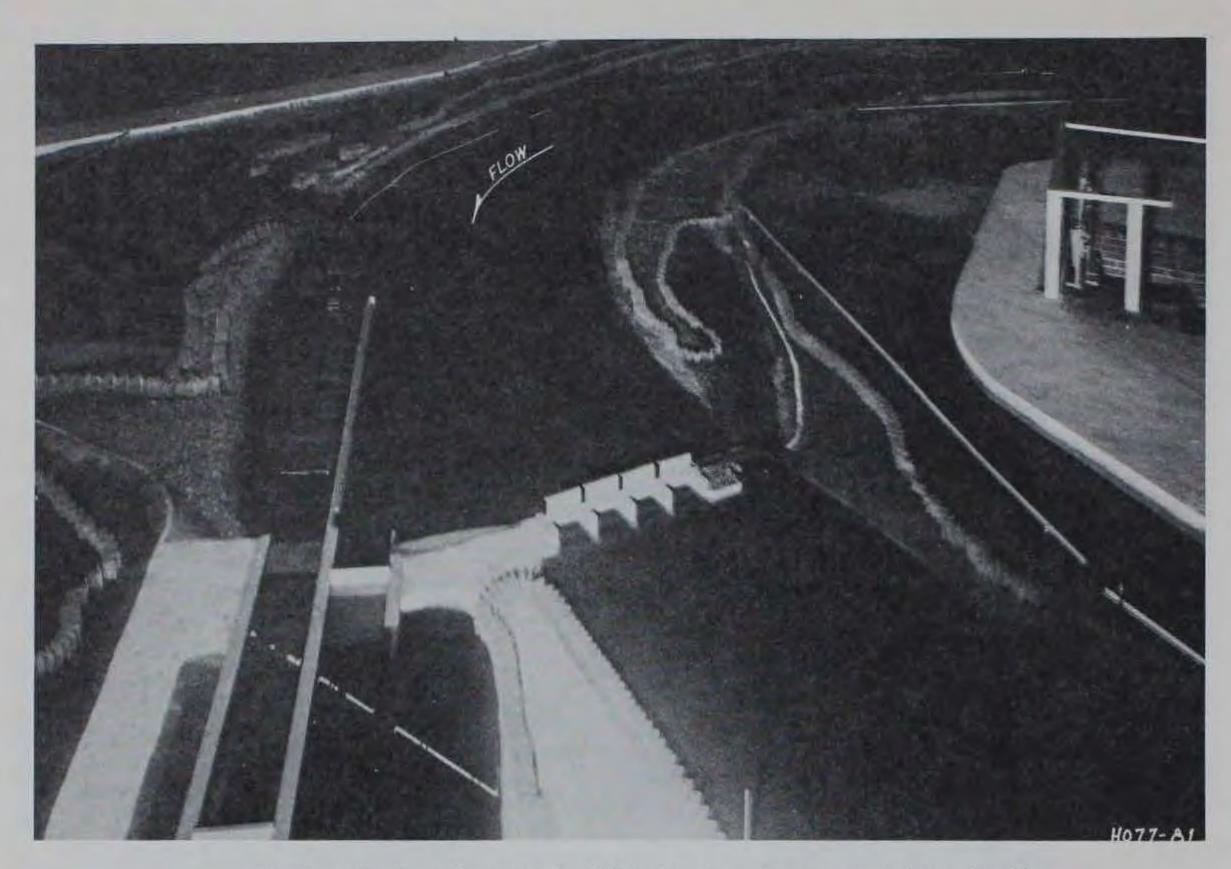
a. Path of downbound 1,200-ft tow approaching lock

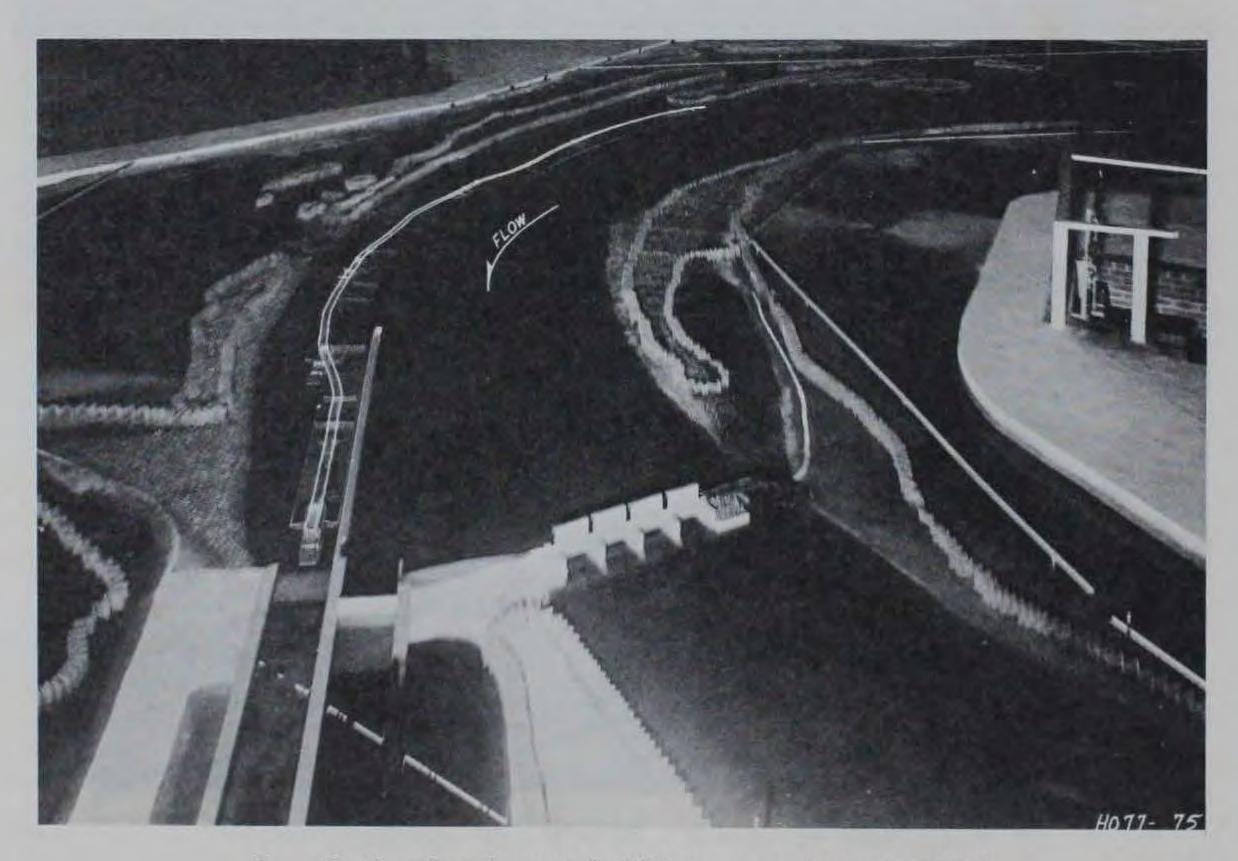
b. Path of upbound 1,200-ft tow leaving lock
Photo 5. Plan A-modified; discharge 36,000 cfs, upper pool el 674.0

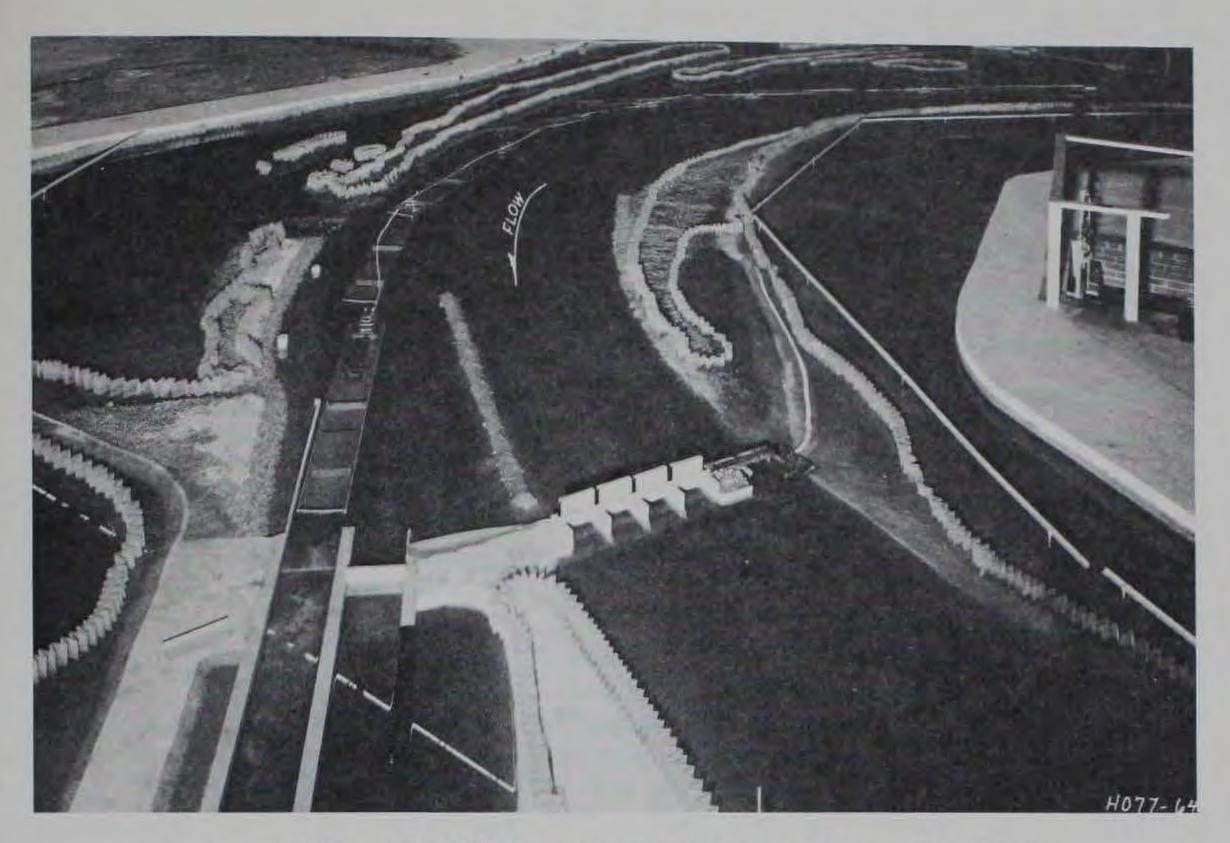
a. Path of 1,200-ft downbound tow approaching lock

66. Navigation conditions with plans H and H-modified were considerably better than those with existing conditions or with any of the other plans tested except with plans A and A-modified. Removal of the two proposed dikes along the right bank eliminated the need for tows to make a turn toward the right bank, and tows properly aligned could drift into the approach from a considerable distance upstream. Unless controlled, tows would tend to drift toward the opening at the lower end of the rock dike and land alongside the dike. However, once past the upper end of the dike downbound tows could easily be maneuvered to approach the guide wall with no danger of being moved toward the dam (Photo 6a). Conditions for larger tows would be better with plan H-modified than with plan H. No difficulties were indicated for upbound tows with either of the two plans (Photo 6b).

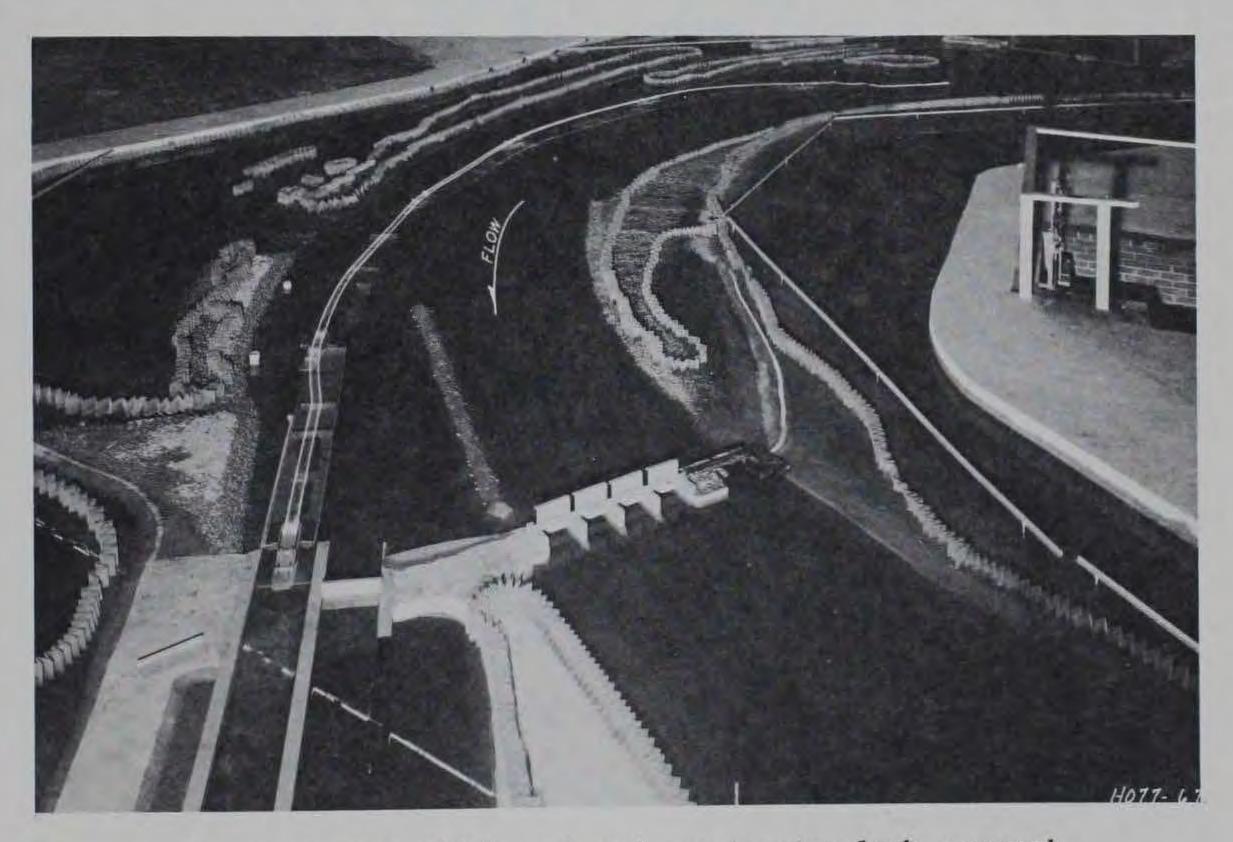
b. Path of 1,200-ft upbound tow leaving lock approach
Photo 6. Plan H-modified; discharge 36,000 cfs, upper pool el 673.7
