Final Environmental Assessment for the

West Puerto de Luna Acequia Rehabilitation Project Guadalupe County, New Mexico Section 1113 of P.L. 99-662 (WRDA 1986)

U.S. ARMY CORPS OF ENGINEERS ALBUQUERQUE DISTRICT 4101 Jefferson Plaza NE Albuquerque, New Mexico 87109

January 2010

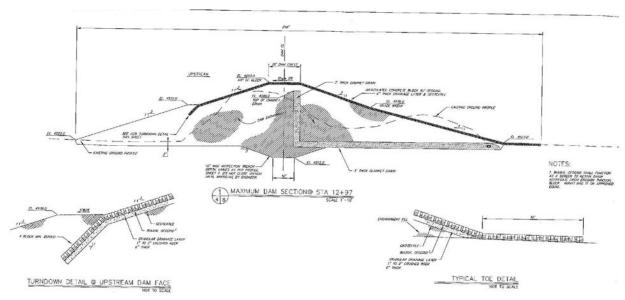
Figure 4: Design cross section

The Corps proposes to rehabilitate the West Puerto de Luna Acequia by reconstructing the washed out fill section of the irrigation diversion dam to pre-disaster function and design (see Appendix A for photos). The new structure would be earth-filled, have a centerline cross section of 120 feet at the top, 60 feet at the bottom, a height of 35 feet and a width of 40 feet (Figure 4). Total earthen fill volume would be 12,834 cubic yards (cy) and would use 2:1 slopes along the stream. The upstream fill face would have grouted rip-rap three feet thick as additional protection. The concrete spillway and rock gabions that were not washed away in 2005 would be removed during the proposed project. Three potential borrow areas for this project have been identified (Figures 2 and 3).

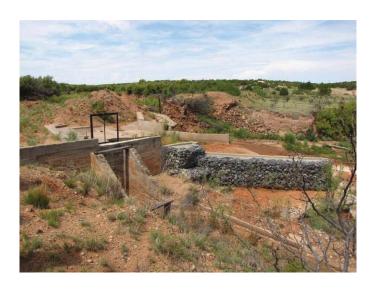
West Puerto de Luna Acequia head gate and washed-out diversion dam, looking north.

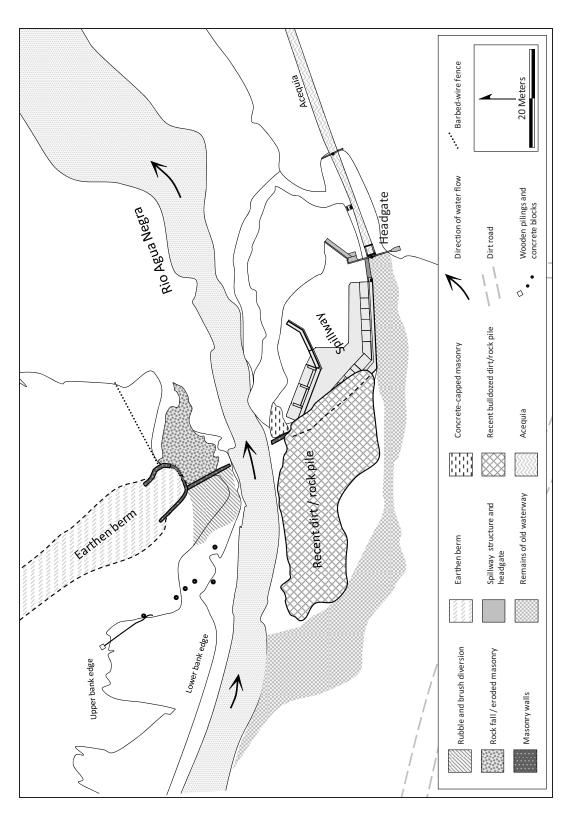
Figure 4.1. Map showing current diversion complex and associated structures.

The diversion complex consists of three major sets of components: a northern earthen berm with retaining walls, a series of wooden pilings, and an armored bank; the diversion itself, a large brush-and-rubble diversion that once crossed the Agua Negra channel; and a southern concrete spillway, with associated gates and other features. An overview illustration of the diversion complex is presented in Figure 4.1. This section will first describe in detail the current condition of this diversion complex, providing drawings and photographs of key elements, followed by a discussion of the extrapolated pre-breach configuration of this complex.

The main components of the diversion complex on the north side of the river are a large earthen berm with associated retaining walls, an segment of the river bank adjacent to the diversion that appears to have been heavily armored with rock; a series of heavy wooden pilings connected to each other with steel cable; and the northern portion (with cross-section) of the rock and brush diversion itself (see again Figure 4.1). Each of these is described in detail below.

On the north side of the river, there is a raised earthen berm extending from the diversion approximately 90 meters to the northwest (Figure 4.2; see again Figure 4.1). As it approaches the diversion, it measures between approximately 8.7 meters wide to a maximum of 13.5 meters wide, with a height above surrounding ground surface ranging between approximately one and two meters. At the berm's southern end, where it reaches the upper river bank and the beginning of the rock-and-brush diversion dam, it is surrounded on west, south, and eastern sides by masonry retaining walls (Figure 4.3).

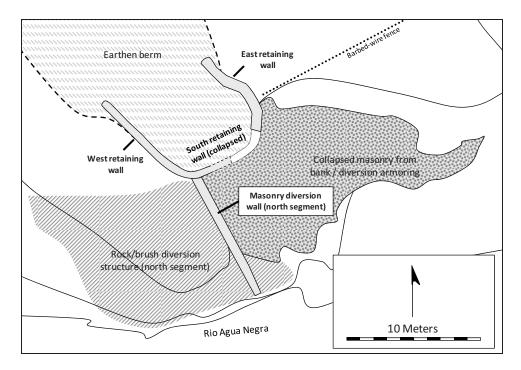
Figure 4.3. Northern portion of diversion complex showing retaining walls, masonry bank armoring, diversion remnants and portion of berm.

The retaining walls are built of coursed and unshaped or minimally shaped tabular sandstone slabs. The walls vary from approximately 70 to 130 cm in height, and between 7 and 10 courses tall. Walls are between one and two courses deep, and none show evidence of mortar. A retaining fence of chicken wire secured to rough-hewn wooden posts extends around the entire southern end of the earthen berm, serving to support all of the remaining masonry retaining walls. The wire fence itself is failing at multiple locations.

As noted above, there is a large, dense scatter of unshaped tabular sandstone covering the northern river bank and the eastern face of the remaining portion of the rock and brush diversion dam, extending in a disorganized and displaced fashion down to near the river channel (Figure 4.3, Figure 4.8, and Figure 4.9). This masonry appears originally to have been installed as a method of armoring the northern river bank against erosion, as well as strengthening the downstream face of the diversion dam and protecting it from erosion as well. After the dam was breached, much of this appears to have been eroded, displaced and collapsed. The original extent of this armoring is unclear, but it appears to have extended over some portion of the northern bank and at least over the entire eastern face of the diversion dam (see discussion of diversion structure below).

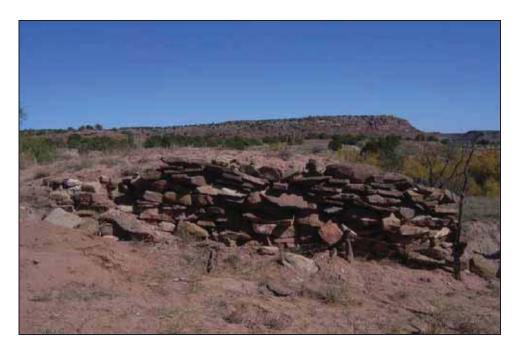
Figure 4.4. Western retaining wall, facing east.

The eastern and western retaining wall segments are still largely intact, the most intact being the western wall. The western retaining wall is mostly straight and largely undamaged. It is between four and ten courses high (Figure 4.4, Figure 4.5). The eastern retaining wall is curved, following the curvature of the end of the earthen berm (Figure 4.6, Figure 4.7). It is two courses deep and between six and nine courses high. It is partially collapsed, but is being held in place by the wire fence, visible in Figure 4.6. The southern retaining wall, however, has largely collapsed, with the rock falling downslope onto a large mass of collapsed sandstone rock originally used to armor the northern river bank (Figure 4.3; also visible in Figure 4.8). The sandstone used in all of these walls and in the collapsed masonry now littering the northern river bank all appears to be of the same type, and likely came from the same general source areas.

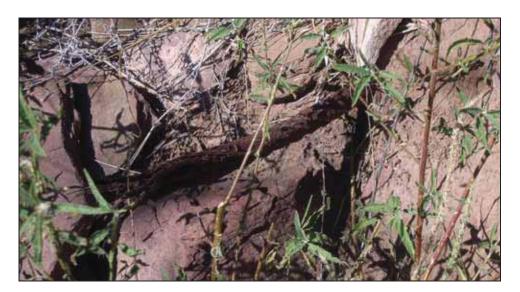
Figure 4.10. Braided steel cable found among collapsed sandstone rubble.

Within the rubble downslope, archaeologists noted a severed segment of one-inch braided steel cable of the same type found associated with wooden posts/pilings appearing west of the berm and diversion structures. These are discussed in greater detail below; the precise association of this cable with those is unclear, however, as the cables on the western side of the berm appear to be connected to a large series of wooden pilings that have not been found on the eastern side of the diversion.

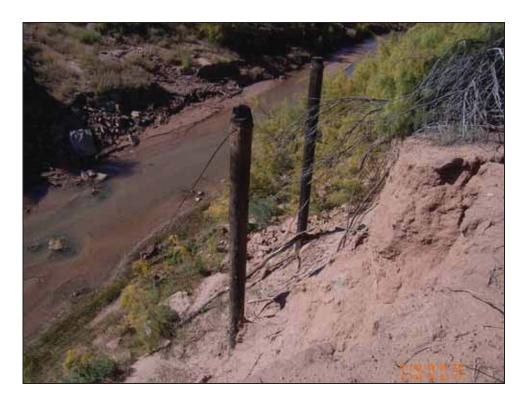
Figure 4.11. Wooden pilings eroding out of northern bank, facing southwest.

The actual purpose of these posts, all apparently connected to other posts with steel cable, is unclear. It is possible that they were intended to shore up and strengthen the diversion structurally. It is also possible that they served as supports for some sort of other structure, such as a bridge or similar feature.

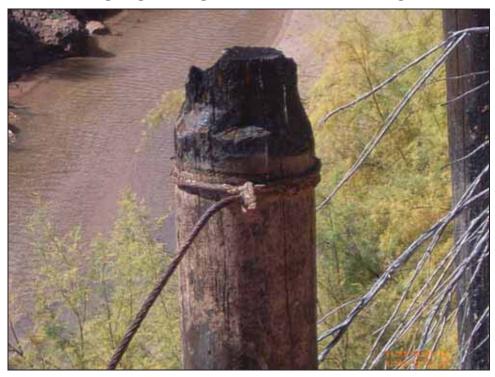
Figure 4.12. Top of one of the wooden pilings eroding out of the south bank, showing attached steel cable, facing west. Dangling cable end points southeast.

In addition to these, a number of additional posts / pilings were observed in less-eroded areas to the north. All posts have the same dimensions (one-foot diameter, and handhewn to a tapered size of approximately nine inches; see Figure 4.12), and several still have segments of steel cable attached (Figure 4.13, Figure 4.14). In all cases, the steel cable is looped once fully around the post. As seen in the site map (Figure 4.1), these are not arranged in a highly ordered fashion or evenly spaced, but with the exception of the two southernmost extant posts, these appear to be arranged in a straight line oriented from northwest to southeast. The two remaining posts eroding out of the bank itself suggest that these may originally have been arranged in two parallel rows; however, the area where this second row might have been has now been completely eroded, and no displaced pilings were noted in the area.

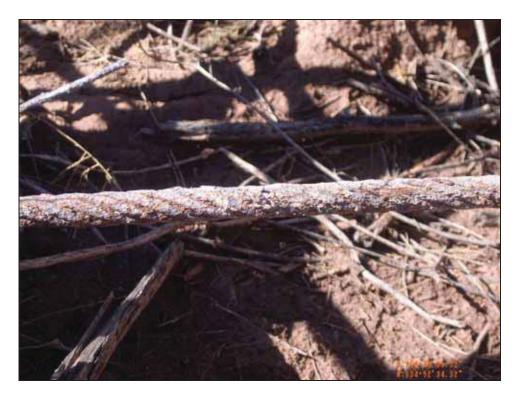
Figure 4.13. Steel cable connecting wooden pilings to one another.

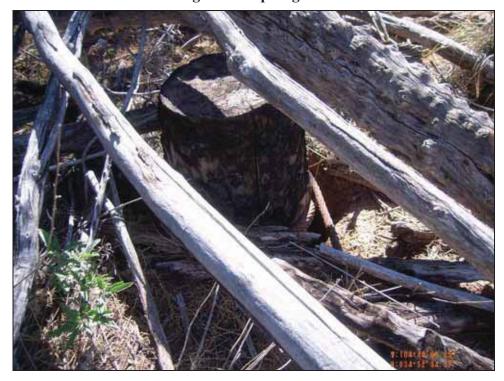
Figure 4.14. Another wooden piling protruding approximately one foot above current ground surface. Note steel cable wrapped around it.

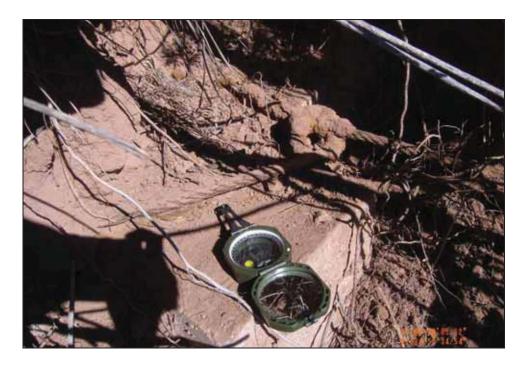
Figure 4.15. Concrete blocks and steel cable.

Following the steel cables in a line toward the northwest, field personnel noted a series of concrete blocks set into the ground and eroding out of an arroyo cut. These concrete blocks appeared to serve as an anchor point for the northernmost segment of steel cable (Figure 4.15). The drawing presented in Figure 4.16 shows the configuration of the blocks that were visible in the field; there appeared to be a minimum of three blocks of roughly cubic shape, measuring 30 centimeters on an edge. The steel cable is formed into a loop with a knot; however, the portion of the assembly that the cable is looped around is not evident in what is now visible.

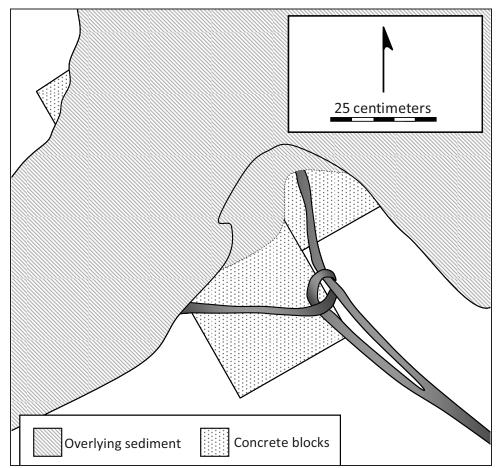
Figure 4.16. Plan-view drawing of steel cable and concrete blocks.

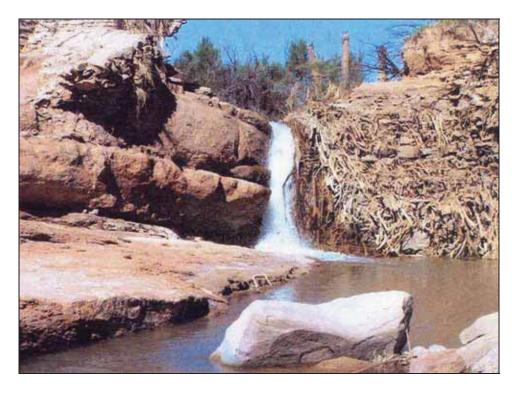
Figure 4.17. View of the diversion dam after the initial 2005 breach, facing west. Note wooden pilings visible over the top left.

In addition to the posts observed during this survey, a photograph of the diversion structure taken after the first incomplete breach in 2005 shows the presence of three pilings matching these in description situated just west of, or possibly within, the diversion dam itself (Figure 4.20). Triangulating from other features in the photograph, however, it does not appear that these are the same three posts that were observed eroding out of the bank during the survey; based on other landmarks in the photograph, it appears that these posts may have been located within the diversion structure itself. No remnants of these posts were noted on survey.

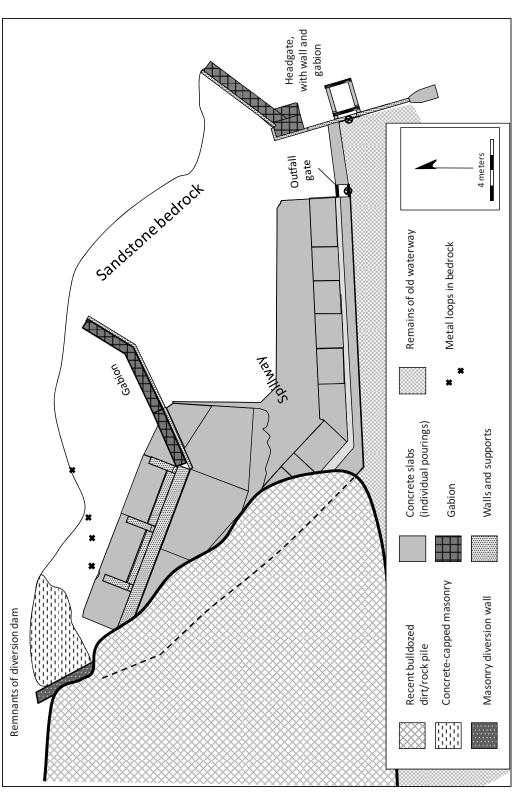
Figure 4.18. Overview of spillway and headgate, showing remnants of diversion dam (masonry wall with concrete-capped masonry armoring), outfall, and headgate.

The south side of the river is dominated by the acequia diversion's spillway, an agglomeration of concrete, masonry, and gabion elements (Figure 4.18). In addition to the spillway is an outfall gate immediately southeast of the spillway, and the headgate to its east. The headgate structure is essentially a concrete wall and gabion with a sliding metal gate. In addition, the south side also contains remnants of the original diversion structure, including a portion of a masonry wall that once extended across the channel as part of the diversion dam (joining with the northern segment mentioned immediately above), and a portion of masonry that originally armored the eastern face of the dam and was capped with concrete (Figure 4.18, near upper left portion of drawing).

The spillway is a set of connected concrete and masonry elements that together worked to channel the flow of water along the spillway's southern margin to the location of the headgate just east of the spillway's southern edge. Excess water would then flow over the top of the spillway's southern margin and down a series of flat and/or concave concrete slabs and three natural large sandstone bedrock ledges before returning to the Rio Agua Negra (Figure 4.18, Figure 4.22; see also Figure 4.1).

As illustrated in Figure 4.18, the primary components of the spillway are: a low wall forming a rough "L" shape, which directed water toward the headgate; a series of flat and concave concrete slabs immediately adjacent to the "L"-shaped wall, armoring the ground and directing flow of water spilling over the wall; a sandstone masonry wall plastered with concrete, with three perpendicular support walls abutting the wall's north face; and an additional concrete wall with gabion extending northeastward from the wall's eastern edge. Descriptions of each of these components follow.

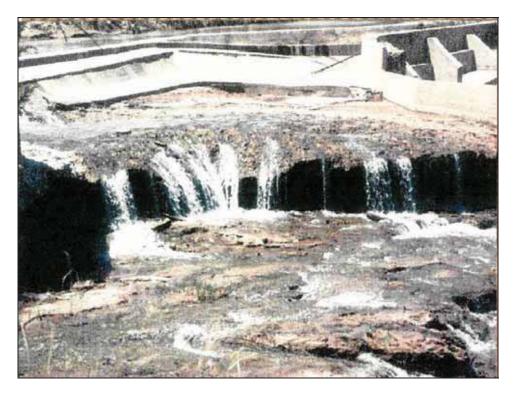
Figure 4.19. Spillway before breach, facing southwest. (Photograph courtesy of the West Puerto de Luna Acequia Association).

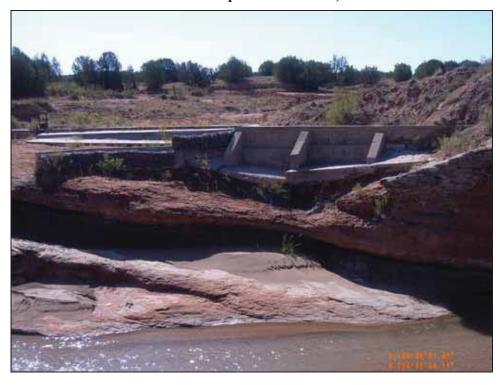
Figure 4.20. Overview of wall and gabion portions of spillway complex, facing south.

On the northern side of the masonry/concrete spillway wall, there are three small concrete support walls oriented perpendicular to the main wall, and reinforced with smaller concrete bracing elements oriented parallel to and abutting the main wall (Figure 4.29; see also Figure 4.18 and Figure 4.20). These rest on two separate concrete slabs, one of which (the eastern one) appears to be older than the other. Based on abutment and superposition relationships, the construction sequence appears to be: (1) masonry/concrete wall; (2) horizontal slabs; (3) vertical/perpendicular reinforcement walls; and (4) parallel

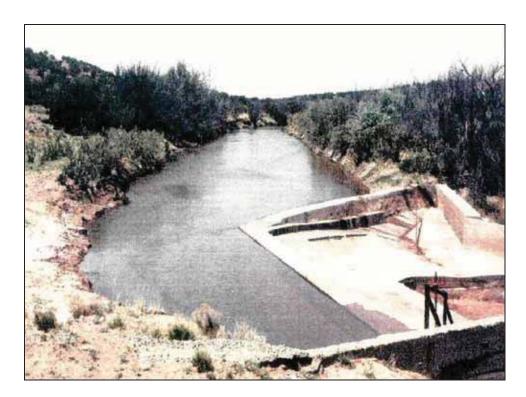
Figure 4.21. Diverted water approaching spillway and headgate, before the breach. (Photograph courtesy of the West Puerto de Luna Acequia Association).

The southern portion of the spillway served as a low wall to channel water diverted from the Rio Agua Negra eastward toward the headgate, as shown in the photograph in Figure 4.21, taken when the acequia was still functioning. If water levels exceeded the height of the low wall (approximately 30 centimeters in height), the excess would flow over the wall and concrete slabs that form the spillway, emptying onto bare sandstone bedrock. The water would flow over three discrete sandstone ledges (see Figure 4.1 and Figure 4.19) before emptying into the river channel. At present, the spillway is partially covered on its western edge by a large pile of dirt and rock, bulldozed into place within the last four years, dating after the breach of the diversion (Figure 4.22, Figure 4.23).

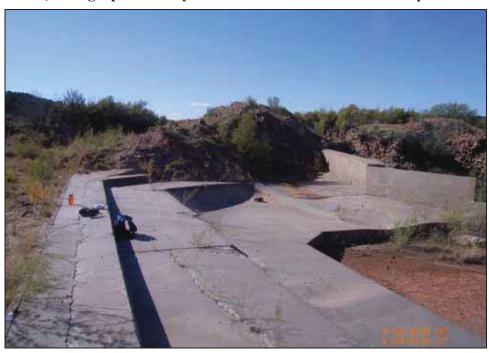
Figure 4.22. View of southern portion of spillway, facing west. Note recent bull-dozed rock / dirt pile covering the spillway's western edge.

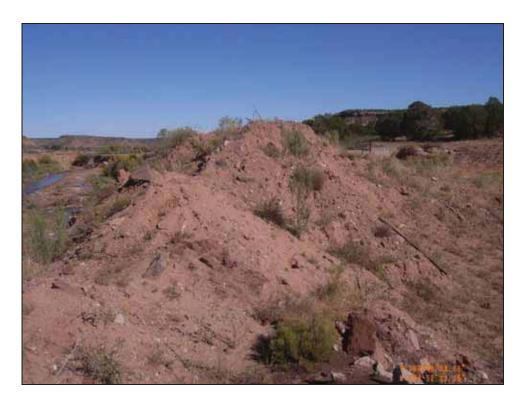
Figure 4.23. Large pile of rocks and dirt recently bulldozed over part of the spillway. This was done after the diversion was breached in 2006.

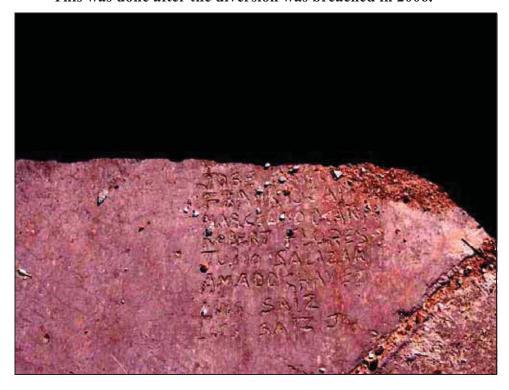
Figure 4.24. Inscription in concrete slab near southern spillway edge, listing names of acequia association members. Date inscribed is June 1957.

The concrete slabs that make up most of the spillway were laid at different times; most of them appear to be fairly old based on the levels of erosion and wear present on them, while others appear to be later patches and additions. One slab, located near the elbow of the "L" shape, bears an inscription dated June 1957 (Figure 4.24); the full text of the inscription is as follows:

SEO PROJECT 18E
JUNE 1957
ORMONDE EARP.
JOSE GARCIA
FRANK OCANA
MARCELINO OCANA
ROBERT FLORES
JULIO SALAZAR
AMADO CHAVEZ
LUIS SAIZ
LUIS SAIZ JR.

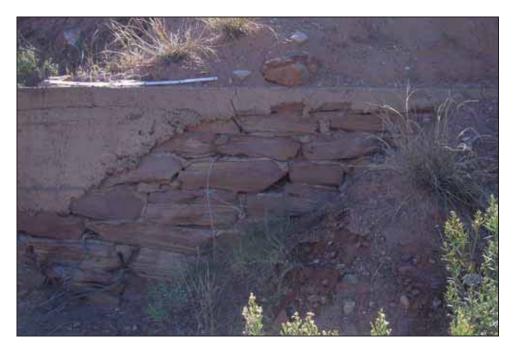
Figure 4.25. Eastern portion of northern spillway wall, showing original sandstone masonry visible under fragmented concrete plaster. Folding ruler at top left is one meter in length.

As the photograph in Figure 4.25 shows, this masonry wall was later plastered over with concrete; the masonry itself is only visible on the northern face of the wall at its far western end, where it is nearest to the remnants of the masonry diversion wall. The concrete used to cover the masonry wall was reinforced by an irregular array of wire segments, which still protrude from the wall surface, as seen in Figure 4.26.

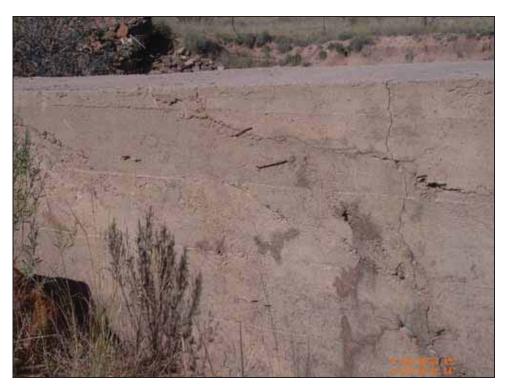
Figure 4.26. Southern face of the masonry spillway wall, facing north, showing wire used to reinforce concrete plastering covering wall face. Note also multiple patching / plastering events visible on this wall face.

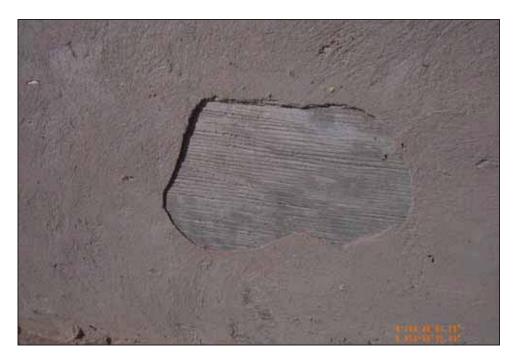
Figure 4.27. Close-up of hole in concrete plaster, showing different concrete surface underneath.

bracing walls. The time between these construction episodes is unclear; however, it appears that the original construction of the masonry wall likely predated the construction of the other elements by some time, as they are of substantially dissimilar construction. The reinforcement walls and bracing elements may very well have coincided with the original addition of concrete plaster to the masonry wall, however, as wood grain patterns of the type seen in Figure 4.27 are highly visible on almost all surfaces of these later support elements.

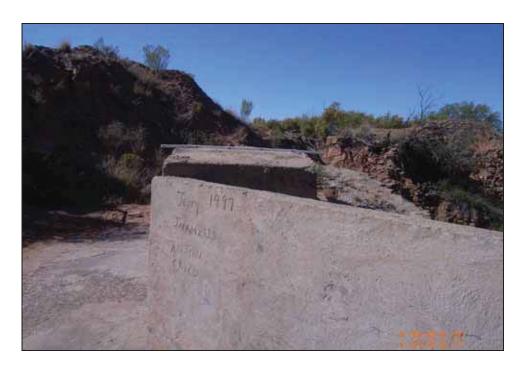
Figure 4.28. End-on view of masonry/concrete spillway wall, facing west, showing wall with gabion in foreground.

Adjoining the eastern end of this original wall is another wall that extends to the northeast, and which abuts a gabion basket structure oriented the same way (Figure 4.28, Figure 4.29; see again Figure 4.18). This wall abuts and therefore postdates the earlier wall, and appears to be quite recent; an inscription in the concrete surface of this wall reads "1997 JERRY JARAMILLO ANTON CHICO." While this might only date the plastering of the wall, the condition of the wall and gabion are such that this likely dates their construction.

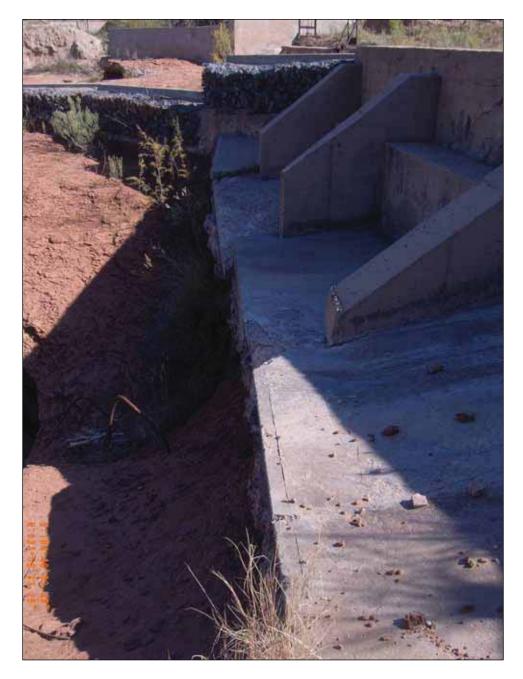
Figure 4.29. View of wall at north end of spillway, with gabion in background.

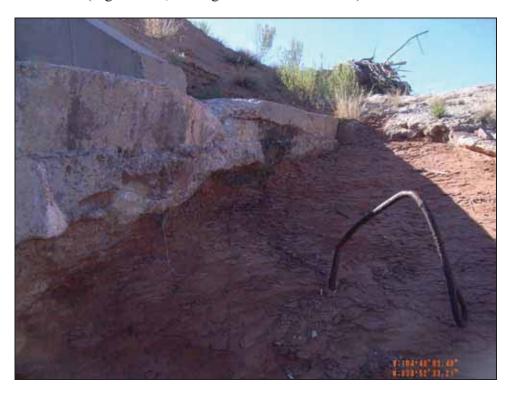
Figure 4.30. Metal rebar loop driven into bedrock adjacent to spillway structure.

Just north of the spillway, driven into the exposed bedrock, are four metal loops of undetermined function (Figure 4.30; see Figure 4.18 for locations).

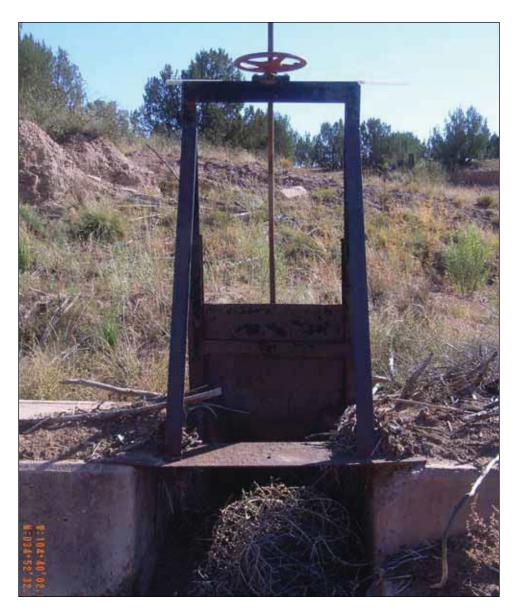
Figure 4.31. Sliding metal outfall gate with screw-type mechanism, situated at eastern end of spillway.

Immediately adjoining the southwest corner of the spillway is a metal outfall gate (appearing before the headgate) allowing water to be released back into the river before entering the headgate. This gate is a welded steel frame with a sliding metal gate, controlled with a screw-type mechanism operated via a metal wheel mounted parallel to the ground (Figure 4.31). This gate is of similar construction to the acequia's headgate, described later in this chapter.

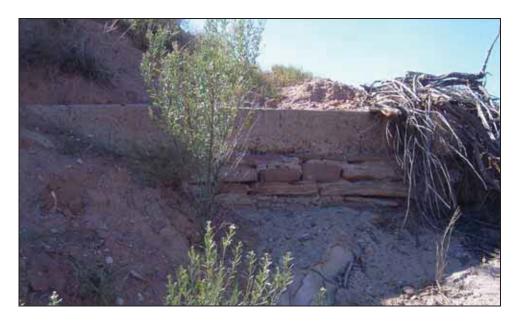
Figure 4.32. Segment of masonry diversion wall adjacent to northwestern corner of spillway.

While the masonry diversion wall (noted above in the description of the area north of the river) is not properly part of the spillway, it does connect to it and will be briefly described here. A segment of this wall, which once traversed the river channel as part of the diversion structure itself, remains on the very edge of the southern bank of the river, and adjoins the spillway at the spillway's northwest corner (Figure 4.18). The wall is of tabular sandstone masonry, the same type as both the northern segment of the same wall, and the same as the northern spillway wall (Figure 4.32). Immediately to the east of this wall segment is a concrete-capped clump of masonry that once formed part of the diversion's eastern face; this remains in place due to the adhesion of the concrete to the bedrock. These elements will be described in further detail below, in the description of the diversion.

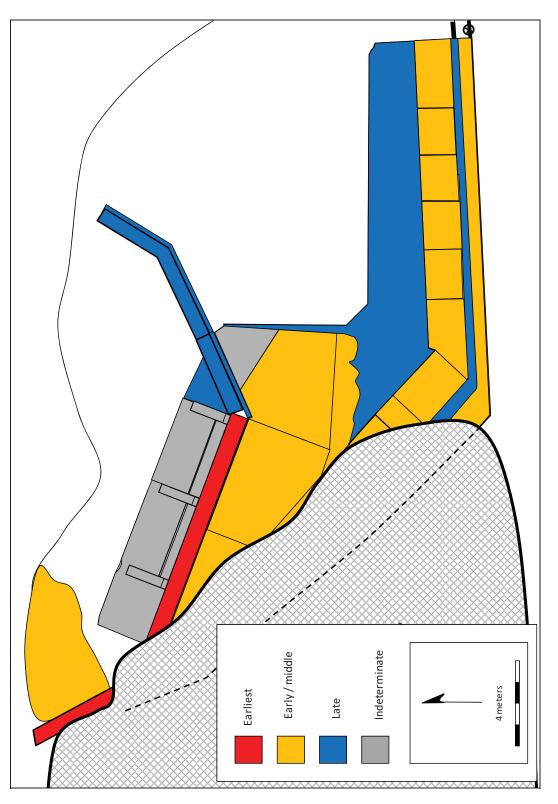
Figure 4.33. Schematic diagram of spillway, showing approximate relative ages of elements.

Figure 4.33 shows the relative sequence for the overall spillway and nearby structures. The northern spillway wall and the adjacent masonry diversion wall appear to be the earliest portions of the complex, and are assumed to date to the dam's 1940s construction. After these, the next oldest portions appear to be the flat concrete slabs forming much of the spillway, and including the slab with the 1957 date described above; the concrete cap on the masonry armoring the diversion face is here termed of "early / middle" age, given that it likely post-dates the masonry wall, but it is not clear by how long. The late portions of the complex appear to be a concrete patch extending along the southern edge of the spillway, as well as the large strip of concrete forming the northern and eastern margins of the spillway itself (not including the northern spillway wall and gabion). In addition, the gabion adjoining the northern spillway wall appears to be the latest addition to the spillway.

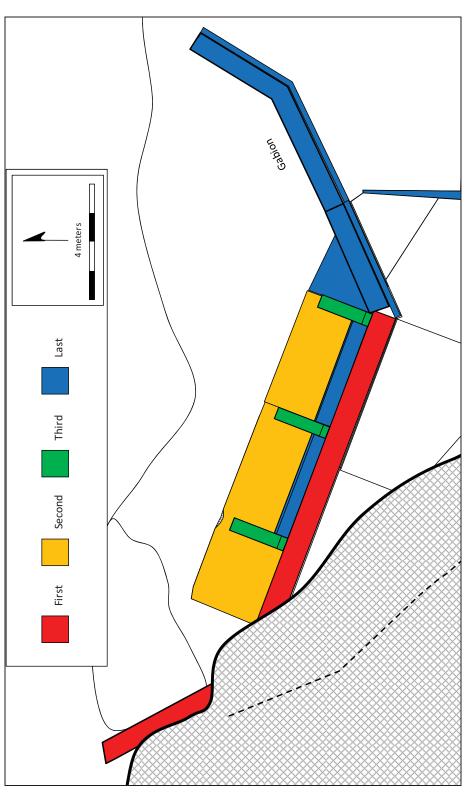
Figure 4.34. Schematic diagram of spillway walls only, showing relative construction sequence based on abutment relation-

Figure 4.34 shows the relative construction sequence for the northern spillway wall based on abutment relationships. The wall itself was constructed first, followed by the flat concrete slabs. Upon these slabs were constructed the three vertical/perpendicular reinforcement walls, and the bracing elements between them were constructed last.

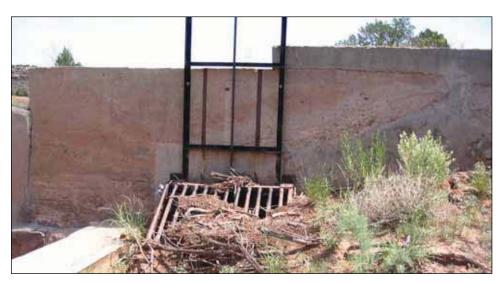
Figure 4.35. View of headgate, facing east.

The headgate is set into a concrete wall that appears to have been built in at least two episodes, as evidenced by the different types of concrete visible on the faces of the wall (Figure 4.35). This wall is 25 centimeters thick at all points, and measures approximately 9.5 meters in length and between 195 and 225 centimeters high. The headgate assembly itself is a welded metal frame measuring 120 centimeters in width, and supports a sliding metal gate operated via a screw-type mechanism operated with a metal wheel. At the wall's southern end, there is a wider concrete pad set into the ground approximately 180 cm in length (Figure 4.36, Figure 4.37).

Immediately in front of the headgate is a large grating made up of 13 welded metal pipes (each pipe two inches in diameter), which served to block large debris from entering the acequia (Figure 4.35, Figure 4.36). This grating is approximately triangular in cross-section, with a base measuring approximately 2 meters in length and a height of approximately 60 centimeters.

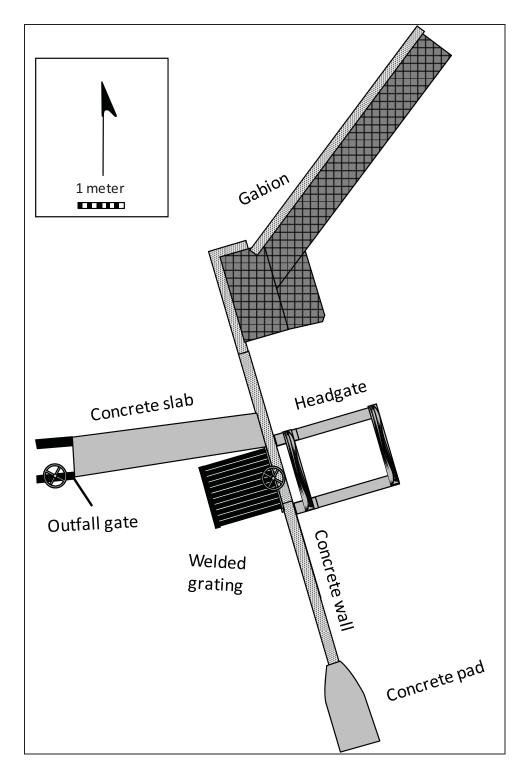
Figure 4.36. Diagram of headgate and associated features.

The headgate feature consists of a concrete wall oriented approximately northwest to southeast; a gabion extending from the wall's northern end toward the northeast; a welded metal frame with sliding metal gate on the west side of the wall, and two smaller concrete walls on the eastern side of the wall, leading directly into the acequia itself (Figure 4.36). This headgate and associated features will be left intact by the current project.

Adjoining this concrete wall at its northern end is a gabion and associated wall, which extend at an angle toward the northeast (Figure 4.36, Figure 4.37, and Figure 4.40). The gabion is approximately seven meters long and 80 centimeters wide, and matches the gabion adjacent to the spillway wall in form and construction. A date inscribed on the exterior of the concrete wall associated with the gabion reads:

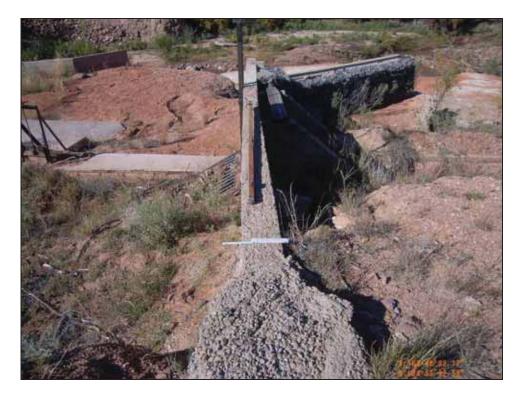
Figure 4.37. View of the headgate structure from the south, showing concrete wall and gabion.

The eastern side of the wall contains two smaller concrete walls perpendicular to the main wall and flanking the gate opening as the water enters the acequia (Figure 4.38, Figure 4.39). These walls are approximately 20 centimeters thick, and are approximately 230 centimeters long at the base. They are trapezoidal in cross-section, tapering at the top to a length of 51 centimeters. (see Figure 4.37).

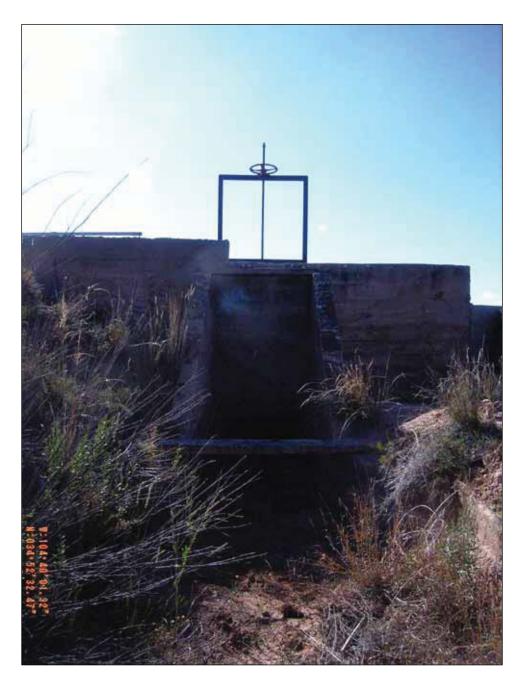
Figure 4.38. Headgate, facing east.

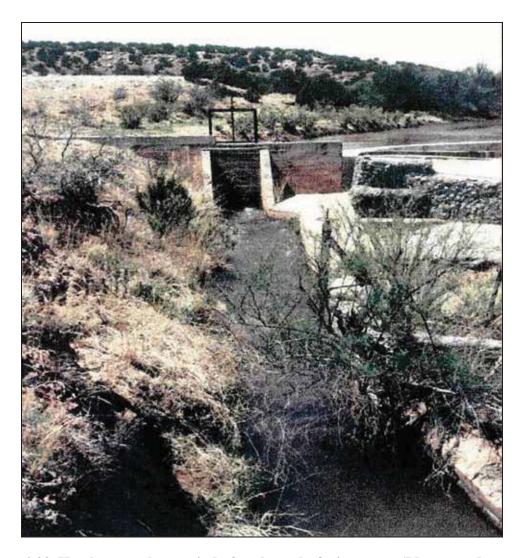
Figure 4.39. Headgate and acequia before breach, facing west. (Photograph courtesy of the West Puerto de Luna Acequia Association).

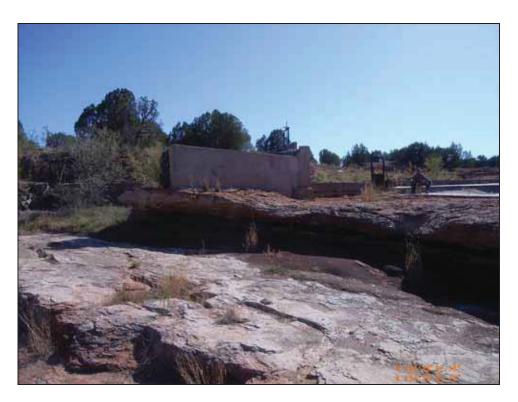
Figure 4.40. View of headgate and gabion, facing south.

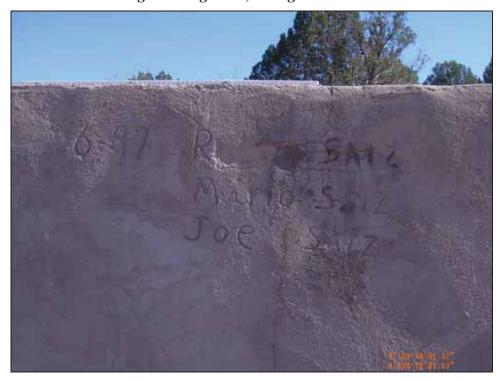
Figure 4.41. Inscription on outer wall of gabion, showing construction date of "6-97."

6-97 Ruben Saiz Mario Saiz Joe Saiz

Given the 1997 date and the similarity of construction, it is likely that this gabion and the spillway gabion were constructed at approximately the same time.

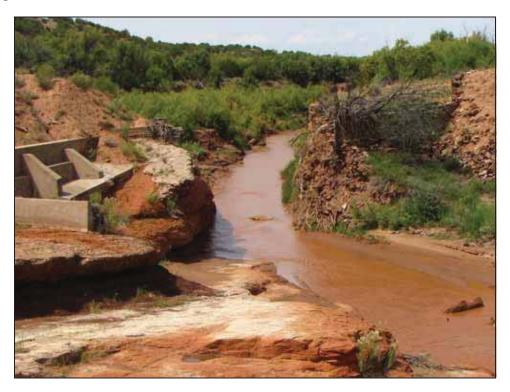
Figure 4.42. Overview of diversion complex, facing west.

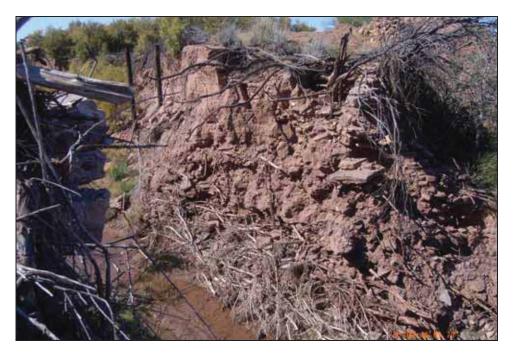
Figure 4.43. Northern cross-section of diversion dam, showing successive layers of rock and brush, facing northwest.

This brush and rubble construction is easily visible in the northern cross-section of the diversion as it exists now. As shown in Figure 4.43, Figure 4.44, and Figure 4.45, the bottom layer is dominated by brush, while upper layers are more dominated by rock. The photograph in this figure reveals stratigraphy showing the successive layers of large rock and smaller material including brush. Indeed, the contrast between the brush-dominated base layer and the upper layers is striking (Figure 4.44); it is even possible that this bottom layer may be a remnant of a separate and earlier construction event, perhaps even being a remaining portion of the earlier nineteenth-century dam.

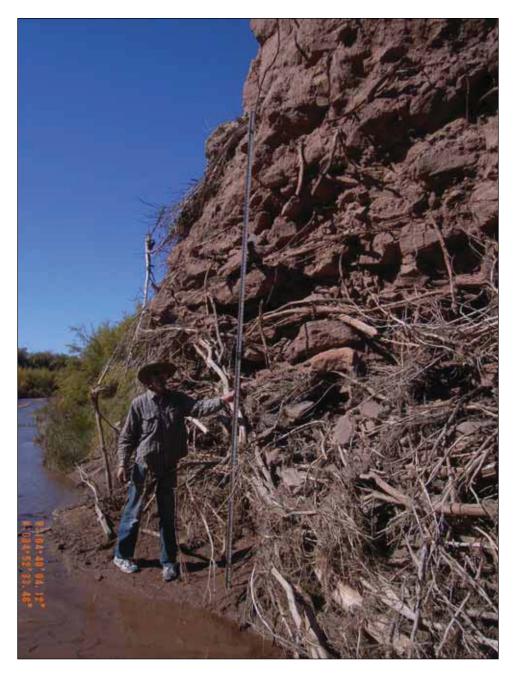
Figure 4.44. View of the northern cross-section of the diversion, showing base brush-dominated layer and multiple overlying layers of rock and brush.

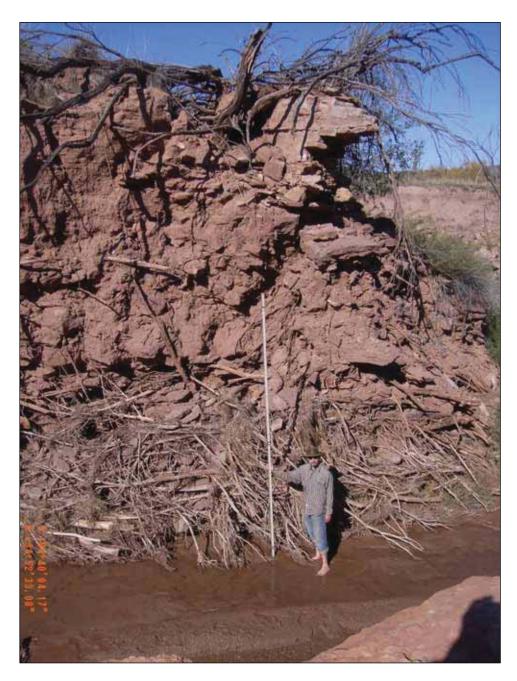
Figure 4.45. Another view of the northern cross-section of the diversion dam, facing northeast. Note remnants of masonry wall visible in cross-section.

The wall that remains as short segments on the north and south sides of the river once traversed the channel as a primary portion of the diversion dam. It is constructed of large pieces of tabular sandstone (visible in cross-section in Figure 4.45), with larger pieces occurring in the parts of the wall that are within the diversion, and somewhat smaller ones being found along the top. As it is visible from the top of the diversion, it is clear that the masonry wall segments at north and south are aligned with one another and once formed parts of the same wall (see Figure 4.47). The wall appears to have been built at the same time as the current diversion, as it appears to be footed on top of the bottom brush-dominated base layer (Figure 4.46). At its northern end, the wall is capped with concrete (Figure 4.48), and contains areas on the western face where the faces are inconsistently plastered or surfaced with concrete (Figure 4.49). On the western face, only approximately one meter or less of the wall is exposed above the ground surface of the dam top.

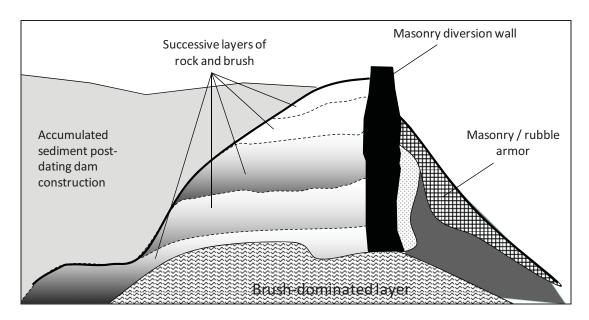
Figure 4.46. Generalized cross-section of diversion dam (facing north), showing primary stratigraphy, as well as the masonry diversion wall and rubble armoring on the diversion's eastern face.

In addition to the original diversion itself, the current cross-section also shows that abundant sediment accumulated behind the dam (i.e. west of it) to such an extent that ground surface was effectively raised to the height of the dam for a distance of some 80 meters upstream. A generalized representation of the stratigraphy of the diversion dam is presented in Figure 4.46.

As noted above in Figure 4.46, the eastern face of this masonry wall is obscured by additional sediment, which is in turn heavily armored with medium to large tabular sandstone rubble of the same type that was presumably also used to armor the northern bank of the river, and described earlier in this chapter. On the eastern face, only two to three vertical meters of wall are visible before disappearing behind this less-organized armoring rubble (Figure 4.53).

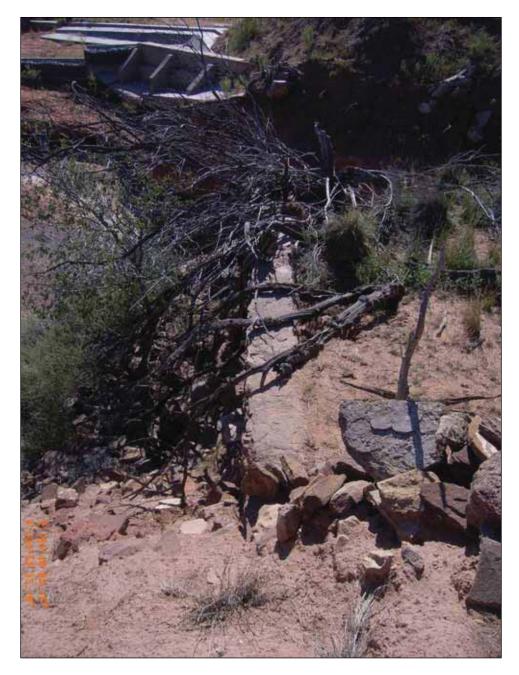
Figure 4.47. The alignment of both extant segments of masonry diversion wall are visible here, facing south across the river channel. The northern segment is in foreground.

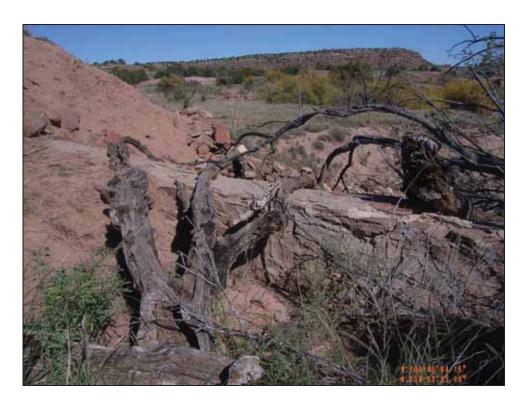
Figure 4.48. Northern segment of masonry diversion wall that once traversed the channel, facing east.

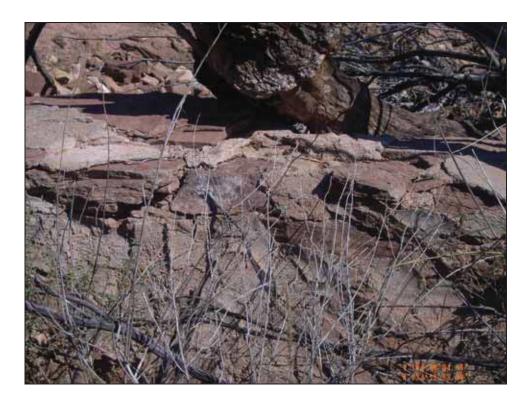
Figure 4.49. Close-up of masonry wall, showing concrete plastering, facing east.

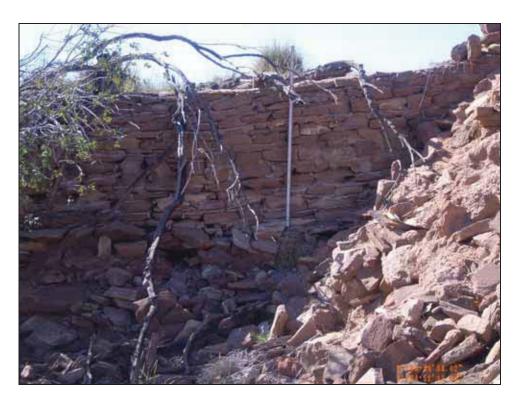
Figure 4.50. Northern segment of masonry diversion wall, facing west.

On the eastern face, more of this wall is exposed (Figure 4.50) ranging from approximately two to three meters, with no evident concrete plastering. Some concrete mortar is visible between the stones on this face, however. In its current state, the top of this wall extends out over the breach due to the presence of the capping layer of concrete over the top of the wall (Figure 4.51, Figure 4.52).

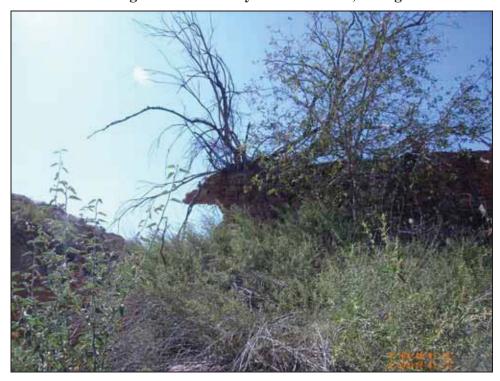
Figure 4.51. Northern segment of masonry diversion wall, facing west, showing remnant portion overhanging the breached diversion.

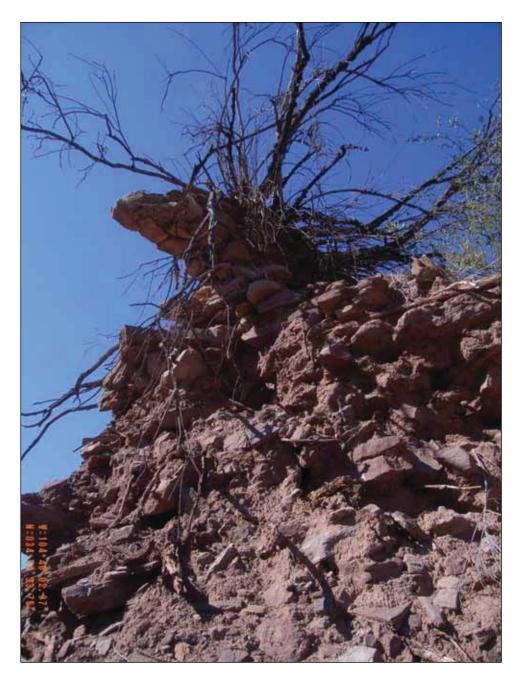
Figure 4.52. Northern segment of masonry diversion wall, from below and facing northwest, showing overhanging remnant.

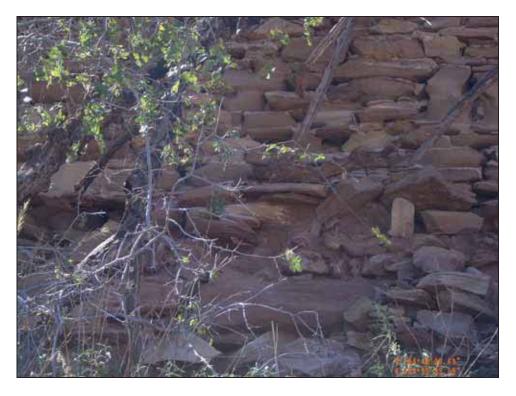
Figure 4.53. Base of masonry diversion wall, facing west, showing transition to rubble bank armoring.

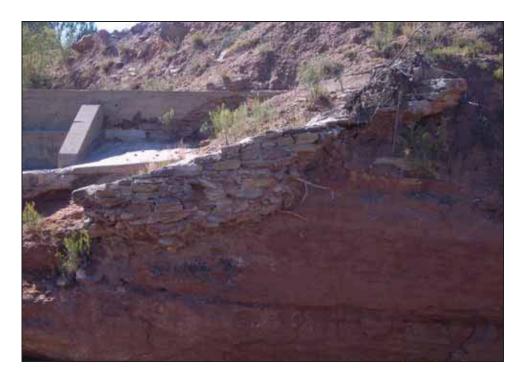
Figure 4.54. Remnants of masonry diversion wall and concrete-capped sandstone as viewed from the north side of the river, facing south.

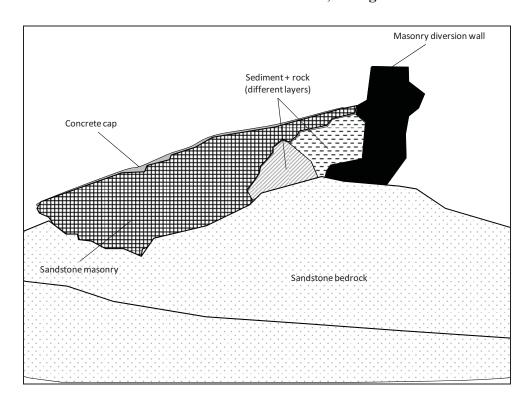
Figure 4.55. Schematic cross-section of southern portion of diversion wall and concrete-capped sandstone, with stratigraphy.

Much less of the diversion is visible in the southern profile. All of the rock and brush that formed the core of the diversion dam is now gone, revealing only large layers of sandstone bedrock, upon which are situated a small portion of the masonry diversion wall, and an agglomeration of tabular sandstone capped with concrete that is presumably a continuation of the rubble bank armoring seen on the northern side of the river. The primary difference appears to be that this was capped with concrete and may have contained some additional mortar, which have allowed it to remain in place – indeed, hanging precariously over the river channel with little support from beneath (Figure 4.54). The construction of the masonry diversion wall on the southern side of the river appears consistent with that on the northern side: tabular sandstone masonry capped with concrete, and with some concrete mortar. A schematic cross-section of what remains of the diversion on this side of the river is presented in Figure 4.54.

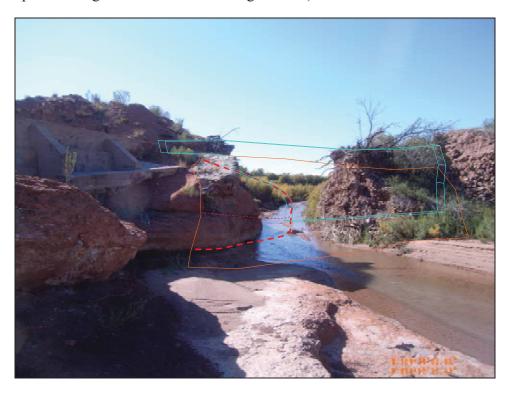
Figure 4.56. Approximate extrapolated positions of bedrock (dotted line), masonry wall (blue), and rubble armoring (orange).

Now, having described the extant components of the diversion complex above, it is now possible to discuss the likely pre-breach configuration of the diversion complex. In sum, the diversion complex consisted of a large rock-and-brush diversion dam which included a sandstone masonry wall near its eastern face. On the north, a long earthen berm with masonry retaining walls extended to the northwest to channel water during high-flow events. The diversion was armored on its eastern face by a deep and extensive covering of sandstone, likely arranged in an organized fashion (i.e. coursed and stacked where possible), and was capped with concrete on at least its southern end. This armoring extended around to the north, protecting the steep north bank of the river from erosion as well. Figure 4.56 presents an approximate picture of the relative locations and extents of the masonry diversion wall (blue) and the armored surface of the dam's eastern face (orange). (Note that the extent of the sandstone bedrock has changed since before the breach; the bedrock once extended further out into what is now the river channel; compare the photo in Figure 4.56 with that in Figure 4.17).

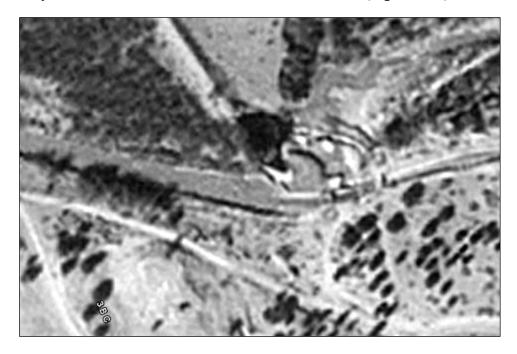
Figure 4.57. Aerial imagery of diversion complex dated May, 1997, showing location and shape of waterway leading to spillway and headgate. Imagery produced by U.S. Geological Survey and retrieved from Google Earth Pro (copyright 2009 Google and Europa Technologies).

Further, extensive sedimentation had built up behind the dam such that, by 1997, the effective width of the diversion was some 80 meters wider than the original rock-and-brush structure. This is evident both by observing the current cross-section of the northern bank (see again Figure 4.46), and by examining an aerial photograph of the project area from 1997, before the dam was breached. This photograph, obtained via Google Earth Pro, shows the area currently occupied by the river channel west of the diversion to be heavily vegetated, while the water from the river departs from its present channel approximately 80 meters to the west of the diversion's location (Figure 4.57).

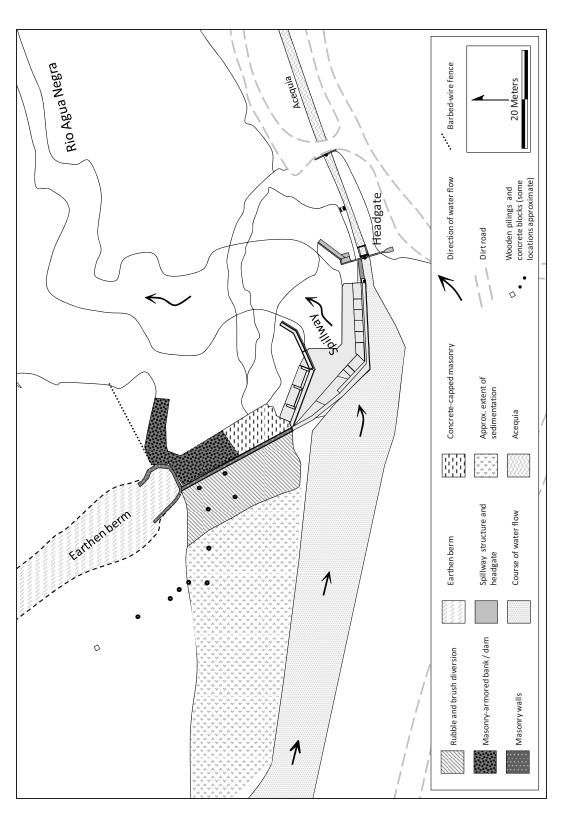
Figure 4.58. Map showing approximate extrapolated pre-breach configuration of diversion complex.

Figure 4.58 represents our best understanding and reconstruction of the complex's prebreach state, based on information from the above aerial photograph combined with the detailed examination of the remaining portions of the diversion complex presented in this chapter.

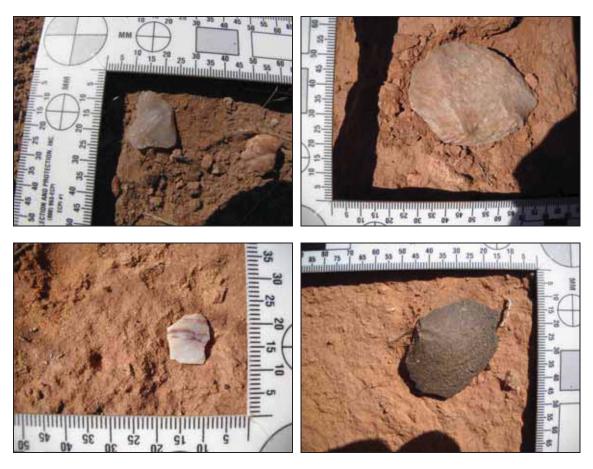
Figure 4.59. Photographs of representative samples of the IOs. From top left to bottom right IO1, IO2, IO3, and IO4.

Seven IOs were encountered during survey. All seven IOs are located in the northeastern potential borrow area (see Figure 1.2 for the location of the borrow area, while confidential location of the IOs is presented in Appendix A, Table A.2 and Appendix A, Figure A.1). All IOs are lithic artifacts made from local materials. None are considered significant. Details on the IOs are presented in Figure 4.59 and Table 4.1. There are too few IOs to conduct a meaningful analysis.
