C- HYDRAULIC MODEL INVESTIGATION

TECHNICAL REPORT NO. 188-1

Blue River Channel Improvement Project at Kansas City, Missouri

CONDUCTED BY DIVISION HYDRAULIC LABORATORY U. S. ARMY CORPS OF ENGINEERS NORTH PACIFIC DIVISION BONNEVILLE, OREGON

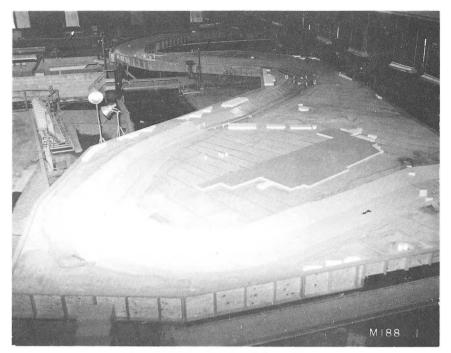
Looking downstream

Looking upstream

Photograph 1. Blue River Channel model (before final roughness adjustment for verification, bridge superstructure removed to show piers)

5. Constructed to a scale ratio of 1:40, the model included the 3,443-foot-long concrete-lined channel section adjacent to the Armco rolling mill, 4,322 feet of rock shell channel, 609 feet of grouted riprap channel followed by 2,397 feet of rock shell and earth-cut channel, and the overbank flow area in the Armco rail The reach modeled convard adjacent to the concrete channel. tained 11 bridges and the Independence Avenue overpass in the rail The area was bounded by high ground and buildings of the vard. steel mill that acted as principal flow boundaries. The main study area was at bridges B-5 and B-6, which were located at the downstream end of the concrete channel. The bridges had large skewed piers in the channel and were located in the middle of a into the riprapped channel downstream. extended curve that Details of the model as originally studied are shown on photographs 1 through 11 and plates 2 and 3.

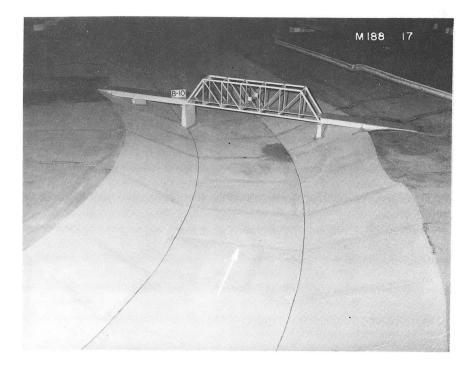
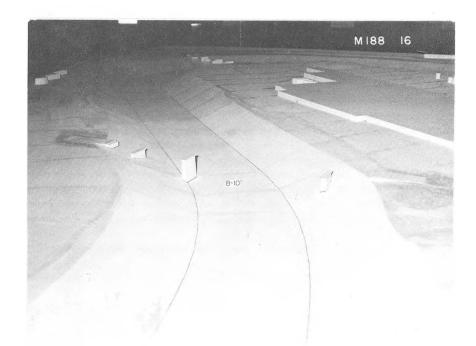
Photograph 2. Bridge B-10 and adjacent channel Electric furnace building in background (upper right) (Before final roughness adjustment for verification)

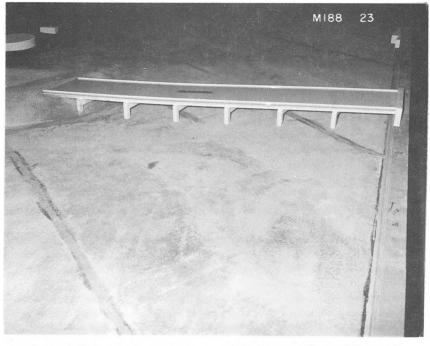
Independence Avenue overpass and railyard Looking downstream

Bridges B-7B and B-8 (Independence Avenue) and adjacent channel and overbank, Independence Avenue overpass in background

Photograph 4. Station 512+00 to 522+00 (before final roughness adjustment for verification)

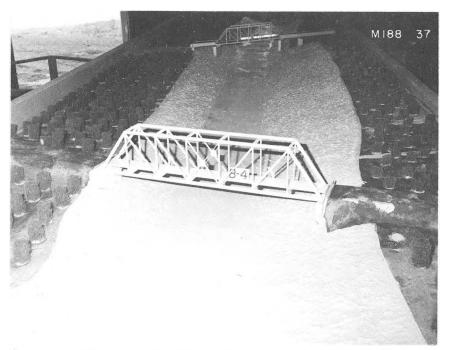
After verification of channel

Before verification of channel

Photograph 10. Bridge B-4 and adjacent channel

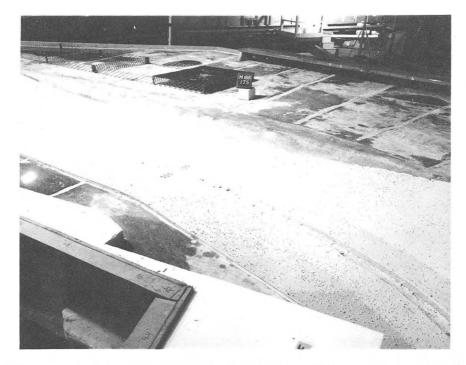
Photograph 12. Verified concrete channel at station 535+00, rolling mill building and flood wall in foreground

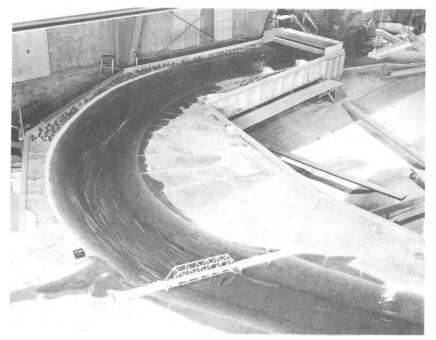
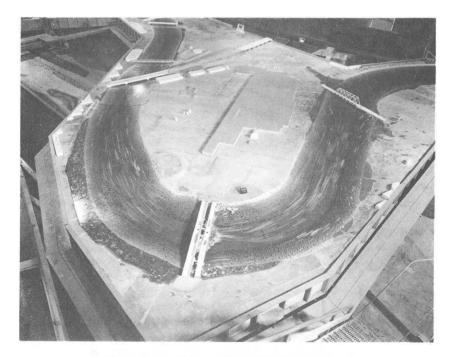
Upstream from bridge B-10

From bridge B-10 to B-8

Photograph 14. Flow conditions with discharge of 35,000 cfs and Missouri River at 10-year discharge

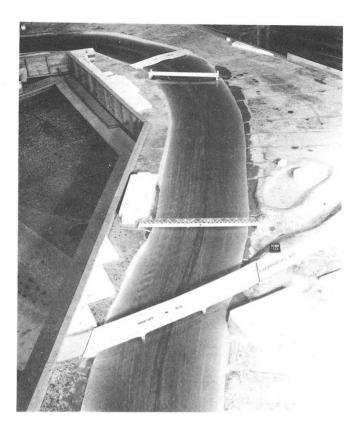
From bridge B-8 to B-7

From bridge B-7 to B-6

Photograph 15. Flow conditions with discharge of 35,000 cfs and Missouri River at 10-year discharge

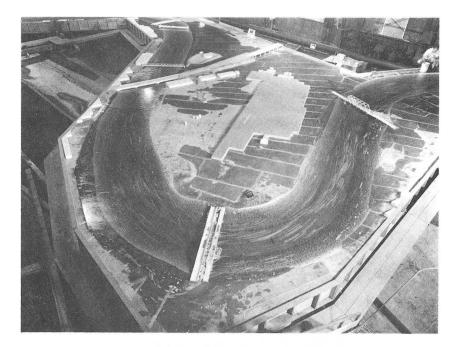
Upstream from bridge B-10

From bridge B-10 to B-8

Photograph 17. Flow conditions with discharge of 42,000 cfs and Missouri River at 10-year discharge

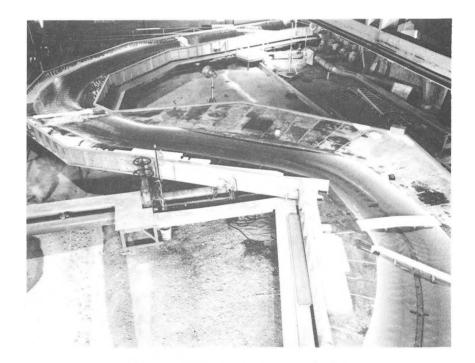
From bridge B-8 to B-7

From bridge B-7 to B-5

Photograph 18. Flow conditions with discharge of 42,000 cfs and Missouri River at 10-year discharge

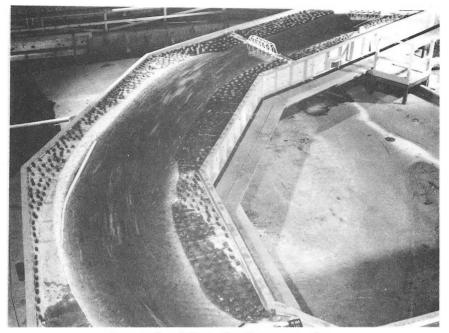
From bridge B-5 to B-4

At bridges B-4 and B-3

Photograph 19. Flow conditions with discharge of 42,000 cfs and Missouri River at 10-year discharge

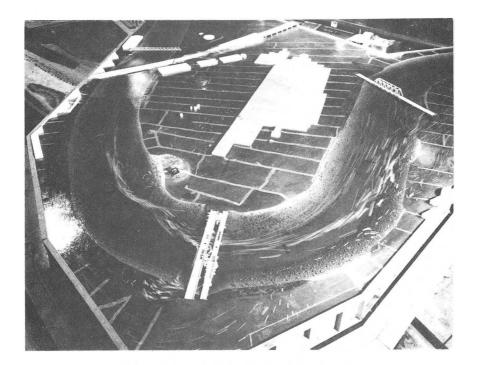
Photograph 20.

Upstream from bridge B-10

From bridge B-10 to B-8

D. Flow conditions with discharge of 52,800 cfs and Missouri River at 10-year discharge

bridges B-6 and B-7 was not overtopped. Flow in the curves near the upstream end of the floodwall near bridges B-7 and B-7A was superelevated 1.4 and 0.8 feet, respectively. Localized areas of supercritical flow occurred around the main in-channel piers of Overbank flow initially began with a disbridges B-5 and B-6. charge of about 37,000 cfs and occurred along the left bank of the channel between stations 470+00 and 490+00 (bridge B-10). Extensive overbank flooding through the rail yard on the right bank of the channel between stations 490+00 and 528+00 (bridge B-7) occurred with a discharge of approximately 40,000 cfs. Flow conditions with a discharge of 42,000 cfs (50-year flood) are shown on plates 8 and 9 and photographs 17 through 19. The entire length of the floodwall at the rolling mill was overtopped. With a discharge of 52,800 cfs (100-year flood), the entire area modeled was flooded. As shown on plates 10 and 11, water overtopped the right bank near station 487+00 (just upstream from bridge B-10) with velocities of 7 to 8 fps, flowed overland through the rail yard with velocities up to 11 fps, and reentered the main channel at numerous locations between stations 500+00 and 545+00. Photographs 20 through 22 show flow conditions along the channel reach.

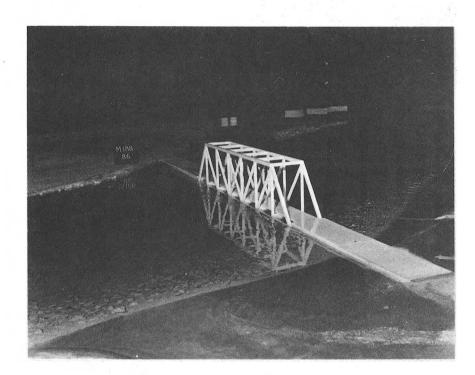
Bridges B-5 and B-6

Photograph 23. Flow conditions with discharge of 35,000 cfs and Missouri River at 10-year discharge

Bridge B-10

14. With the design discharge and tailwater, flow impinged on bridges B-4, B-6, B-7, B-7A, and B-10. Flow conditions at bridges B-4, B-5, B-6, and B-10 are shown on photographs 23 and 24. Plates 19 through 25 show water surface cross sections both up and downstream from bridges B-4, B-5, B-6, B-7, B-7A, B-8, and B-10 for various discharges with the design tailwater condition. Bridge head loss from the upstream side of B-6 to the downstream side of B-5 with the design discharge and tailwater was 2 feet and increased to 4.4 feet with the minimum tailwater condition.

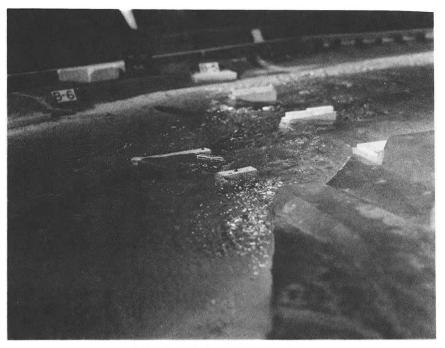
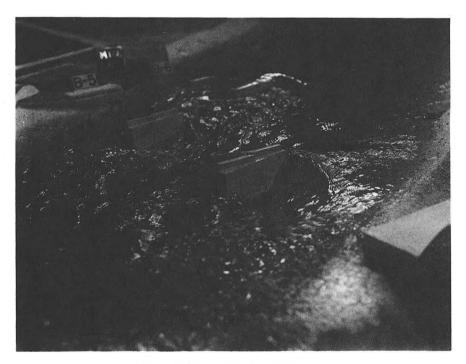
Photograph 26.

Looking downstream

Looking upstream

Flow around existing piers of bridges B-5 and B-6, discharge of 35,000 cfs with minimum tailwater

15. Flow conditions at bridges B-5 and B-6 with their existing piers are shown in photographs 25 and 26 and on plates 26 through 29 for the design discharge with design and minimum tailwaters. The center pier (pier 2) of bridge B-6 was large, blunt nosed, and skewed to the flow near the center of the channel and the large, skewed right pier of bridge B-5 was in its wake. The maximum water surface differential side to side on the B-5 bridge piers was 9 feet with design tailwater and 11 feet with minimum tailwater.

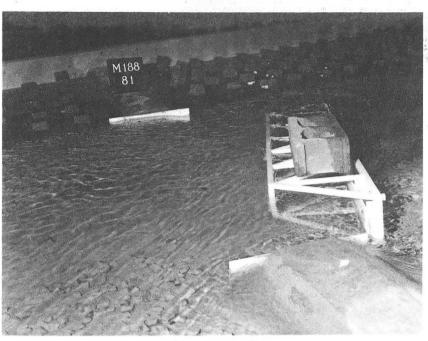
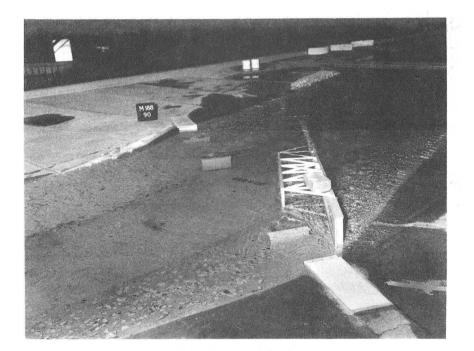
Bridge B-4

Bridge B-10

Photograph 29. Bridges swept from piers into channel on their sides. Discharge of 35,000 cfs with Missouri River at 10-year discharge.

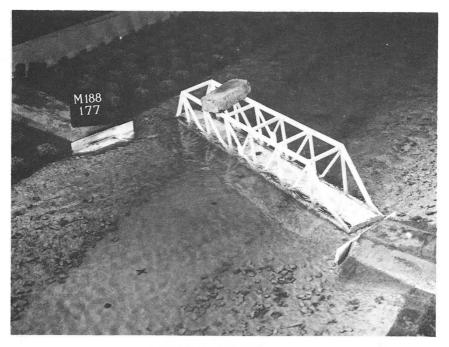
Bridge B-4

Bridge B-10

- Photograph 30. Bridges swept from piers into channel in upright position. Discharge of 35,000 cfs with Missouri River at 10-year discharge.

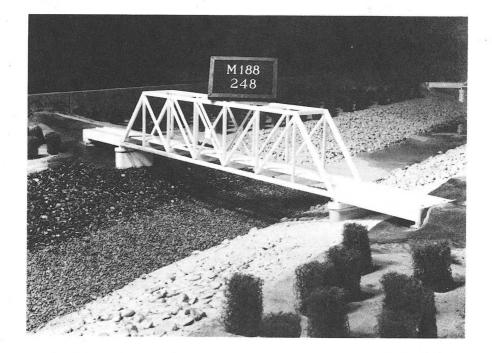
Photograph 34. Revised bridge B-4 (end spans added) looking downstream

upstream of bridge B-6 were determined with the existing bridges (plate 37) and with various combinations of bridge modifications including (1) improvement (photograph 33) and removal of piers at bridges B-5 and B-6, (2) addition of end spans at bridge B-4 (photograph 34), and (3) addition of streamlined cowls on the upstream bottom girder of the bridges. Plates 38 through 44 and photographs 35 through 43 show water surface profiles and flow conditions with the various improvements tested in the model. As shown in table 1, the largest decrease in water level upstream of bridge B-6 (2.2 feet at design discharge) resulted when the piers of bridges B-5 and B-6 were removed from the flow. Modification of the B-5 and B-6 bridge piers was also relatively successful in decreasing water levels upstream of bridge B-6. Neither addition of end spans to bridge B-4 nor streamlining the upstream bottom girder of the three bridges with 3.5 feet radius quarter-round sections were effective. Cross sectional velocity distribution through bridges B-5 and B-6 with the design discharge (design and minimum tailwater) with bridge piers removed from the flow and with the bridge B-6 pier improved is shown on plates 46 through 48. The water surface profiles along both sides of bridges B-5 and B-6 bridge piers with the B-6 pier improvement are shown on plates 49 and 50 for the design discharge condition with design and minimum tailwater, respectively. Plate 51 illustrates the bridge B-4 cross-sectional water surface profile with end spans added to the bridge.

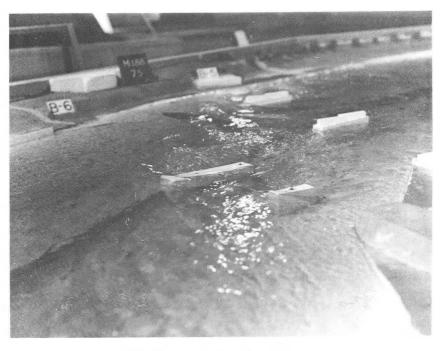
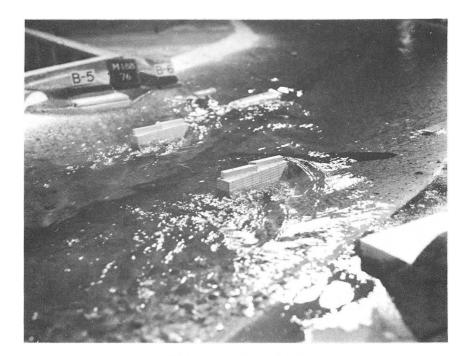
Looking downstream

Looking upstream

- Photograph 44.
- Flow conditions at bridges B-5 and B-6 with revised pier 2 of bridge B-6. Discharge of 35,000 cfs with Missouri River at 10-year discharge.
