Navigation Systems Research Program

Repair of Corroded Steel Girders of Hydraulic Steel Structures (HSS) Using Fiber-Reinforced Polymers (FRP)

August 2023

Final Technical Report (TR)

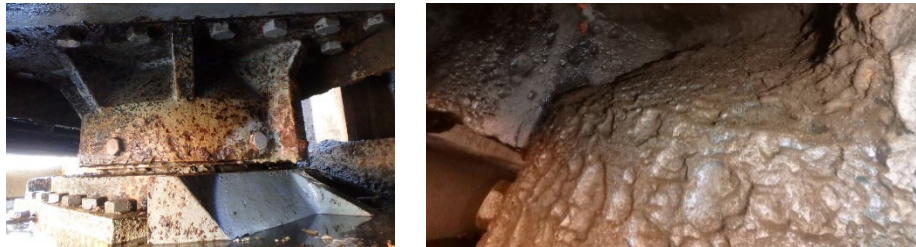
Figure 1. Pitting corrosion on a miter gate pintle.

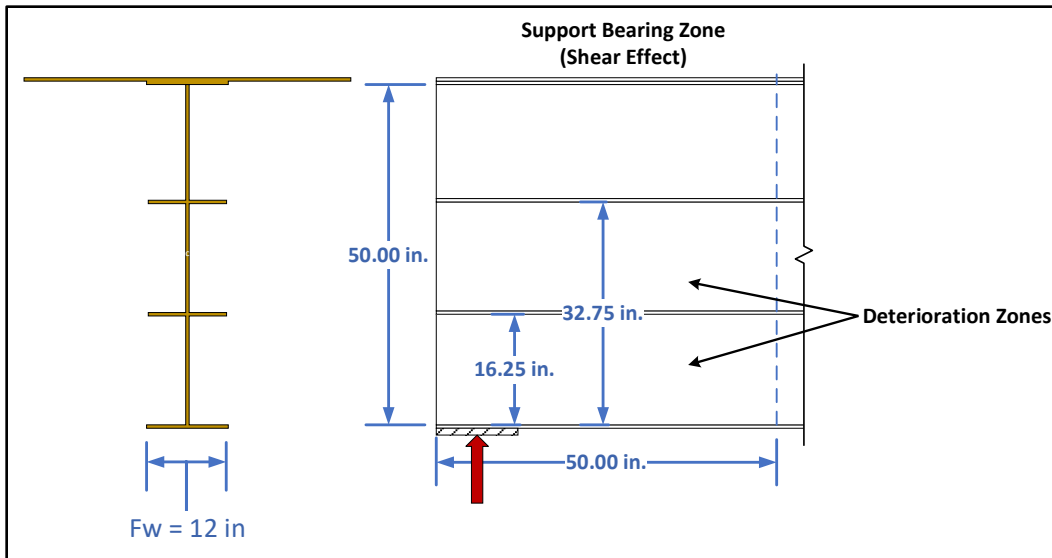
Figure 3. Web deterioration shear zone over support.

In simply supported beams, the maximum shear stress occurs at the web near the supports. This deterioration also translates in loss of bearing capacity. Figure 3 shows the zone over the support where deterioration of the web was investigated. This zone is where all the bearing forces are transmitted to the support and where the maximum shear stresses are at the web. The web is 50 in. tall. The section has two longitudinal stiffeners, each located at approximately a third of the height of the girder. The two panels from the support side will be deteriorated as indicated in the figure. The deteriorated area extends 50 in. in the longitudinal direction, a distance equal to one web height.

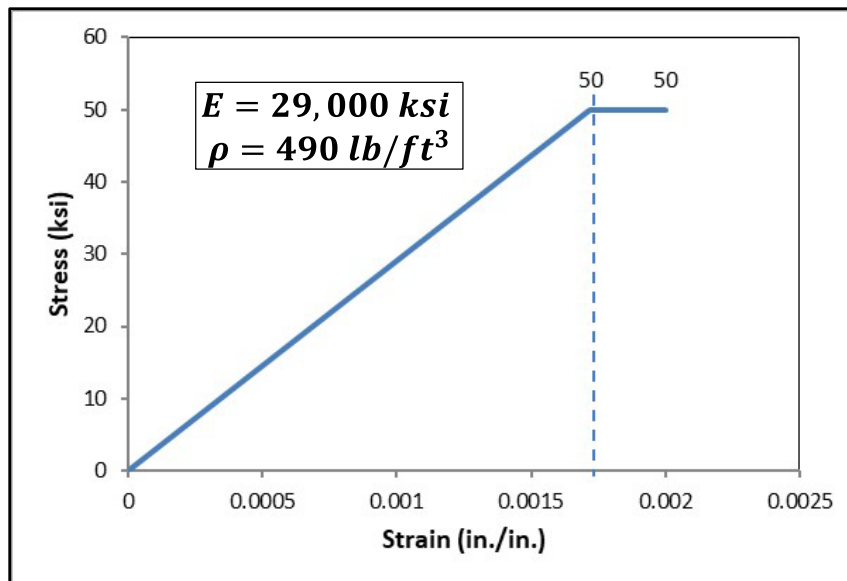
Figure 7. Steel ideal stress-strain curve.

The stress-strain curve of the steel used for the girder is shown in Figure 7. It was defined as elastic-perfectly plastic, with 50 ksi yielding strength. Although the analysis was conducted in the elastic range, plastic analysis was conducted to verify yielding initiation loading and to correlate with hand calculations.

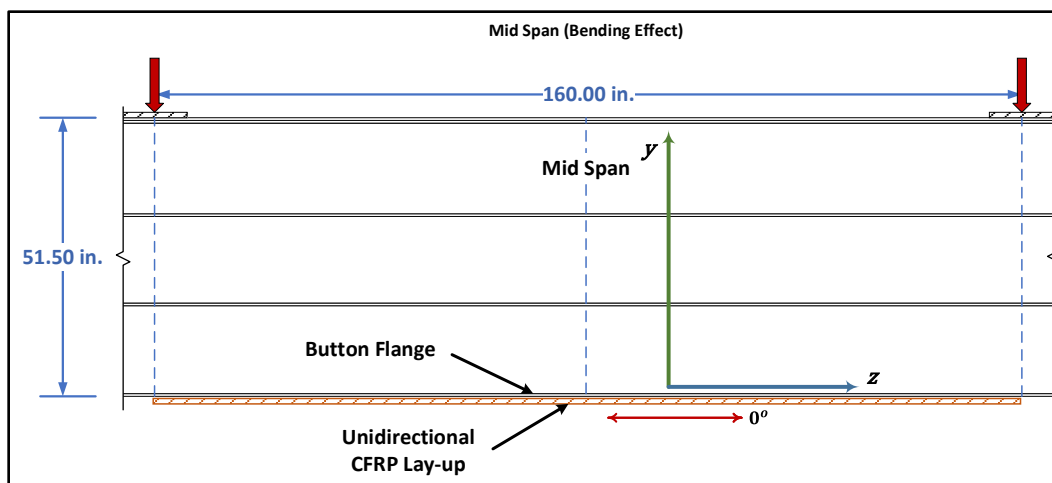
Figure 12. Location of the unidirectional repair applied to the bottom flange.

In the case of tensile flange deterioration (bending), because the stresses are acting only in the longitudinal direction, unidirectional layers aligned with the girder's longitudinal axis are needed. To determine the amount of layers needed to repair the corrosion damage to the bottom flange, a series of 1, 2, 3, 4, 8, and 10 layers was evaluated. The laminate extended from loading point to loading point (only half of the model is used considering symmetry) as shown in Figure 12, covering the series of defined degradation extension lengths that were previously defined and illustrated in Figure 4. The figure also shows that the fiber principal direction (0°) is parallel to the longitudinal direction of the girder.

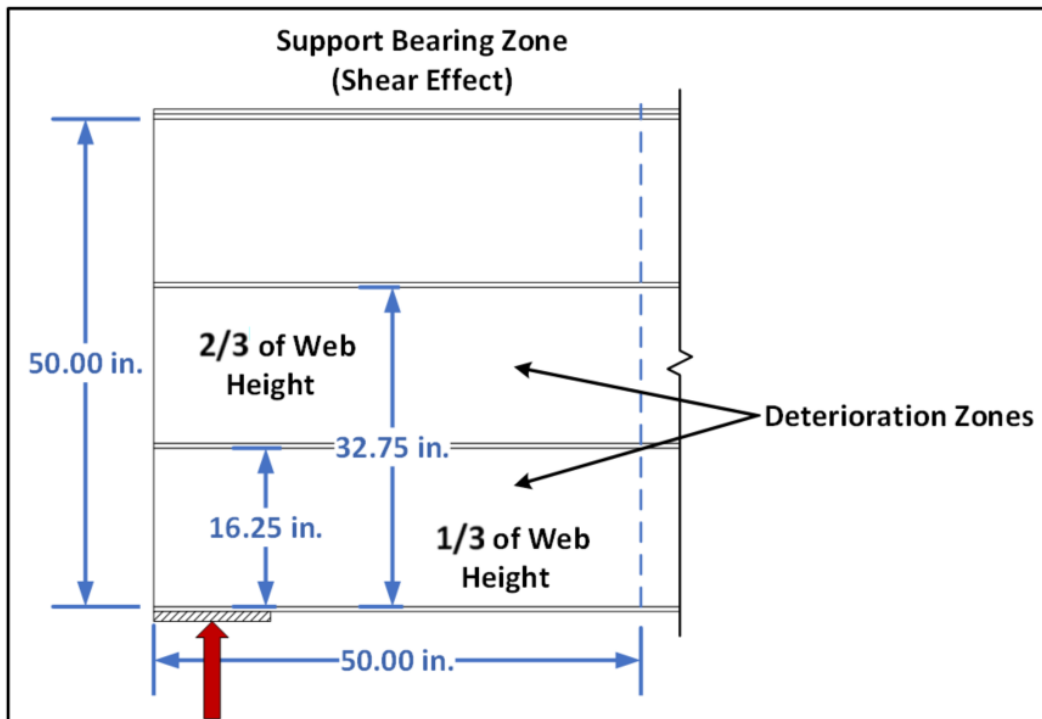
Figure 18. Illustration of the deterioration zones defined as one-third and two-thirds of the web height.

The deterioration scheme used was for 10% and 25% reduction in web section at one-third and two-thirds of the web height measured from the bottom flange (Figure 18). The 40% and 50% schemes were not performed because preliminary results showed that it was not feasible to repair beyond the 25% deterioration.

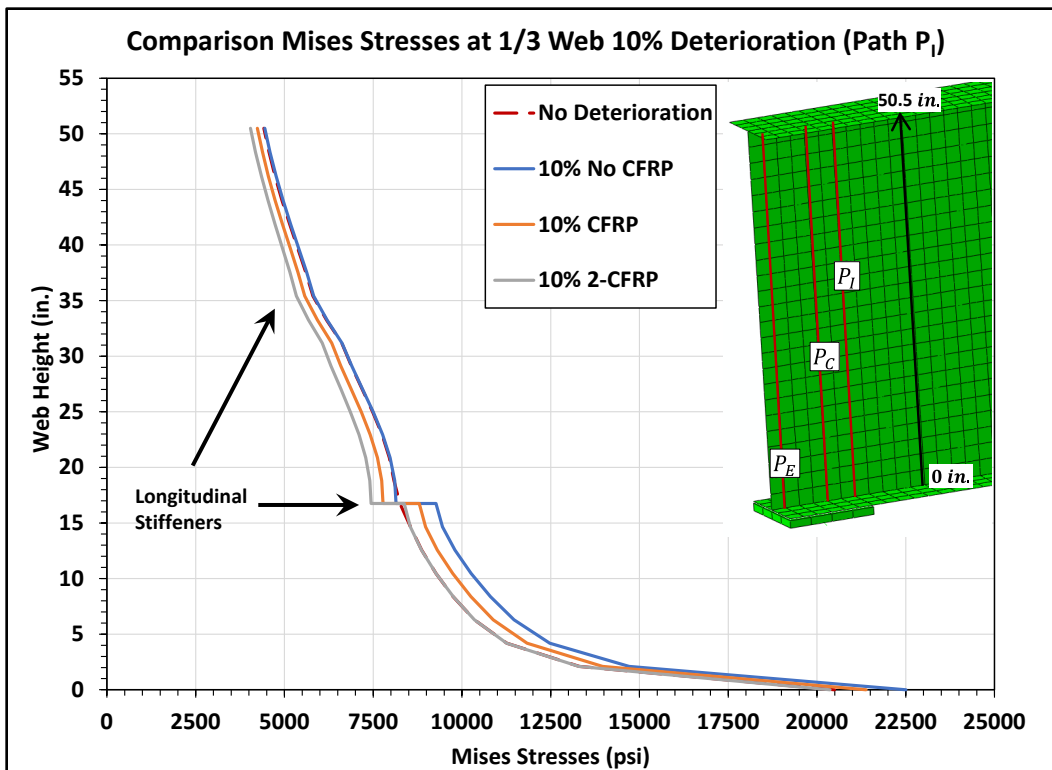
Figure 22. Comparison of the von Mises stresses produced along path P_I for the bottom one-third of the web with no deterioration and 10% deterioration with no CFRP, CFRP, and 2-CFRP.

Comparison of the results of the analysis for 10% deterioration at one-third of the web height for paths P_E , P_C and P_I is shown in Figure 20 through Figure 25. The graphs show the von Mises stresses comparing the undamaged and damaged condition with the evaluated CFRP repair schemes. Figures 20–22 compare the results with the isotropic CFRP layers, and Figures 23–25 compare the results from the laminate layups. The red curve in both sets of graphs is the stresses without deterioration at the applied load of 87,760 lb. The light blue line (only in Figures 20–22) is the stresses of the deteriorated web without any repair technique. The kinks in the curves are the locations of the longitudinal stiffeners; the first one is located at 16.25 in. from the bottom flange. At the applied load, the two layers of the isotropic CFRP returned the stresses at the steel to the undamaged level (Figures 20–22). However, from the laminate layups shown in Figures 23–25, the only layup that did not reduce the stresses along the paths P_E and P_C is the ANGLPLY layup. The rest of the schemes reduced the stresses in the deteriorated steel below the undamaged condition.

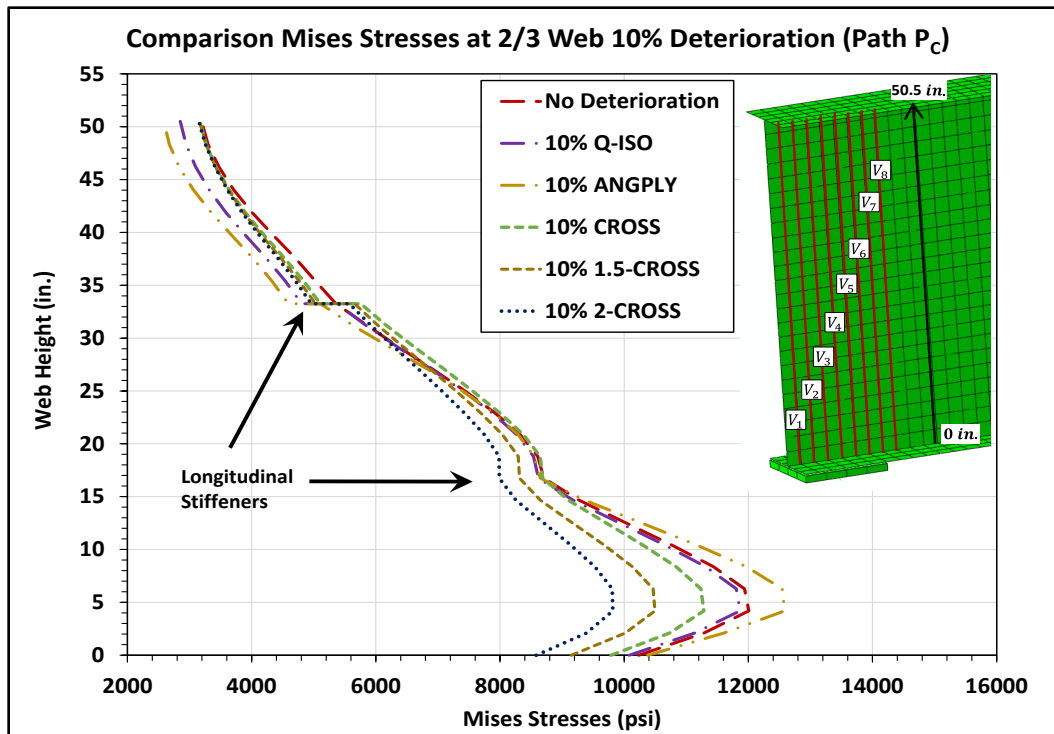
Figure 30. Comparison of the von Mises stresses produced along path P_C for the bottom two-thirds of the web with no deterioration and the five laminate configurations repairing the 10% deteriorated web.

Similarly, Figures 26–28 and Figures 29–31 show similar comparisons but for the deterioration from the bottom flange up to two-thirds of the web height along paths P_E , P_C , and P_I . The conclusions from these results are the same as the previous results for the one-third height shown in Figures 20–22 and Figures 23–25.

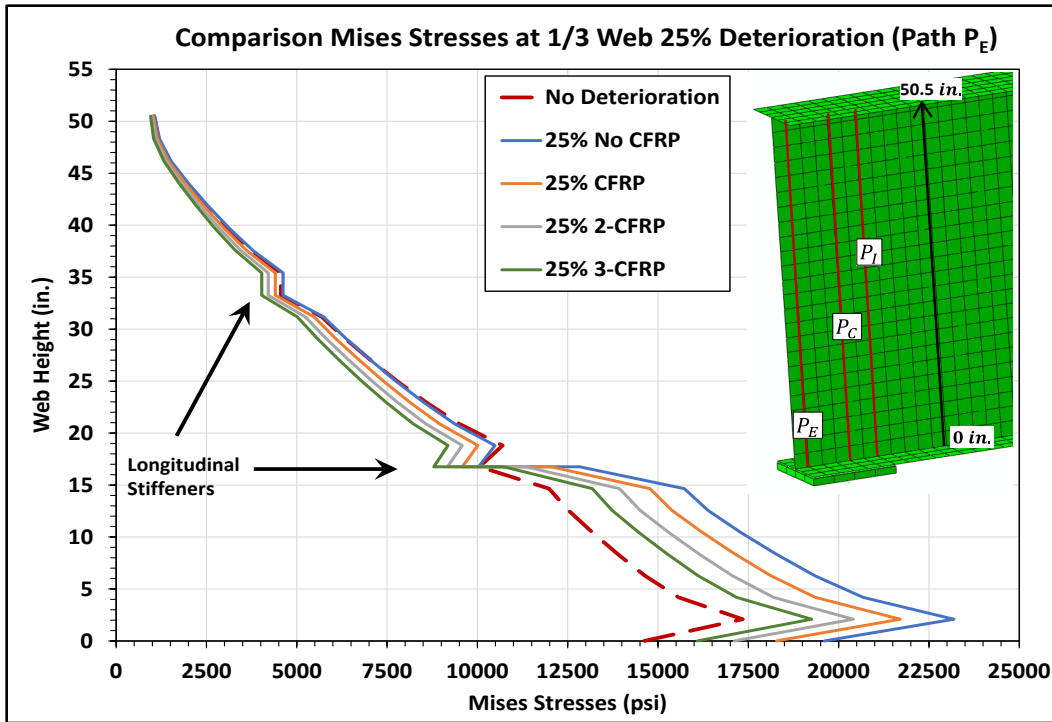
Figure 32. Comparison of the von Mises stresses produced along path P_E for the bottom one-third of the web with no deterioration and 25% deterioration with CFRP, 2-CFRP, and 3-CFRP.

Figures 32–34 and Figures 35–37 show stresses along the paths P_E , P_C , and P_I for a deterioration level of 25% up to one-third of the web height. In Figures 32–34, none of the isotropic CFRP schemes reduced the stresses to the level of the undamaged condition. In Figures 35–37, only the repair schemes of 1.5 CROSS and 2.0 CROSS showed a reduction of stress level at the steel of the web for path P_E , but the reduction did not reach the undamaged condition for the other two paths. However, if the deterioration reaches two-thirds of the web from the bottom flange (results shown in Figures 38–40 and Figures 41–43), the repair schemes do not help to reduce the stresses at the web. Improvement occurs only very close to the bottom flange.

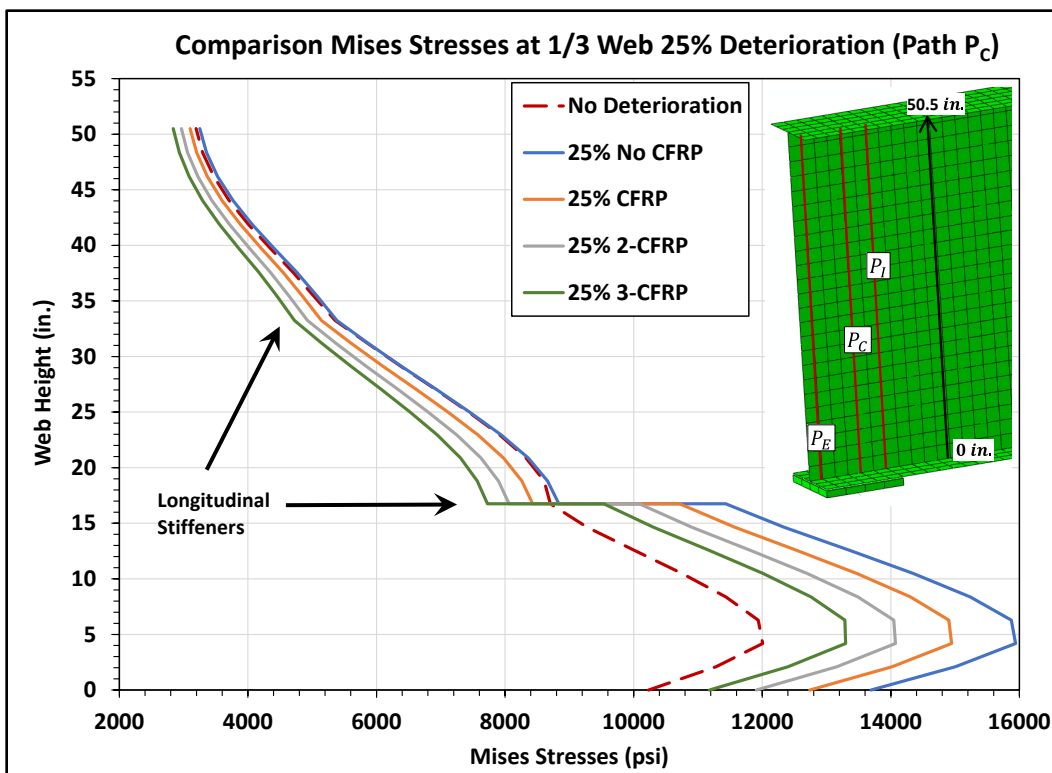
Figure 33. Comparison of the von Mises stresses produced along path P_C for the bottom one-third of the web with no deterioration and 25% deterioration with CFRP, 2-CFRP, and 3-CFRP.

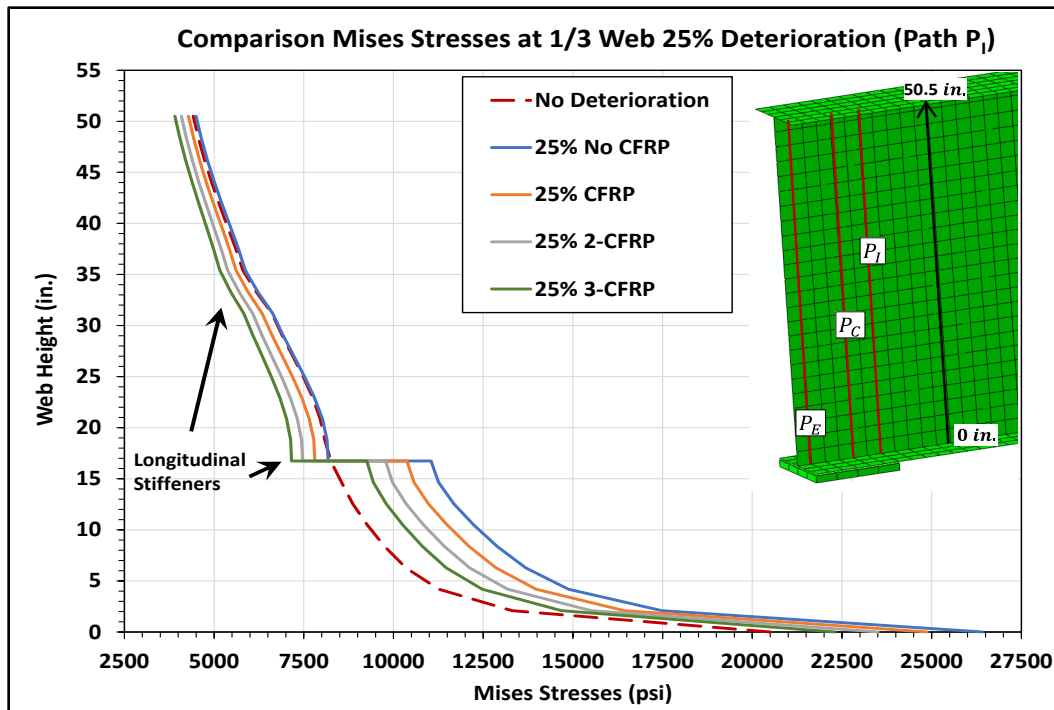
Figure 34. Comparison of the von Mises stresses produced along path P_I for the bottom one-third of the web with no deterioration and 25% deterioration with CFRP, 2-CFRP, and 3-CFRP.

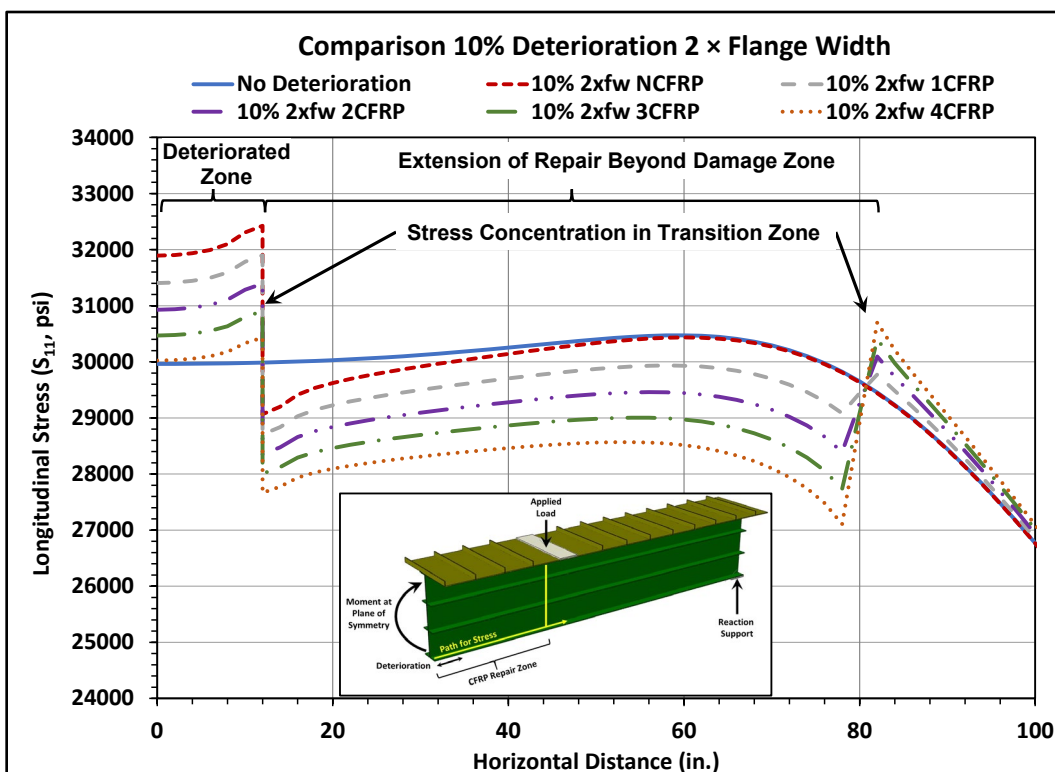
Figure 45. Comparison of tensile stresses with 10% deterioration along the bottom flange under repair scheme 2 times the flange width.

Figures 45–48 show results of the flange with 10% deterioration at lengths of 2, 4, and 8 times the flange width. From the analysis it is found that the stresses are reduced if only four layers of CFRP are used. It is also observed that the shorter deteriorated length (2×) produce higher stresses than the other three deterioration lengths.

All results show two stress concentration points as a localized increase and drop in the stress magnitudes. This is a numerically induced behavior from the radical transition of thicknesses between the deteriorated zone and the CFRP end location. In the actual application, the deteriorated zone is cleaned, and the rough edges are smoothed out. The CFRP layers can be

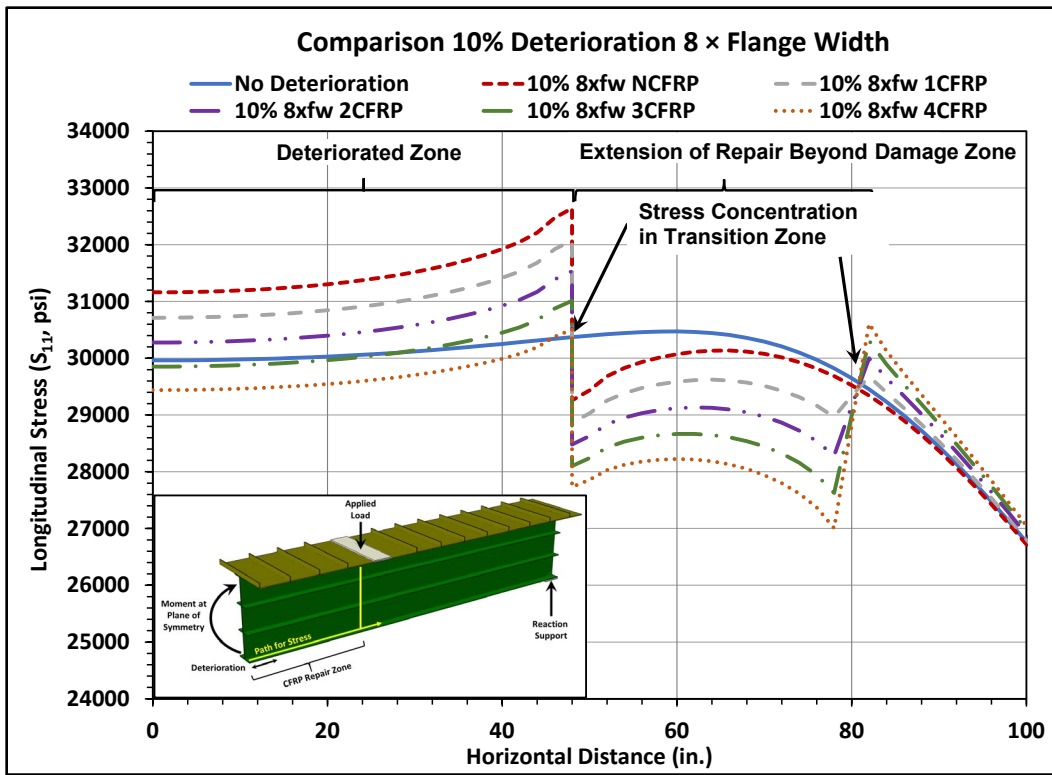
Figure 48. Comparison of tensile stresses with 10% deterioration along the bottom flange under repair scheme 8 times the flange width.

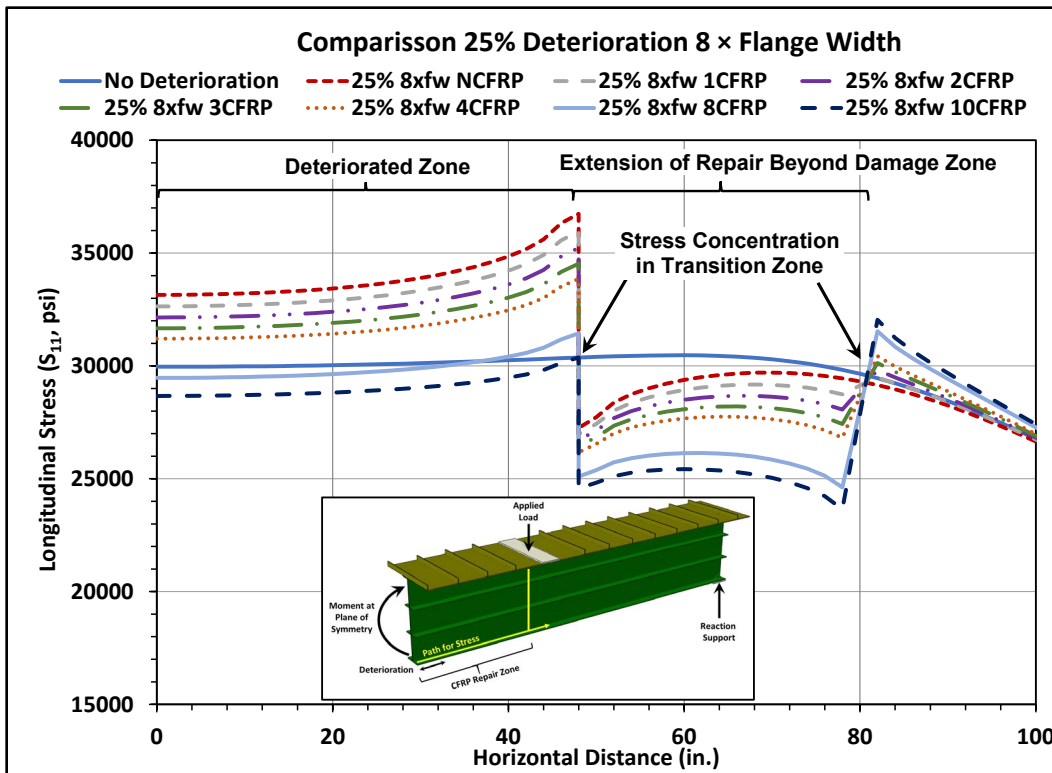
Figure 52. Comparison of tensile stresses with 25% deterioration along the bottom flange under repair scheme 8 times the flange width.

Figures 49–52 show results of the 25% tensile flange deterioration and CFRP repair. The CFRP applied pattern was from 1 to 4 layers, then 8 and 10 layers. Again, it can be observed that for the shorter deterioration length (2×), 10 layers of CFRP reduce the stresses in the steel to the point of the undamaged section. But as the length increases, 8 layers are sufficient to drop the stress levels to the undamaged condition. This is something that has to be accounted for when applying repair techniques.

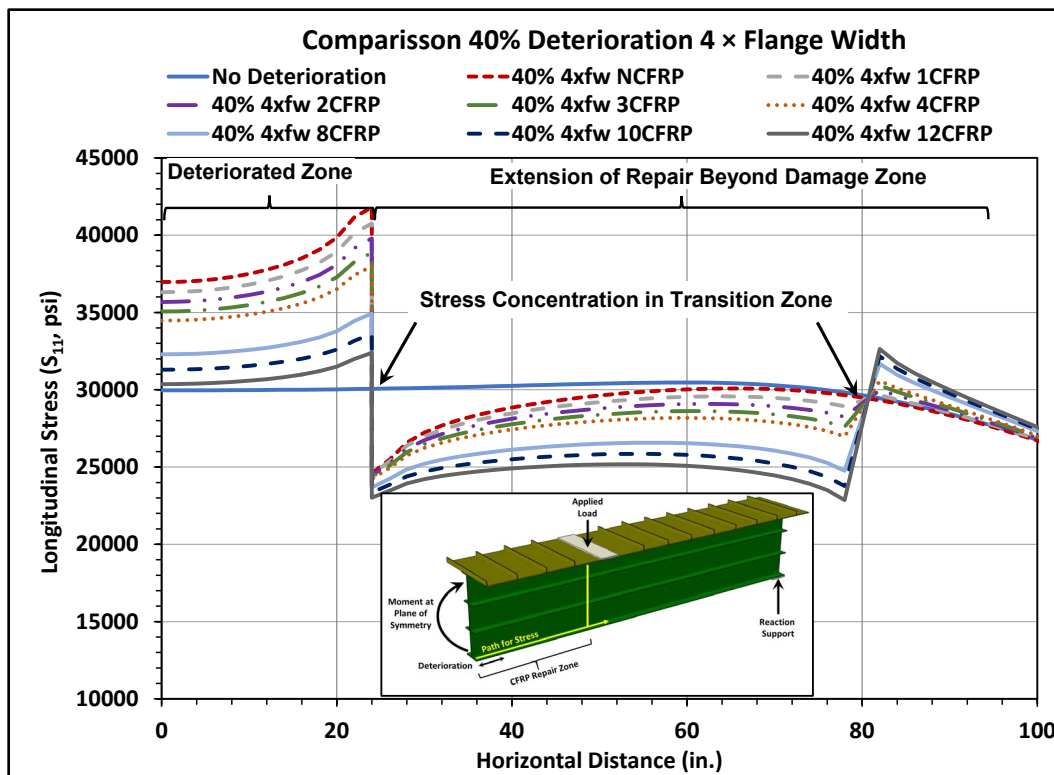
Figure 54. Comparison of tensile stresses with 40% deterioration along the bottom flange under repair scheme 4 times the flange width.

As opposed to the shear (bearing) zone, the 40% deterioration level was also investigated applying the same repair techniques for the 25% case. These results are shown in Figures 53–56. It was found that for this level of deterioration, 10 layers of CFRP are not effective for the shorter deterioration lengths. Only for the larger deterioration zone (8×) is it observed that the effect of the repair is to reduce stresses to the undeteriorated magnitude. More layers of CFRP will be needed to repair such large deterioration and loss of section.
