# Rapid Maximum-On-Ground (MOG) Enhancement Technologies

Report 1

Matting Systems for Contingency Helipads and C-130 Test Sections

January 2005

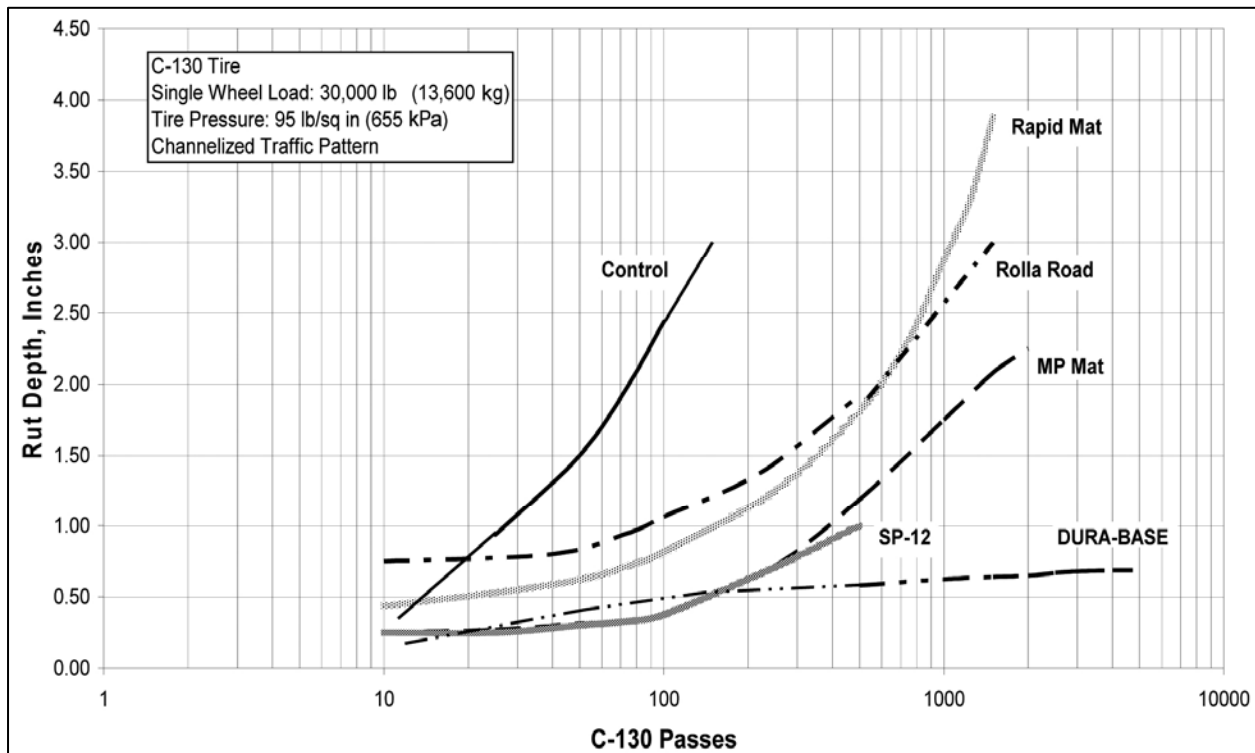
Figure 4. Rut depth for high-strength subgrade (40 to 50 CBR) test items

Failure was achieved once the total rut depth (crest to trough of the rut) reached a value of 76.2 mm (3 in.) or greater or when a minimum of 20 percent of the mat system experienced severe damage or breakage. This failure value was measured with the mat in place, using the rod and level and the rut bar, described in the following section. The mats were not removed from the subgrade until the failure condition was reached. Photo 34 shows measurement of the final rut depth after the removal of the Rapid Mat system from the clay gravel surface. The target for a mat to pass this evaluation was  $\geq 2,000$  passes with less than 76.2 mm (3 in.) of total rut with the mat in place over the soil. The rut data for each test item are shown in Figures 4 through 6.

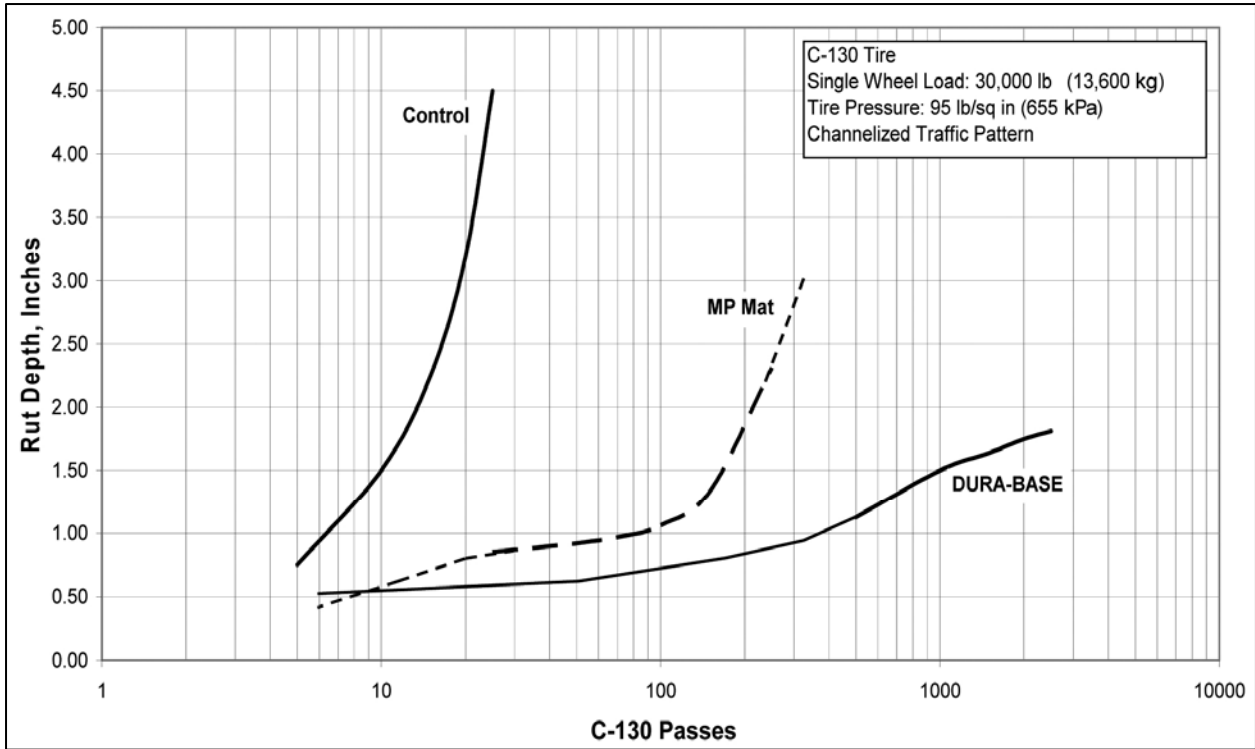
Figure 5. Rut depth for medium-strength subgrade (8 to 10 CBR) test items

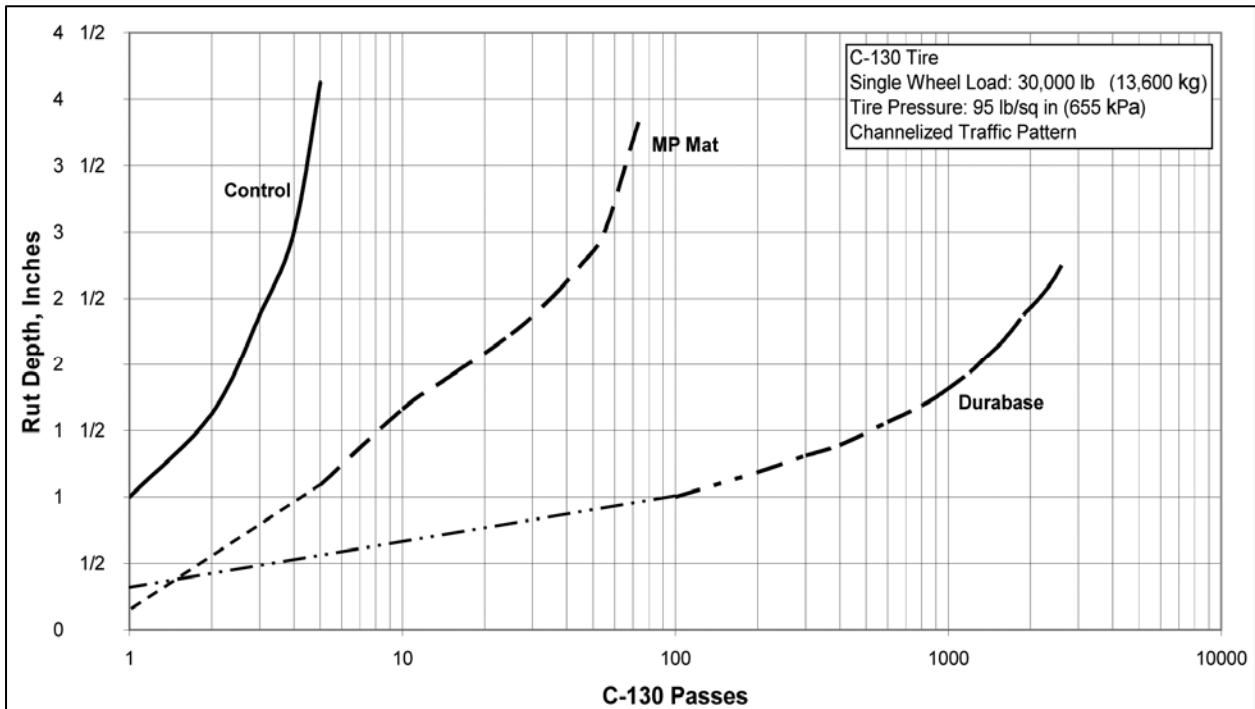
Figure 6. Rut depth for low-strength subgrade (3 to 5 CBR) test items

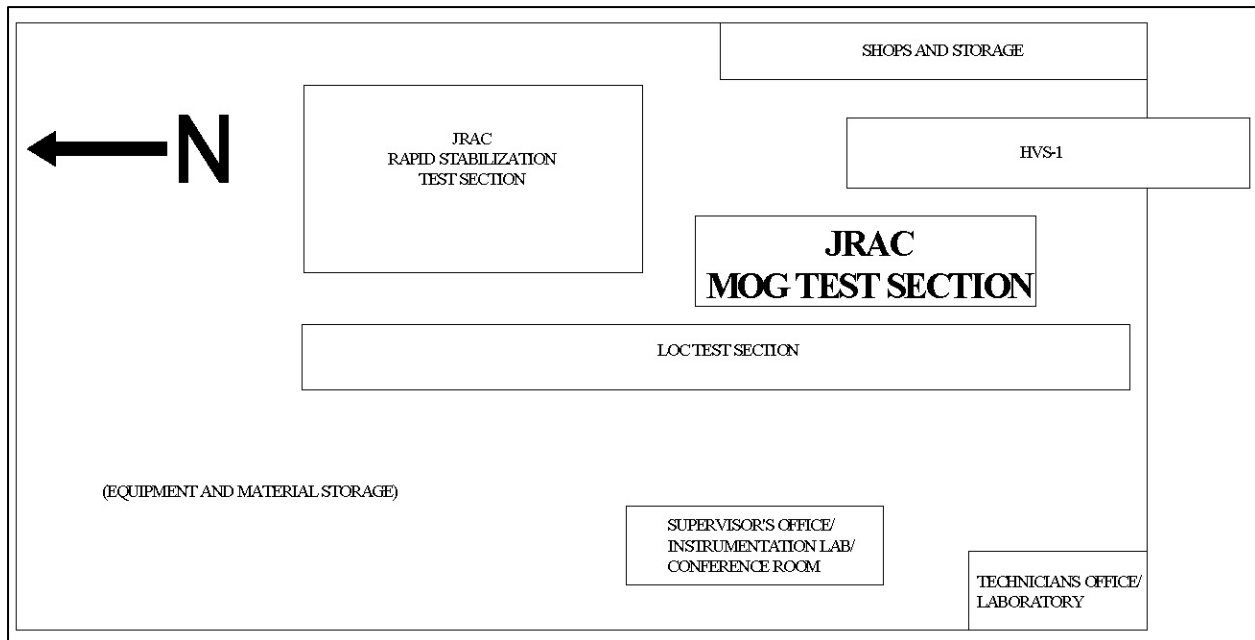
Figure 7. Hangar 4 Pavement Testing Facility test section layout

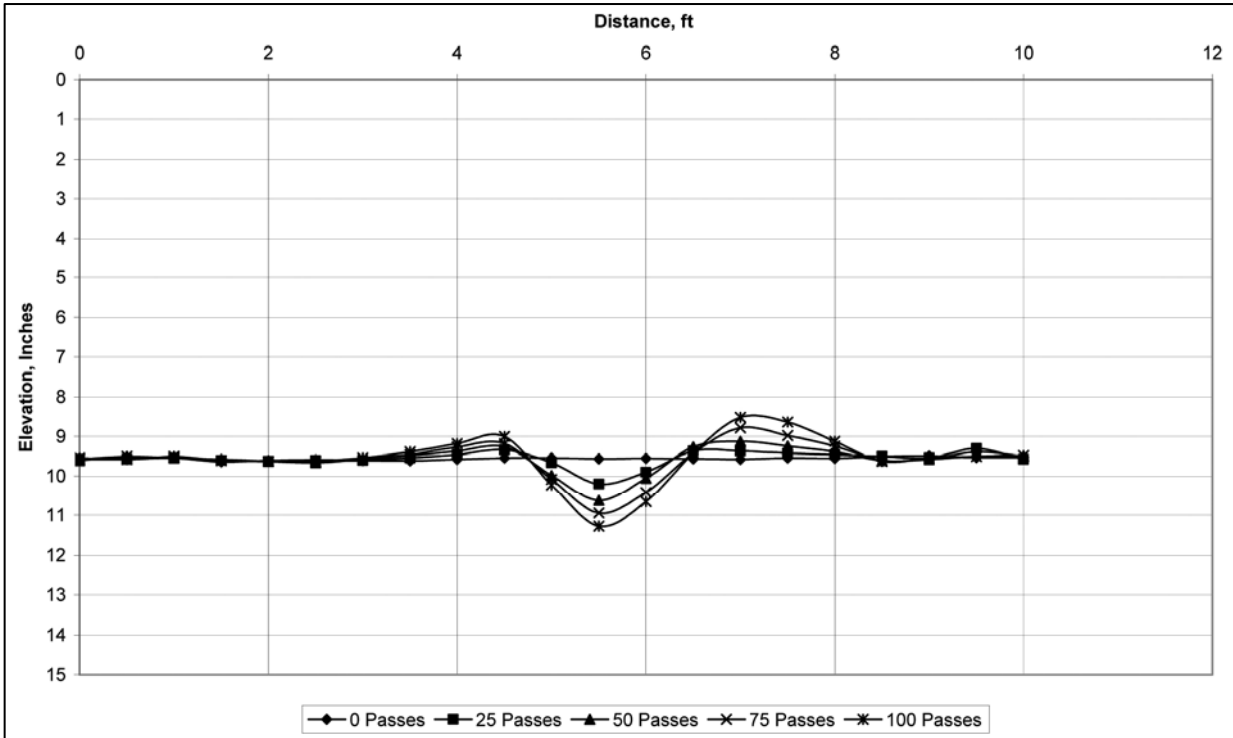
Figure 8. Permanent surface deformation cross section for control (no mat) on high-strength subgrade (40 to 50 CBR)

During each phase of testing, a control section was included to compare the rutting of the soil with no matting systems applied to that with matting systems applied. With a high-strength subgrade (40 to 50 CBR), the control section reached a rut failure ( $\geq 3$  in. rut) at approximately 105 passes. During the medium-strength subgrade analysis (8 to 10 CBR), the control section failed at approximately 25 passes. Finally, using the low-strength subgrade (3 to 5 CBR), the control section achieved rut failure at approximately 5 passes of a C-130 wheel load.

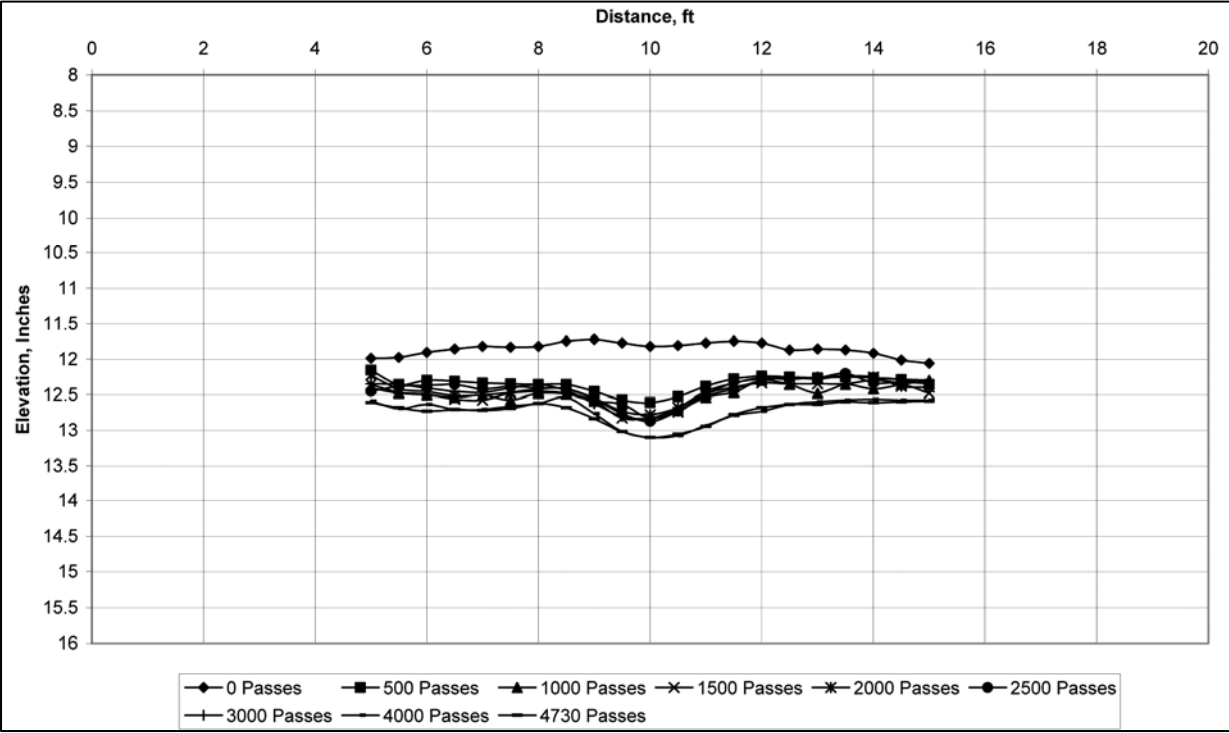
Figure 9. Permanent surface deformation cross section for DURA-BASE on high-strength subgrade (40 to 50 CBR)

The DURA-BASE matting system performed very well, allowing well over 2,000 passes of the load cart under all the soil conditions investigated with less than 76.2 mm (3 in.) of mat deflection. The mat surface did show signs of traffic and wear by the end of the investigation, but even with this wear, the surface still offered ample traction. The only major sign of failure was some permanent deformation in the mat's midsection during the final stages of testing. The mats exhibited no tears, ruptures, or pin connection failures during the entire investigation.

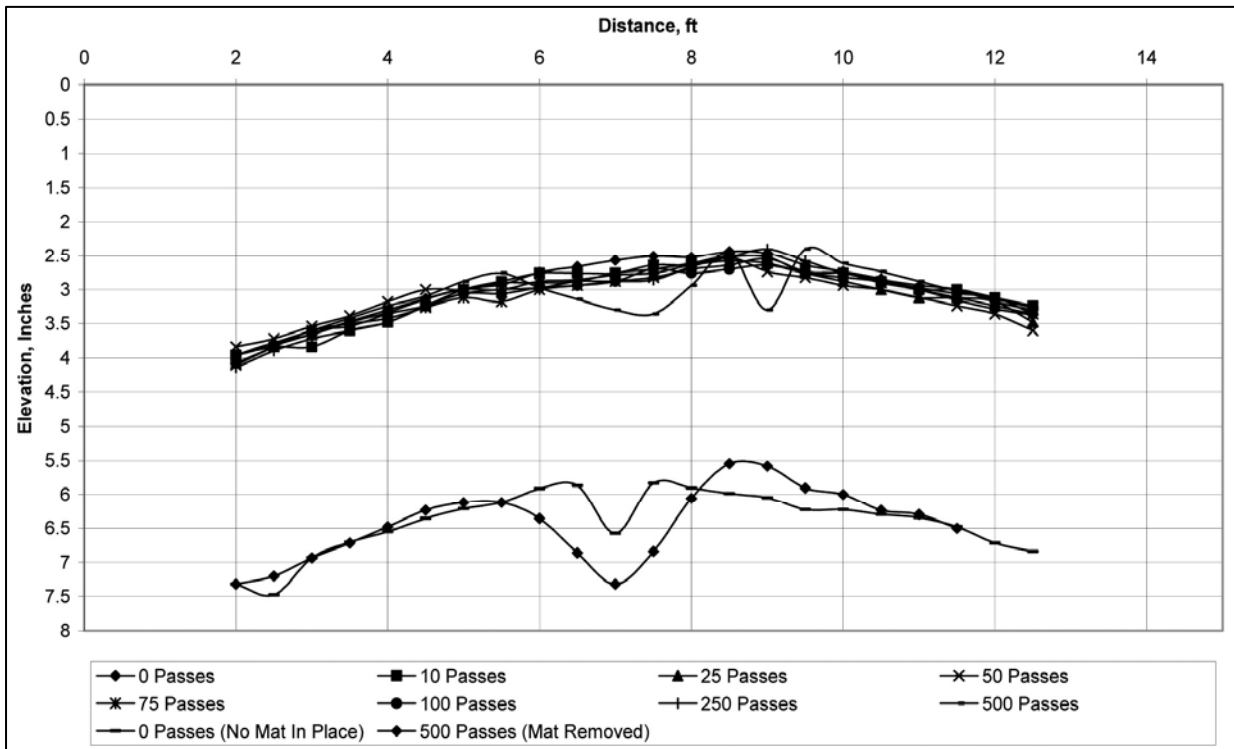
Figure 13. Permanent surface deformation cross section for SP-12 mat on high-strength soil (40 to 50 CBR)

The SP-12 Mat appeared to perform well on the high-strength subgrade (40 to 50 CBR), allowing 500 passes with only 25.4 mm (1 in.) of rut. The mat tested was a prototype model developed and trial-produced by the manufacturer and shipped to ERDC specifically for this test. This mat is still in the developmental phases, and during testing it was found that the welding between the “skin” and “ribbing” or “core” of the mat was faulty, and contact between the two pieces was less than 20 percent. These flaws caused the mat to fail mechanically before failure due to rutting occurred. It is therefore not appropriate at this time to pass final judgment on this product. The initial testing of this product indicates a mat system with much potential, but the flaws with the manufacturing process must be resolved before further testing and conclusions can be formed.

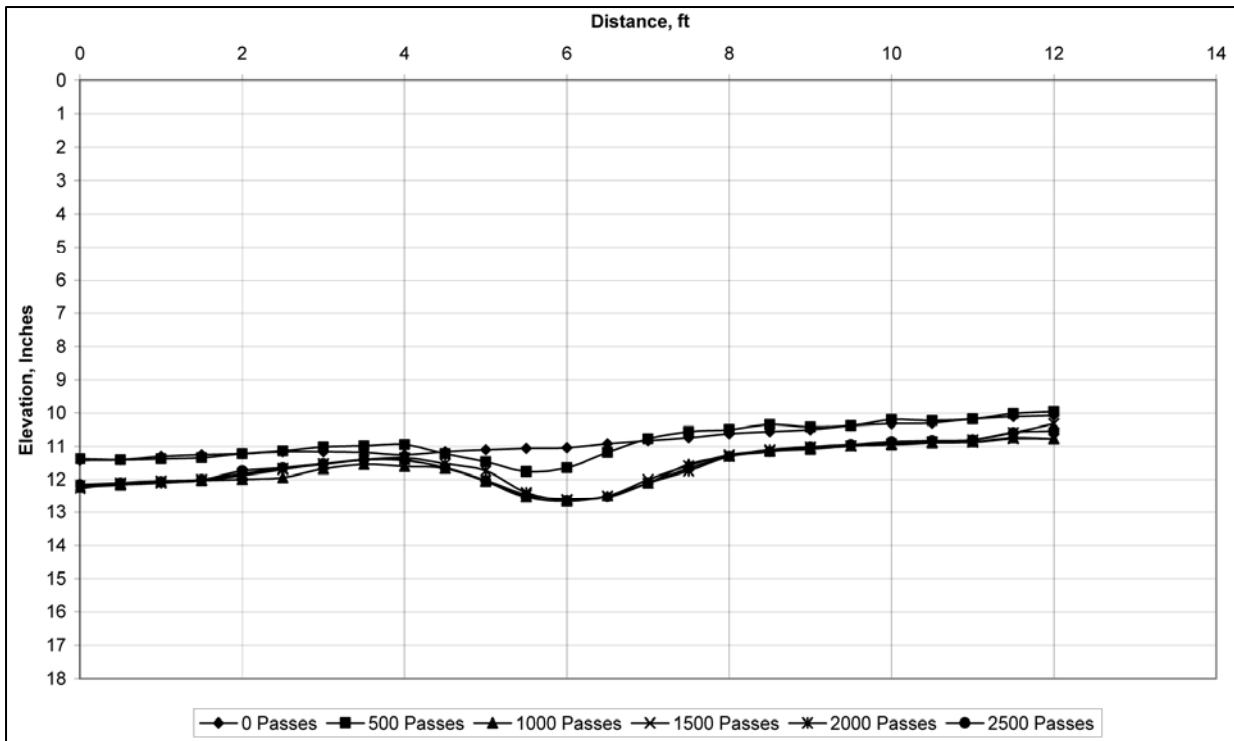
Figure 15. Permanent surface deformation cross section for DURA-BASE on medium-strength soil (8 to 10 CBR)

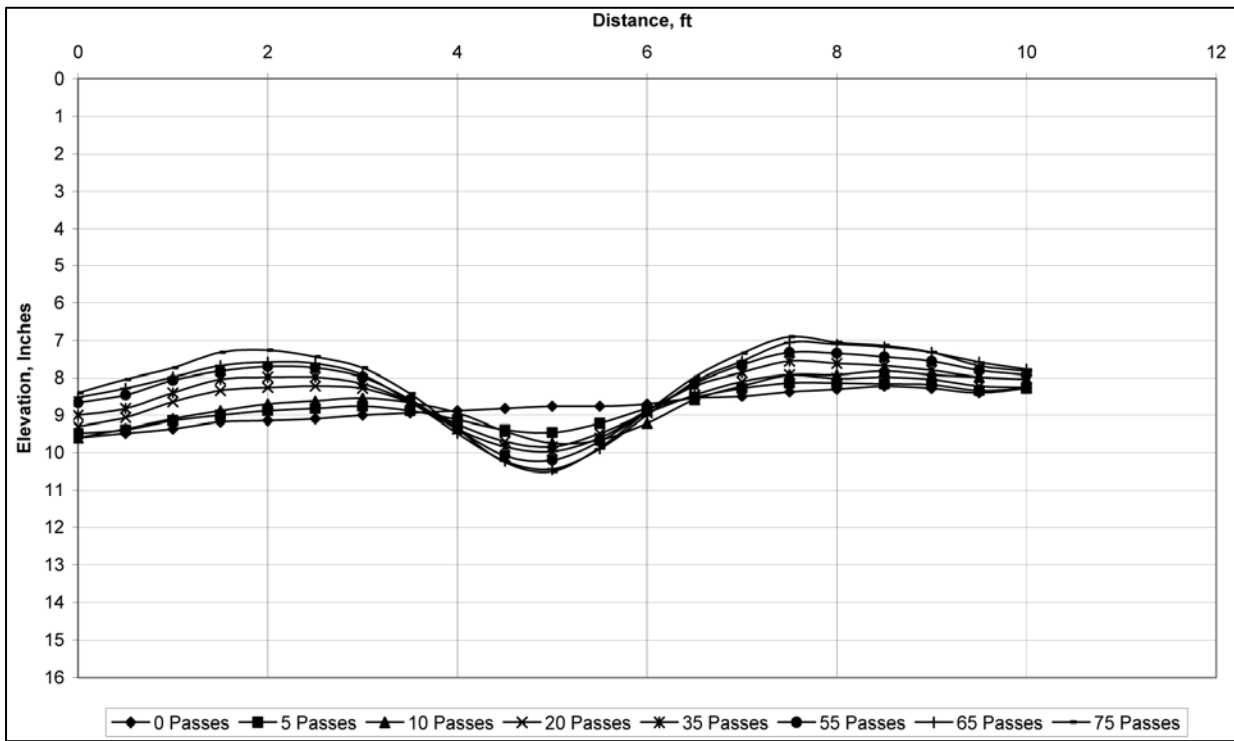
Figure 19. Permanent surface deformation cross section for MP Mat on low-strength soil (3 to 5 CBR)

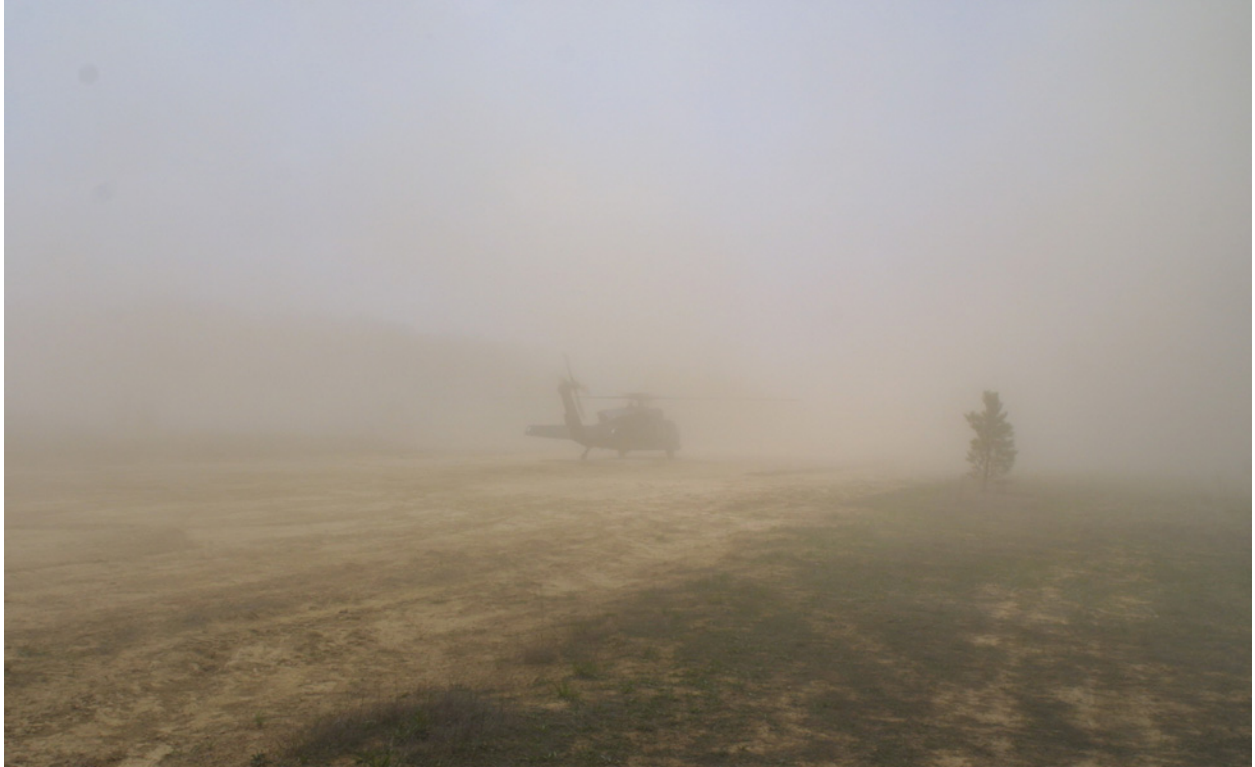
Photo 1. Brownout conditions resulting from helicopter operations in dusty environment

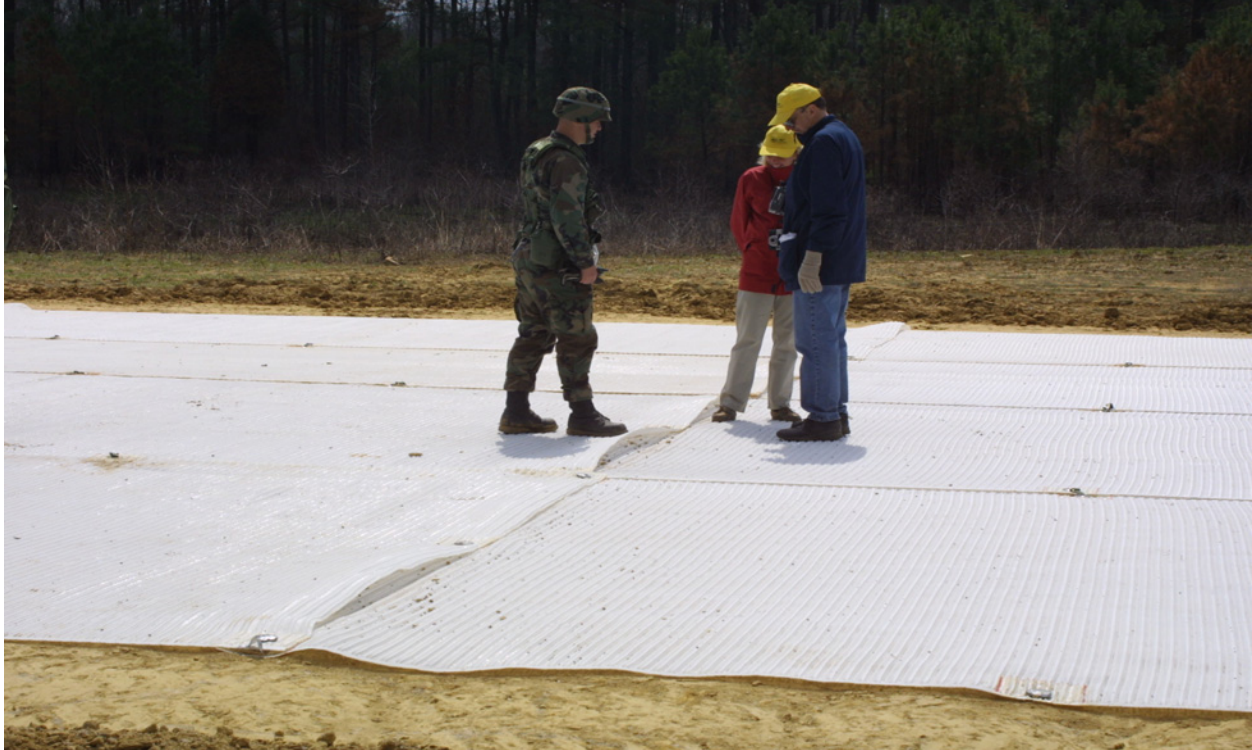
Photo 7. Completed Mobi-Mat helipad. (Note tops of pins used to hold it in place)

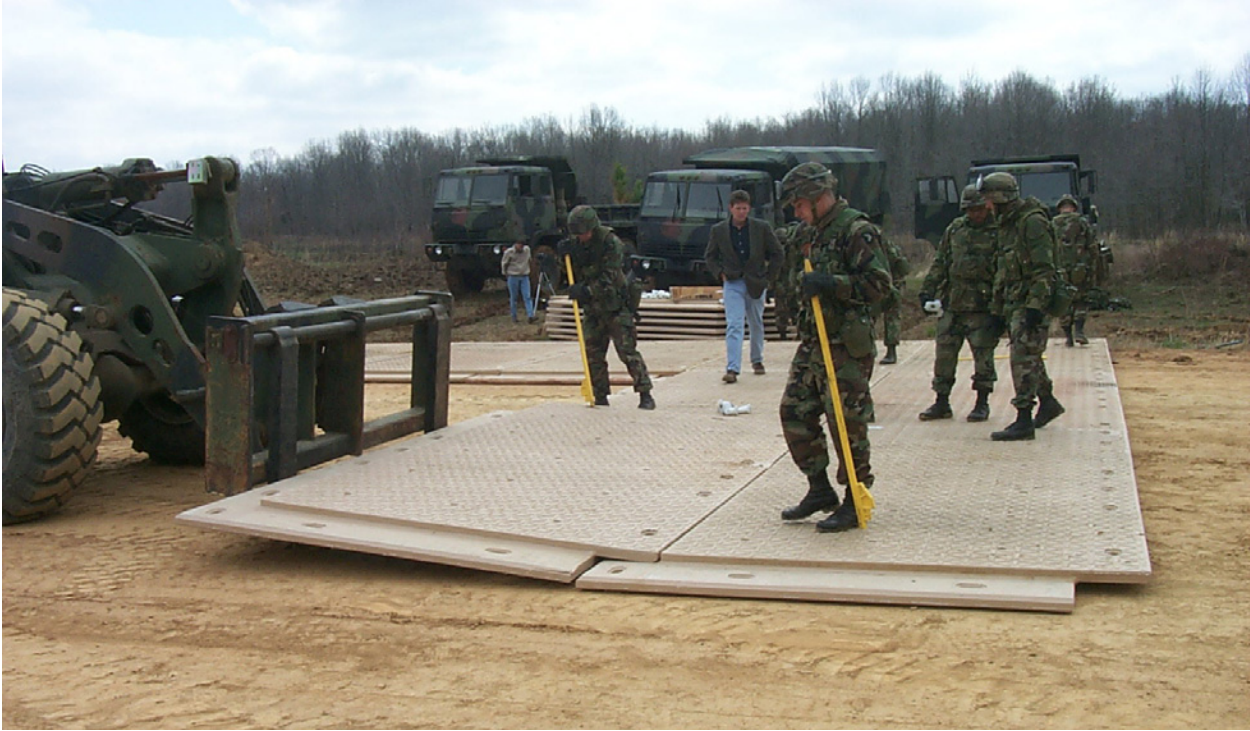
Photo 9. Bar tools used to align connector pinholes during placement

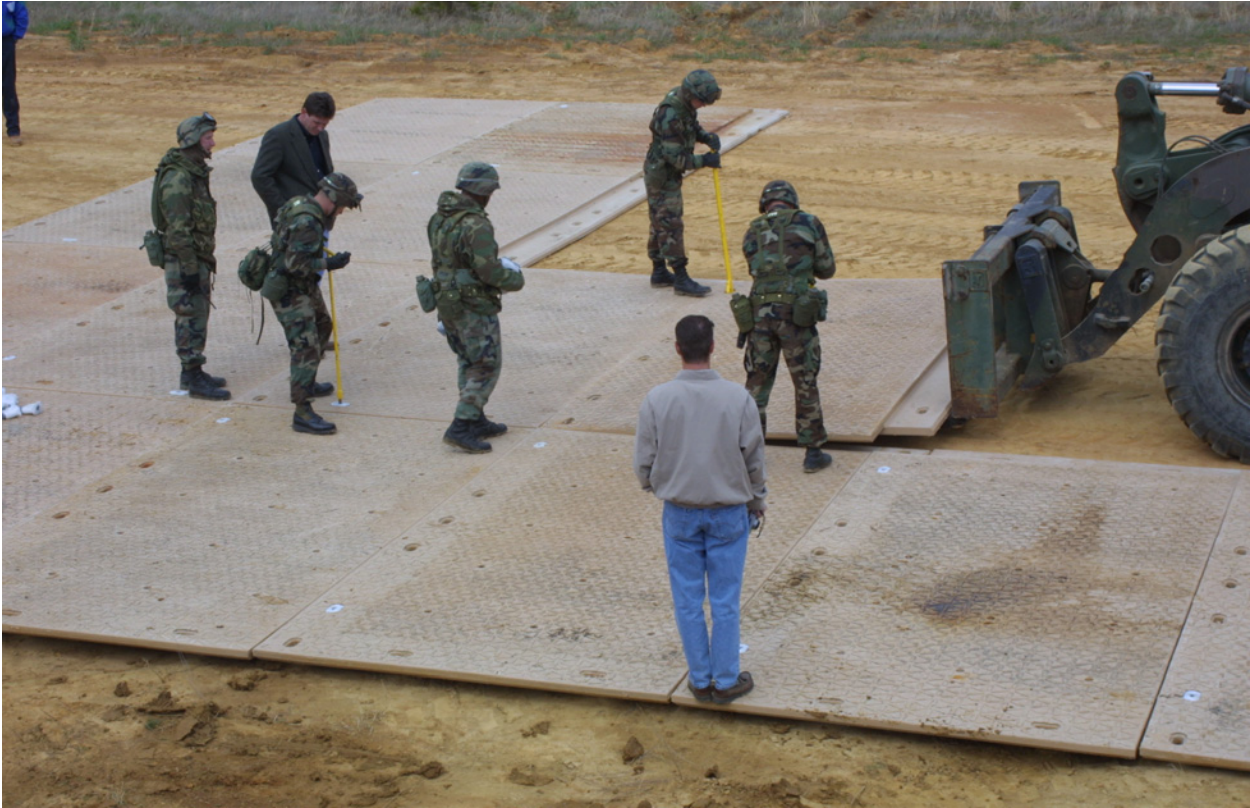
Photo 10. Dual-use bar tool used to align panels and lock in connector pins

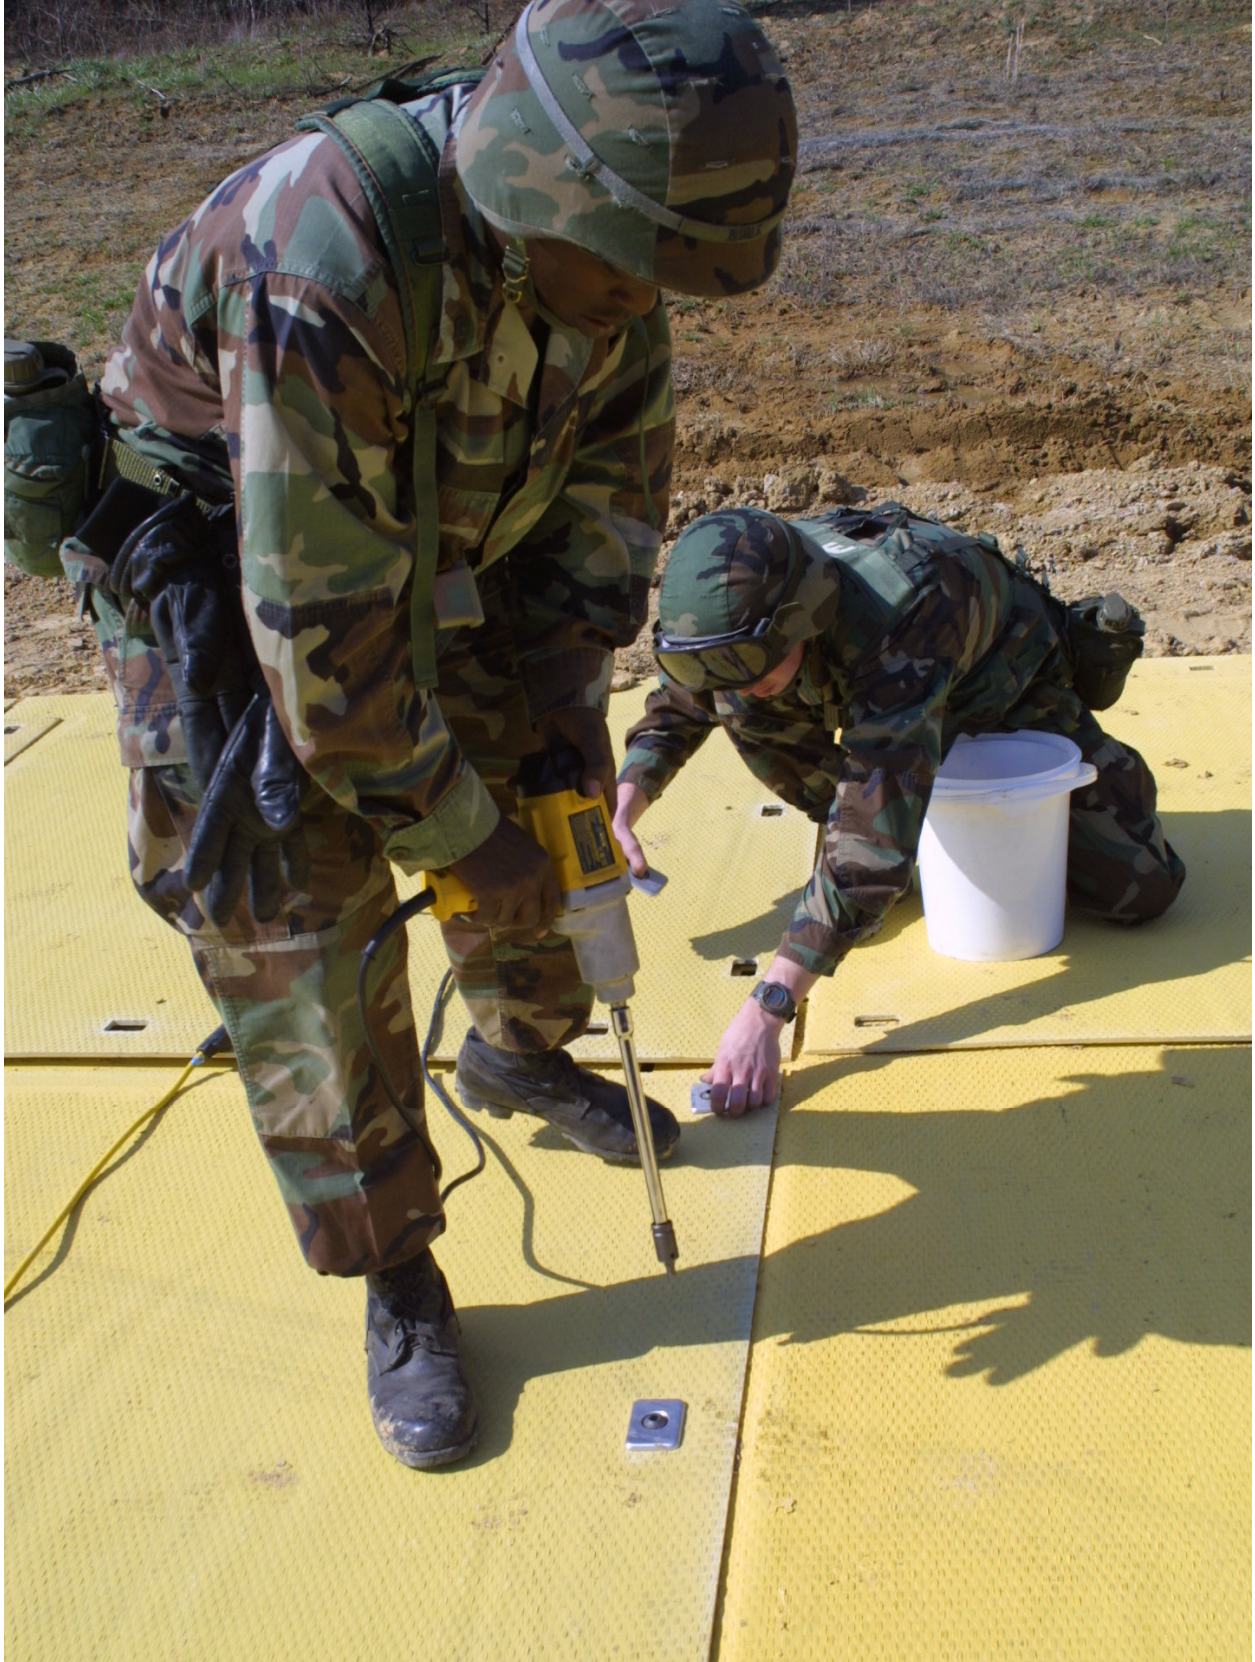
Photo 17. Placing MP Mat connector pins and locking pins with electric impact wrench

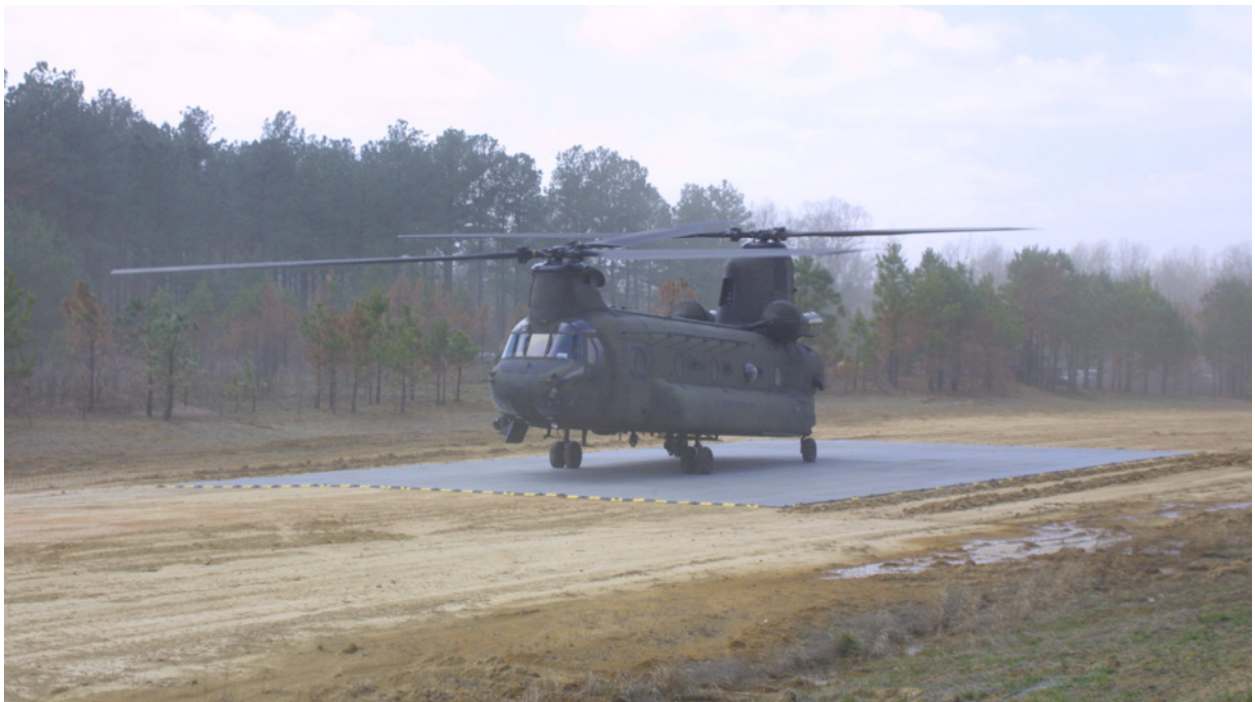
Photo 23. CH-47 Chinook operating on SUPA-TRAC helipad

The SUPA-TRAC system performed reasonably well during the helicopter tests. Excess dust and FOD were reduced while the aircraft were hovering directly above or operating on the matting system itself (Photo 23). Inspection of the mats after the limited helicopter operations showed that the plastic panels did sustain some damage (Photo 24). It was not determined if the limited damage occurred as the result of static or dynamic loads. Also, one edge panel loosened during testing because of rotor wash, but no significant deflection or upheaval resulted from this failure. The SUPA-TRAC system is expected to provide improved load-bearing support, but system component durability is questioned because of the damage noted after the very limited traffic and installation.

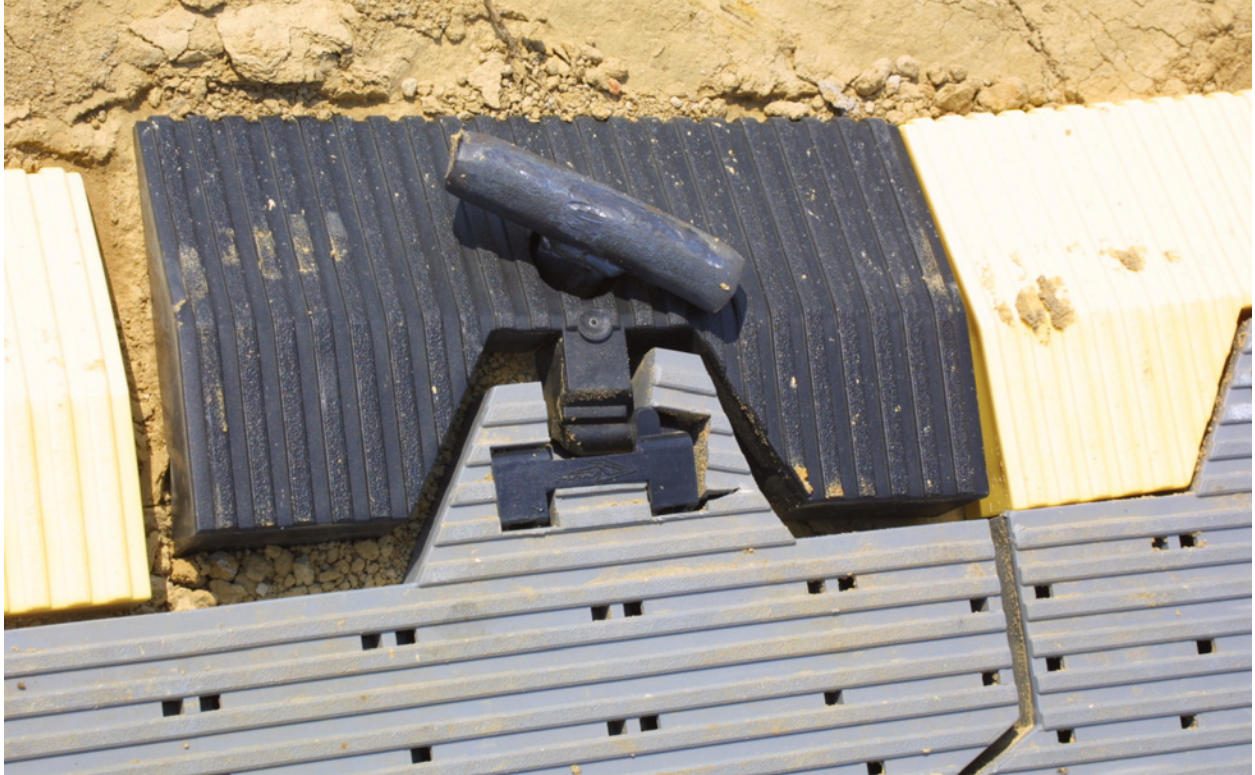
Photo 24. Isolated structural damage to SUPA-TRAC matting system at helipad edge

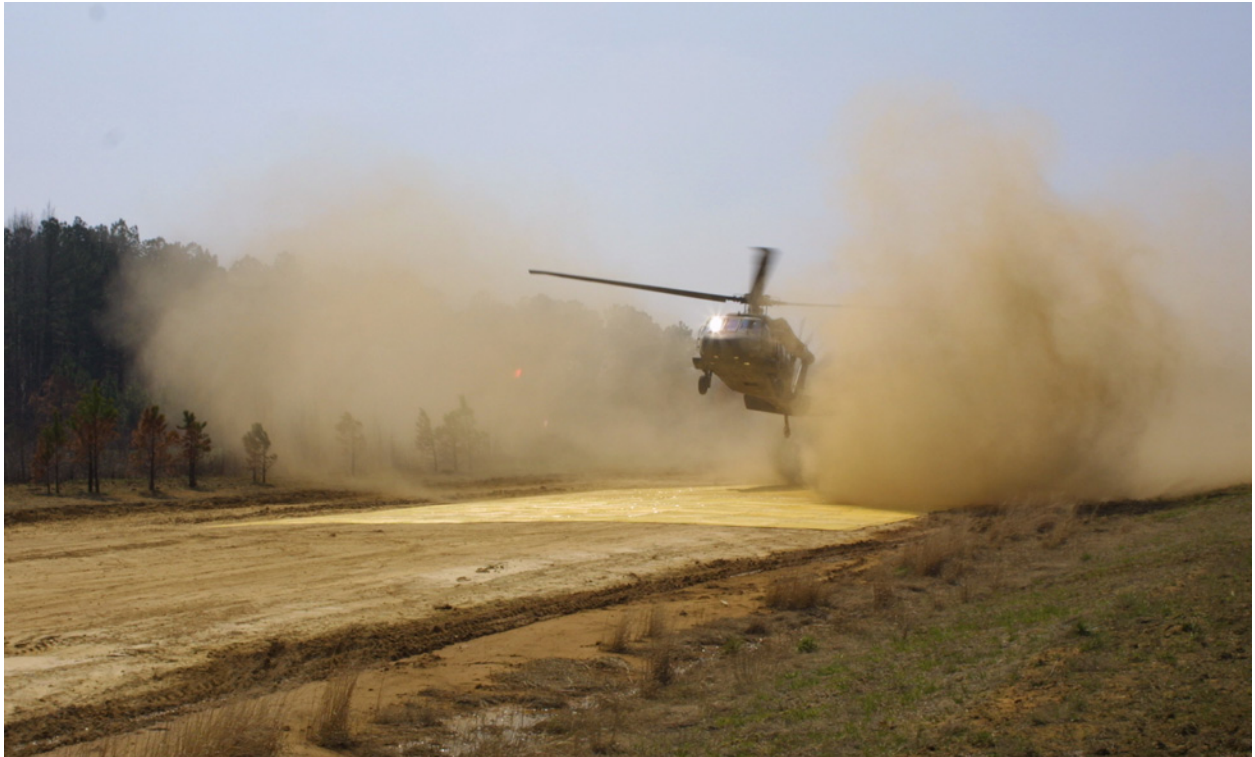
Photo 25. MP Mat helipad diffusing dust cloud as UH-60 Blackhawk approaches helipad

The MP fiberglass reinforced mats performed extremely well under all helicopter tests by significantly reducing dust while providing a firm helipad surfacing for taxiing and static loads. Some minor deflections were noted when the helicopters touched down and rolled, but no damage or dangerous undulations were observed. The helicopter tests suggested that only corner connector pins are actually needed for helicopter loads. Also, it was agreed that the duckbill anchoring system was excessive, and that a simple edge staking system should be more than adequate to resist uplift or other movement from rotor wash. Photo 25

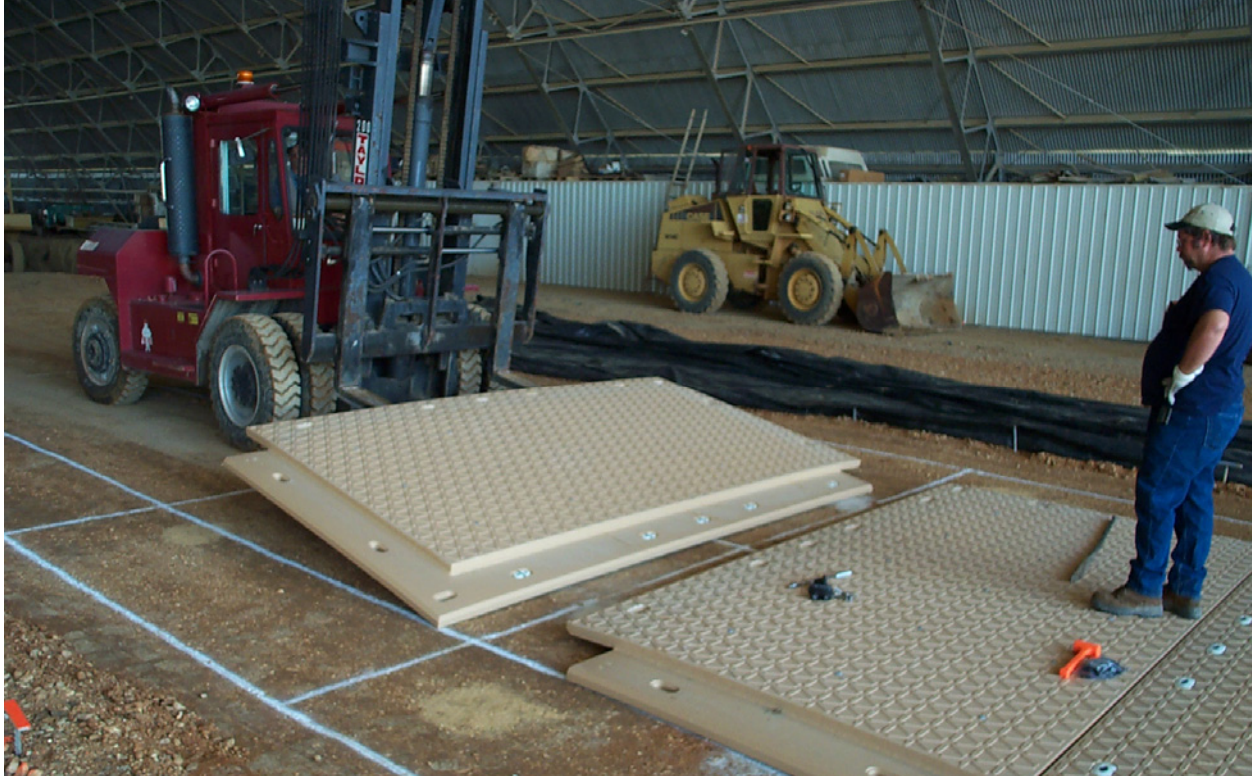
Photo 26. Installing DURA-BASE matting system

This matting system was originally designed and manufactured as a temporary load-bearing work platform system for use on low- and medium-strength soils by the oil-drilling industry. These mats have been found to be durable for the application of heavy truck traffic over soft, low-strength soils. The primary applications would be taxiways and parking aprons for contingency airfields, extensions or temporary additions to existing airfields, temporary helipads, and equipment storage pads. A material description of DURA-BASE is given in the Chapter 2 of this report. Photo 26 shows the installation of DURA-BASE on the test section.

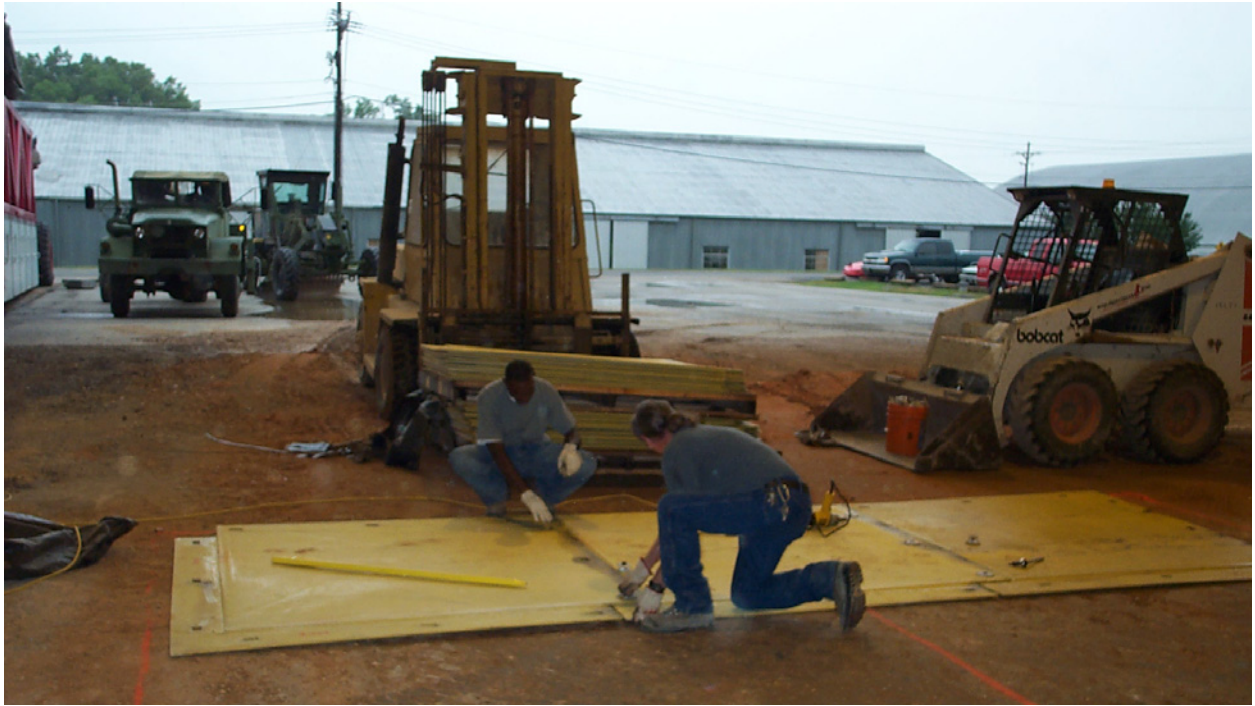
Photo 27. Installing 5-ply MP matting system

This matting system was originally developed for expedient road construction over sandy soils. MP Mats, like the DURA-BASE Mats, have been found to be durable for application of heavy truck traffic over loose, sandy soils. They can also be used in the same applications listed for the DURA-BASE. A material description of MP Mat is given in Chapter 2 of this report. Photo 27 shows the assembly of MP Mat on the test section.

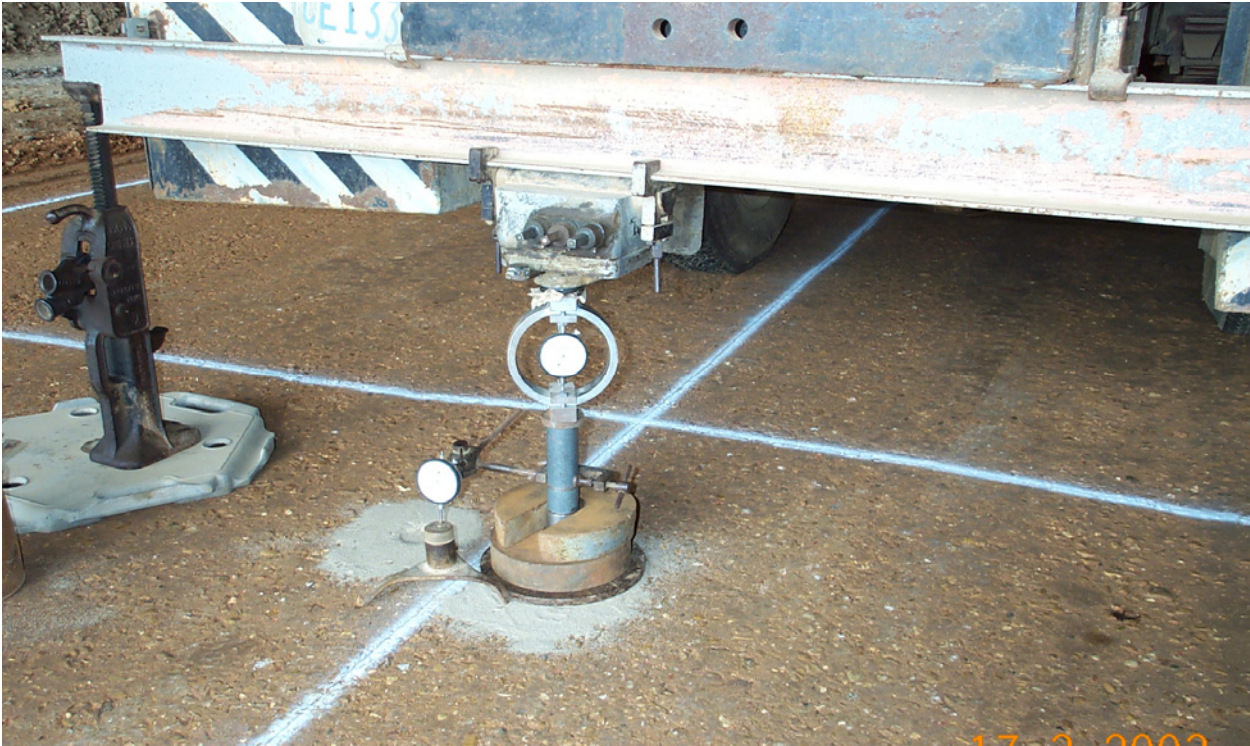
Photo 31. Field CBR test setup

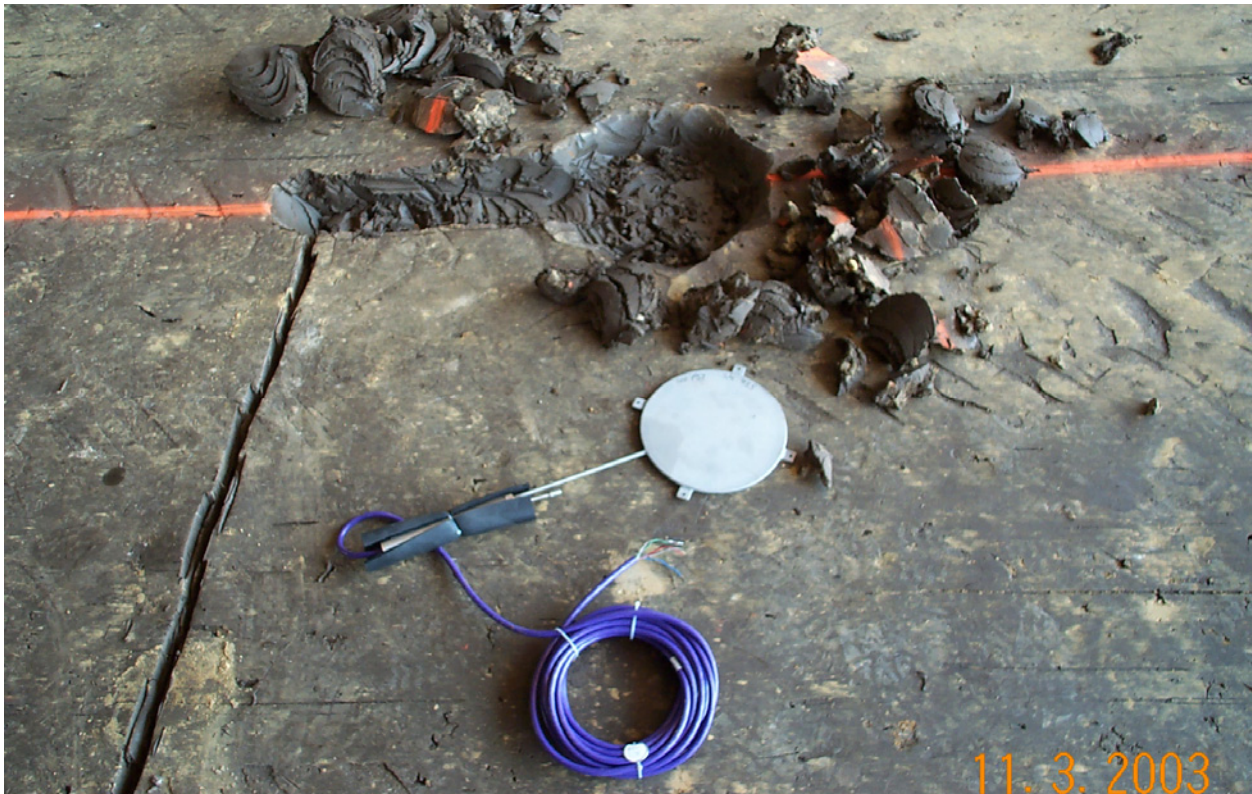
Photo 33. 100-psi GeoKon Pressure Cell awaits placement in CH clay

The instrumentation used for this test section consisted of subsurface pressure sensors. Although failure criteria for this project were limited to rut depths and mat system failure, it was determined that gathering information on soil pressures during trafficking could be useful for this and other projects. The sensors used were GeoKon 0.7-MPa (100-psi) pressure cells that were connected by radio telemetry to a data acquisition system located in Hangar 4. The project began with four of these pressure cells. One of these cells was destroyed during its extraction between the testing of the unsurfaced control and the first mat system. The remaining three cells continued to function with some repairs as the testing progressed. The cells were generally placed at a depth of 6 in. below the surface on which the mats were laid (either clay gravel or CH clay). Photo 33 shows a typical pressure cell and a location excavated in the CH clay where it was installed. The cells were placed such that at least one was located below the center of a mat in the middle of the lane, and another in the middle of the lane and below a joint between two mats. In all cases, the cells were placed farther than 10 ft from one another. The pressure cell data were collected at only specified numbers of passes.
