# Rapid Maximum-On-Ground (MOG) Enhancement Technologies

Report 1

Matting Systems for Contingency Helipads and C-130 Test Sections

January 2005

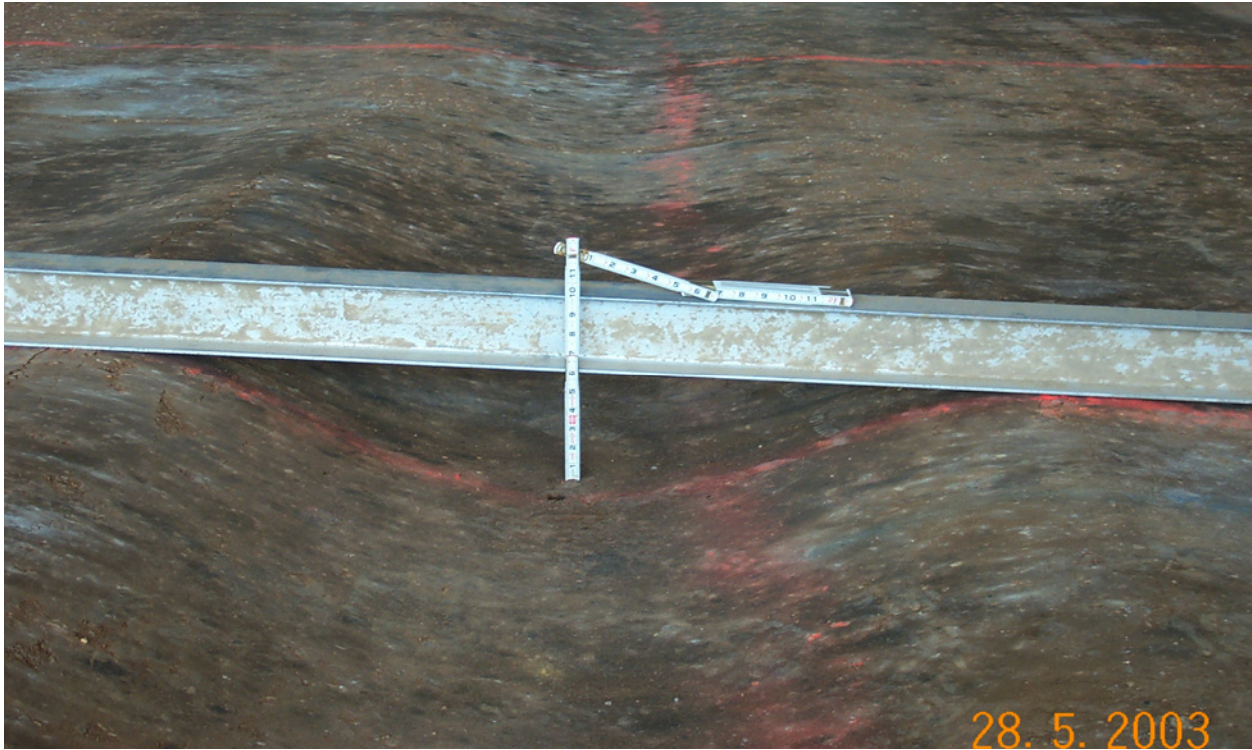
Photo 34. Measuring final rut depth on the Rapid Mat test (mat has been removed)

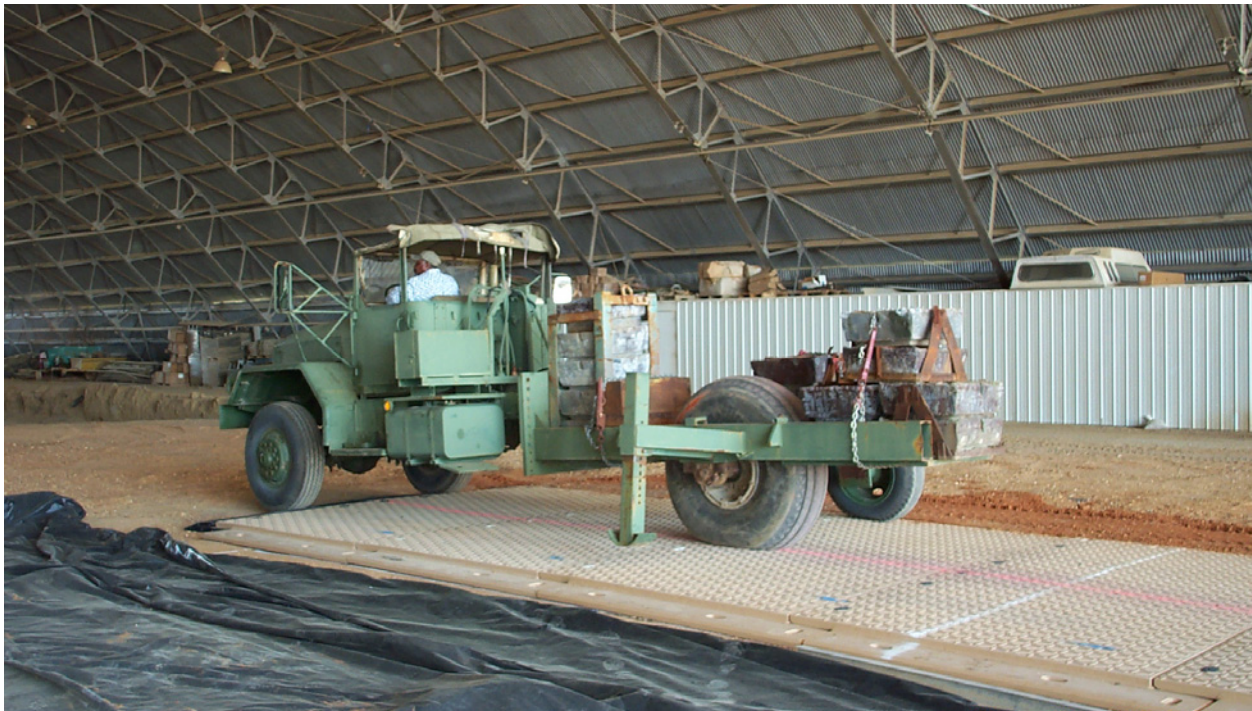
Photo 35. Loaded C-130 load cart performing traffic test on DURA-BASE matting

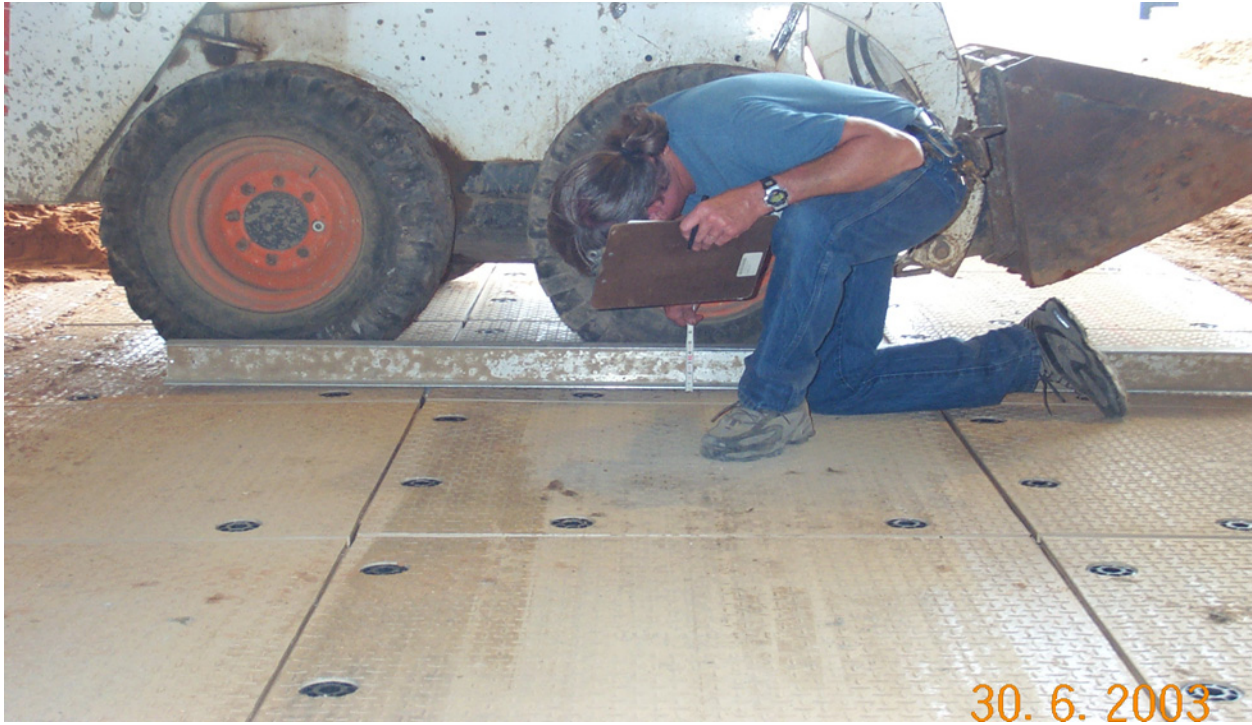
Photo 36. Using the skid-steer multipurpose machine to measure mat in-place rutting

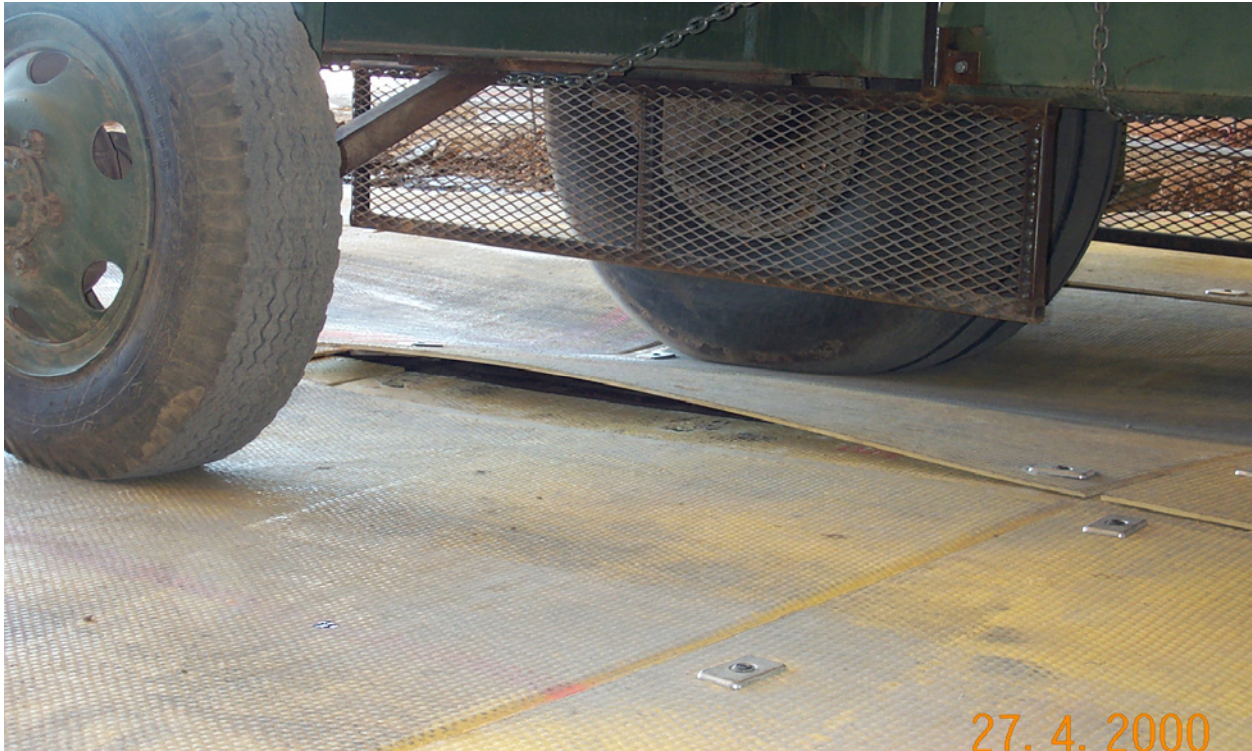
Photo 37. Secondary deflection of MP Mat on low-strength soil (3 to 5 CBR)

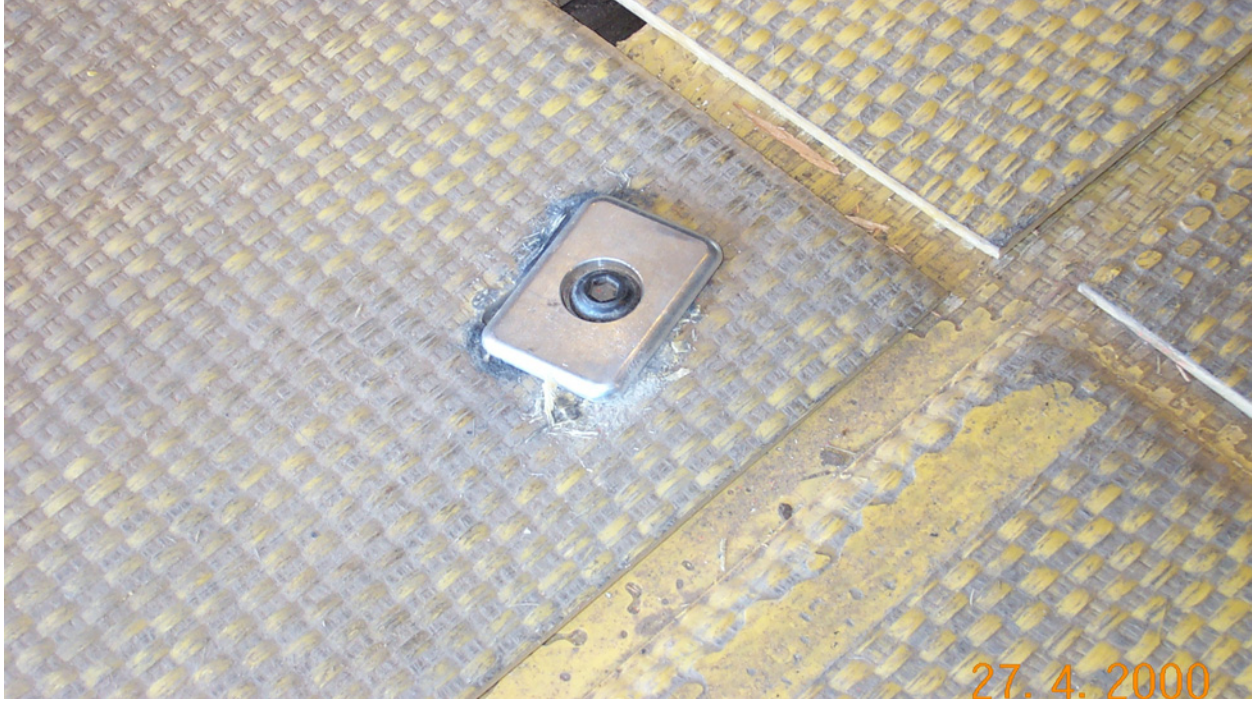
Photo 38. Movement of MP Mat pin within connection. Pin did not fail. (Low-strength soil, 3 to 5 CBR)
