ERDC/CERL SR-05-41

Fort Leonard Wood Maintenance and Repair Manual

Black Officers' Club

Maintenance and Repair Manual Building 2101—Black Officers' Club

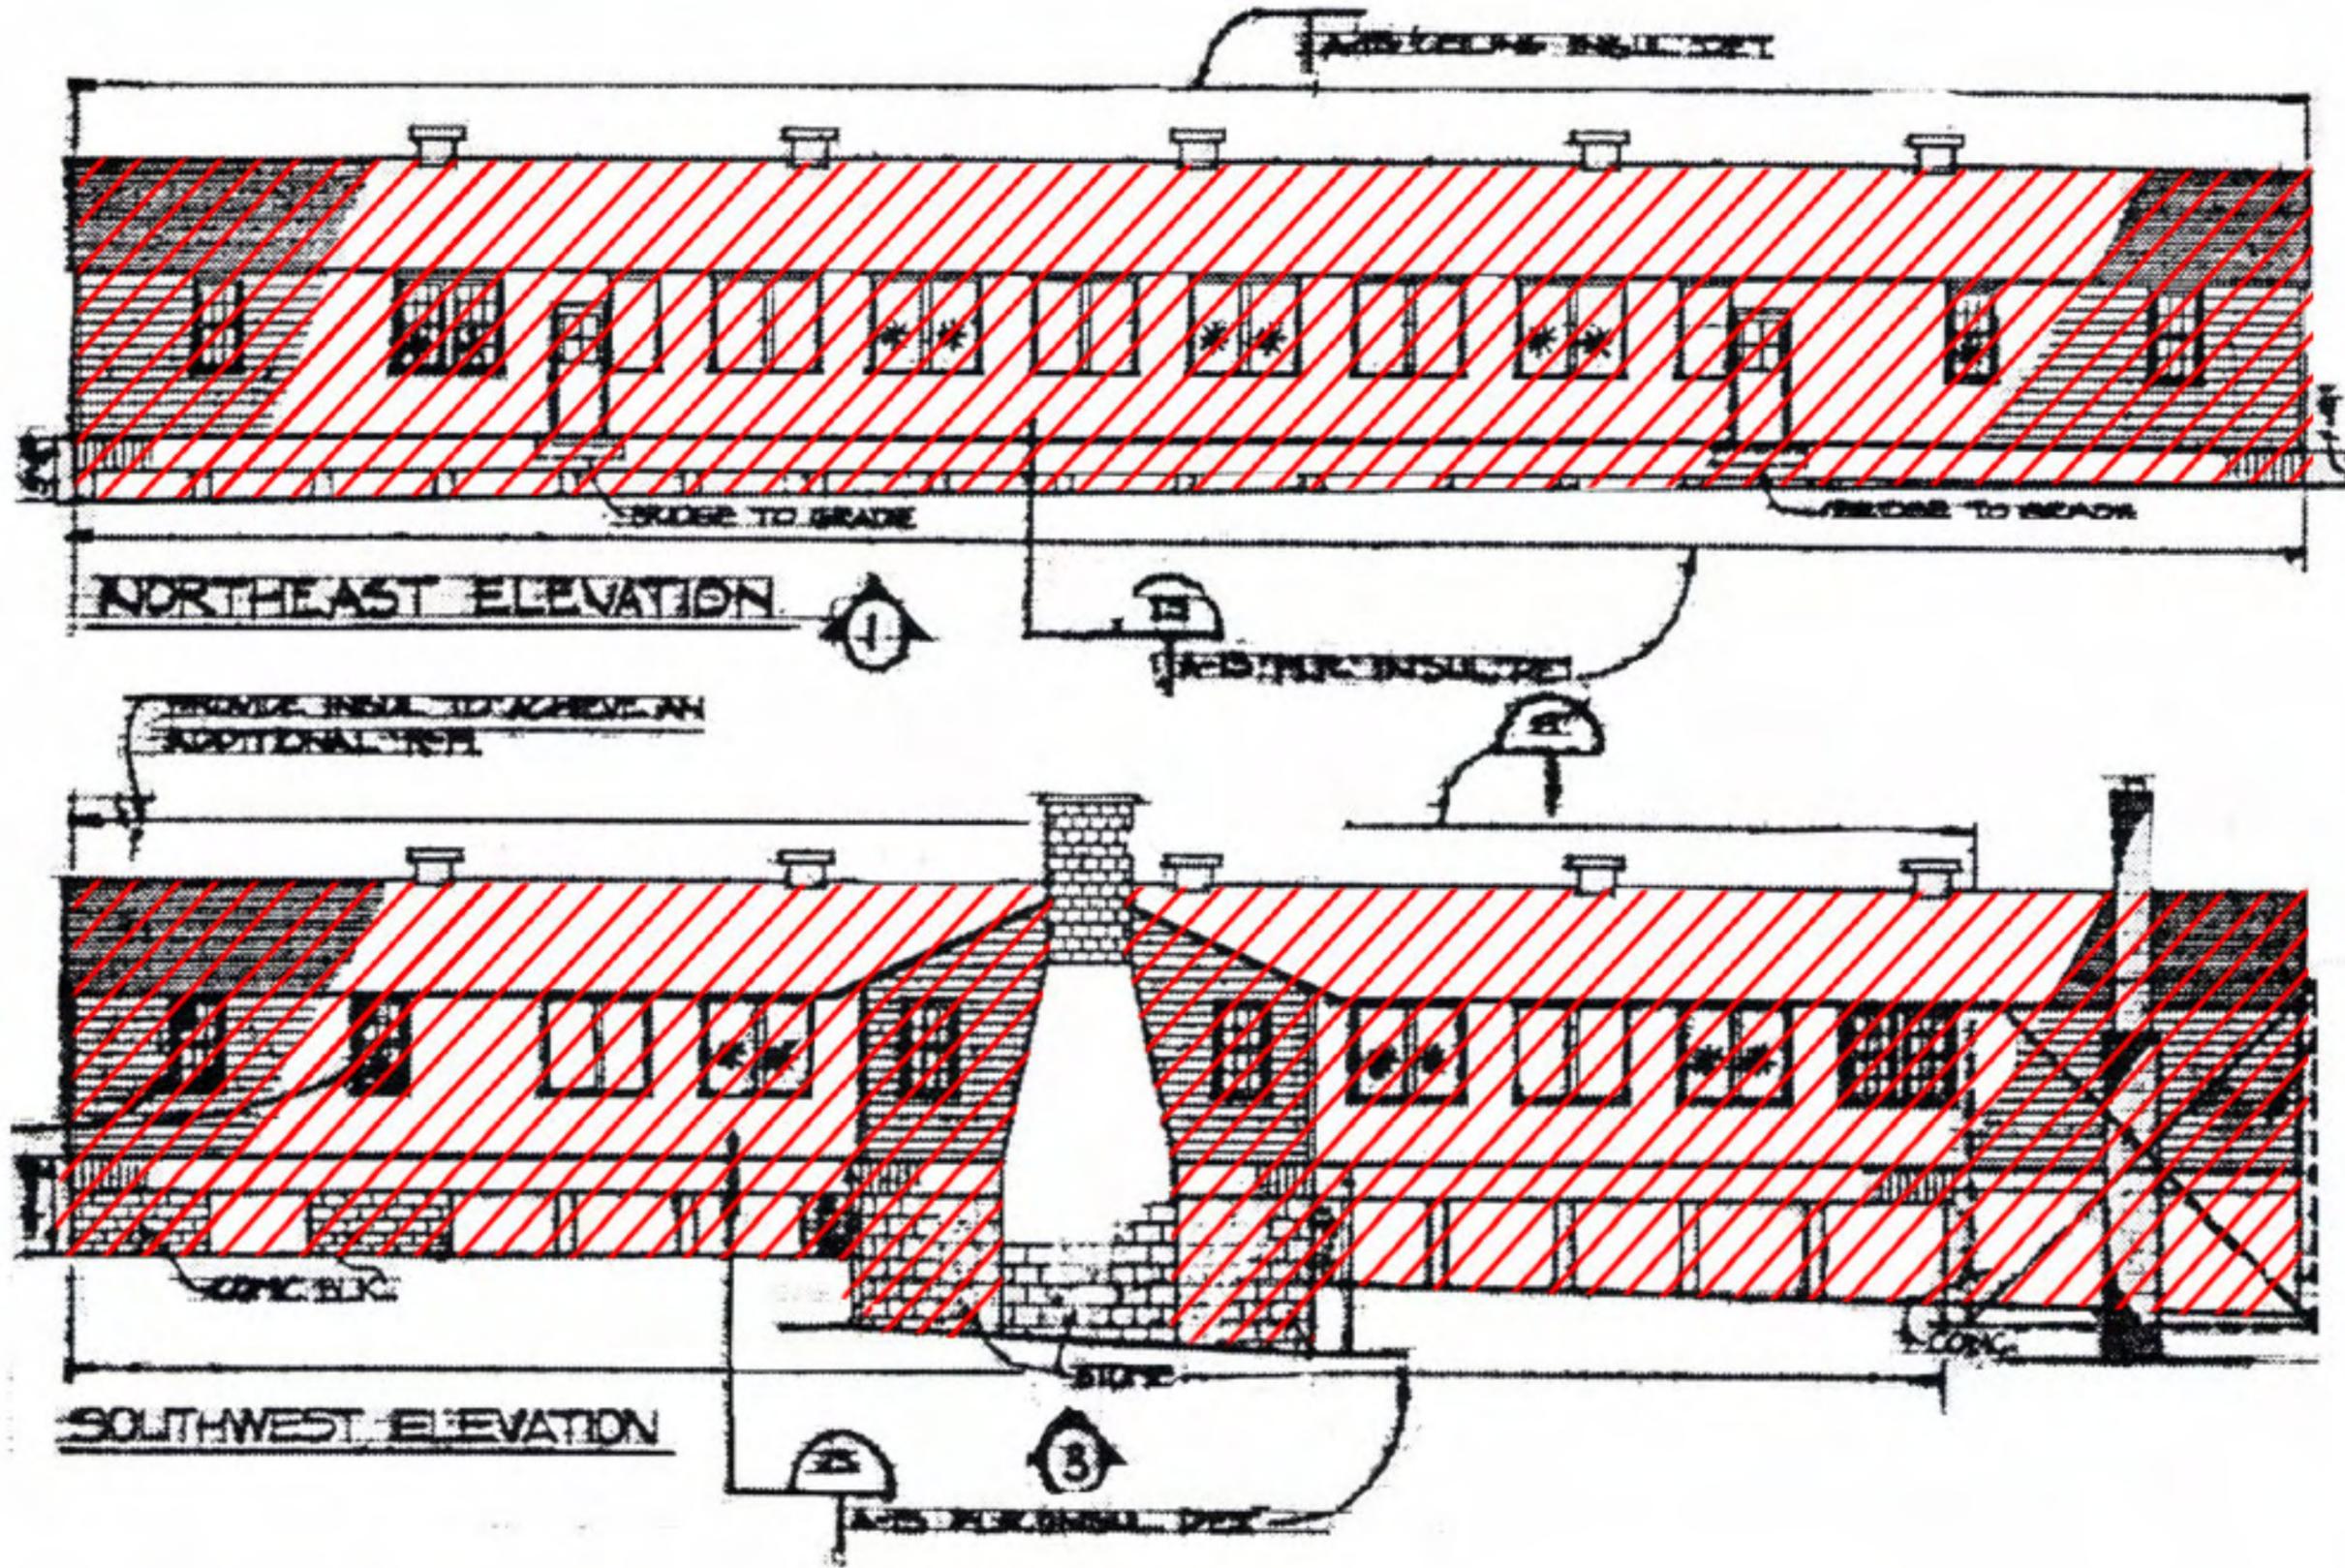
Figure 3: Building
2101 Building Zone
Diagram

The Black Officers' Club has been insensitively adapted using metal siding and detailing, which creates a mechanism for the deterioration of the original wood elements below. At this time we strongly suggest the removal of the metal siding and the restoration of the original wood materials beneath. These areas are striped red on the elevations.

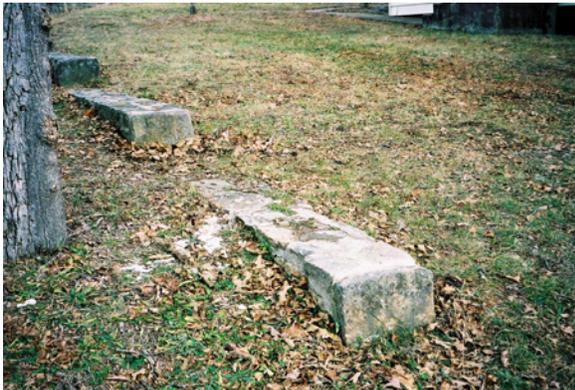
The grounds surrounding the Black Officers' Club, Building 2101, consist of stone drainage ditches along the perimeter of the building and stone retaining walls and swales at the site perimeter. The stone walls run along the outer perimeter and around the platform for the generator at the east side of the building. The stone swales begin at the outer west perimeter of the site and continue along the south side eventually leading to the stone steps on the east. Generally the terrain surrounding Building 2101 slopes toward the south. There do not appear to be any major drainage problems.

Stone work should be clear from all vegetation by lowering grade along the sides.

- Remove the soil and plants covering any stonework, and
- lower grade on the sides of the stone retaining walls, and
- grass and shrub should be trimmed regularly to maintain a desired height, and
- standard preventive maintenance practices and building conservation methods have not been followed, and/or
- there is a reduced life expectancy of affected or related building materials and/or systems, and
- there is a condition with long-term impact beyond 5 years.

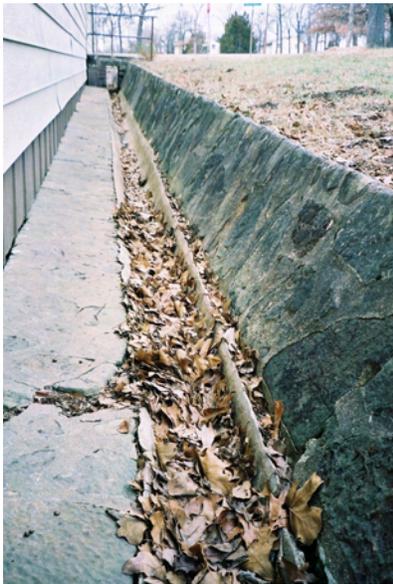
There are two drainage ditches for the building, the base of which are constructed of concrete. The ditch one foot away from the perimeter of the building is two feet wide with two sloping sides to guide water to the drain. The second ditch runs along the south swales and it is also about two feet wide with one sloping side to guide water to the drain.

Remove leaves from drainage ditch to ensure proper water drainage.

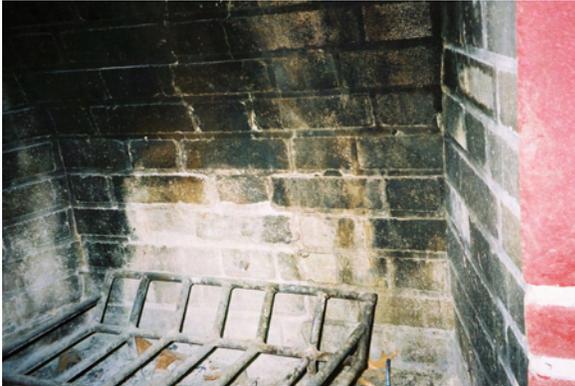
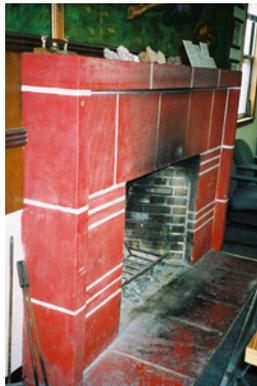
The mantle and outer frame of the interior fireplace cavity supporting the mantle are constructed of stone with recessed mortar joints. The stone is painted red and the recess of the jointing is filled in with unpainted plaster so that the surface is flush with the stone.

The mortar in the fireplace interior cavity requires spot repair and repointing.

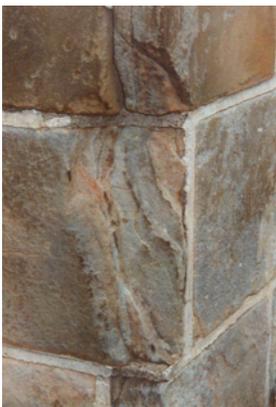
The chimney is made of cut stones and is located on the south facade of the south wing of the Black Officers' Club. The stone is spalling near the base, which could affect the stability of the chimney. This will need to be addressed, before the condition worsens and causes a threat to those who use the building.

The stone is showing signs of age and wear. The exterior stone is spalling in areas, and the mortar is cracking.

- Replace exterior stone with more than 50% surface spalling and repoint mortar where necessary using materials in-kind to original in both appearance and mechanical properties.
- Treat stone for mildew growth.
- NR Rating: 112

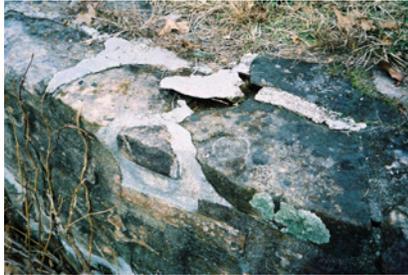
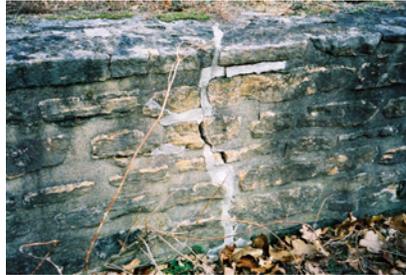
The retaining walls are constructed of stones assembled using mortar bonds to form a wall. They run along the east side of Building 2101—the Black Officers’ Club and the patio. The walls are have been poorly repaired and will need some attention.

Discolored and cracked mortar should be repointed. Remove existing repaired mortar job and repoint with matching color mortar.

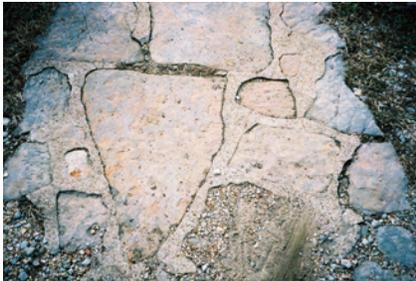
The sidewalks are composed of cut stones assembled using mortar bonds which are flush with the stone surfaces. The sidewalks are located at the north entrances of the building and connect the building to the street.

The sidewalk stone should be cleared of all vegetation and repointed using a mortar similar in both appearance and mechanical properties to the original.

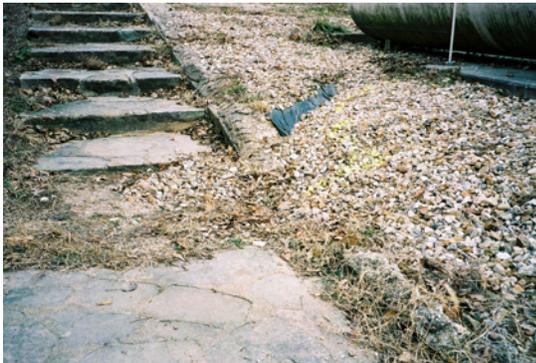
Stone steps are located on the east side of the building and connect the patio to the north sidewalks.

Stone steps should be cleared from all leaves and sticks.

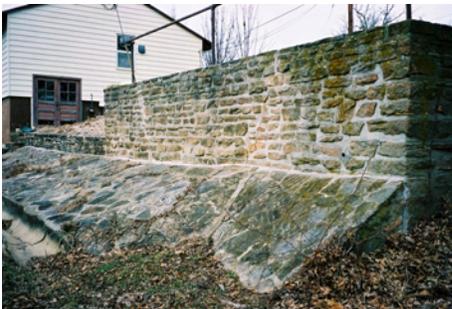
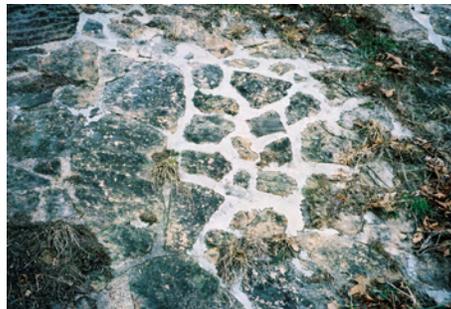
The swale is located along the south facade and the outer perimeter of the property on the south and west facades.

Mortar used to repoint does not match original in neither appearance nor mechanical properties.

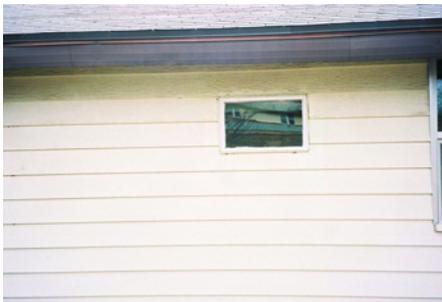
A painted metal fascia covers the original wood fascia. This repair was made at the time the siding was covered. All metal siding, fascia, and endcaps should be removed to reveal the original wood underneath. This wood will then need to be treated as per preservation standards; repaired as needed, replaced where beyond repair, cleaned, scraped, primed and repainted to restore the original historic appearance of the structure.

Metal fascia should be removed to reveal the wood fascia below.

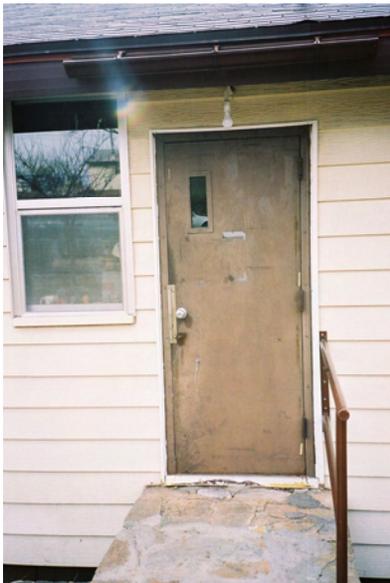
On the east elevation, a gutter has been installed just over the two north doors. This element is not historically relevant to the structure and should be removed.

The metal gutter is above the northeast entrance door.

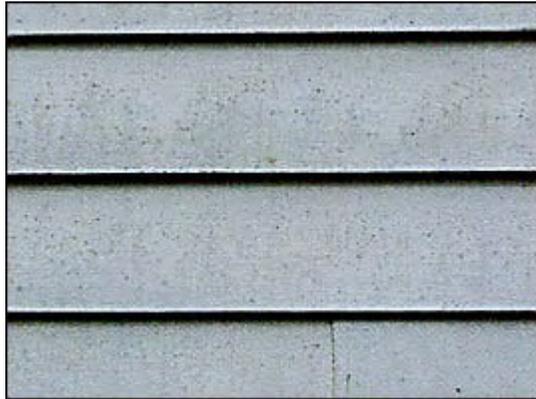
B. MILDEW:

Black, gray, or brown areas of fungus growth on the surface of paint or caulk.

Because mildew can only exist in shady, warm, moist areas, attention should be given to altering the environment that is conducive to fungal growth. The area in question may be shaded by trees which need to be pruned back to allow sunlight to strike the building; or may lack rain gutters or proper drainage at the base of the building. If the shady or moist conditions can be altered, the mildew is less likely to reappear. A recommended solution for removing mildew consists of one cup non-ammoniated detergent, one quart household bleach, and one gallon water. When the surface is scrubbed with this solution using a medium soft brush, the mildew should disappear; however, for particularly stubborn spots, an additional quart of bleach may be added. After the area is mildew-free, it should then be rinsed with a direct stream of water from the nozzle of a garden hose, and permitted to dry thoroughly. When repainting, use specially formulated exterior latex "mildew-resistant" primer and then a top-of-the-line exterior latex paint.

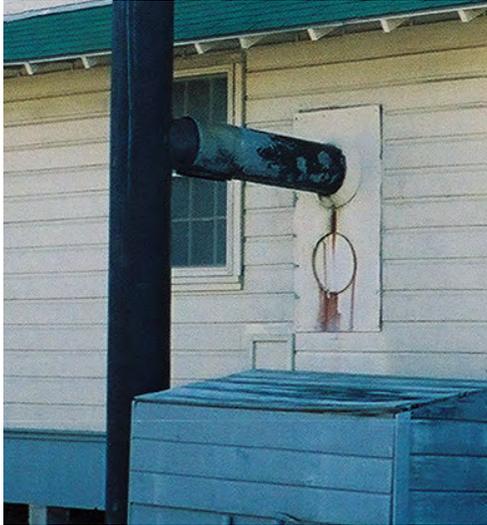
C. STAINING:

Staining of paint coatings usually results from excess moisture reacting with materials within the wood substrate. There are two common types of staining, neither of which requires paint removal. The most prevalent type of stain is due to the oxidation or rusting of iron nails or metal (iron, steel, or copper) anchorage devices.

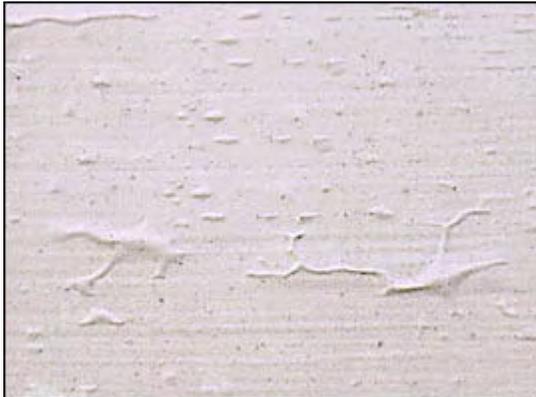
B. WRINKLING:

A rough, crinkled paint surface occurring when paint forms a "skin."

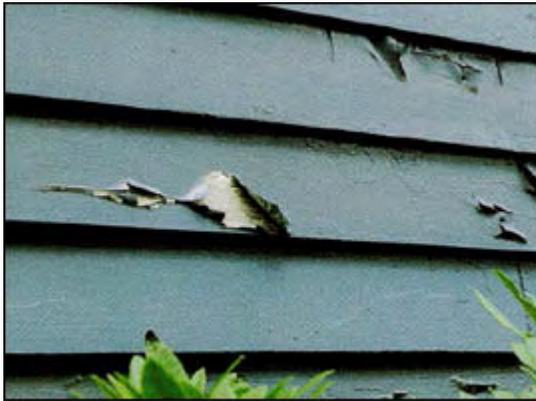
A. PEELING:

Loss of paint due to poor adhesion or moisture. Where there is a primer and topcoat, or multiple coats of paint, peeling may involve some or all coats.

There is no reason for repainting before dealing with the moisture problems because new paint will simply fail. Therefore, the first step in treating peeling is to locate and remove the source or sources of the moisture, not only because moisture will jeopardize the protective coating of paint, but if left unattended, it can ultimately cause permanent damage to the wood. Exterior moisture should be eliminated by correcting the following conditions prior to repainting: faulty flashing; leaking gutters; defective roof shingles; cracks and holes in siding and trim; deteriorated caulking in joints and seams; and shrubbery growing too close to painted wood. After the moisture problems have been resolved, the wood must be permitted to dry out thoroughly. The damaged paint can then be scraped off with a scraper or stiff wire brush, sand rough edges, and apply appropriate primer. Repaint with a top quality acrylic latex exterior paint for best adhesion and water resistance.

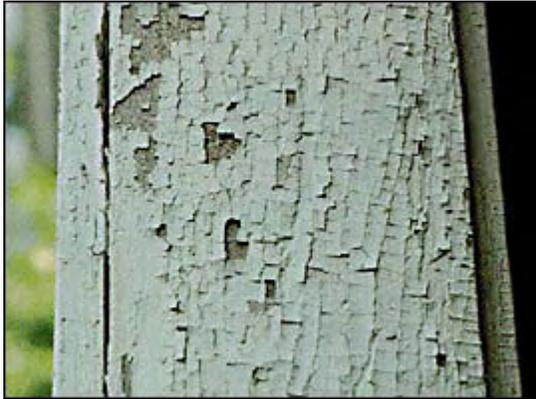
B. CRACKING / ALLIGATORING:

Cracking involves the splitting of a dry paint film through at least one coat, which will lead to complete failure of the paint. Early on, the problem appears as hairline cracks; later, flaking of paint chips occurs.

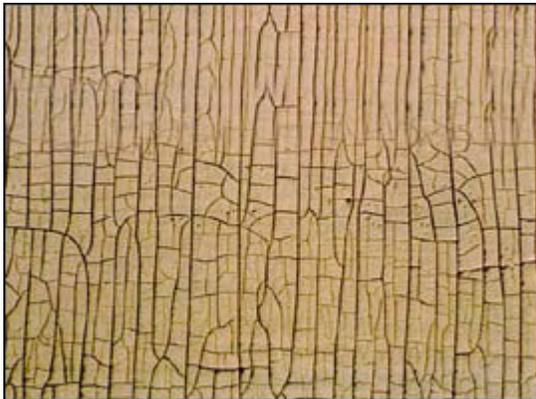
Alligatoring is the patterned cracking in the surface of the paint film resembling the regular scales of an alligator.

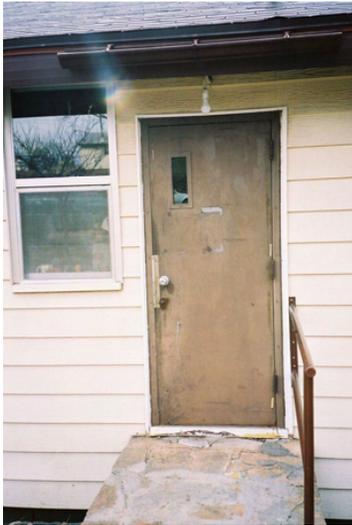
Two single metal doors are located on either side of the north elevation and one single metal door is centered on the west elevation. These doors are not original to the structure and their repair should be undertaken sensitive to the original appearance of the building.

All metal doors show signs of age and wear.

- Wood doors will need to be replaced. Appropriate doors can possibly be found in the other temporary buildings. This should be the primary source for replacement doors for any of the historic buildings.
- Metal doors are in poor condition and will need to be replaced using doors from other temporary buildings.
- NR Rating: 115

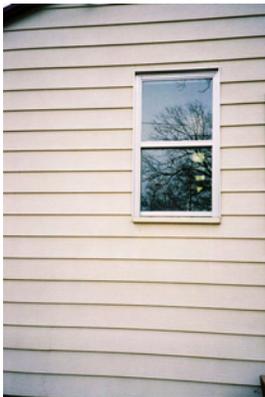
Painted aluminum double-hung windows are located on all facades of the Black Officers’ Club. They appear to be in reasonable condition and should be maintained regularly.

Metal windows are in good condition.

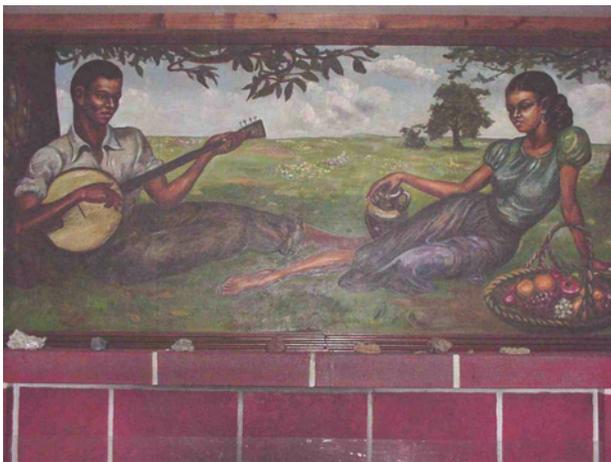
The mural above the fireplace was painted by Samuel Albert Countee during the World War II time period and contributes to the significance and historic appearance of the Black Officers' Club because it is artistically distinctive.

The mural above the fireplace is in good condition and should be repaired as needed by a qualified professional.

- Cleaning and repair of the mural will result only from professional recommendation.
- Repair or maintenance of the mural is to be executed only by a qualified professional.
- NR Rating: 111
