Demonstration of Three Corrosion-Resistant Sustainable Roofing Systems

Final Report on Project F08-AR02

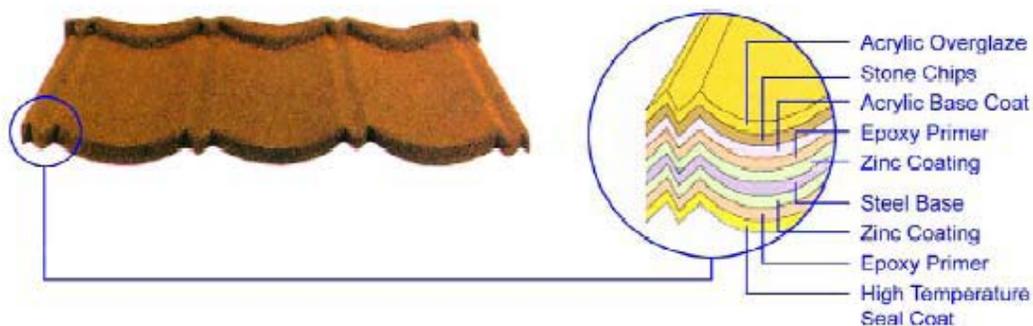
Figure 1. Material layers in stone-coated metal shingle. Source: www.decra.com.

The stone coated metal shingle used in this demonstration is manufactured by Decra Roofing Systems, Inc.* They derive their corrosion resistance from multiple coating layers, which include a zinc coating over a steel substrate, epoxy primer over the zinc coating, and a layer of stone chips encased in a corrosion- and UV-resistant acrylic binder (Figure 1). The stone chips provide additional protection from heat and abrasion. The “fawn grey” color that was chosen is ENERGY STAR® qualified (<http://www.energystar.gov>) and has an initial solar reflectance of 0.25 and unchanged reflectance of 0.25 after 3 years of exposure. The shingles have a very good initial thermal emissivity value of 0.97. This product, when installed on a pitch of 4 in. over 12 in. or more, qualifies for a 50-year warranty from the manufacturer with protection against damage from hail and wind up to 120 mph.

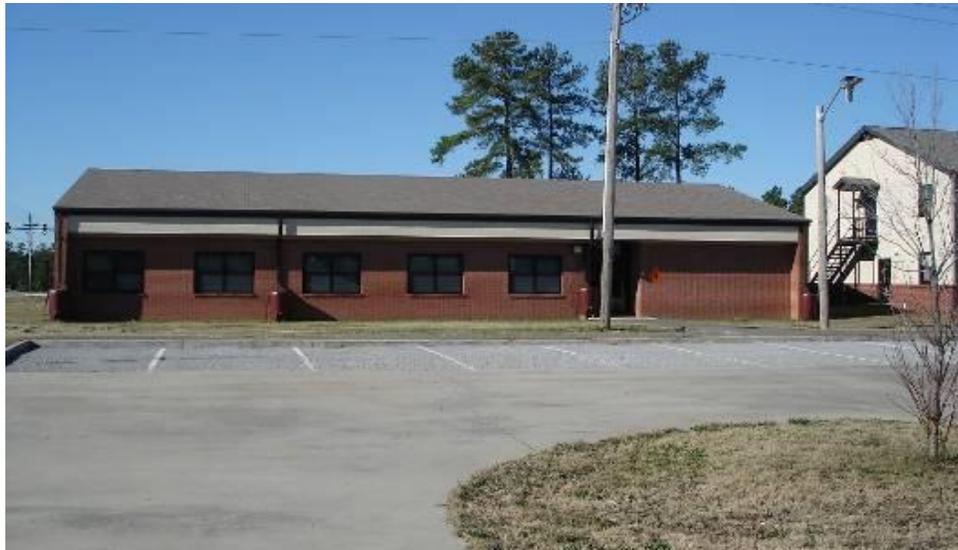
Figure 2. Building 3-2631 with original roof.

The metal shingle roofing systems were installed at Building 3-2631 Figure 2 and Building 8-3846 Figure 3. Building 8-3846 is located next to a structurally identical building (3-3249), which was used as a control to monitor the effects of the demonstrated technology on attic conditions. Temperature and relative humidity sensors were installed in all three buildings to assess performance.

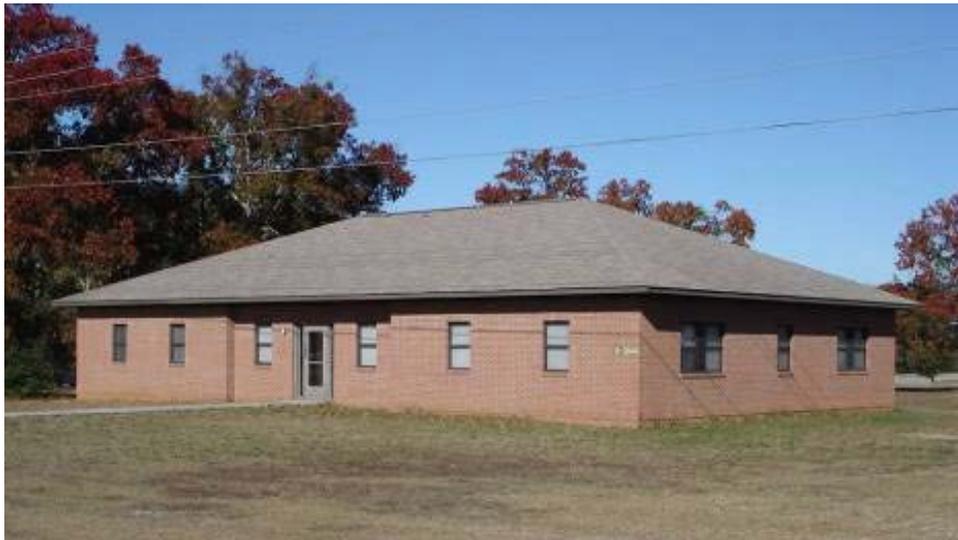
Figure 3. Building 8-3846 with original roof.

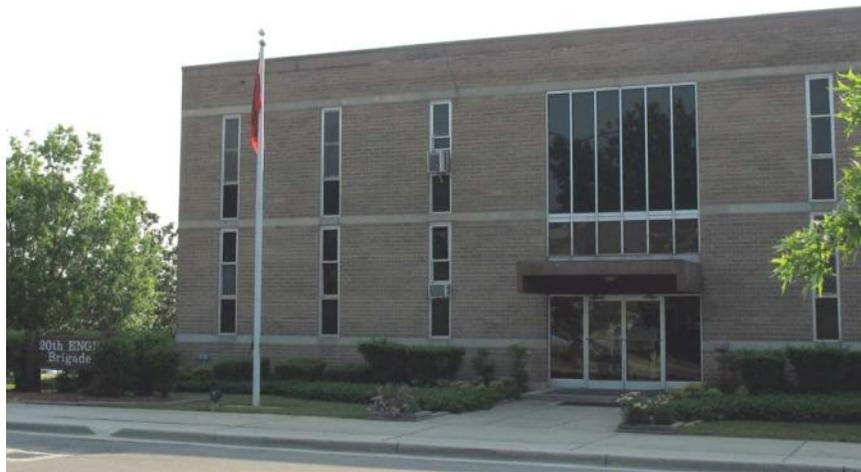
Figure 4. Building H-5834 with original low-slope roof and parapets.

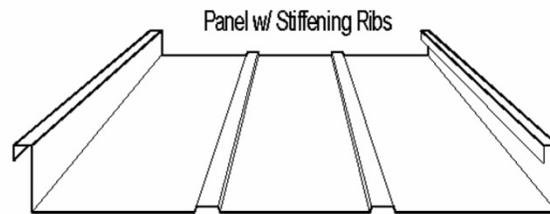
Figure 5. Replacement panel profile.
Source: Construction Metal Products, Inc.

The Construction Metal Products CMP S-2500 18 in. panel SSMR system was selected for the demonstration.* The 26-gauge galvalume-coated steel panel has an additional protective coating comprised of a high performance resin (70% polyvinylidene fluoride (PVDF)) and a "cool pigment" (PPG Industries, Inc. DURANAR ULTRA-Cool). The coating provides optimal corrosion resistance. The color, sierra tan, was chosen to match the surrounding building architecture. It has an initial solar reflectance of 0.49, a solar reflectance of 0.45 after 3 years of exposure, and an emissivity value of 0.83. The dark rubber EPDM membrane already in place had a solar reflectance of 0.06 and thermal emissivity of 0.06. The panel profile and description can be found in Figure 5.

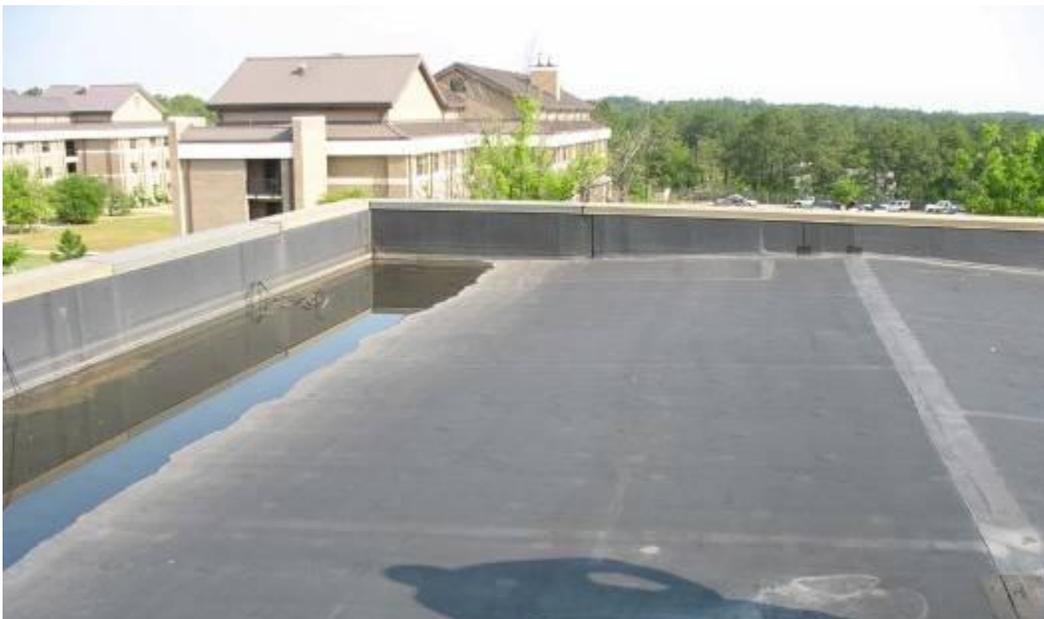
Figure 6. Ponding on pre-demonstration roof due to clogged drains.

The SSMR system manufacturer states that it is appropriate for roof slopes as low as $\frac{1}{2}:12$. However, adding a sloped SSMR roof over top of the existing low-slope roof eliminates water intrusion into the roofing system and building interior caused by clogged drains, which had occurred in the past on this building (Figure 6). Conversion to a steep-slope roofing system also provided the opportunity to incorporate a ventilated attic space above the original roof deck. An engineering analysis determined that the existing roof could accommodate the new structure above it.

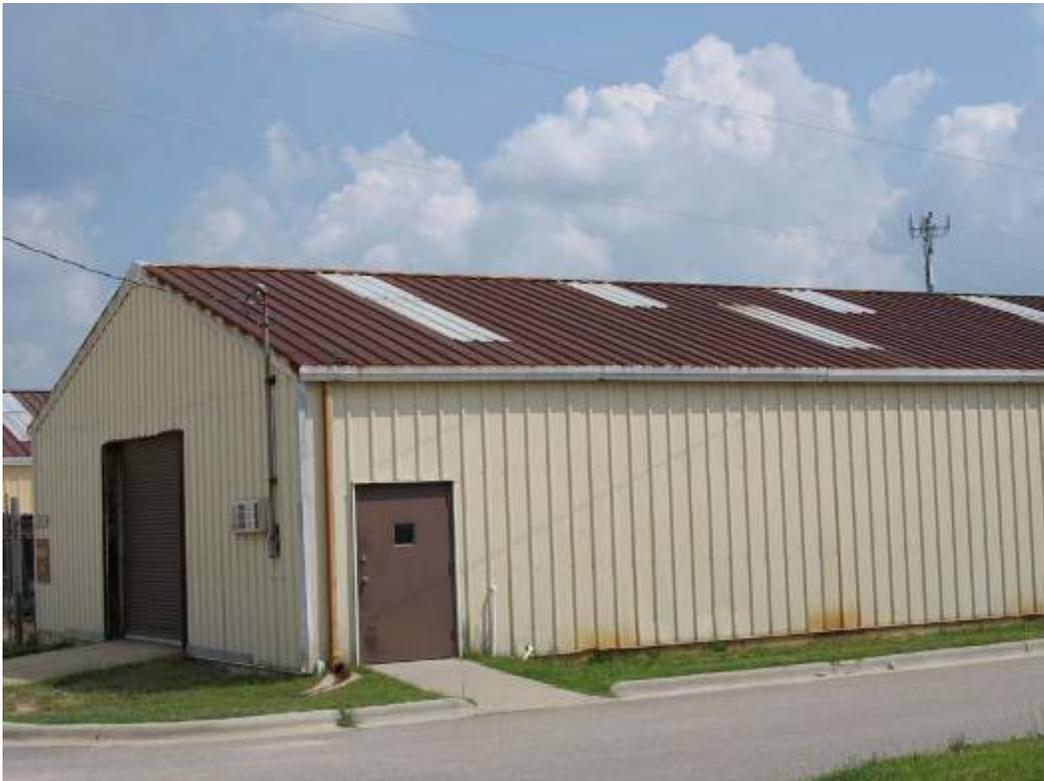
Figure 7. Pre-demonstration metal roof on one of the project buildings.

One such product, Tuff Span[®] from Enduro Composites^{*}, was selected to demonstrate as a replacement for severely corroding metal roofs on three pre-engineered metal buildings (Buildings 3-1735, 3-1736, and 3-1737). All three buildings, similar in size and construction, are used for storage of grounds maintenance equipment (Figure 7). The FRP replacement panel has a corrugated profile (Figure 8) and is composed of a lightweight multi-layer material that is corrosion and chemical resistant (Figure 9). The product is expected to provide improved corrosion resistance and better protection against water intrusion that can cause damage to the material and equipment stored in the buildings.

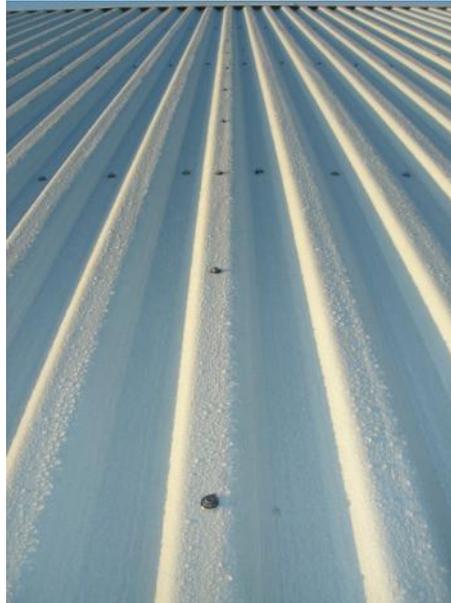
Figure 8. Installed FRP panel showing corrugated profile.

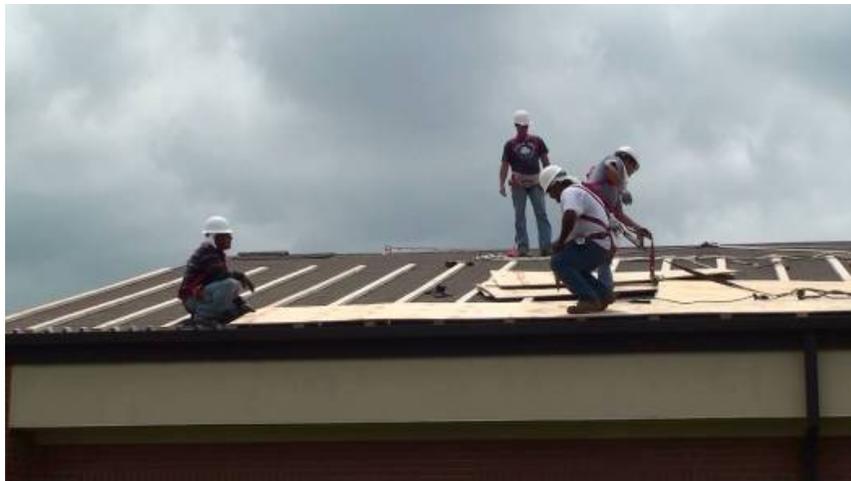
Figure 10. Attachment of plywood sheathing, Building 3-2631.

For both roof installations, the first step was to attach battens over the existing asphalt shingles. The battens consisted of nominal 2 x 4 boards spaced 2 ft apart and fastened to the truss chords that support the in-place roof deck. Attachment and layout of the battens for Building 3-2631 can be seen in Figure 10. Once the battens were in place, 0.5 in. thick exterior plywood sheathing was added and secured to the battens with fasteners to create the base for the new roofing system (Figure 10). Figure 11 shows the air gaps created above the previous roof by the battens and sheathing. Design loads and fastening requirements for the battens and sheathing are detailed in the project design drawings (Appendix A).

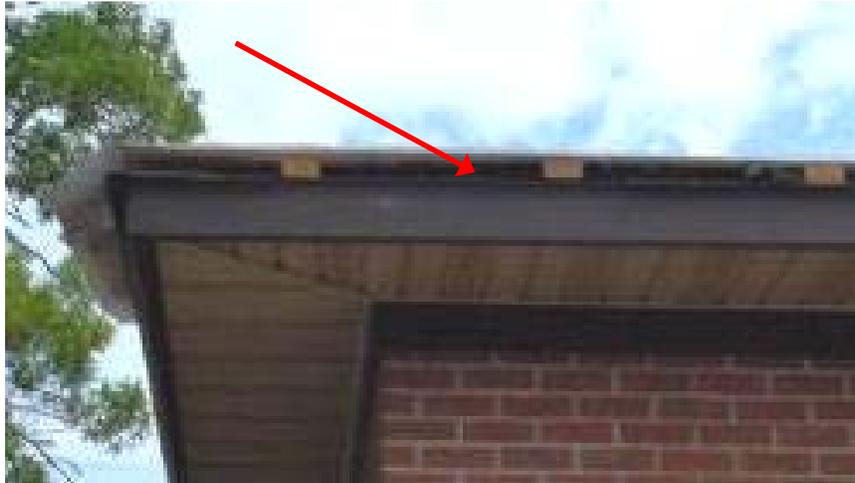
Figure 11. Air gap between existing and new roof, Building 8-3846.

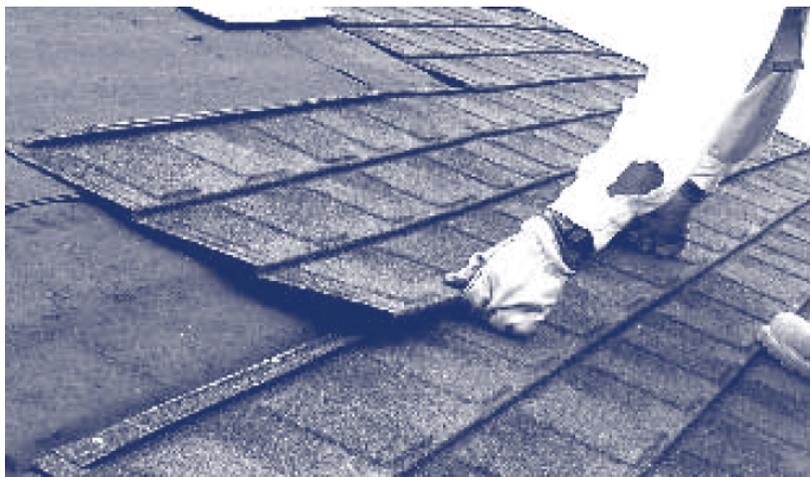
Figure 12. Manufacturer's illustration of panel positioned to mate with the clip lock on panels in the course below.

The new sheathing was covered with one shingled layer of asphalt-saturated organic felt underlayment (ASTM D 228, Type 1). The stone-coated shingles were installed in accordance with the procedures recommended in the manufacturer's literature. The first rows of shingles, at the eave, were attached to an integrated starter clip/drip edge. The bottom edges of subsequent rows were locked into place with clips that are formed into the top edges of the preceding rows. This procedure is illustrated in a photo from the manufacturer's literature (Figure 12). As directed in the manufacturer's installation guidelines, the right side of each panel was compressed in order to interface with the side-lap locking mechanism formed into the left side of the adjoining panel at its right. Once each panel was locked into place, it was attached to the sheathing along the upper edge with four corrosion-resistant #8 hex-head screws.

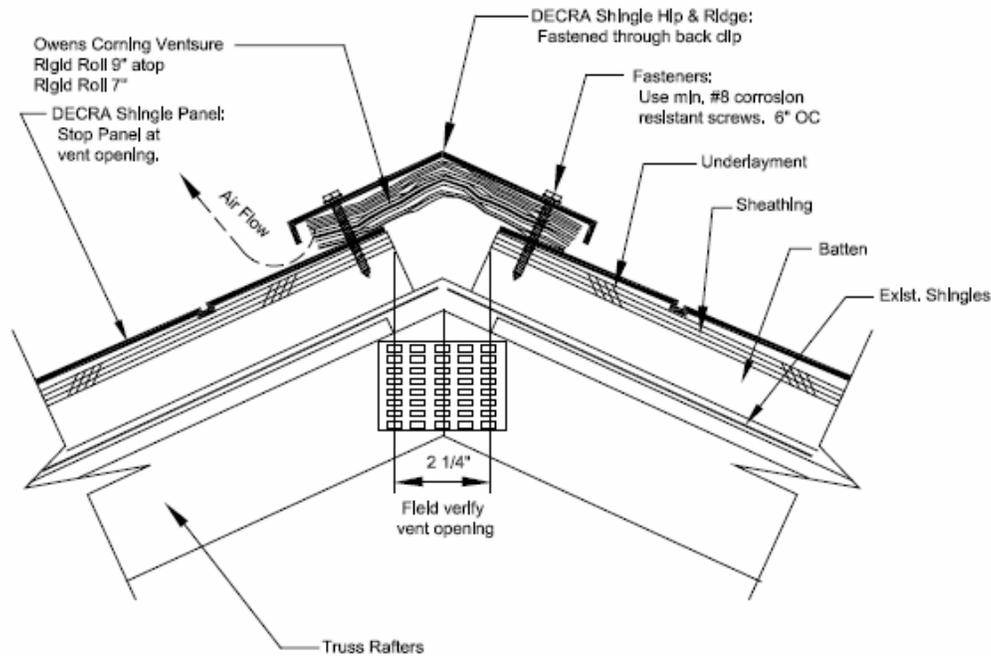
Figure 13. Vented ridge detail for Buildings 8-3846 and 3-2631.

The original attic space and the air gap between the new substrate and previous roof of both buildings are vented at the soffits and through the new ridge and hip vents. A rigid-roll corrugated plastic product was specified to provide vented closure at these locations. Details for the ridge and eave are shown in Figure 13 and Figure 14.

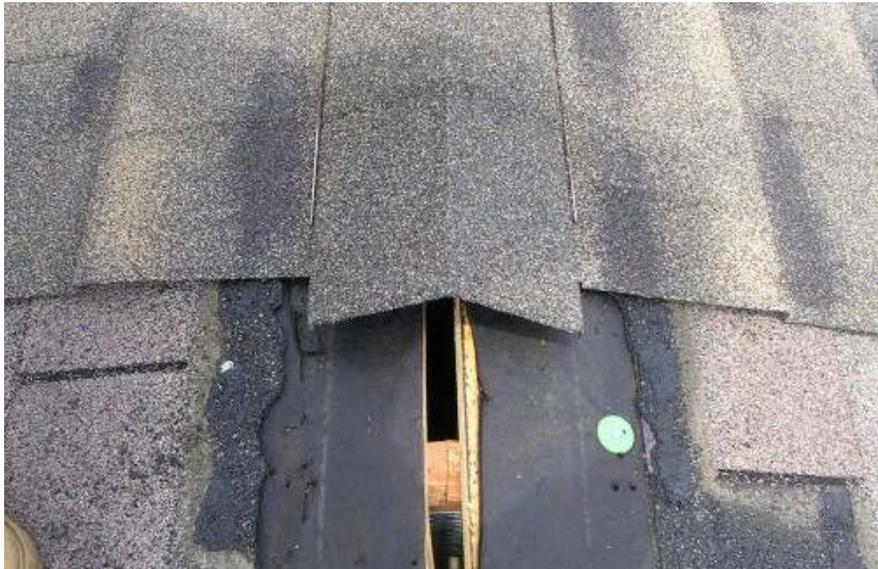
Figure 15. Ridge vent mockup for Building 3-2631.

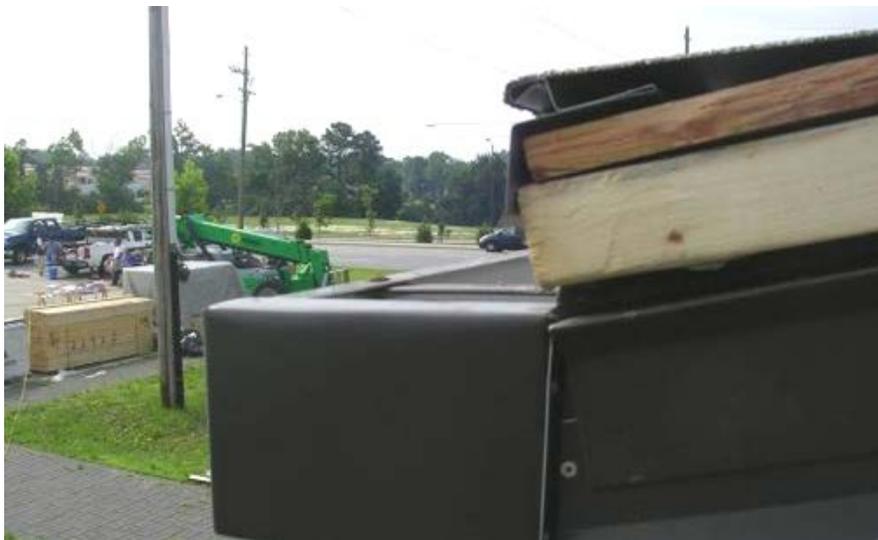
Figure 16. Completed roofing system gutter detail, Building 3-2631.

With the new roofs installed on the buildings, all gutters were replaced to their original configuration. During the system installation on Building 3-2631, the general contractor noticed the existing gutters were not being raised in conjunction with the new roof, resulting in a drop of more than 2 in. from the new roof to the gutters (Figure 16).

The subcontractor's roofing engineer analyzed the configuration. Using the design rainfall conditions, analysis indicated that the gutter location was acceptable and able to contain runoff. These calculations are shown in Appendix B. The completed roofing system for Building 8-3846 is shown in Figure 17.

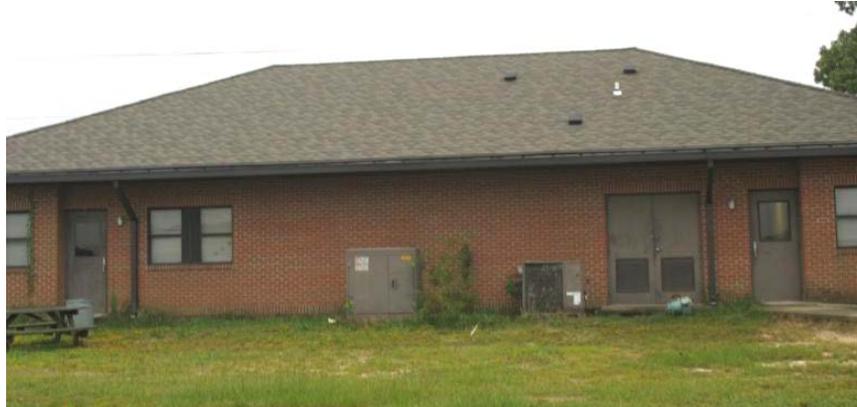
Figure 17. Completed roofing system Building 8-3846.

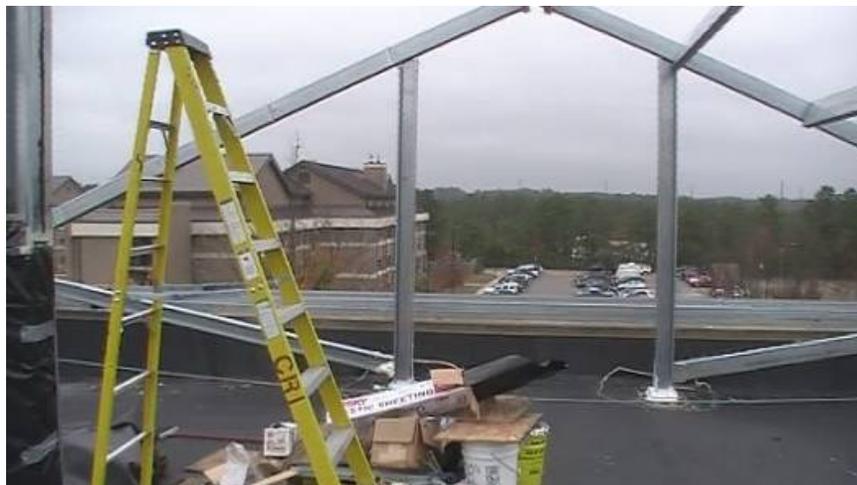
Figure 18. Rafter frame system for slope conversion retrofit.

The Building H-5834 conversion to a steep-sloped gable roof required the construction of a retrofit steel truss system. It consisted of six light-gage steel rafter frames (Figure 18), each of which was anchored to the building frame at four locations. Rafter frames were attached at their ends, along the perimeter of the roof, and at intermediate points aligned with the structural beams that support the original roof framing. Engineering drawings for the framing system and SSMR are provided in Appendix C.

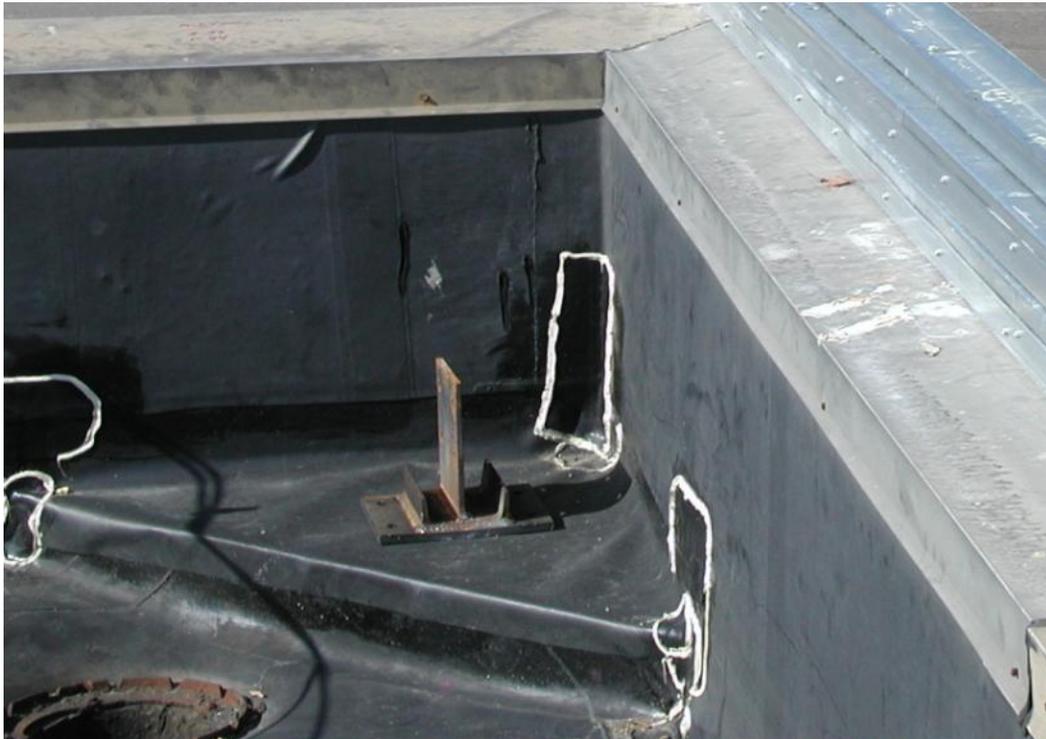
Figure 19. Completed construction of pad and anchor bracket at corner.

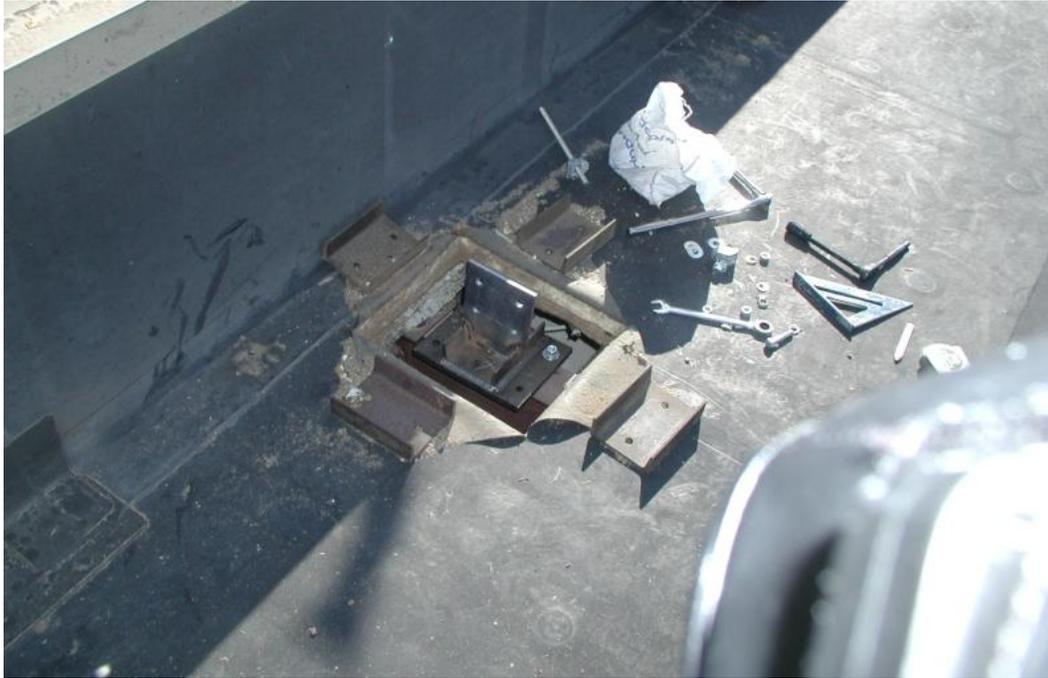
Figure 20. Attachment of anchor bracket to roof beam at perimeter wall.

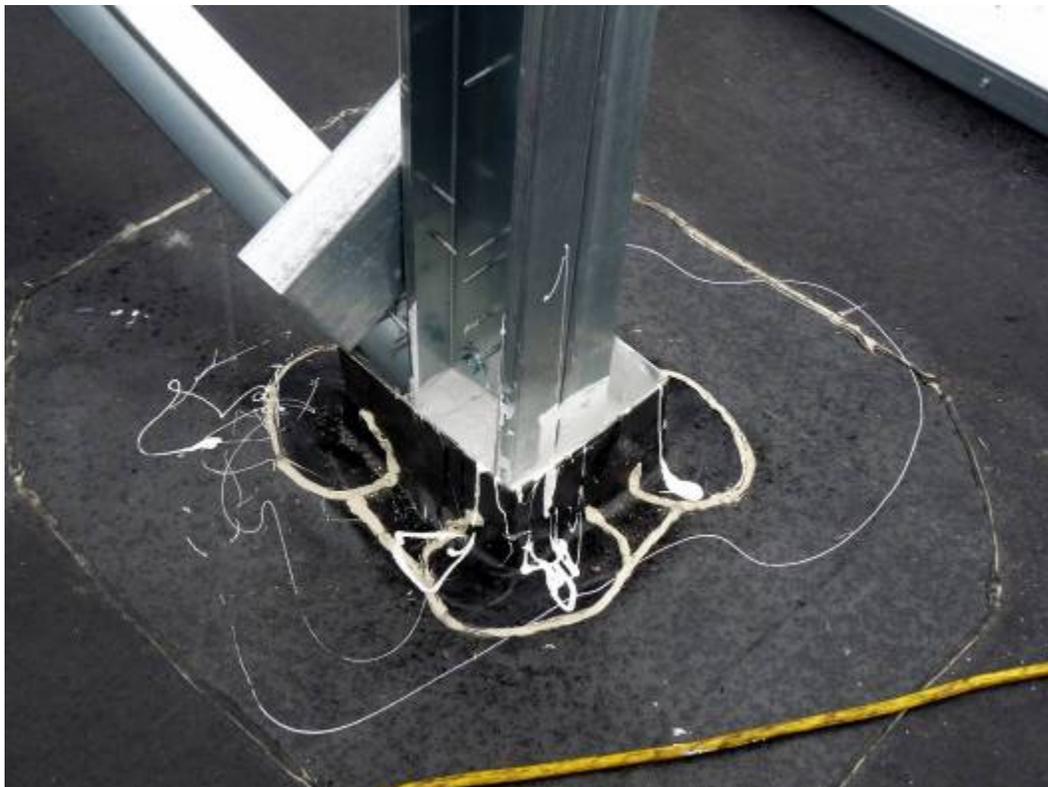
Figure 21. Pitch pan being constructed around roof penetration at attachment point.

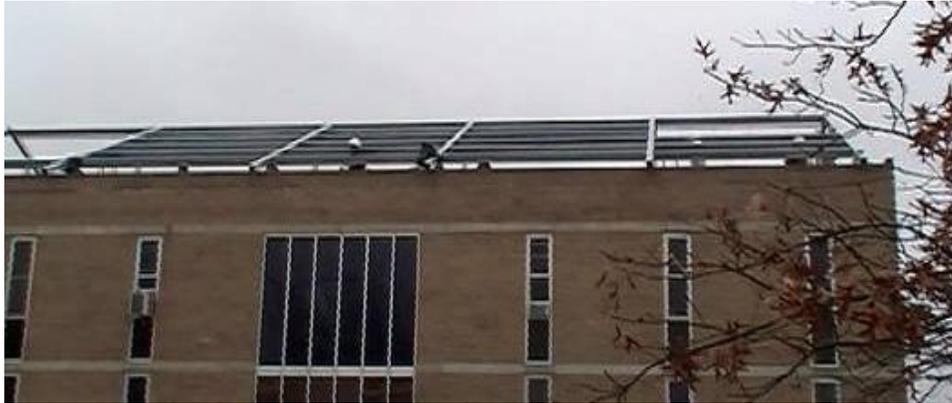
Figure 22. Completed rafter system with some of the purlins installed.

system, were then attached to the frames. The complete rafter frame system, with most of the purlins installed, can be seen in Figure 22.

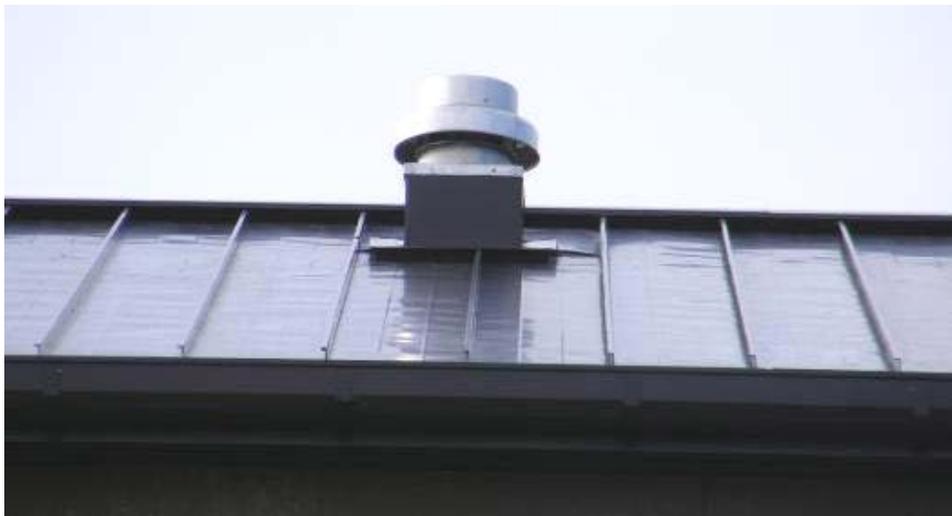
Figure 23. Completed SSMR with existing powered bathroom exhaust relocated on top of the new roof.

The SSMR was constructed with a fixed connection at the eave and sliding clip connections at the purlins and ridge to allow for thermal expansion and contraction of the roof panels. Because the panels are allowed to move along the slope of the roof, the roof framing required structural diaphragm bracing to be placed within the plane of the roof. This was done before the metal roof panels were installed. The completed roofing system is shown in Figure 23 and Figure 24.

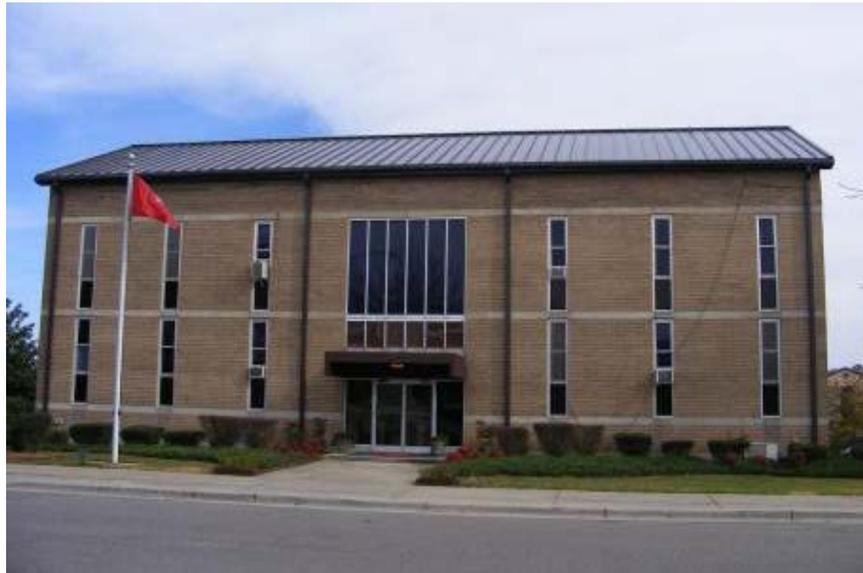
Figure 24. Completed SSMR, exterior view.

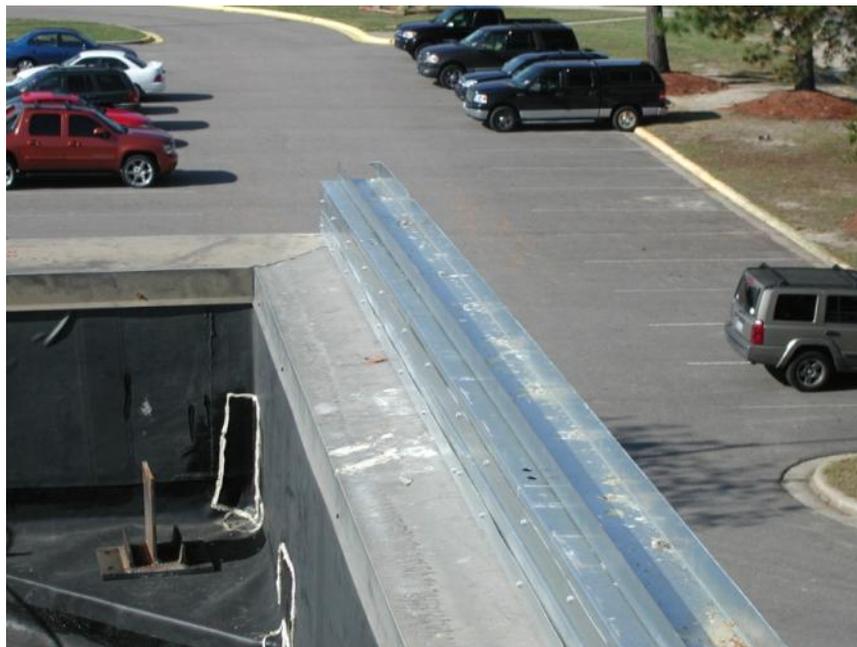
Figure 25. Steel blocking attached on parapet wall at gable end.

To complete the building enclosure, exterior wall panels were constructed at both gable ends. This was accomplished by attaching steel blocking along the top of the parapet walls. For ease of construction, the blocking was fixed in place before the rafter frames were erected (Figure 25).

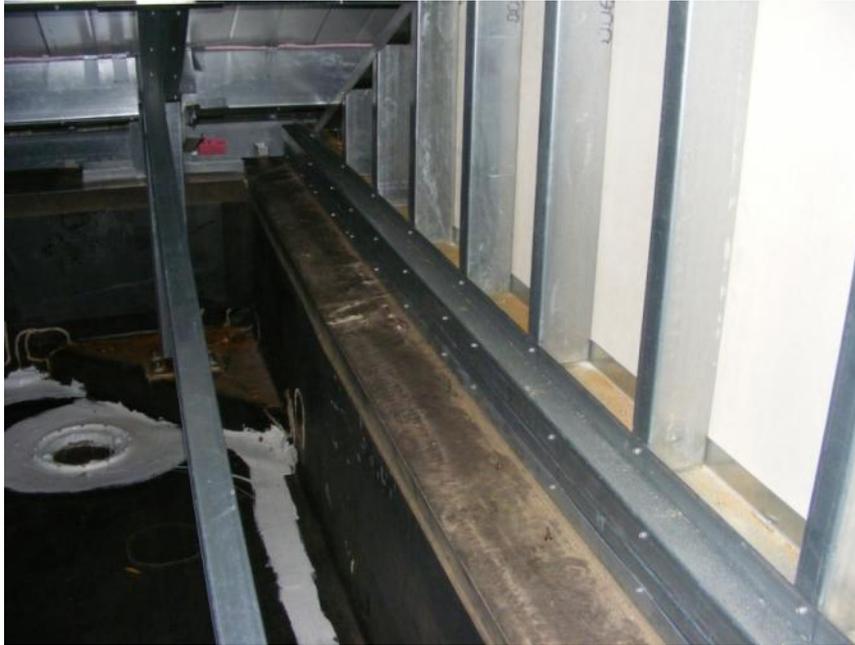
Figure 26. Steel stud wall frame at gable end, interior view.

After completion of the SSMR, the metal wall frame was constructed (Figure 26), and a substrate of 0.5 in. thick fiberglass mat gypsum boards was attached to the studs (Figure 27). Next, an exterior insulation and fin-

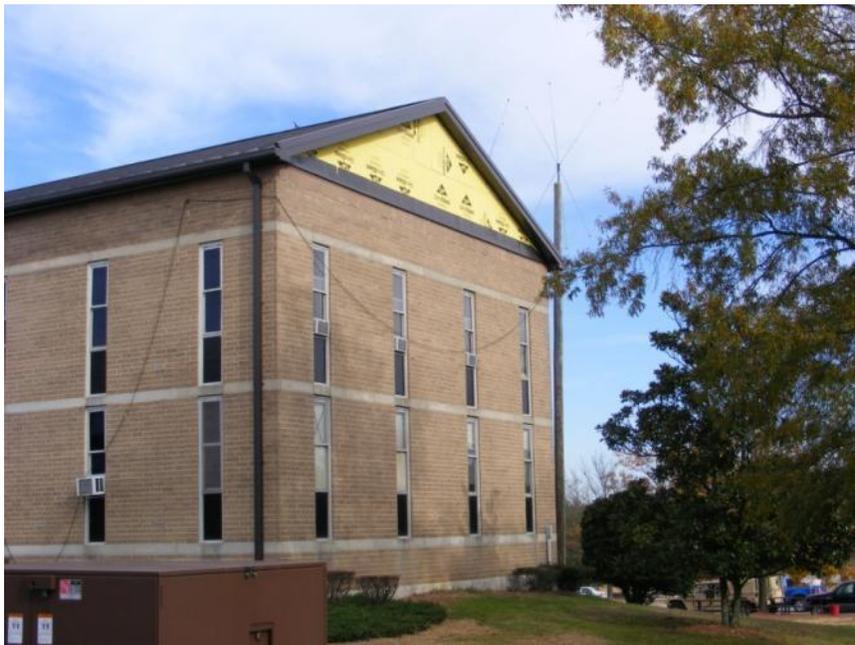
Figure 27. Exterior wall at gable end before EIFS application.

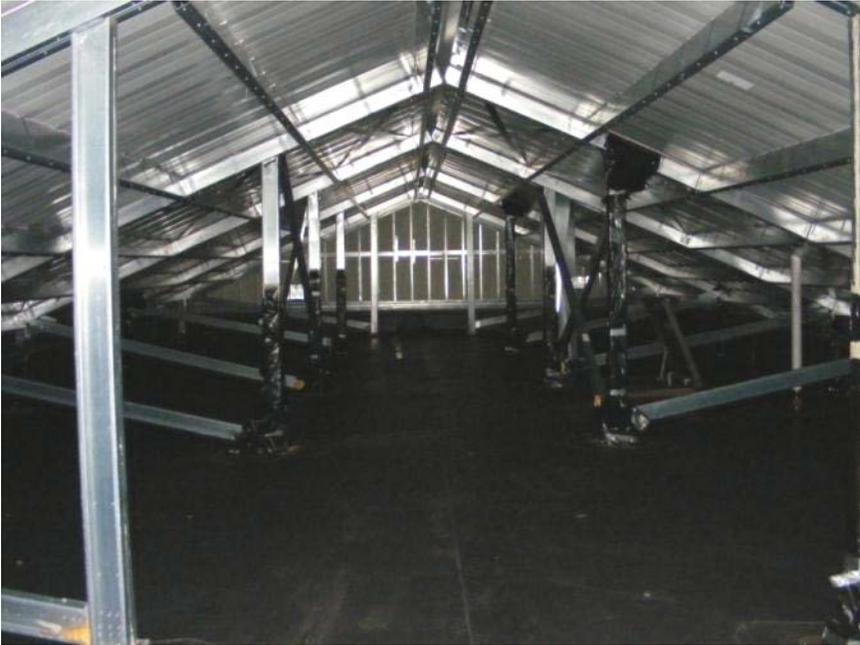
Figure 28. Interior view of new attic space.

ish system (EIFS) was installed to complete the construction. Venting of the new attic space between the old roof and the new SSMR roof (Figure 28) was provided by venting at the soffit (Figure 29) and ridge.

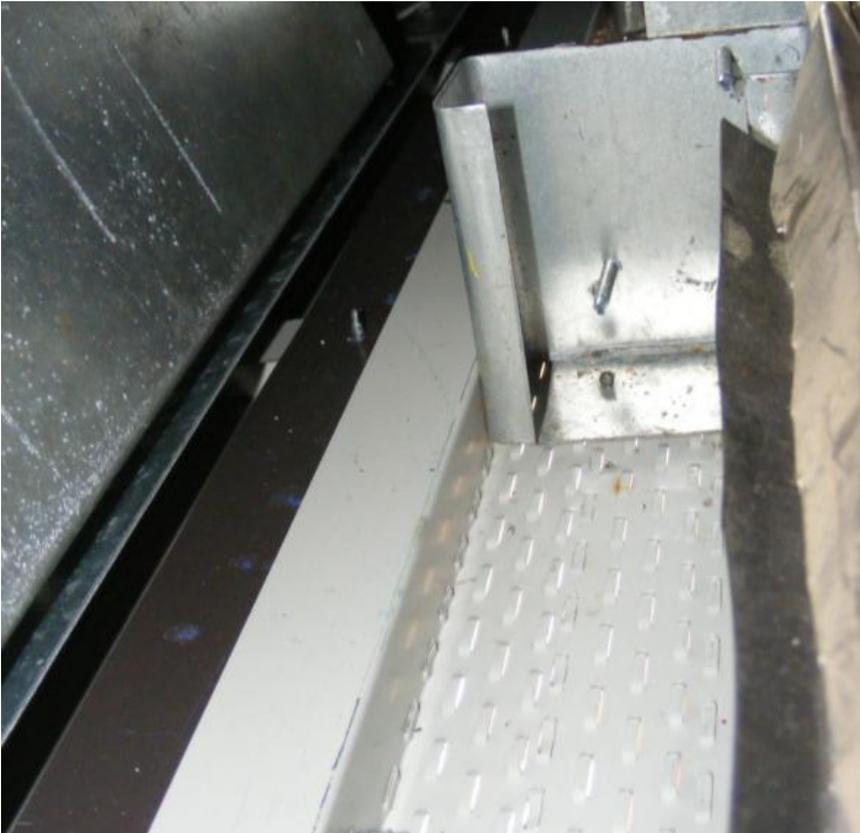
Figure 29. Ventilated soffit panel, attic interior view.

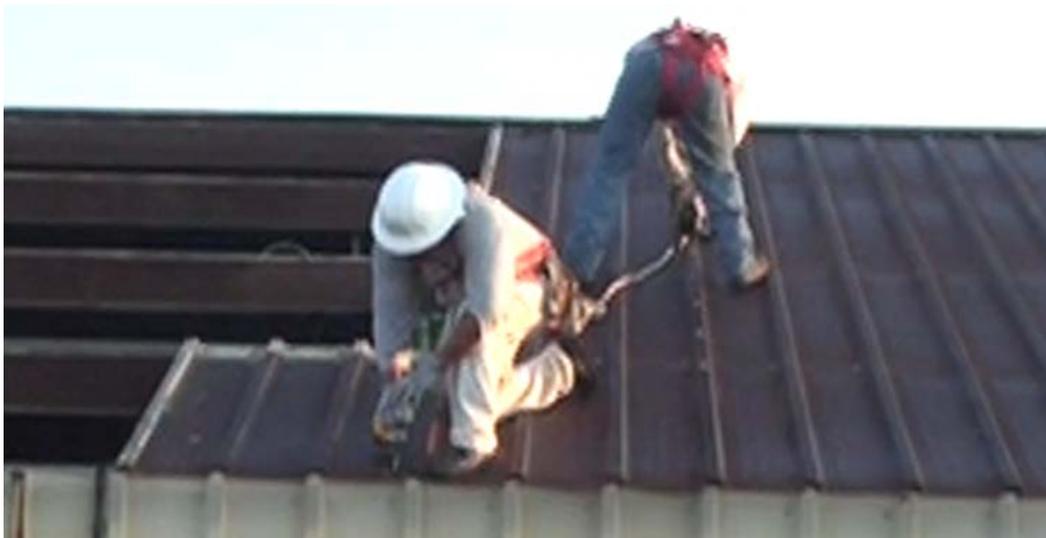
Figure 30. Removal of metal roof panels.

The FRP roofing panel system was installed on each of the three pre-engineered buildings in a section-by-section progression to keep the building interiors covered at all times after work hours. The first step was to dismantle the existing downspouts and gutters. Next, the contractor's crew removed the metal roofing panels and integrated skylight panels using screw guns to extract the attachment screws (Figure 30). The support structure and roof purlins were left in place.

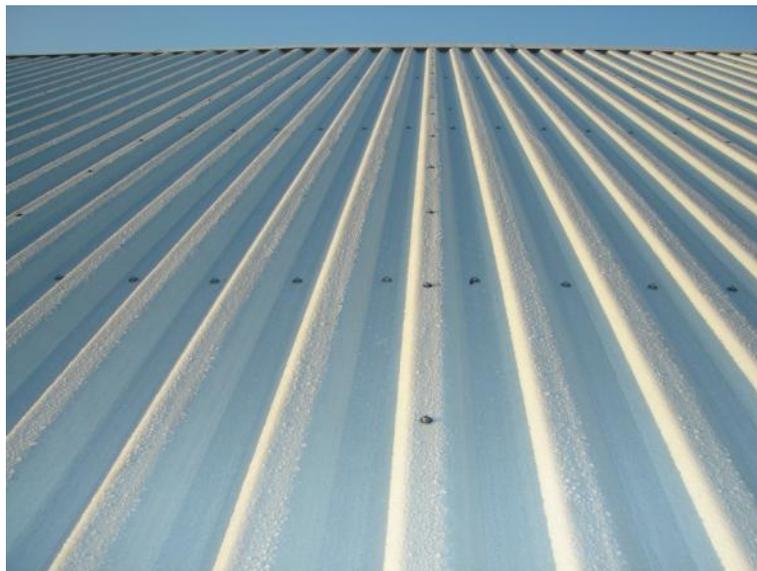
Figure 32. View showing layout of panel fasteners.

Using the same type of fasteners, the panel was attached directly to underlying purlins at each lower rib. The side laps of adjacent panels were joined with fasteners spaced at 18 in. through the high ribs. The layout of panel fasteners can be seen in Figure 32. After all panels were in place, an FRP cap piece was installed at the roof ridge and attached to underlapping panels (detail shown in Figure 33). The attachment was made using the fasteners having the neoprene sleeves placed at every-other high rib.

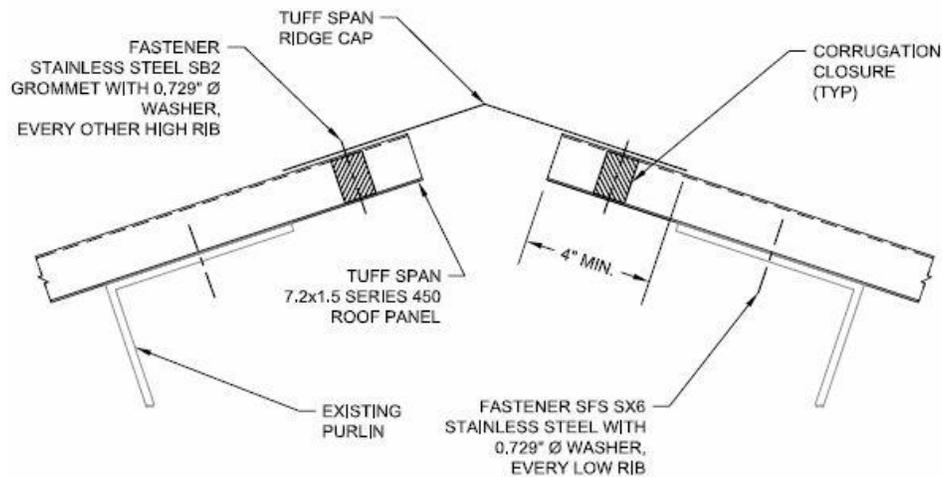
Figure 33. Ridge cap detail.

All fasteners, being made of stainless steel, have superior corrosion resistance. The grommet feature inhibits leakage at the fastener. Other system features that promote watertightness included a nonshrinking, nonhardening butyl tape field-applied in the lap area of all adjoining panels (Figure 34) and the placement of preformed foam panel closures at the openings under the panels located at the eaves.

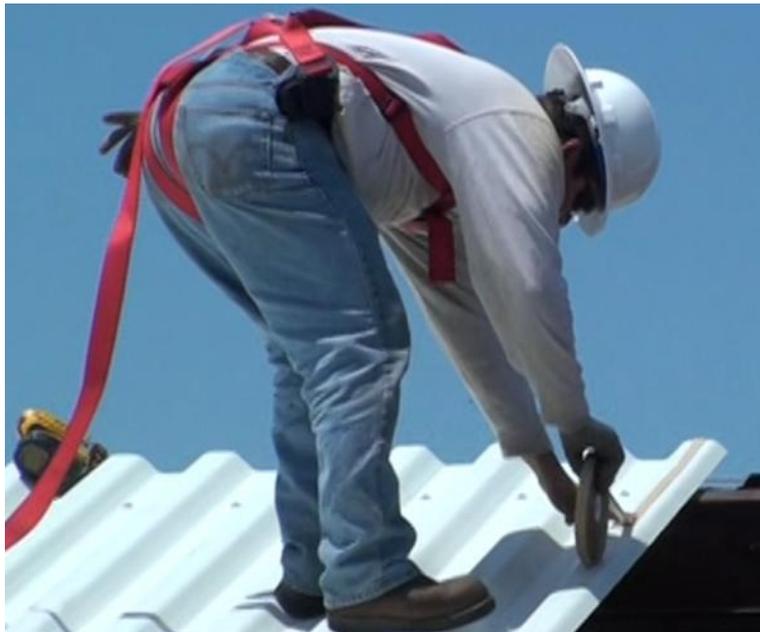
Figure 34. Application of butyl tap in lap seam.

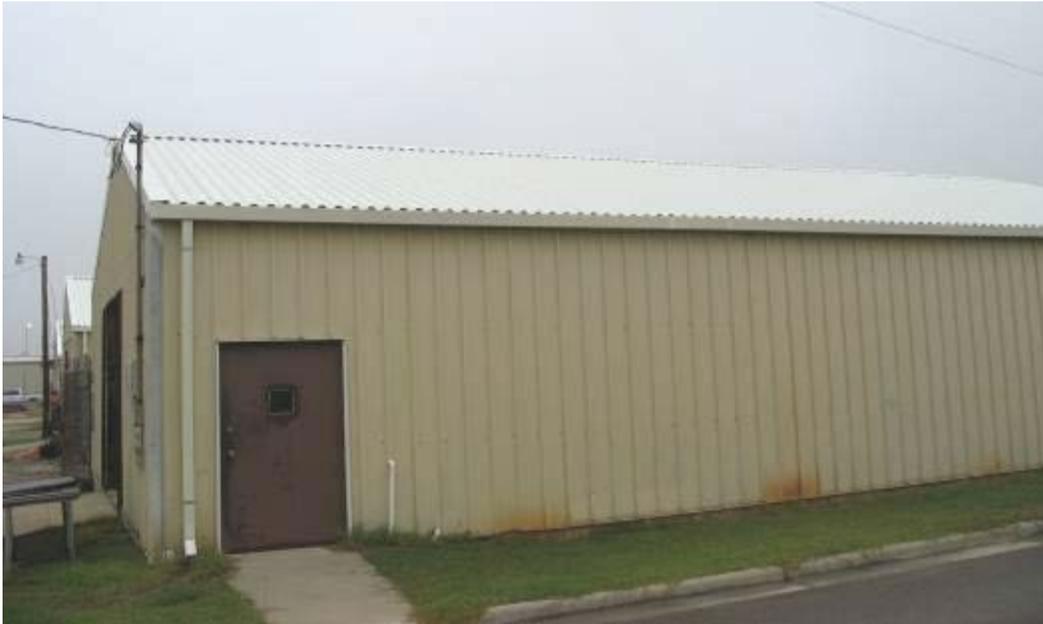
Figure 35. View of completed FRP panel roof system.

Design drawings for the roofs are provided in Appendix D. The completed roofing system on one of the buildings is shown in Figure 35.

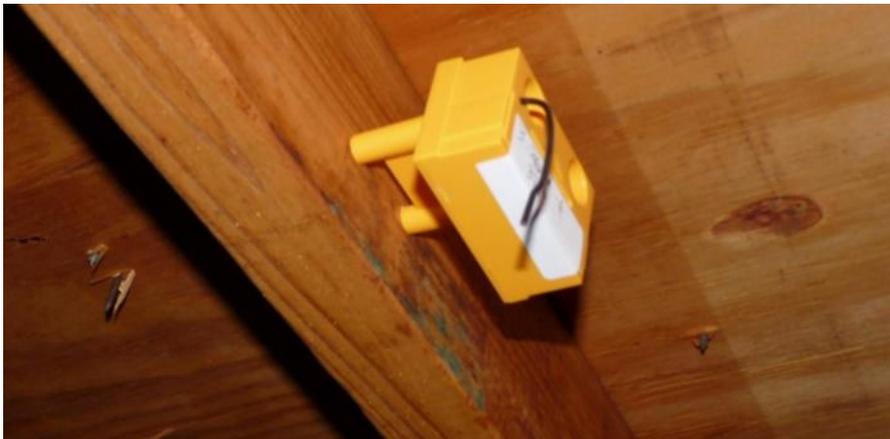
Figure 36. OmniSense 900-S-1 sensor.

placed in the attic of the control structure, Building 8-3749, to provide baseline data for comparison and evaluation of shingle system performance. The control building and Building 8-3846 are adjacent to each other, and identical in age, size, and exterior design and construction. The OmniSense 900-S-1 sensors (Figure 36) were monitored wirelessly at 915 MHz by G-900-E wireless gateway that reports to the monitoring server through a cellular uplink. Both components were produced by OmniSense LLC*. The system provided a basis for evaluating the impact of the metal shingle system on building conditions as compared with the control facility. Sensor locations for these two buildings are shown in Figure 37.

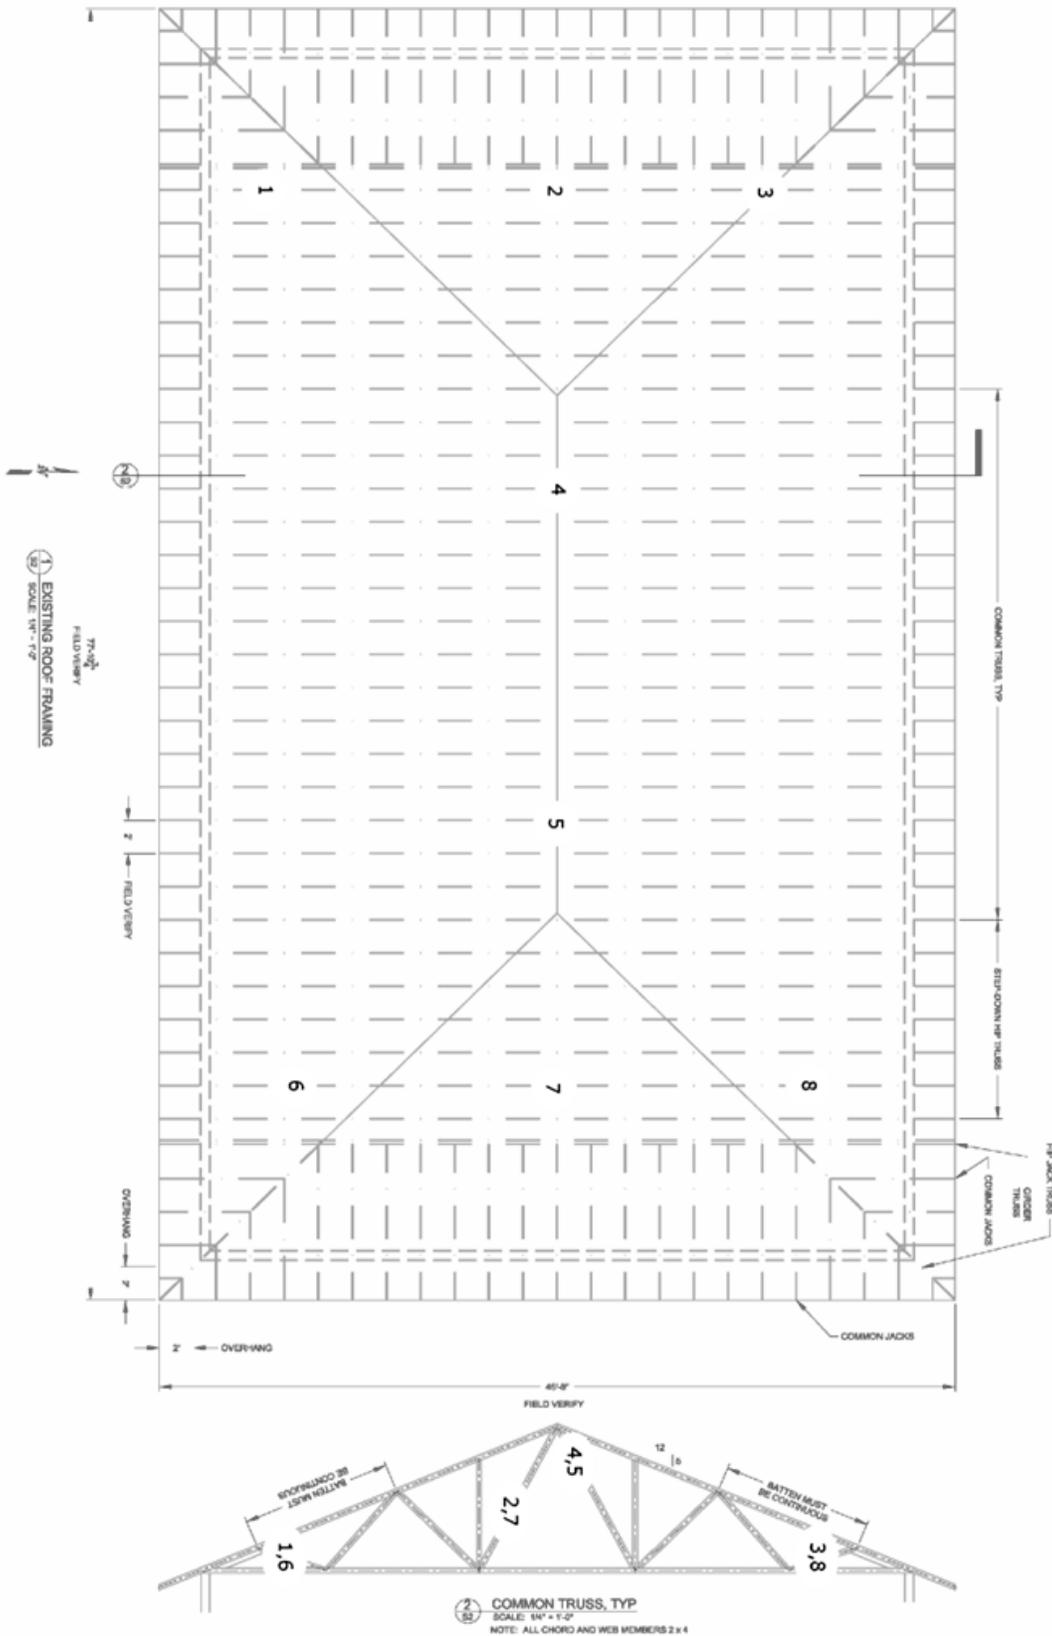
Figure 37. Sensor locations, Buildings 8-3846 and 3-3749.

Sensors were installed in the ventilated attics spaces of the buildings with the stone-coated metal shingle system. The sensors capture temperature and relative humidity data at regular intervals. A similar system was
