Demonstration of Three Corrosion-Resistant Sustainable Roofing Systems

Final Report on Project F08-AR02

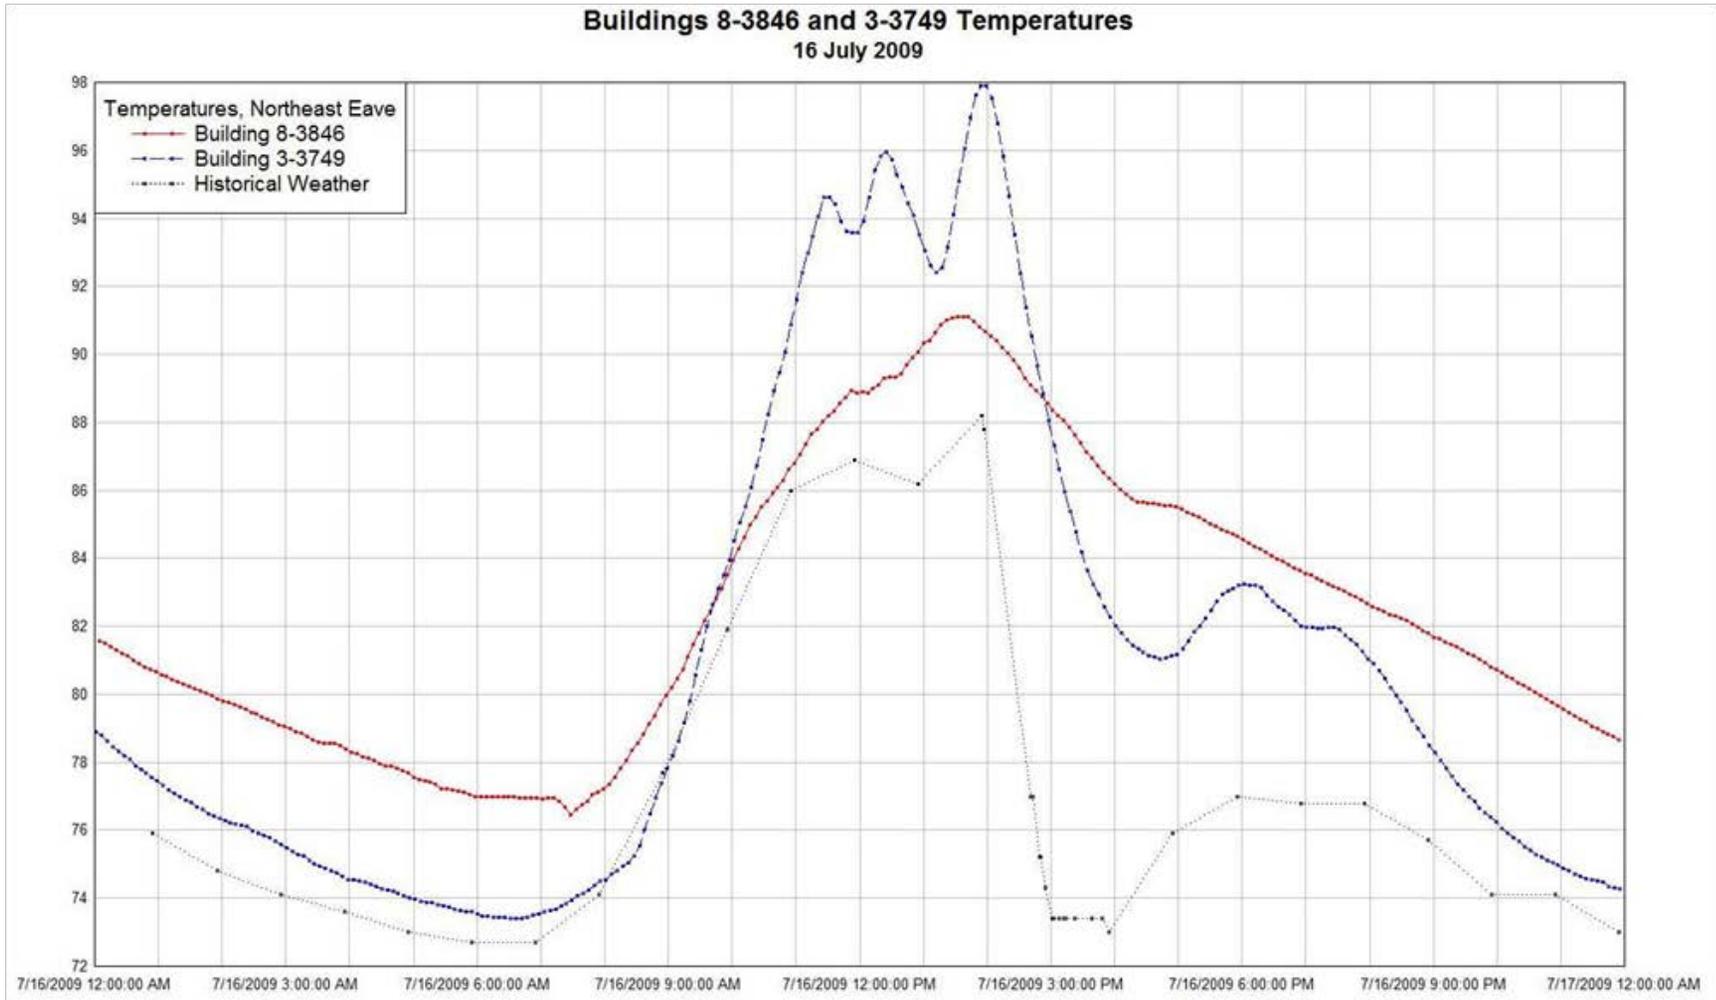
Figure 39. Temperature comparison between Buildings 8-3846 and 3-3749, northeast eaves (16 July 2009).

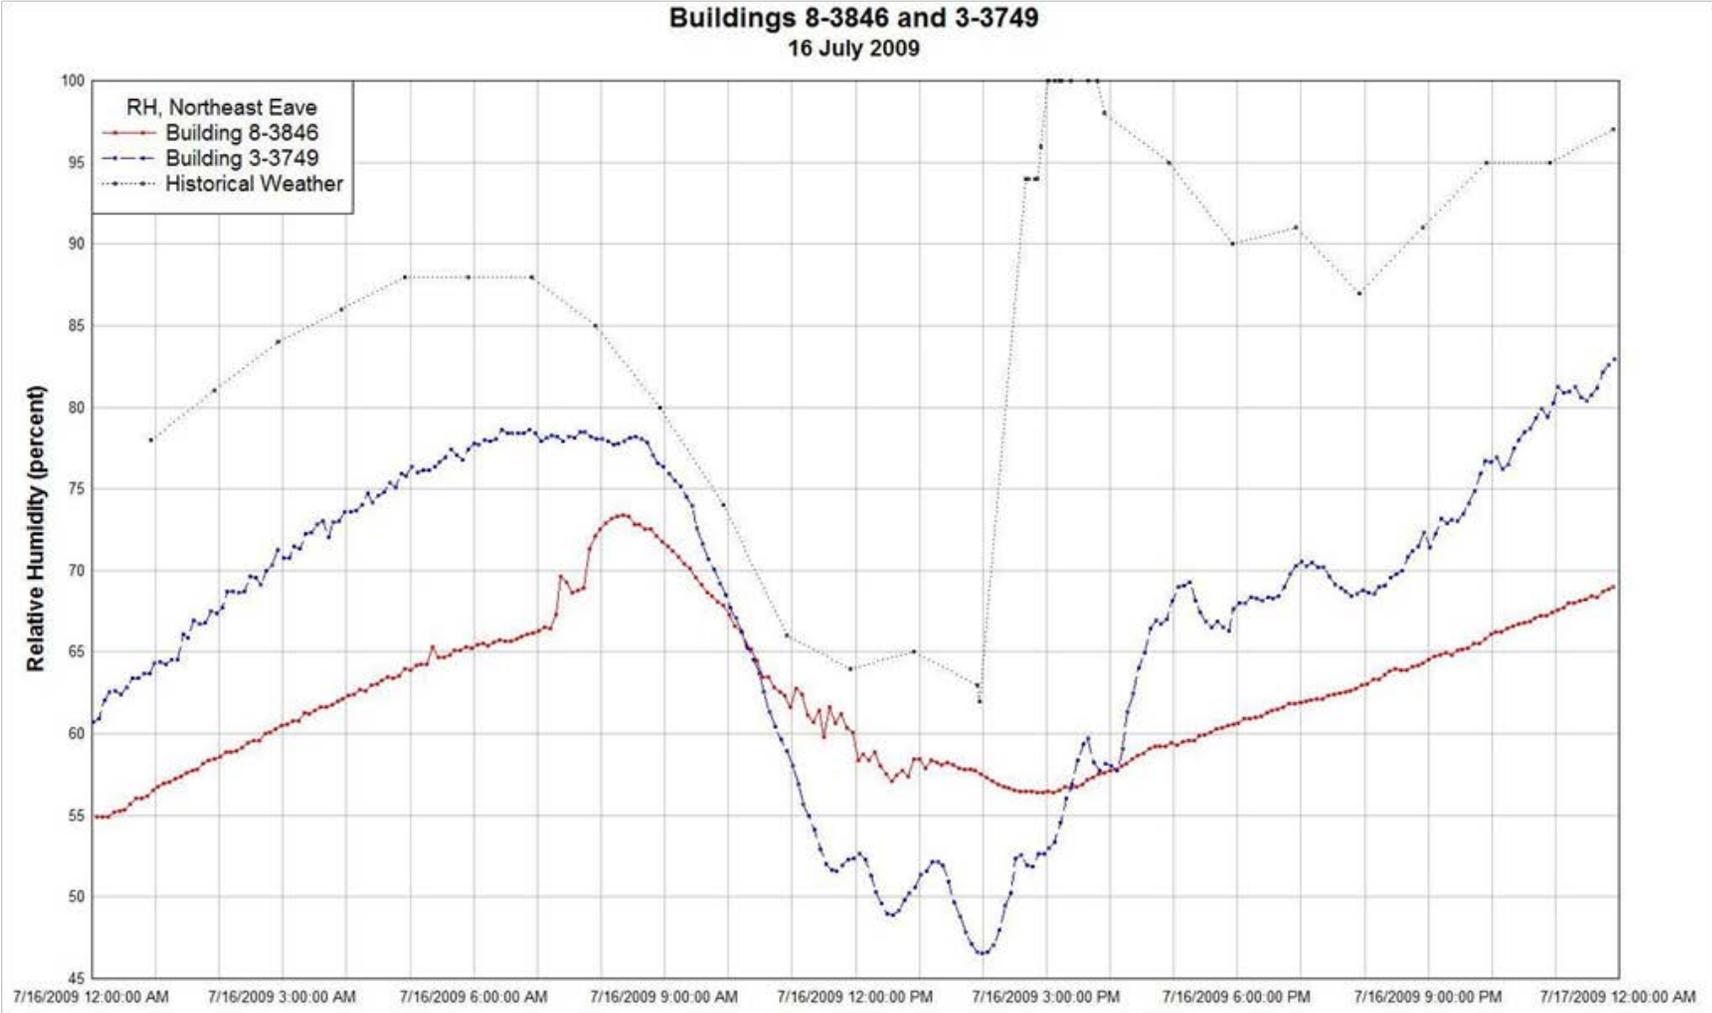
Figure 40. Relative humidity comparison between Buildings 8-3846 and 3-3749, northeast eaves (16 July 2009).

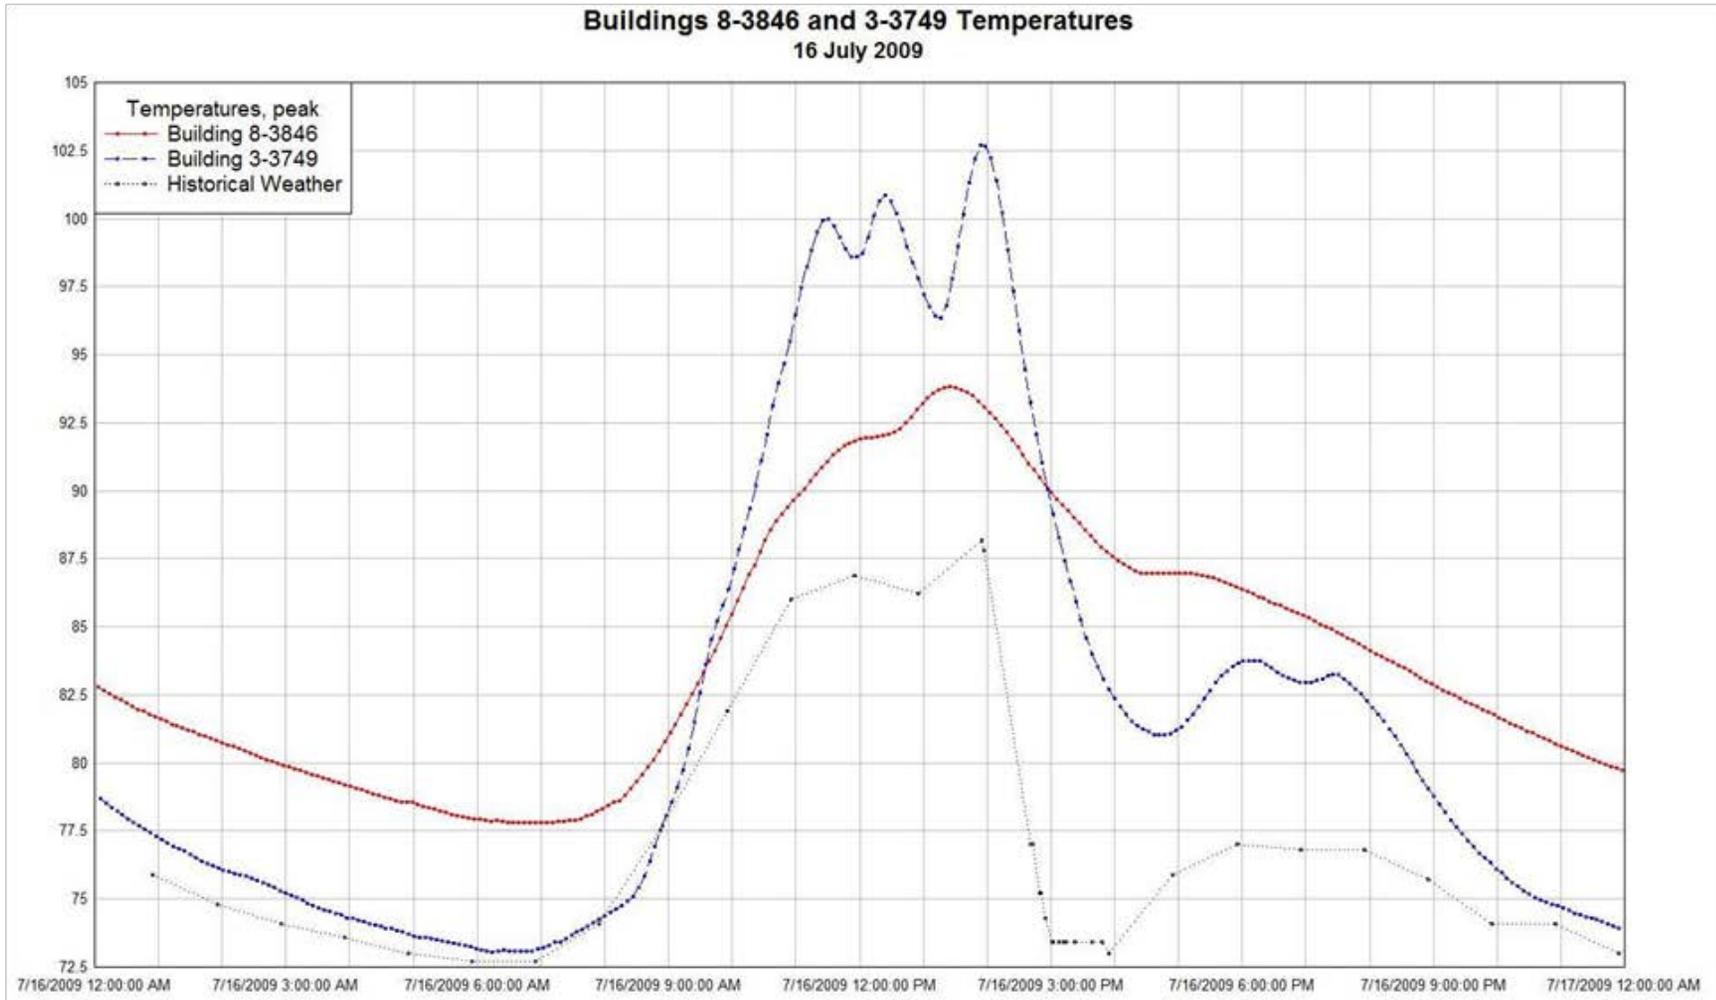
Figure 41. Temperature comparison between Buildings 8-3846 and 3-3749, attic peaks (16 July 2009).

A plot of the recorded temperature data taken on that same day (16 July 2009) from a different set of attic sensors located at the northern peaks of Buildings 8-3846 and 3-3749 (the same buildings) is shown in Figure 41. As seen at the northeast eaves, the plots show the attic space of the metal-shingle roof with ASV changing in temperature at a slower rate than that of the control building. Also, the peak attic temperature during the day for the demonstration building is about 10 °F lower than was reached in the control building. These results indicate a potential for reducing cooling energy requirements during peak demand times.

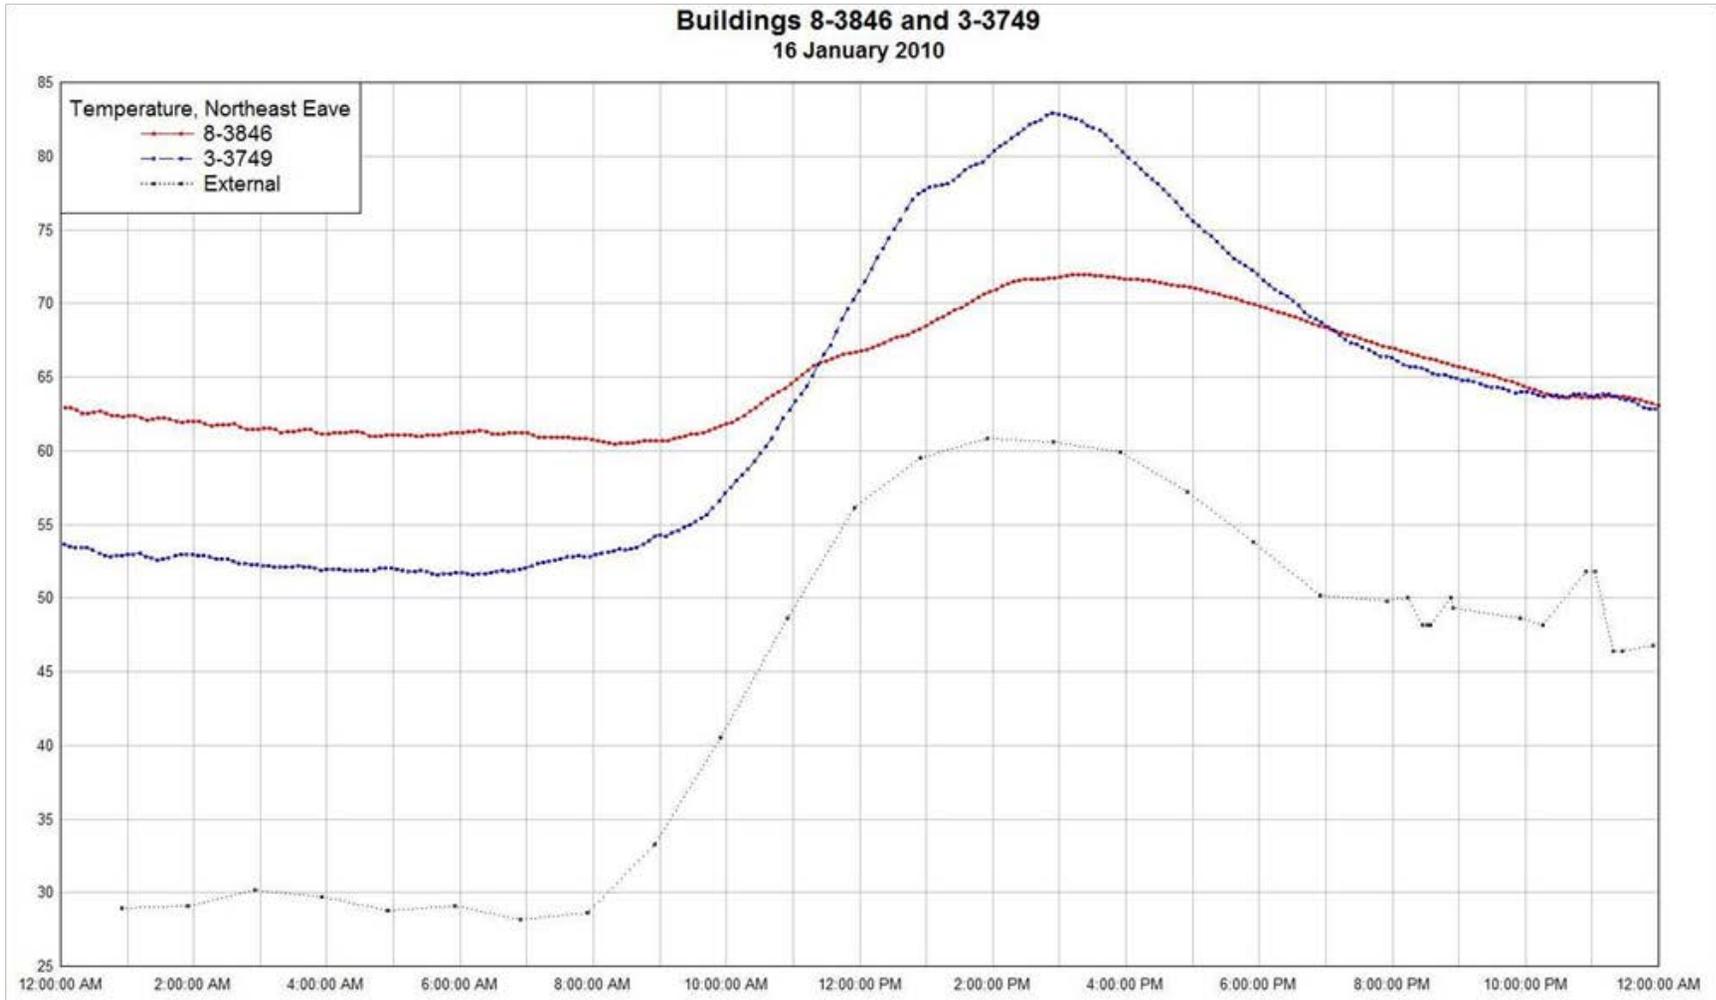
Figure 42. Temperature comparison between Buildings 8-3846 and 3-3749, northeast eaves (16 January 2010).

In addition to examining the attic conditions during a summer day, the temperatures on a winter day (16 January 2010) were also examined. Figure 42 shows a plot of the attic temperatures at the northeast eaves on the two buildings on 16 January 2010. In this case, the demonstration building with the metal shingles and ASV held a higher attic temperature during the night. But as the daytime ambient air warmed up, the attic temperature fell below that of the control building. If the attic space is able to serve as a thermal buffer during the nighttime, it is possible that heating costs may be reduced during the winter. The same inference would indicate that heating costs could increase during the daytime. As seen for the summer comparison, the attic temperatures for the building with the stone-coated metal shingle and ASV change at a slower rate as compared to the attic of the control building.

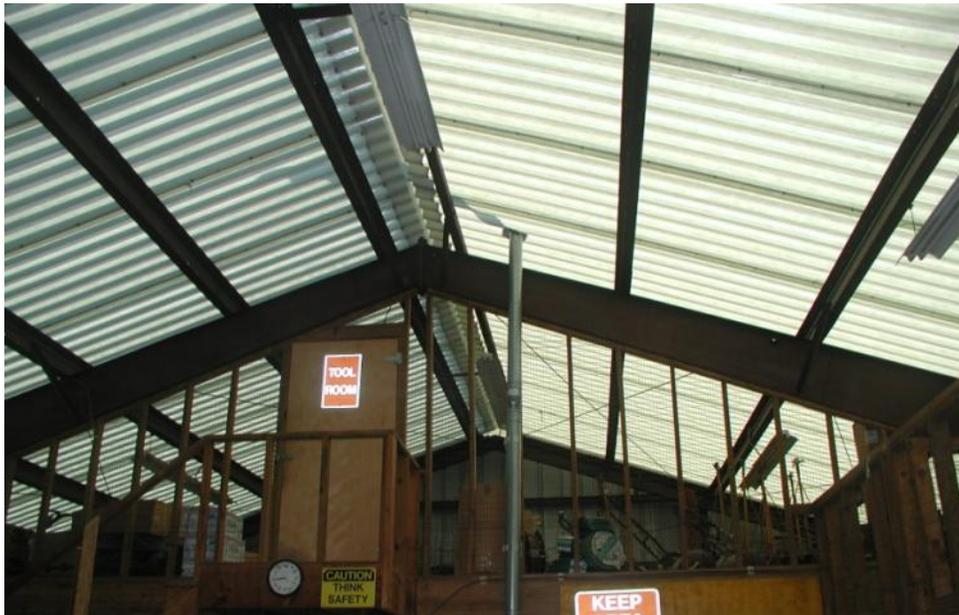
Figure 43. View of building interior showing affect of additional ambient lighting provided by FRP roof.

During the visits, grounds maintenance workers expressed satisfaction with the light-transmitting characteristics of the FRP panel roofing, stating that there was rarely a need to use electric lighting inside the buildings during daylight hours. The additional diffuse interior lighting provided by the translucent FRP panels proved to be much greater than the project team had expected (see Figure 43).

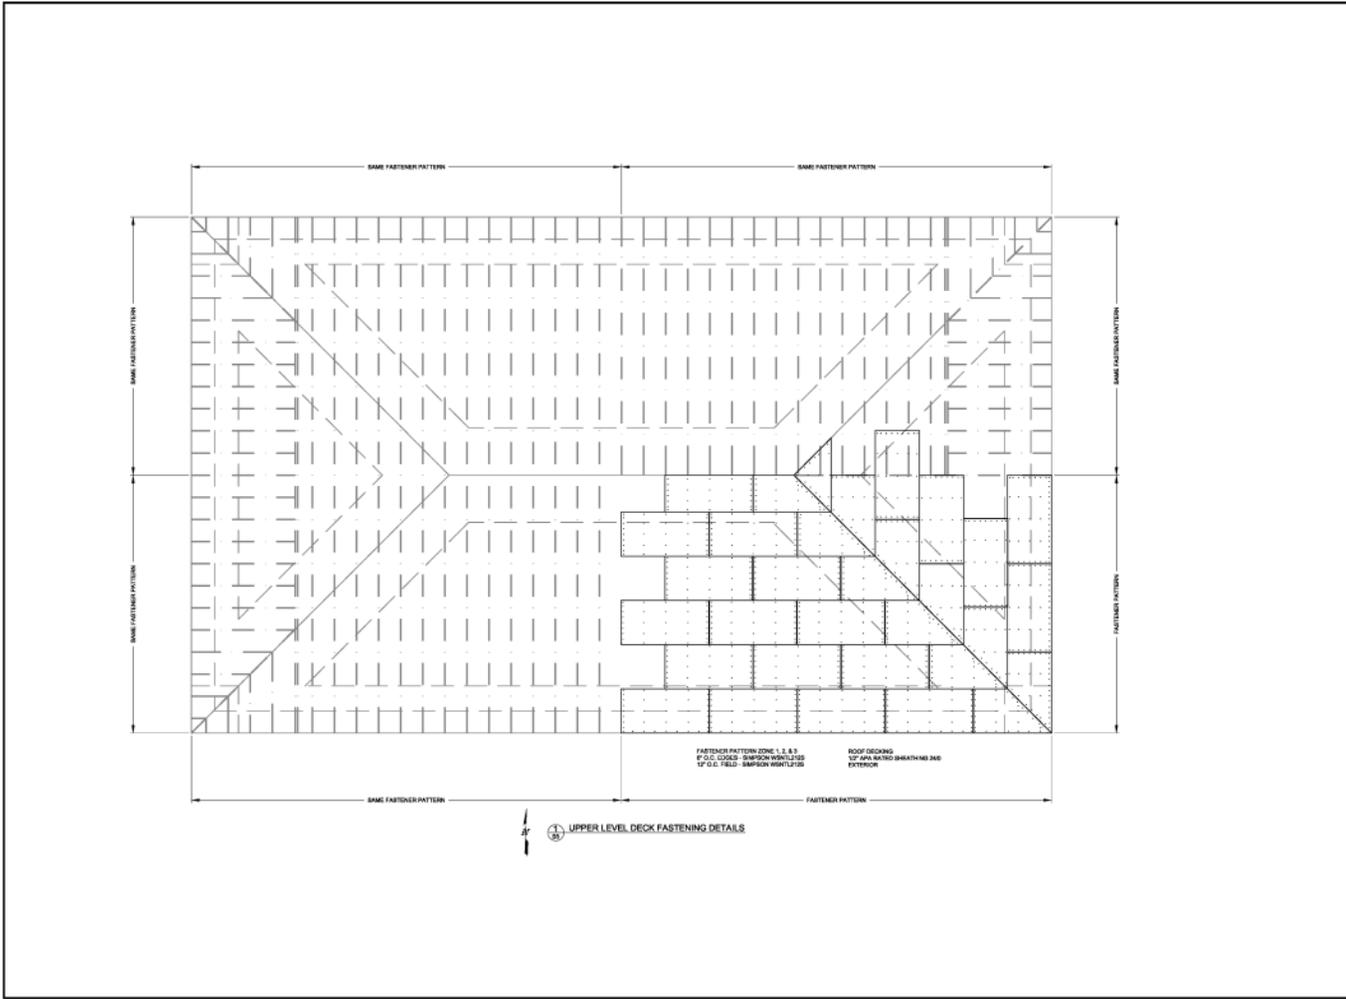
REV	DESCRIPTION
BUILDING 8-3846 ROOF RENOVATIONS	
CONTRACT NO. W9132T-06-D-0001 08T0054	
FORT BRAGG, NORTH CAROLINA	
PENTA ENGINEERING GROUP, INC. 6755 Peachtree Industrial Blvd Suite 150 Atlanta, Georgia 30360 678-282-1999 FAX 678-282-1993	
DESCRIPTION ROOF SHEATHING DETAILS	
PROJECT	08-4-1260
DATE	4-27-09
SHEET	S5 OF 7

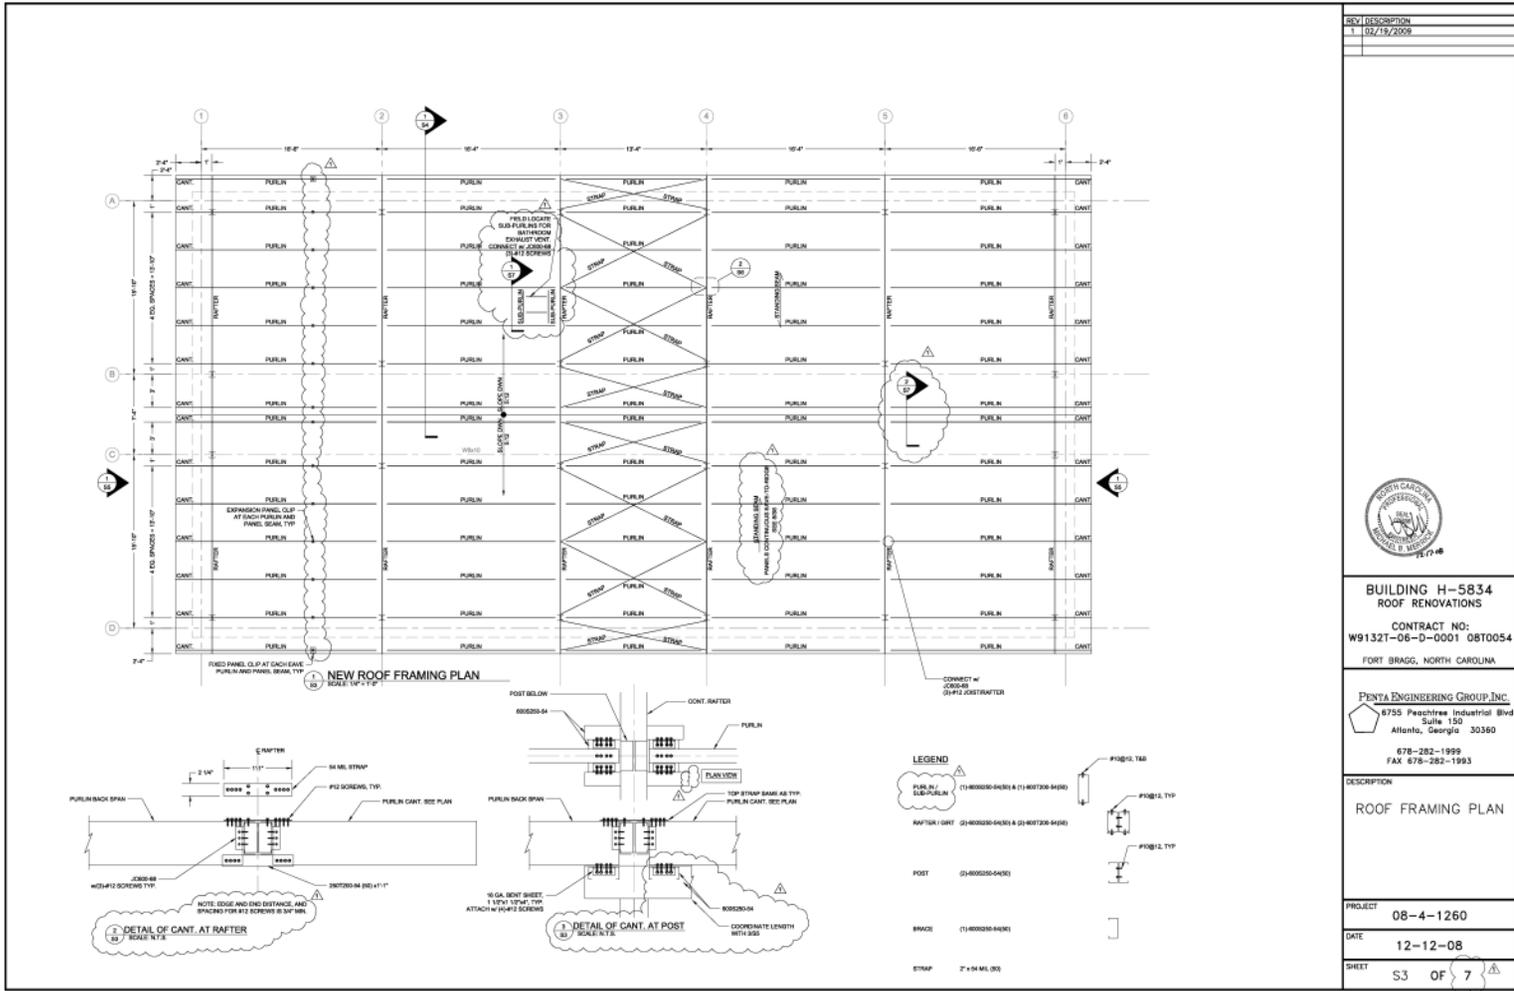
BUILDING H-5834 ROOF RENOVATIONS	
CONTRACT NO: W9132T-06-D-0001 08T0054	
FORT BRAGG, NORTH CAROLINA	
PENTA ENGINEERING GROUP, INC. 8755 Peachtree Industrial Blvd Suite 100 Atlanta, Georgia 30360 678-282-1999 FAX 678-282-1993	
DESCRIPTION ROOF FRAMING PLAN	
PROJECT	08-4-1260
DATE	12-12-08
SHEET	S2 OF 7
