US Army Corps
of Engineers®

Branchbox Breakwater Design at Pickleweed Trail, Martinez, CA, Section 227 Demonstration Project

by Stephen T. Maynard, Michael F. Winkler, and David E. Demko

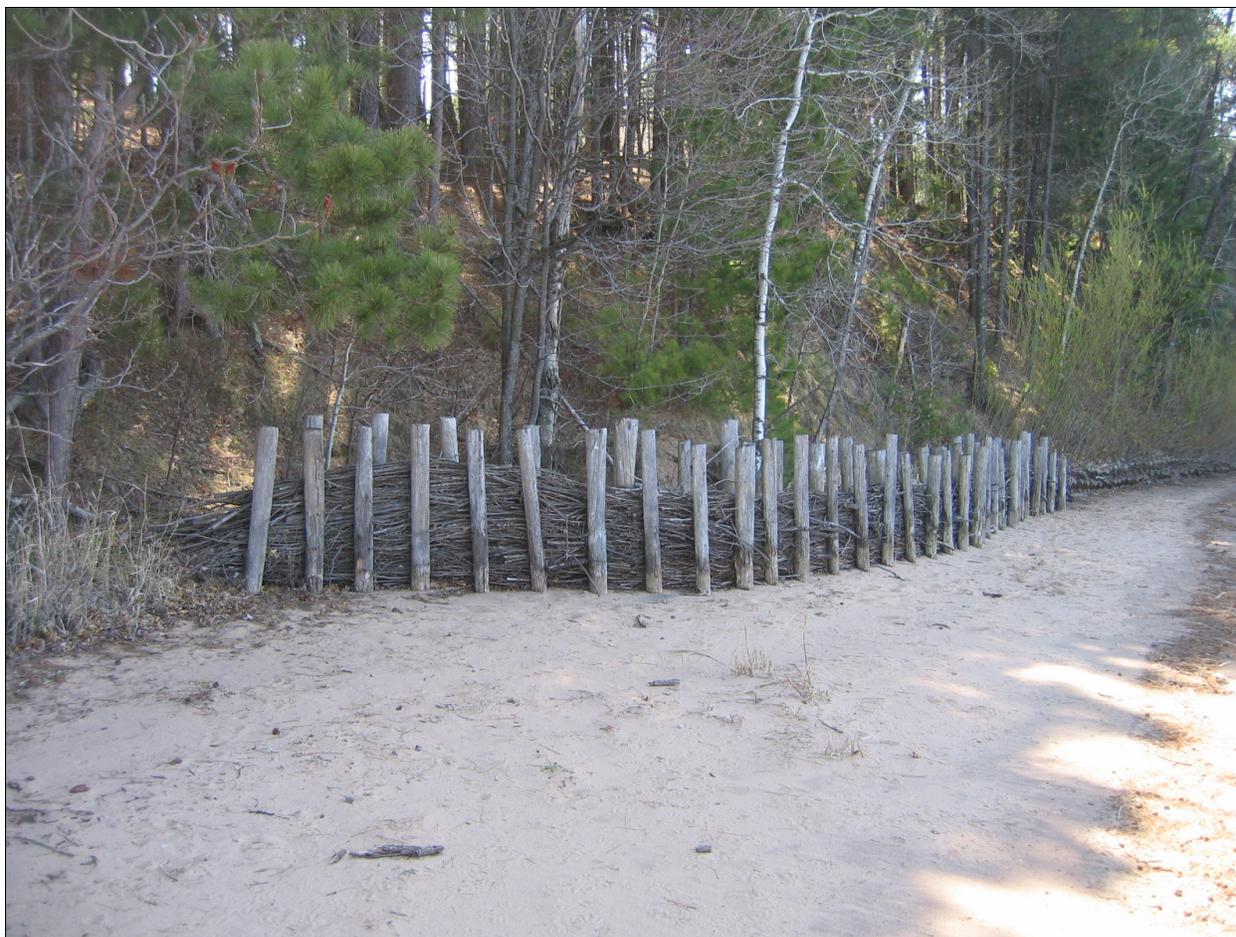
Figure 6. Branchbox breakwater at Rice Reservoir, front view

The overall performance of the branchbox breakwater is affected by several factors. The first factor is that the Wisconsin Department of Natural Resources (WDNR) restricted the placement of the structure in the permit to a distance of 4.5 m outward from the bank line. WDNR has since revised this and now allows a branchbox breakwater to be placed up to 9.0 m from an existing bank line. Though approximately 0.03 m of sediment has been deposited since 1999, Rice Reservoir contains very little suspended sediment, and it was expected that minimal accretion would occur landward of the breakwater. Vegetation was placed in front and behind the breakwater after construction. The vegetation in front of the breakwater was destroyed by wave action within the first year. Because the area behind the breakwater is shaded by shoreline vegetation, some of the vegetation landward of the breakwater was lost. Plant survival and possibly sediment accretion would have improved if the breakwater had been allowed to move further from the bank line. Smaller poles might be possible, but the effects of the ice heave were not known at the time of installation. Overall the branchbox breakwater has lasted over 10 years and has stabilized the bank line. Of all the shoreline stabilization methods tested by WVIC, the branchbox breakwater has proven to be the least expensive. Figures 6 and 7 show the branchbox breakwater in April 2005.

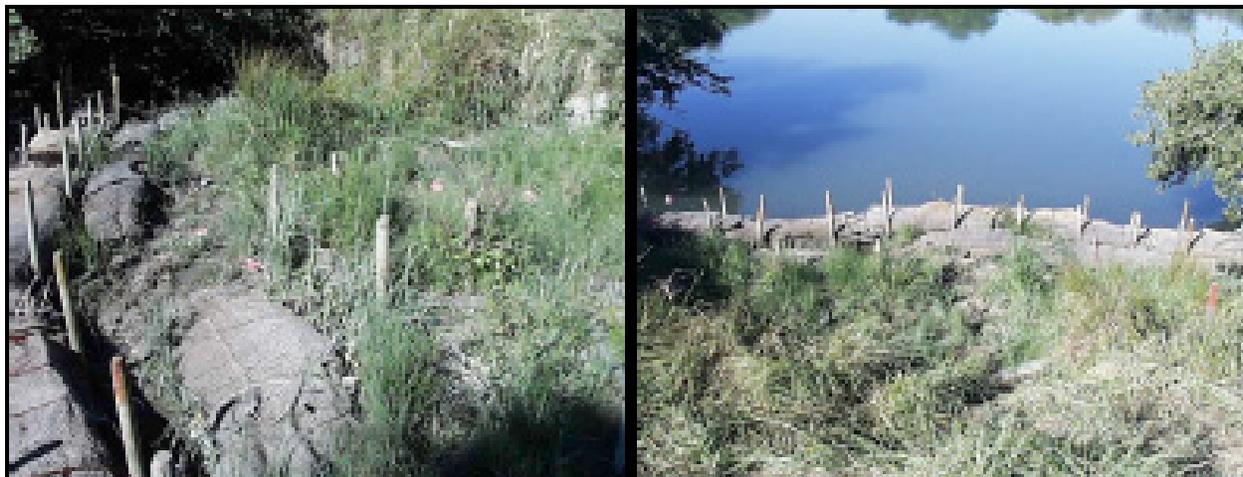
Figure 9. Branchbox breakwater at bank scallop on Georgiana Slough (1 year later from Figure 8)

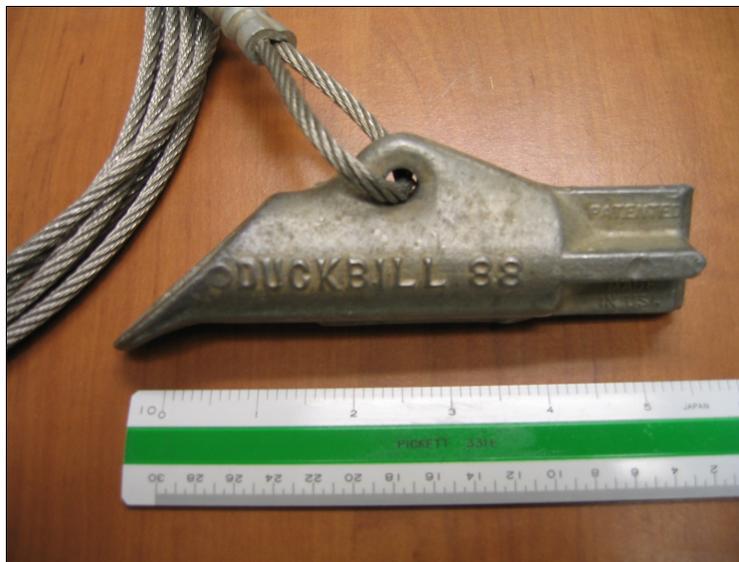
Figure 11. Duckbill anchor used to secure bundles

After the bundles were finished, but still in the jig, they were then bound together with stainless steel strapping. After strapping, they were transported and placed along a predetermined alignment to form a breakwater. The bundles were placed with the top of the bundle just below the normal pool elevation at St. Albans and Quincy. At this vertical position, the bundles were constantly in the water. The bundles were then anchored to the ground using Duckbill No. 88 anchors and 5-mm-diam stainless steel cable (Figure 11). The anchors were driven to about 1.8 m or refusal.
