## **Causes of Pretension Loss in High-Strength Bolts**

Hussam N. Mahmoud, Santiago Rodriguez Lopez,  
and Guillermo A. Riveros

June 2016

Final report

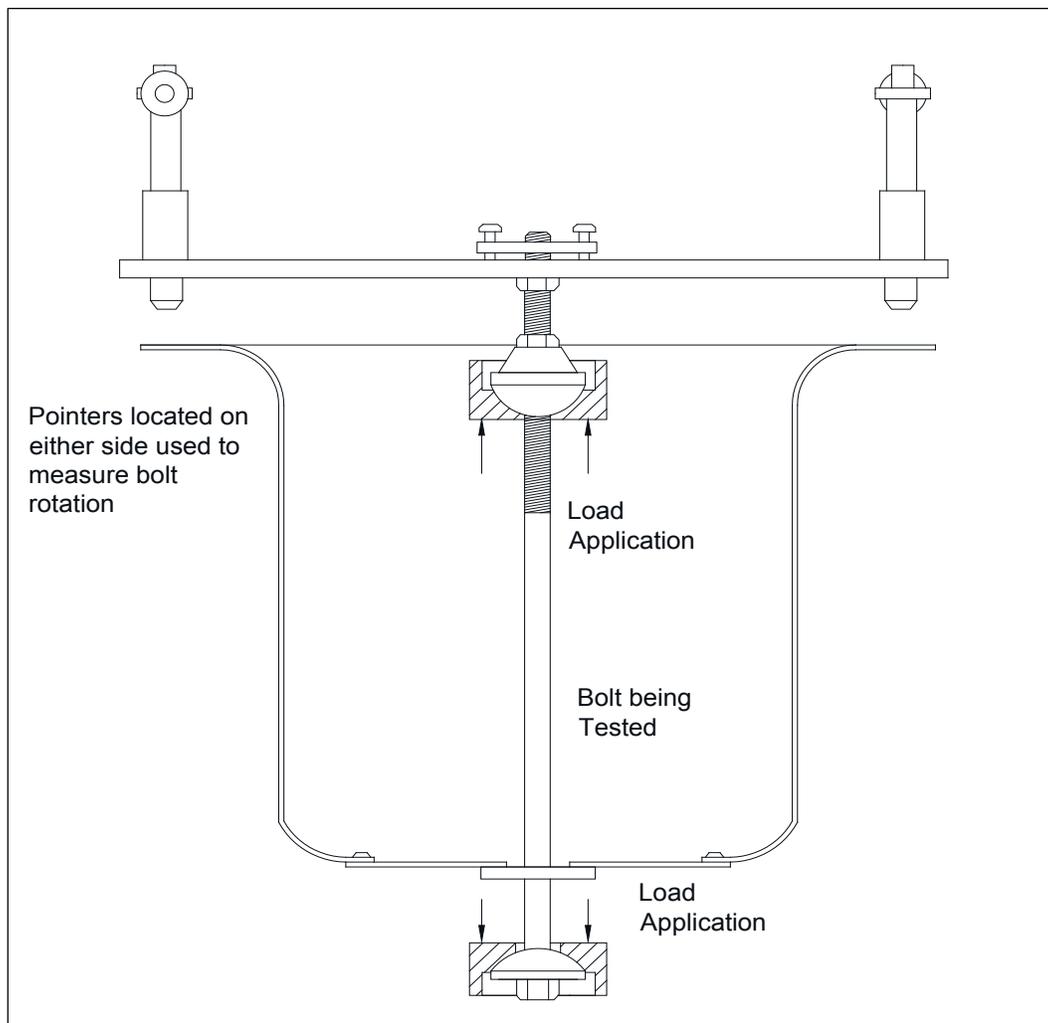
The first theories about rotational loosening were based on the assumption that an oscillatory axial load on the bolt would have the effect of rotating the nut loose. The first researchers to propose a theory of axially loaded loosening were Goodier and Sweeney (1945). In their study, 19 mm (3/4 in.) bolts were loaded from 2.22 kN to 26.69 kN (500 lb to 6000 lb) in tension while monitoring the rotation of the nut. The maximum rotation detected was 2 degrees, and the minimum was 0.7 degrees in 500 cycles. Figure 1 illustrates the arrangement used to conduct axial loading tests.

Figure 1. Axial oscillation set-up (Goodier and Sweeney 1945).

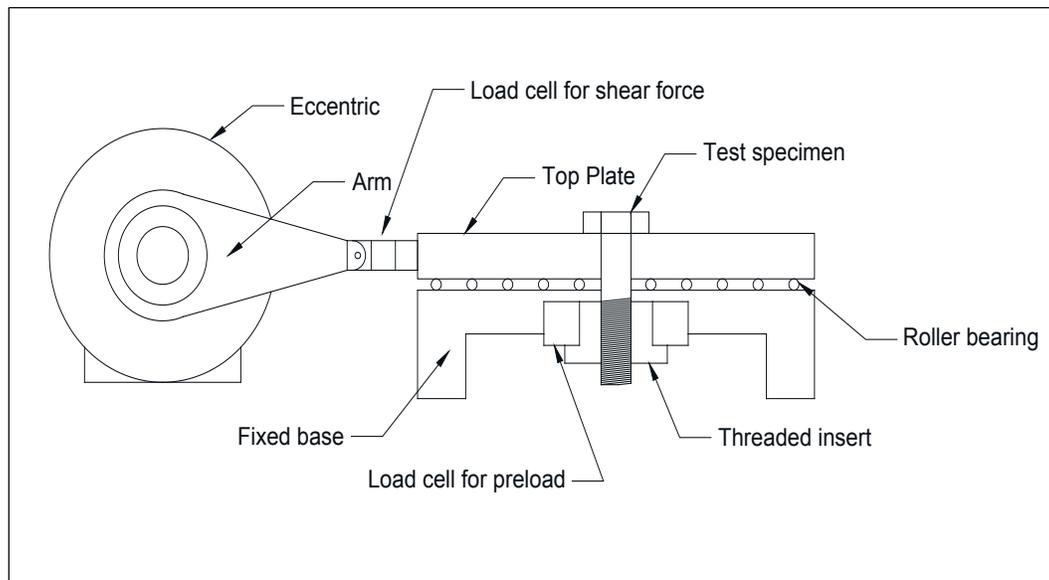
Pioneered by Gerhard Junker (1969), bolt loosening has been experimentally investigated in a variety of setups. Junker's innovative device was designed for testing loosening of fasteners caused by transverse vibration. Junker carried out tests on hex head cap screws DIN 933, M10x1.5x30, and socket head cap screws, 1960 series, 3/8 in.-16 × 1-1/4 in., subjecting them to a displacement controlled vibration. It was found that pre-tension was lost within 200 to 500 cycles and is due to both rotation of the nut and relaxation of the material the bolt is in contact with. This result was obtained in several tests run at frequencies of 10 cpm (cycles per minute) and 3000 cpm. For both frequencies, a similar behavior was observed as a function of the number of cycles (Junker 1969), hence, showing that the phenomenon of loosening is independent of frequency. Notably, the plots of Transverse Force vs. Number of Cycles resemble fatigue S–N curves, which later led Hashimura and Socie (2006) to study fatigue and loosening together. In addition, it was concluded that when sufficient force was applied to overcome static friction and cause the head of the bolt to slip, there will be rotational self-loosening of the fastener. This term was coined as *critical slip*. However, the concept of *critical slip* has been revised by the concept of localized slip at the threads by Pai and Hess (2002). Figure 2 shows the basic test setup for a loosening experiment.

Figure 2. Schematic of a typical transverse vibration loosening experiment: after Pai and Hess (2002).

Pai and Hess (2002) conducted an “experimental study of loosening of threaded fasteners due to dynamic shear loads.” Their study tested 63.5 mm (2.5 in.) and 76.2 mm (3 in.) long grade 5 and grade 8, 0.5 UNC 13 (0.5 in. diameter and 13 threads per in.) screws with varying types of lubrication to induce different friction coefficients for the threads and the head. The results showed that loosening occurs at significantly lower shear forces than those required to initiate slip of the head. This occurs via localized slip in the threads, which is stored through friction on the back cycle and expands throughout the rest of the threads. In fact, the data showed that shear loads of 59%–66% of those required to cause complete slip of the head were sufficient to generate sustained loosening. The study highlighted the different factors contributing to loosening, and the source of loosening was eventually isolated through alternating types of lubricant on threads and head. Figure 3 shows the mechanism for the progressive loosening of a bolt via the accumulation of slip in the threads with varying direction of the shear force ( $F_s$ ) throughout each cycle.

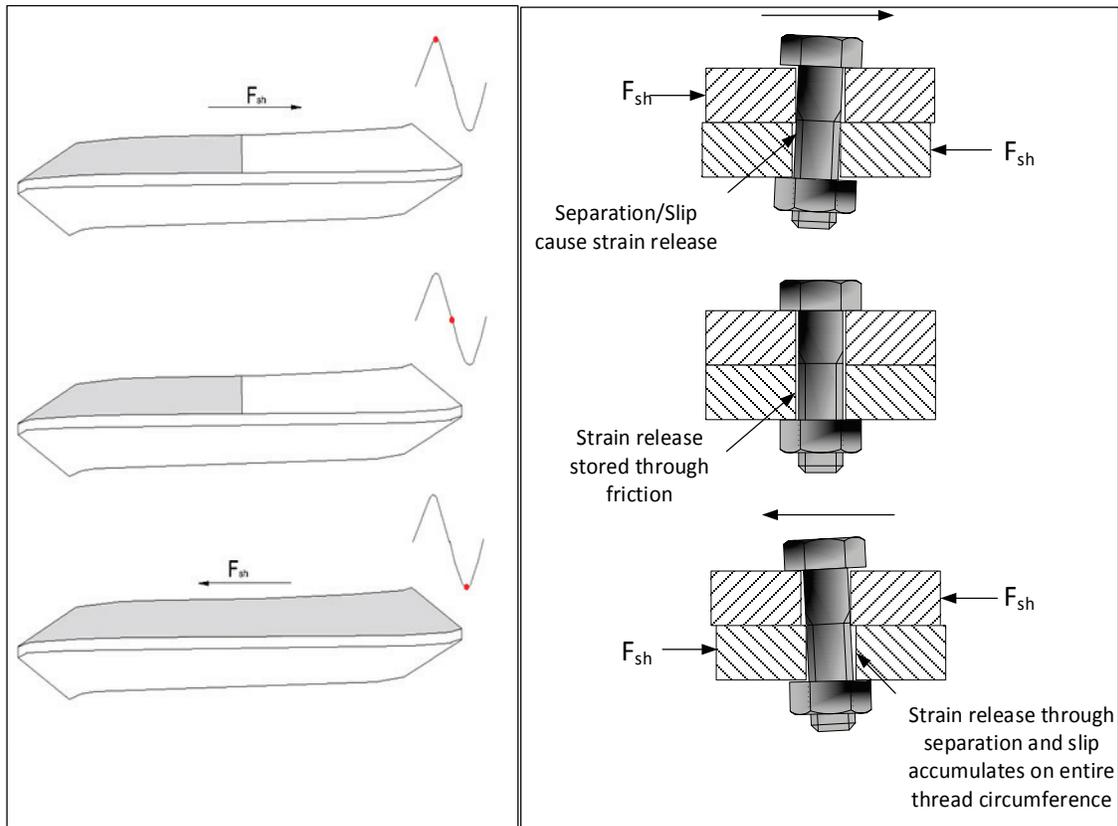
Figure 3. Thread slip accumulation with points of stick, slip, and strain for each point during the shear reversal.

Jiang et al. (2003) investigated the early stage self-loosening of bolts under shear load. The results showed that early stage self-loosening is caused by local cyclic plastic deformation in the threads. Figure 4 shows the difference between early stage loosening and the faster rate of loosening in the second stage. In addition, comparing the displacement versus load-control tests revealed that displacement between the plates is a more influential factor in loosening compared to the shear force.

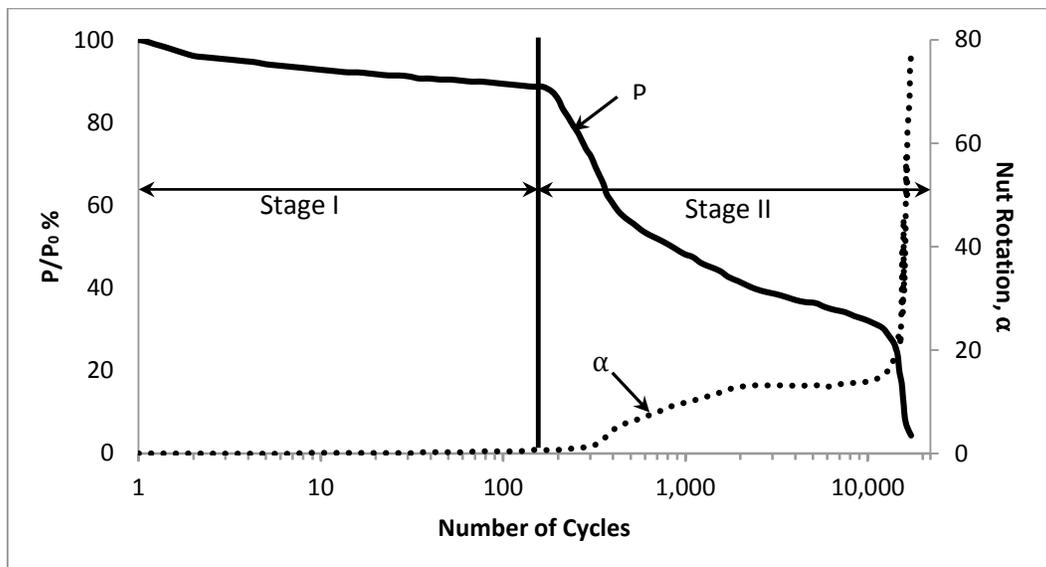
Figure 4. Two stages of loosening and nut rotation (Jiang et al. 2003).

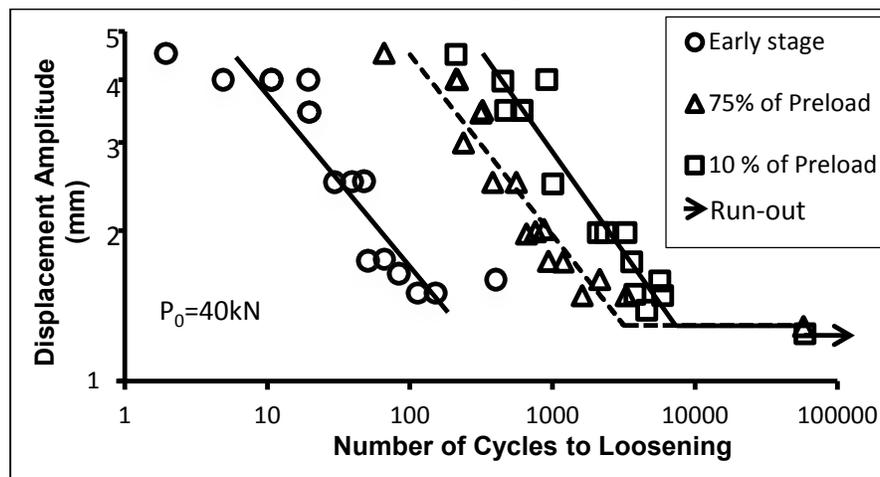
Figure 5. Typical plot of displacement amplitude vs. number of cycles (Jiang et al. 2004).

dividing line between early stage loosening and continued self-loosening was at 0.5 degrees of nut rotation. In the early stage, the loss of preload occurs because of non-rotational causes such as stress relaxation. This loss then initiates the second stage of self-loosening in which the rotation of the nut dominates the loss of preload. Additionally, the plots of the amplitude of the displacement vs. the number of cycles to failure resemble fatigue S–N plots. Figure 5 shows a typical plot of the displacement amplitude against the number of cycles to loosening. For this study, total loosening was considered to have happened when the preload reached 10% of its initial value.

These plots are comparable to the ones developed by Junker (1969) where the transverse force applied to the bolt plotted against the number of cycles to complete rotational loosening resembles a fatigue S–N curve. Following this lead, Hashimura and Socie (2006) studied the loss of preload as a coupled phenomenon, namely loosening-fatigue under transverse load. This issue is discussed further in section 3.2.

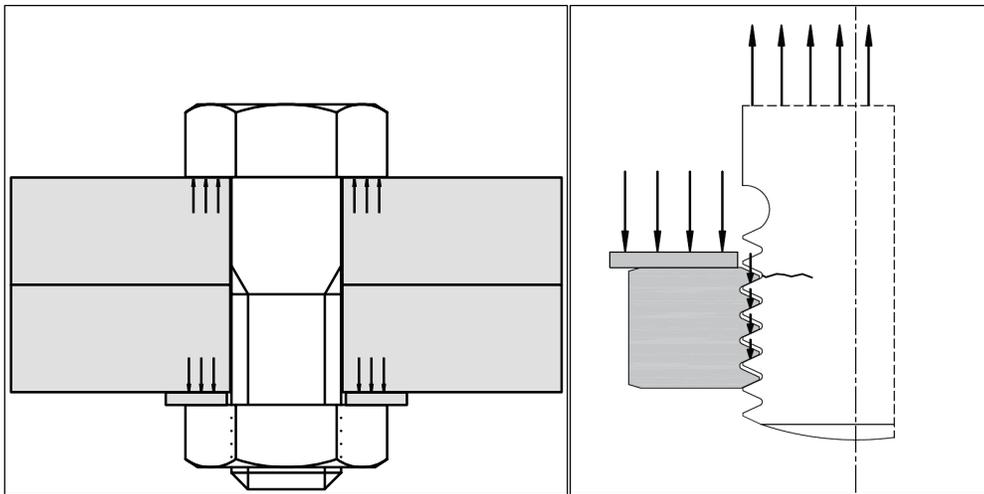
Figure 6. Bolt subjected to cyclic tension and crack nucleation at the first engaged thread: after Schijve (2001).

some prying action. They determined that these idealized pinned ended connections would fail because of bolt failure due to thread stripping at a rotation greater than 0.025 radians (1.43 degrees) on the ribbed bolts, which contained shallow threads. Conversely, A 325 bolts that had been properly pre-tensioned to 70% of proof strength developed ductile behavior, and the failure occurred in the angles. Figure 6 shows a preloaded bolt subjected to cyclic tension and a crack nucleating at the first engaged thread.

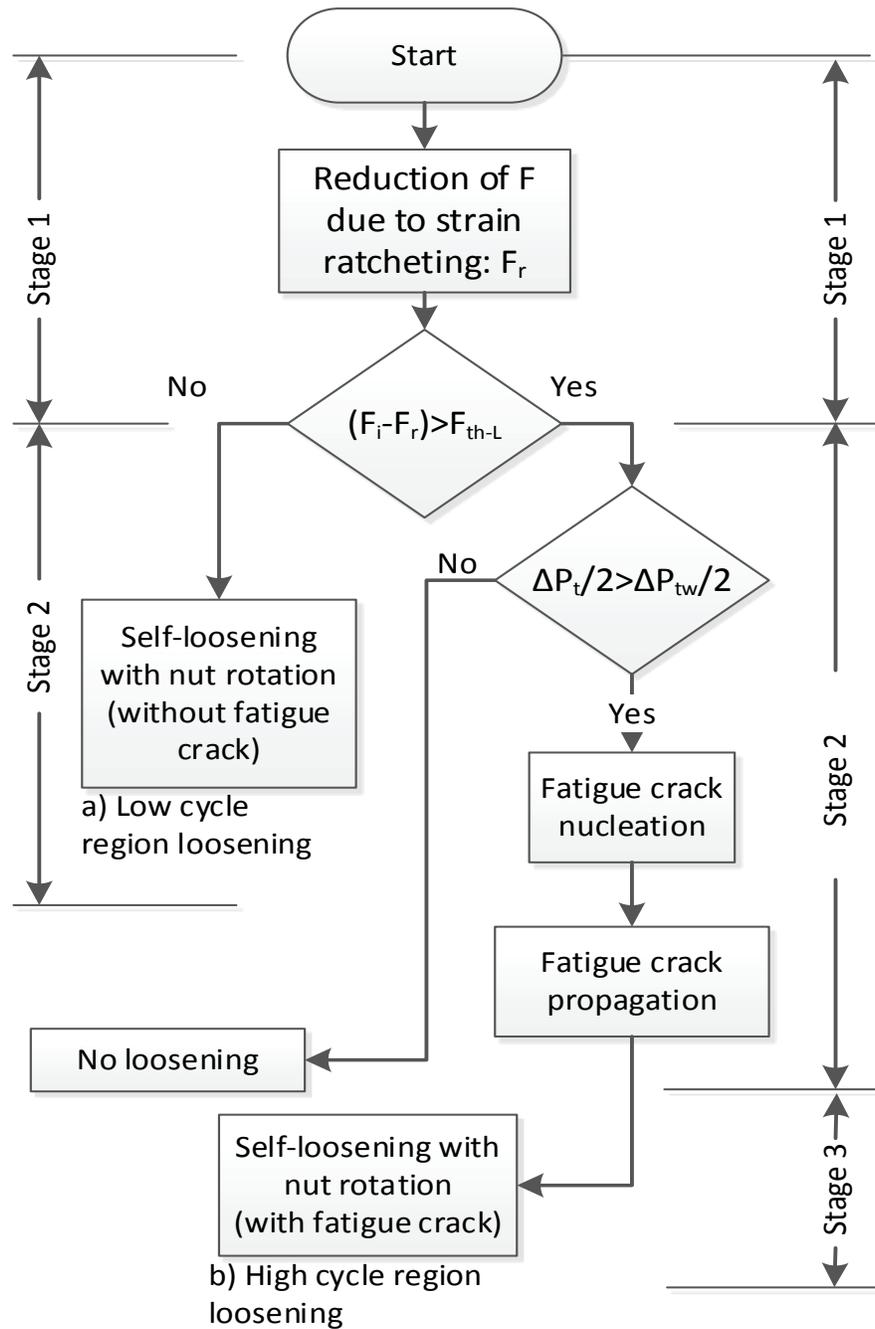
Figure 7. Loosening fatigue mechanism (Hashimura and Socie 2006).

Following the lead of the similarity of the loosening curves to the S–N fatigue curves developed for bolted and welded connection, Hashimura and Socie (2006) studied the coupled phenomenon of loosening and fatigue of bolted joints subjected to transverse vibration. The study included testing M10 bolts without washers and with threads in the shear plane. The experiment was run under displacement control with the use of rollers in between the plates to reduce friction. Preloads were applied only

up to a maximum of 50% of the yield strength of the bolts. The study showed that if a bolt loosens in the low cycle region of  $10^3$  to  $10^4$  cycles, crack nucleation is not present and that the loss of pre-tension is attributable to rotational loosening. Alternatively, if the bolt loosened in the high-cycle region of  $10^5$  to  $10^6$  cycles, a crack was observed at the root of the first engaged thread in every bolt tested (Hashimura and Socie 2006). Figure 7 illustrates the different mechanisms by which a bolt may loosen or fatigue as presented by Hashimura and Socie (2006).

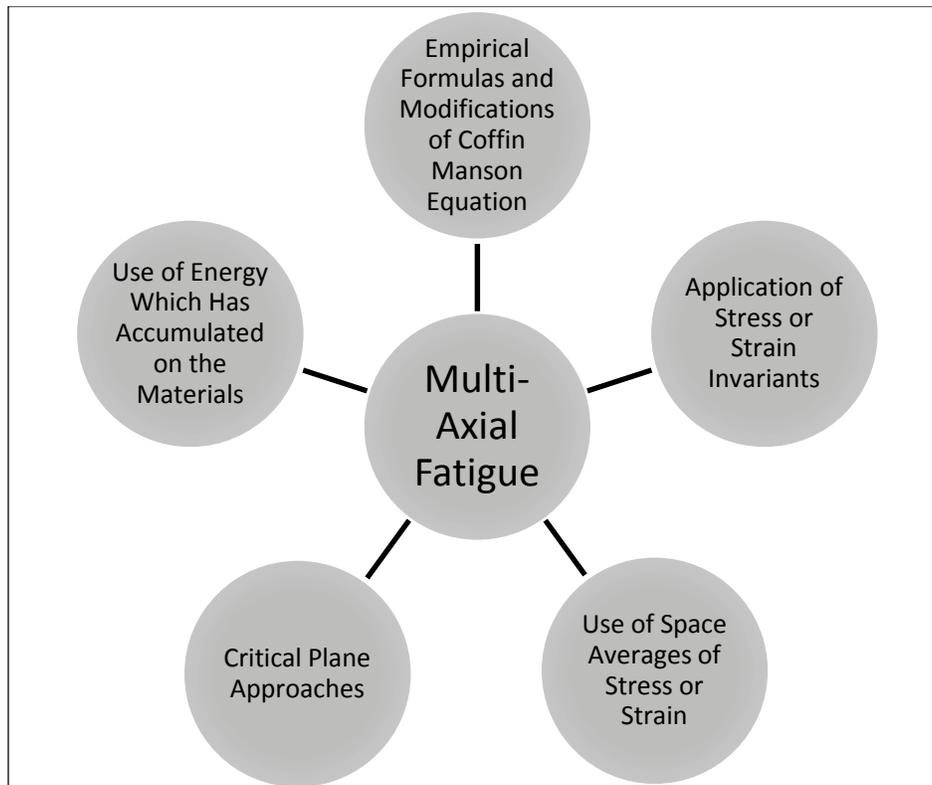
Figure 8. Categorization of multi-axial fatigue approaches according to You and Lee (1996).

You and Lee (1996) reviewed and classified research conducted since 1980 on multi-axial fatigue. Most multi-axial assessments reduce multi-axial loading to an equivalent uniaxial loading. Approaches to multi-axial fatigue were classified by You and Lee (1996) into five different categories as shown in Figure 8. The results of this review study indicated that the major improvements in multi-axial fatigue assessment methods during this period were the consideration of material anisotropy and the application of Mohr's circle within energy methods. Several models were investigated and their applications and limitations discussed.
