TECHNICAL REPORT C-75-2

A CONCEPT FOR RAPID REPAIR OF BOMB-DAMAGED RUNWAYS USING REGULATED-SET CEMENT

George C. Hoff

July 1975

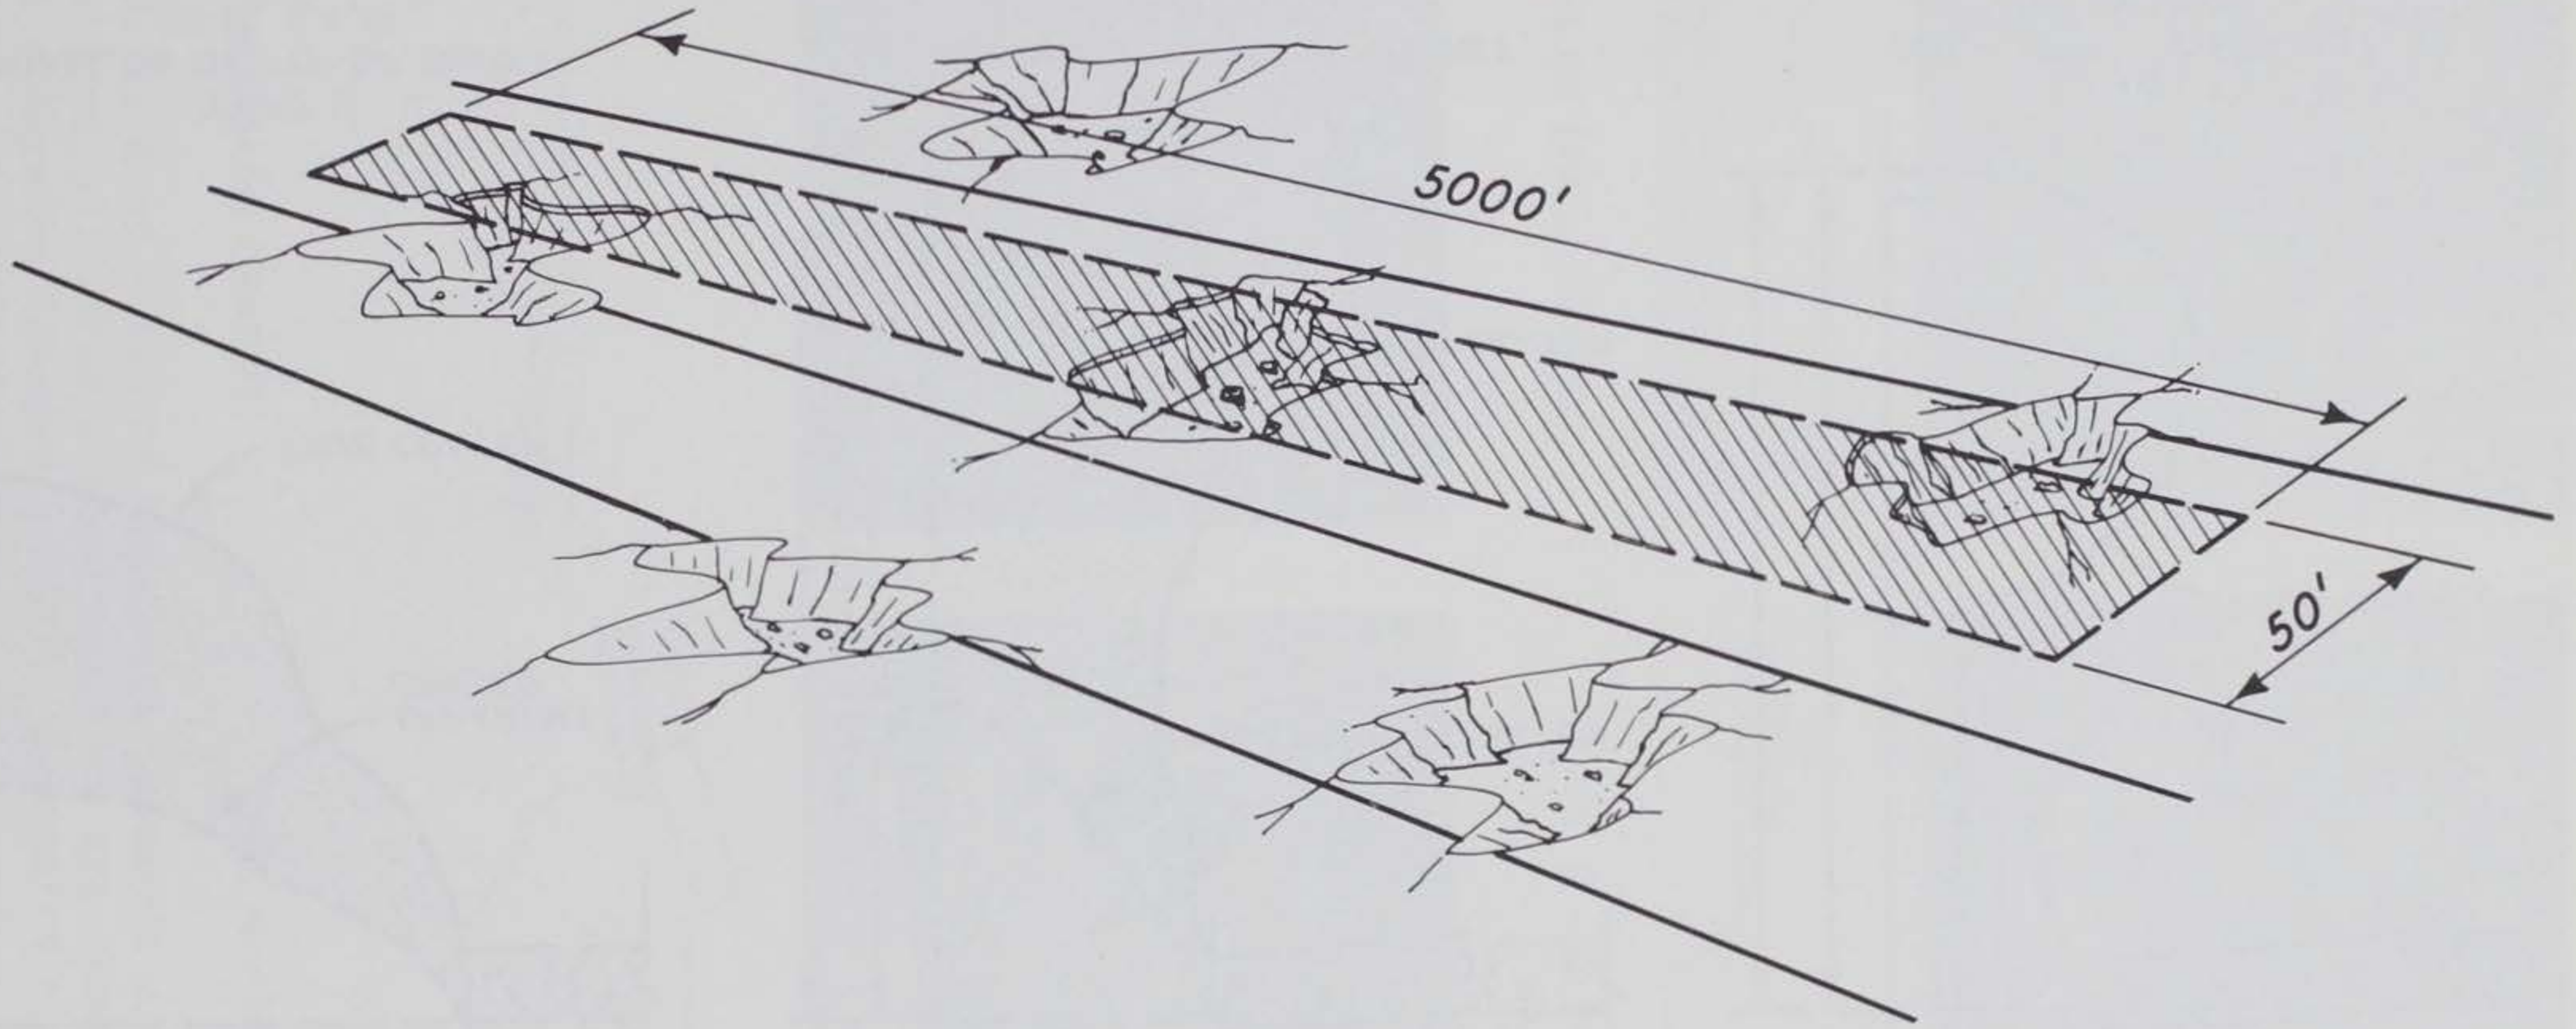
Figure 1.1 Required operational area on a bomb-damaged runway.

Immediately after an attack on the runway, a damage assessment team determines which craters are to be repaired to obtain the desired runway surface (Figure 1.1). Each repair team then separates into three groups--one group each for runway cleanup and crater filling, landing mat retrieval and assembly, and select-fill retrieval and transport. Two large front-end loaders (FEL's) are used on each crater to clear debris from undamaged runway around the craters (Figure 1.10). A grader and sweeper are used to clear an adjacent area for assembly of the landing mat (Figure 1.11). The two FEL's and a bulldozer push debris in the crater lip area into the crater (Fig. 1.12). As filling progresses, the bulldozer compacts debris in the bottom of the crater while simultaneously loosening and pushing up damaged pavement around the crater (Figure 1.13); these pieces of pavement are either pushed off the runway or back into the crater. Landing mat necessary to cover the crater is simultaneously assembled adjacent to the crater (Figure 1.14). The select fill is removed from stockpiles (Figure 1.15) and moved by dump truck to the crater where it is spread by a dozer and leveled and compacted by the grader. A final compaction is applied by a tractor-towed vibratory roller. The assembled landing mat is then pulled over the fill area and anchored; when this is completed for all three craters, the runway should be operational.

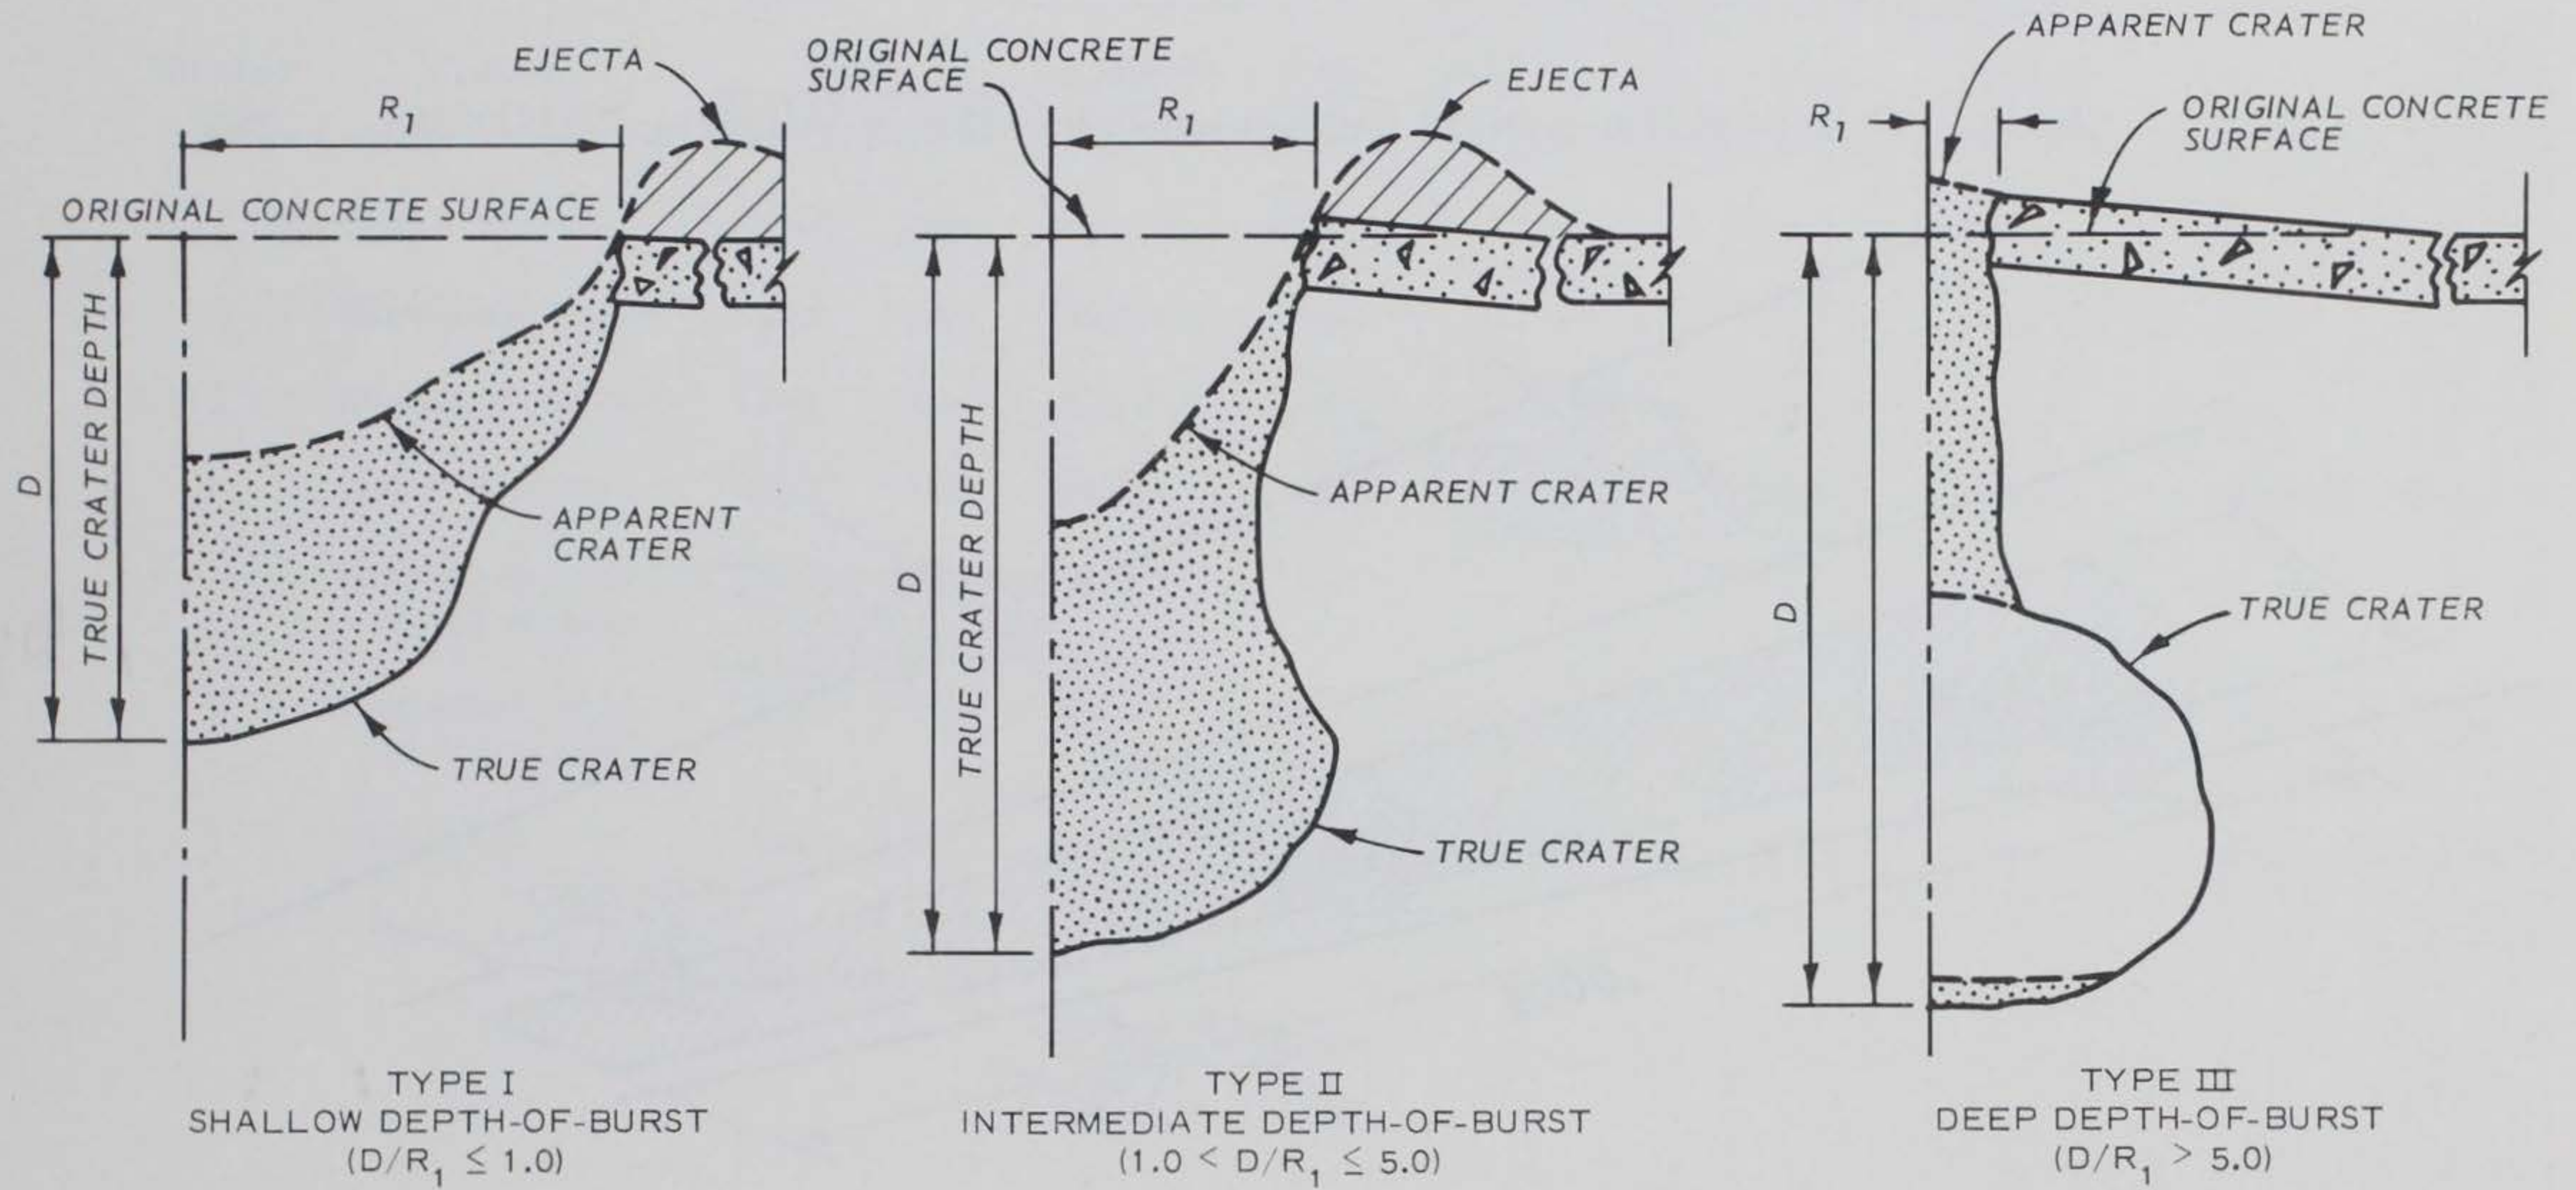
Figure 1.2 U. S. Air Force pavement crater classifications (Reference 2).

on pavement thickness, pavement subgrade, the size and type of munition, and its depth of penetration into the pavement and underlying subgrade (Reference 2). The U. S. Air Force has described craters as Types I, II, and III, as shown in Figure 1.2, based on depth of burst. A Type I crater (shallow depth of burst) is generally hemispherically shaped with widely spread debris but with no appreciable heaving or cracking in adjacent pavement. A Type II crater (intermediate depth of burst) is generally conical with widely spread debris; the adjacent pavement is cracked and heaved. Both Types I and II craters are partially filled with debris fallback that provides an apparent crater surface. The Type III crater (deep depth of burst) has a large cavity in the subgrade and from the pavement surface does not appear to be cratered at all. There is very little debris, but the adjacent pavement is cracked and heaved in large wedge-shaped sections. For repair purposes, the Type III crater can be transformed into a Type I or II shape using additional smaller detonations. The U. S. Army Corps of Engineers has refined the pavement crater description with classifications that range from Types 1-7 (Reference 3), as shown in Figure 1.3; a description of these craters is contained in Table 1.1.

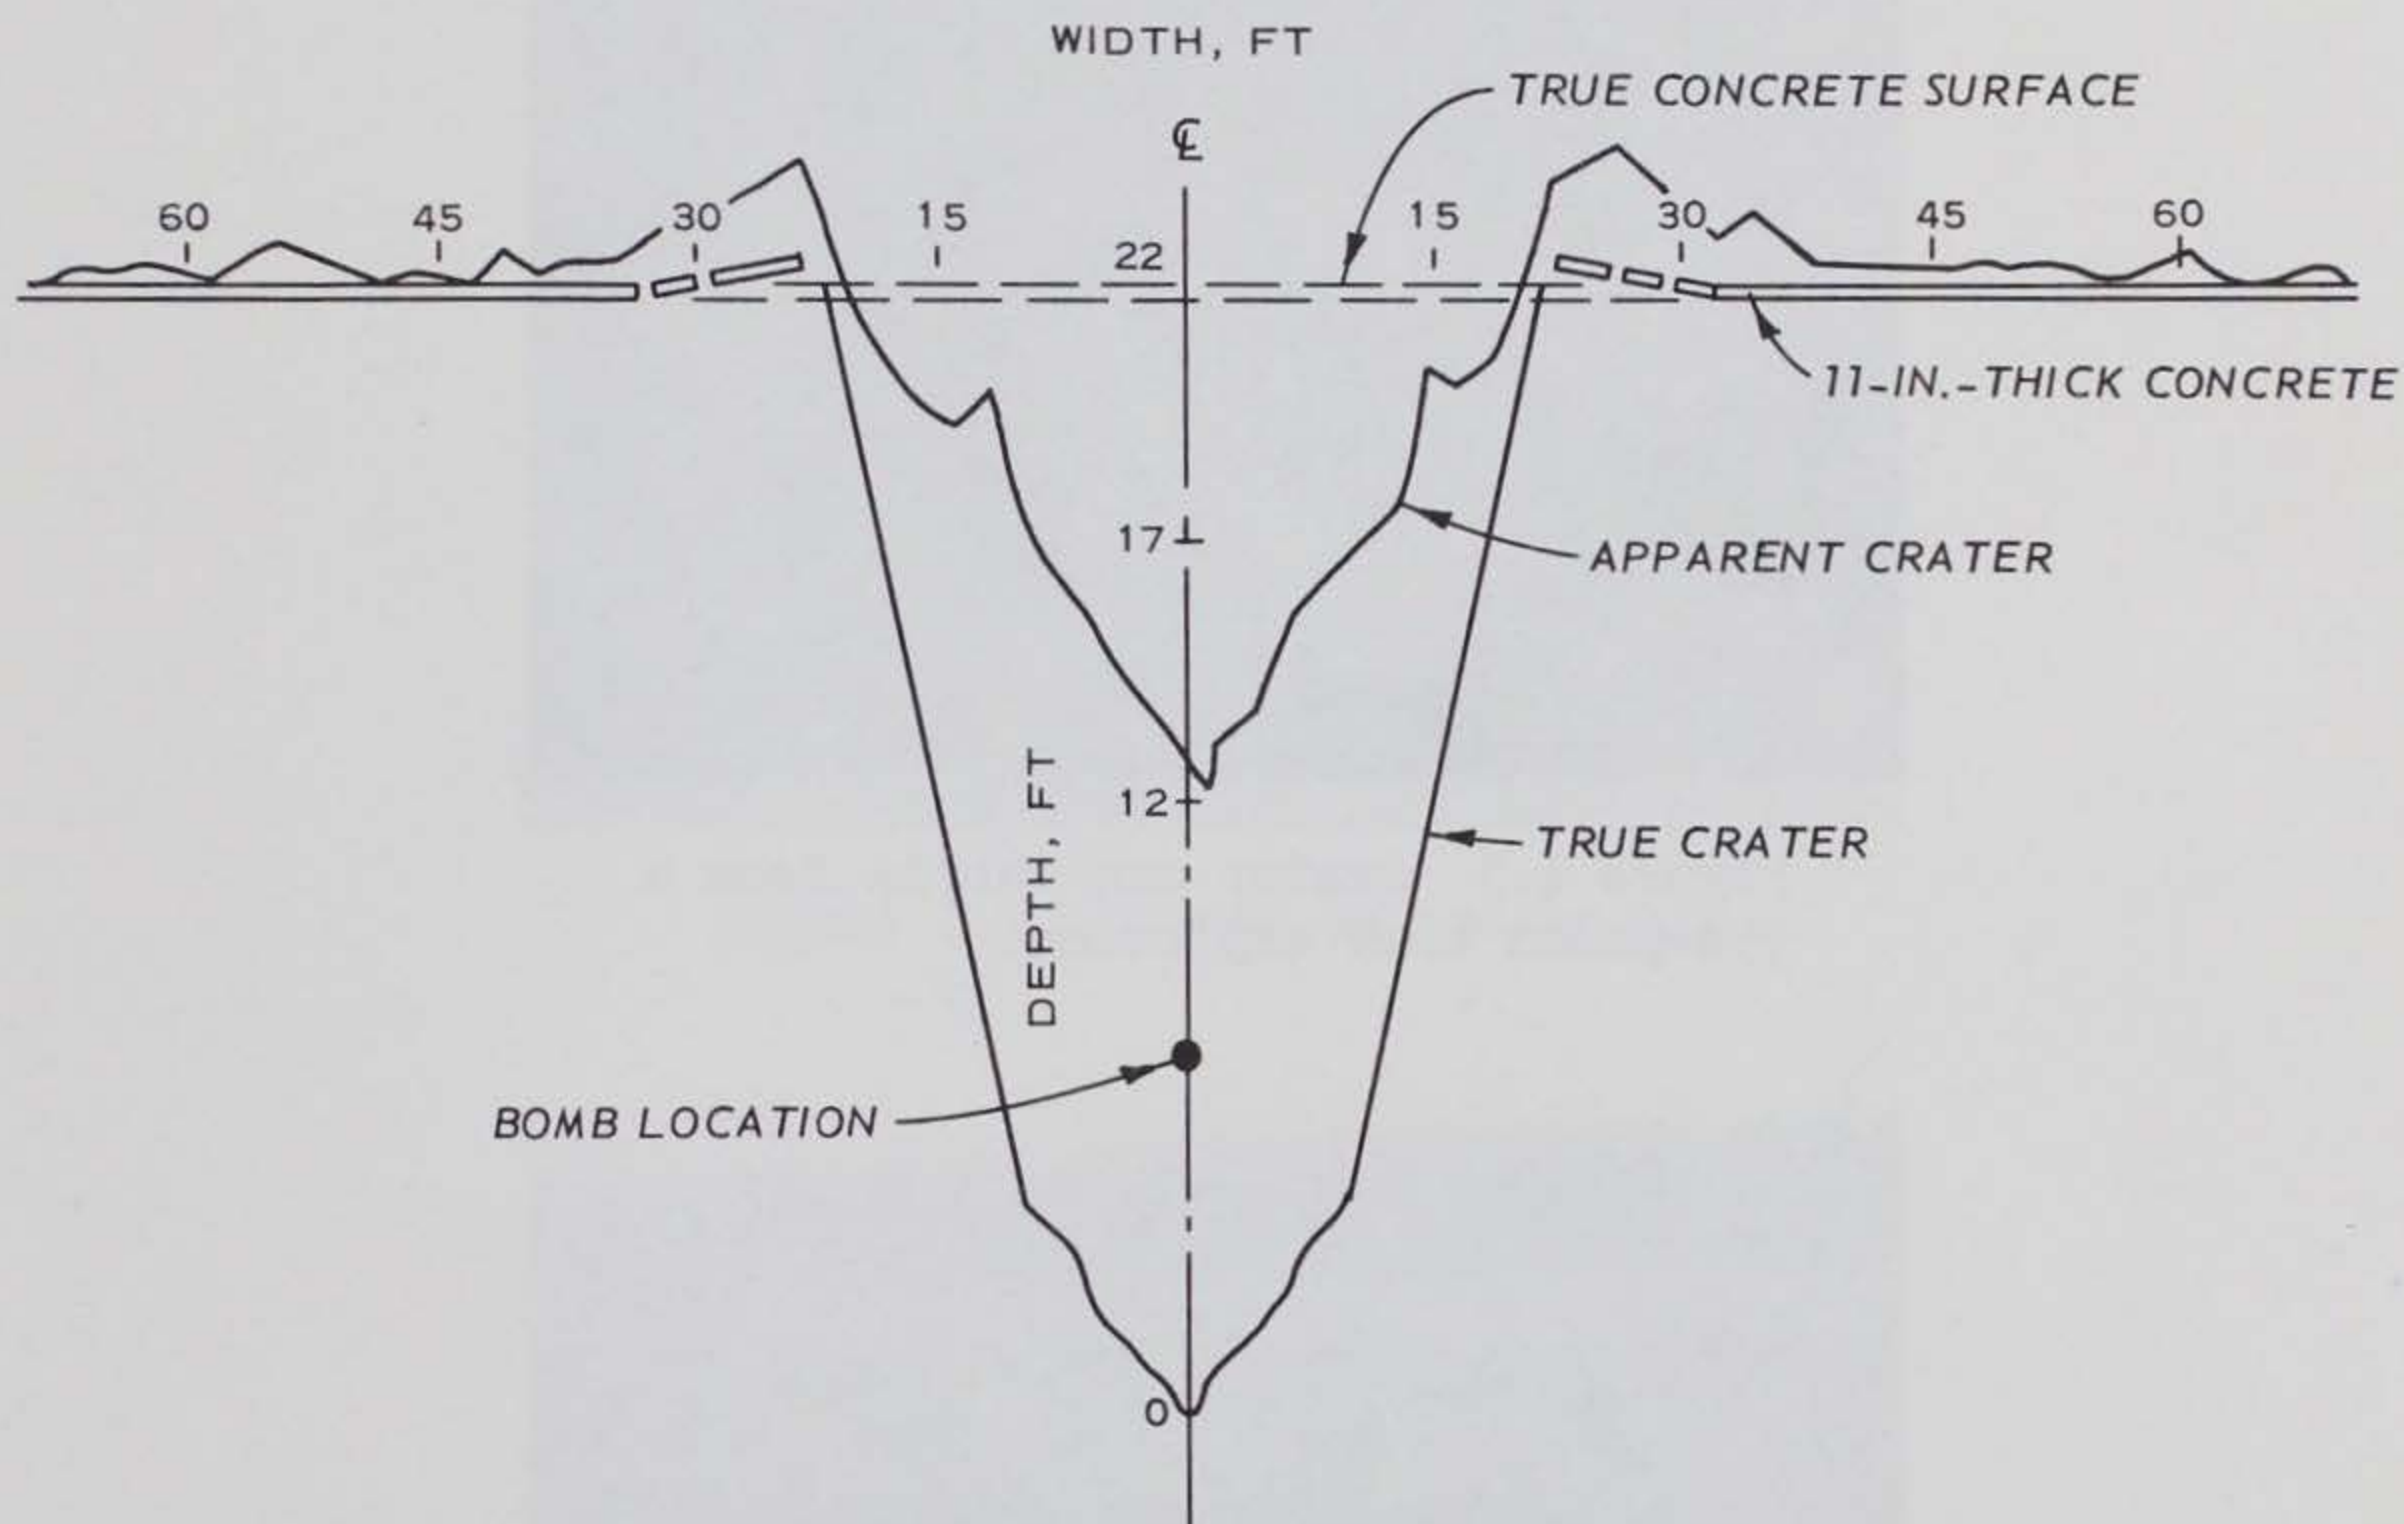
Figure 1.4 Cross section of 750-pound bomb crater, Hays, Kansas (Reference 4).

2.2.1 Crater Repair Volumes. Using the damage area shown in Figure 1.4 as a model of the standard crater for repair, a simplified crater approximating the Type 3 crater (Figure 1.3) in shape was developed as shown in Figure 2.2. It is assumed that, to obtain a satisfactory pavement surface after repair, all damaged pavement would have to be removed along with a small amount of base course (approximately 2 feet total in depth) to a point 35 feet from the center of the crater, thereby necessitating the replacement of a 70-foot-diameter section of pavement surface. In actual practice, the amount of damaged pavement to be removed is determined by using a straightedge to identify pavement rises that exceed an 11/16-inch rise in each 4 feet of horizontal distance; this pavement must be removed (Reference 6).

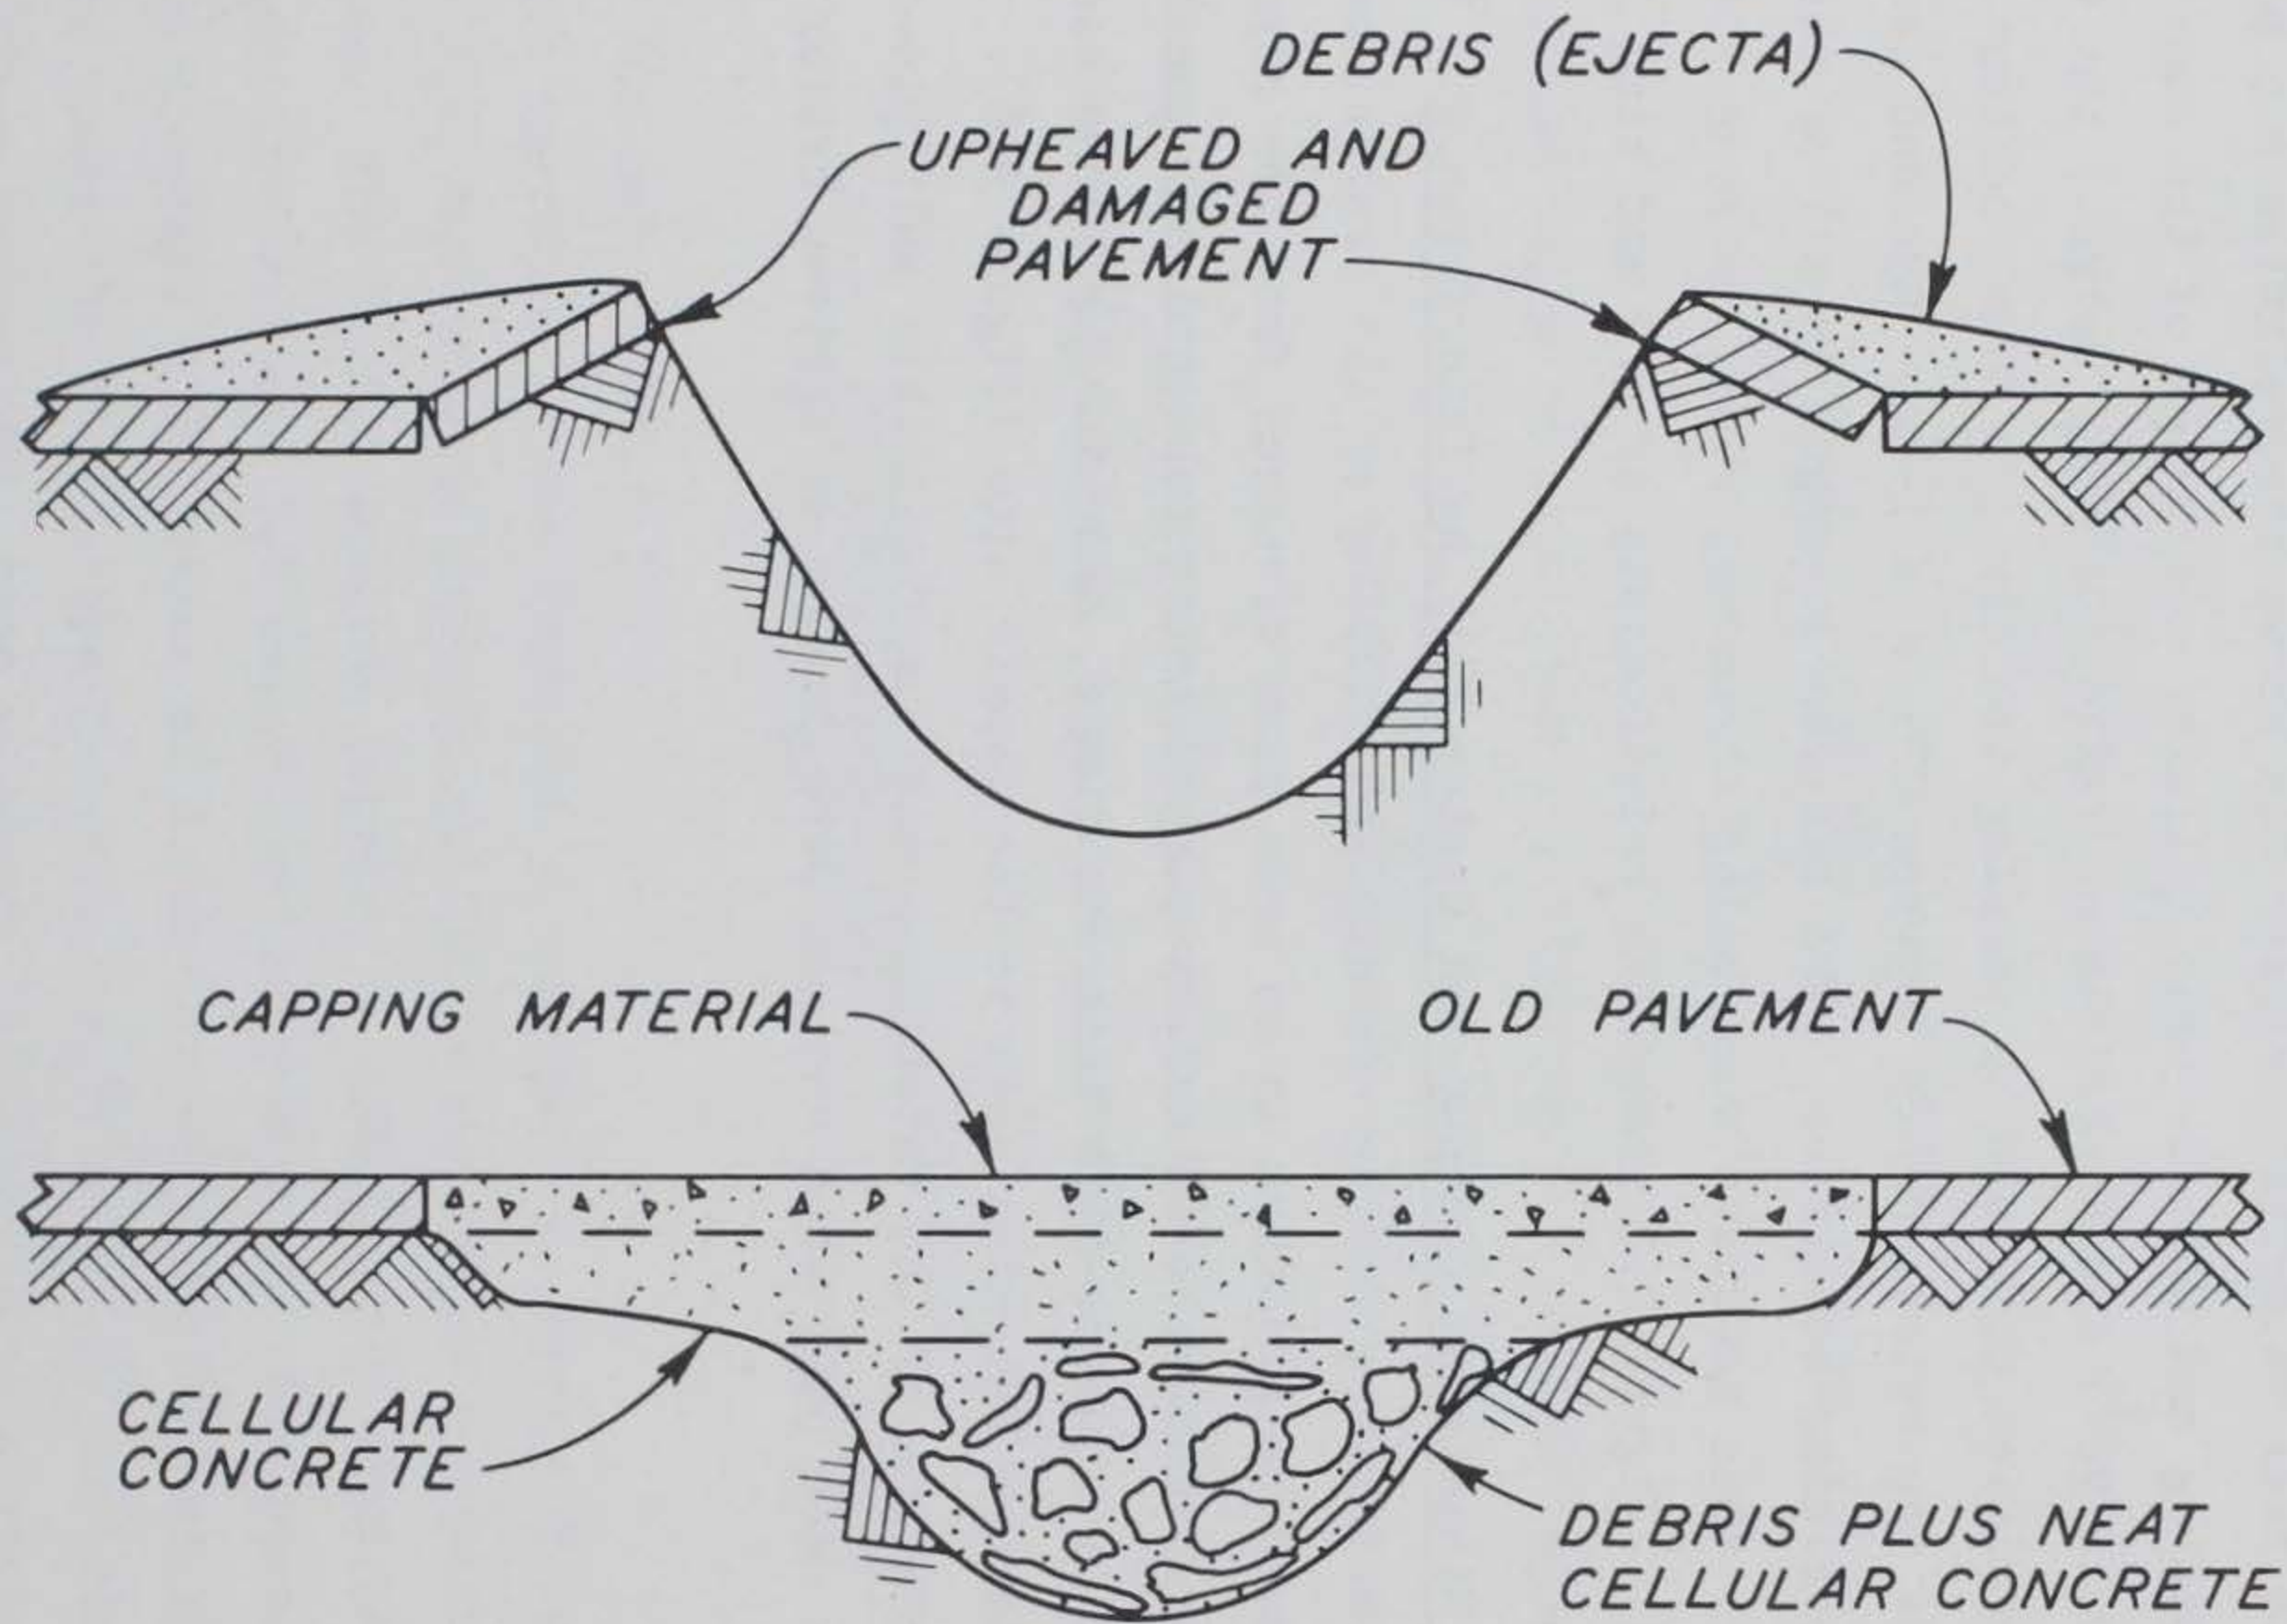
Figure 2.1 Regulated-set cement repair scheme for bomb-damaged pavements.

The regulated-set cement repair scheme for craters in bomb-damaged runways is shown in Figure 2.1. The lower portion of the crater is filled with a combination of debris and neat (no aggregate) cellular concrete. This concrete, often referred to as foamed concrete, is made with regulated-set cement, water, and a preformed foam. It has a very high air content and low density and will flow readily around the debris dumped or pushed into the crater concurrently with cellular concrete during the filling of the crater. The crater is filled in this manner until it reaches a point approximately 3 feet from the desired top surface of the runway. At that point, no more debris is placed in the crater. The foam content, which is mostly air, of the concrete is reduced, and sand is added to the cellular concrete as aggregate. Bank-run sand and gravel could also be used providing the aggregate size was not so large that it could not be pumped with the type of pumps described in Section 4.6.5. These procedures increase the density and bearing strength of the cellular concrete. The filling operation continues using this cellular concrete containing aggregate to a point approximately 11-12 inches below the desired pavement surface. All preformed foam (or air) is then left out of the concrete, with the resulting cement, sand, and water composite providing the capping material which will function as the structural wearing surface. The capping material is placed to the desired level, screeded off, and finished, if desired.

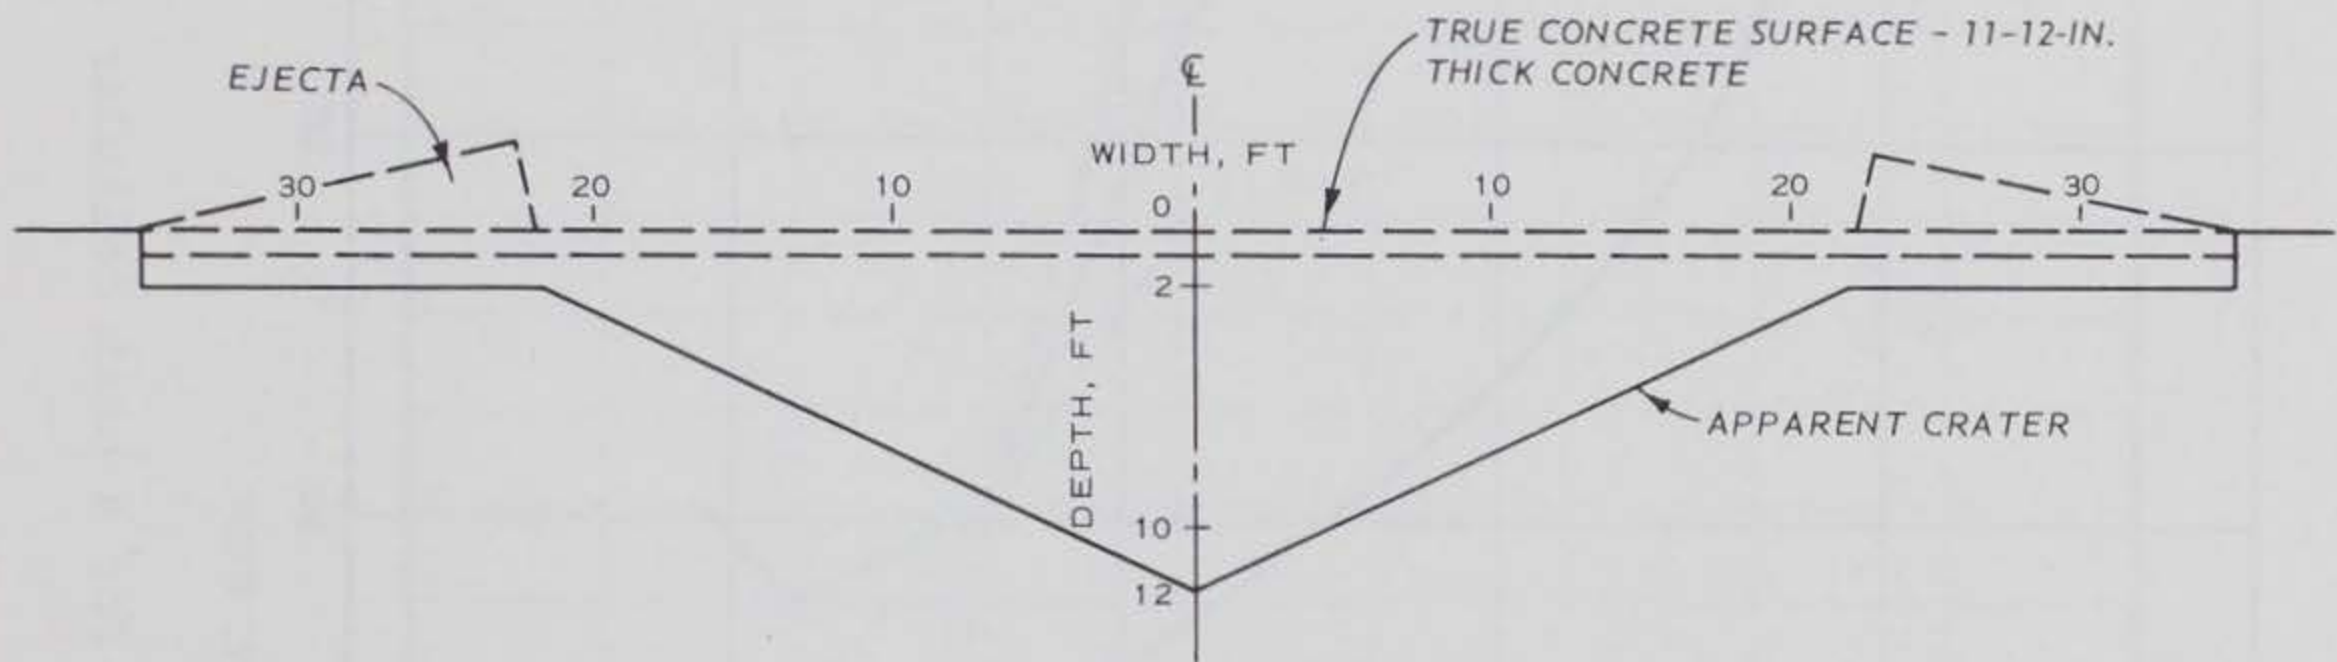
Figure 2.2 Simplified crater for repair.

The maximum depth from the pavement surface to the surface of the apparent crater is assumed to be 12 feet. A triangular cross section for the apparent crater profile was used to obtain the volume of the subgrade portion of the crater. This volume plus the volume for the damaged pavement removal totals a repair volume of approximately 473 yd^3 of which 131 yd^3 would be the replacement of

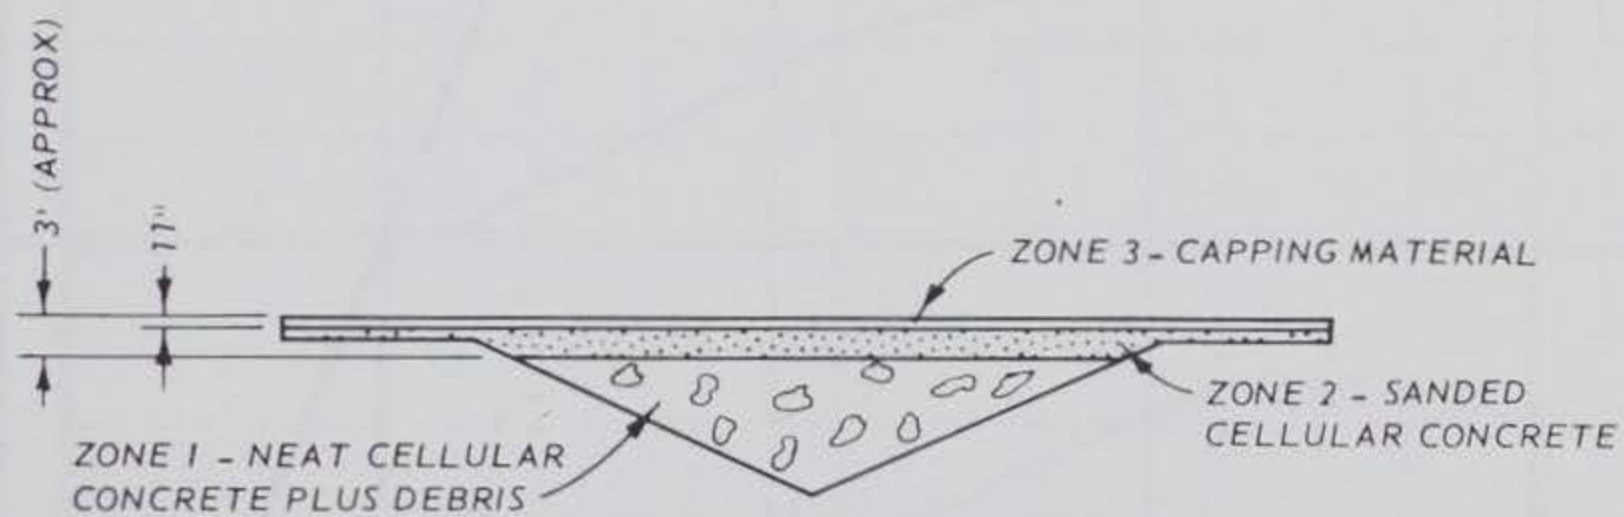
ZONE 1 - BACKFILL	= 137 CU YD
ZONE 2 - SUBBASE	= 205 CU YD
ZONE 3 - STRUCTURAL CAP	= <u>131</u> CU YD
TOTAL	= 473 CU YD

Figure 2.3 Crater repair scheme plus volumes involved.

an 11-inch-thick pavement surface. For repair purposes, the simplified crater is delineated into three zones as shown in Figure 2.3. Zone 1, the lower portion of the crater, will be filled by both debris and neat cellular concrete. Zone 2 will be repaired by sanded cellular concrete (no debris). Zone 3 is the capping material. Approximate volumes for Zones 1, 2, and 3 are 137, 205, and 131 yd³, respectively.

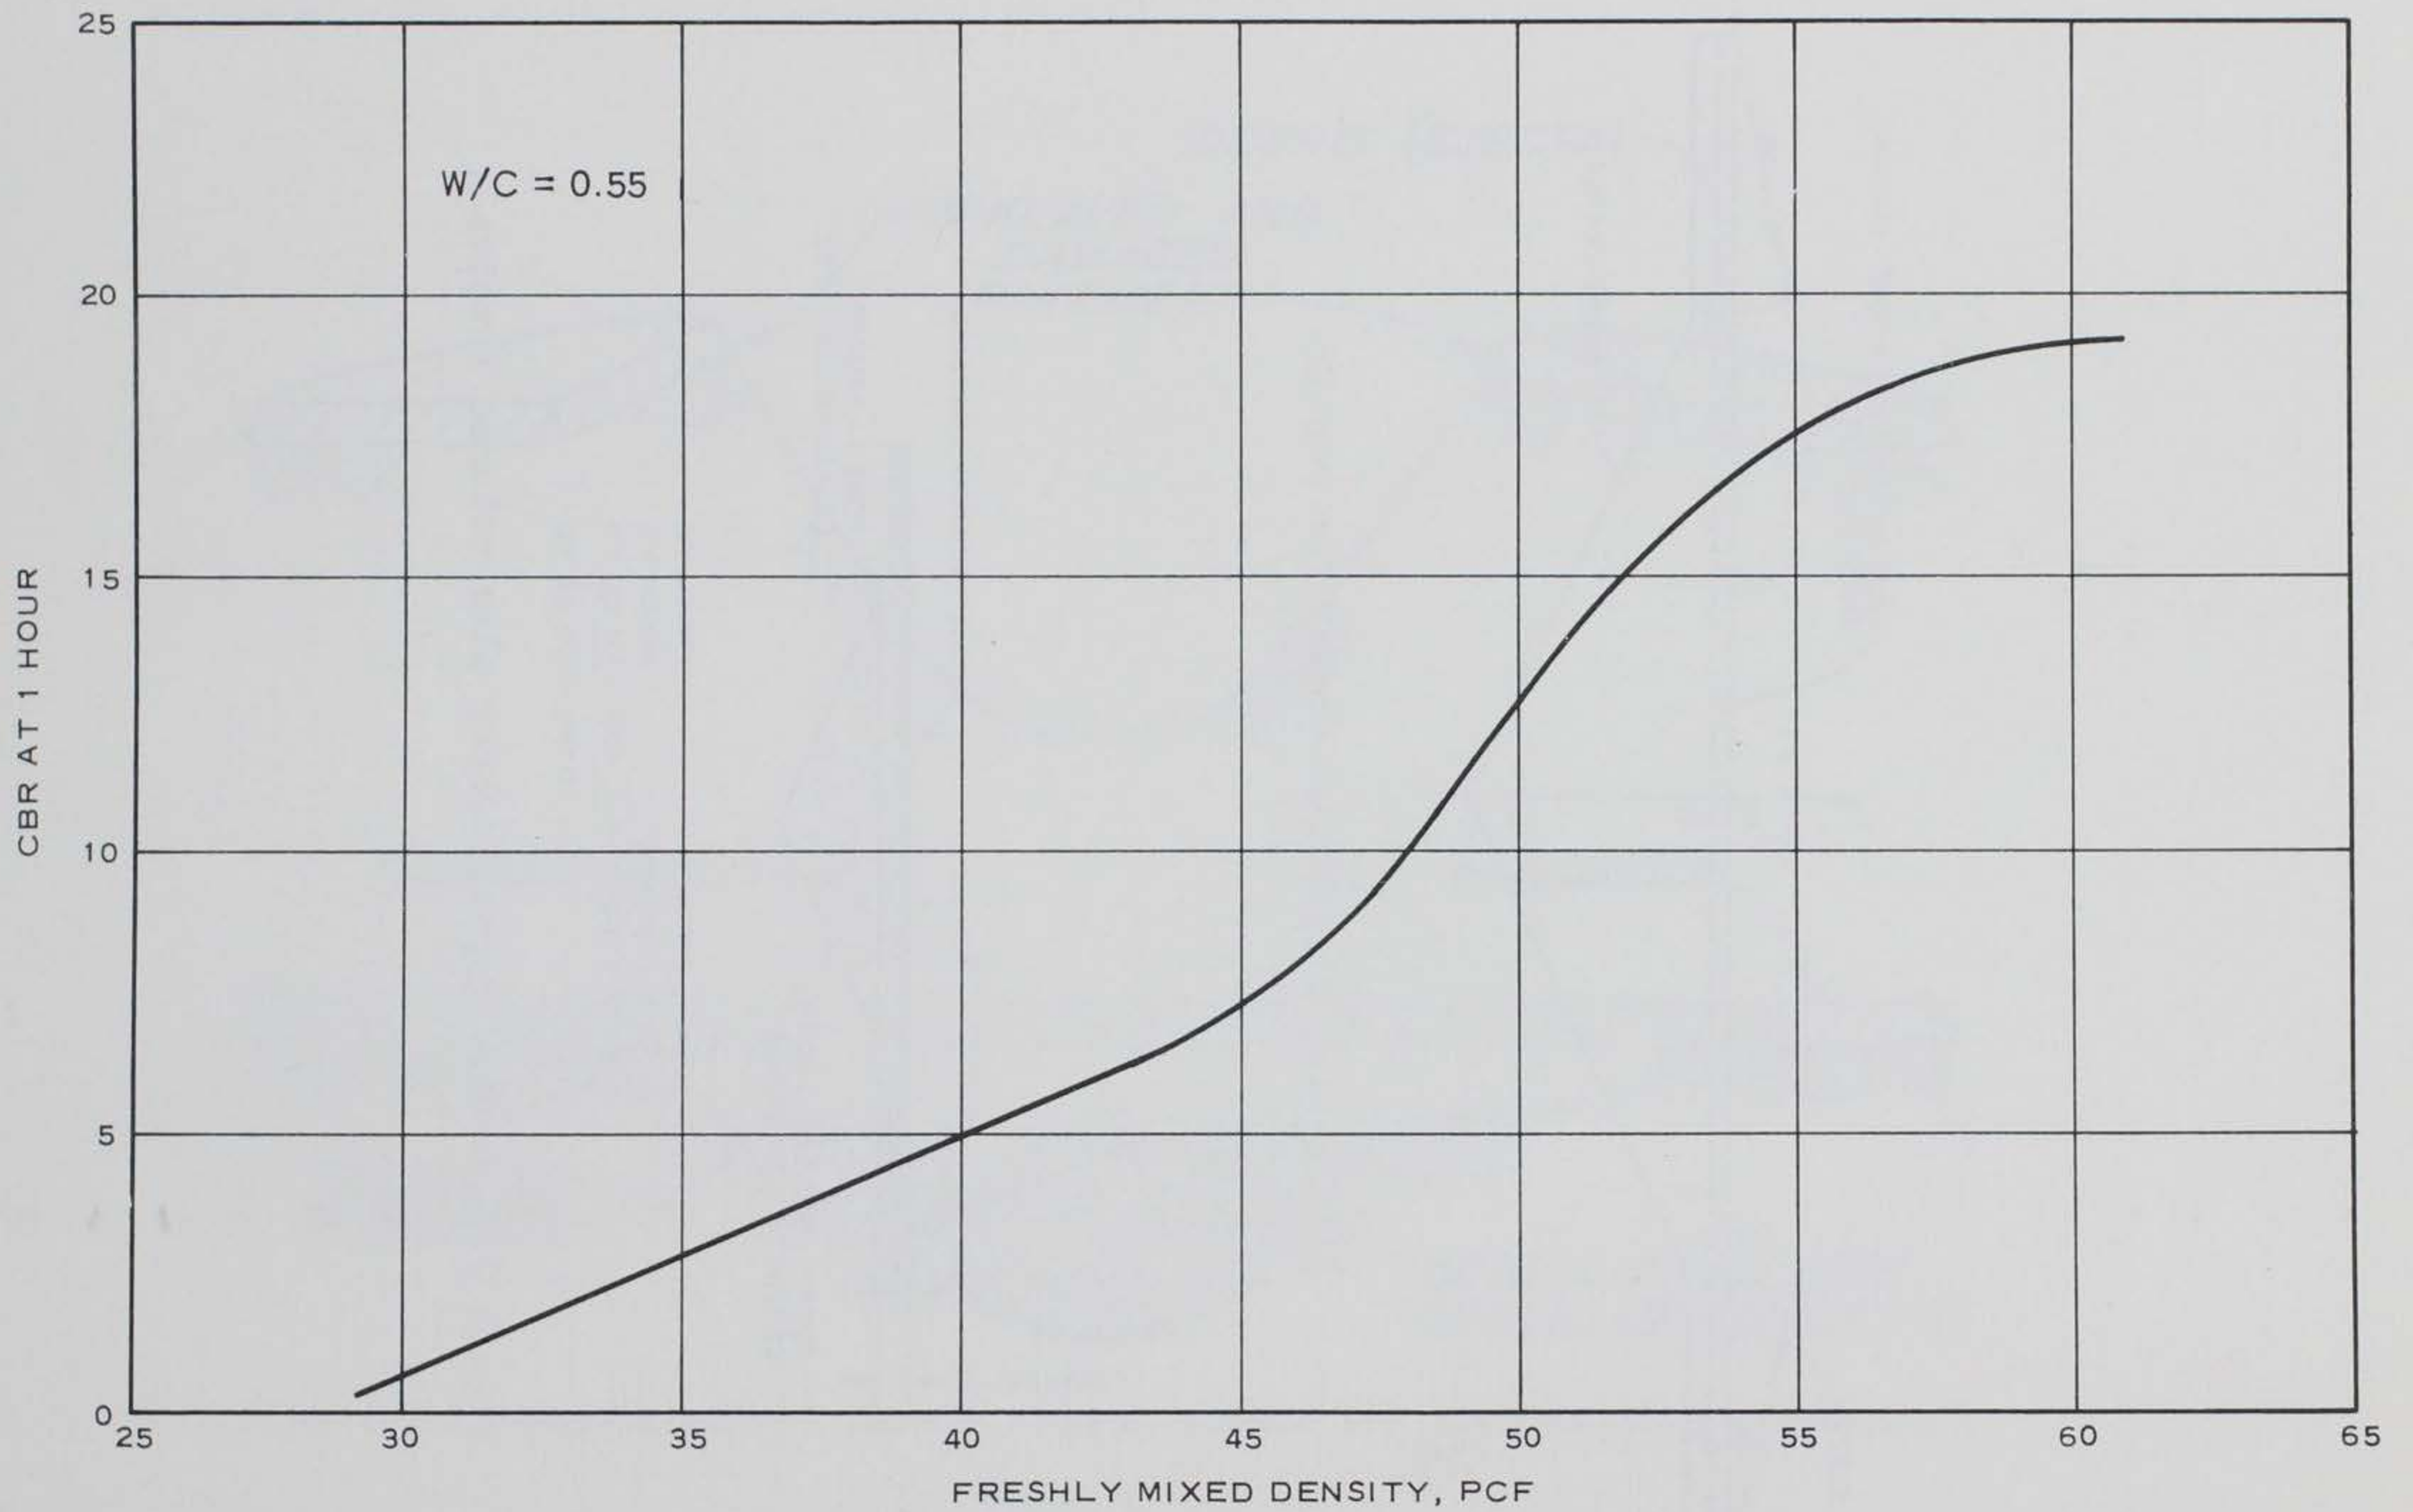
Figure 2.4 One-hour CBR value versus density for a neat cellular concrete.
