TECHNICAL REPORT C-75-2

A CONCEPT FOR RAPID REPAIR OF BOMB-DAMAGED RUNWAYS USING REGULATED-SET CEMENT

George C. Hoff

July 1975

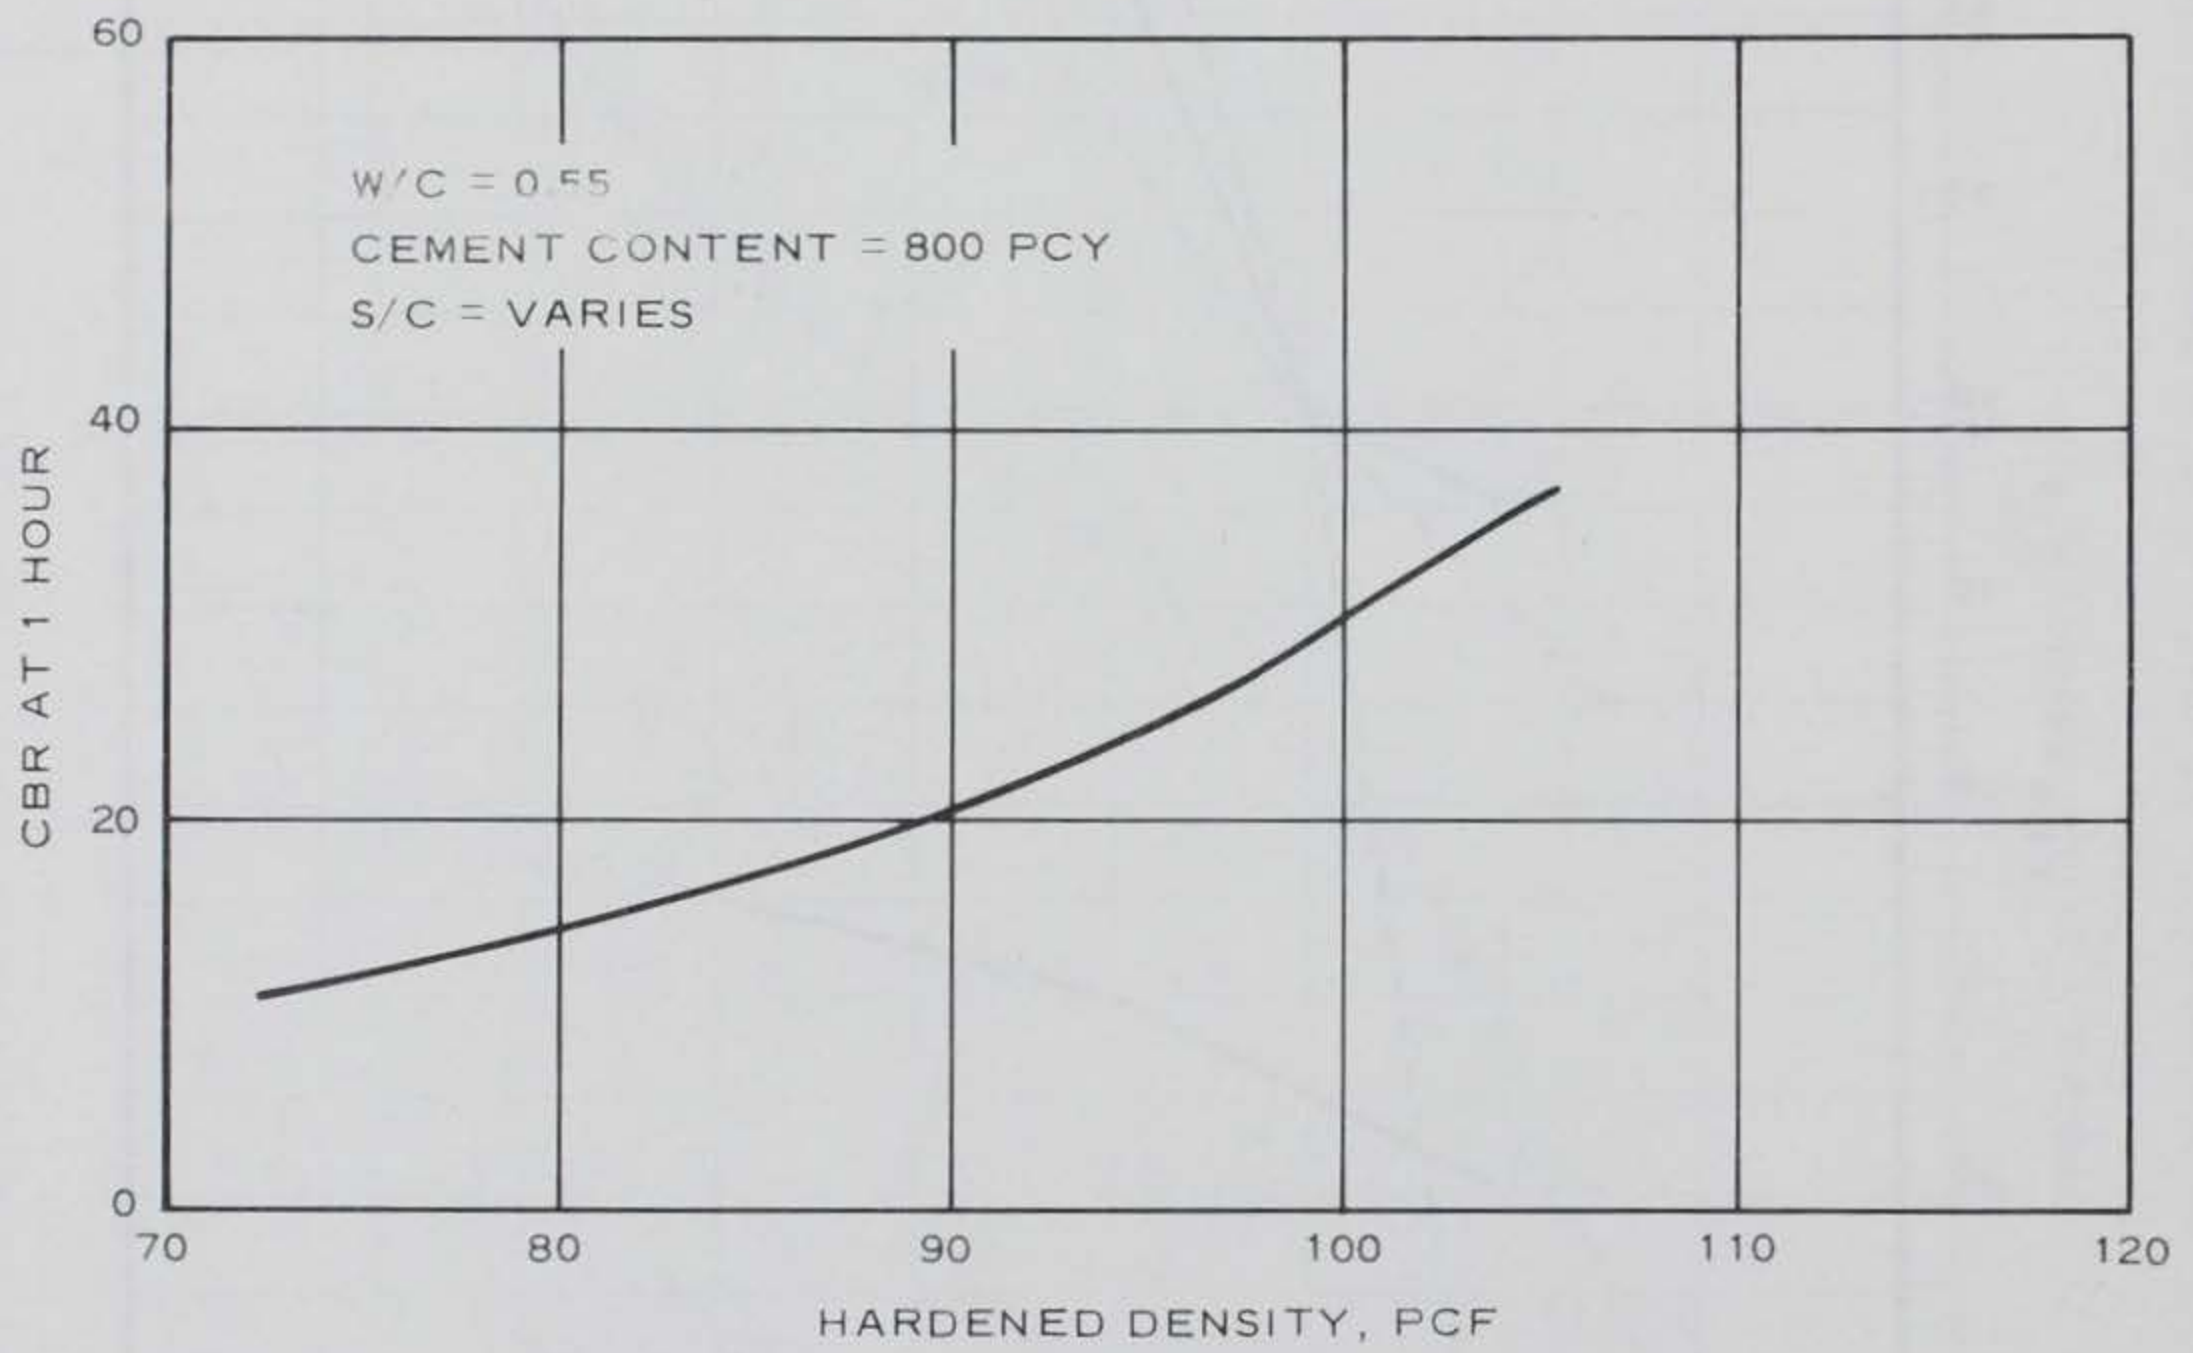
Figure 2.6 CBR at one hour versus density for sanded cellular concrete.

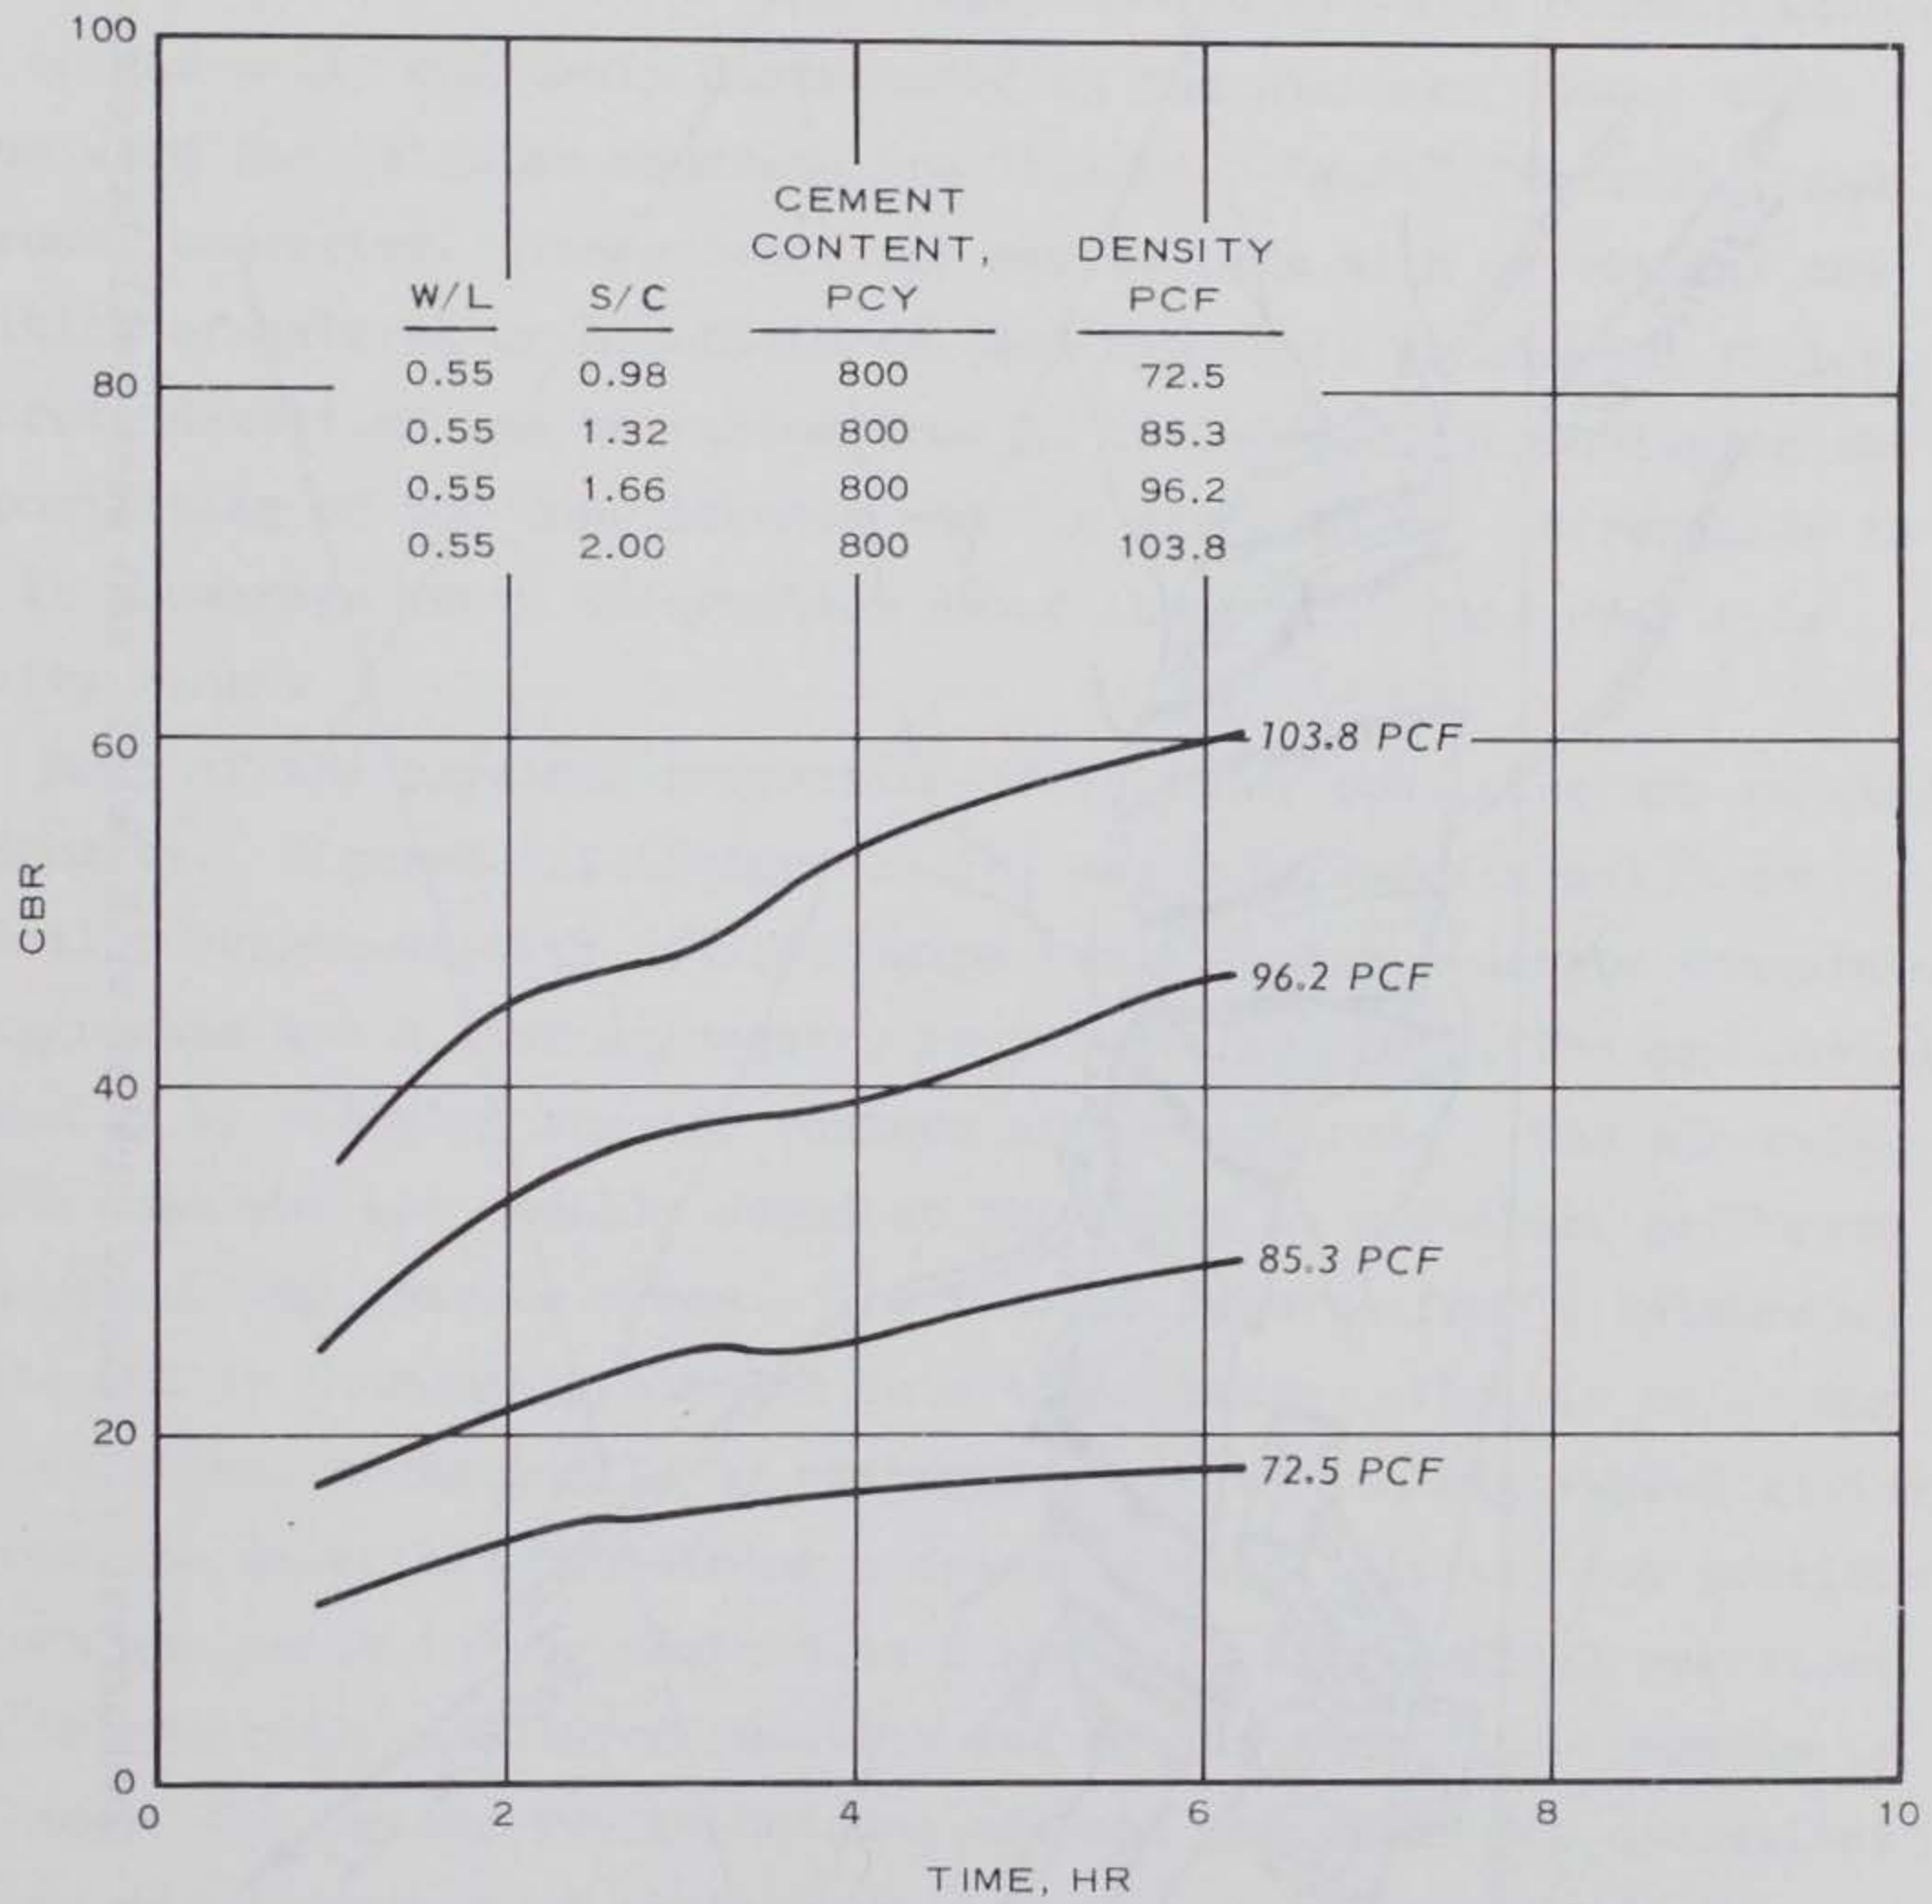
Figure 2.7 CBR versus time for sanded cellular concrete.

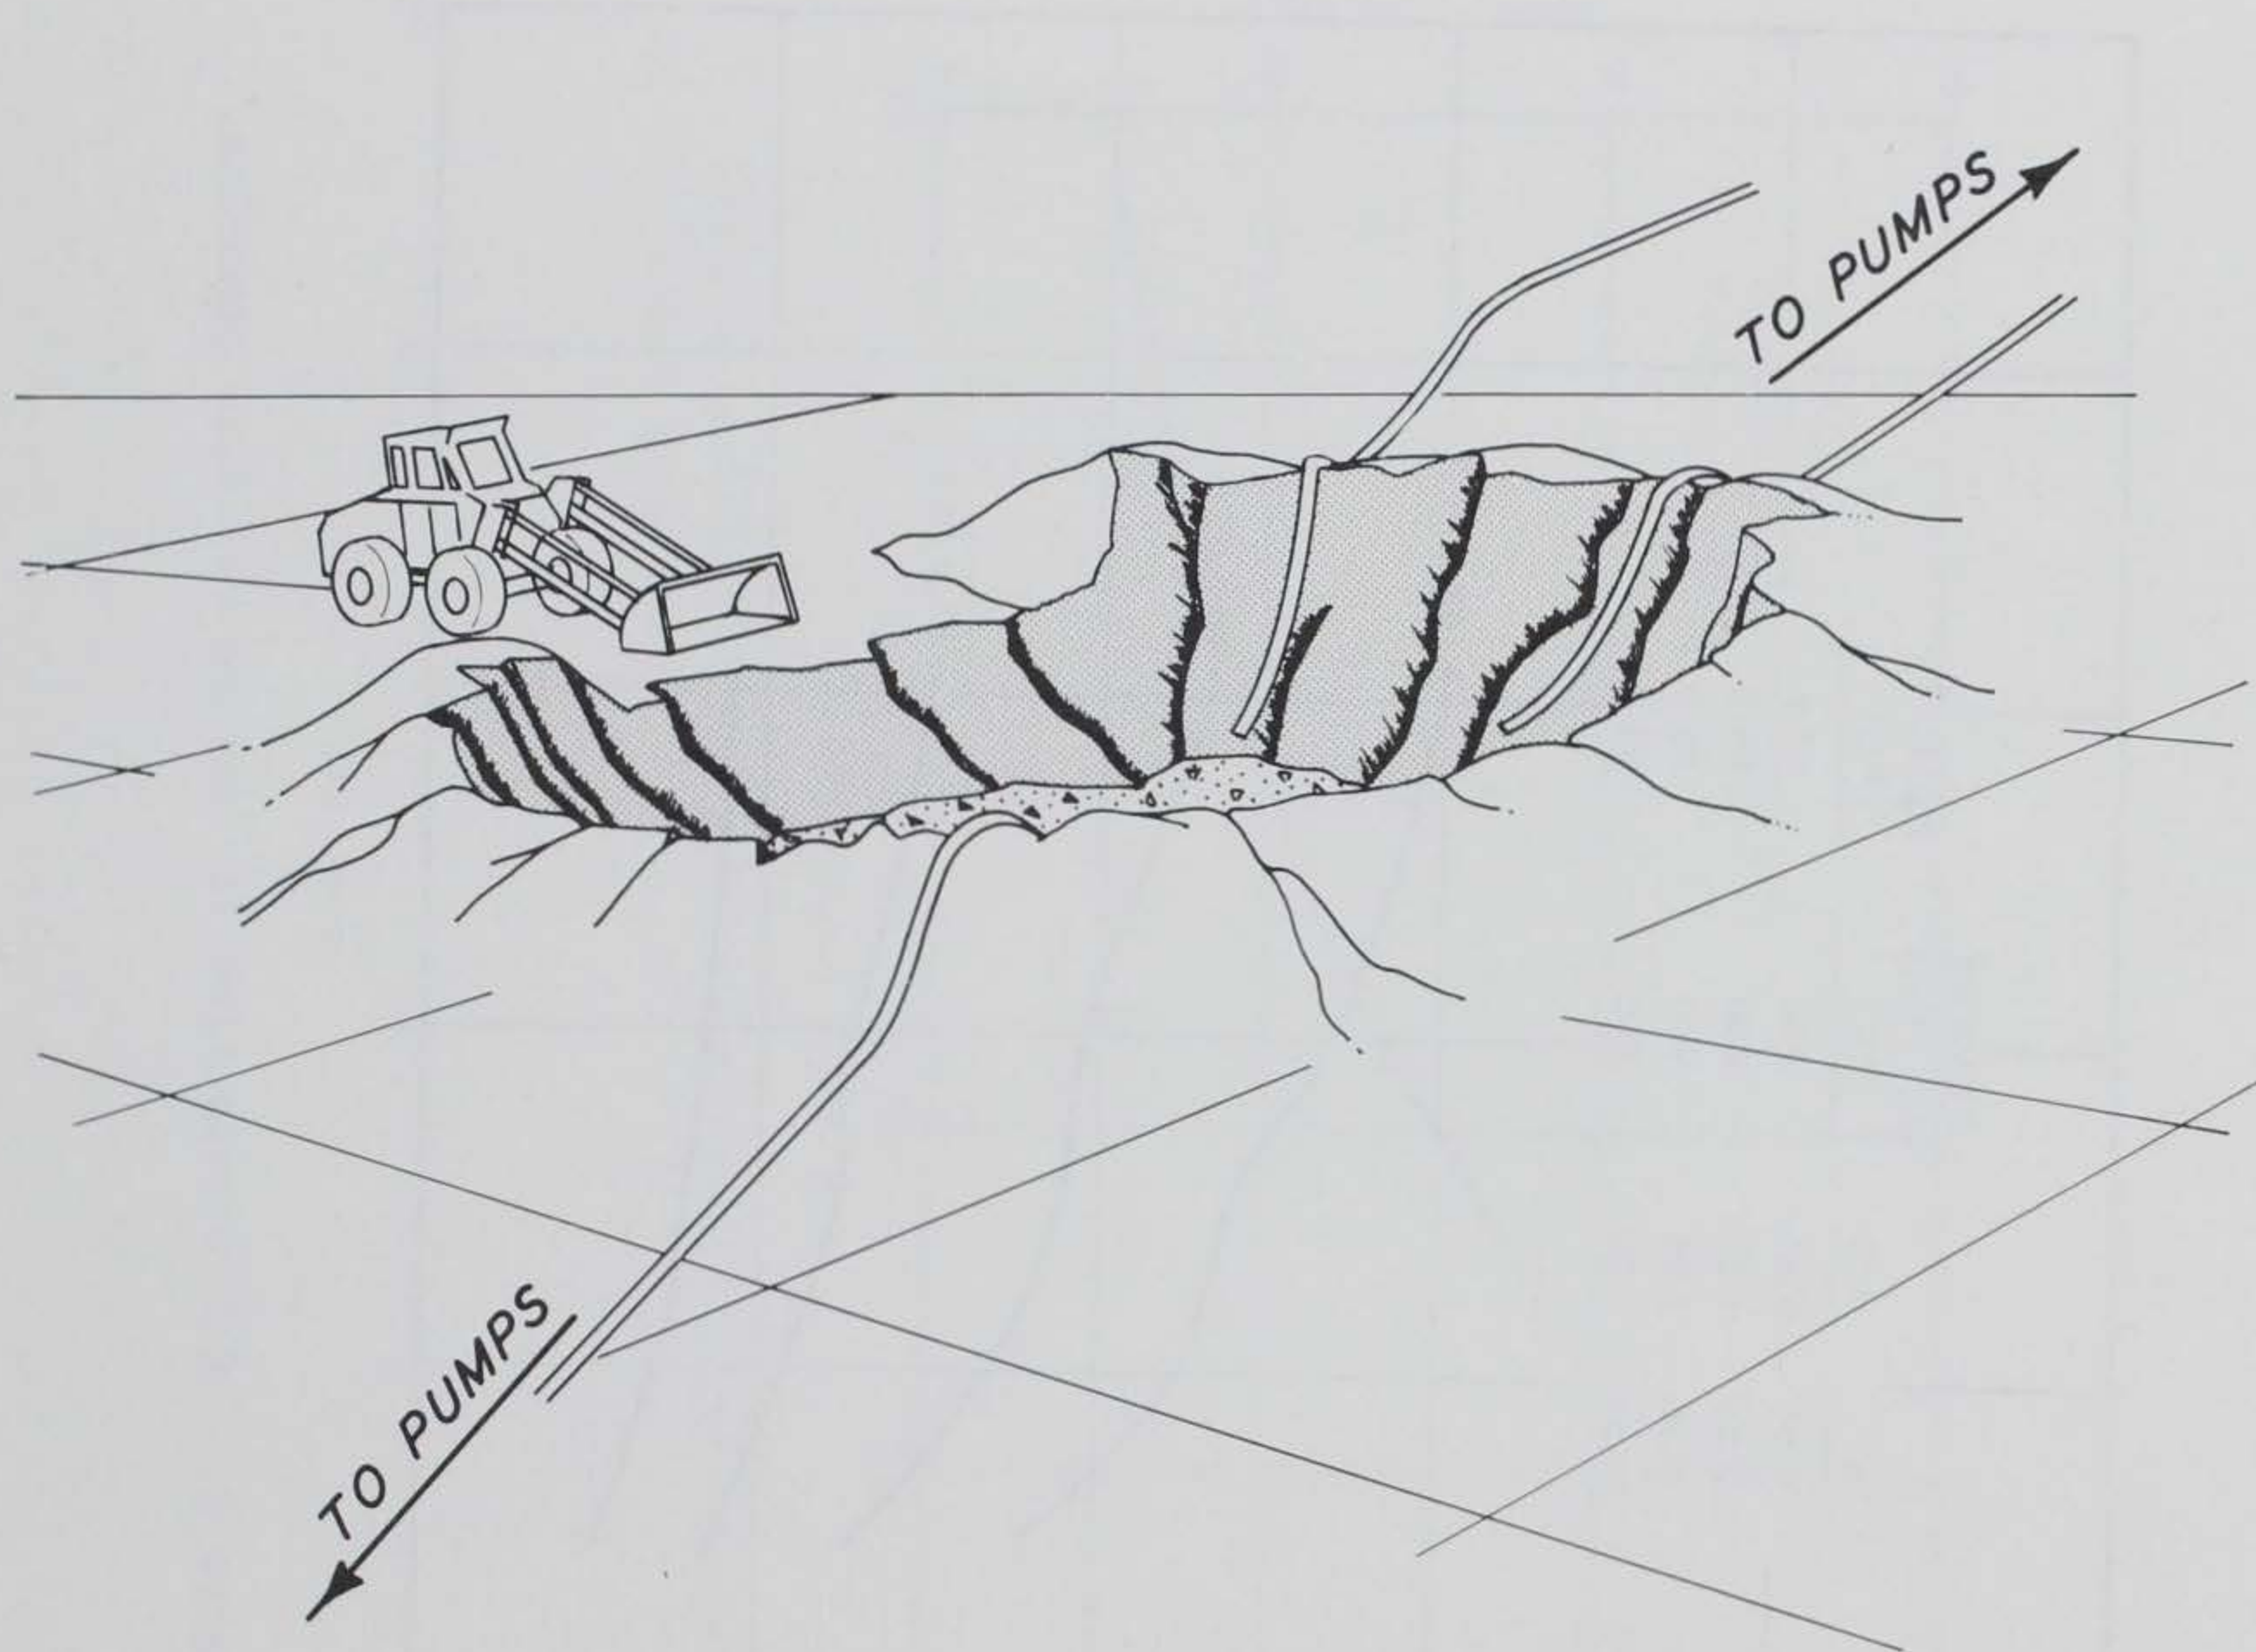
Figure 2.8 Concurrent filling of crater with debris and neat cellular concrete.

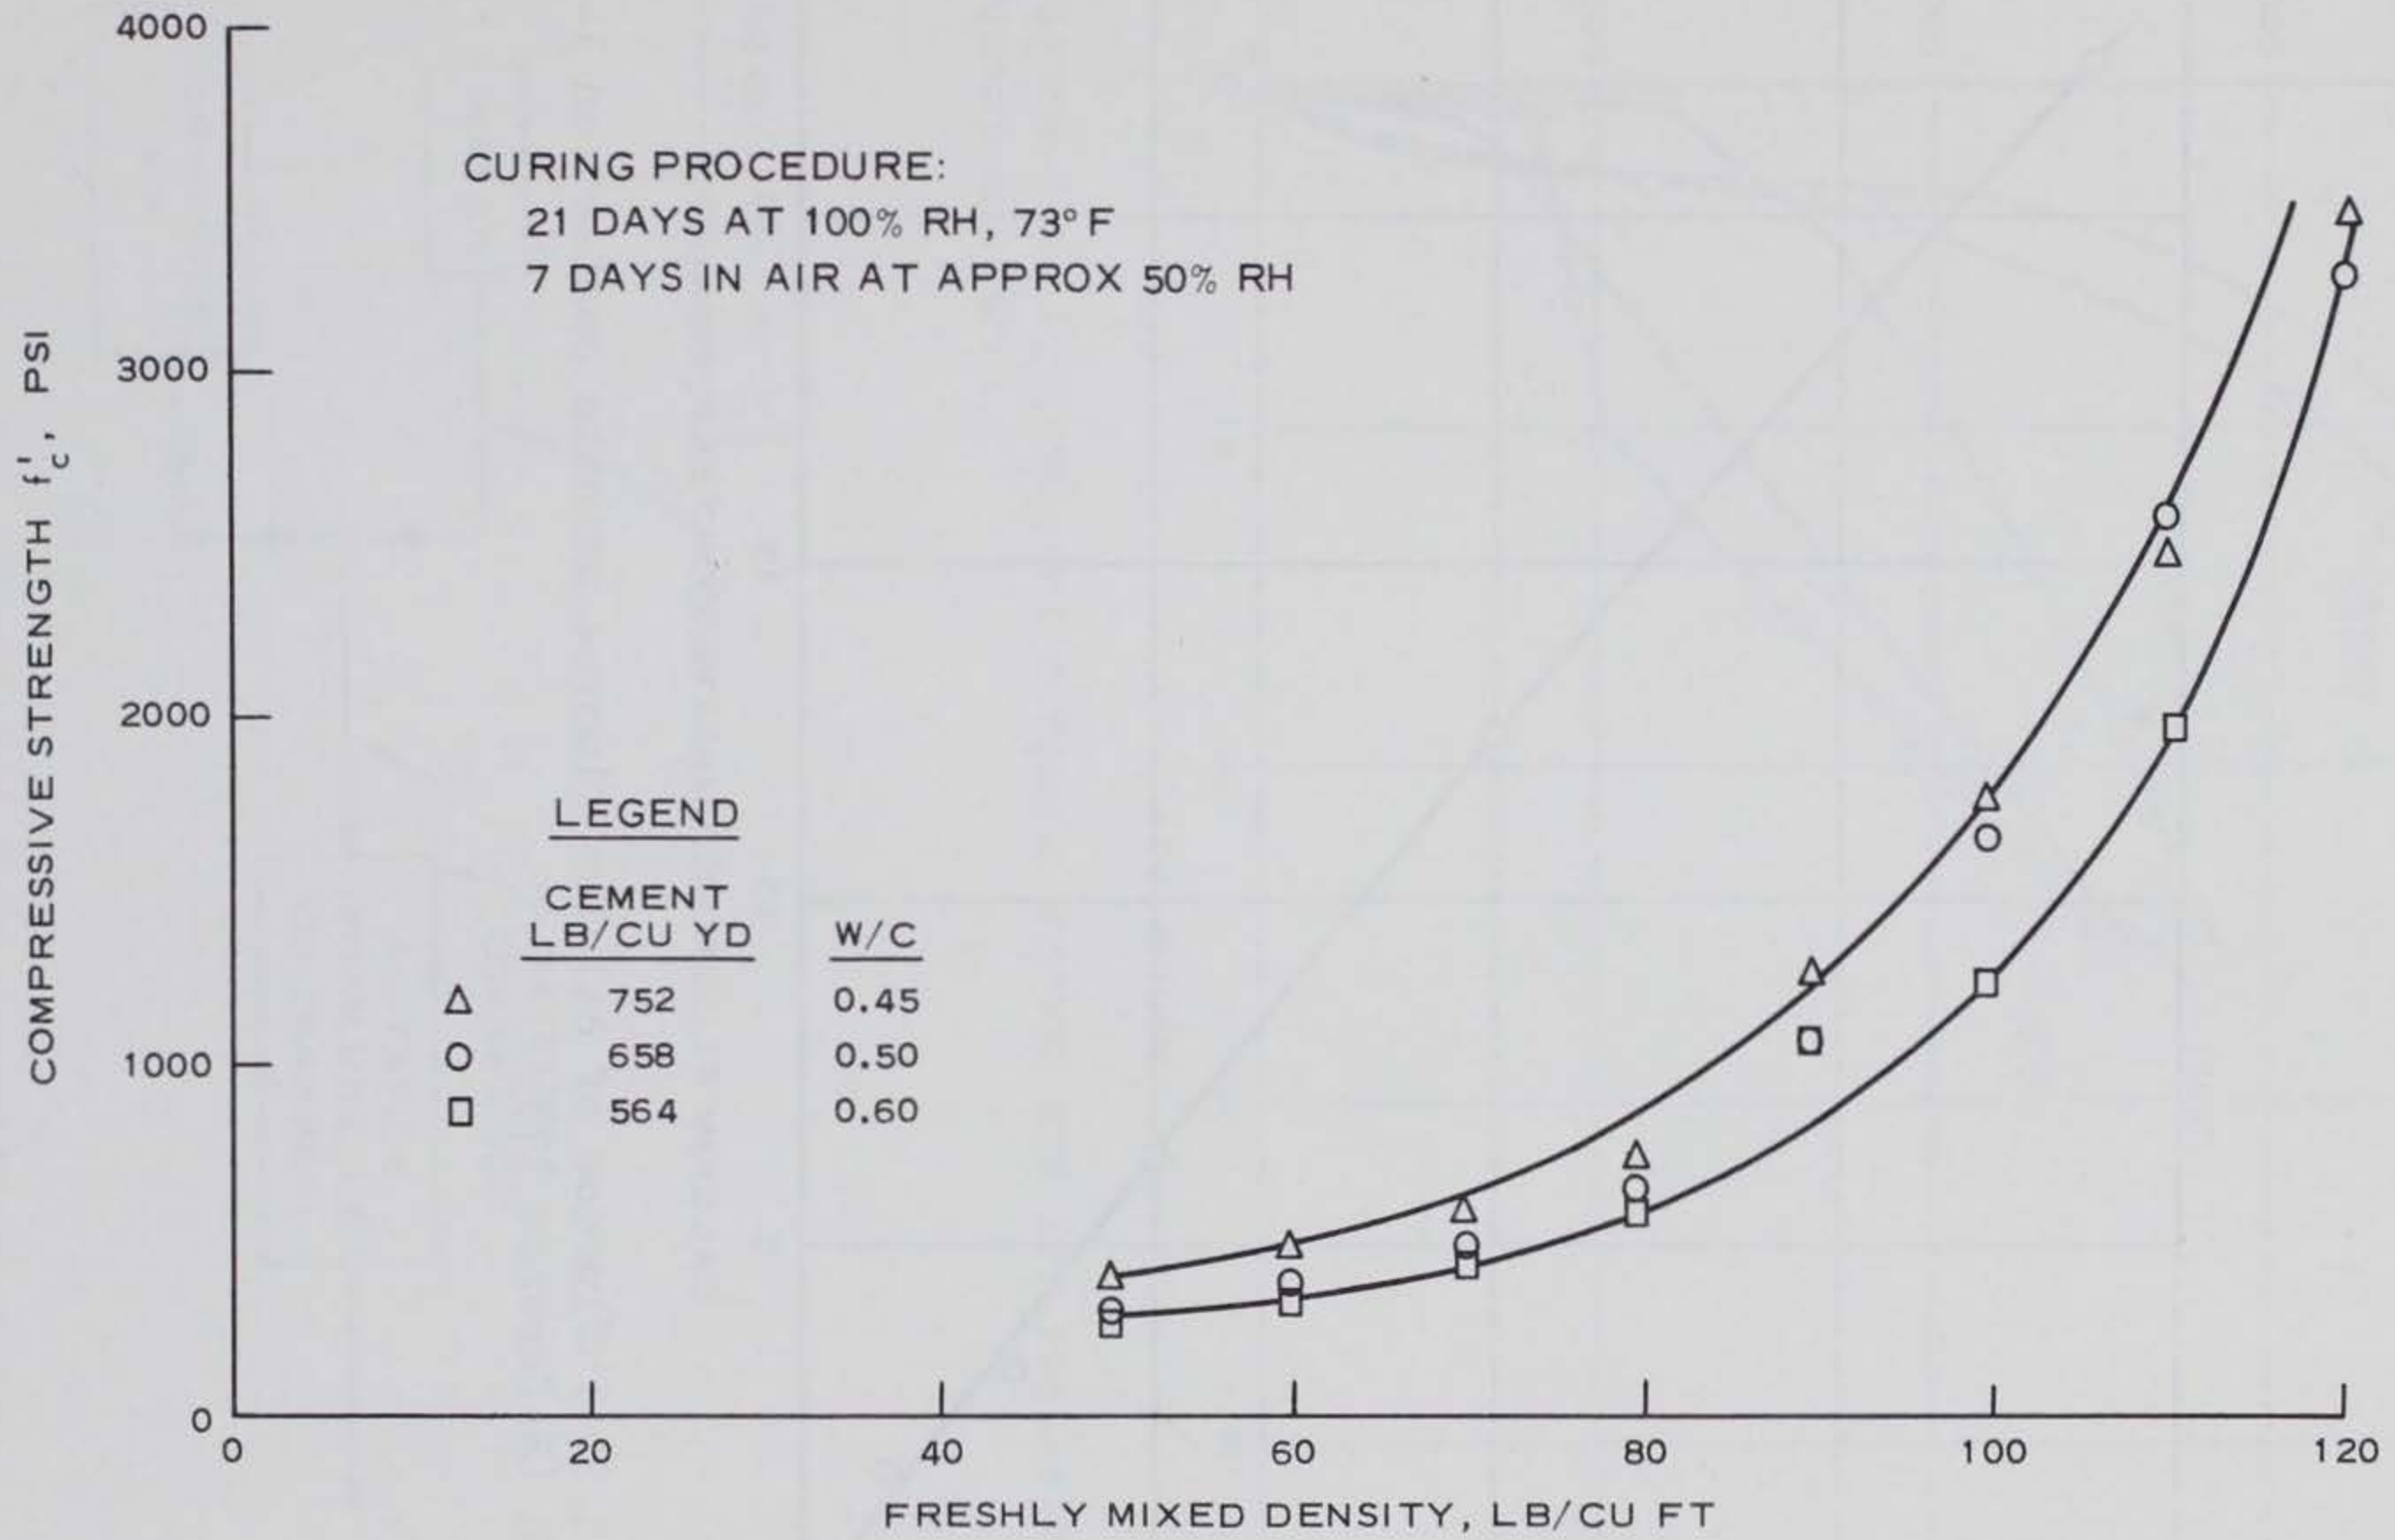
Figure 3.2 Strength versus density for sanded cellular concretes (Reference 13).

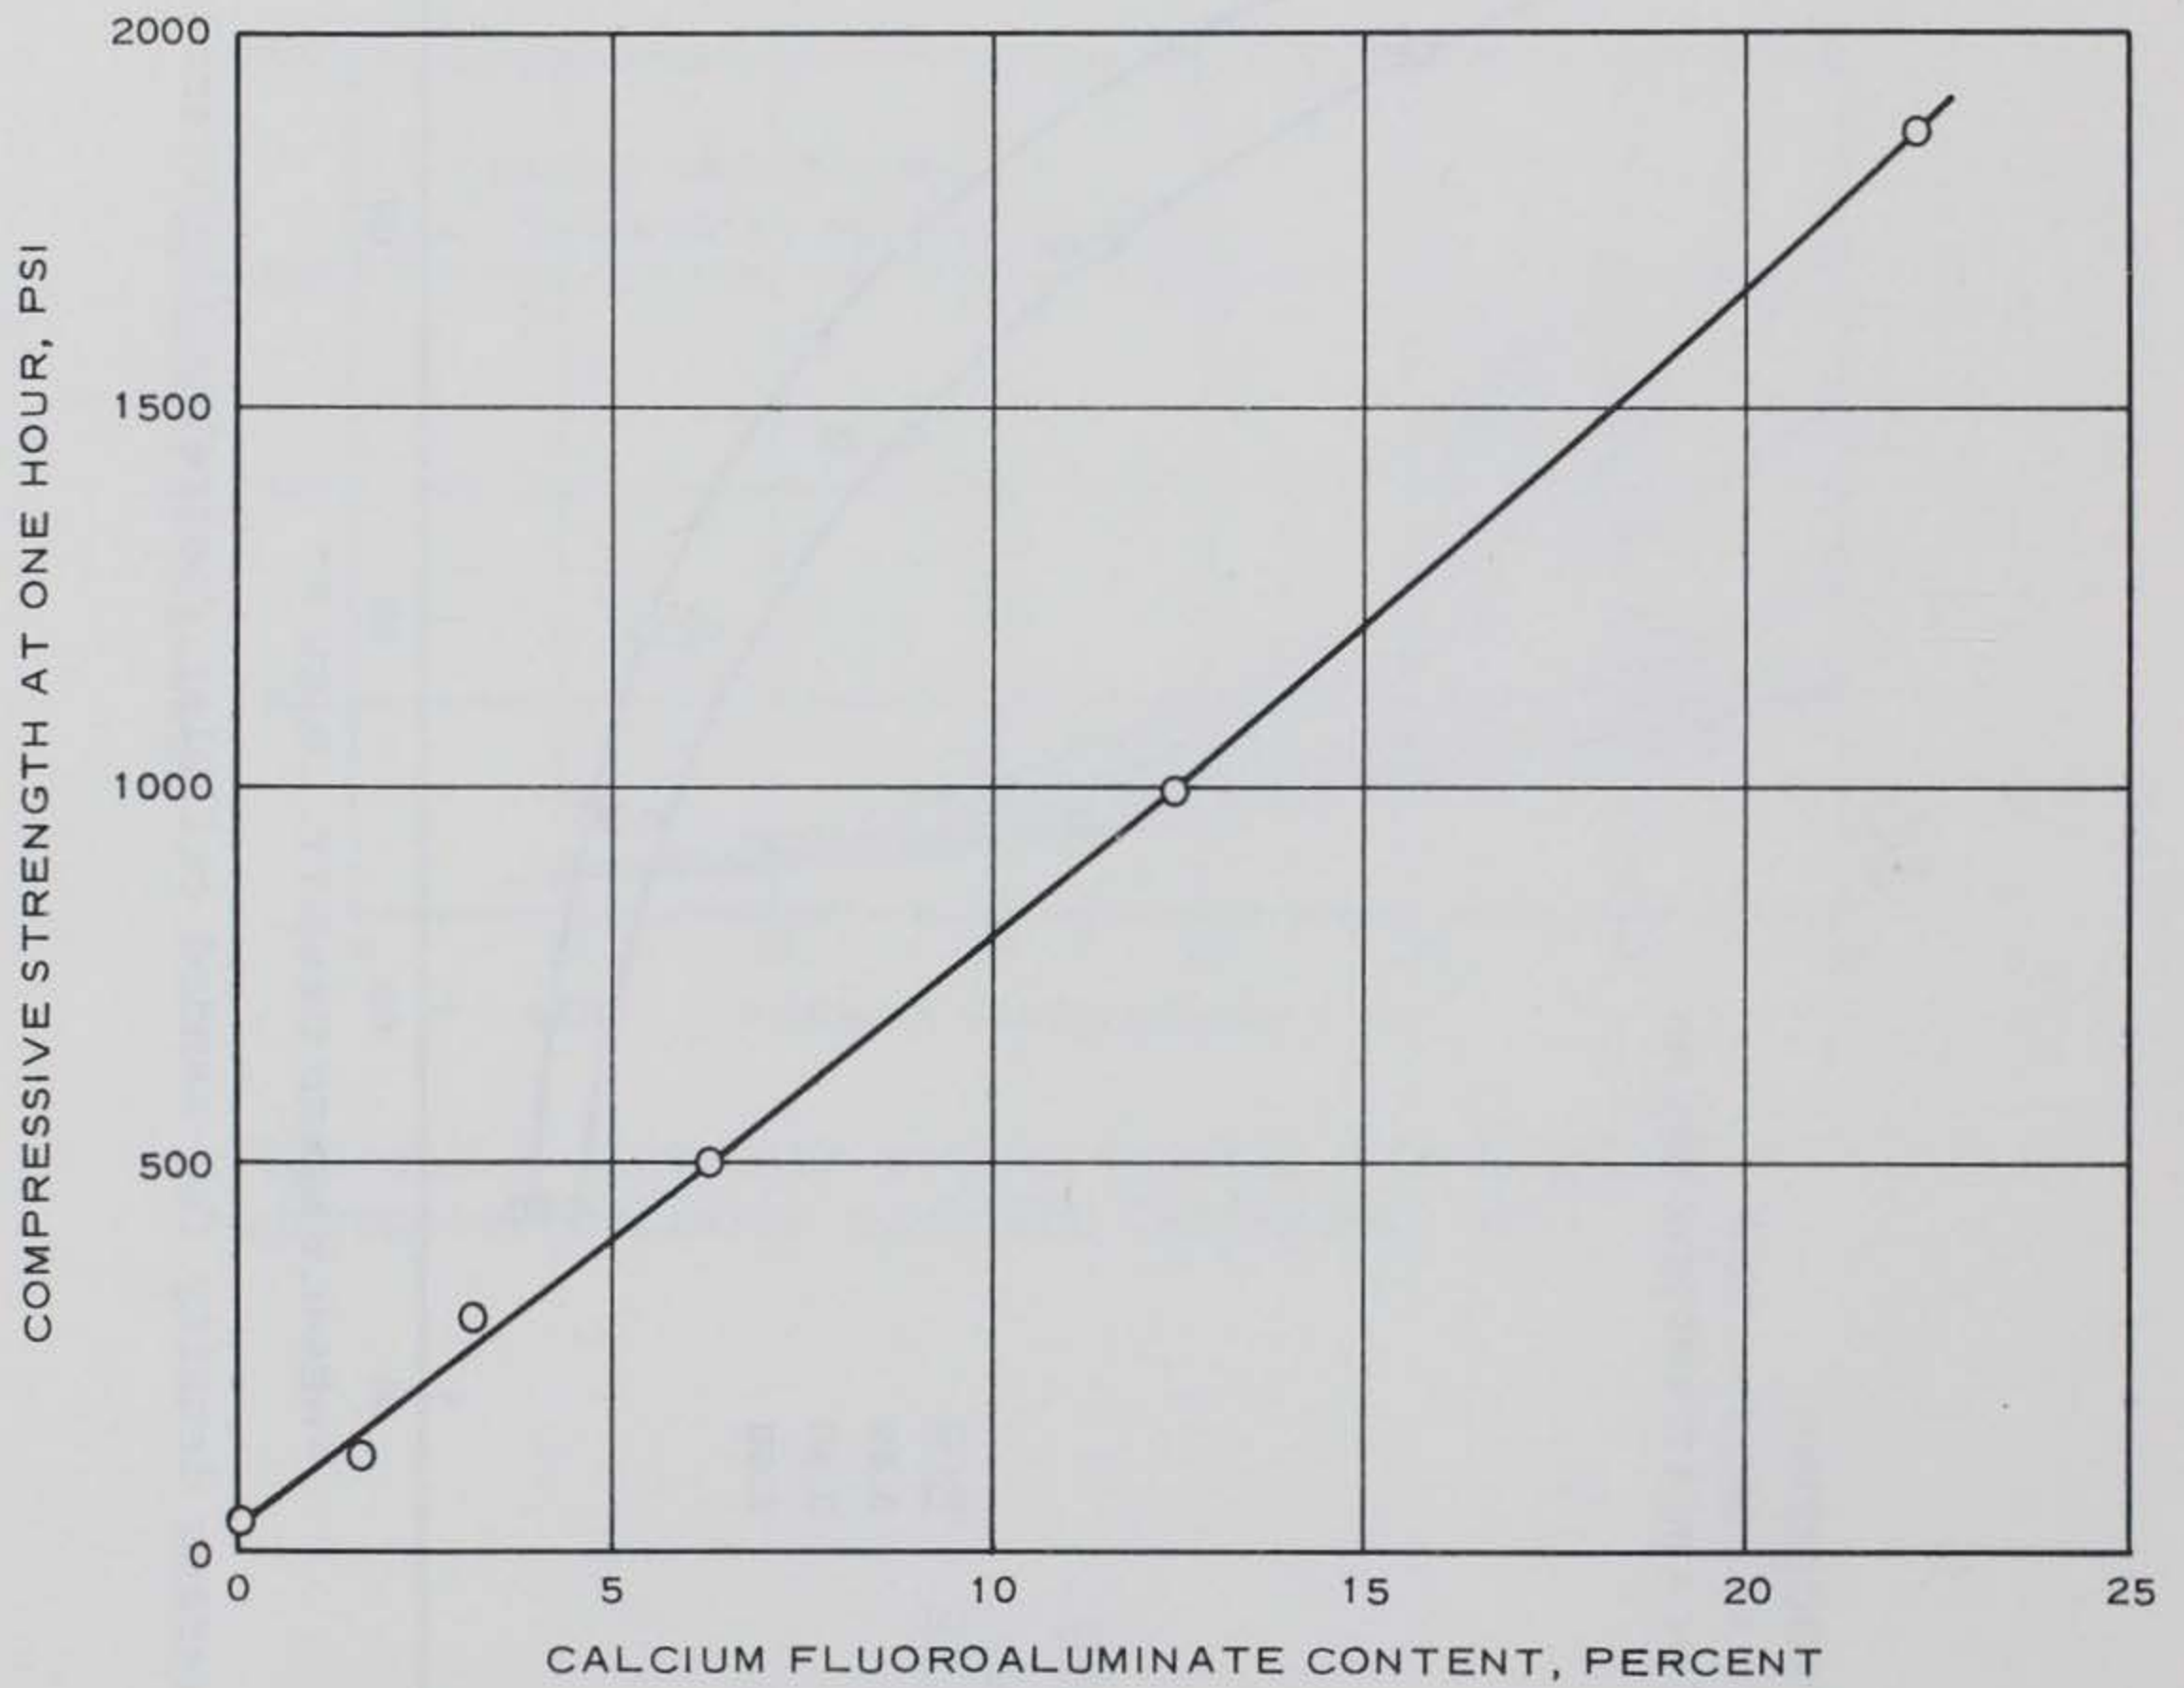
Figure 3.3 Influence of calcium fluoroaluminate content on 1-hour strength (Reference 17).

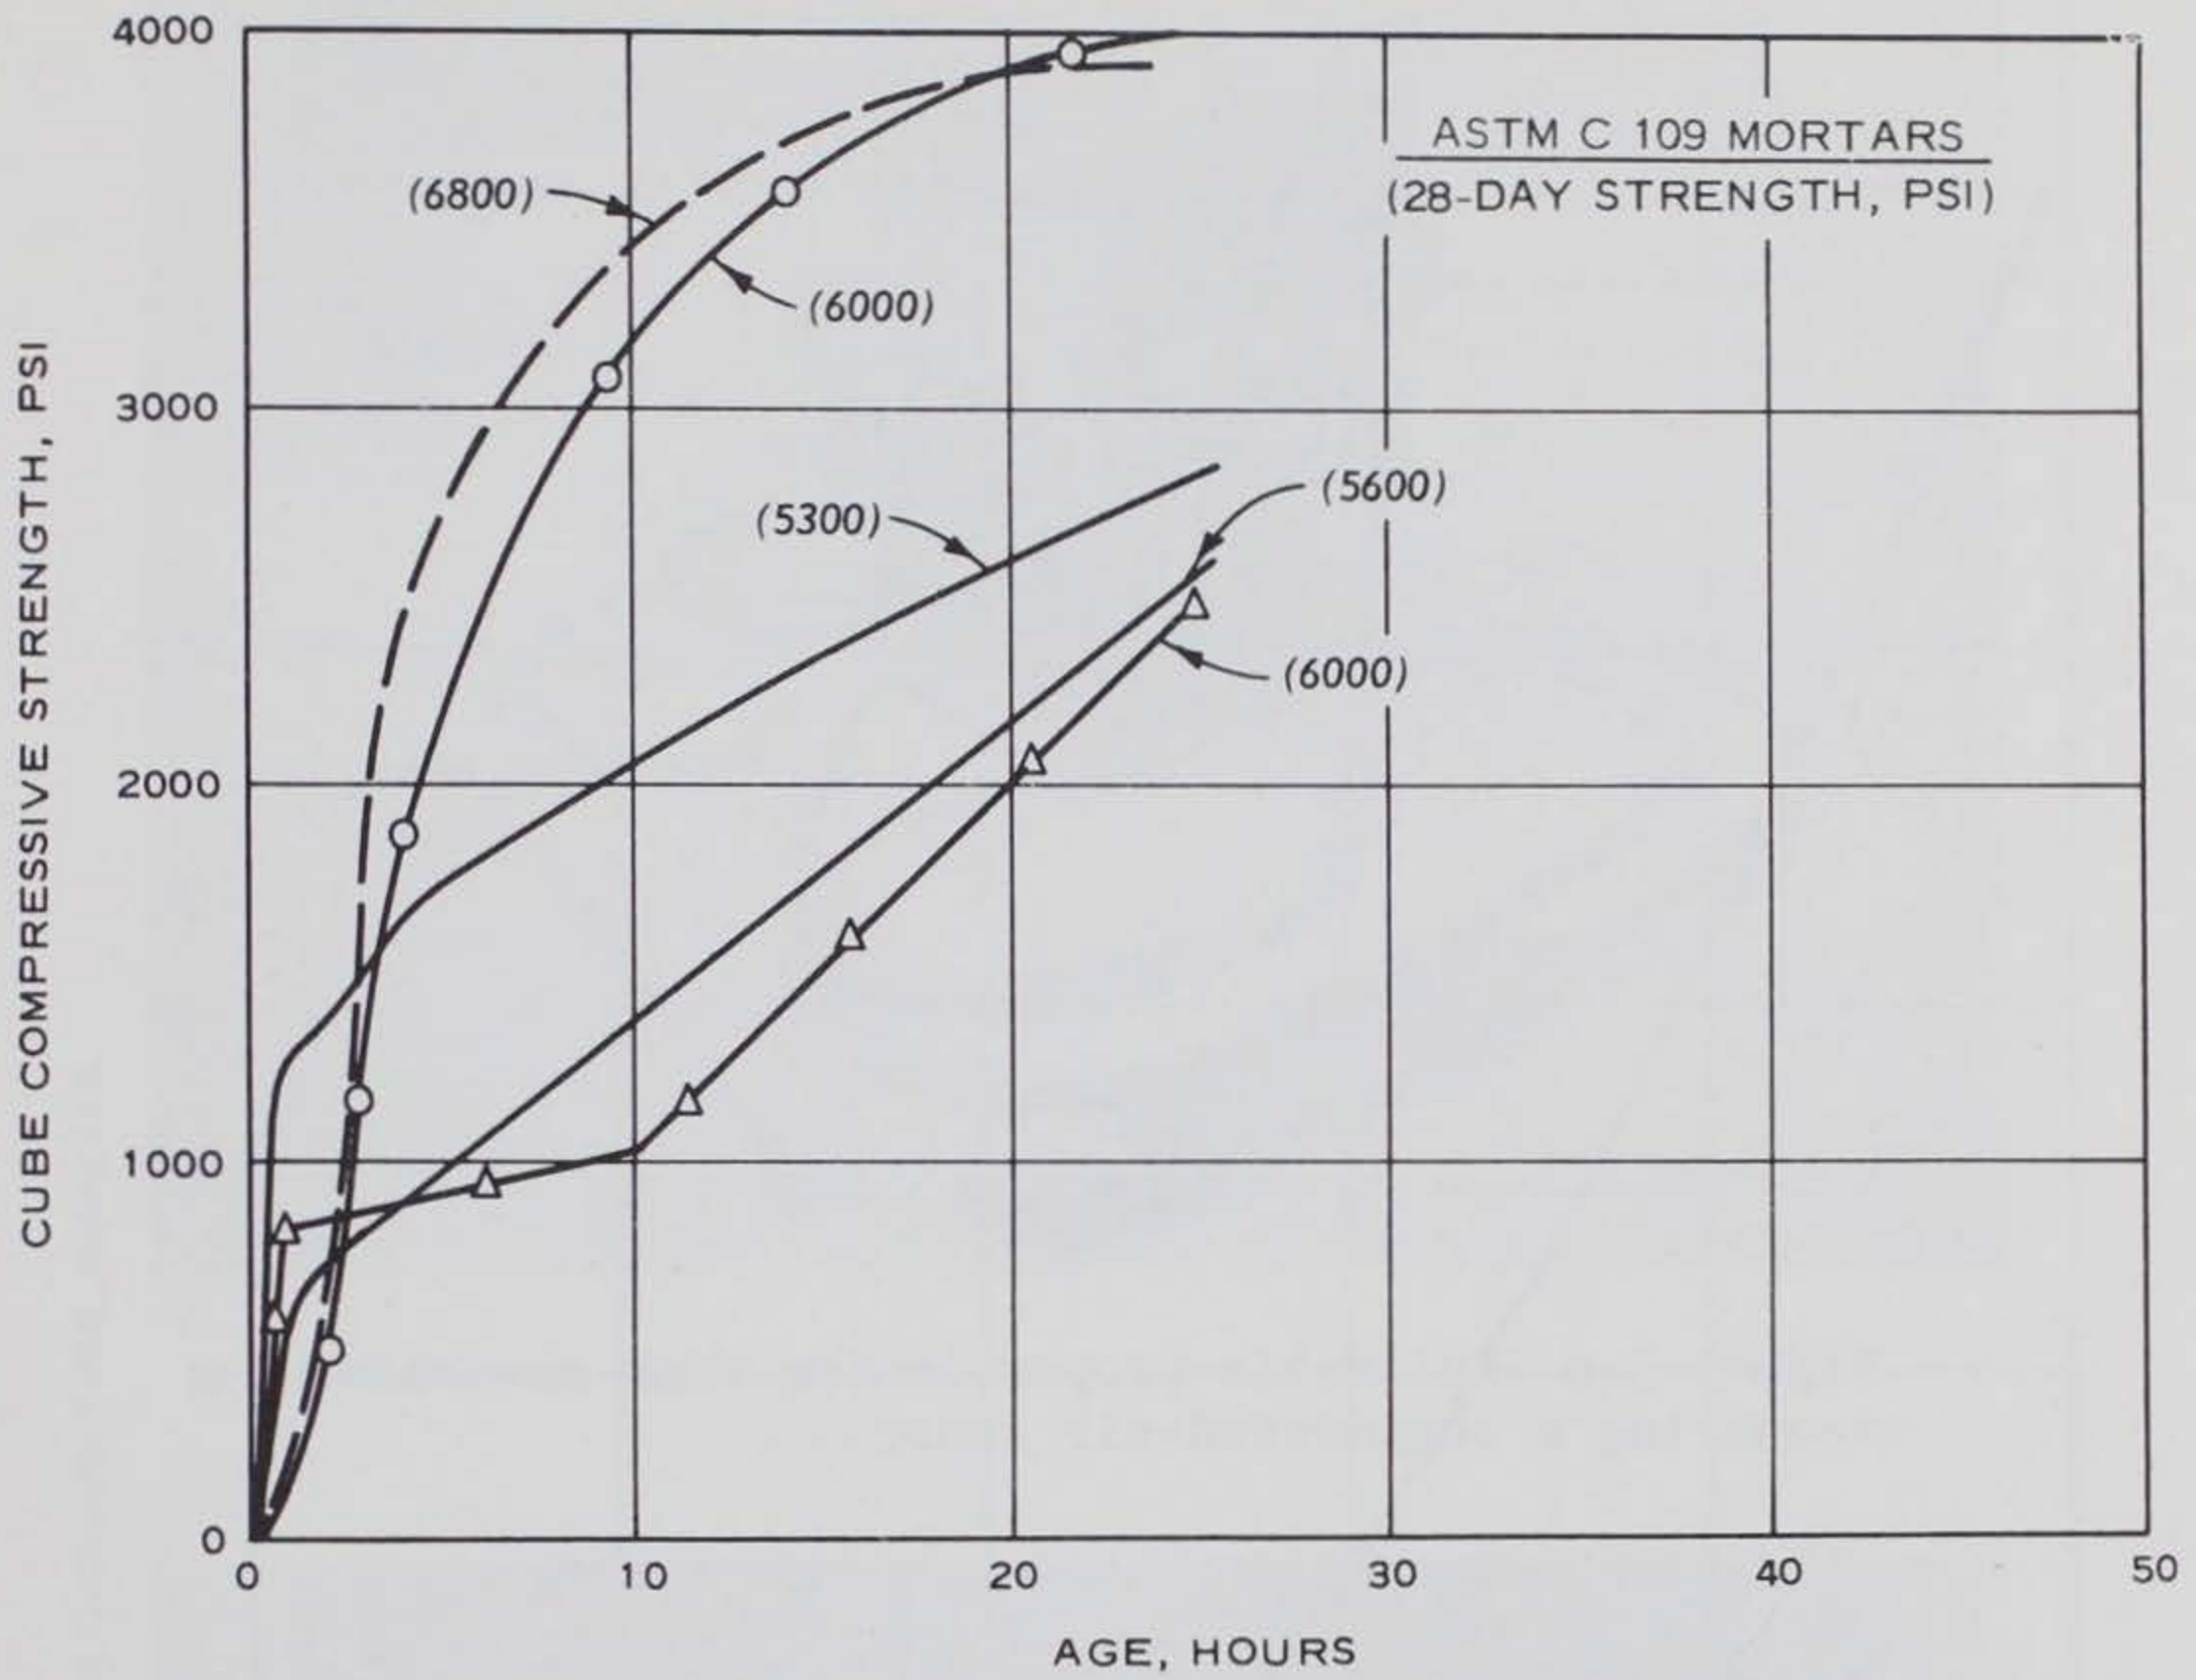
Figure 3.4 Compressive strength versus age for regulated-set cement mortars.
