TECHNICAL REPORT C-75-2

A CONCEPT FOR RAPID REPAIR OF BOMB-DAMAGED RUNWAYS USING REGULATED-SET CEMENT

George C. Hoff

July 1975

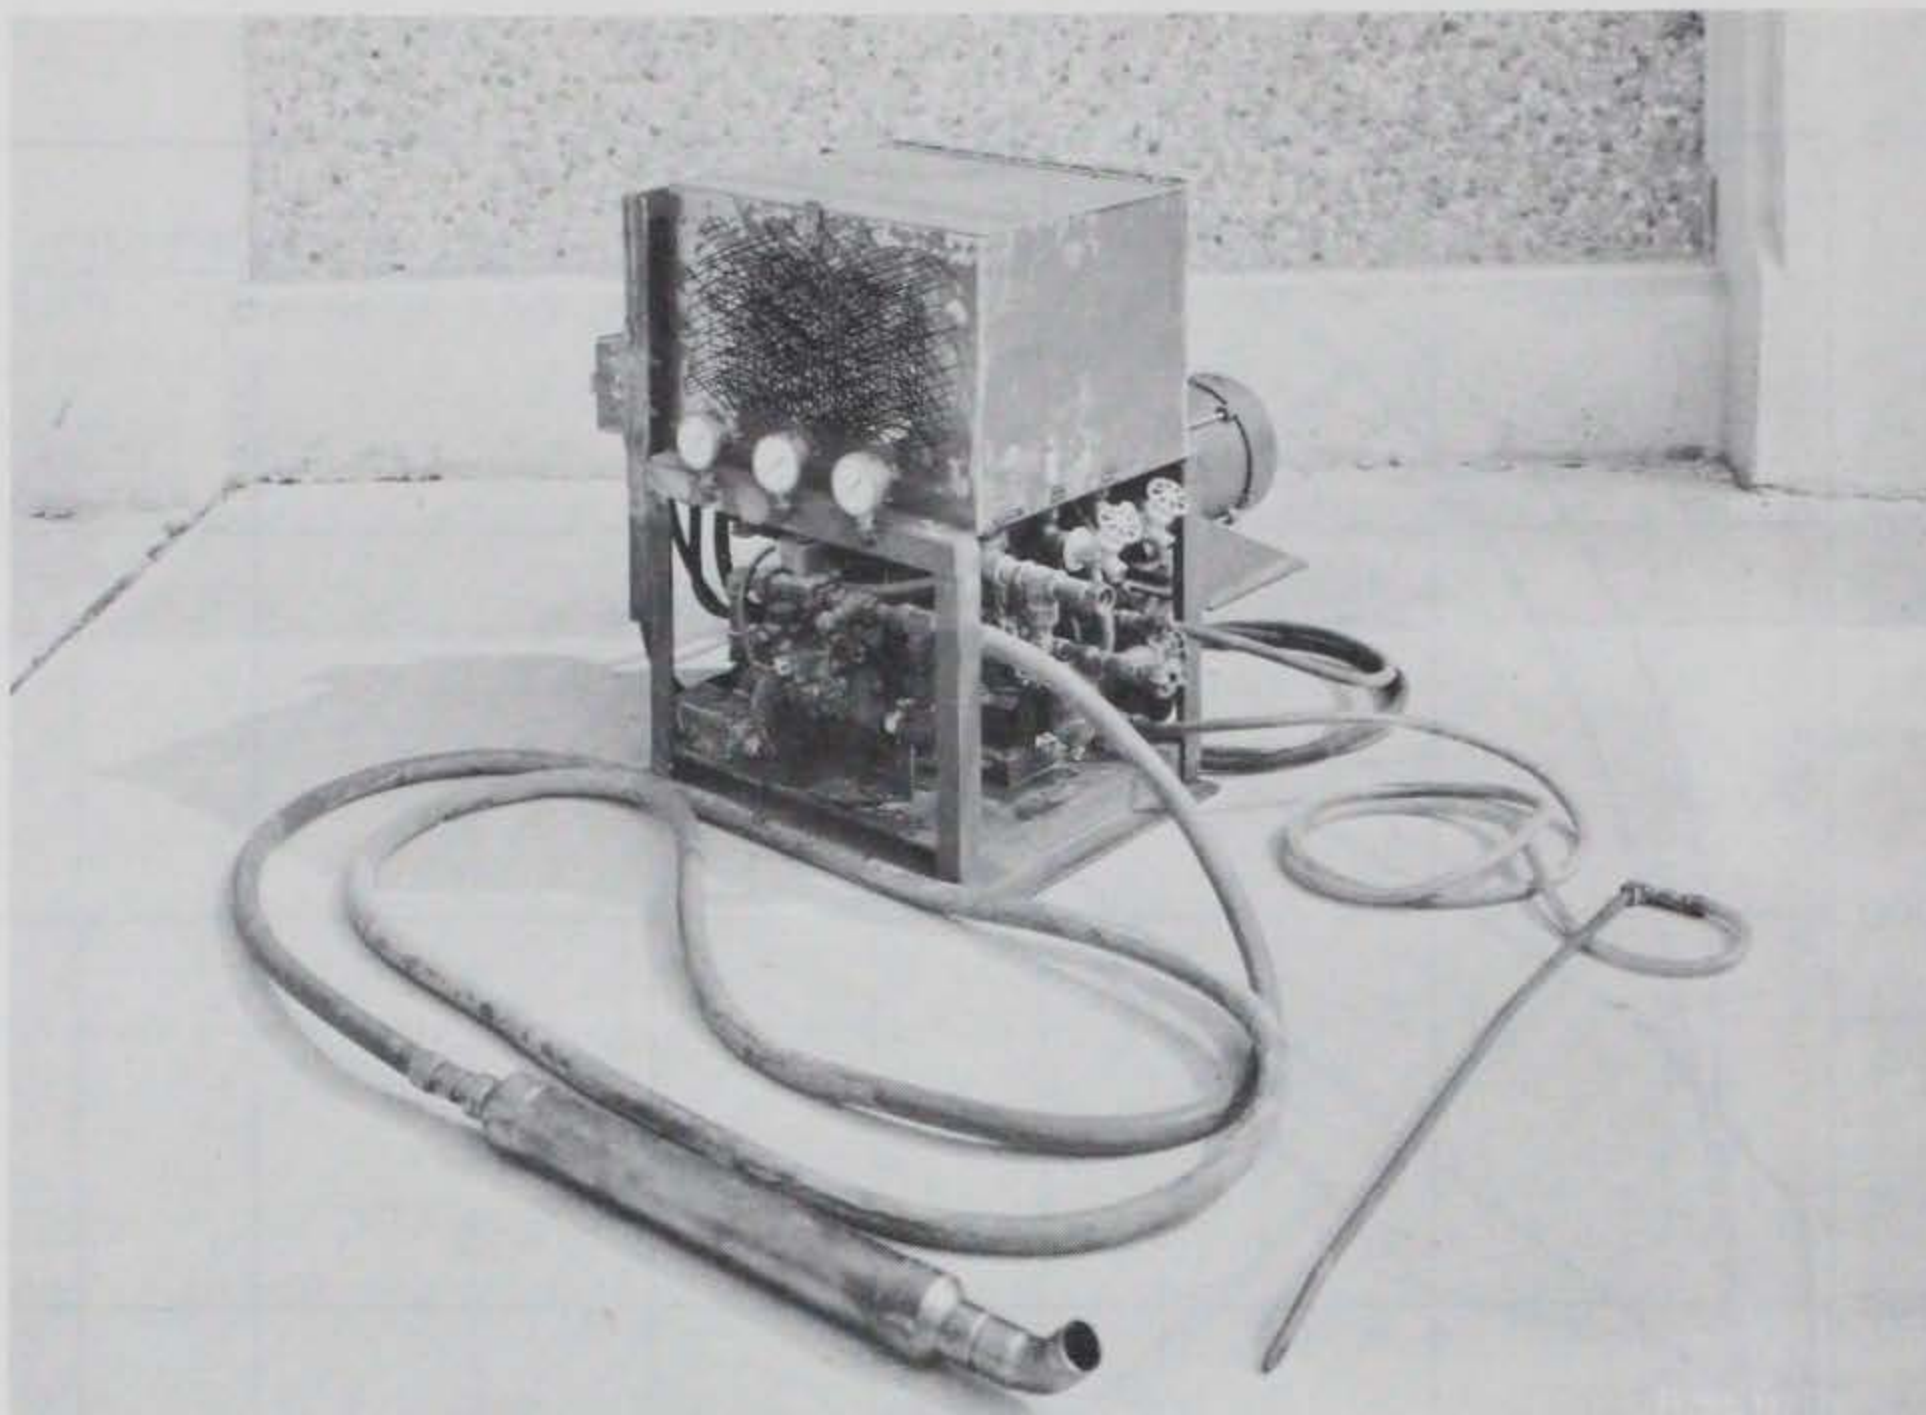
Figure 3.6 Automatic proportioning foam generator requiring a compressed-air source.

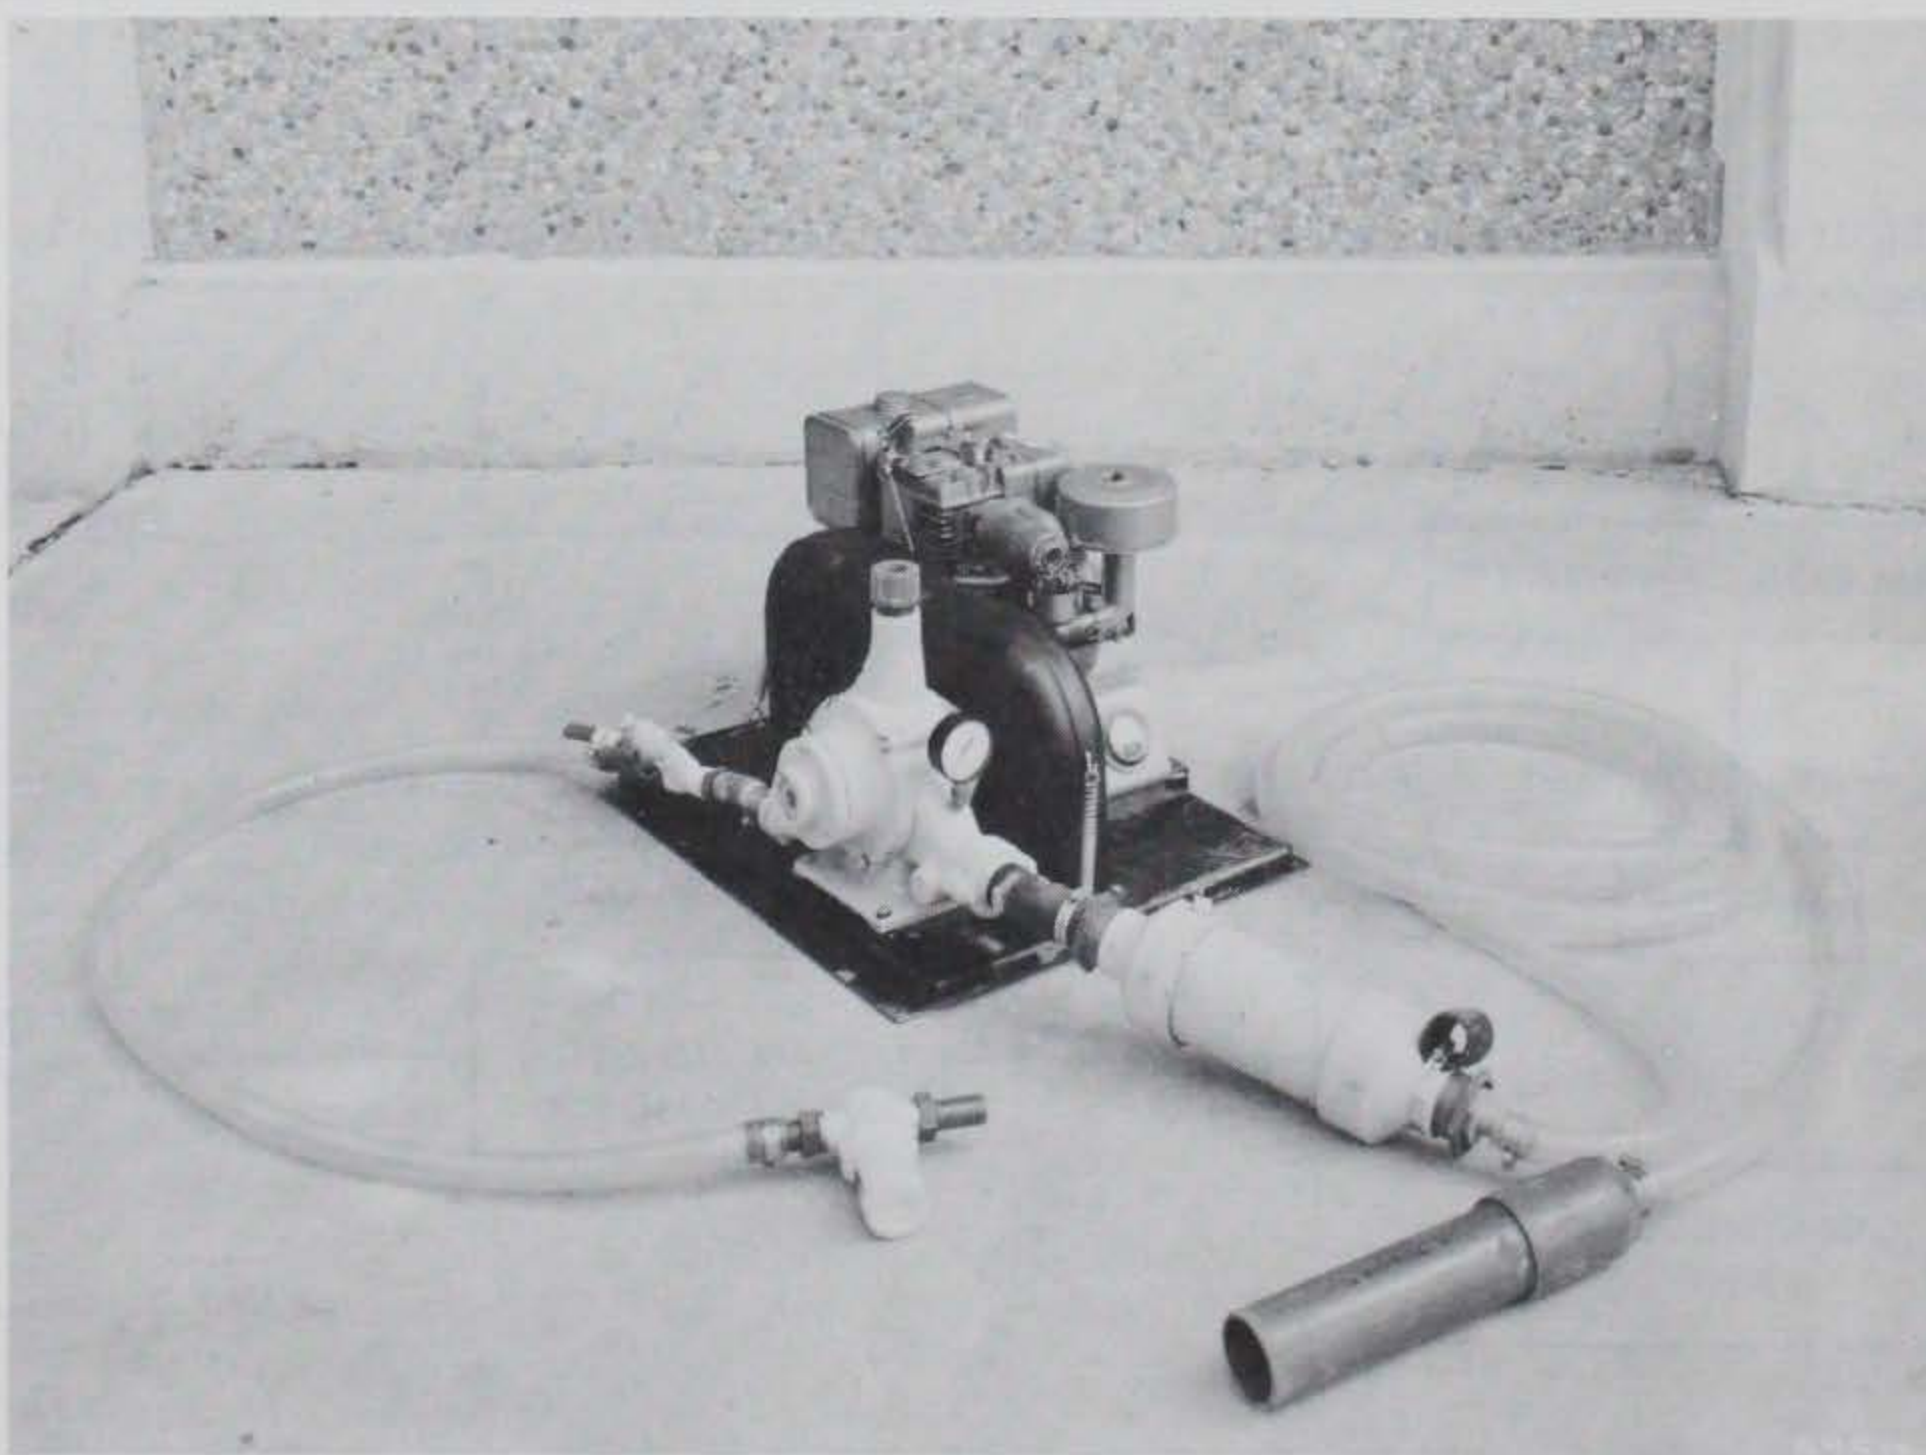
Figure 3.7 Foam generator requiring an auxiliary proportioning tank but no air source.

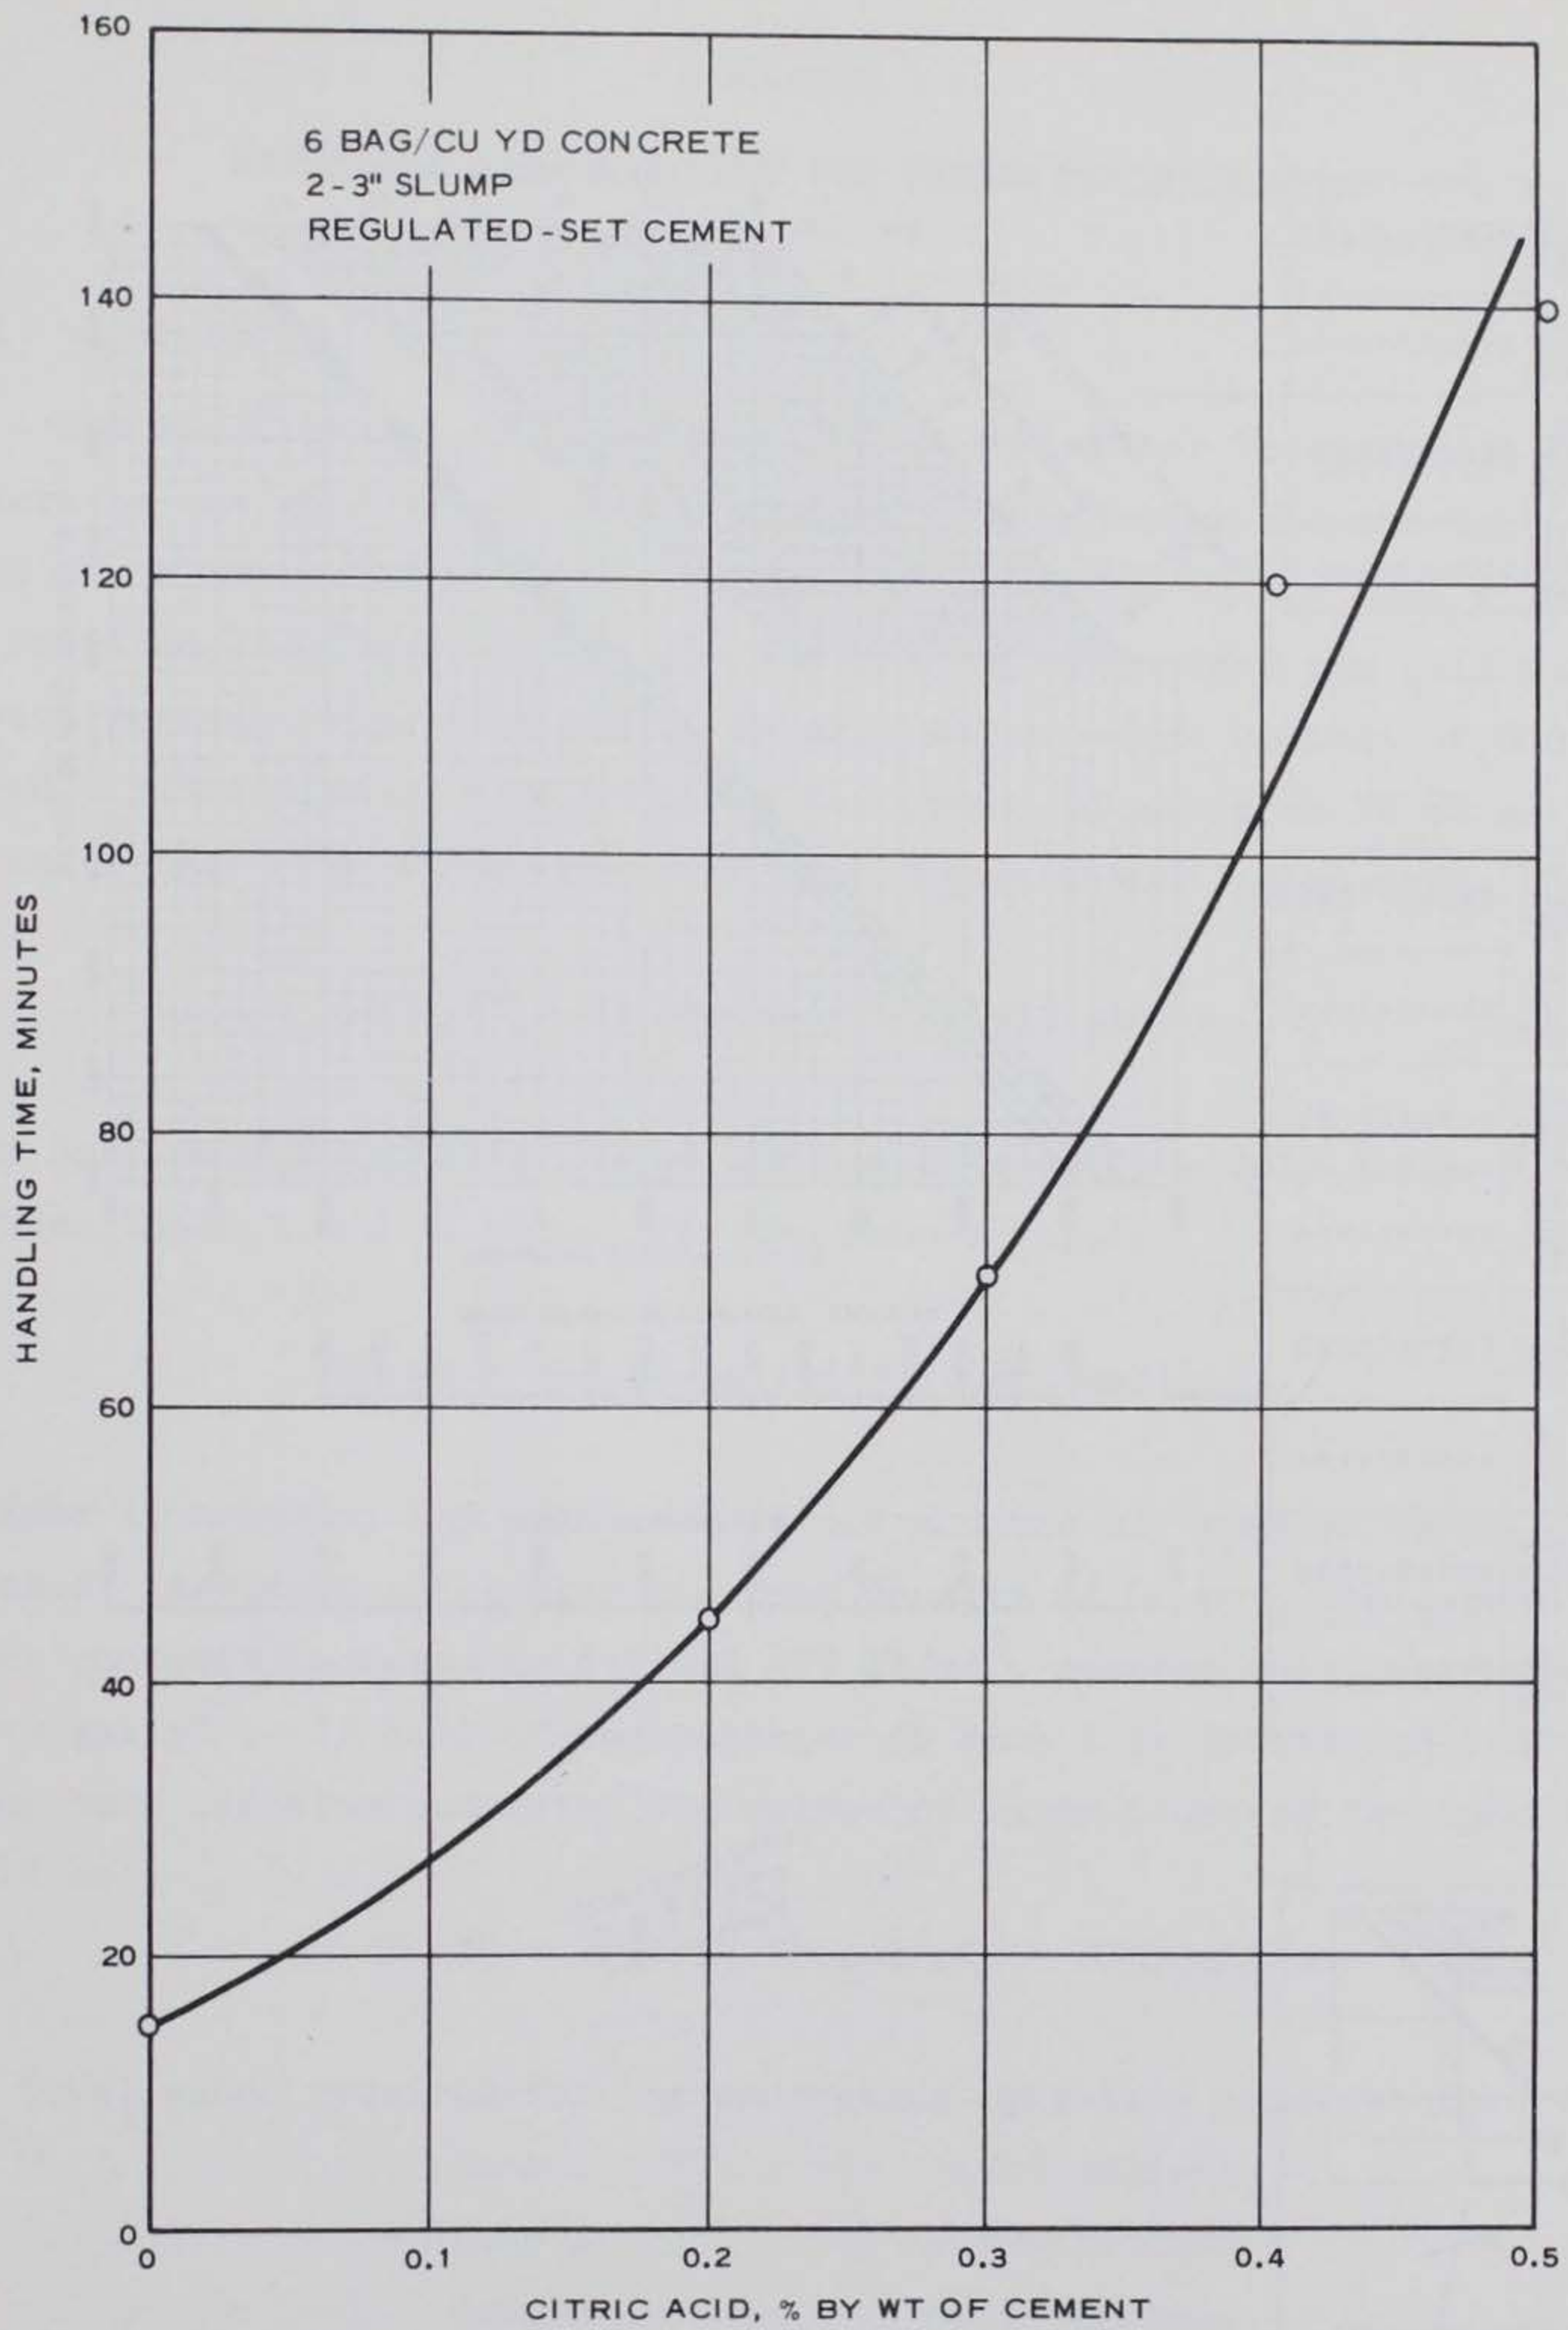
Figure 3.8 Effect of citric acid on handling time of concrete (Reference 17).

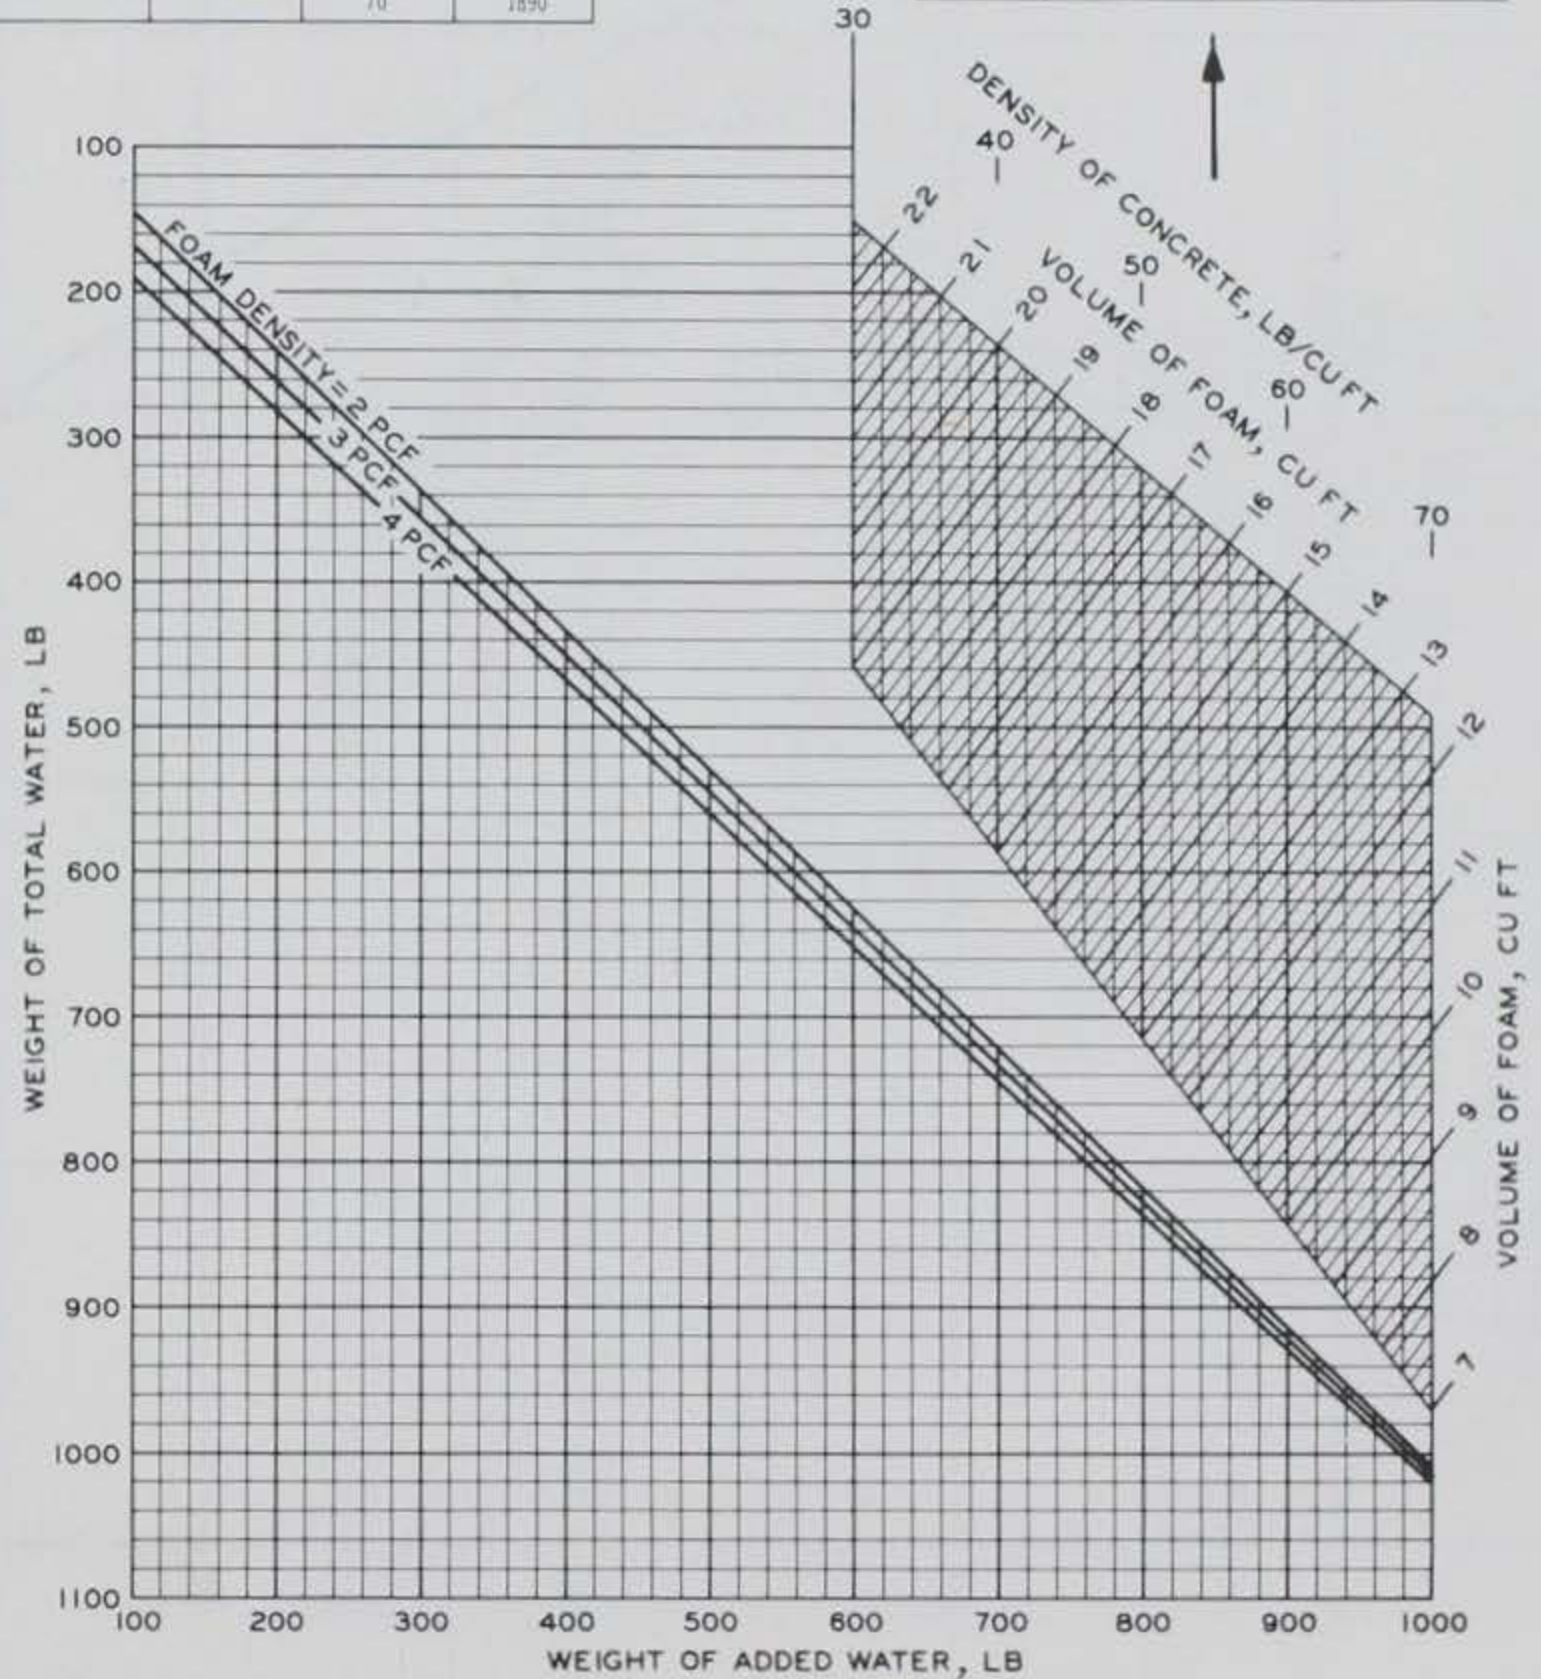
Figure 3.9 Nomograph for proportioning neat cellular concrete.

3.8.2 Nomographs. The crater will be actually repaired in a stress situation in which the time for calculations such as those shown in Section 3.8.1 will be minimal, if any time is available at all. In these circumstances, the individual in charge of the repair should know in advance which densities of concrete are needed in the various parts of the crater, which water-cement ratio should be used, the density of the preformed foam, and the discharge rate of the foam generators. With this information, and a nomograph (Figure 3.9), the quantities of materials needed can be determined in a few seconds.

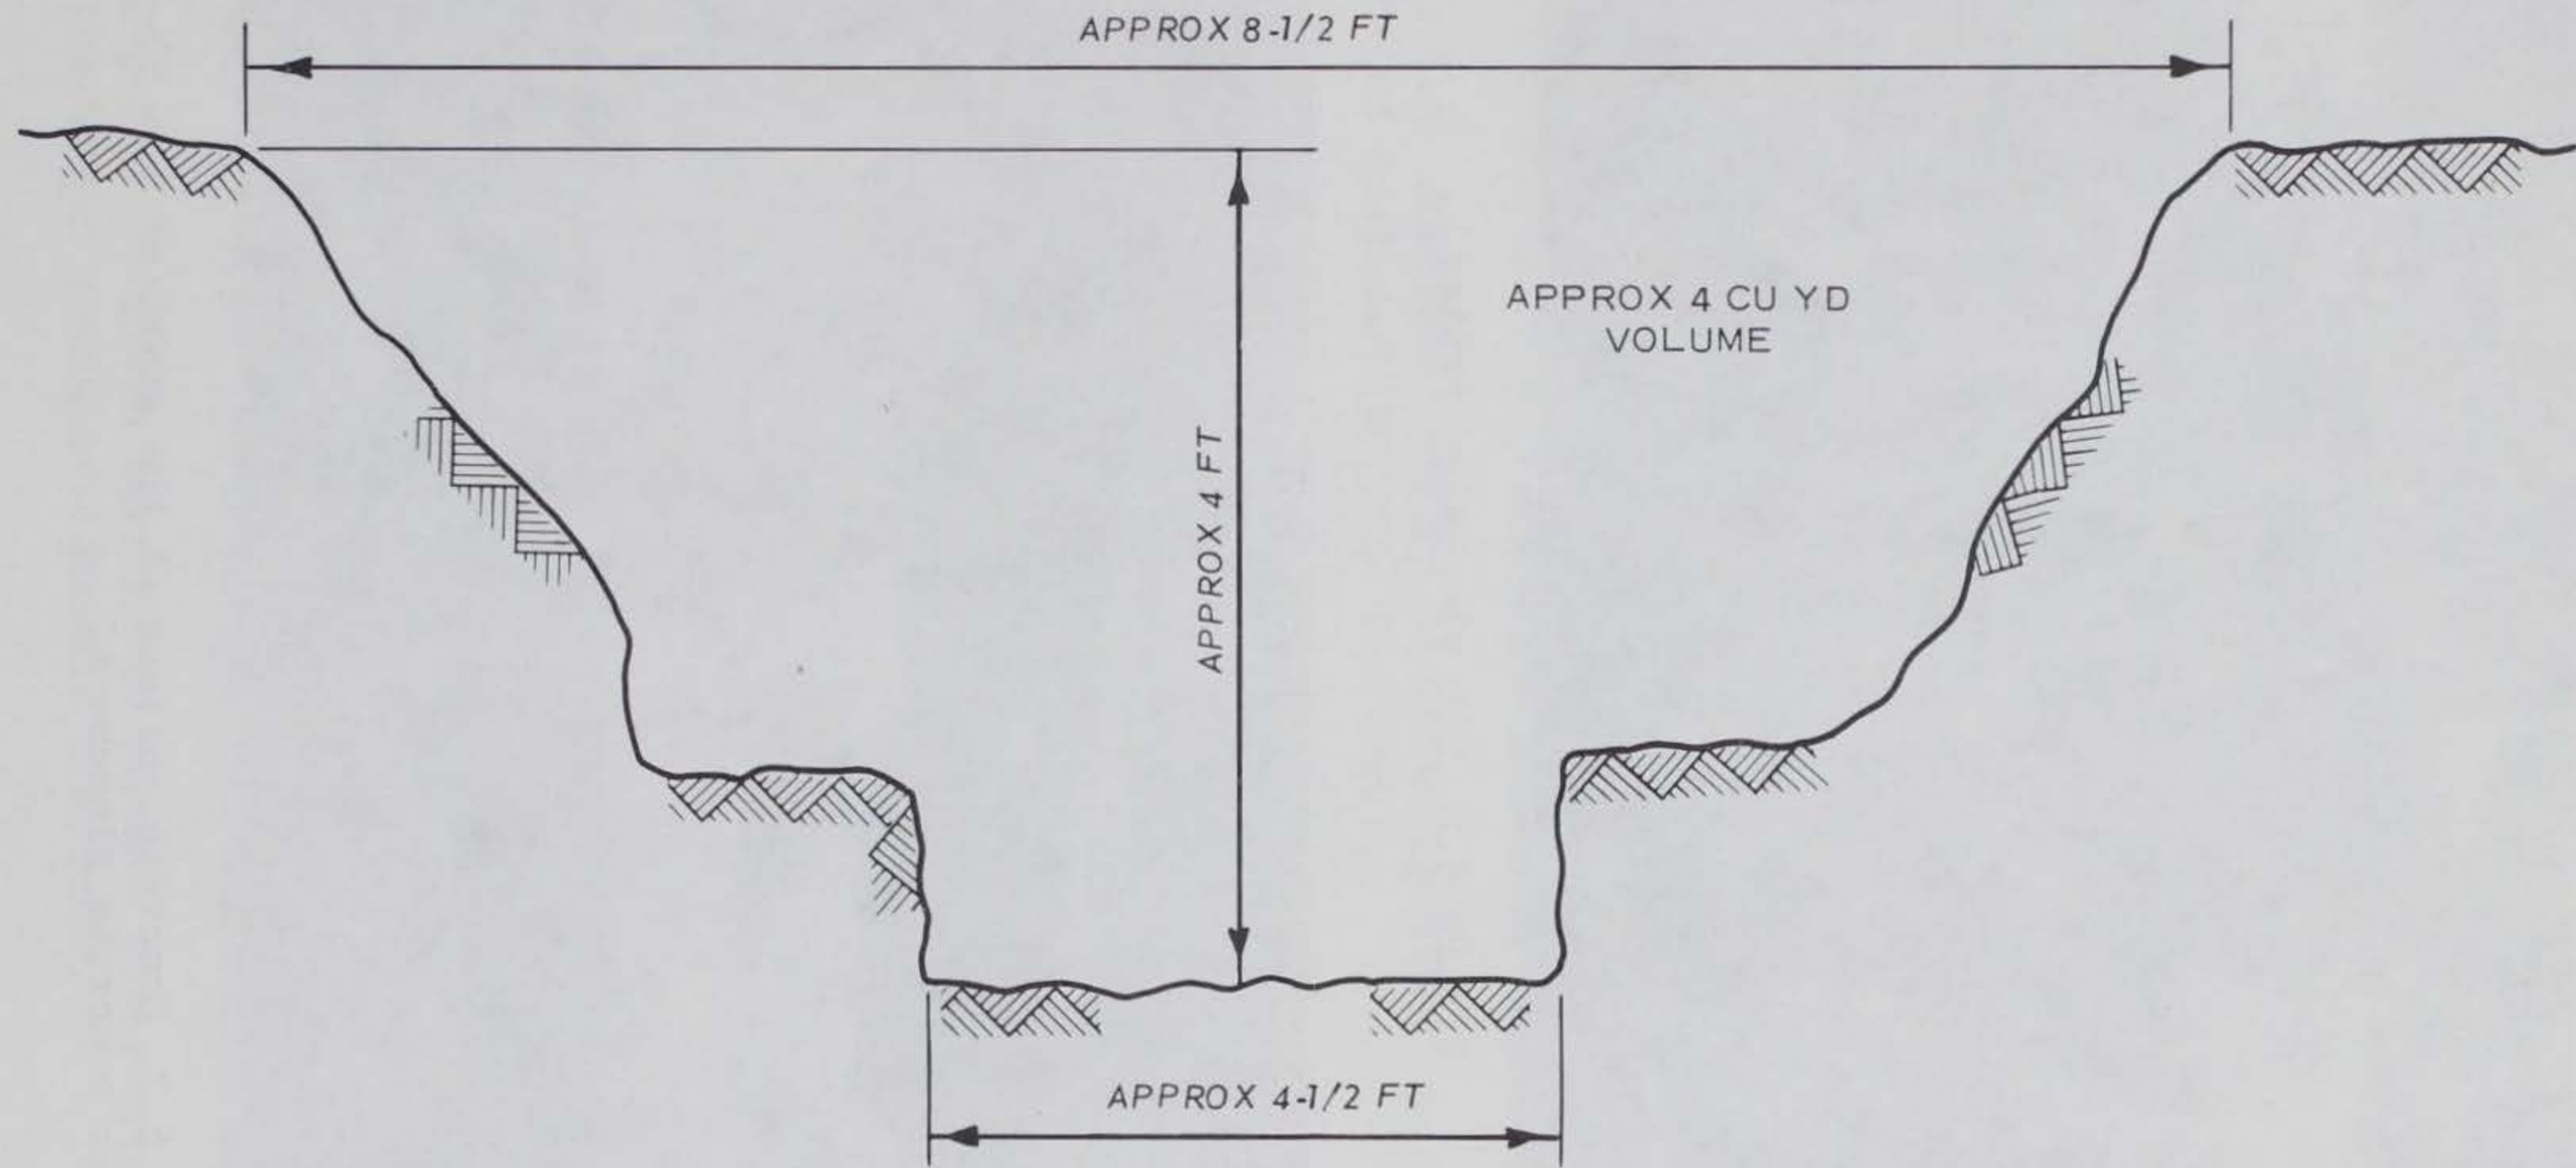
Figure 5.1 Cross section of small simulated crater.

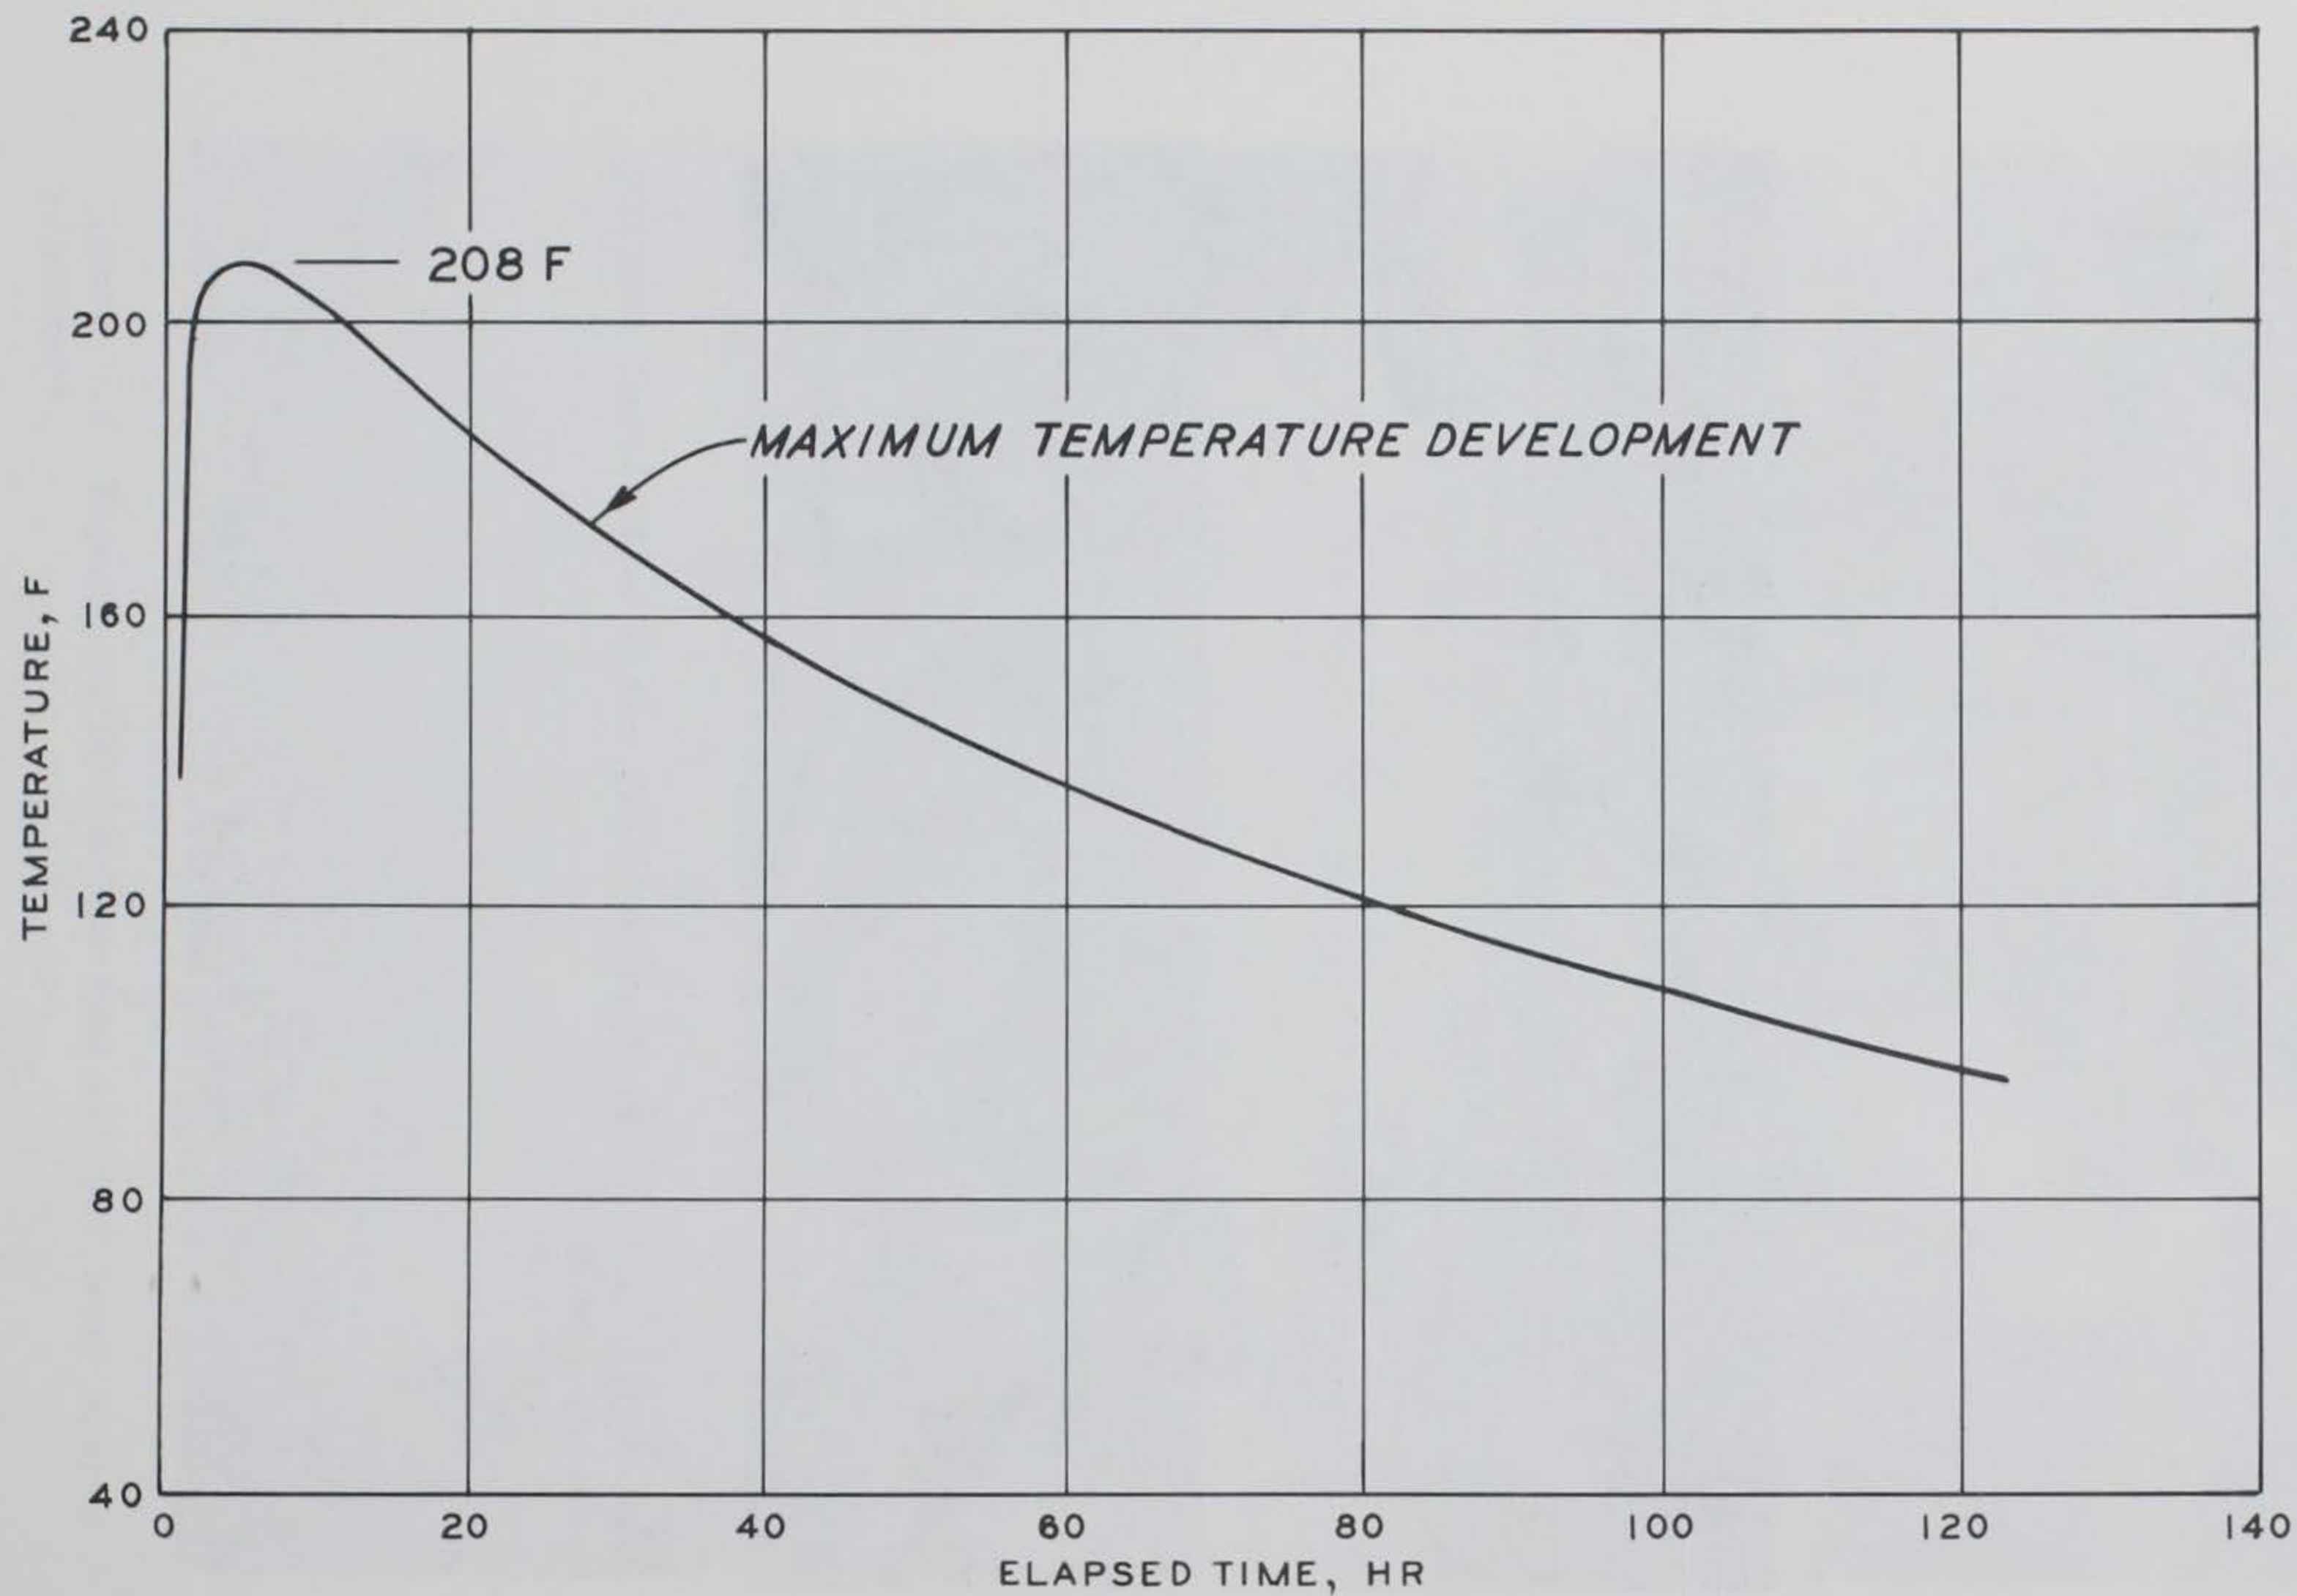
Figure 5.9 Maximum temperature development versus time after placing relation for simulated crater repair.

As mentioned in Sections 5.1.1 and 5.1.2, the heat development in large sections of regulated-set cement concrete is substantial. The temperature of the air in the loaded pipes was 220°F. Extremely warm temperatures were noted for the PVC module tests conducted at WES (Section 5.1.2), but softening of the pipes was not observed because it was not looked for in the test. The PVC pipes at WES appeared hard but were never loaded. The maximum temperature developed in the Tyndall crater was approximately 30°F greater than in the WES crater. This is probably due to the larger volume of cement used and the fact that the temperature of the mixture at placement at Tyndall was 18°F greater than at WES.

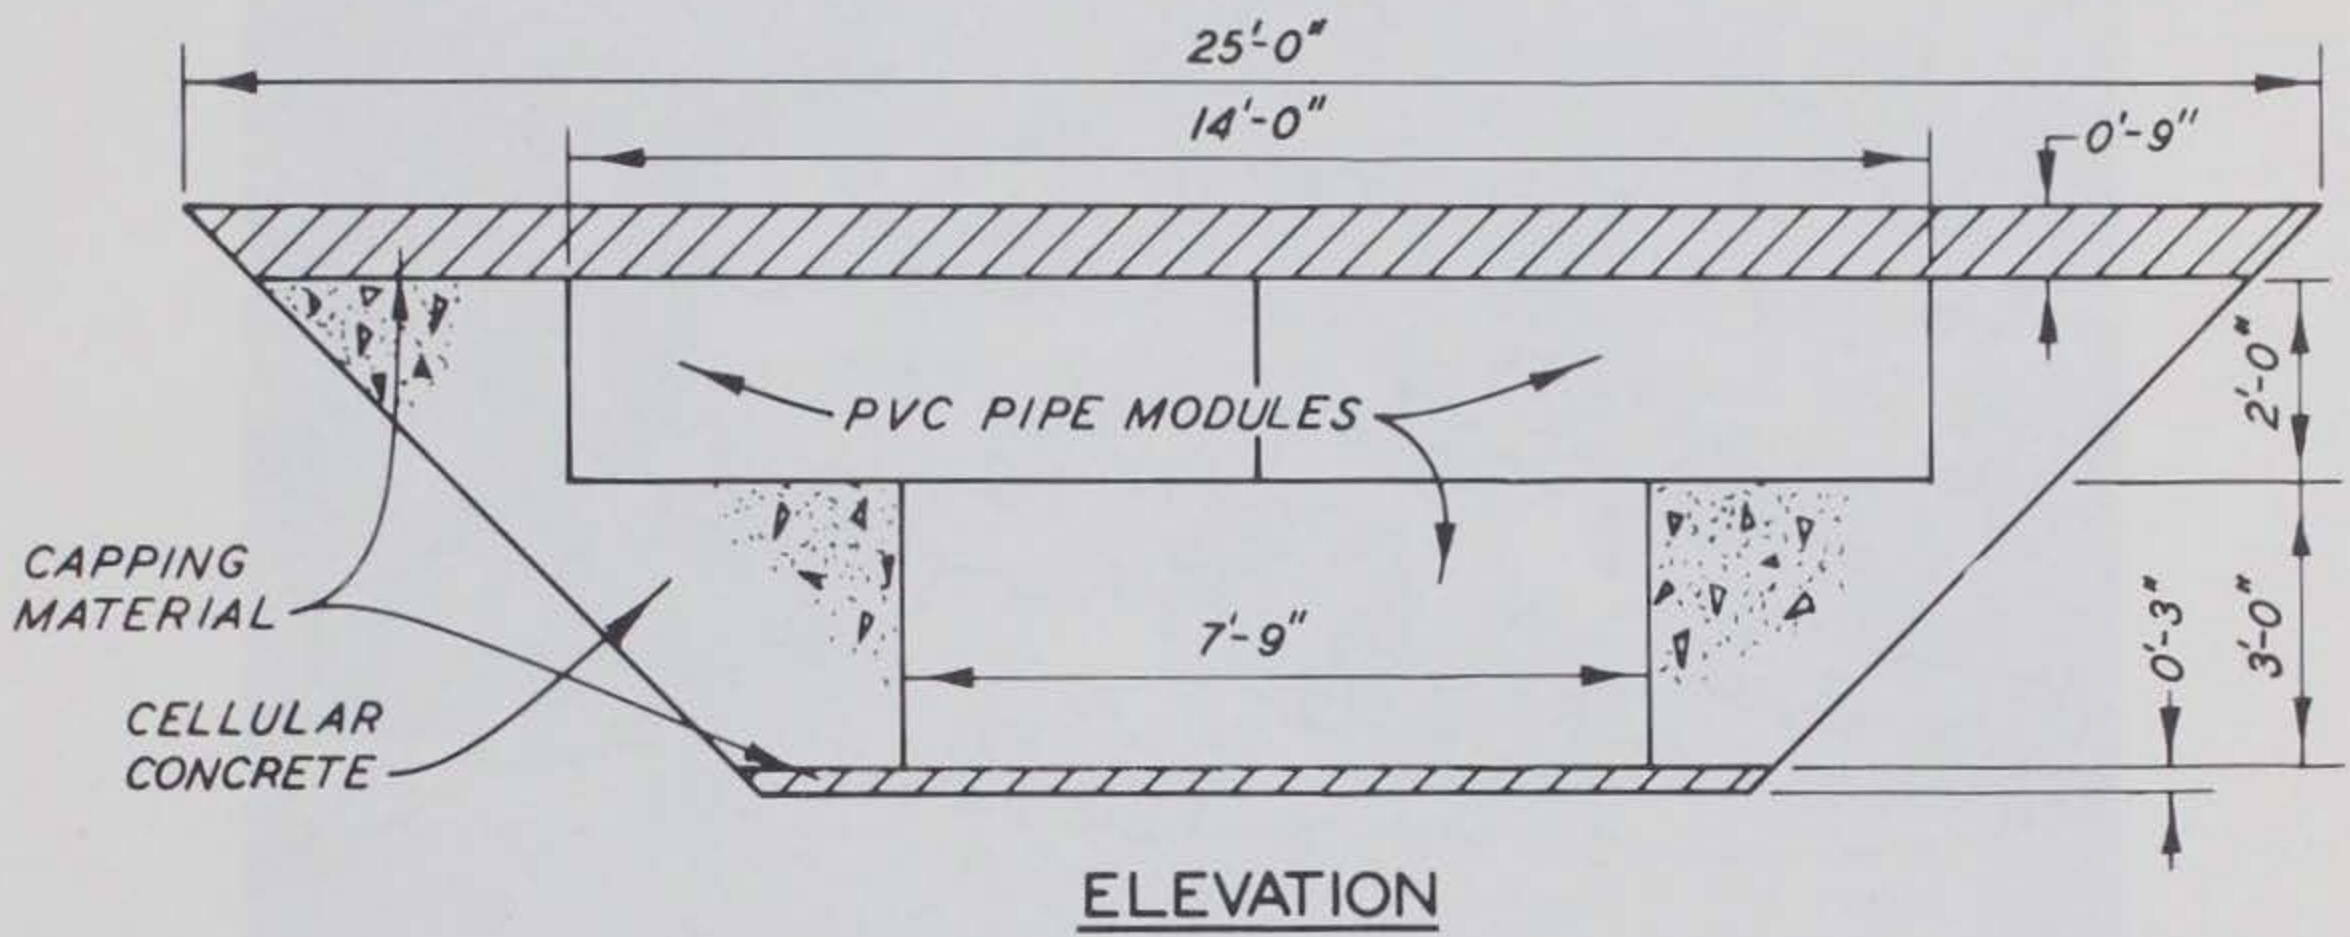
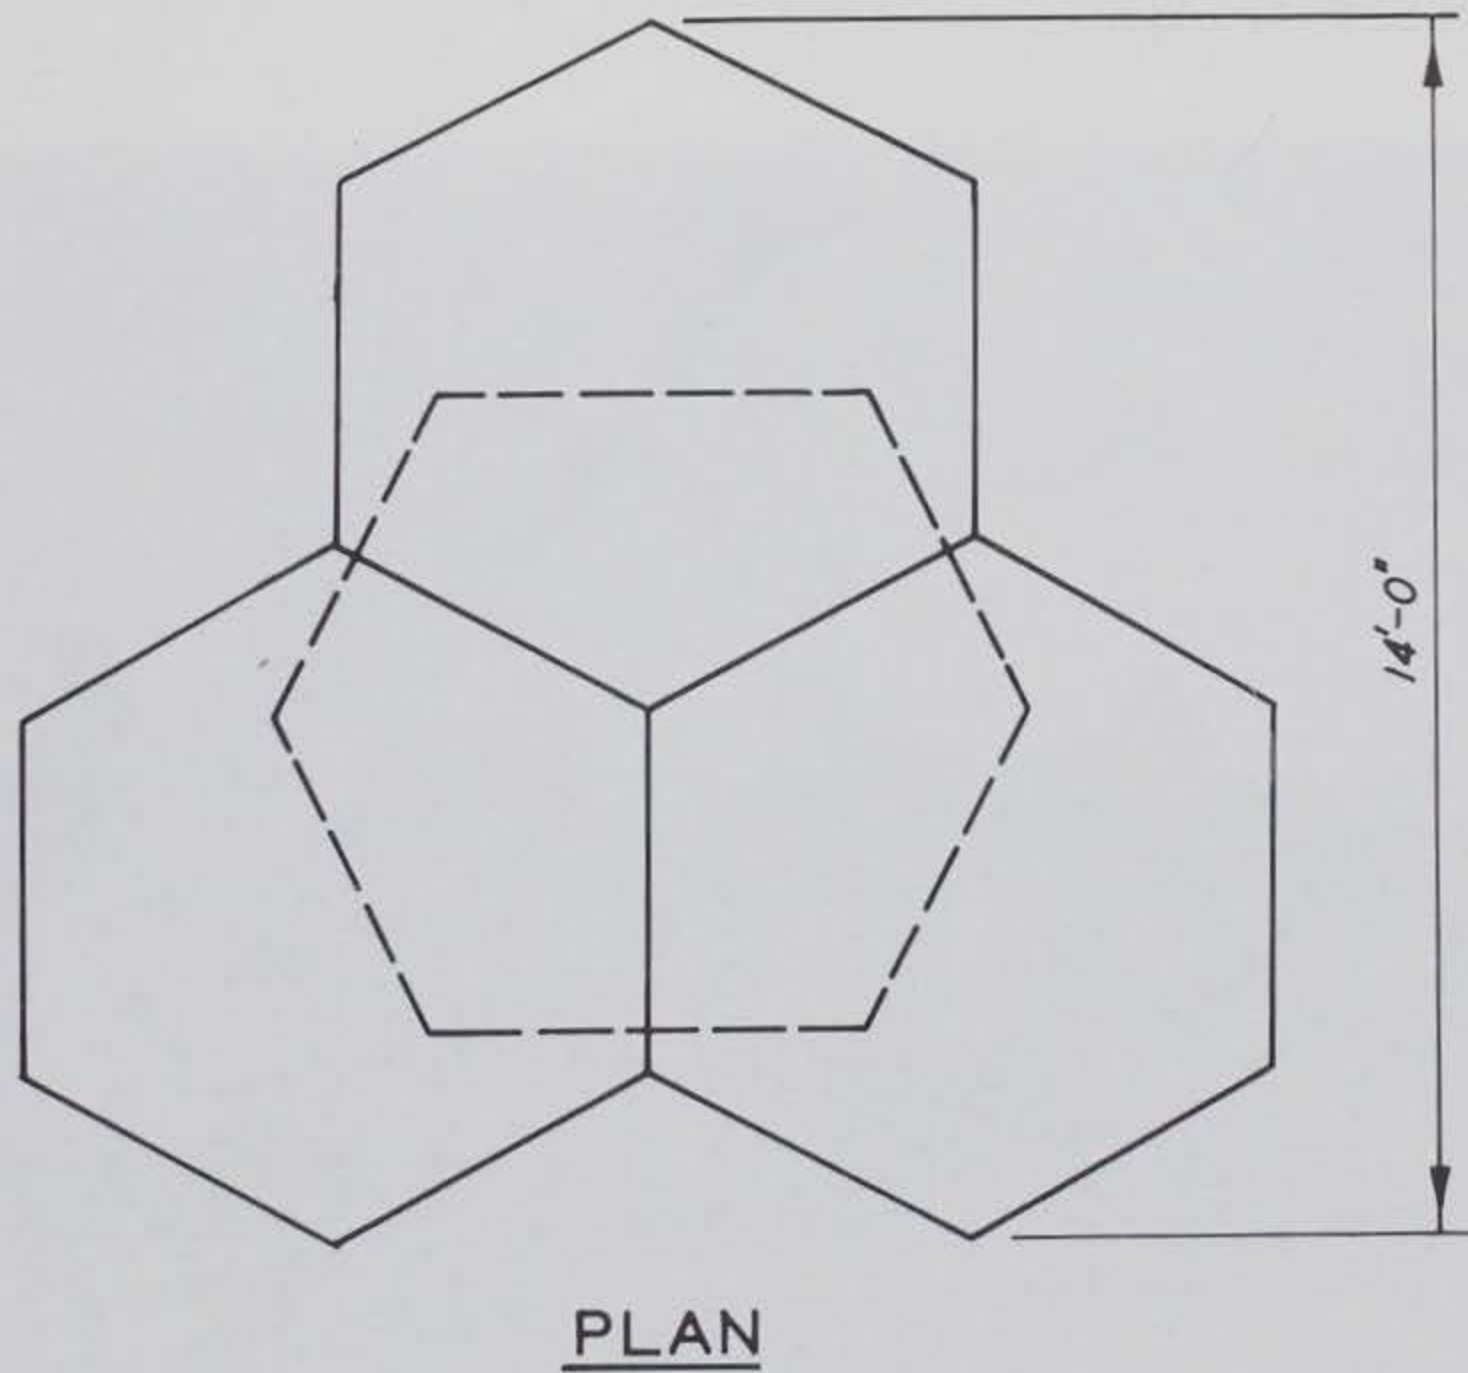
Figure 5.10 PVC pipe module repair scheme.
