TECHNICAL REPORT C-75-2

A CONCEPT FOR RAPID REPAIR OF BOMB-DAMAGED RUNWAYS USING REGULATED-SET CEMENT

George C. Hoff

July 1975

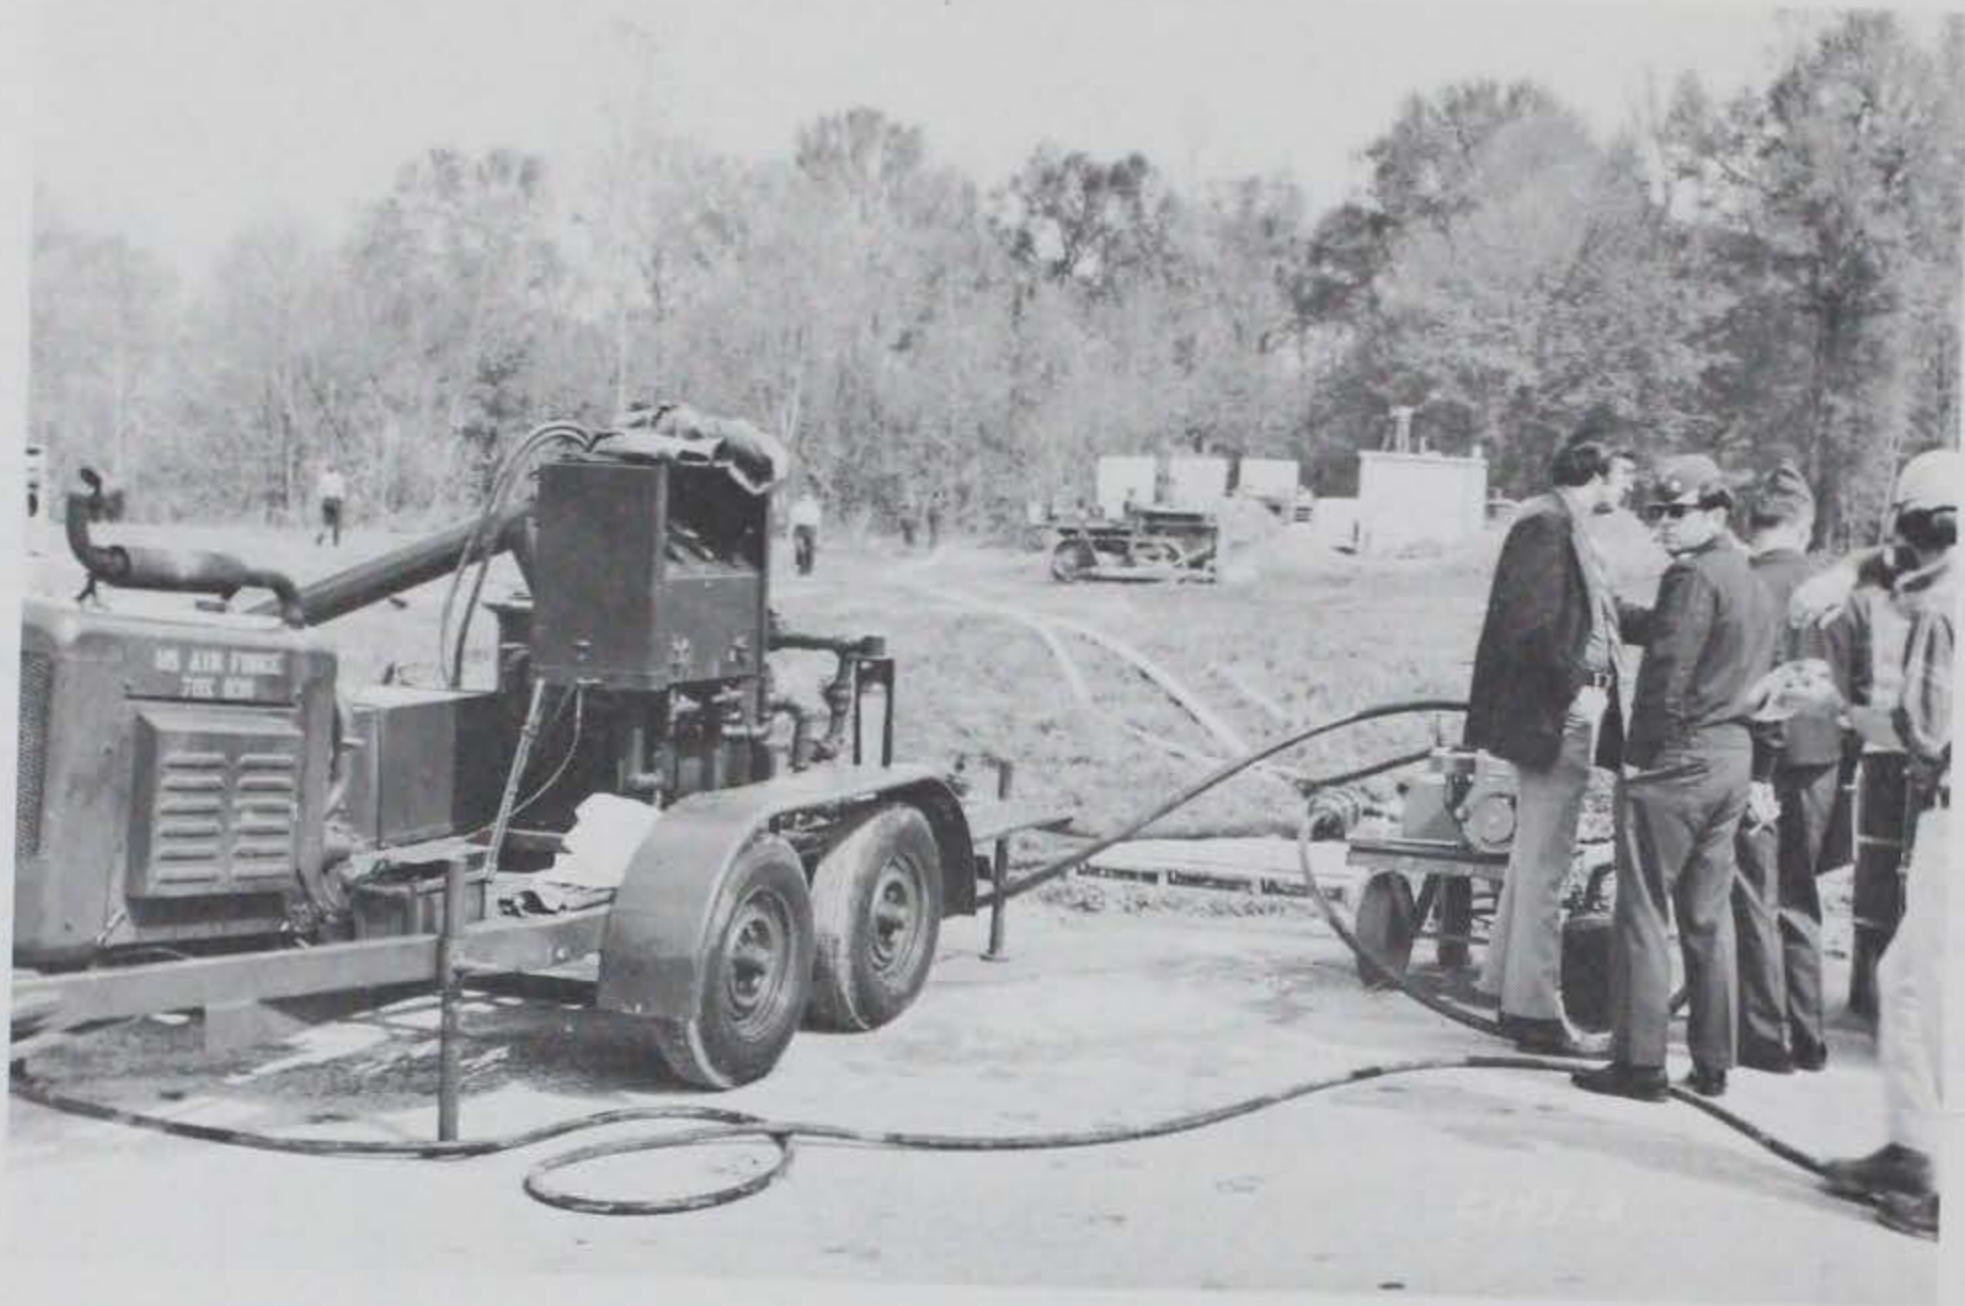
Figure 5.11 Batching and pumping unit - WES one-sixth-size crater trials.

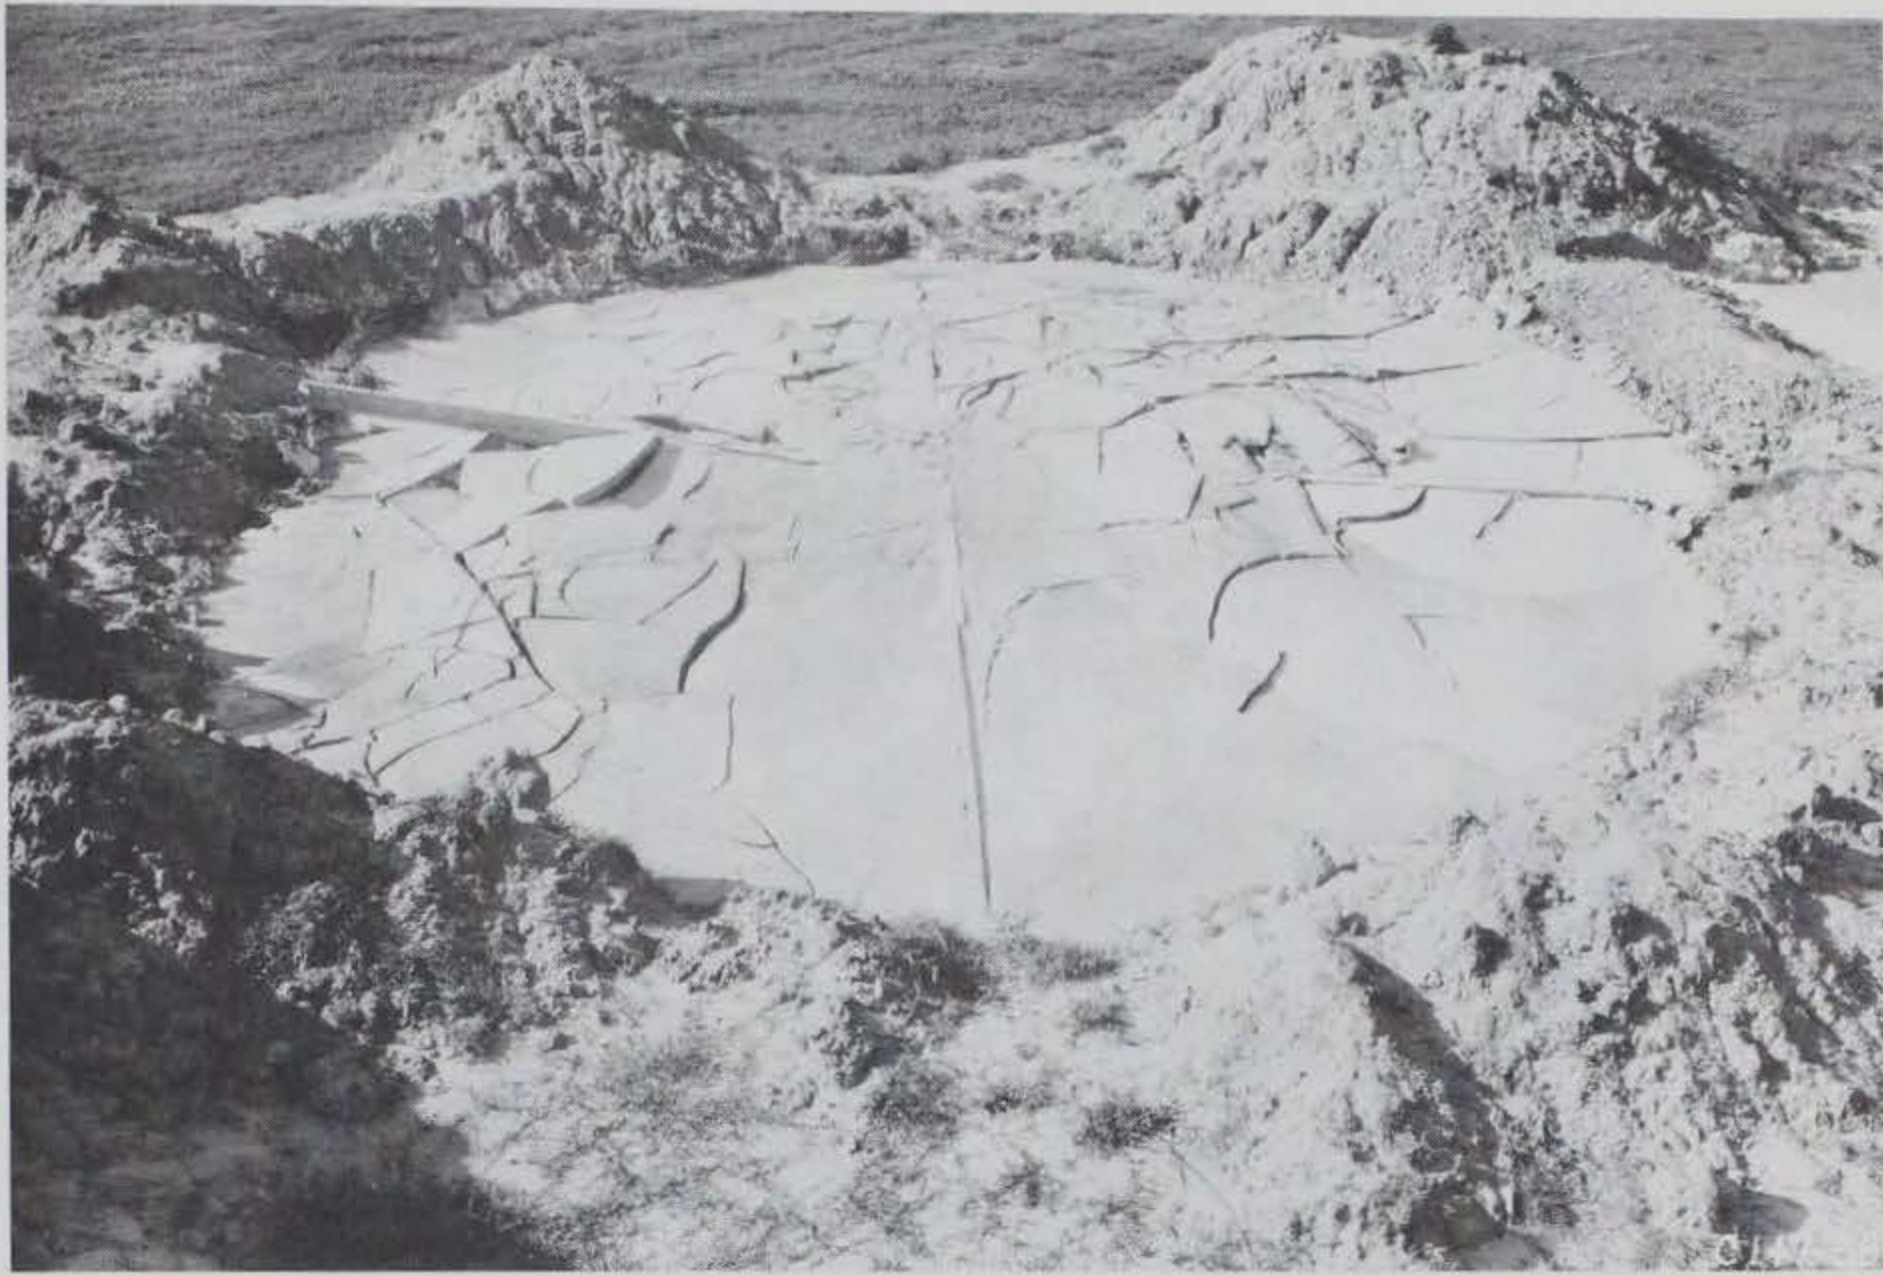
Figure 5.29 Severe drying shrinkage cracking.

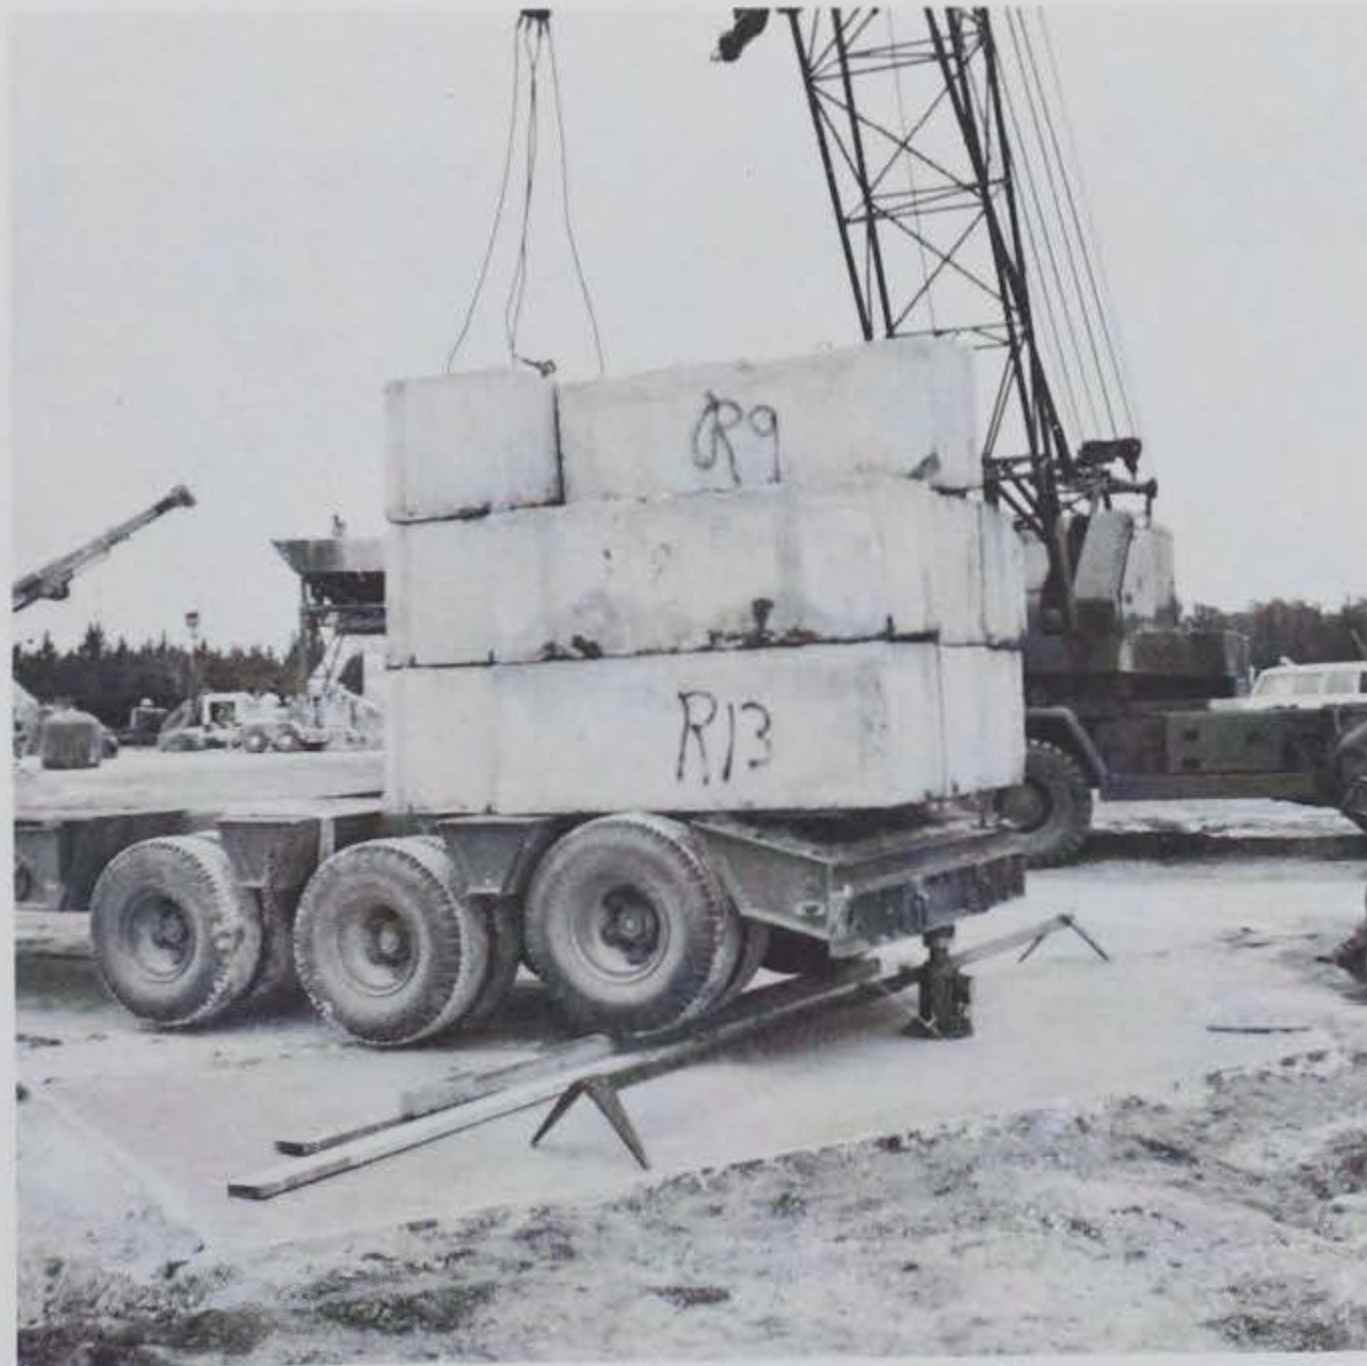
Figure 5.50 Loading of repaired crater by cart loaded with 50,000 pounds of blocks.

crater. This cart exerted a 30,000-pound load to the pavement through an F-4E tire inflated to 265 psi. The tire of the load cart penetrated the cap until stopped by the axle. The failure was a classical punching shear type. Examination of the hole after the cart was removed revealed that the PVC pipes had softened considerably due to the heat developed by the hydration of the cement and were offering no support to the cap. In effect, the cap was acting as an unreinforced slab spanning an empty hole except for some edge support provided by the cellular concrete. This lack of subgrade support from the PVC modules also explains the failures during the load plate test. Strain gages on the PVC pipes indicated that the pipes had compressed under the load and had retained the deflected shapes upon removal of the load.

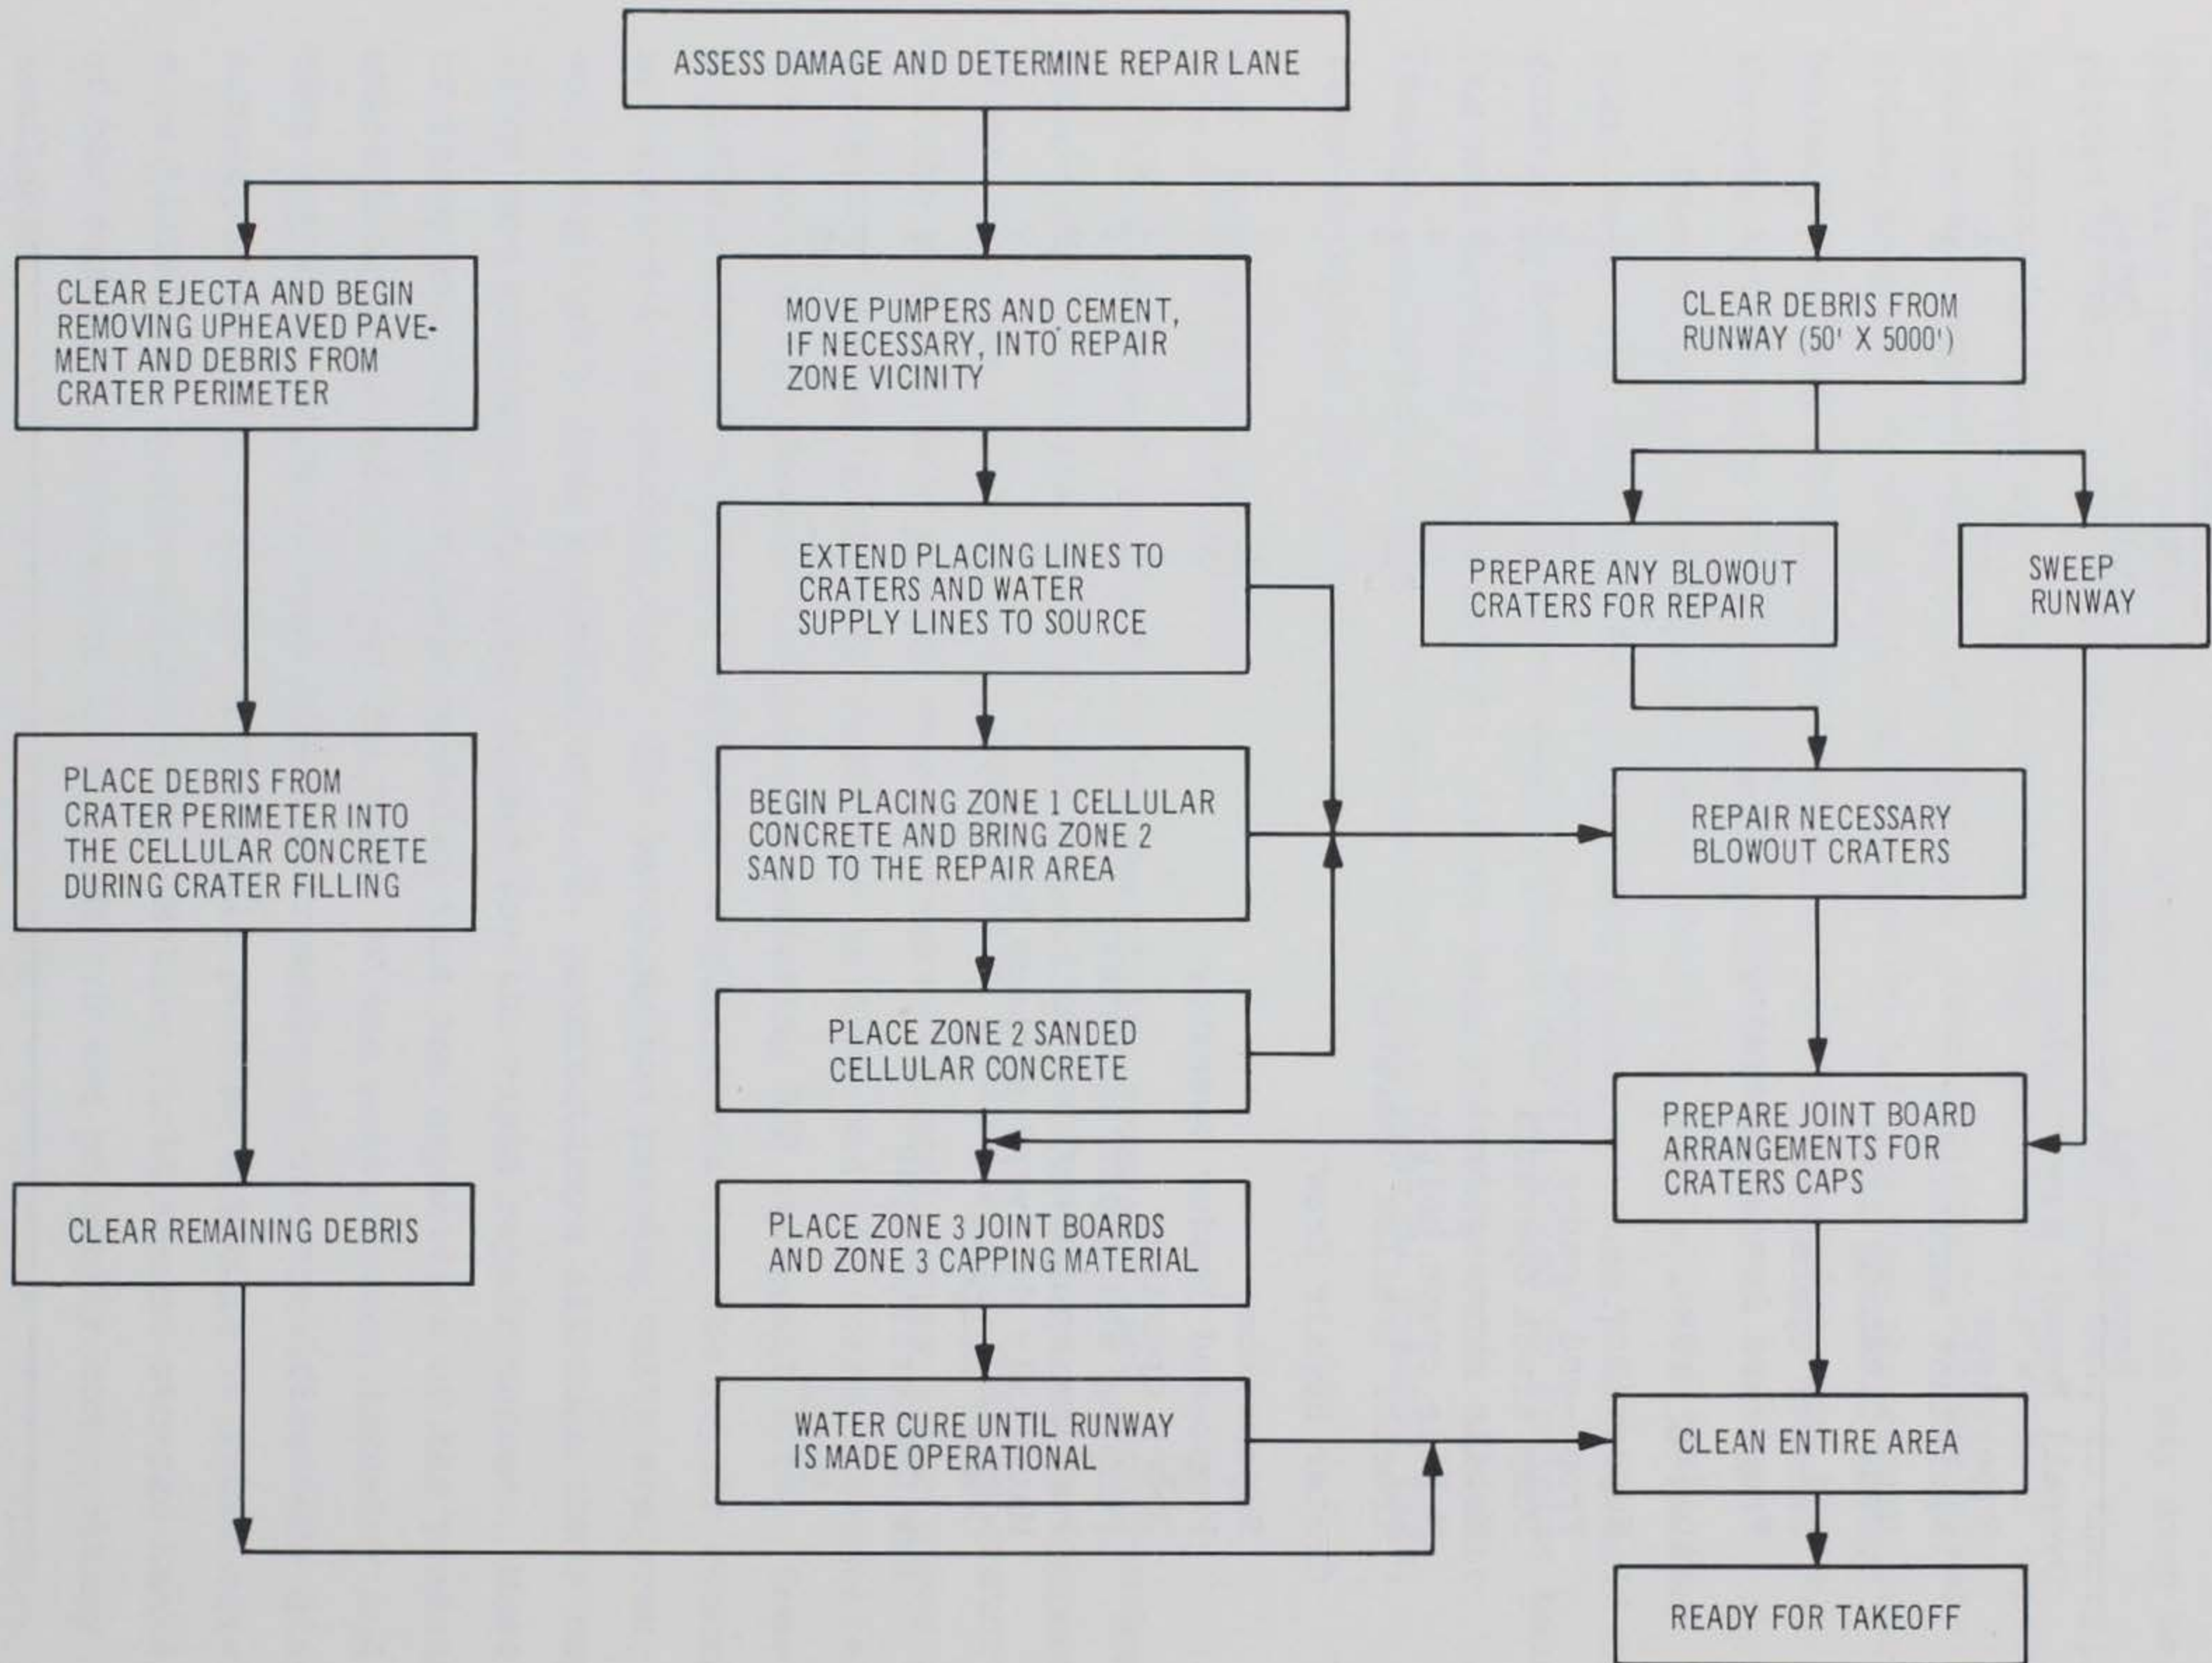
Figure 6.1 Regulated-set cement system repair flow diagram
