ACEQUIAS REHABILITATION PROGRAM

## **ENVIRONMENTAL ASSESSMENT FOR REPAIR OF THE VILLANUEVA DIVERSION DAM, PECOS RIVER, SAN MIGUEL COUNTY, NEW MEXICO**

October 2014

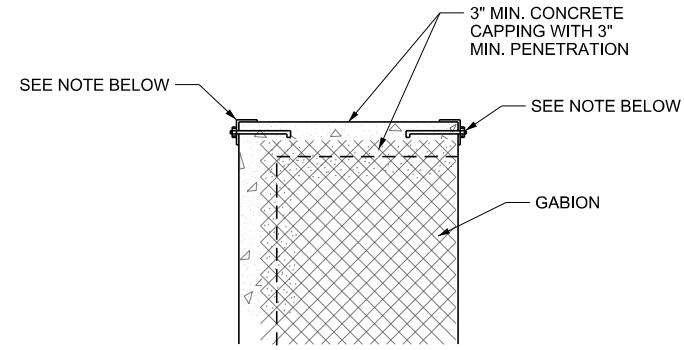
TYPICAL CONCRETE CAPPING DETAIL  
NOT TO SCALE

NOTE:  
CONTINUOUS 4" X 4" X 3/8" ANGLE WITH 3/4" X 10" LONG ANCHOR BOLT (1" HOOKED END) WITH NUTS. ANCHOR BOLTS SHALL BE SET AT 4' O.C. BEGINNING 2' FROM EACH END OF ANGLE. NUTS SHALL BE WELDED TO ANGLE. ANGLE TO END 1/2" FROM SIDES OR APPROVED EQUAL. 2" MINIMUM COVER FOR ANCHOR BOLT.

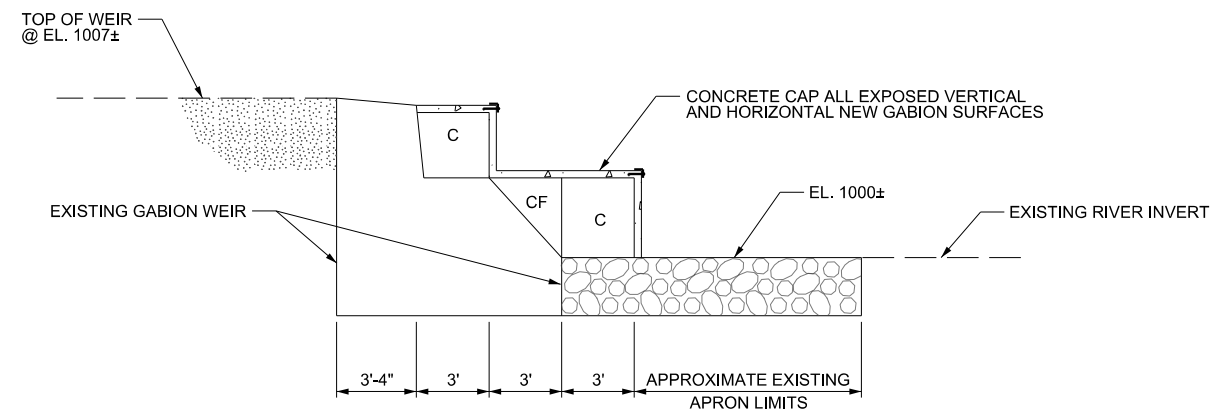
DAM REPAIRS SECTION  
SCALE: 1" = 40'

The planned action involves repairing the Villanueva Diversion Dam. The structure would be stabilized on the downstream side with 30 wire-wrapped, rock-filled gabions. Gabions would be added along the entire length of the dam, widening the top and second steps (see Appendix A, Sheet C-104). The lowest row of gabions would rest on the existing concrete-capped apron. The top and vertical surfaces of all existing and new gabions would be capped with concrete.

The proposed action entails the placement of 30 wire-wrapped, rock-filled gabions along the downstream face of the existing dam structure along its entire length. All placement would be atop an existing concrete-capped apron at the foot of the dam; that is, atop a portion of the structure itself, not on the natural river bottom. The top and vertical surfaces of all existing and new gabions would be capped with concrete.

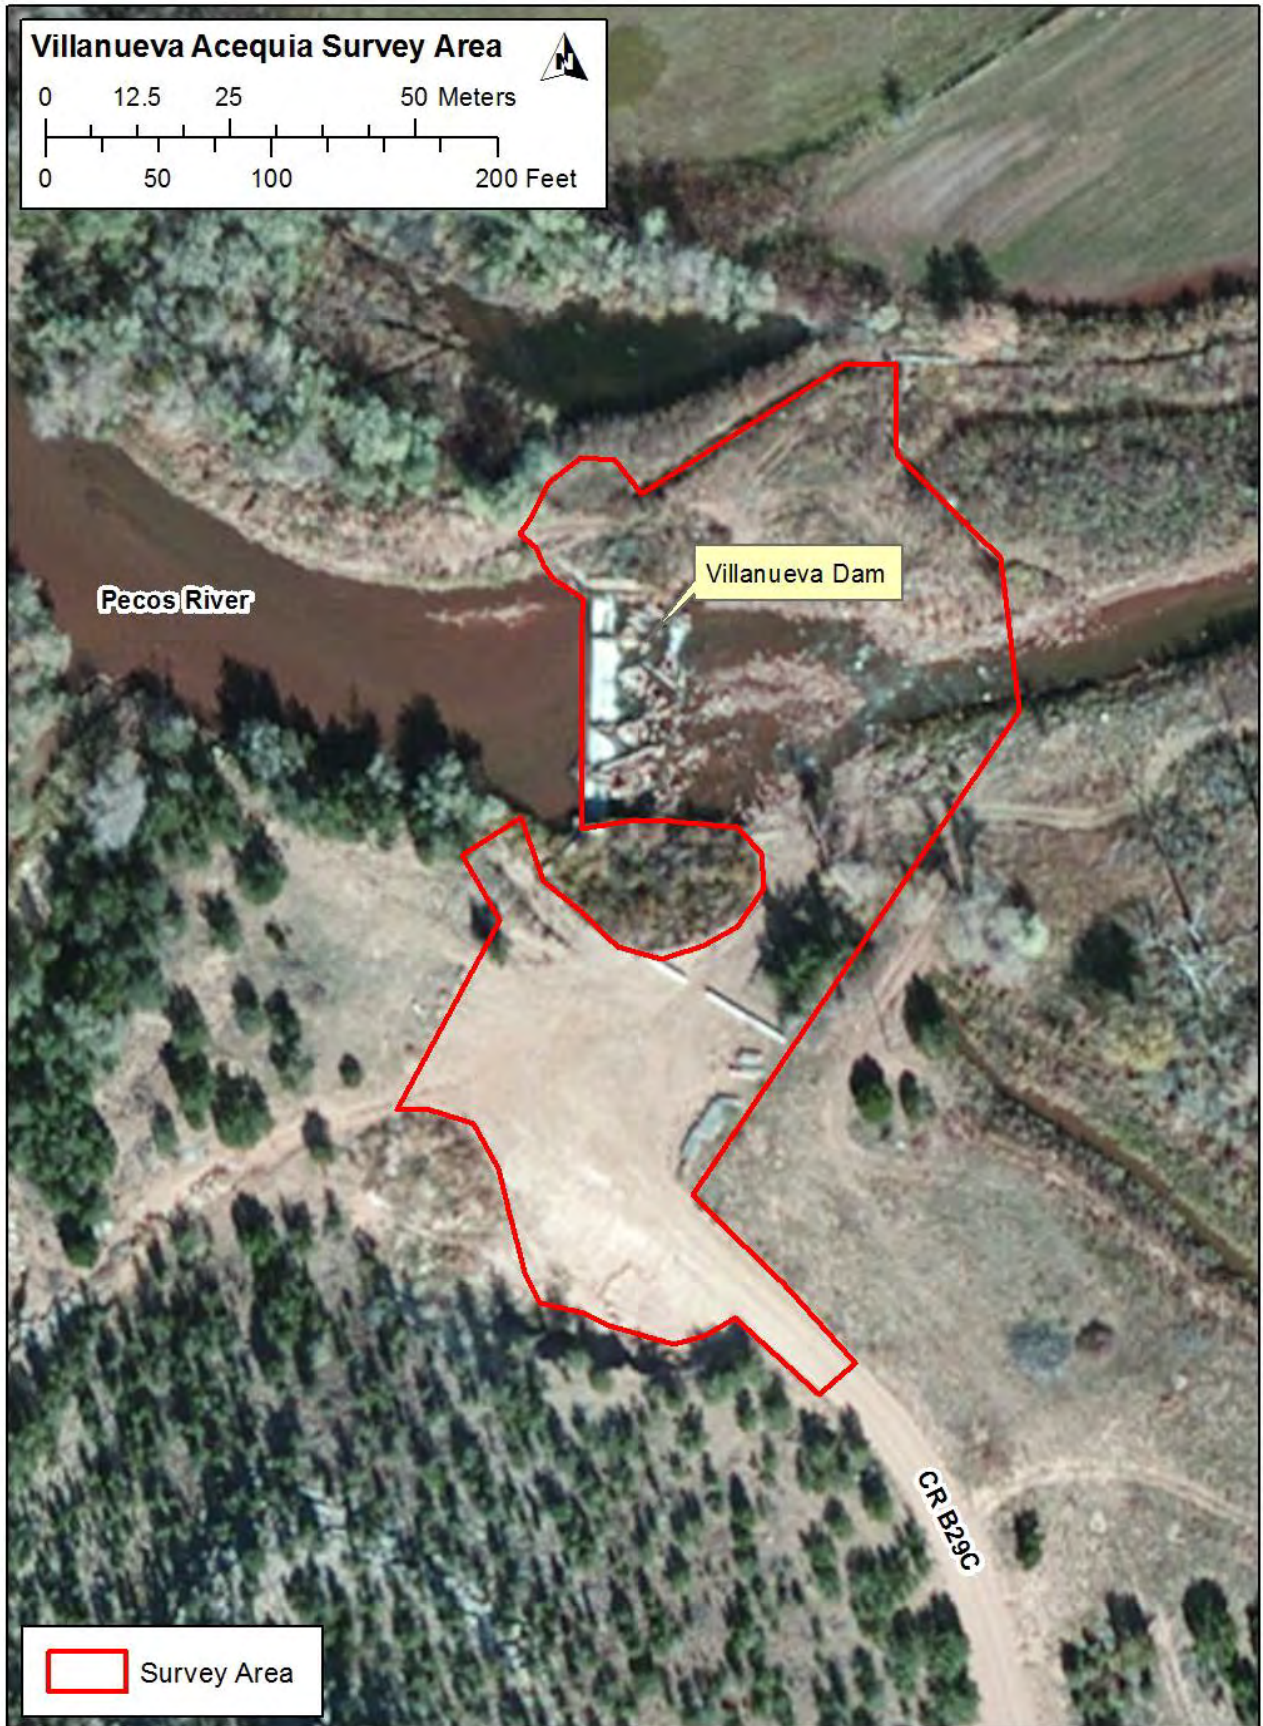
Figure 3: Villanueva Diversion Structure Rehabilitation Project. Project Engineer Drawing.

While the acequia systems are historic, the existing diversion structure is not. It was constructed in 1992 by the Corps. It was recently damaged by high flood flows that resulted from September 2013 storms; the structure's weir is leaning downstream and is in imminent danger of failure. The Corps is planning to install additional rock-filled, wire-wrapped gabion baskets on the downstream side to buttress the existing structure, surface the gabions with concrete, and re-establish the rock rip-rap at the downstream toe of the structure for energy dissipation as necessary. All construction work will be confined to the area downstream of the structure's weir and within the river channel (Figure 3).

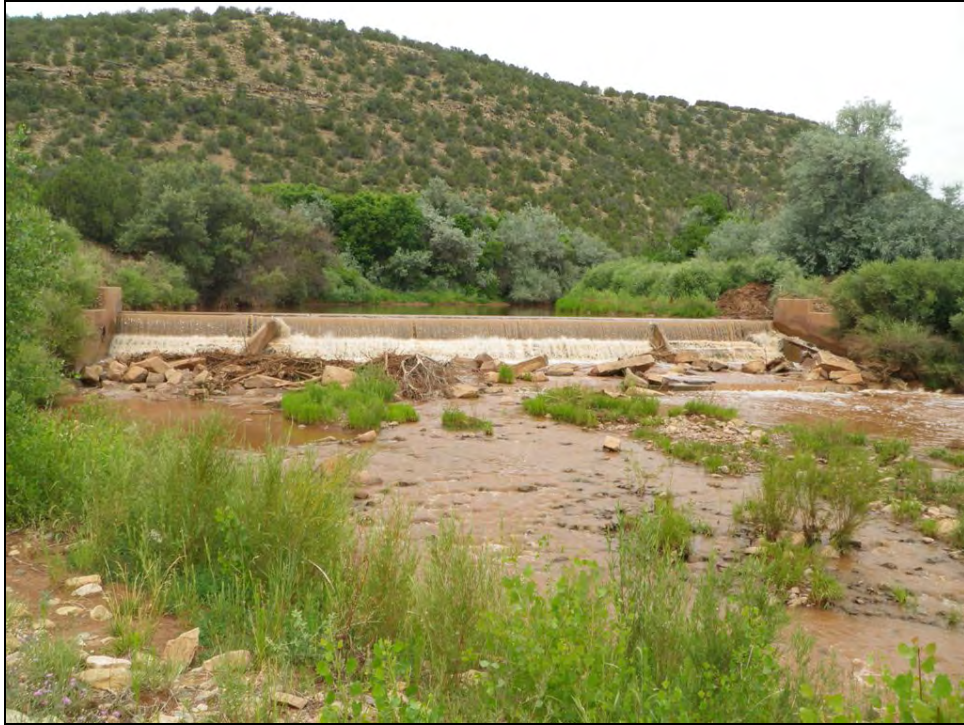
**Photograph No. 6: Overview of the Villanueva Diversion Structure, from downstream. July 15, 2014.**

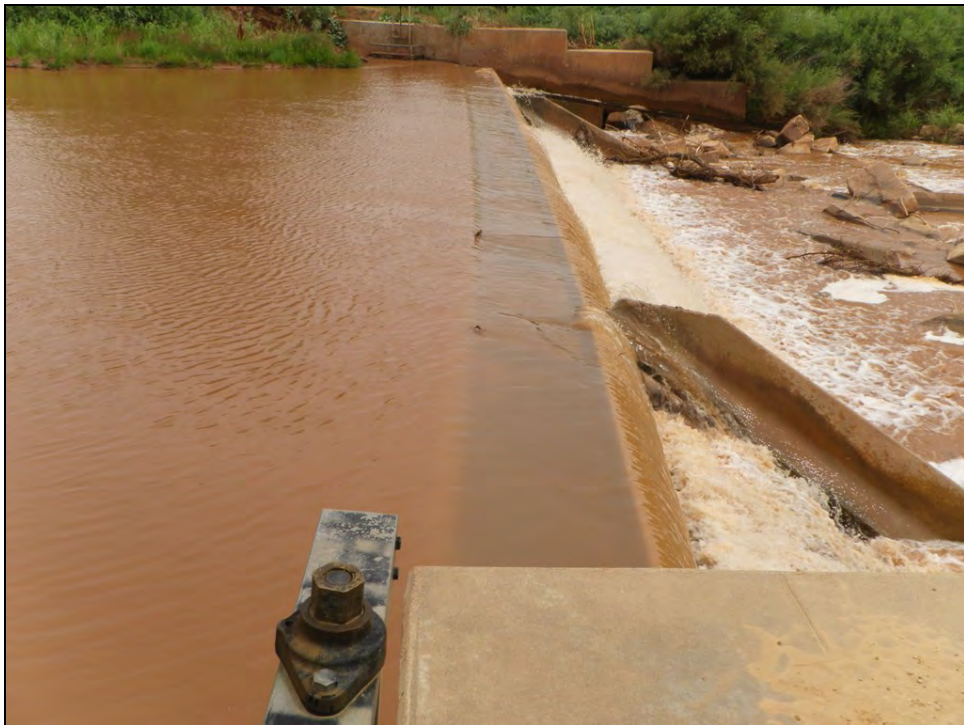
**Photograph No. 23: View to the north of the leaning Villanueva Diversion Structure. July 15, 2014.**

The existing 1992 Corps structure was impacted by high flood flows that resulted from September 2013 storms; the structure’s weir is leaning downstream and is in imminent danger of failure (see representative photographs). The Villanueva North Side and South Side acequias irrigate about 500 acres of farmland that serve about 80 families. The community depends heavily upon irrigated farmland, pastures, orchards, and family gardens for their livelihood. Loss of the use of the diversion structure whether from reduced effectiveness due to storm damages or disrepair that would result in structural failure would be economically devastating to the community. The Corps is planning to install additional rock-filled, wire-wrapped gabion baskets to buttress the existing structure, surface the gabions with concrete, and re-establish the rock rip-rap at the downstream toe of the structure for energy dissipation. All construction work will be confined to the area downstream of the structure’s weir and within the river channel.

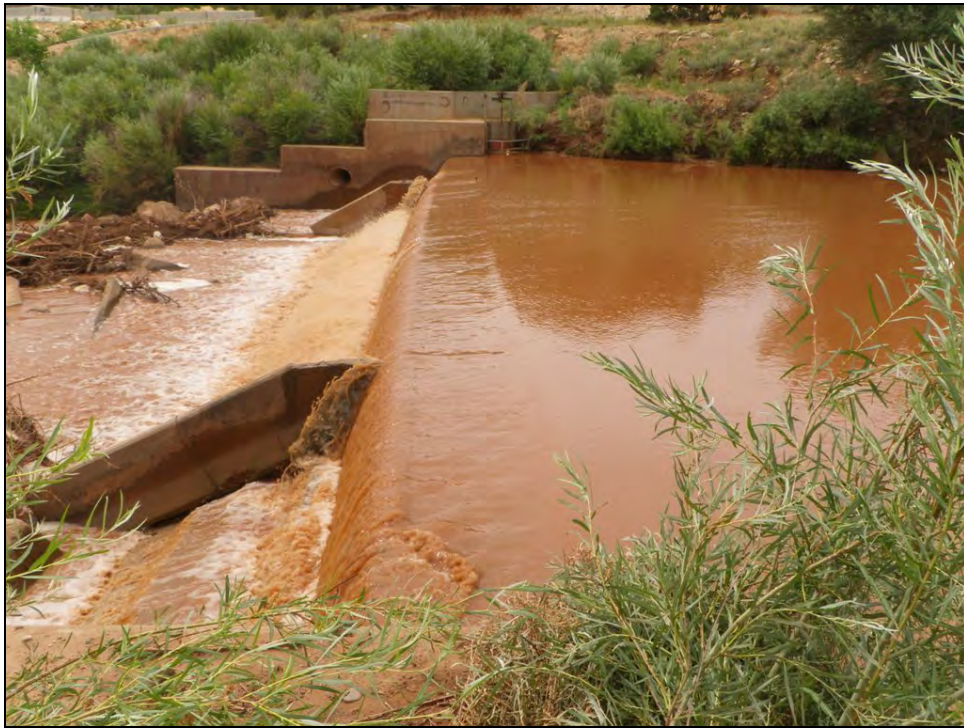
**Photograph No. 59: View to the south of the leaning Villanueva Diversion Structure. July 15, 2014.**

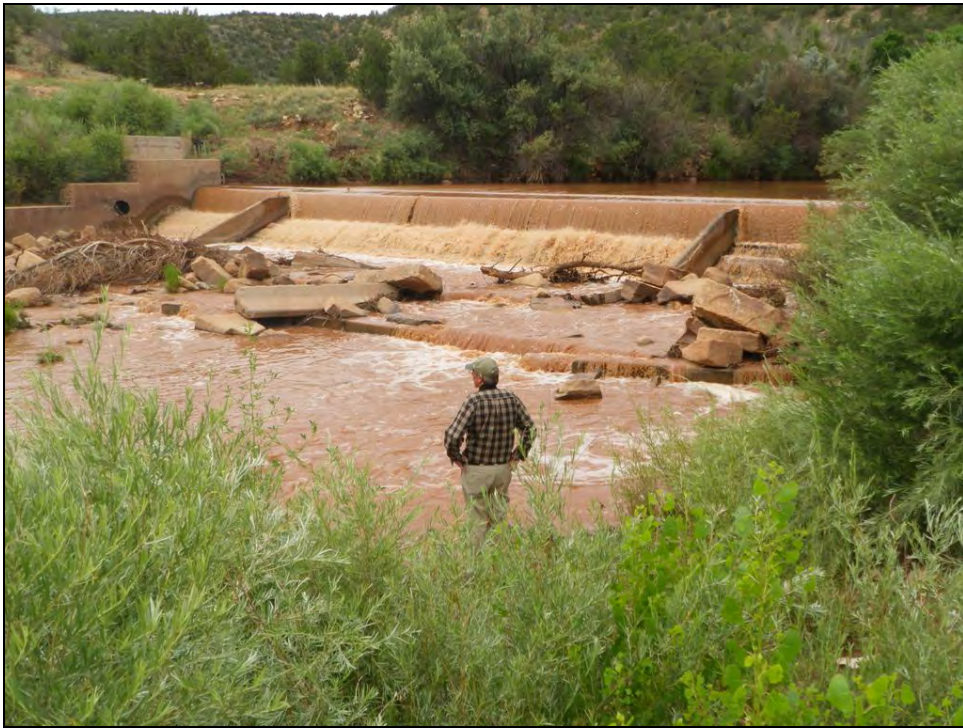
**Photograph No. 36: Overview of the Villanueva Diversion Structure, from downstream on the north bank.  
July 15, 2014.**

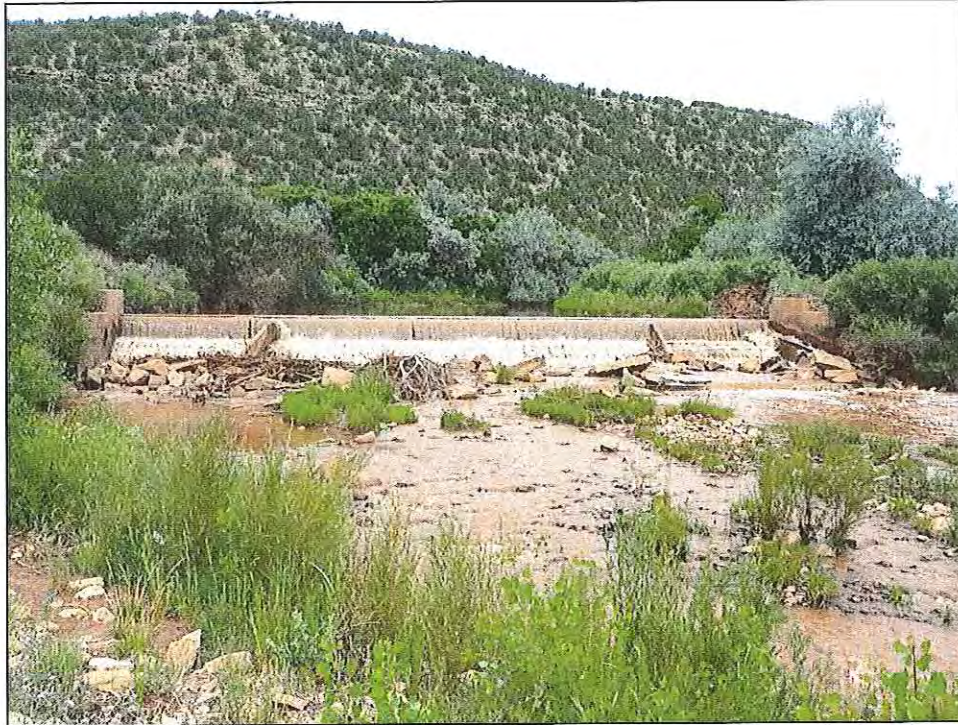
**Photograph No. 6: Overview of the Villanueva Diversion Structure, from downstream. July 15, 2014.**

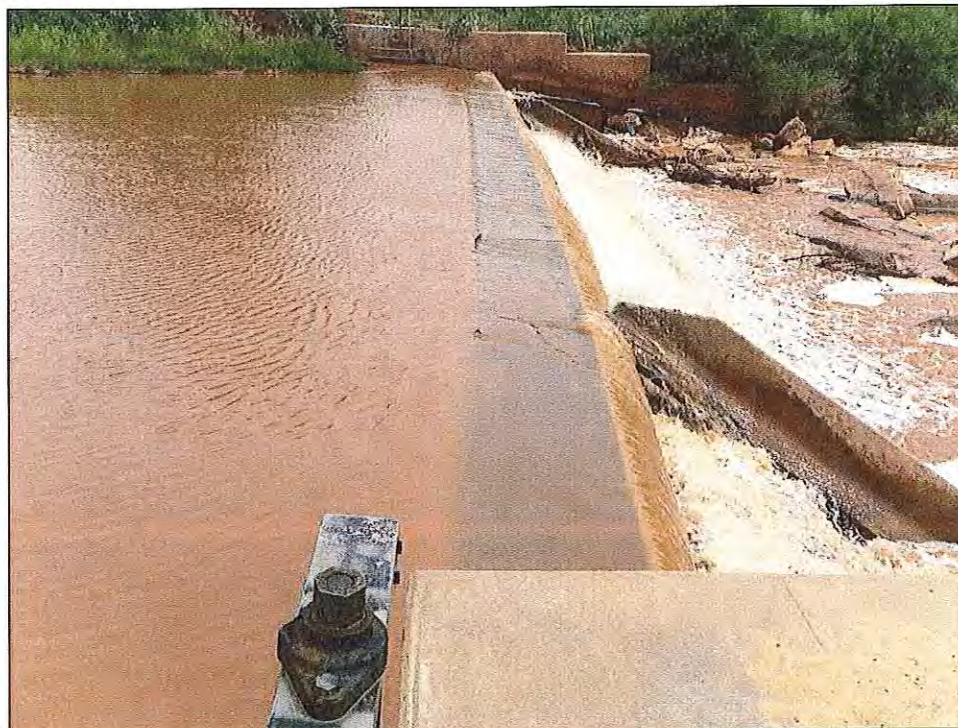
**Photograph No. 23: View to the north of the leaning Villanueva Diversion Structure. July 15, 2014.**

While the acequia systems are historic, the existing diversion structure is not. It was constructed in 1992 by the Corps. It was recently damaged by high flood flows that resulted from September 2013 storms; the structure's weir is leaning downstream and is in imminent danger of failure. The Corps is planning to install additional rock-filled, wire-wrapped gabion baskets on the downstream side to buttress the existing structure, surface the gabions with concrete, and re-establish the rock rip-rap at the downstream toe of the structure for energy dissipation as necessary. All construction work will be confined to the area downstream of the structure's weir and within the river channel.
