TECHNICAL REPORT REMR-GT-3

**GEOTECHNICAL ASPECTS OF ROCK EROSION
IN EMERGENCY SPILLWAY CHANNELS**

ANALYSIS OF FIELD AND LABORATORY DATA

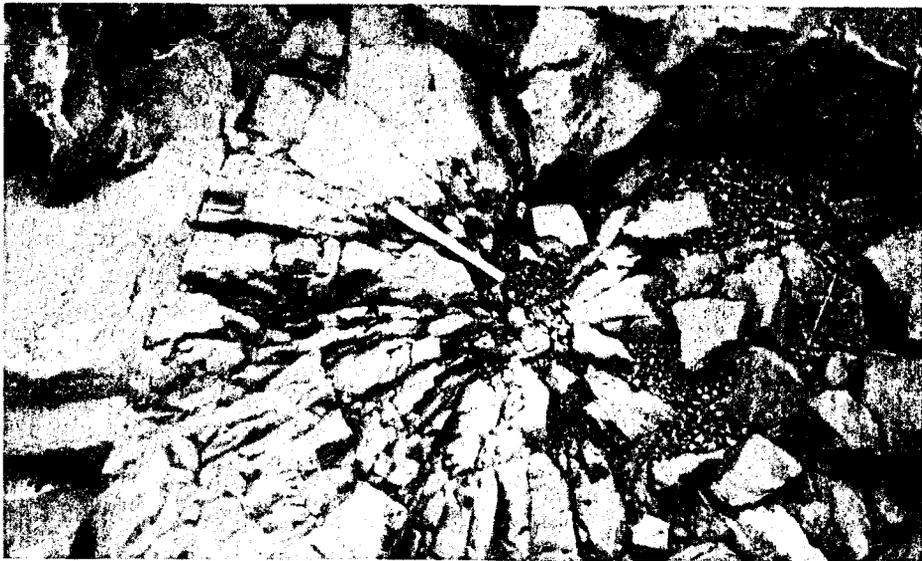
Figure 1. Blasting during excavation of a cut spillway results in a distinctive fracture pattern in hard igneous rock forming the floor of the emergency spillway channel in Lower North River Site 81C (Virginia)

example, illustrates the fracture pattern typically caused by blasting during the construction phase in an excavated emergency spillway channel.

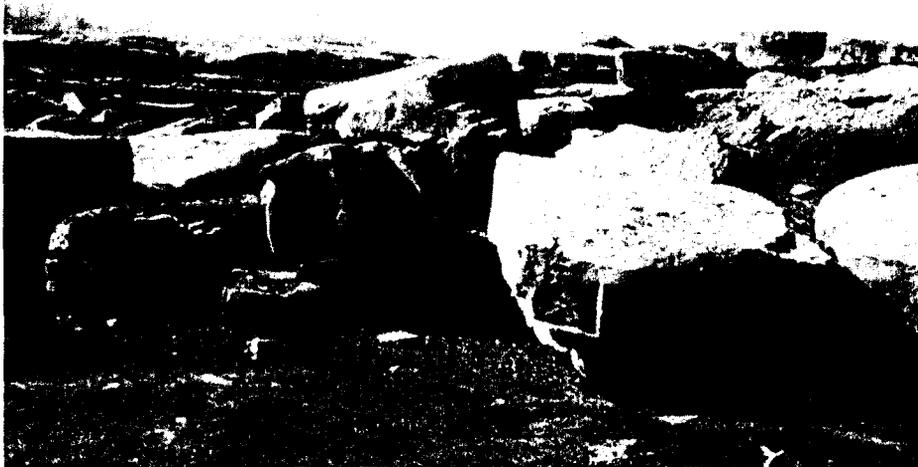
Figure 3. Open joint fissures segment the hard resistant sandstone which floors the upstream portion of the Saylorville spillway (US Army Engineer District, Rock Island (NCR)). Undercutting and retreat of the soft, erodible shale beneath resulted in collapse of the sandstone and the formation of a waterfall

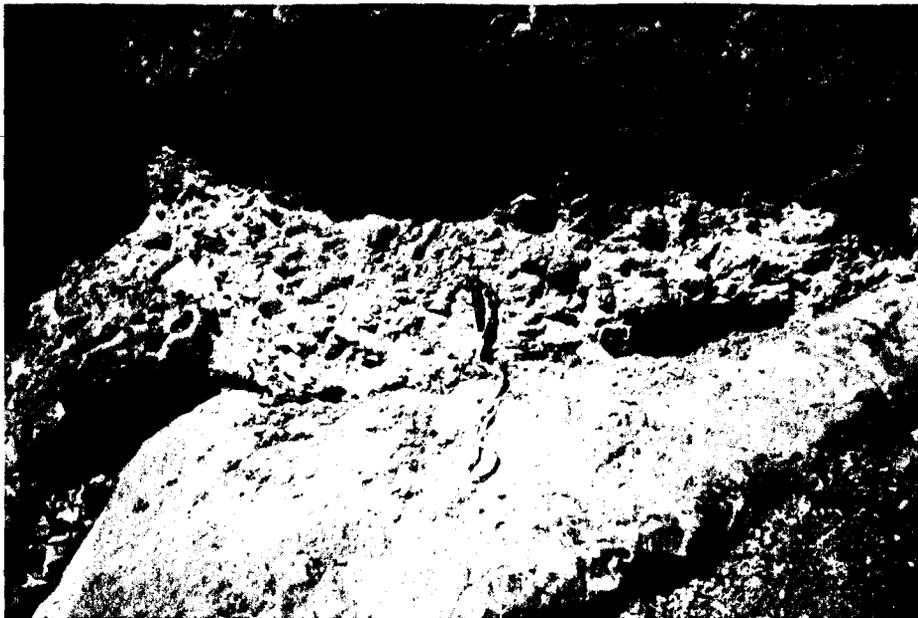
Figure 4. Weathering and the effects of scour during flows in 1983 and 1986 removed fissure fillings of clayey weathered basalt and mudstone from joints and fractures in basalt forming the downstream terminus of the Black Butte (US Army Engineer District, Sacramento (SPD)) spillway channel

19. Joint spacing (i.e. the perpendicular distance between joints of a given set) can be highly variable, with intervals in the range of hundreds of feet down to only a few feet. Where the joint separation is only a fraction of an inch, the term "fracture cleavage" is most appropriate. Joint fissures are the actual fractures which separate the rock. Joint fissures may be tight and filled with mineral-bearing material (clays, crushed rock fragments, sand-like gouge, calcite, gypsum, etc.), particularly in the subsurface, but are often open in the surface and shallow subsurface weathering regimes (Figure 2). The size of the fissure opening (aperture size), or joint-block separation, is often a function of proximity to the surface and slope of the ground or free-air surface. For example, field investigations at the Saylorville, Iowa, emergency spillway showed that the joint fissures in the hard competent sandstone bed forming the floor of the upstream portion of the channel exhibited progressive opening as the downstream terminus of the bed is approached (Figure 3). A similar situation is present at the Black Butte, California, spillway where the fissures in jointed basalt have been opened at the downstream falls by both erosion of fissure fillings and downslope movement of the blocks during flow events (Figure 4).

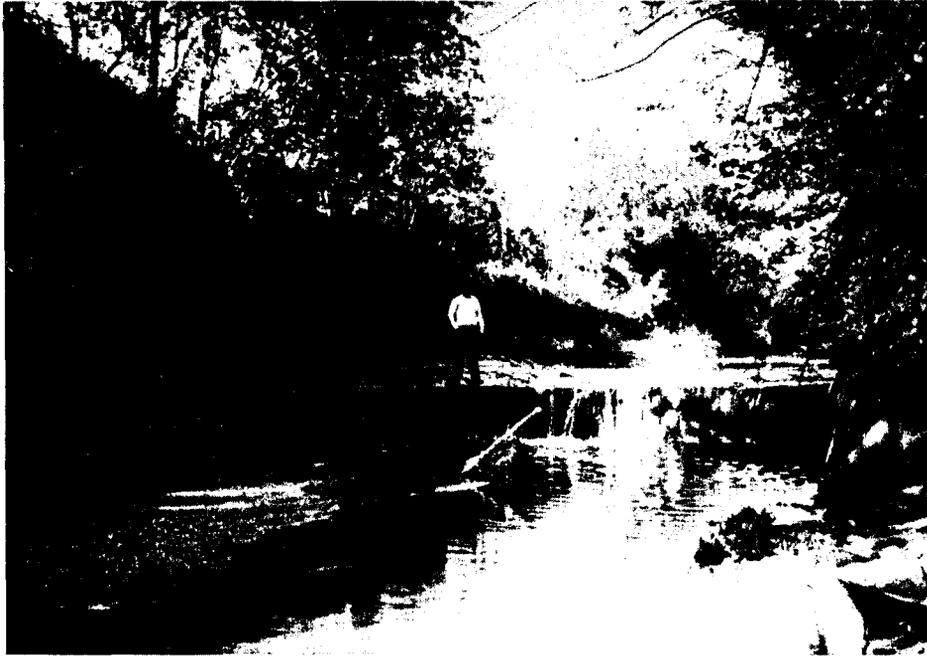
a. Hotopha Creek

b. Tillatoba Creek

Figure 5. Photographs showing natural stream channel knickpoints, Yazoo Basin Uplands, Mississippi (after Whitten and Patrick 1981)

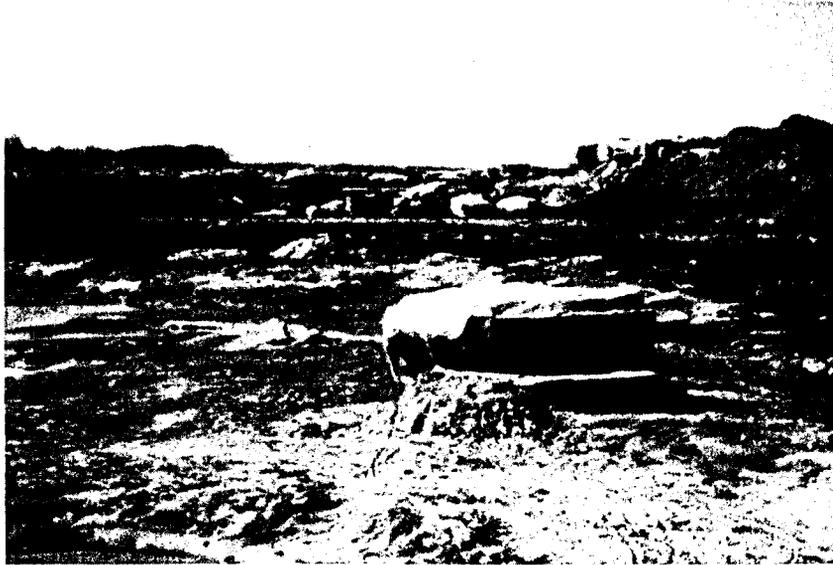
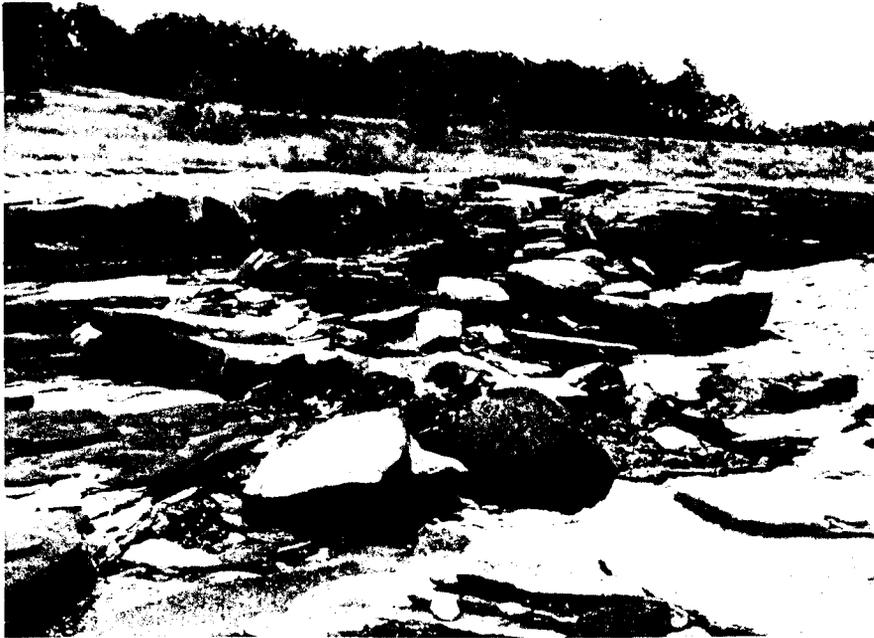
a. Upstream view

b. Downstream view

Figure 7. Photographs showing severe erosion in the emergency spillway channel at Saylorville after the 1984 overflow event. Note stairstep erosional pattern (after Cameron et al. 1986)
