# DREDGED MATERIAL RESEARCH PROGRAM

MISCELLANEOUS PAPER D-78-3

## PERIMETER DIKE RAISING WITH DEWATERED FINE-GRAINED DREDGED MATERIAL AT UPPER POLECAT BAY DISPOSAL AREA MOBILE, ALABAMA

August 1978

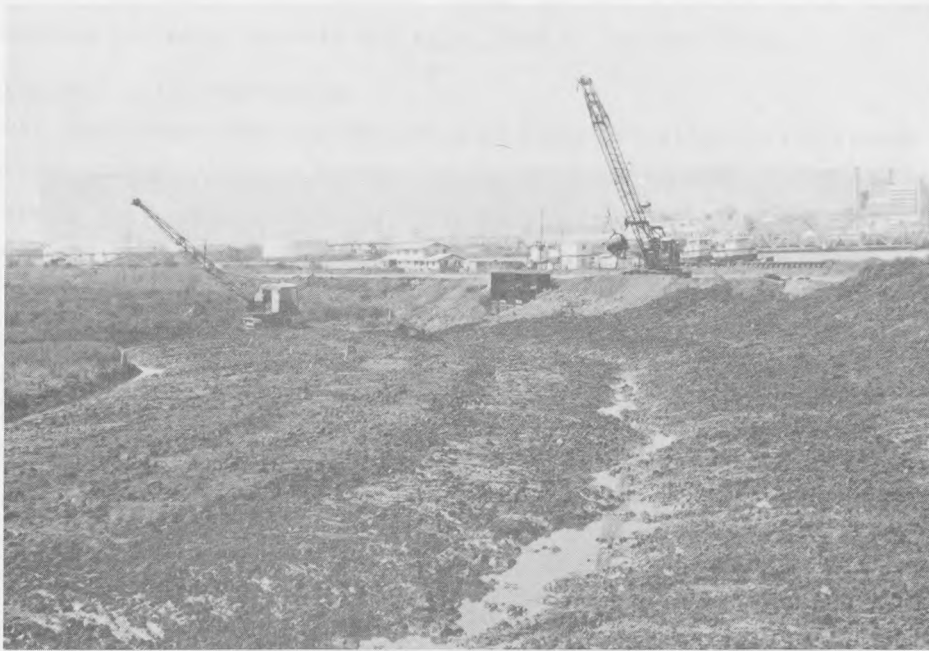
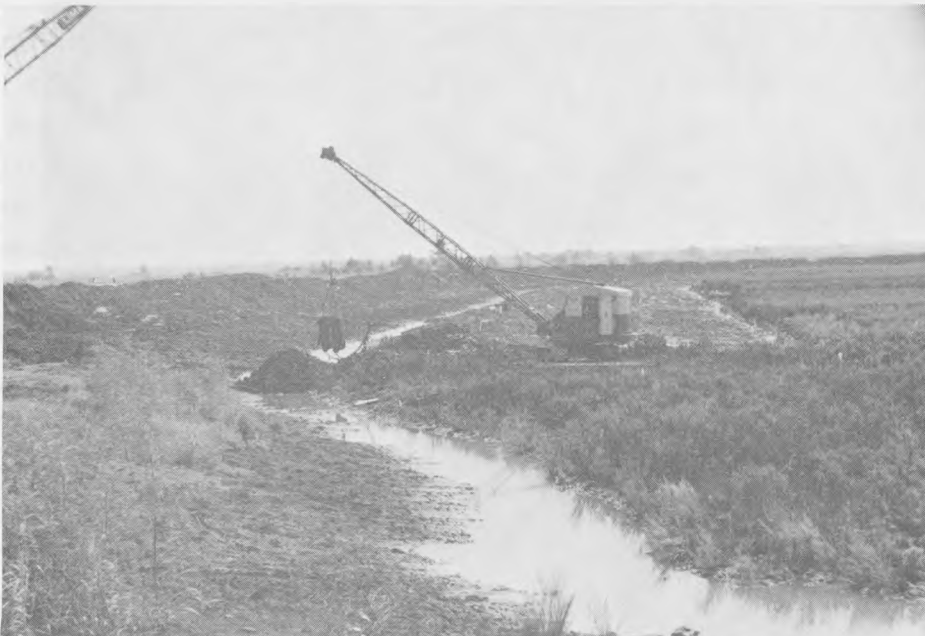
Figure 6. Tandem dragline borrow removal operation

a. Tandem dragline operation removing dewatered fine-grained dredged material. Operation has reached the northmost weir location

b. View of small dragline working on mats inside perimeter dike. Note pile of material placed for large dragline rehandling and drainage ditch maintained after borrow removal

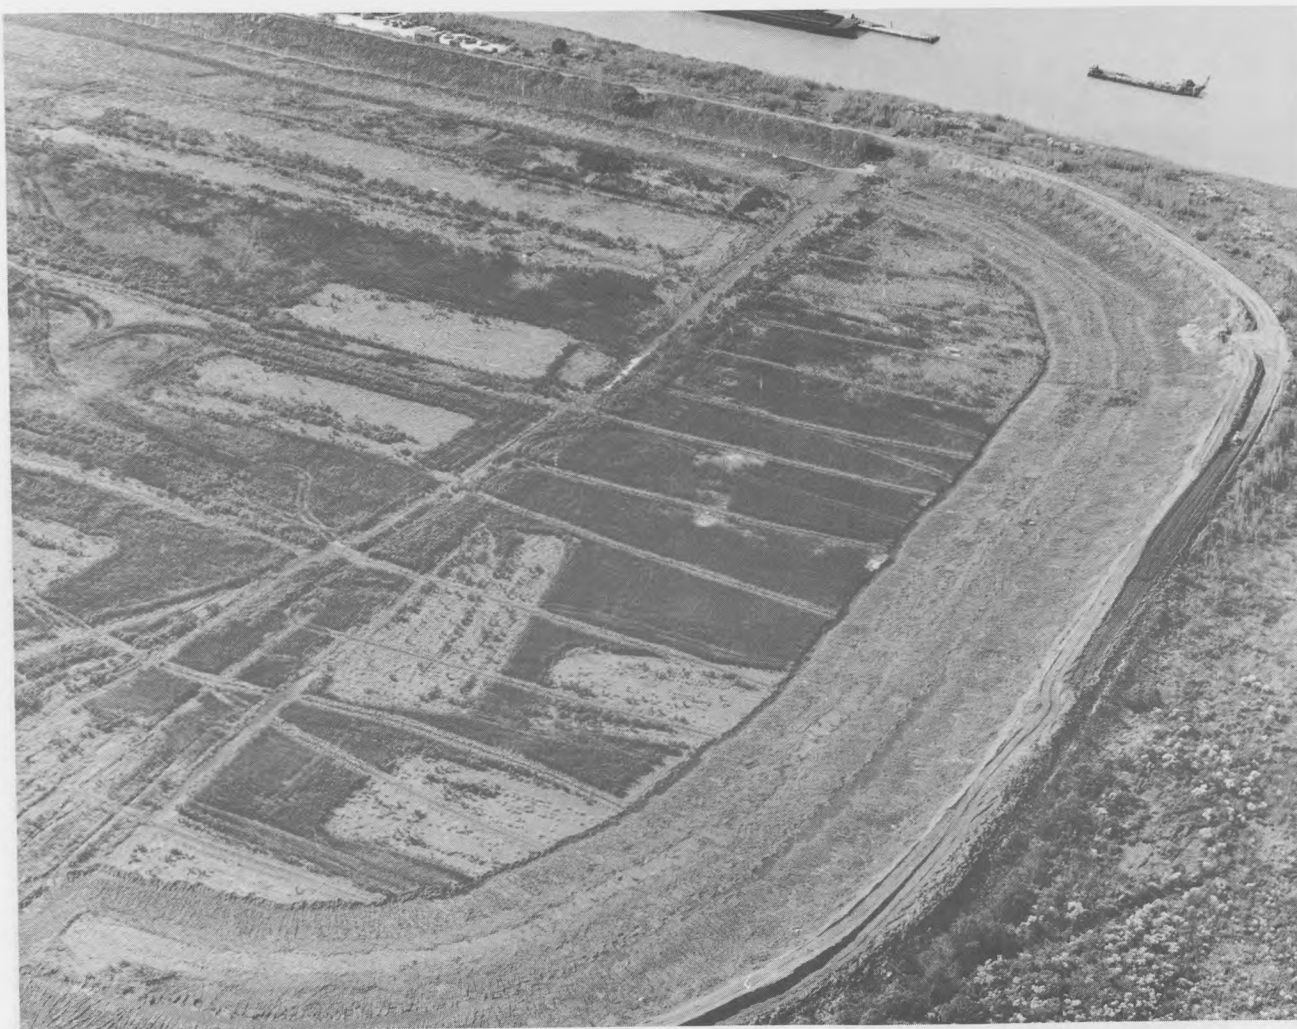
Figure 7. Aerial view of north end of Upper Polecat Bay Disposal Area, looking west southwest from northeast corner. Note strip of dewatered fine-grained dredged material removed around disposal site perimeter

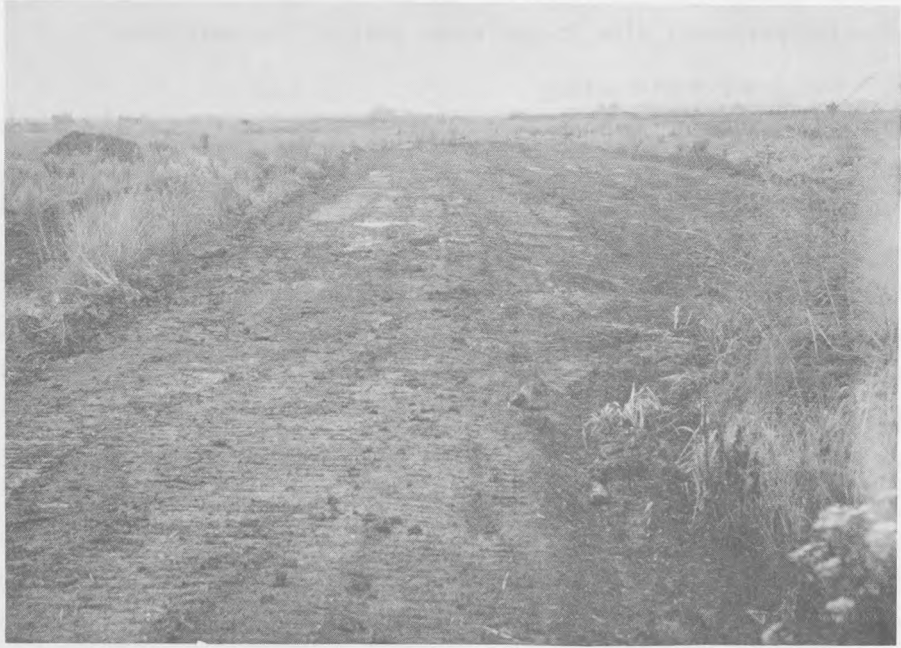
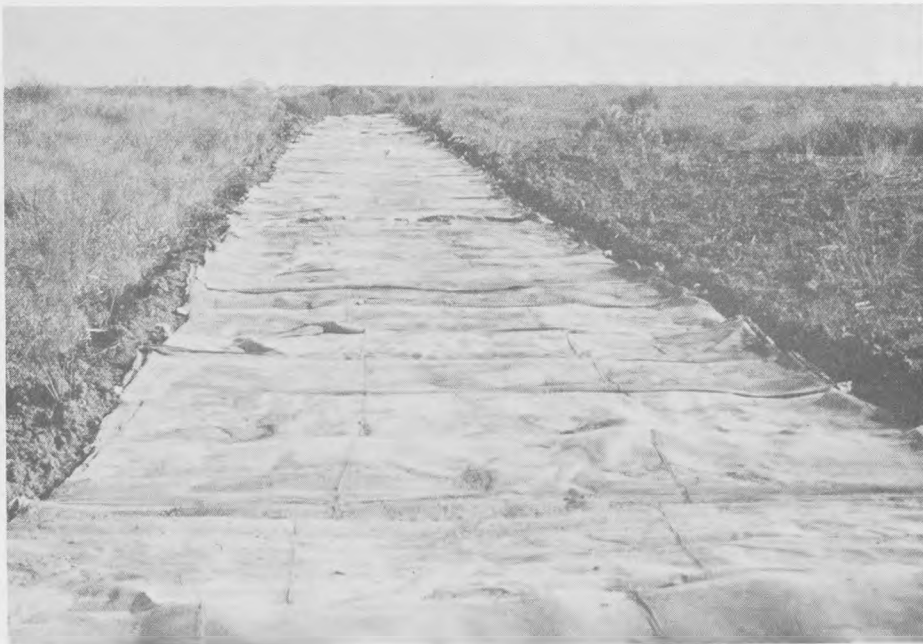
Figure 8. Details of interior haul road construction

a. Mounded subgrade for interior haul roads was constructed with the small wide-track dozer. Material was bladed from the right of the photograph and semicompacted to form the haul road pad shown in the center of the photograph

b. After the pad was complete, 12-ft-square sheets of filter fabric were laid on the pad and overlapped

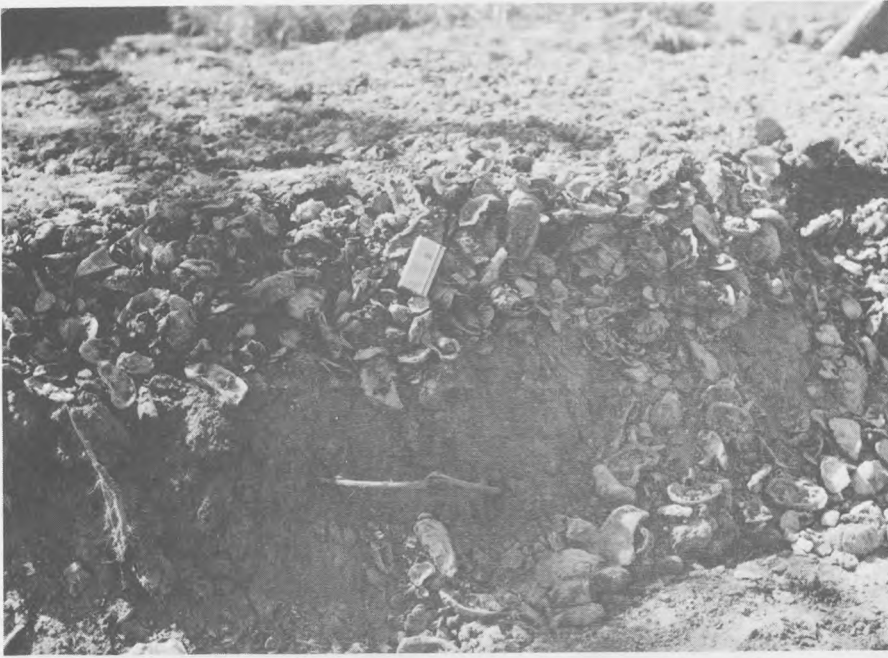
Figure 9. Photograph of completed haul road section showing dredged material surface, semicompacted subgrade mound, and shell surfacing. The fabric was placed at the interface between surfacing and subgrade

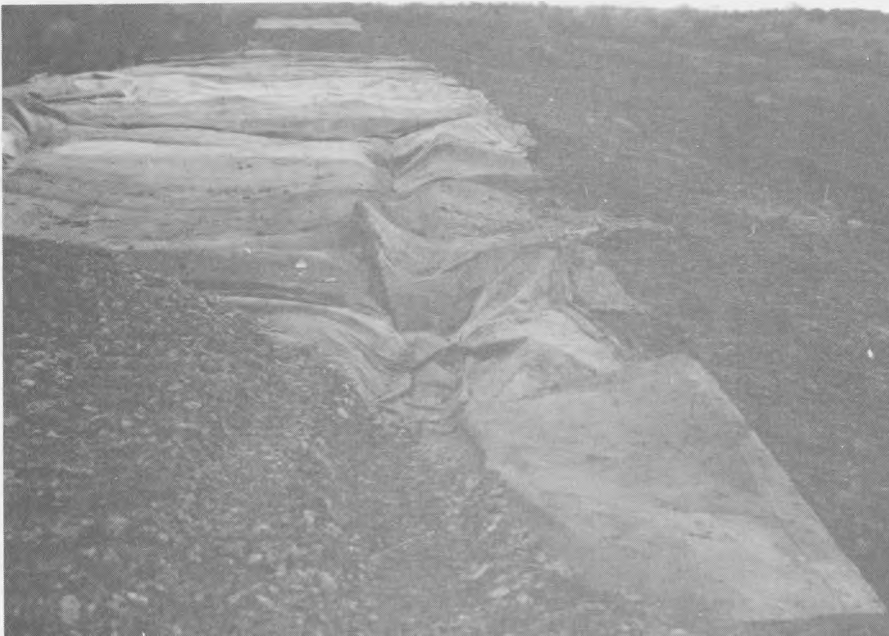
Figure 10. Rutting in the fabric-supported subgrade occurred when trucks backing down the haul road spreading shell continued to back after their load was exhausted. The photograph illustrates the need for fabric cover to obtain desired roadway performance

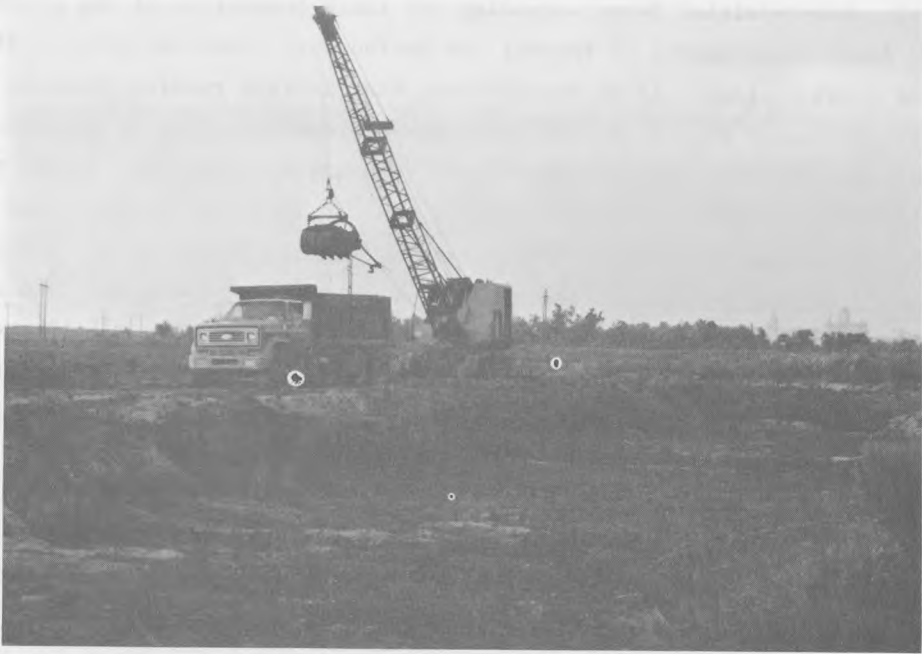
Figure 11. Medium dragline shown loading dump trucks with dewatered fine-grained dredged material in interior borrow area

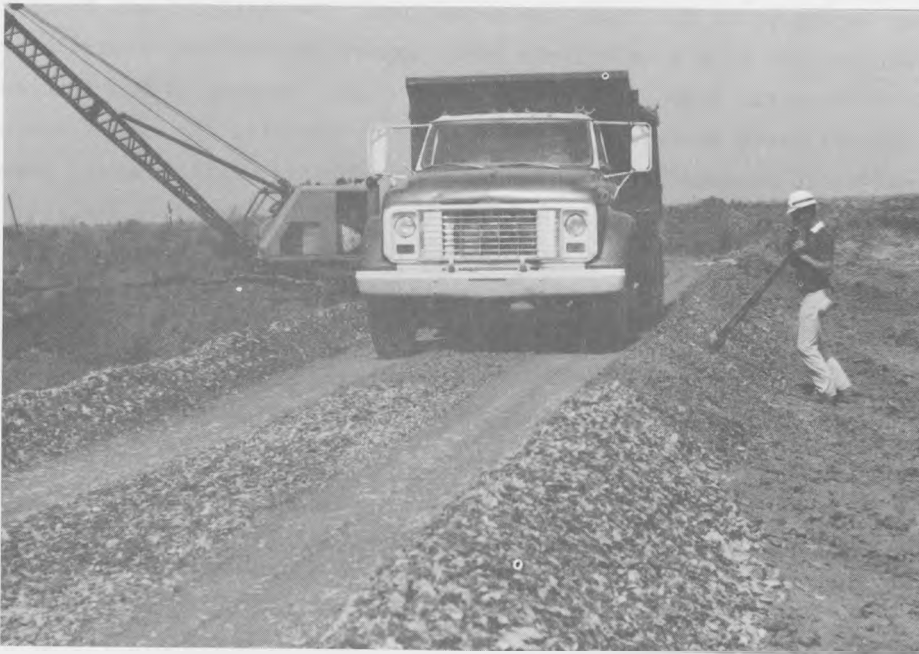
Figure 12. Photograph of spur haul road surface after approximately 300 load repetitions. Note relatively good condition of surface with minimal rutting in wheel paths

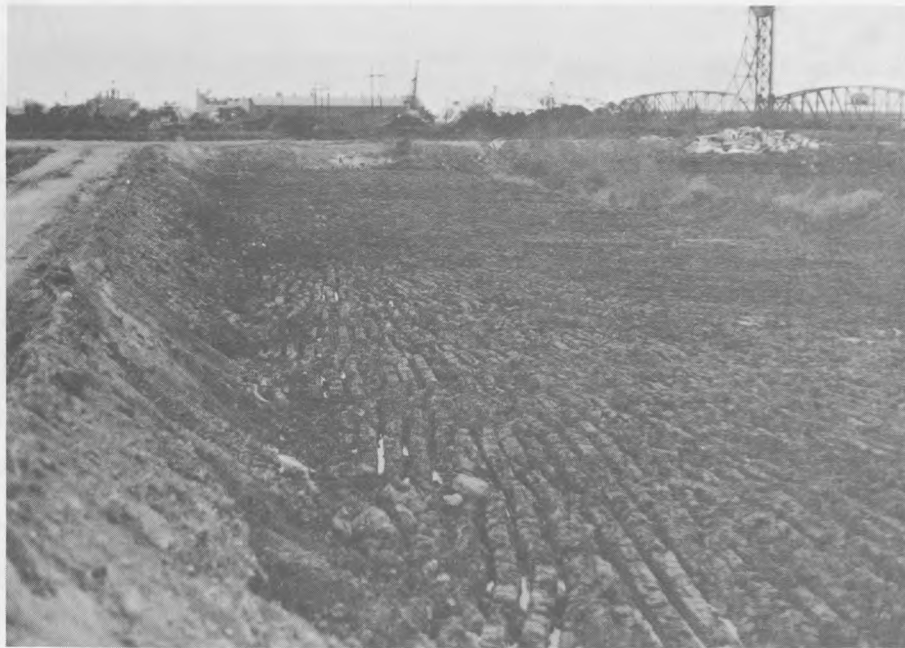
Figure 13. View along edge of spur haul road after dredged material crust had been removed. No evidence of subgrade bulging, foundation bearing failure, or mud waves is seen in the photograph

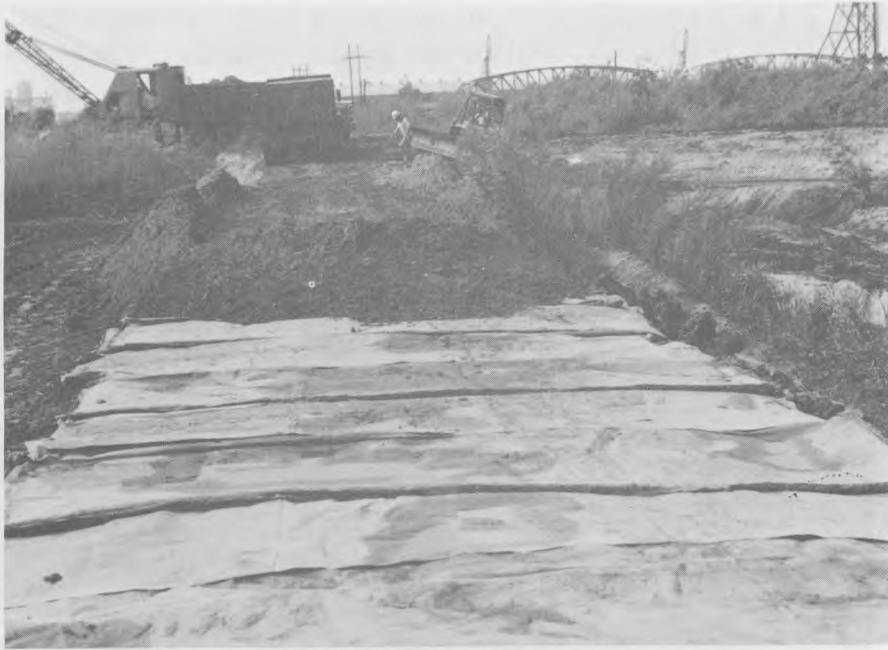
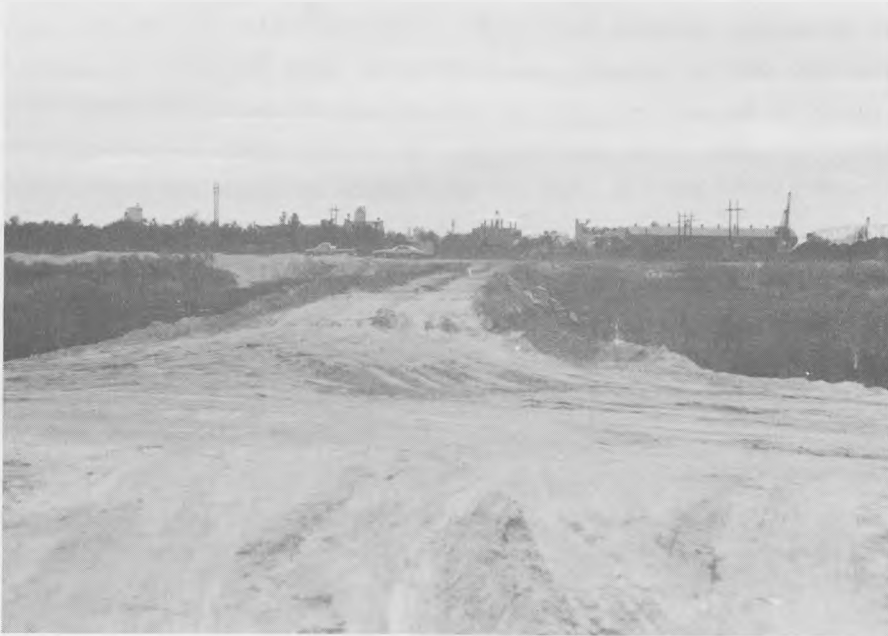
Figure 14. Details of haul road surfacing with cement waste

a. Cement waste evaluated as road surfacing is shown being placed on the fabric-covered subgrade. Note the resemblance of the partially hydrated cement waste to sand

b. Condition of cement waste surface on spur haul road after approximately 400 load repetitions

47. Figure 14a shows the cement waste being placed on the ALCOA-provided filter fabric. Initial attempts at dozer-track compacting this material in a dry state were essentially unsuccessful. Some attempts were made to haul water to the material in the contractor's dump trucks; these attempts were only partially successful. The most successful construction technique for compaction

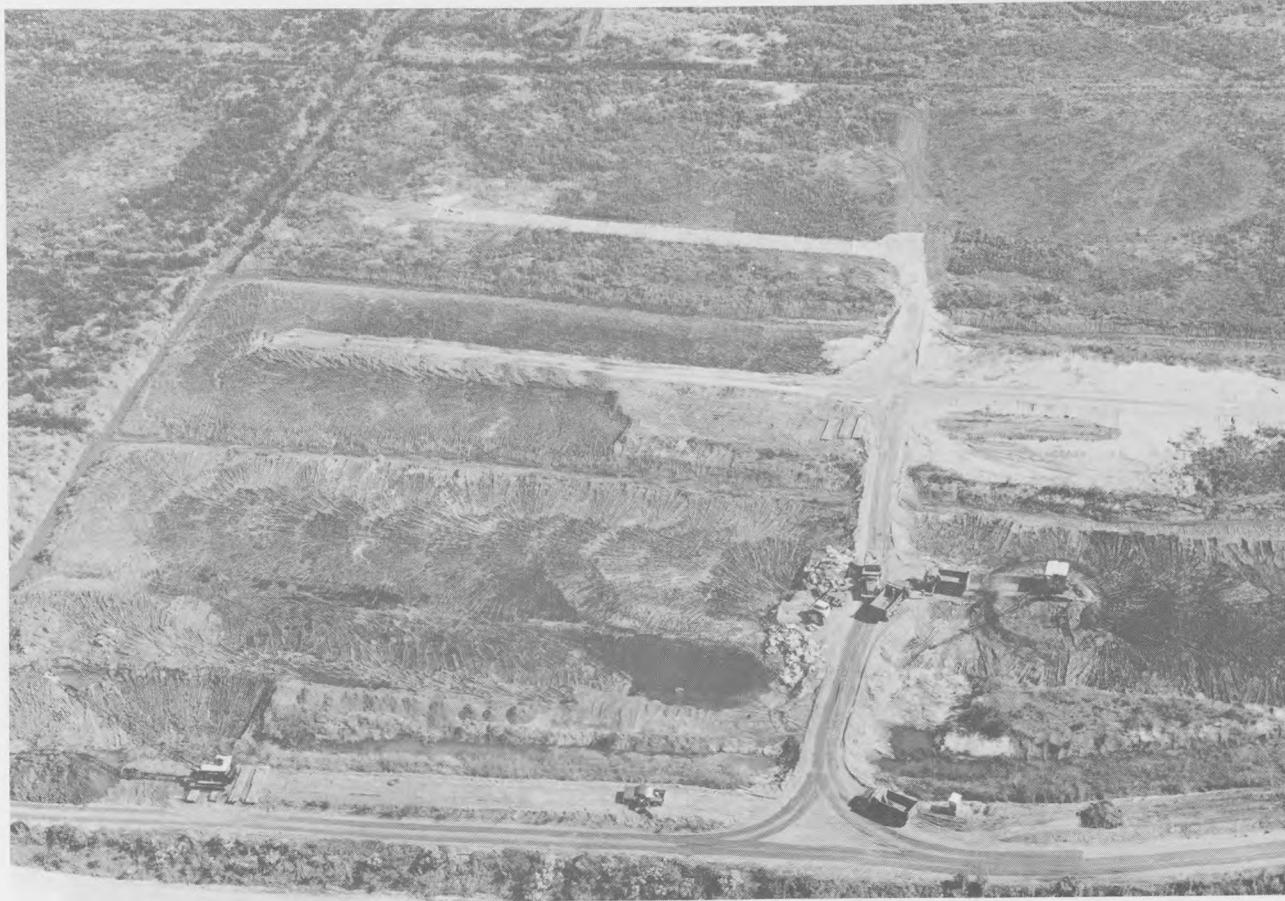
Figure 15. Aerial view of interior borrow area looking east. Note main west-east haul road entering roadway from existing dike crest. The first spur haul road in the left corner of the photograph has already been removed, along with the borrowed crust. Partial borrow operations have been conducted along the second spur haul road and the dragline is currently removing the other arm of the first spur haul road. Also seen in the photograph are a completed haul road spur, not yet in use, in the right center of the photograph and fabric placed for a third haul road spur in the upper center of the photograph. The subgrade pad established for the main haul road may be seen as an extension of the existing main haul road in the upper part of the photo

48. Figure 15 is an aerial view of the haul road area. As may be noted from the photograph, material has been removed from the lower left portion of the photograph and the spur haul road that extended into this area has also been removed. Borrow removal has taken place along one haul road, and another haul road is being removed. An already constructed but not yet used haul road may also be seen in the photograph, as well as fabric placed for another spur haul road.

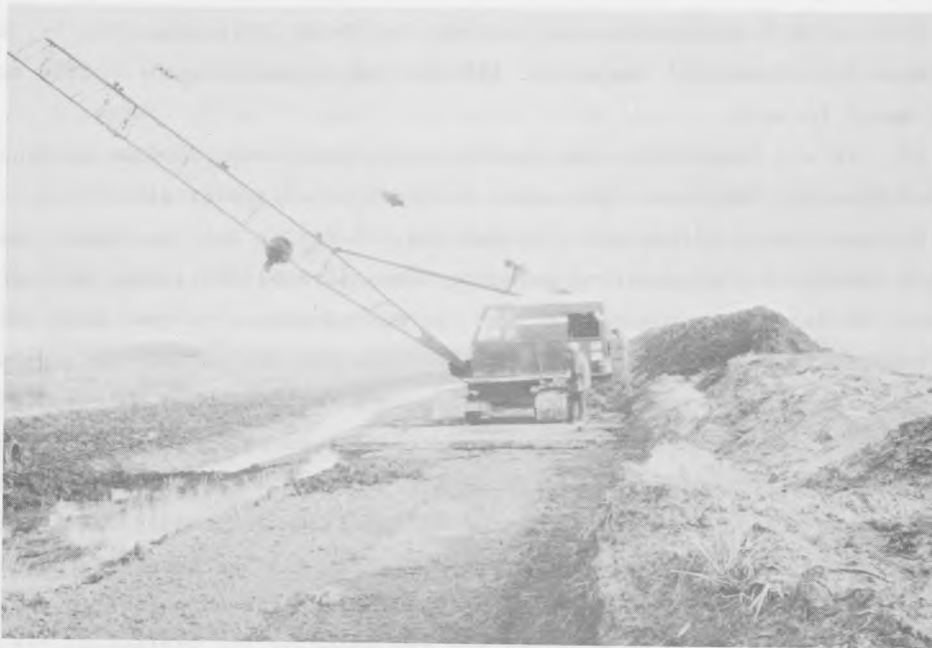
Figure 16. Large dragline shown removing crust from inside perimeter of east dike. Crust bench under dragline mats will be used for construction of second lift. Note mounds of borrow along alignment placed by previous truck haulage from interior borrow area. Small dragline is shown in background placing second lift in long partial segment construction

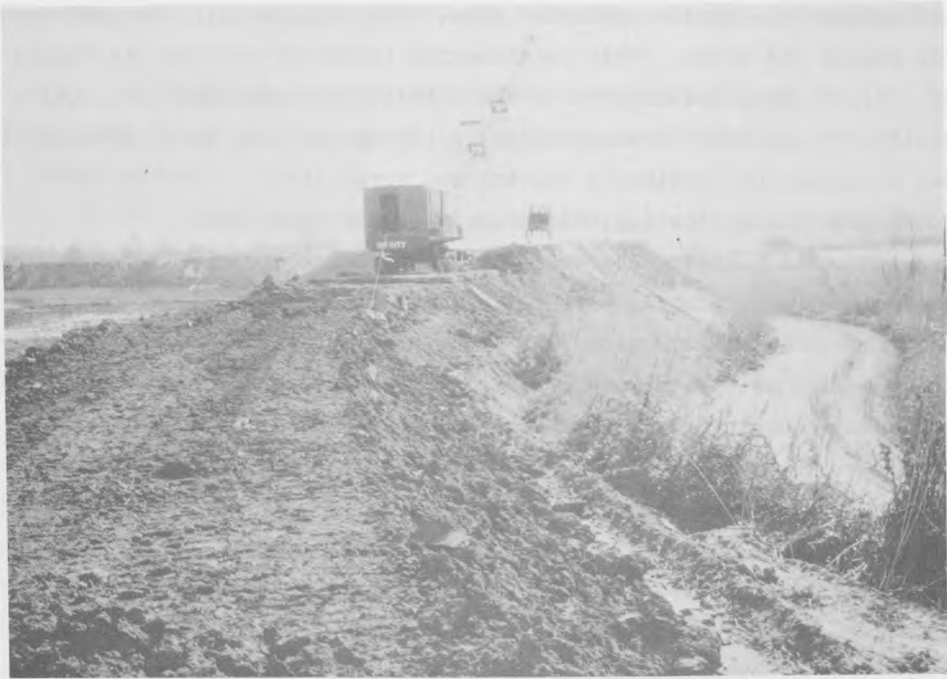
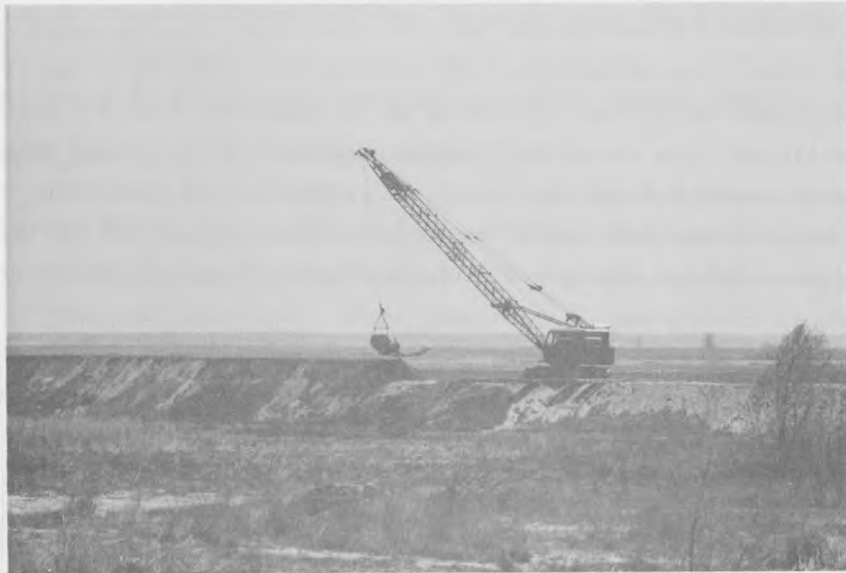
Figure 17. Long partial segment dike construction method

a. Dragline is shown completing first lift along east dike. Borrow in foreground has been roughly shaped by dozer to facilitate precipitation runoff. Ragging on stake in center of photograph indicates El. 20 MSL, crest elevation for first raise lift

b. After initial construction, the second lift was placed and crest and side slopes dressed by the dragline

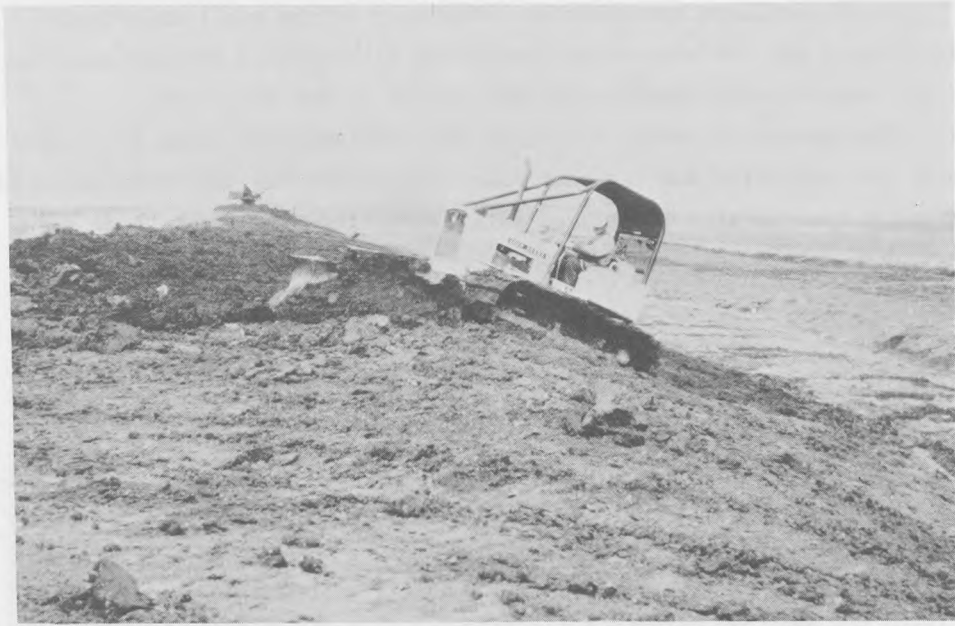
Figure 18. Small wide-track dozer shown constructing first lift while dragline in background of photograph constructs second lift and dresses the crest and side slopes

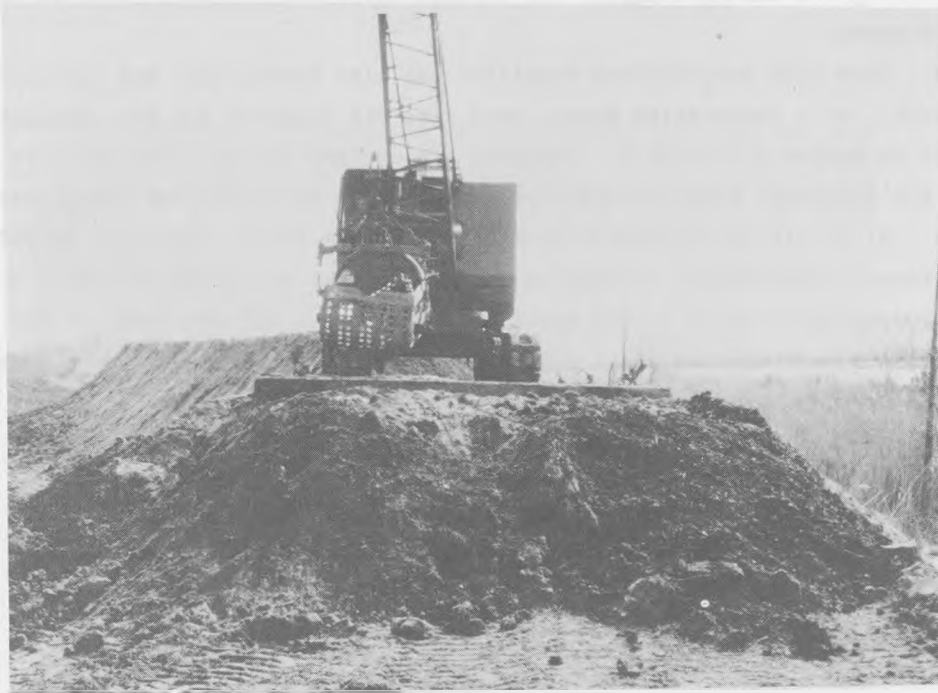
Figure 19. In the sequential dike construction technique, the dragline constructs the first lift ahead for a short distance, then rotates its boom and constructs the second lift behind, while moving down the dike alignment

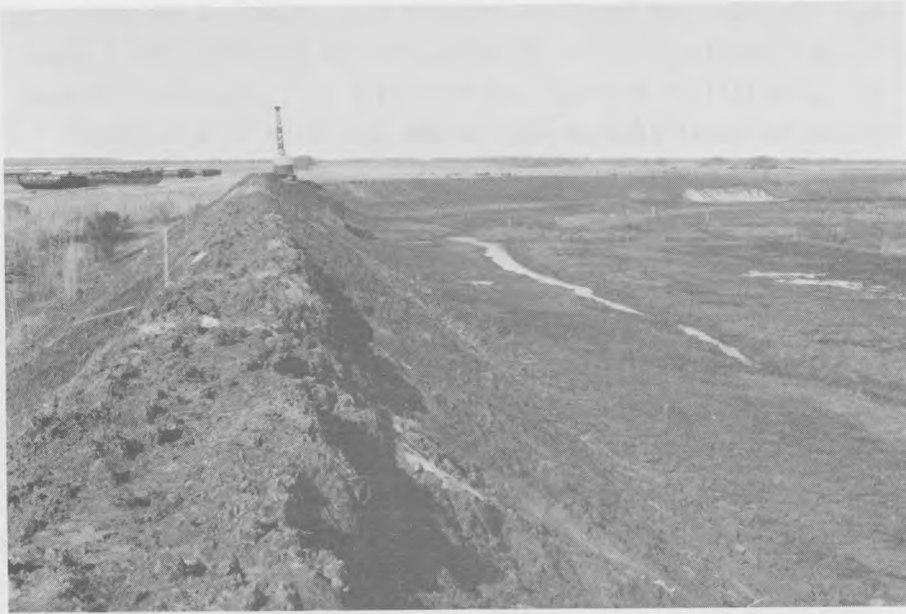
Figure 20. Rain-induced sloughing and sliding of uncompacted second lift. Note rotational slumping on inside slope with crest subsidence. Underlying semicompacted first lift was not affected

65. After approximately 4,000 lin ft of finished dike had been constructed, from the northeast corner of the site west along the north dike and south along the west dike, extremely heavy precipitation, amounting to more than 10 in. in 48 hr, fell over the disposal area. This heavy rainfall infiltrated portions of the uncompacted second lift in the vicinity of the northmost weir (Figure 5) and approximately 1,500 lin ft of the second lift suffered side slope erosion damage and generalized slope sloughing and sliding along both interior and exterior side slopes. The underlying semicompacted first lift was unaffected. The rain-induced damage is shown in Figure 20. Evaluation of this failure indicated that, when placing the second lift, the crest had not been crowned sufficiently to allow rapid precipitation runoff. Ponding thus occurred on the dike crest and resulting infiltration both increased the unit weight of the uncompacted second lift material and reduced its effective shear strength. Also, the ponded water velocity at these localized points produced erosion damage. At other locations along the dike where the second lift was in place with proper crown, the heavy precipitation ran off, with essentially minimal damage to the dike.

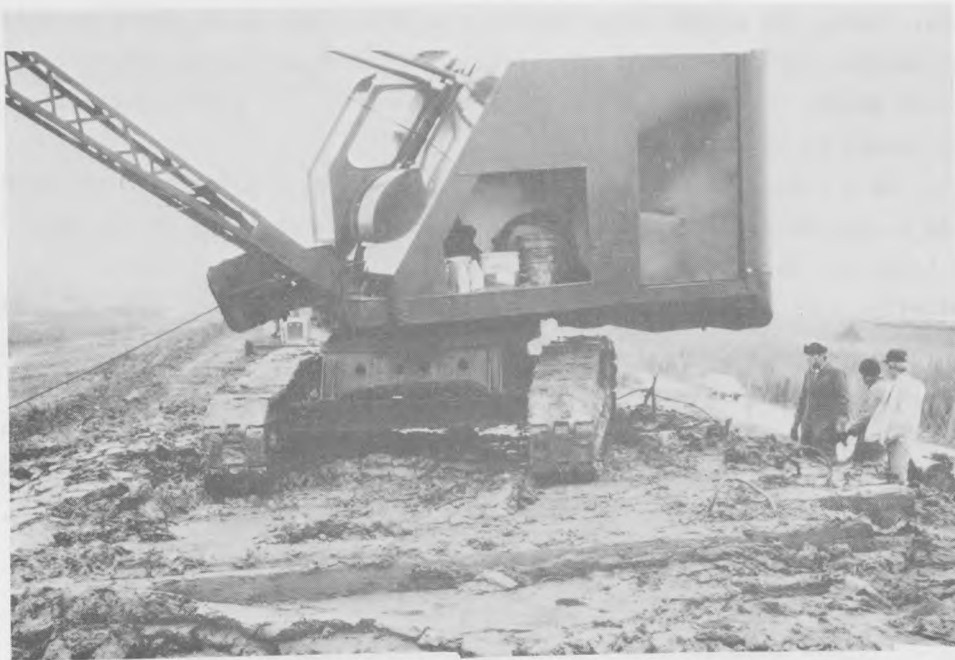
Figure 21. Dragline in mobility trouble on east dike caused from precipitation ponding and infiltration into previously place first lift

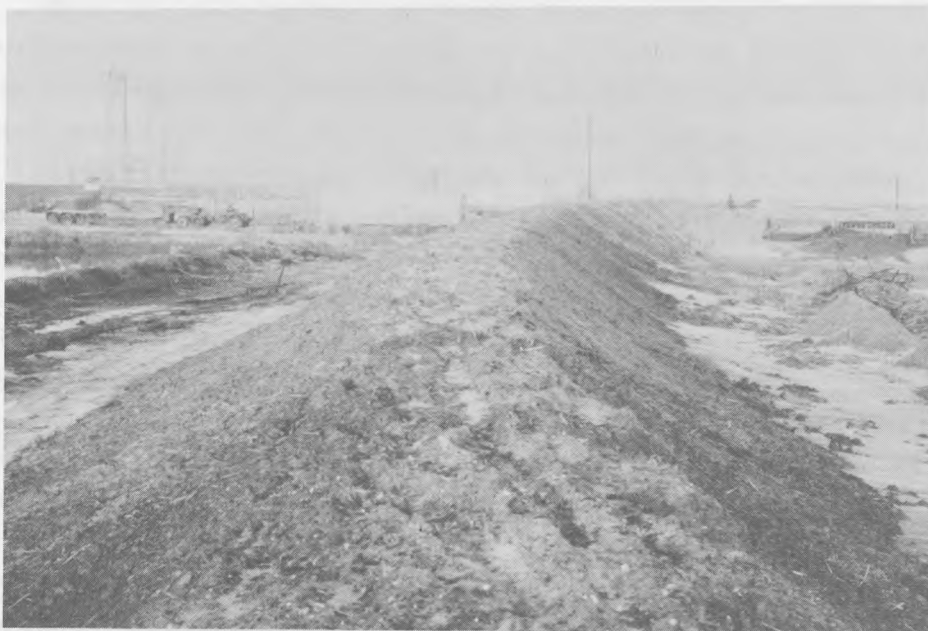
Figure 22. Dike segment of essentially coarse-grained material constructed between east dike and DOP underdrainage experiment location. View looking east from the east dike toward the DOP underdrainage experiment. Note traces of snow on the embankment

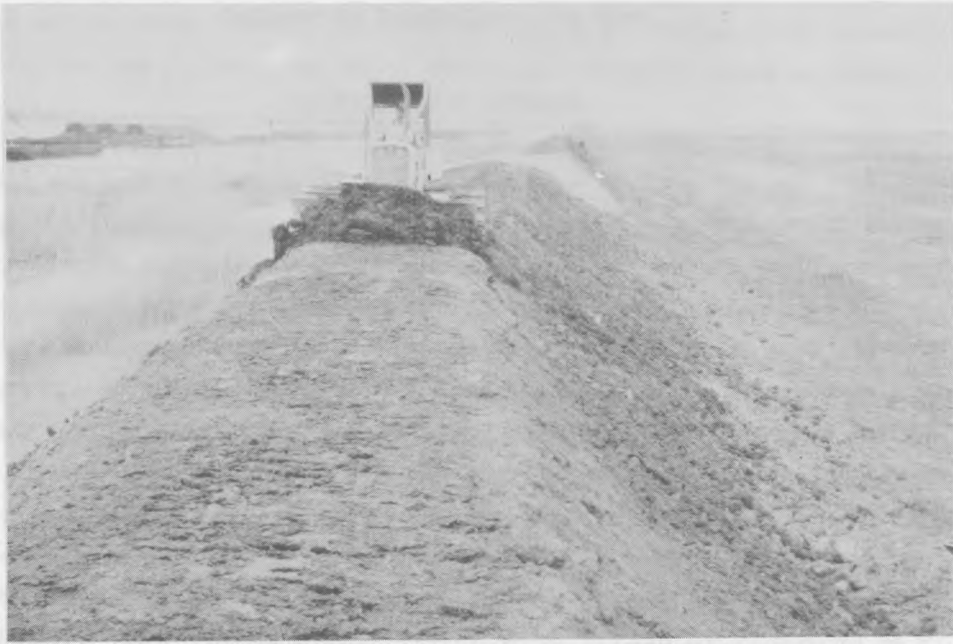
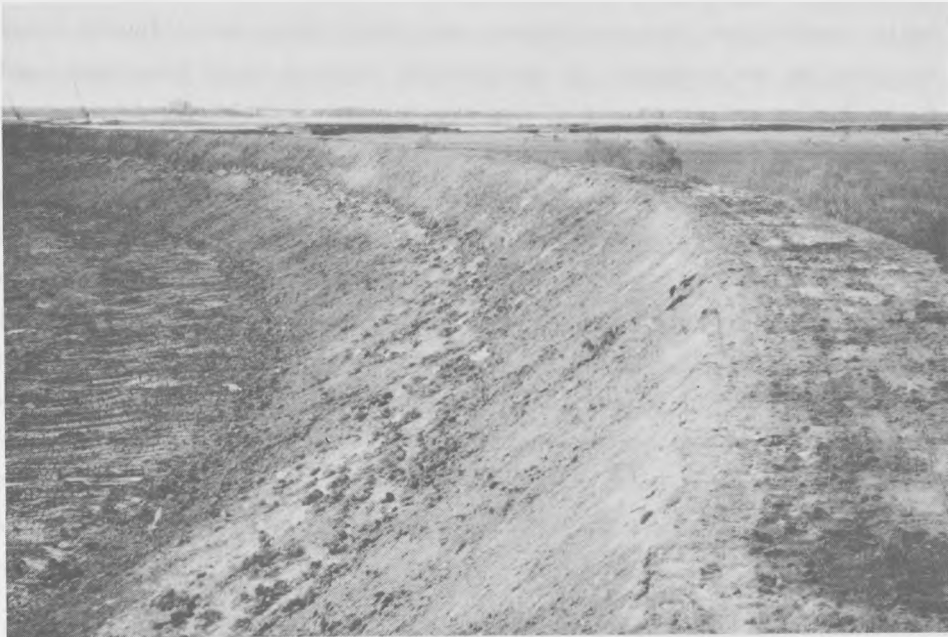
Figure 23. Completion of perimeter dike raising

a. As the last construction operation, the small wide-track dozer bladed the dike to 8-ft crest width at El. 24 MSL

b. View of the completed raised perimeter dike

70. After the entire dike alignment had been raised to El. 25 MSL, the dragline equipment was demobilized and the small wide-track dozer made two passes around the entire perimeter, lowering the final grade to El. 24 MSL while providing some track compaction of the crest. Material bladed from the crest was spilled down the finished embankment side slopes and served to fill in any small erosion gullies. Over most of the alignment, the uncompacted second lift had subsided approximately 6 to 9 in. since construction. Approximately 2 working days were required for the dozer to complete cutting the embankment to El. 24 MSL and shaping the crest to facilitate future precipitation runoff. The dozer operation is shown in Figure 23a and the finished disposal area dike is shown in Figure 23b.
