Application of Regional Sediment Approach to Hickahala Creek Watershed, Northern Mississippi

*by David S. Biedenharn, Chester C. Watson,
John B. Smith, and Lisa C. Hubbard*

PURPOSE. Biedenharn (2004) described the systematic approach to Regional Sediment Management (RSM) that has been developed as part of the Demonstration Erosion Control (DEC) project. The purpose of this Coastal and Hydraulics Engineering Technical Note (CHETN) is to describe how this RSM approach was successfully applied to the Hickahala Creek watershed in northern Mississippi.

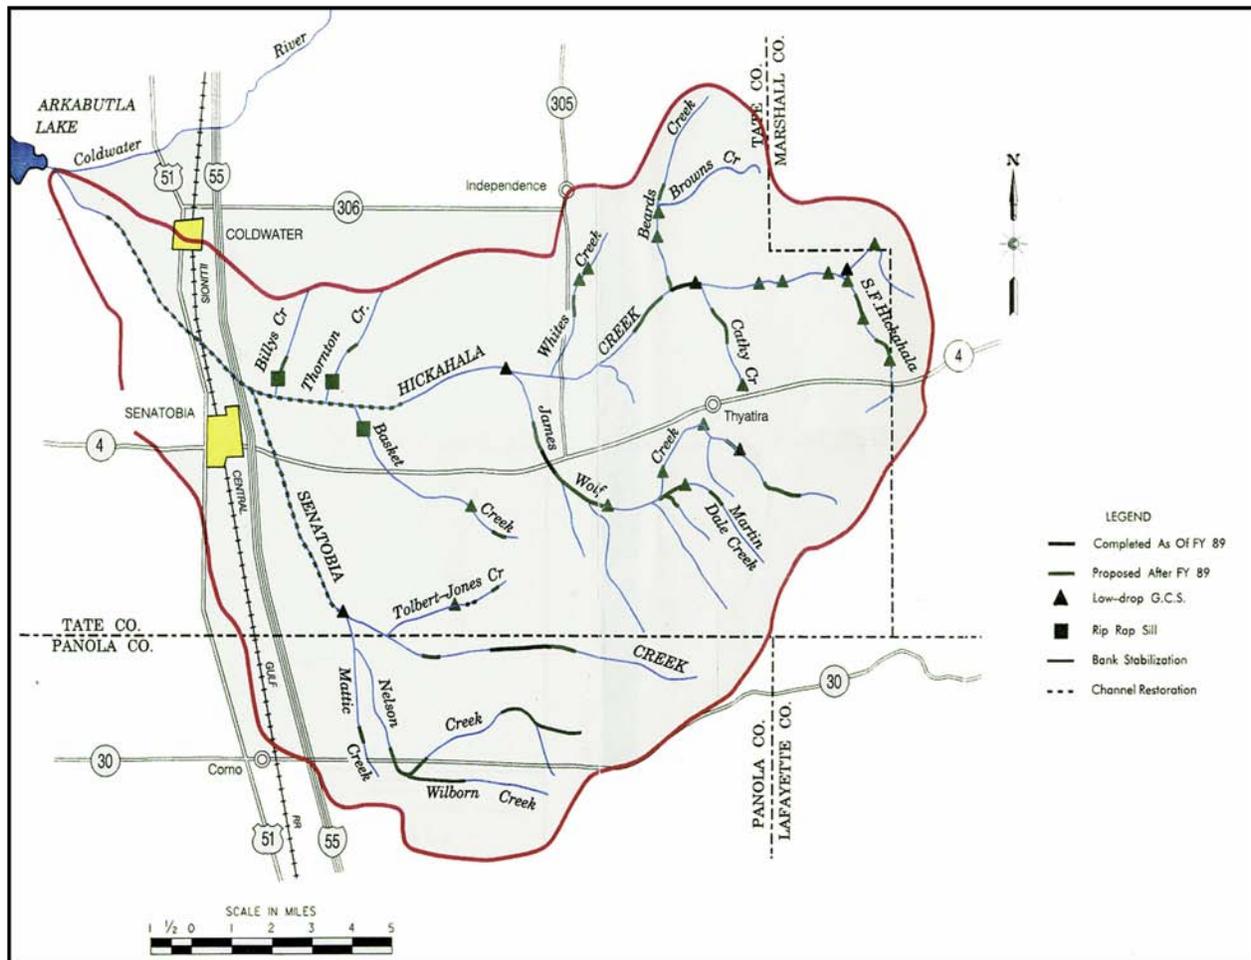
Hickahala Creek and several major tributaries such as Senatobia Creek were cleared and straightened for the first time in the 1930s under the direction of local drainage districts. A flood-control reservoir, Arkabutla Lake, was constructed by the Corps of Engineers on the Coldwater River in the early 1940s. The maximum flood-control pool for the reservoir inundates Hickahala Creek upstream from the confluence with Coldwater River for approximately 10 km, to a point above the confluence with Senatobia Creek (Figure 2).

Figure 2. Hickahala Creek Watershed, Northern Mississippi.

Plan Selection. The data in Table 2 summarize the selected plan for the Hickahala Creek watershed. Figure 2 shows the limits of the channel improvement work, and the location of proposed grade control structures and the general areas requiring bank stabilization.

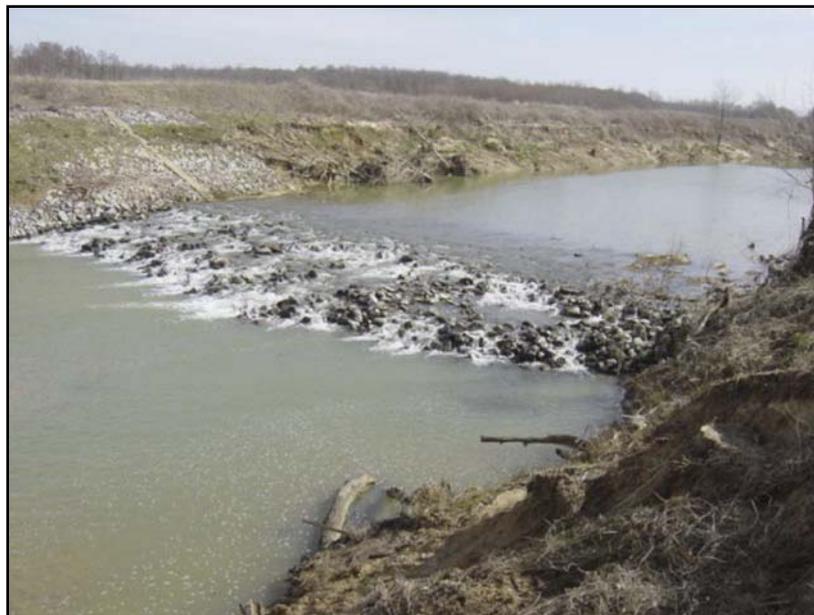
Figure 7. Riprap sill during 2003 field inspection.
