**ERDC/CRREL TR-00-8**

## **Expedient MESL Construction in Cold Weather**

July 2000

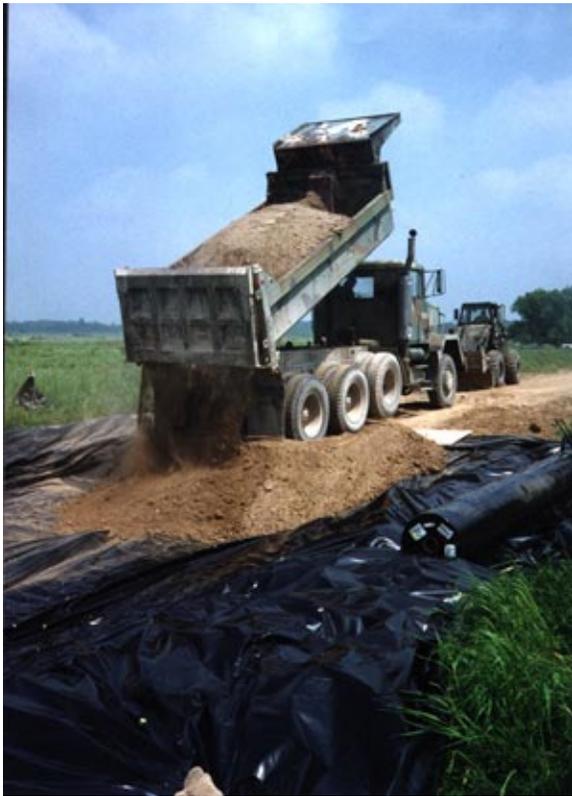
*Figure 5. Using a D-7 to spread soil in the MESL.*

The fill material was transported to the site in 20-ton dump trucks. Because vehicle traffic would damage the membranes, the trucks had to back to the edge of the excavation to dump the fill soil (Fig. 4) and a dozer pushed the material over the membrane (Fig. 5). A loaded 20-ton dump

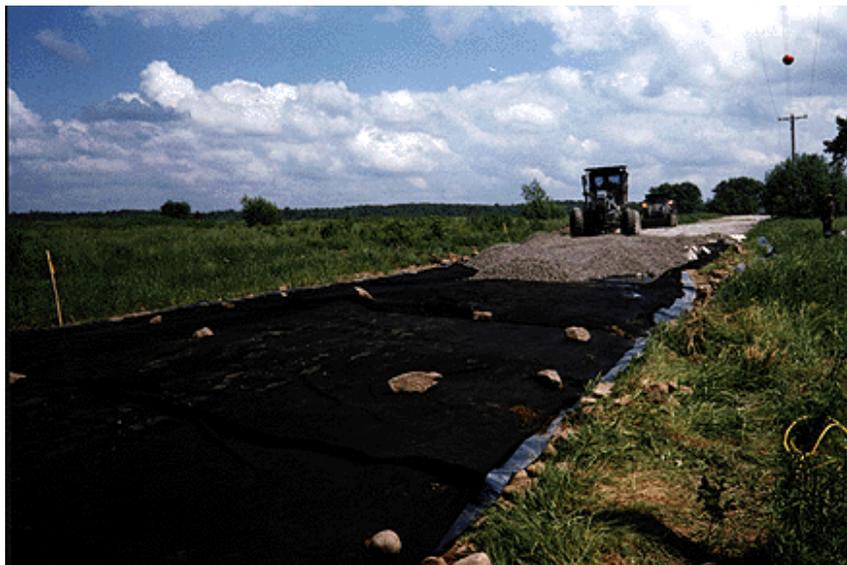
*Figure 7. Spreading the gravel wearing course on the MESL.*

The gravel for the wearing surface was brought to the site in 20-ton dump trucks. Once again the trucks had to back to the edge of the MESL to dump the gravel to avoid damaging the membrane. The D-7 dozer and a bucket loader were used to spread the gravel over the MESL. On the final day of construction a grader was brought from another construction site to spread the gravel to a 152-mm (6-in.) lift (Fig. 7). The gravel was compacted by vehicle traffic.

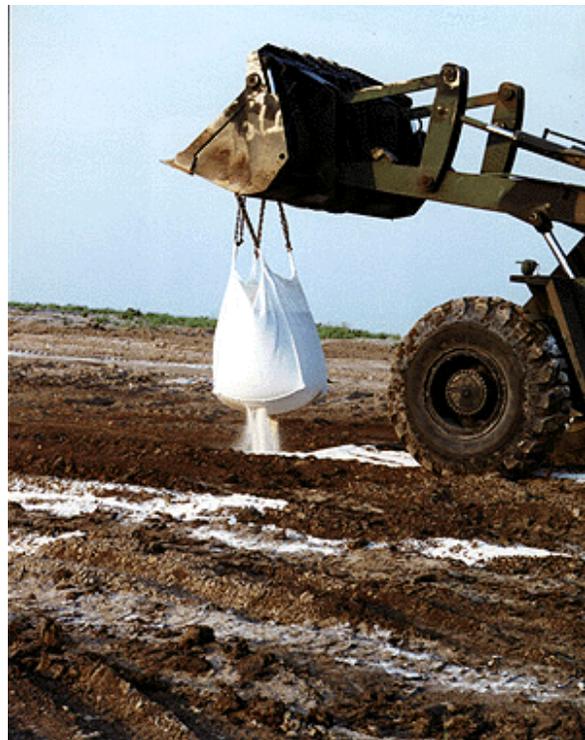
*Figure 8. Bucket loader spreading lime.*

small gullies formed by erosion. The one-ton supersacks of lime were loaded on a lowboy trailer using a forklift and were then delivered to the site where a bucket loader was used for unloading. The supersacks were picked up with the loader using four chains placed through loops on the bag. The bucket loader carried the bags to the mixing area where three holes were cut in the bottom of the bags. The loader then drove back and forth to spread the lime (Fig. 8) in lines with piles of lime where the bags were opened and where the loader changed directions. Water was then spread on the lime to hydrate it and wet the clay. The clay was dry because the soil was sloped and exposed to the sun.

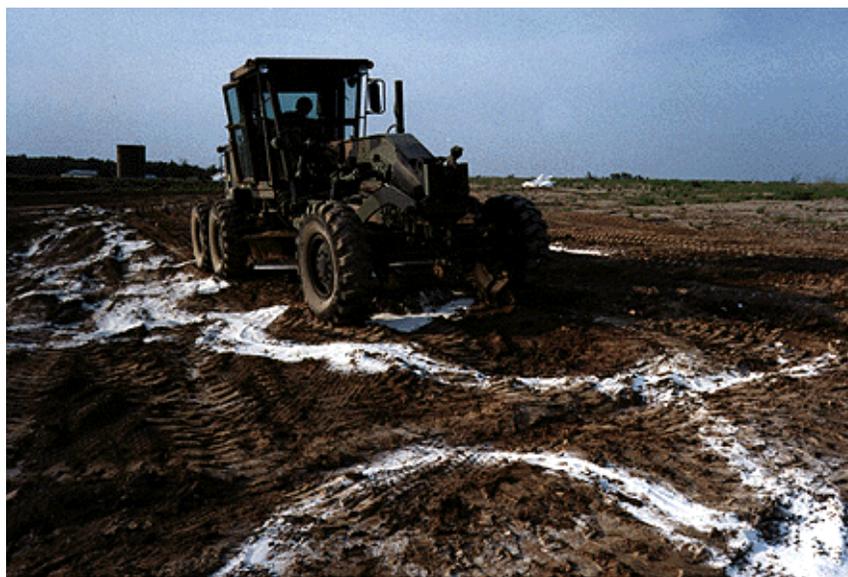
*Figure 9. Grader mixing soil and lime.*

The scarifying teeth of a grader were used to mix lime into the soil to a depth of approximately 102 mm (4 in.) (Fig. 9); the soil also was bladed. Water was added several times until there was enough moisture for compaction.

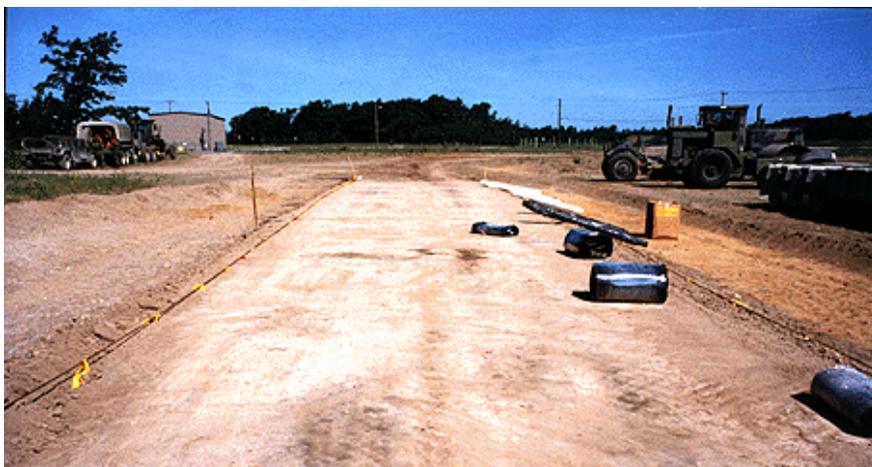
Figure 10. Compacted clay layer used to simulate the top of a MESL.

pan. These trenches provided an area to wash the gravel into when the test was completed. Next, six inches of clay was placed on the test section. Water was added to the clay, scarified, and compacted to simulate the top of a finished MESL, prior to placement of the upper membrane (Fig. 10).

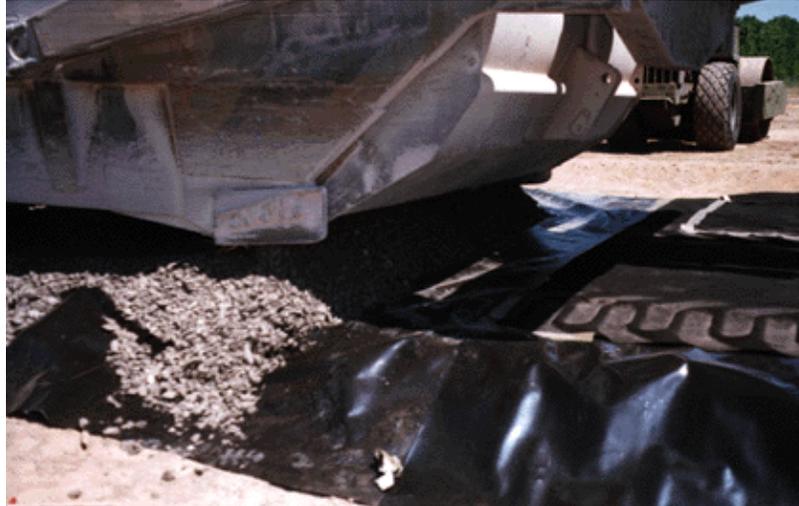
*Figure 12. Pan placing gravel on the test section.*

Normally, vehicles should not be allowed to drive on the geotextile while placing the gravel. This was not possible in this case because dump trucks were not available during test section construction. Instead, pans were used to place the gravel and a grader was used to spread the gravel (Fig. 12 and 13). Six inches of gravel was placed on the test section. The gravel used was 100% crushed stone with angular shape and 51-mm

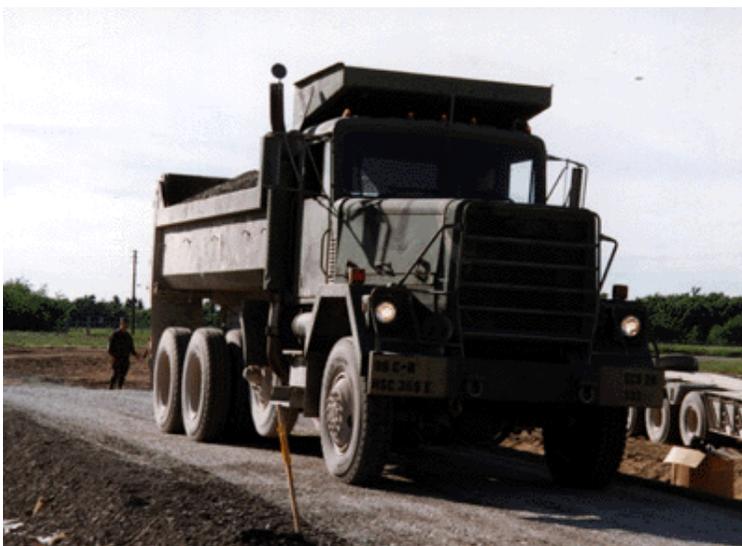
*Figure 14. Trafficking the puncture test.*

The test section was trafficked with a loaded 20-ton dump truck for 170 passes (Fig. 14). The truck made a loop to traffic and traveled at approximately 10 mph on the test section. The truck also followed approximately the same path each time, simulating a worst-case scenario.

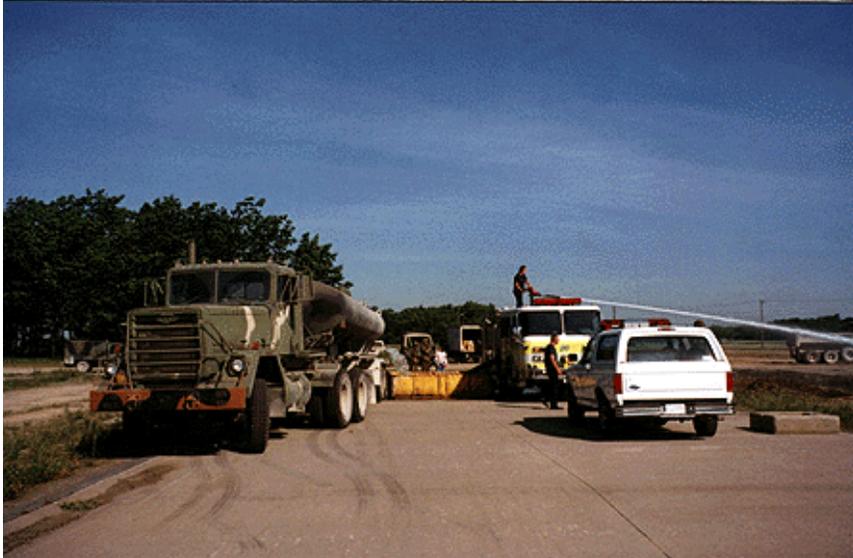
*Figure 15. Equipment used to wash gravel off the test section.*

After trafficking, the gravel was removed to observe any membrane damage. A grader removed the top few inches of gravel from the test section. The Fort Drum Fire Department then used one of its fire trucks to remove the rest (Fig. 15 and 16). This procedure worked well and mini-

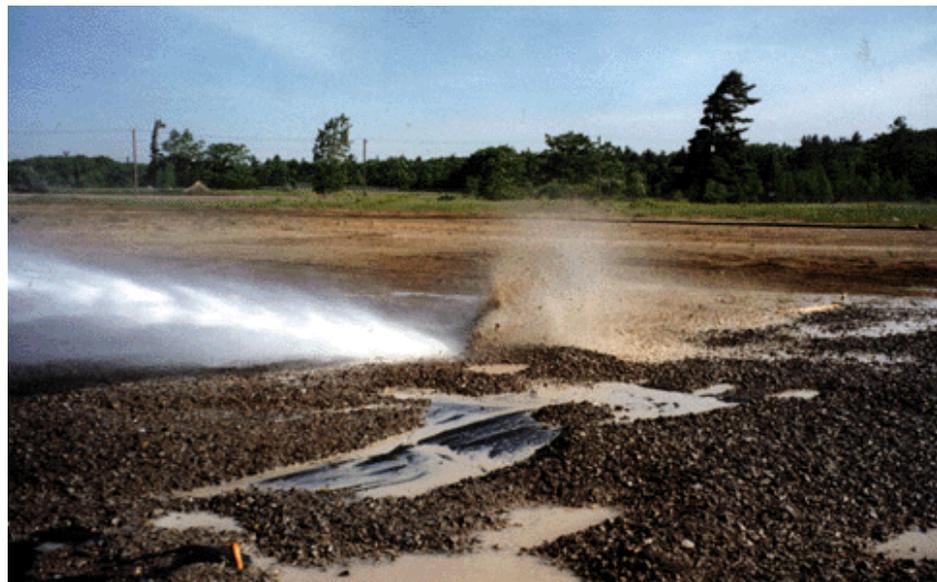
*Figure 16. Washing gravel.*

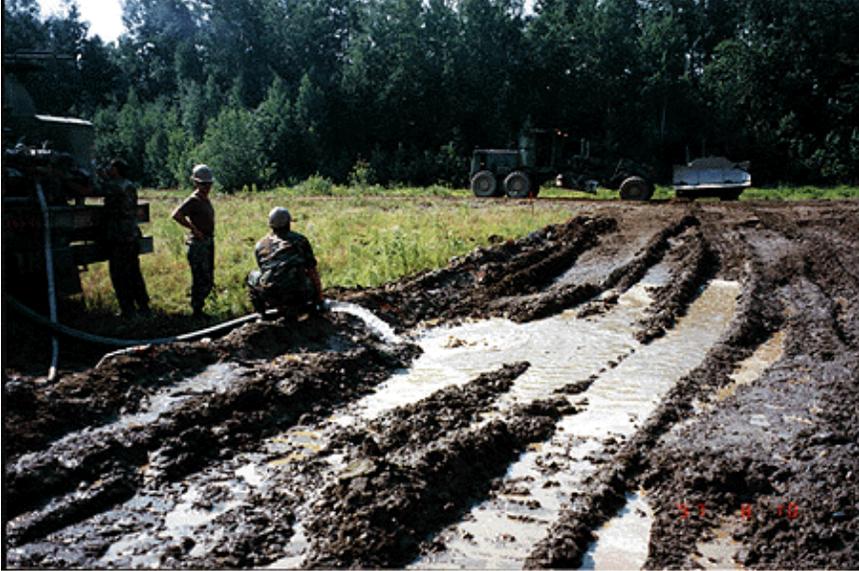
*Figure 17. Adding water to the absorbent test section at Ethan Allen Firing Range, Vermont.*

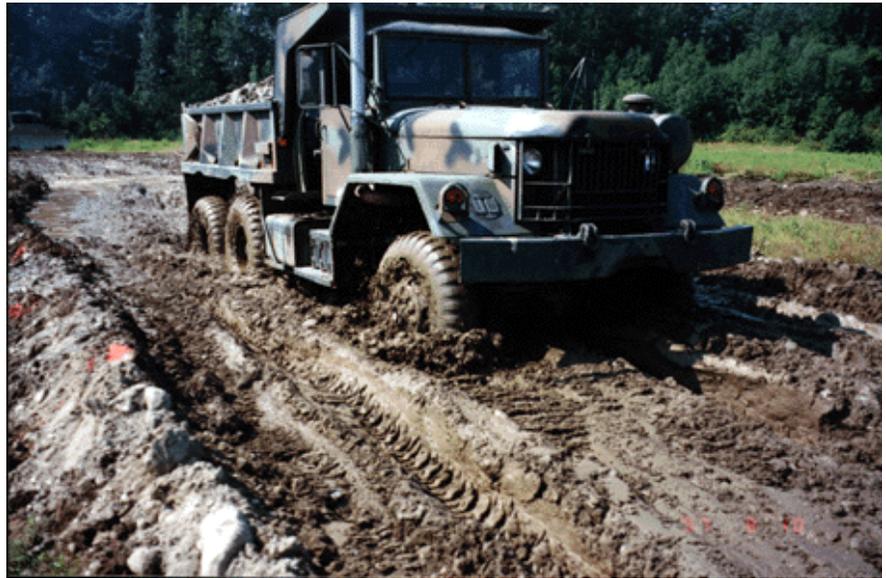
*Figure 18. Trafficking the absorbent test section.*

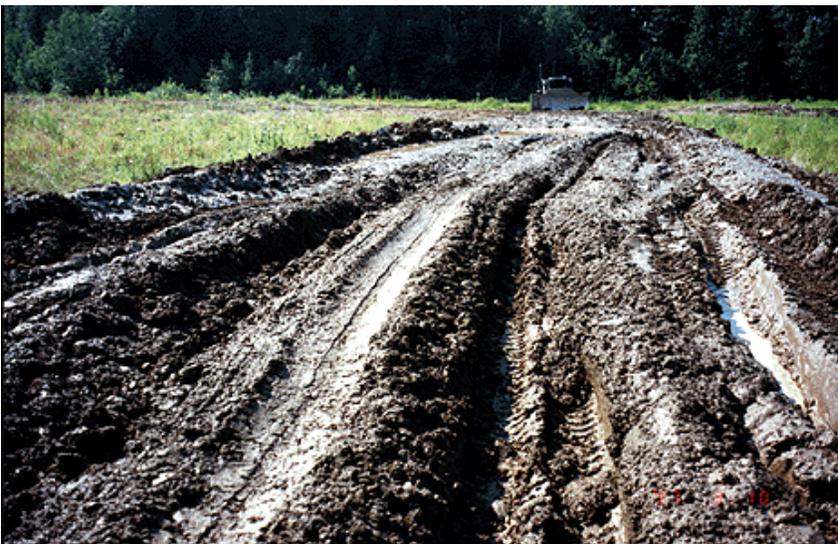
*Figure 19. Wheel ruts after one pass.*

The test site was an old gravel pit. Because of the low quality of the gravel (due to a high fines content), it was typically used as a fill material at least 0.61 m (2 ft) below the road surface. A thin organic layer had formed on the gravel and supported grass growth. A test section approximately 4.57 m (15 ft) wide by 130 m (100 ft) long was prepared for the test. The existing material was mixed together using a dozer, and additional silty sand was added. Water was added to make the soil muddy (Fig. 17). The wet layer was approximately 305 mm (1 ft) deep with a solid layer underneath. When trafficked, a 5-ton truck (Fig. 18) would sink to the hard layer, and in some places the soil was too weak to maintain the wheel ruts (Fig. 19).

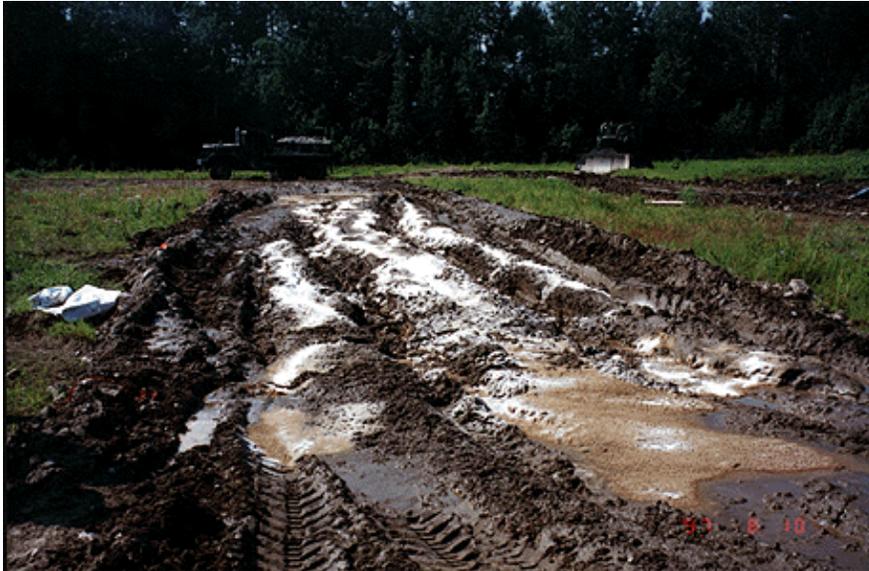
*Figure 20. Absorbent spread on test section.*

Next, 136 kg (300 lb) of the absorbent was added (Fig. 20) and mixed with a grader (Fig. 21). The grader trafficked only the test section and did not use its blade or scarifying teeth to mix the soil and absorbent. After mixing, a dozer was used to back-blade the test section and provide a smooth surface. The center of the section was dryer than the ends. This was due to standing water before the absorbent was added at the far end of the test section and not enough absorbent being added to the near end of the test section.

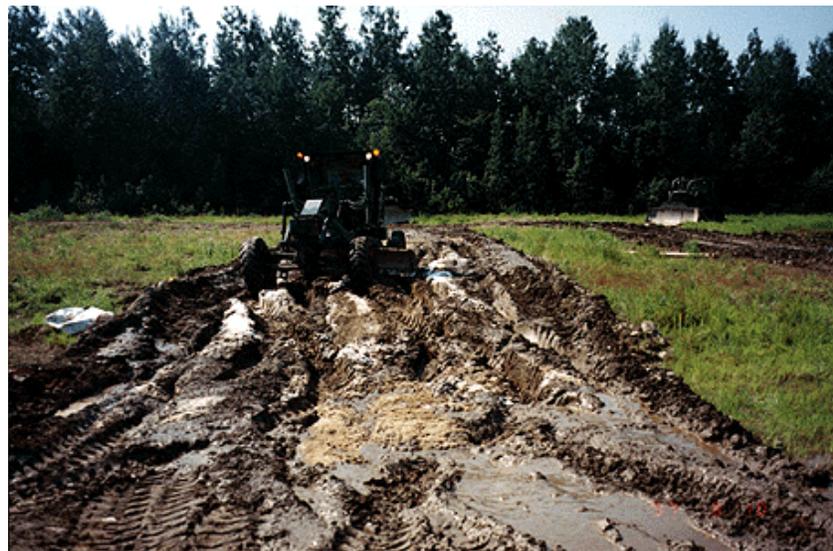
*Figure 21. Mixing absorbent and soil together.*

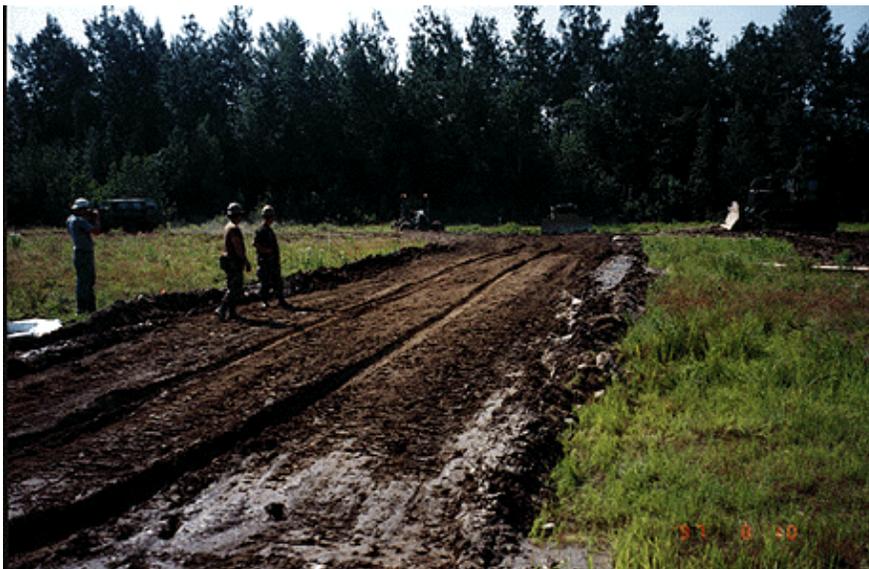
*Figure 22. Test section after one pass with a CUCV.*

A Commercial Utility and Cargo Vehicle (CUCV) was driven across the test section leaving approximately 51-mm- (2-in.-) deep ruts in the center of the section and 152-mm (6-in.) ruts on either end (Fig. 22). The CUCV was able to drive through the test section in 2-wheel drive when

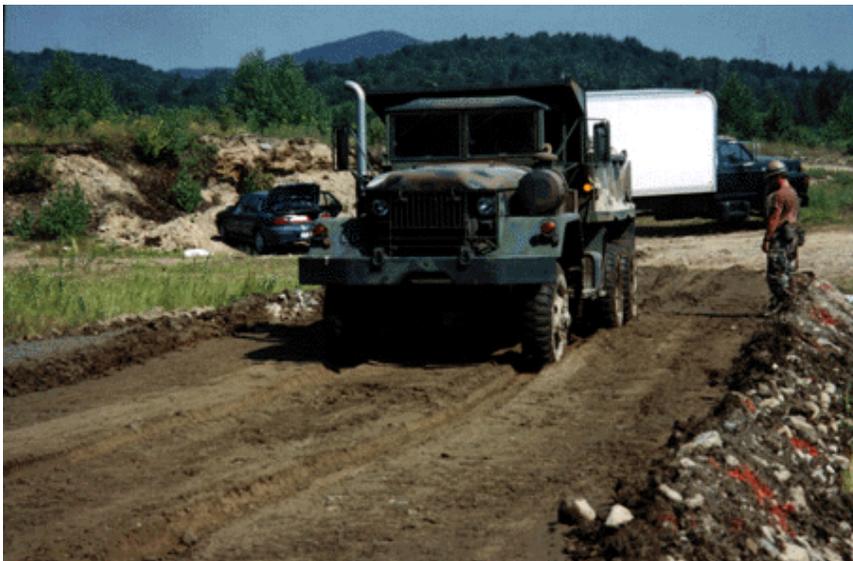
*Figure 23. Trafficking the section with a 5-ton dump truck.*

the test section would have been impassable in 4-wheel drive before treatment. A loaded 5-ton dump truck was then driven through the test section (Fig. 23 and 24). It left approximately 102-mm- (4-in.-) deep ruts in the center and 203-mm- (8-in.-) deep ruts on either end. The 5-ton dump truck then trafficked the section 30 times and left 178- to 279-mm- (7- to 11-in.-) deep ruts in the center and far end and 356-mm- (14-in.-) deep ruts at the near end (Fig. 25). The rutting was not caused by the soil being too “wet” but the result of a lack of cohesion. At the end of the test the soil looked dry and friable. The average water content of the top 76 mm (3 in.) of soil was 17.8%. Its grain size distribution was not determined. The cone penetrometer test results were not valid because the cone hit the larger gravel pieces.

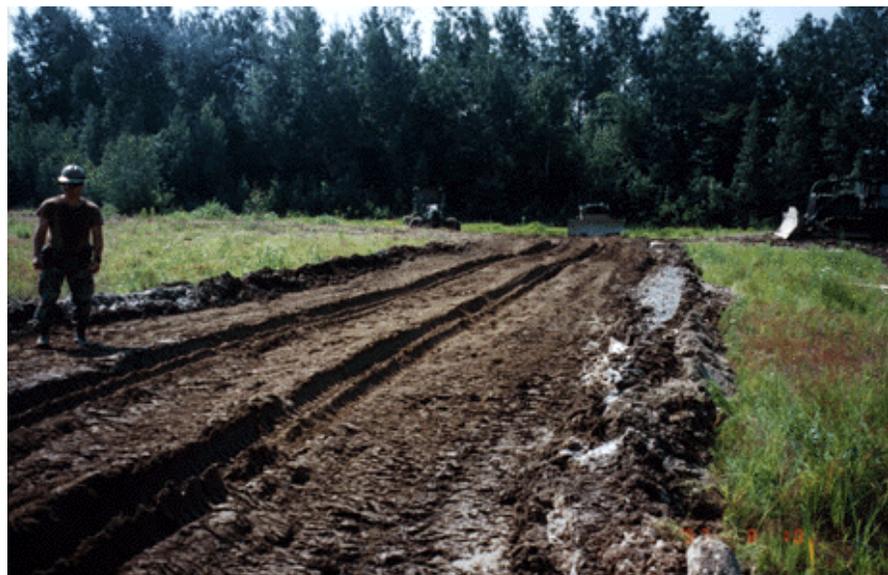
*Figure 25. Test section after 30 passes with a 5-ton dump truck.*

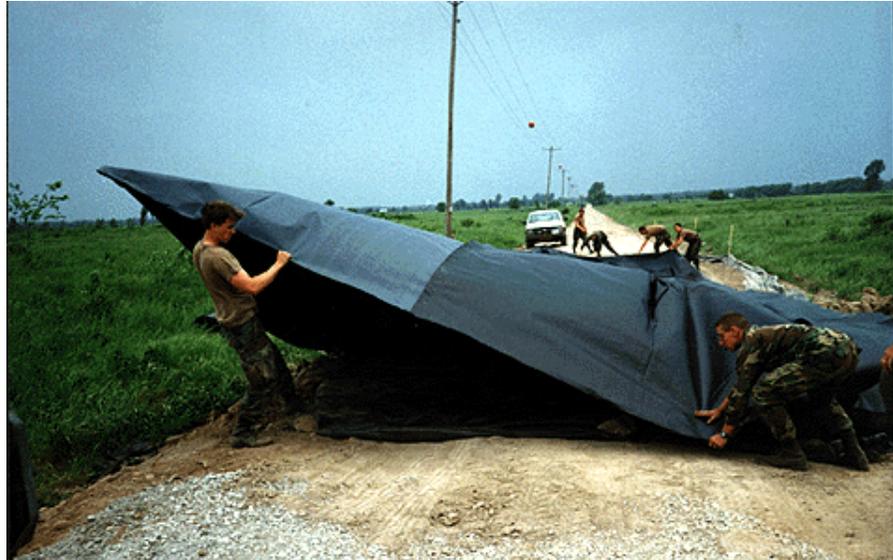
*Figure 26. Placing top membrane during light winds.*

**Placing membranes.** The membranes were easy to place when there was no wind, but because they are very large, a strong wind can make it difficult or impossible to place them (Fig. 26). The membranes also needed to be held down if the wind increased after they were placed.

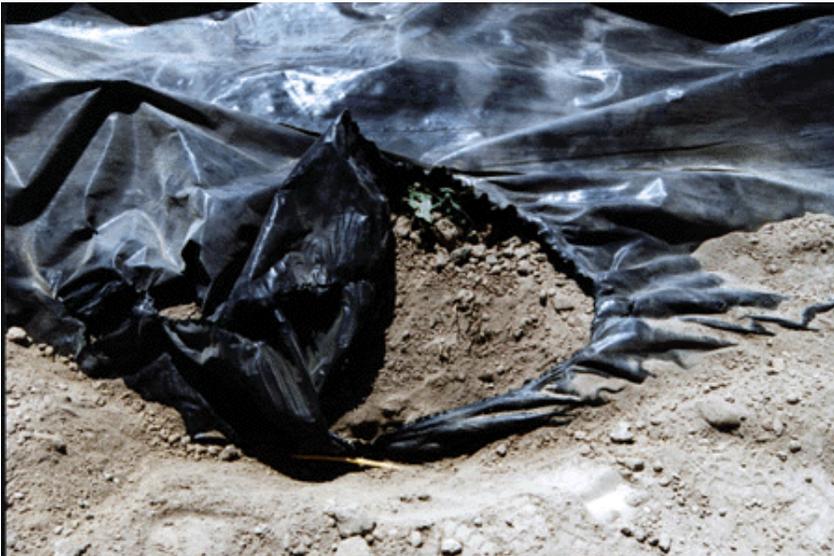
*Figure 27. Membrane tear.*

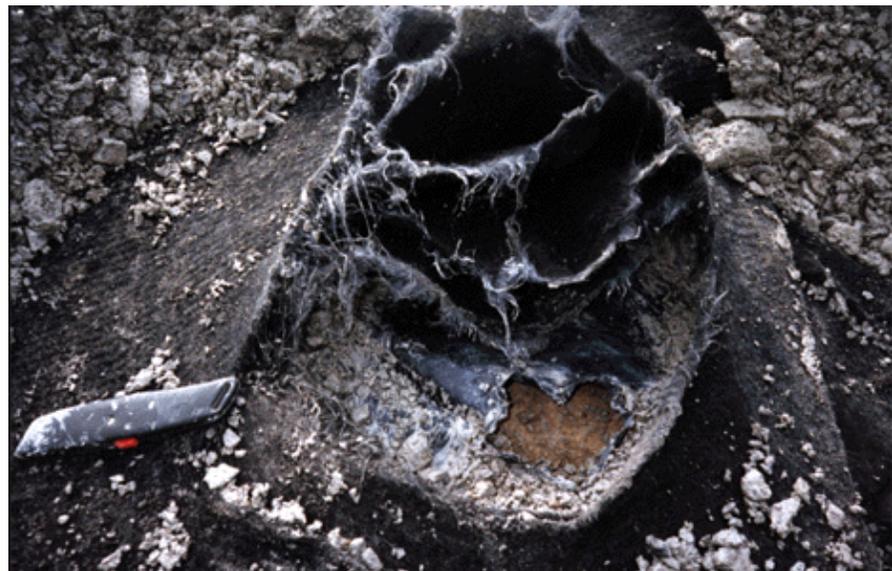
*Figure 28. Top-membrane tear, caused by a bucket loader.*

Placing the wearing course. A 152-mm (6-in.) gravel wearing course was used. It was difficult to place a uniform thickness of gravel because the surface of the MESL was not level. Care is still needed when spreading the gravel. A bucket loader caught the top of the MESL when spreading the gravel (Fig. 28).
