# RE-EVALUATION OF THE LOWER SAN FERNANDO DAM

Report 1

AN INVESTIGATION OF THE FEBRUARY 9, 1971 SLIDE  
VOLUME I: TEXT

GEI Consultants, Inc.  
Winchester, Massachusetts 01890-1943

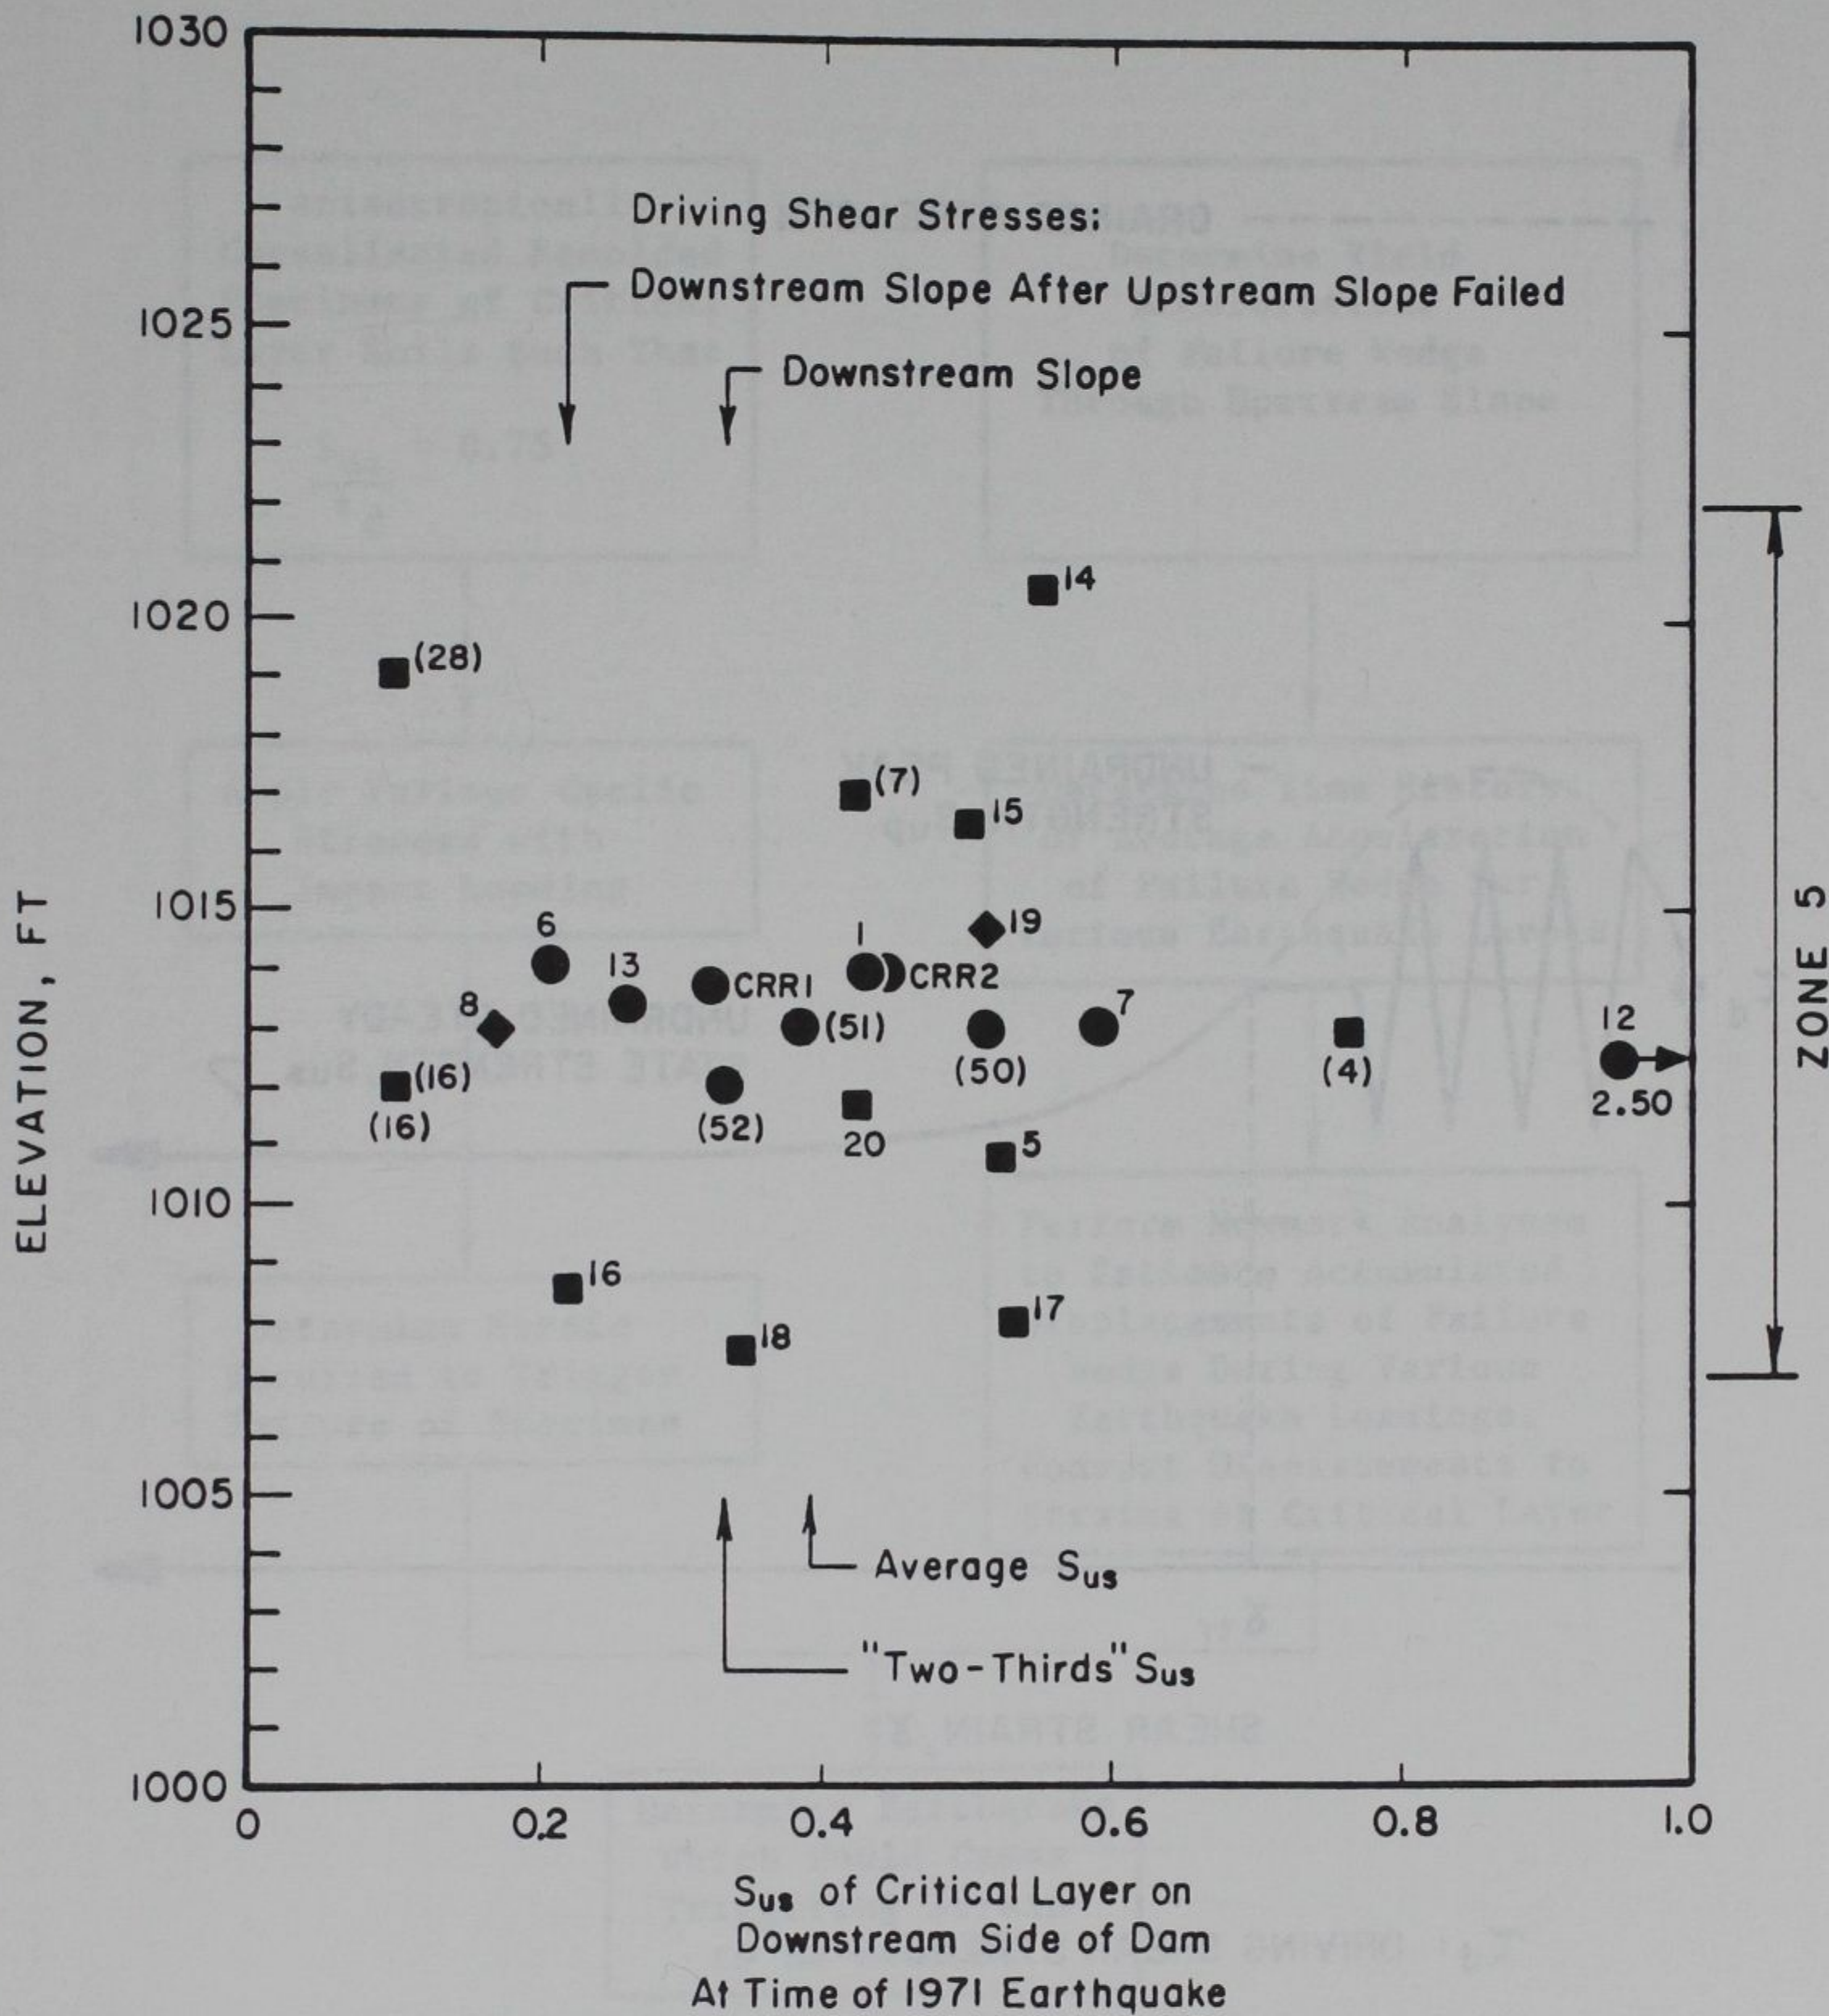
NOTES: Number next to each point indicates  $\bar{R}$  or  $\bar{CRR}$  test number  
 Numbers in parentheses are Stanford Univ. tests (Table 2)  
 $\bar{R}12$  excluded from averaging

Army Corps of Engineers Vicksburg, Mississippi	Re-evaluation of Lower San Fernando Dam San Fernando, California	1971 IN SITU STEADY STATE STRENGTHS OF DOWNSTREAM CRITICAL LAYER SOILS VS. EL.
GEOTECHNICAL ENGINEERS INC. WINDHAM, MASSACHUSETTS	Project 85669	Jan. 15, 1988    Fig. 19

The in situ steady state strength of the downstream critical layer was estimated to be about 0.33 tsf just prior to the 1971 failure. The static driving shear stress in the critical layer on the downstream side of the dam was computed to be about 0.33 tsf prior to the upstream slide and about 0.22 tsf immediately after the slide. Therefore, the factor of safety of the downstream slope against liquefaction susceptibility was about 1.0 and 1.5 prior to and immediately after the upstream slide, respectively. The 1971 earthquake caused high pore pressures and slight deformations in the downstream

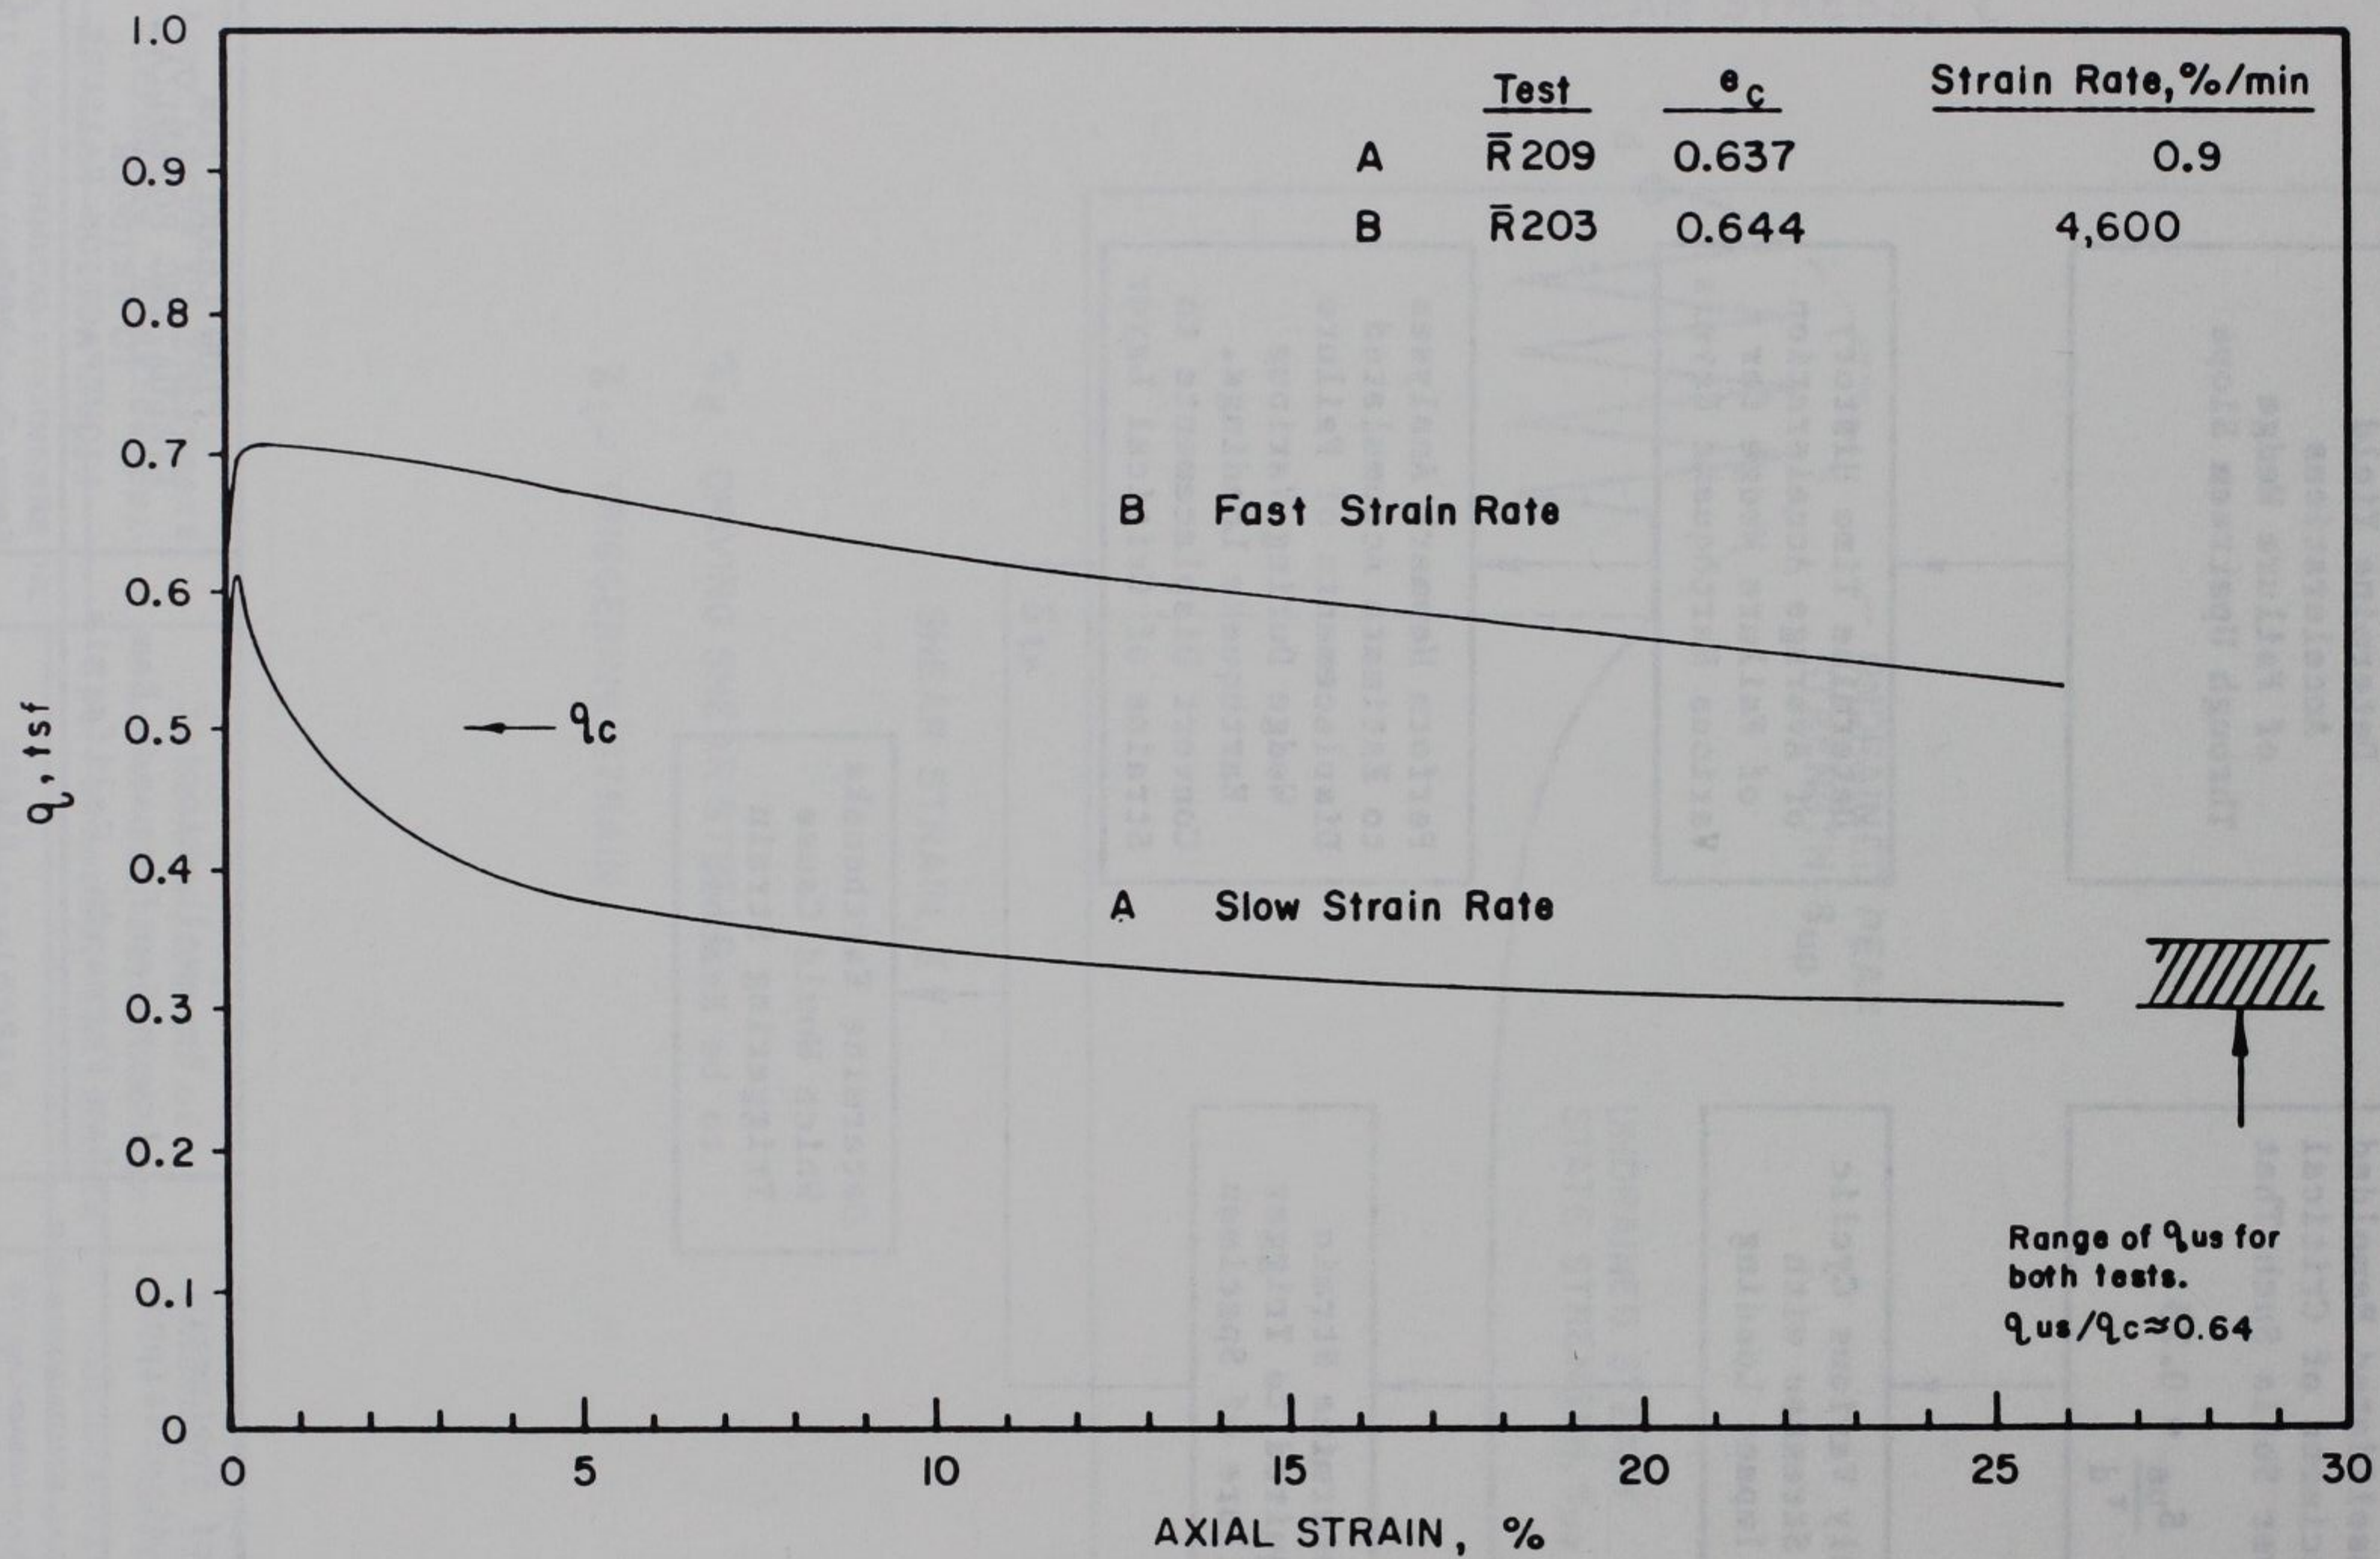
GEOTECHNICAL ENGINEERS INC. WINCHESTER • MASSACHUSETTS	Project 85669	Jan. 15, 1988 <span style="float: right;">Fig. 22</span>

Army Corps of Engineers Vicksburg, Mississippi	Re-evaluation of Lower San Fernando Dam San Fernando, California	STRESS STRAIN CURVES OF ANISOTROPICALLY CONSOLIDATED SAMPLES OF BATCH MIX 7
