MISCELLANEOUS PAPER N-70-5

AIRBLAST LOADING OF A LARGE METAL SHIPPING CONTAINER

Laboratory Investigation

July 1970

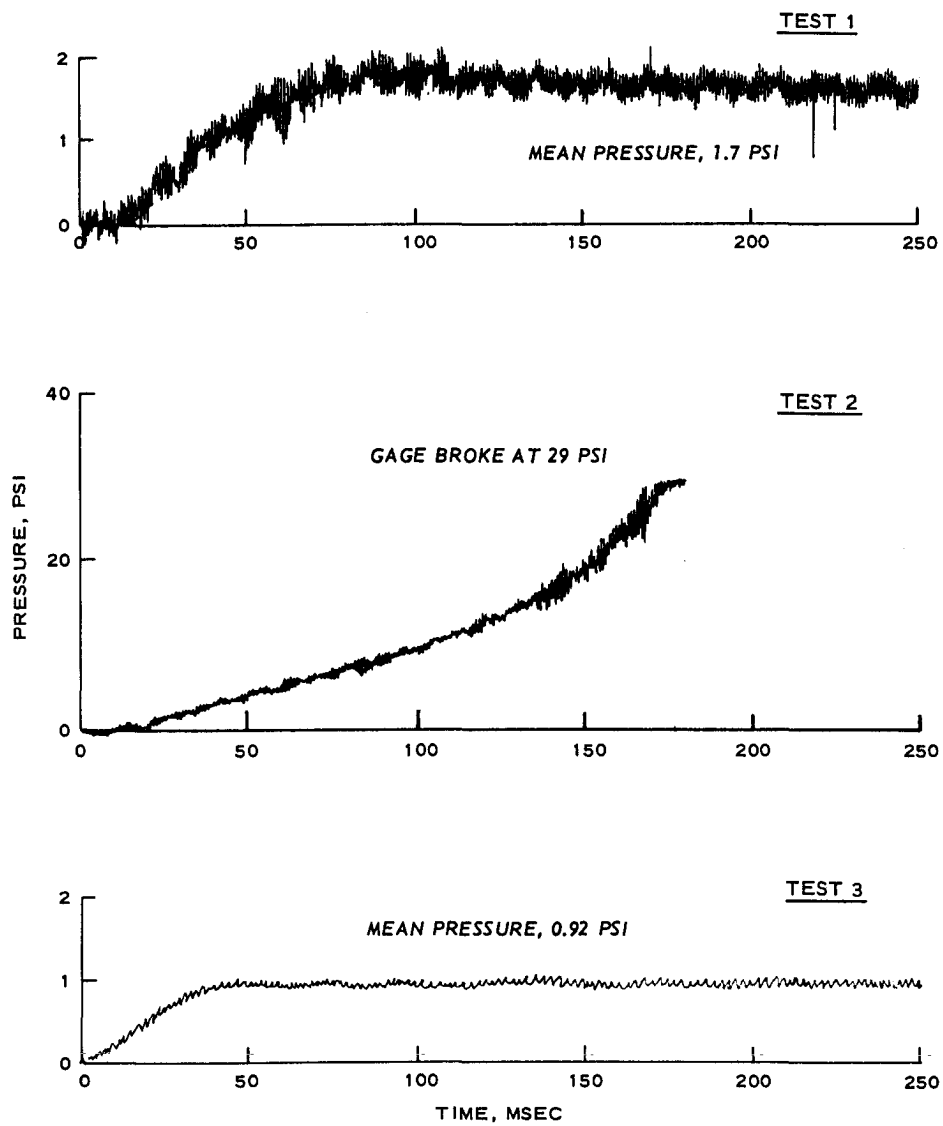
3.2.1 Pressure Data. Typical surface pressure-time and internal pressure-time histories for the three tests are presented in Figures 3.4 and 3.5, respectively. The mean pressures shown in these figures were determined in the following manner: first, a straight line was constructed through the impulse-time histories (plots not shown) for all pressure records of

Figure 3.4 Typical surface pressure histories.

Figure 3.5 Typical internal pressure histories; Gage IP1.

Figure 4.1 was extracted from a paper (Reference 4) on the effects of overpressures on the human ear. Recorded peak internal pressure from Test 1 was less than 2 psi; consequently, the probability of ruptured eardrums of occupants appears to be approximately 0.1 percent. The peak internal pressure from Test 3 was considerably less than that measured in Test 1.
