ERDC/CHL TR-03-16

Assessment of Changes in Channel Morphology and Bed Elevation in Mad River, California, 1971-2000

Kevin Knuuti and Dinah McComas

September 2003

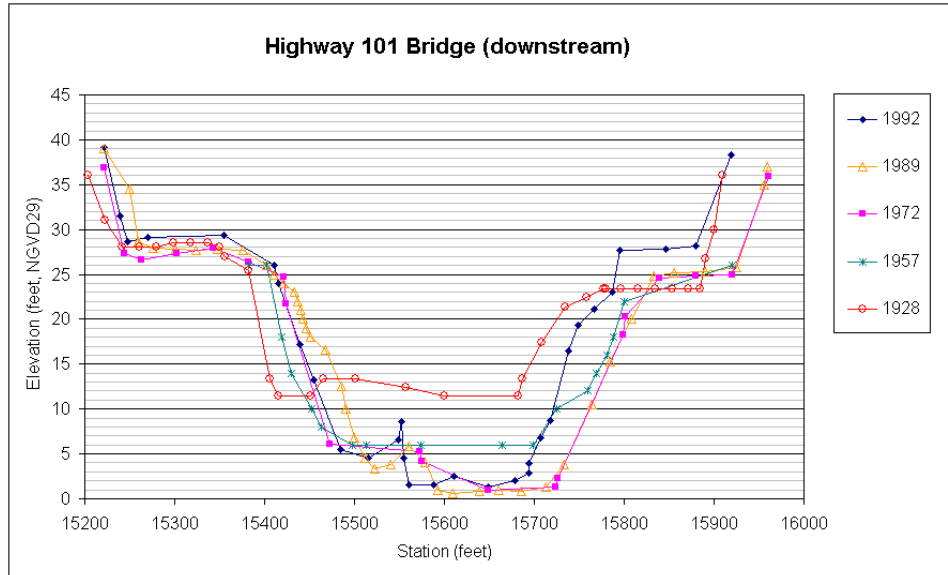
Figure 8. CalTrans surveyed cross section, downstream side of Highway 101 bridge

For the Highway 101 bridge, CalTrans measured upstream and downstream channel cross sections in 1928, 1929, 1957, 1972, 1989, and 1992. The 1928 (downstream) and 1929 (upstream) channel cross sections are based on data that were collected during or immediately after construction and represent the as-built condition.

Accounting for the uncertainty associated with the methods CalTrans used in measuring the Highway 101 bridge cross sections, the cross sections still indicate approximately 6 ft of bed degradation between 1957 and 1992. They also indicate approximately 1 ft of degradation between 1972 and 1992.

degradation (greater in some cases and less in others). Regardless of this, the cross section information makes it clear that the riverbed in the vicinity of the two bridges has lowered significantly since at least 1960 and perhaps back as far as 1928 (101 bridge) and 1941 (299 bridge).

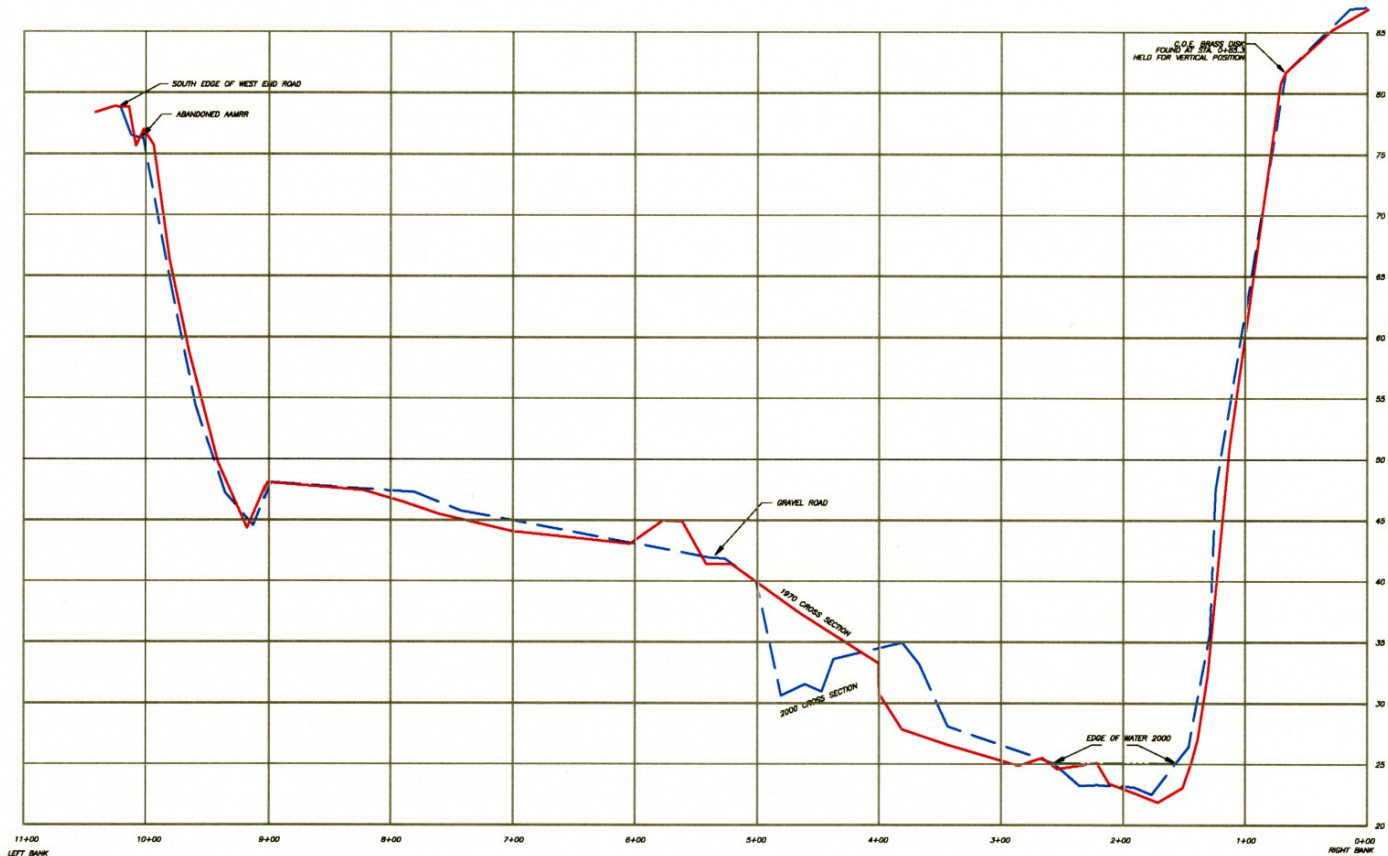
Figure B9. Survey of Mad River cross section 18

CROSS SECTION 18

OVERALL END POINT COORDINATES ARE:
 LEFT: N. 2,221,217.4, E. 5,894,842.4
 RIGHT: N. 2,221,220.5, E. 5,894,842.4
 BEARING: S 08° 21' 21" N, 1018.8'

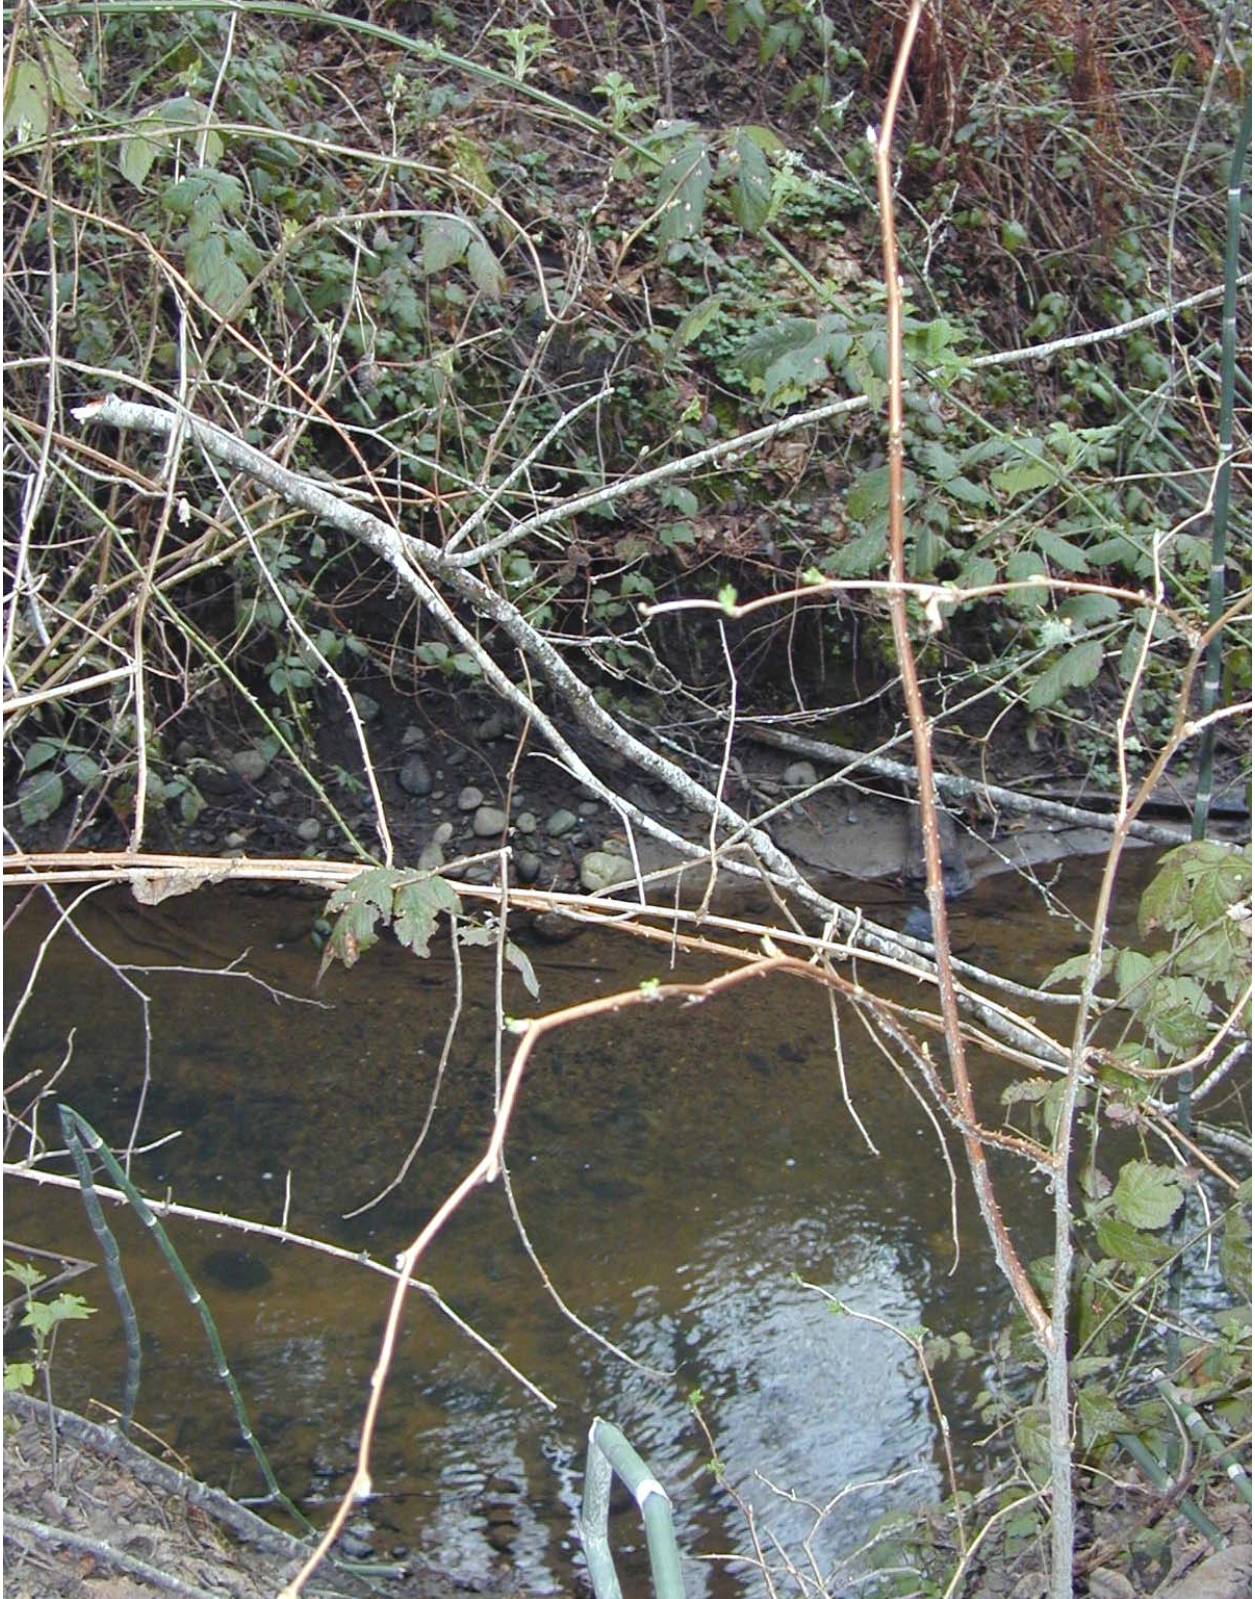
Figure C29. XC19 (left bank) – approximately 3 ft of incision on Warren Creek downstream of AMRR crossing

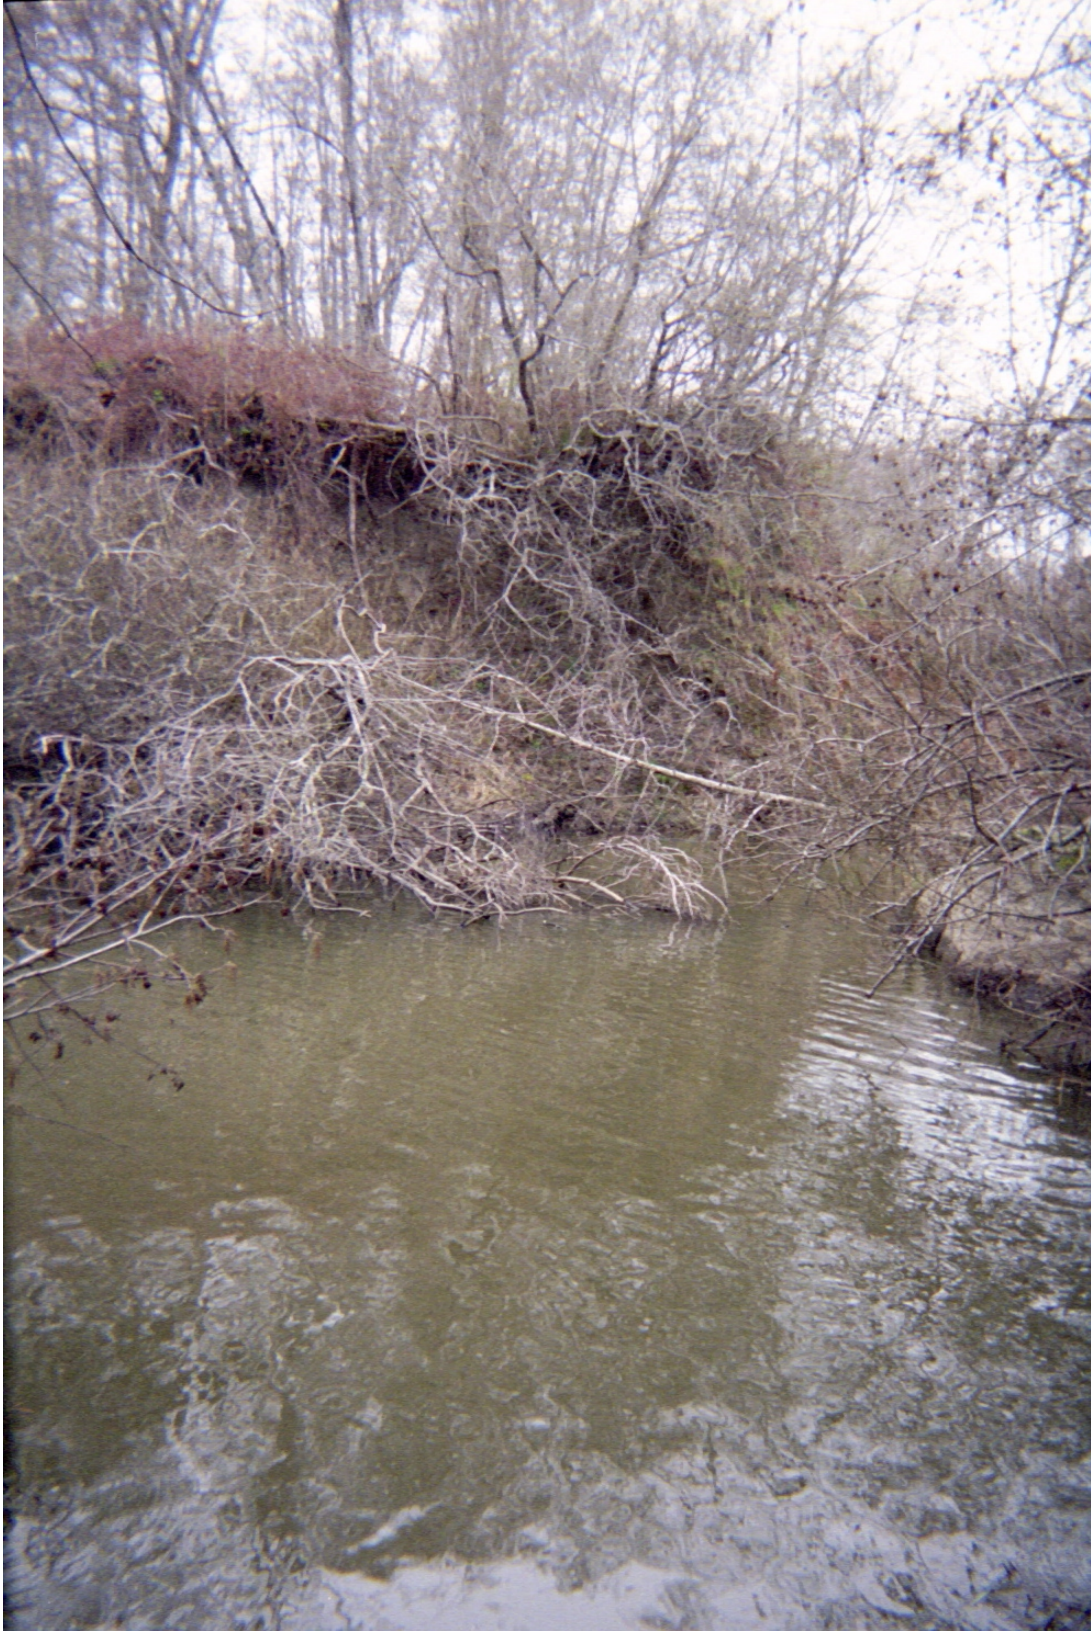
Figure C39. XC21 (right bank) - Looking at (incised) mouth of Lindsay Creek

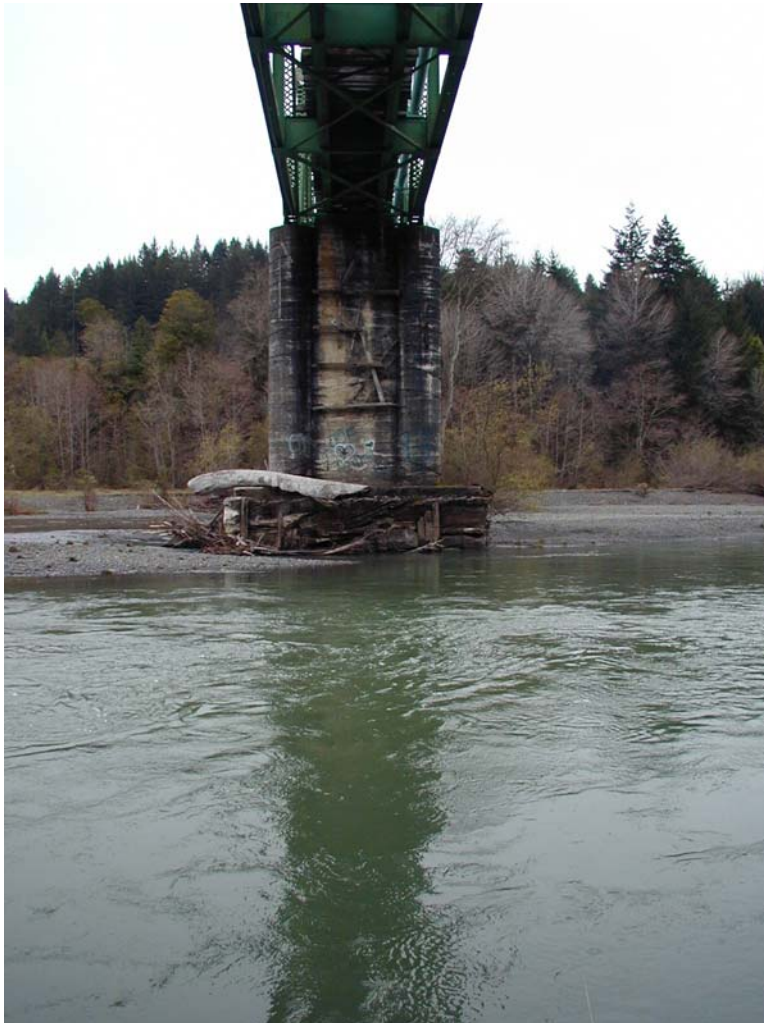
Figure C41. XC21 (right bank) - Looking at degradation near pier

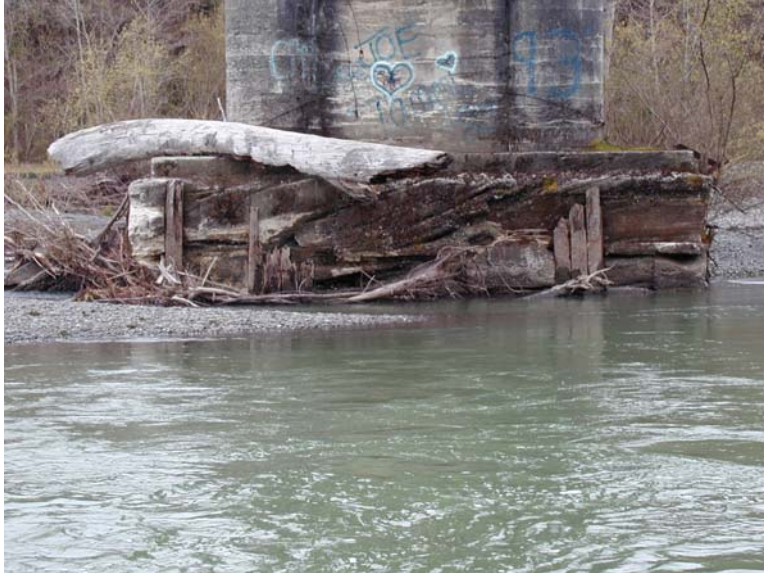
Figure C42. XC21 (right bank) - Looking at degradation near pier
