Implementation Guidance for the Control of Undesirable Vegetation on Dredged Material

PURPOSE: The purpose of this technical note is to provide guidance for implementing selected management practices to control undesirable vegetation on dredged material.

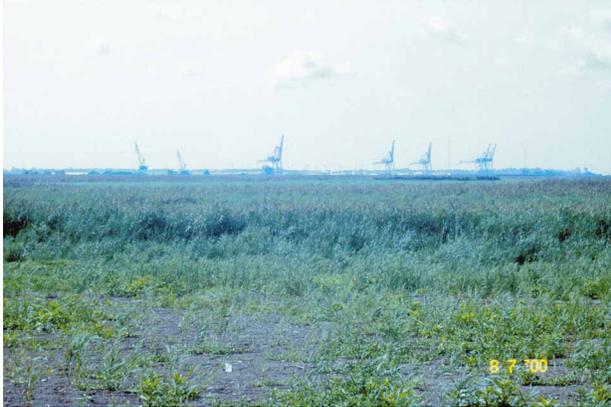
Figure 1. Phragmites (*Phragmites communis*) covering Eagle Island CDF, Wilmington, NC

Wilmington, NC. The Eagle Island CDF was totally covered with 3-m- (10-ft-) tall common reed (Figure 1). The aboveground stems and tops (3 m (10 ft) tall) were cut with a box blade and placed into piles for burning or composting. Because burning can contribute to poor air quality, composting

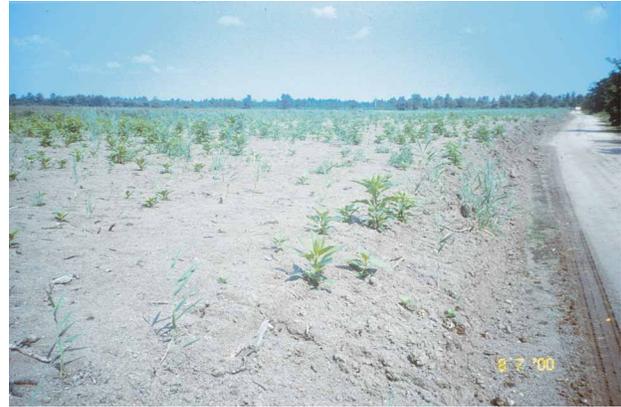
Figure 2. During dike raising at Eagle Island CDF, NC, undesirable vegetation established rapidly

INTRODUCTION: When dredged material is placed in a CDF and/or an upland environment to construct dikes or levees, various management strategies are used ranging from no management to different degrees of management. No management normally results in a wide variety of aggressive vegetation colonizing the site. In many areas, the vegetation that will establish is common reed or Phragmites (Figure 1), willow, poplar, and cottonwood as well as any weeds that might exist in the adjacent surroundings (Figure 2).

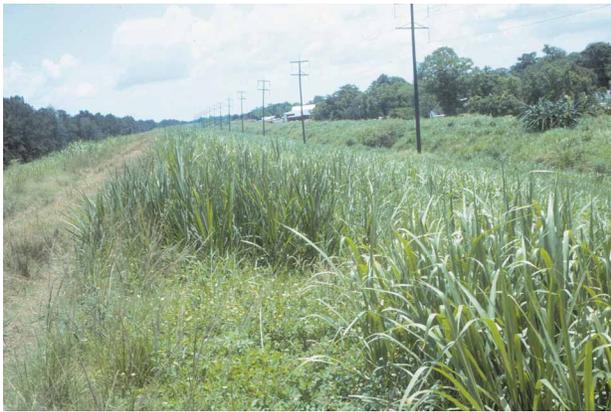
Figure 3. Napier grass (*Pennisetum purpureum*) on the Herbert Hoover Dike around Lake Okeechobee, FL

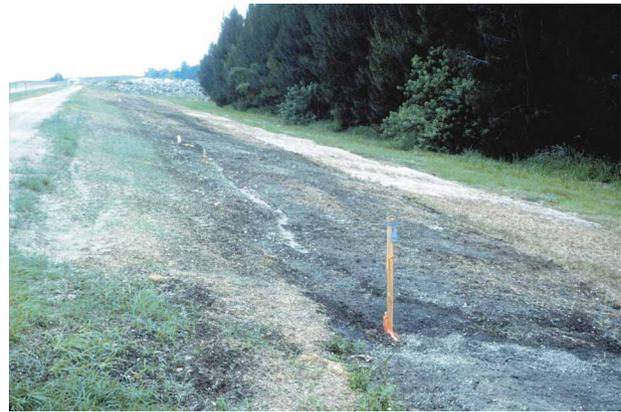
Figure 4. Incorporation of yardwaste and N-Viro biosolids into sandy, droughty dredged material on Herbert Hoover Dike (Jun 95)

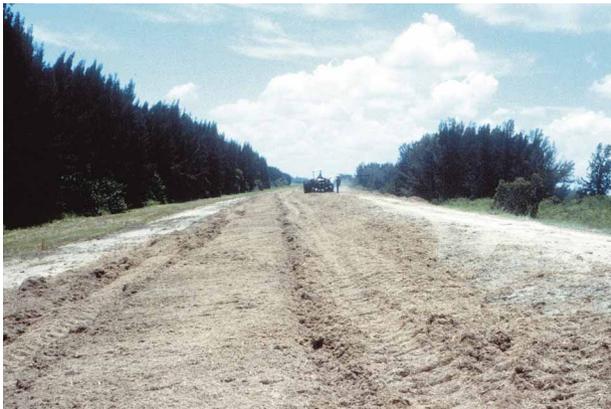
Figure 5. Incorporation of bagasse and N-Viro biosolids into sandy, droughty dredged material on Herbert Hoover Dike (Jun 95)

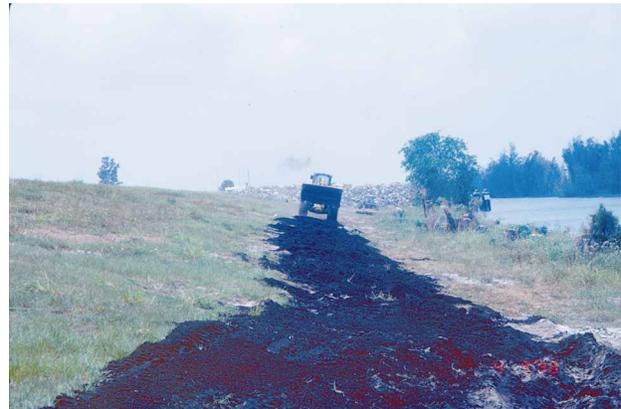
Figure 6. Melaleuca compost applied to the Herbert Hoover dike dredged material and incorporated by disking

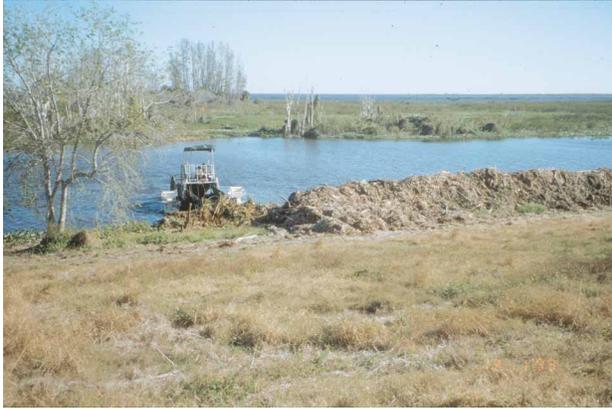
Figure 7. Lake debris harvested from Lake Okeechobee following hurricanes and piled on the shoreline of the Herbert Hoover dike

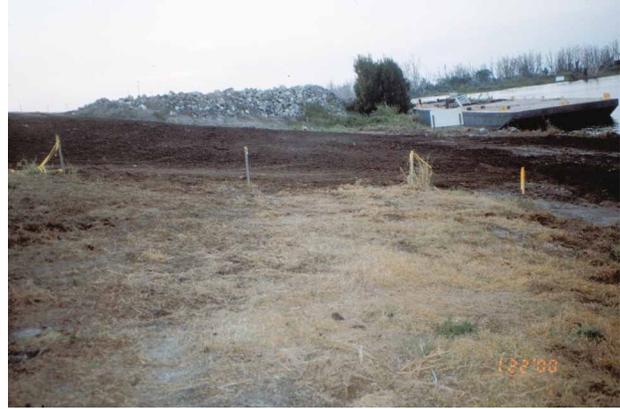
Figure 8. Lake debris in combination with N-Viro biosolids (left side of photo) and Bionsoil biosolids (right side of photo) incorporated by disking

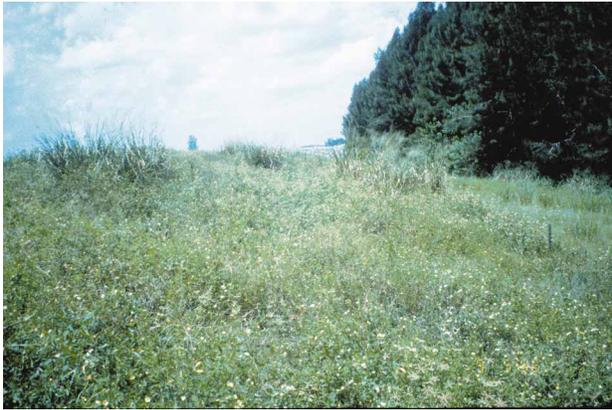
Figure 9. Massive native weed growth on the yardwaste and N-Viro biosolids demonstration plots (Jun 96)

Soil samples were collected for each mile of the Herbert Hoover dike from each side of the dike for the entire dike system. The soil samples were sent to the University of Florida at Gainesville for soil fertility testing. Minimum fertilizer for the maintenance of desired vegetation was recommended based on the soil test results. These fertilizer rates were applied to the dike. In addition to reduction of applied commercial fertilizer being evaluated, other ways to improve soil fertility using available residual materials and management of vegetation were considered. The application of recycled soil manufacturing technology (RSMT) and the use of plant species such as perennial peanut (*Arachis glabrata* Benth. cultivar Florigraze) that required less fertilizer and mowing were also evaluated in the demonstration. Demonstration plots were established using RSMT by incorporating cellulose in the form of yardwaste (Figure 4), bagasse (Figure 5), melaleuca compost (Figure 6) and lake debris (Figures 7 and 8) in combination with biosolids such as N-Viro Soil® (reconditioned sewage sludge) and BionSoil® (reconditioned animal manure). These plots improved the soil fertility substantially but also increased the growth and amount of undesirable weeds whose seed had accumulated in the dike soil over the years (Figure 9). Consequently, weed control was required on

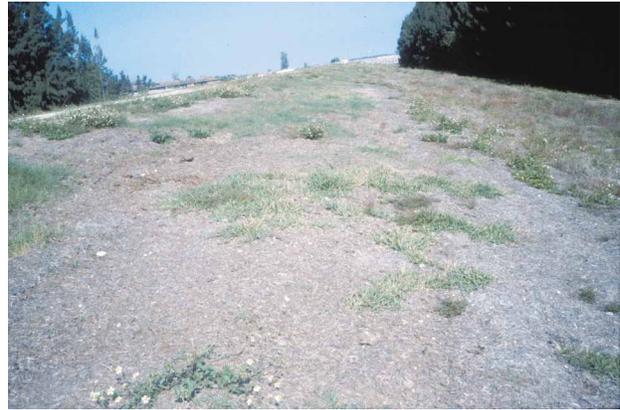
Figure 10. Planted desirable vegetation established on the bagasse and N-Viro biosolids demonstration plots (Jun 96)

all demonstration plots. The bagasse and N-Viro biosolids plots showed the least amount of undesirable vegetation and the best growth of planted desirable vegetation (Figure 10). After 2 years of herbicide wiping, Spanish needle continued to reestablish from the massive seed bank collected over the years (Figures 11 and 12). However, perennial peanut became established on the bagasse and N-Viro plots despite the continuous regrowth of Spanish needle (Figure 13).

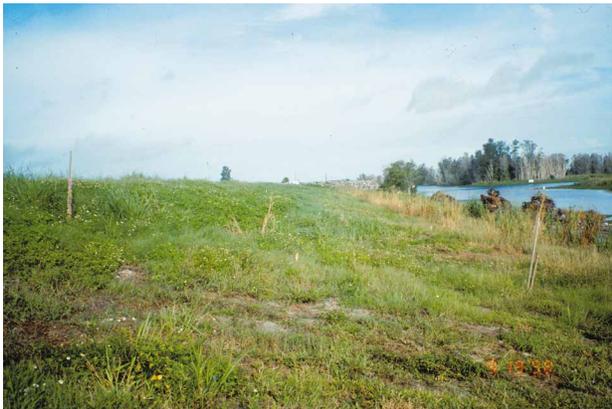
Figure 11. Vegetative cover on yardwaste and N-Viro biosolids demonstration plots (Sep 98)

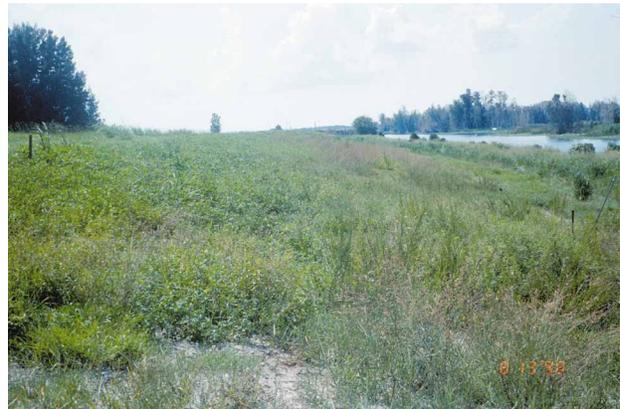
Figure 12. Vegetative cover on bagasse and N-Viro biosolids demonstration plots (Sep 98)

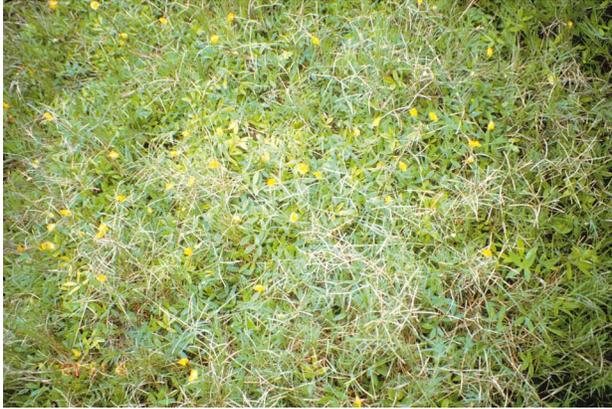
Figure 13. Perennial peanuts established with Bermuda grass on bagasse and N-Viro biosolids demonstration plots (Sep 98)

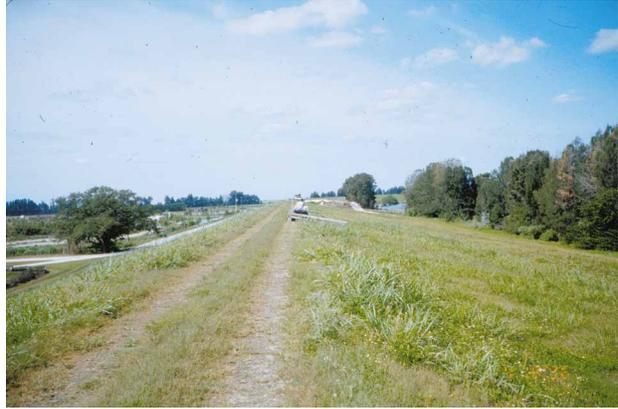
Figure 14. Herbicide wiping of undesirable vegetation on Herbert Hoover Dike dredged material at South Bay (Apr 96)

The initial wiper was constructed of an aluminum panel measuring 102 mm by 203 mm by 3 m (4 in. by 8 in. by 10 ft) long covered with coarse sand grit comparable to coarse sandpaper. The herbicide was applied to the gritted surface by plastic tubes and micropumps. The panel became wet with herbicide. As the wiper came into contact with the undesirable plant leaf, the grit surface scratched the leaf surface and applied herbicide in the wound. The herbicide entered the plant leaf immediately and was translocated to the plant root, resulting in total plant kill. This innovative technique can be used when herbicide spraying cannot be used because of windy conditions or other adverse weather conditions. The wiper technique used approximately one-quarter of the herbicide used by typical sprayers to kill undesirable vegetation and does not injure nontarget (desirable) vegetation that might come in contact with spray drift.

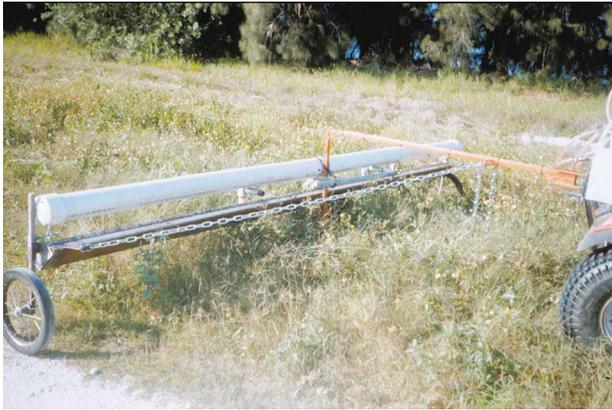
Figure 15. Wiper applicator set at 305 mm (12 in.) above ground to wipe herbicide on taller undesirable vegetation (Apr 96)

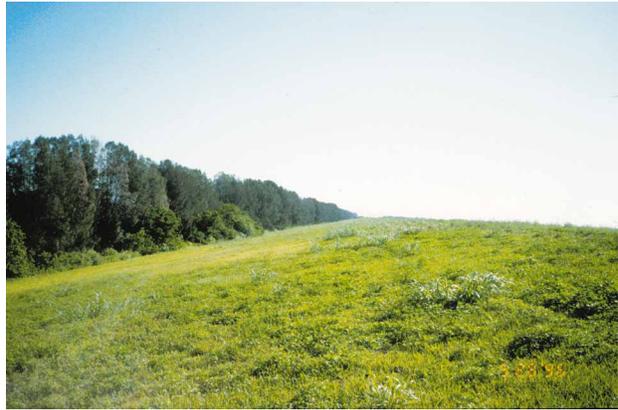
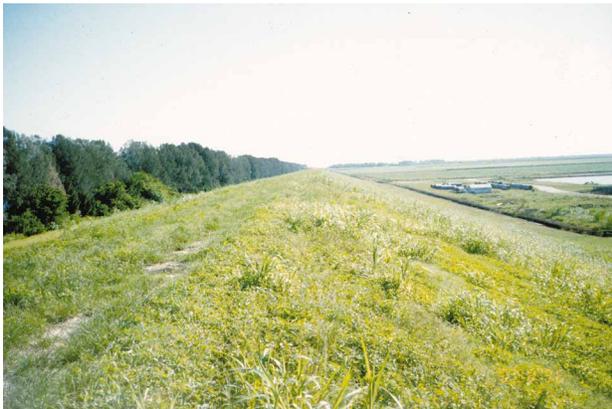
Figure 16. Less napier grass and more Spanish needle 1 month after wiping (May 96)

Figure 17. Untreated vegetation on right side of photo (May 96)

In areas of predominately napier grass, four wipings (Figures 16 and 17) were required to almost eliminate that plant. However, as soon as the napier grass disappeared, Spanish needle covered the area (Figure 18). Two additional wipings of 2.3×10^2 ml/ha (32 oz/acre) of Round-Up® herbicide were required to control the Spanish needle vegetation. A combination of wiping and mowing over 2 years was required to control napier grass and Spanish needle vegetation and allow the Bermuda grass and Bahia grass to reestablish on the area. The wiper applicator also successfully controlled undesirable weeds on all of the RSMT demonstration plots established on the dike.

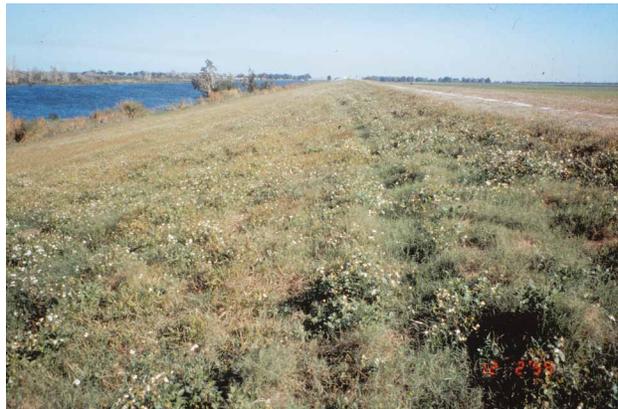
Figure 18. Elimination of napier grass, reduction of Spanish needle, and increased regrowth of Bermuda grass (Dec 99)

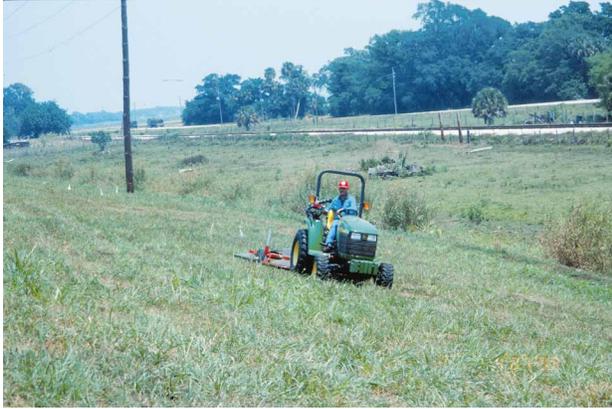
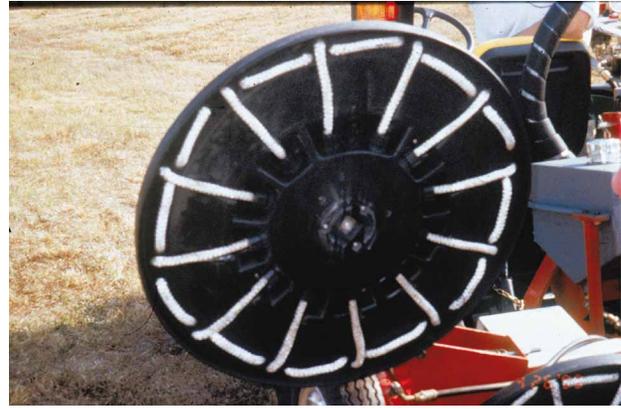
Figure 19. Wiping napier grass with the Weedbug® applicator (Apr 99)

Figure 20. Closer view of Weedbug® applicator (Apr 99)

Other equipment has been developed using the same principles of wiping herbicide on plant leaves versus spraying. A demonstration was conducted in 1999 in cooperation with Monsanto/Weedbug, using newer equipment called the Weedbug®. This equipment, developed in Australia, uses nylon rope instead of the grit panel as the carrier for the herbicide. The saturated rope spins around in a disk-shaped applicator, scratches the plant leaves, and puts herbicide in the scratches for a total kill of the plant. The centrifugal force keeps the ropes saturated equally for a uniform distribution of the herbicide. This is an improvement over the wiper panel, since the tubes on the wiper panel can sometimes get clogged and result in uneven distribution of the herbicide application, producing streaking of the missed plants. These areas are usually eliminated in subsequent wipings. A demonstration area was established near Canal Point, FL, with the Weedbug® applicator (Figures 19 and 20). Again the napier grass was almost totally killed after two wipings and Spanish needle became established (Figure 21).

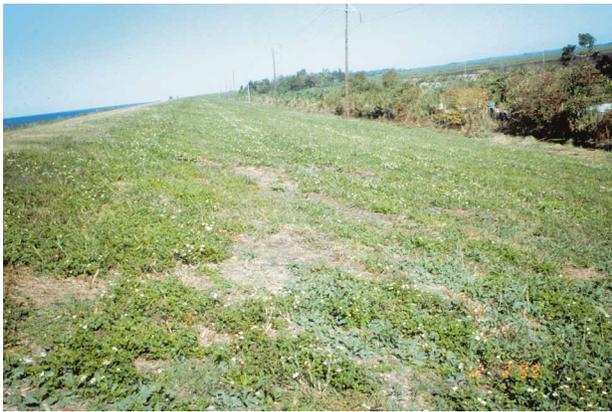
Figure 21. Napier grass eliminated, massive Spanish needle developed (Dec 99)

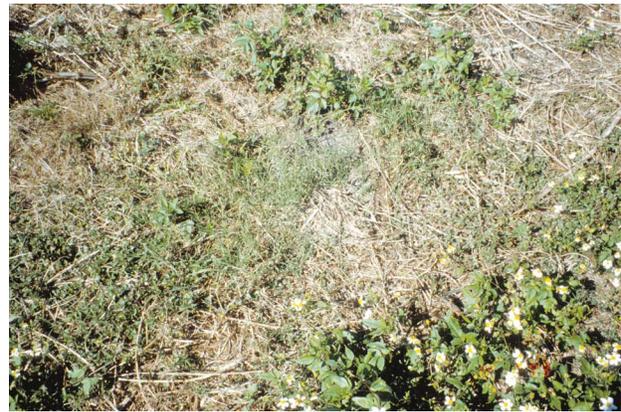
Figure 22. Bermuda grass regrowth among Spanish needle on herbicide-wiped plot (Dec 99)

Additional wiping and mowing were conducted and eventually Bermuda grass recovered (Figure 22) and spread over the area. The untreated control plot was covered with napier grass and Spanish needle (Figure 23). Desirable vegetation is usually present on the dike, but suppressed by the more dominant and aggressive undesirable napier grass. Once the aggressive undesirable vegetation is eliminated, other plant species present get an opportunity to grow. On the Herbert Hoover Dike system, the next plant species to overgrow the areas is Spanish needle. After it is controlled, the more desirable vegetation like Bermuda grass and Bahia grass recover and become dominant. It will take 3 to 4 years of wiper/mowing management to reverse the vegetation progression that has occurred over the past 10 or more years on the Herbert Hoover Dike. A combination of herbicide wiping and reduced fertilizer applications will return the dike system to more desirable vegetation that will be easier to manage. In addition to this weed control program, other technologies such as RSMT are being demonstrated and can improve the long-term fertility of the droughty dike dredged material/soil. The conversion to perennial peanut, which requires only potassium fertilizer and does not require mowing, will substantially reduce fertilizer and mowing costs for vegetative maintenance of this dredged material dike system.

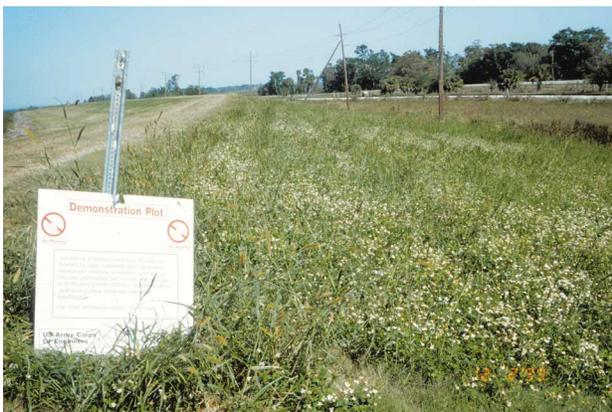
Figure 23. Control plot, no herbicide applied. Massive napier grass and Spanish needle developed (Dec 99)

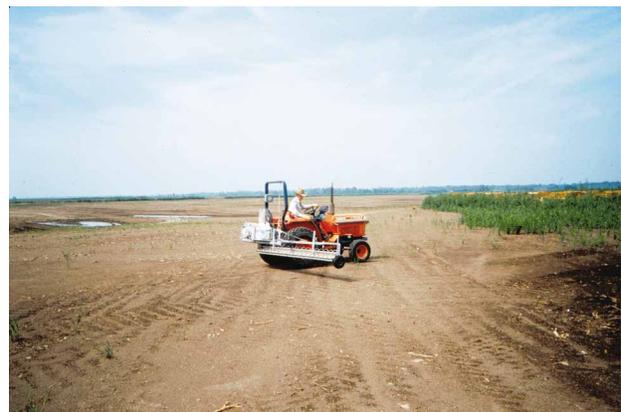
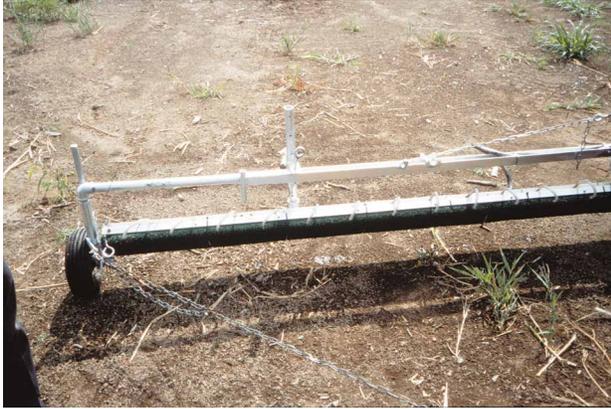
Figure 24. Modified wiper applicator on Eagle Island CDF, Wilmington, NC

Figure 25. Close-up view of carpet wiper applicator

The wiper applicator was improved by covering the aluminum panel with an AstroTurf™ type carpet material. Plant leaves are chafed by the brace chains ahead of the panels and scraped by the AstroTurf™ carpet material. The improved panel works as well as the grit panel and provides for more even distribution of herbicide solution through a series of check valves installed to prevent gravitational flow within the panel while working at acute angles on the side of the levee. Additional improvements were made by applying a 7.01×10^3 ml/ha (96-oz/acre) solution of glyphosate chemical and water. Mixing rates have been 9.46×10^2 ml (32 oz) chemical/18.92 $\times 10^2$ ml (64 oz) of water or 710 ml (24 oz) chemical/2,129 ml (72 oz) of water. The water reduces the viscosity of the herbicide, thus making it easier for the plant to absorb and translocate. The diluted herbicide solution also disperses on the plants better than the pure chemical.

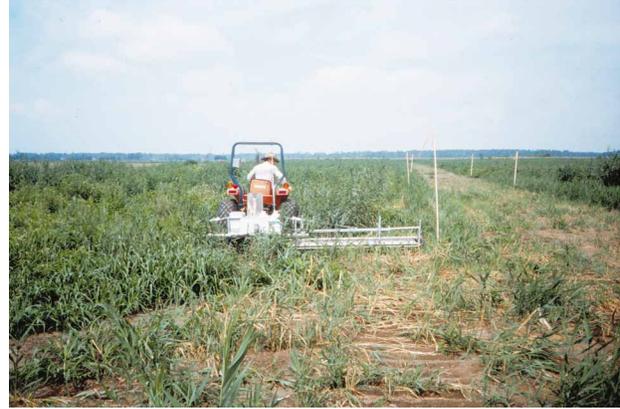
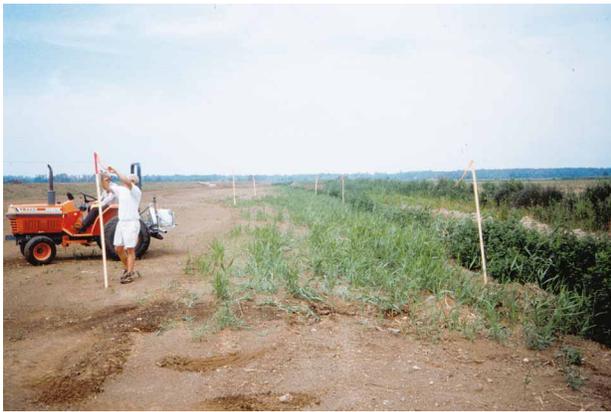
Figure 26. Wiper applying Round-Up® herbicide at a rate of 2.3×10^2 ml/ha (32 oz/acre) adjacent to Plot 1 at Eagle Island CDF, NC (23 May 00)

Figure 27. Wiper applying Round-Up® herbicide at a rate of 2.3×10^2 ml/ha (32 oz/acre) adjacent to Plot 2 at Eagle Island CDF, NC (23 May 00)

was sought to manage the plant tops. After 6 months, the compost was used as cellulose in a manufactured topsoil according to RSMT. On May 23, 2000, the new regrowth of the Phragmites was wiped with a wiper panel on two separate demonstration plots (each 6 by 30 m (20 by 100 ft)) with the glyphosate herbicide Round-Up® at a rate of 2.3×10^2 ml/ha (32 oz/acre) once (Figures 24-27) and then a second time after 4 days. Two similar size control (untreated) plots were established for comparison. The plant height was approximately 0.6 m (2 ft) high each time wiping was performed. Effects of the wiping were observed on 24 Jun 2000 (32 days) (Figures 28 and 29). On 5 Jul 2000 (44 days), some new regrowth was observed (Figures 30 and 31). A gallon of ready-to-use Round-Up® was applied by hand spray to spot-spray the green leaves present on each demonstration plot. The concentration of glyphosate was 0.96 percent as the isopropylamine salt. Observations (Figures 32 and 33) were made on 22 Jul 2000 (60 days after the initial wiping and 14 days after hand spot-spray application). Control plots that were not wiped with herbicide were covered with Phragmites and other undesirable weeds (Figures 34 and 35). It is expected that the roots/rhizomes of Phragmites in these plots will be dead allowing material from that area to be used for RSMT manufactured topsoil or other uses without the interferences caused by Phragmites.

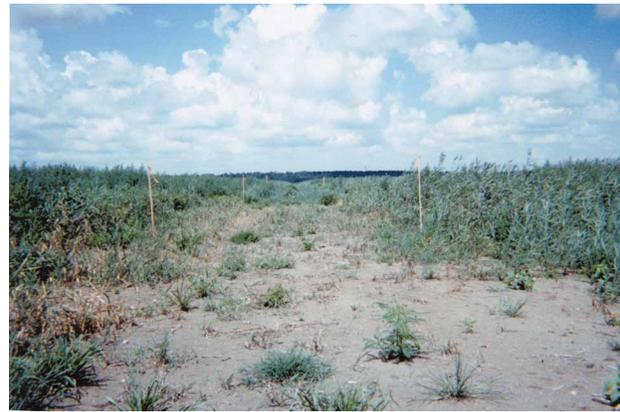
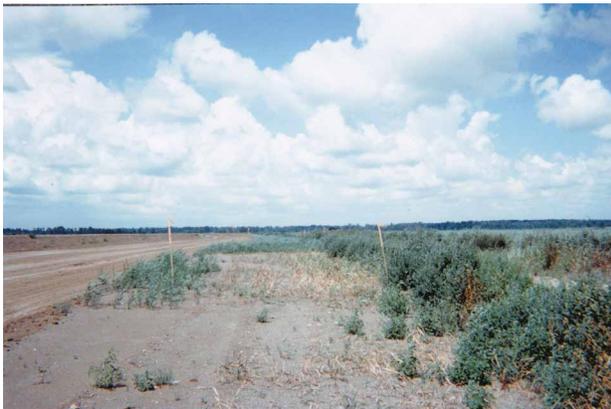
Figure 28. Observation at 32 days of the herbicide-wiped Plot 1 in the foreground with the unwiped control in the background (24 Jun 00)

Figure 29. Observation at 32 days of the herbicide-wiped Plot 2 in the foreground with the unwiped control in the background (24 Jun 00)

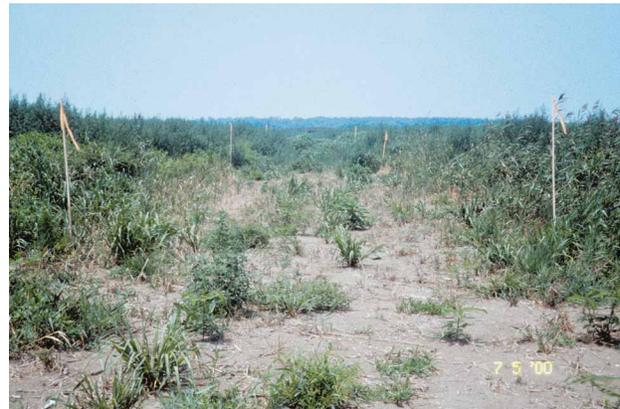
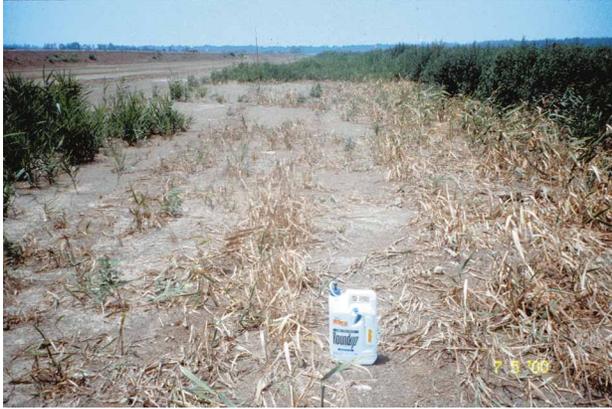
Figure 30. Observation at 43 days of the herbicide-wiped Plot 1 in the foreground with the unwiped control in the background (5 Jul 00)

Figure 31. Observation at 43 days of the herbicide-wiped Plot 2 in the foreground with the unwiped control in the background (5 Jul 00)

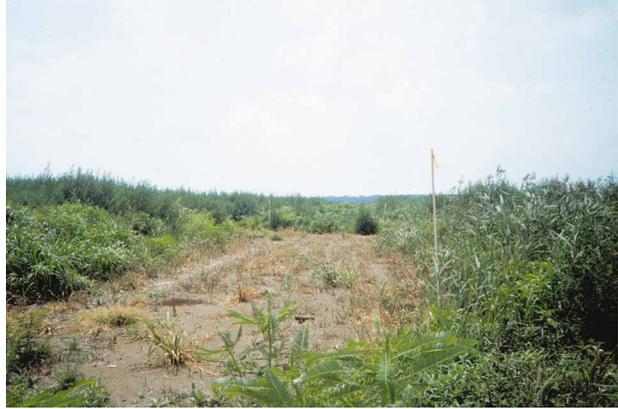
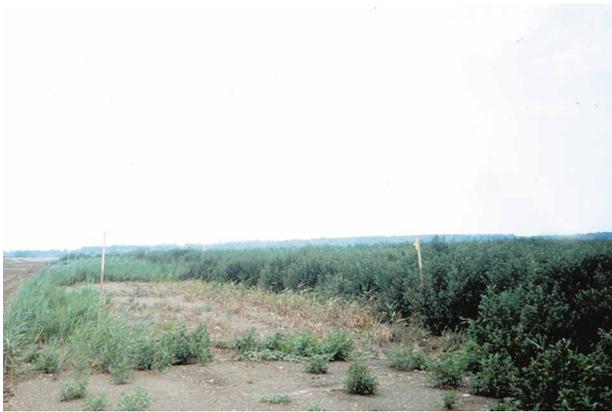
Figure 32. Observation at 60 days of the herbicide-wiped Plot 1 in the foreground with the unwiped control in the background (22 Jul 00)

Figure 33. Observation at 60 days of the herbicide-wiped Plot 2 in the foreground with the unwiped control in the background (22 Jul 00)

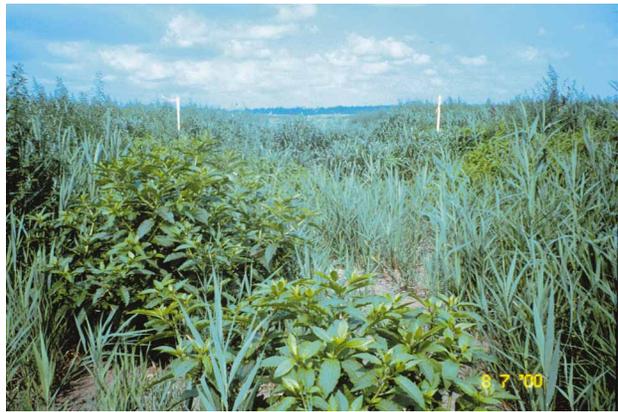
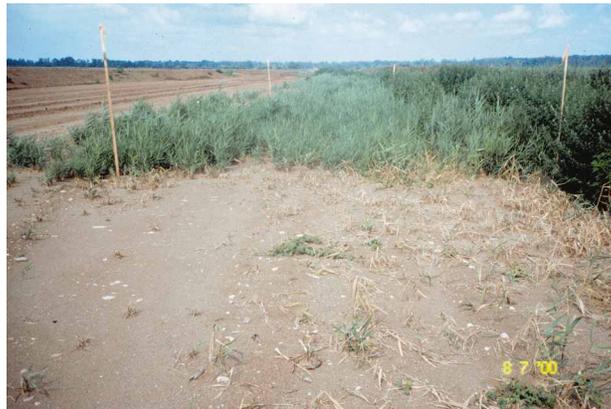
Figure 34. Plot 1 control, unwiped (Jul 00)

Figure 35. Plot 2 control, unwiped (Jul 00)
