Environmental analysis of the Upper Susitna River Basin using Landsat imagery

L.W. Gatto, C.J. Merry, H.L. McKim and D.E. Lawson

January 1980

Prepared for
DIRECTORATE OF CIVIL WORKS
OFFICE, CHIEF OF ENGINEERS
By
UNITED STATES ARMY
CORPS OF ENGINEERS
COLD REGIONS RESEARCH AND ENGINEERING LABORATORY
HANOVER, NEW HAMPSHIRE, U.S.A.

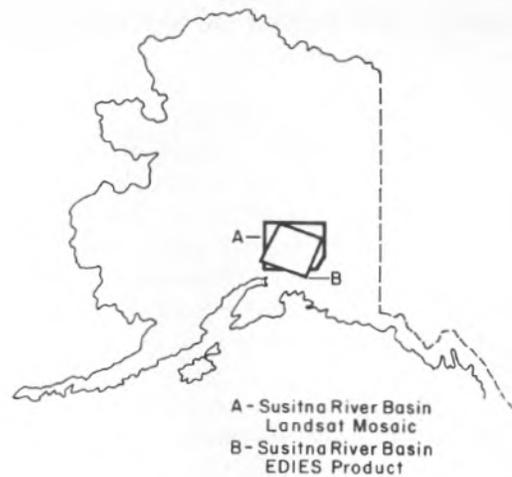
Figure 2. Location of the EDIES product and the photomosaic used for mapping.

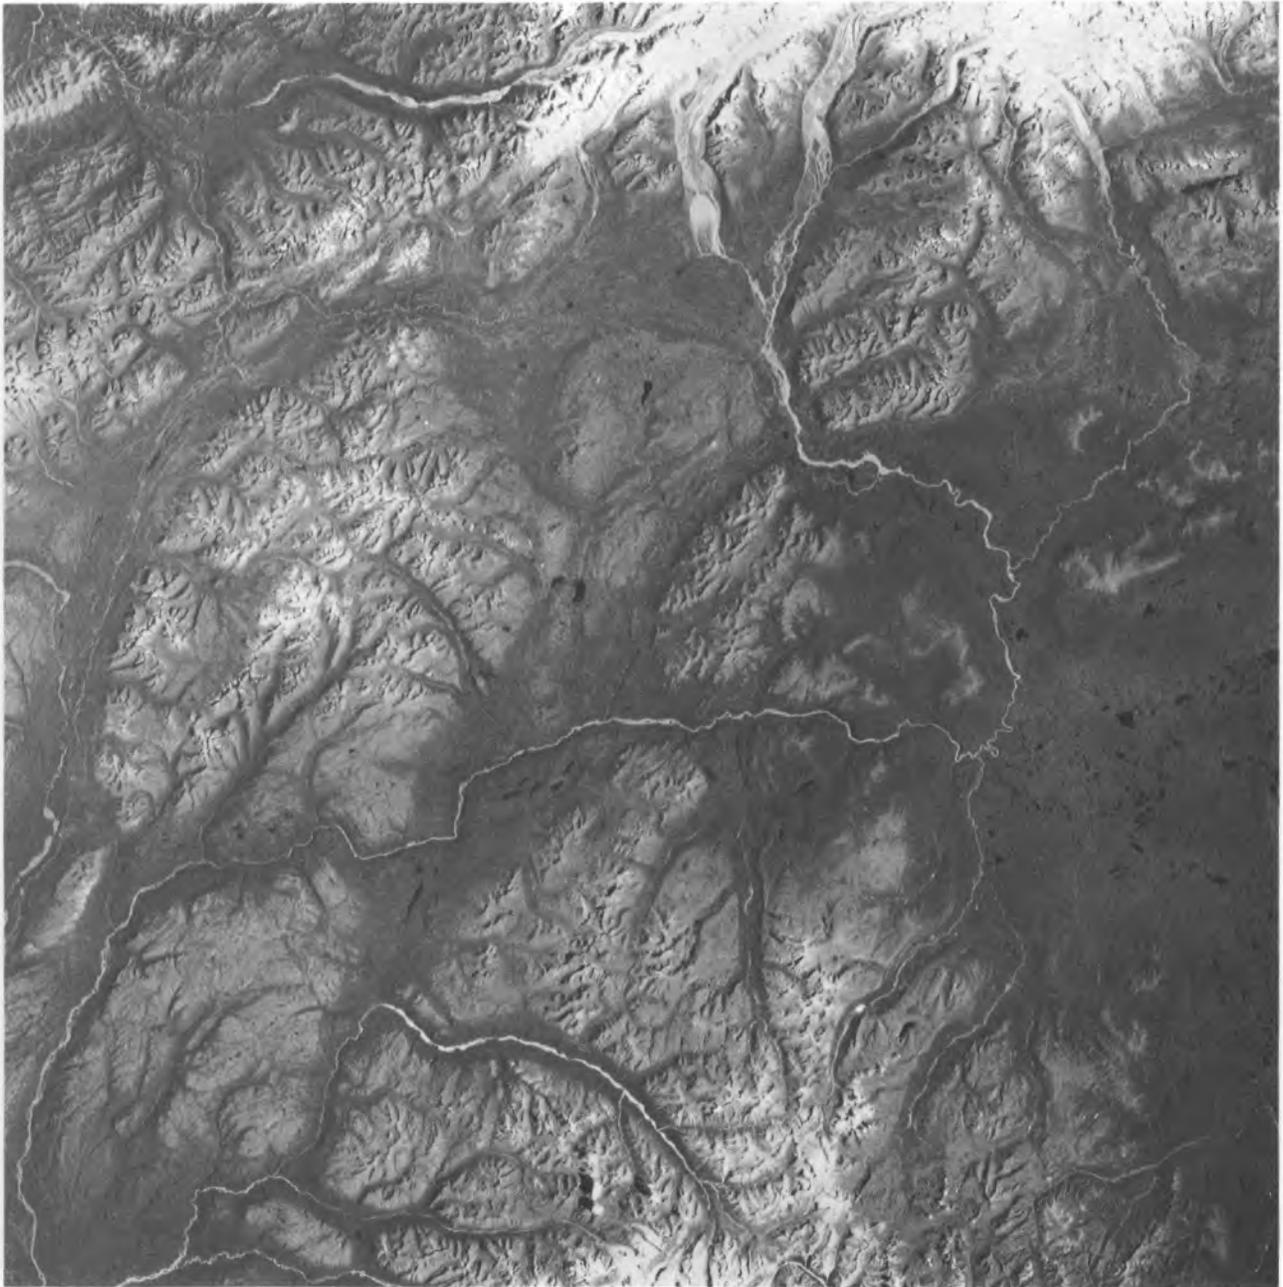
a. Band 4.

Figure 4. Single band EDIES images of scene 5470-19560.

b. Band 5.

c. Band 6.

d. Band 7.

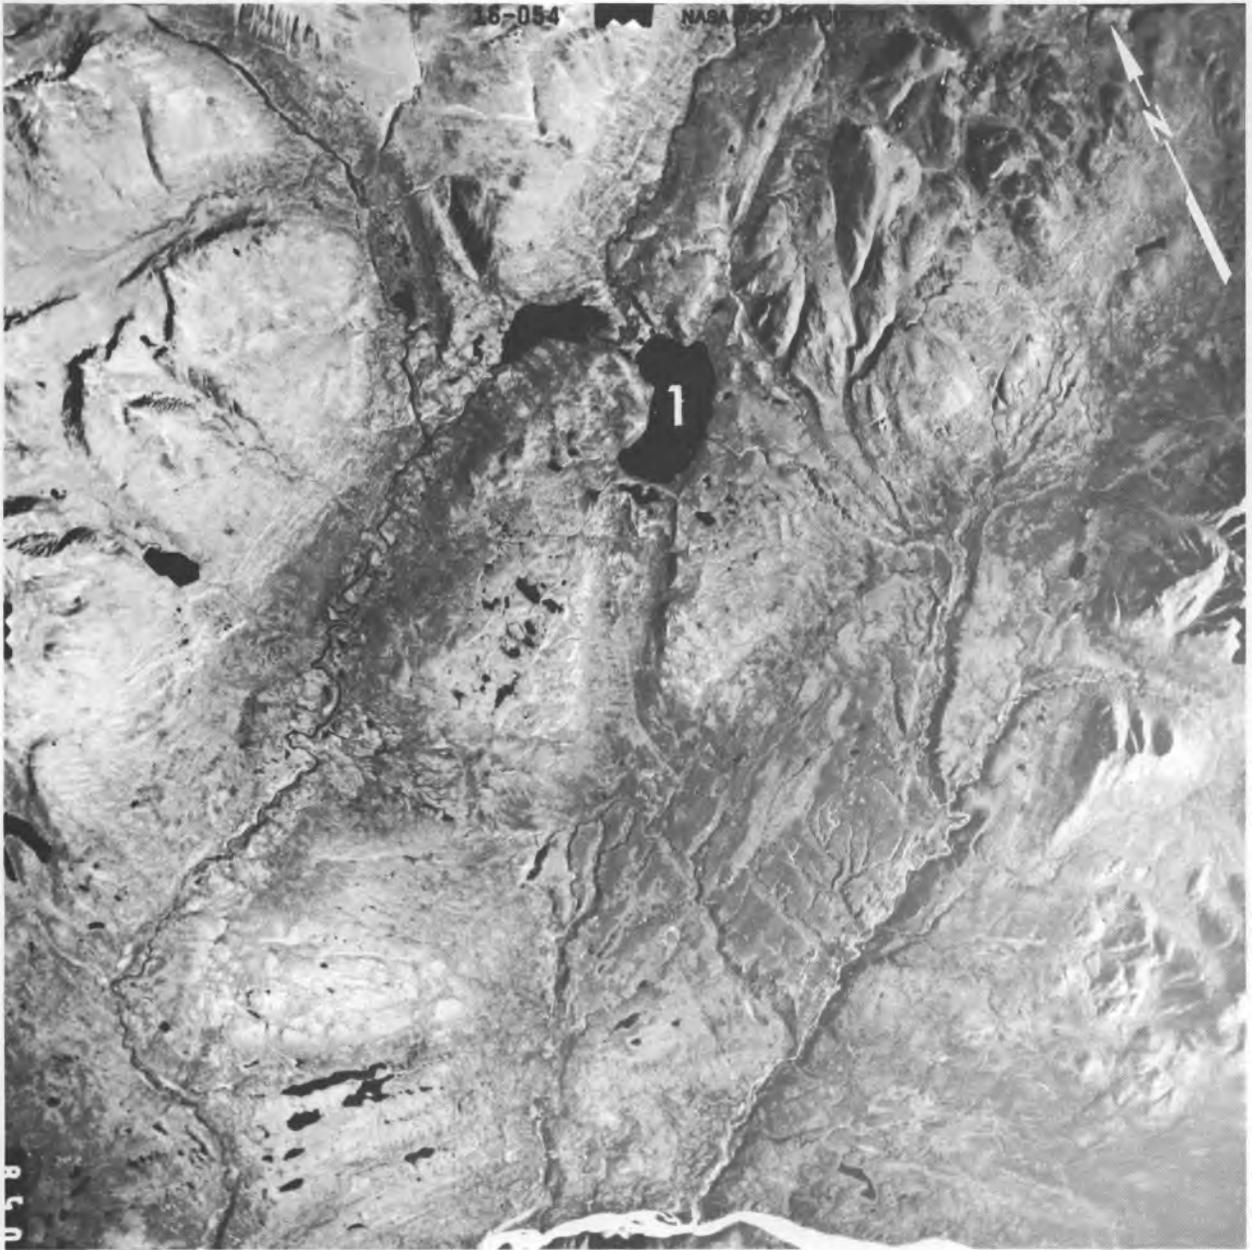
Figure 9. Big Lake (1) and surrounding area, taken on 28 July 1977 during NASA mission 364; scale, 1:160,000.

I compared the distribution of lakes mapped from the Landsat imagery to that on the NASA aerial photographs and the Healy topographic map. NASA photograph 16-054 (Fig. 9) shows the lakes in the Big Lake (1) area of the basin. Most of the lakes shown can also be seen on the Landsat EDIES image (Figs. 3 and 4d). NASA photograph 16-060 (Fig. 5) shows the area around the confluence of the Maclaren and Susitna rivers. Many of the lakes are so small that their shape could not be mapped accurately but are easily observed on the Landsat scene. Frequently, the shape of the lakes is not as well-defined on the Landsat image as on the NASA photographs because of the difference in resolution between the photographs and the imagery.

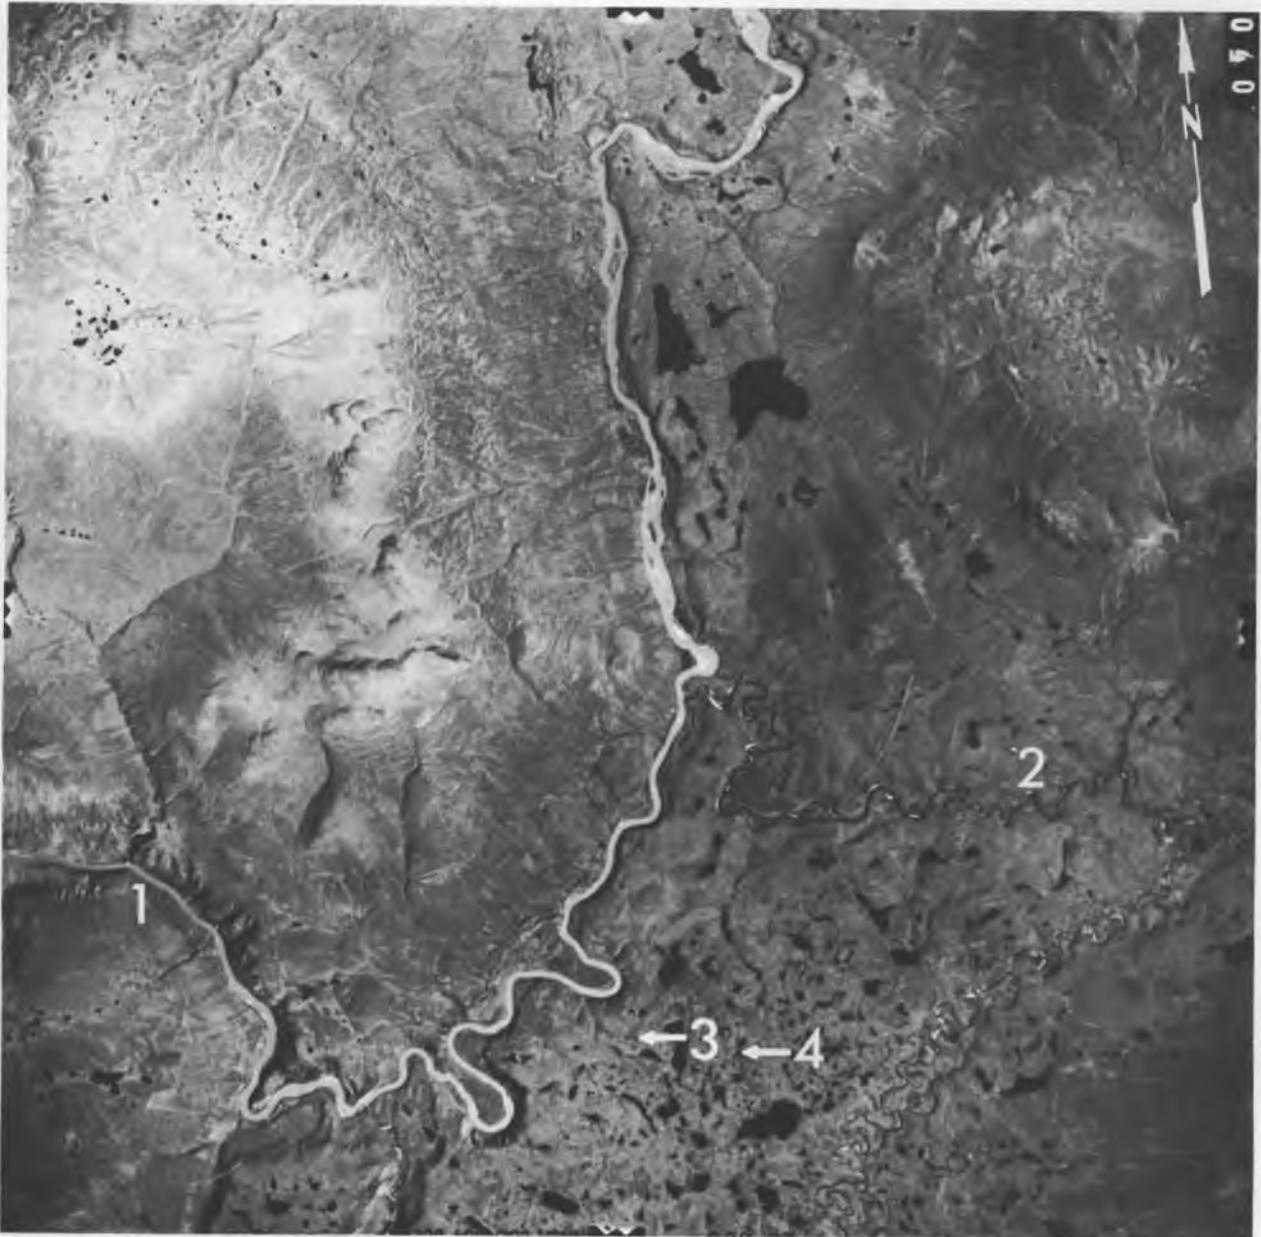
Figure 11. Area near the confluence of the Susitna (1) and Tyone (2) Rivers; lake 3 is marginally visible on the Landsat EDIES image, lake 4 is clear; taken on 28 July 1977 during NASA mission 364; scale, 1:160,000.

NASA photographs: Figure 11, NASA photograph 16-036; Figure 12, NASA photograph 19-058; and Figure 13, NASA photograph 19-056.

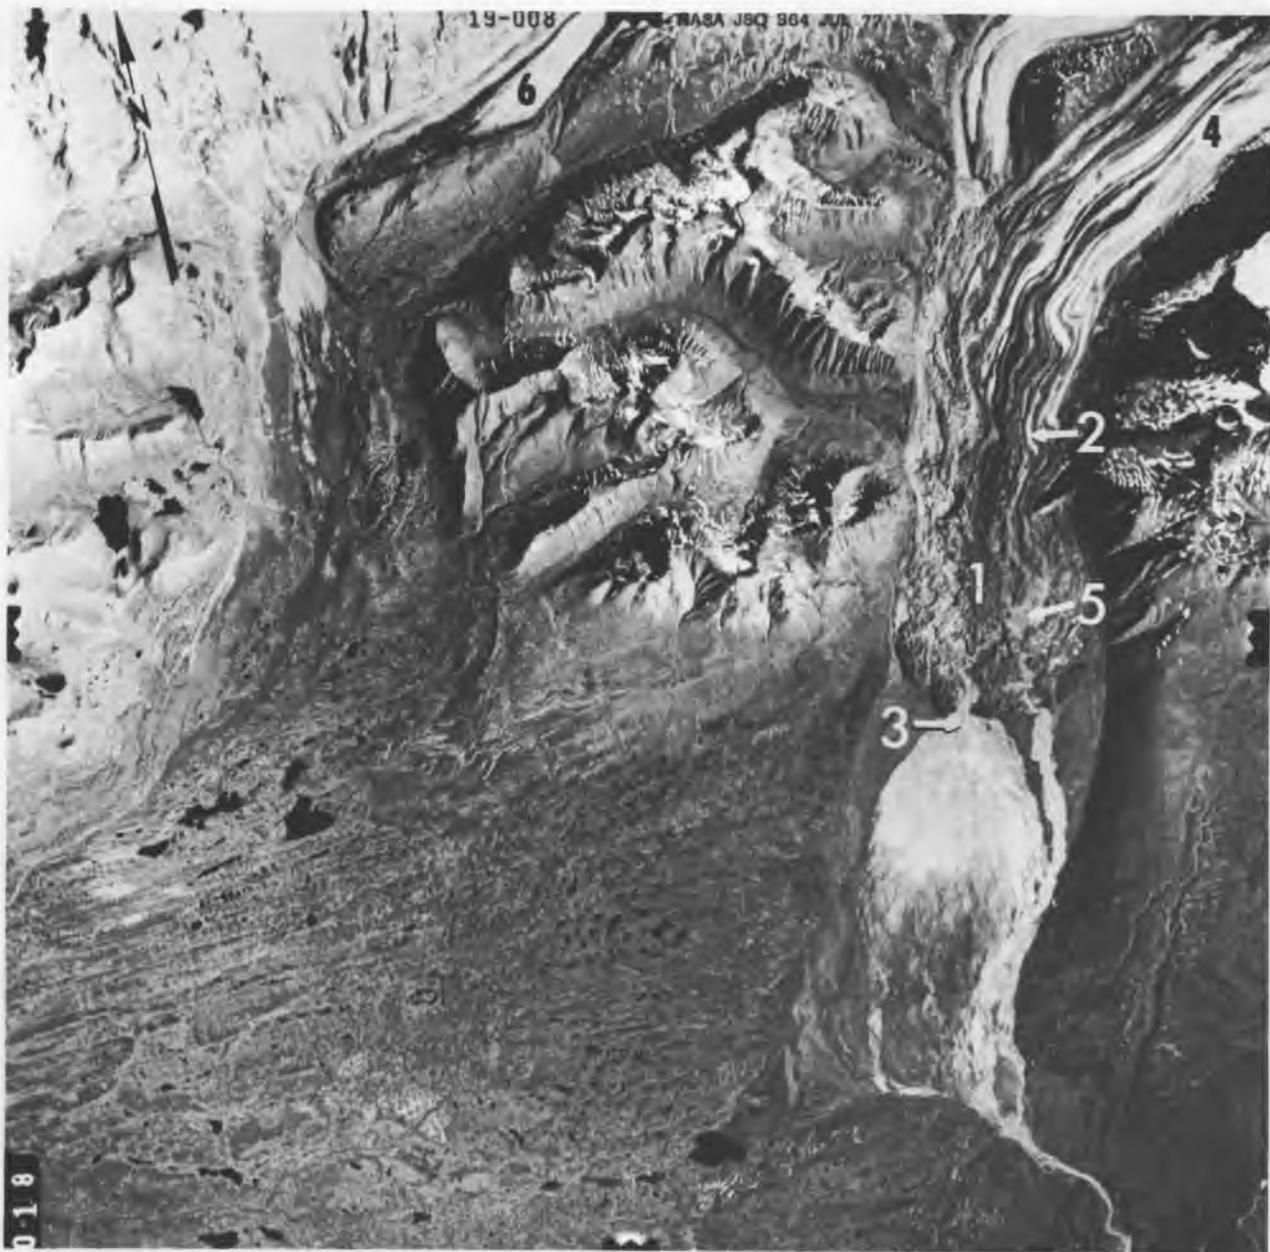
Figure 14. Terminus of the West Fork Glacier (4), exposed ice (2), meltwater streams (3), debris at terminus (1), surface water (5), Nenana Glacier (6); taken on 29 July 1977 during NASA mission 364; scale 1:160,000.

age (Fig. 3) and NASA photograph 19-008 (Fig. 14). Surface water (5) on the surface of the terminus is also apparent on both; however, small-scale roughness is apparent only on the NASA photograph.

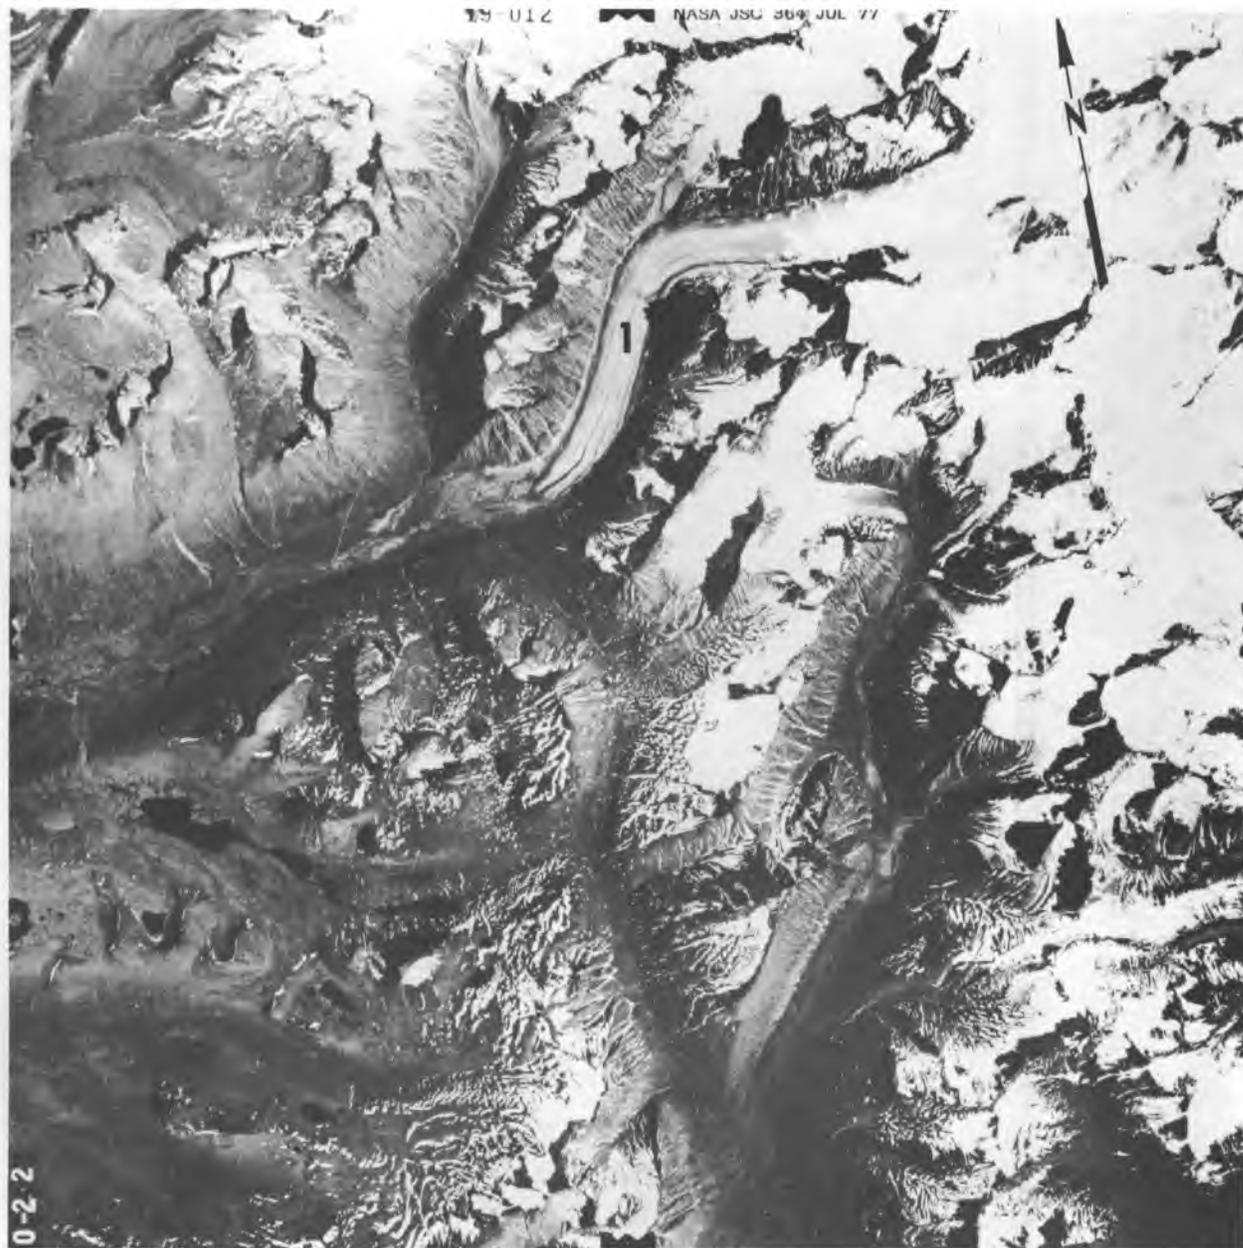
Figure 15. East Fork Glacier (1); taken on 29 July 1977 during NASA mission 364; scale, 1:160,000.

The lateral and medial moraines are well defined. Their patterns are evident on the Landsat image and NASA photographs. The patterns apparent on the Landsat EDIES image (Fig. 3) and NASA photographs 19-008 (Fig. 14), 19-012 (Fig. 15), and 19-010 (Fig. 16) show this comparison.

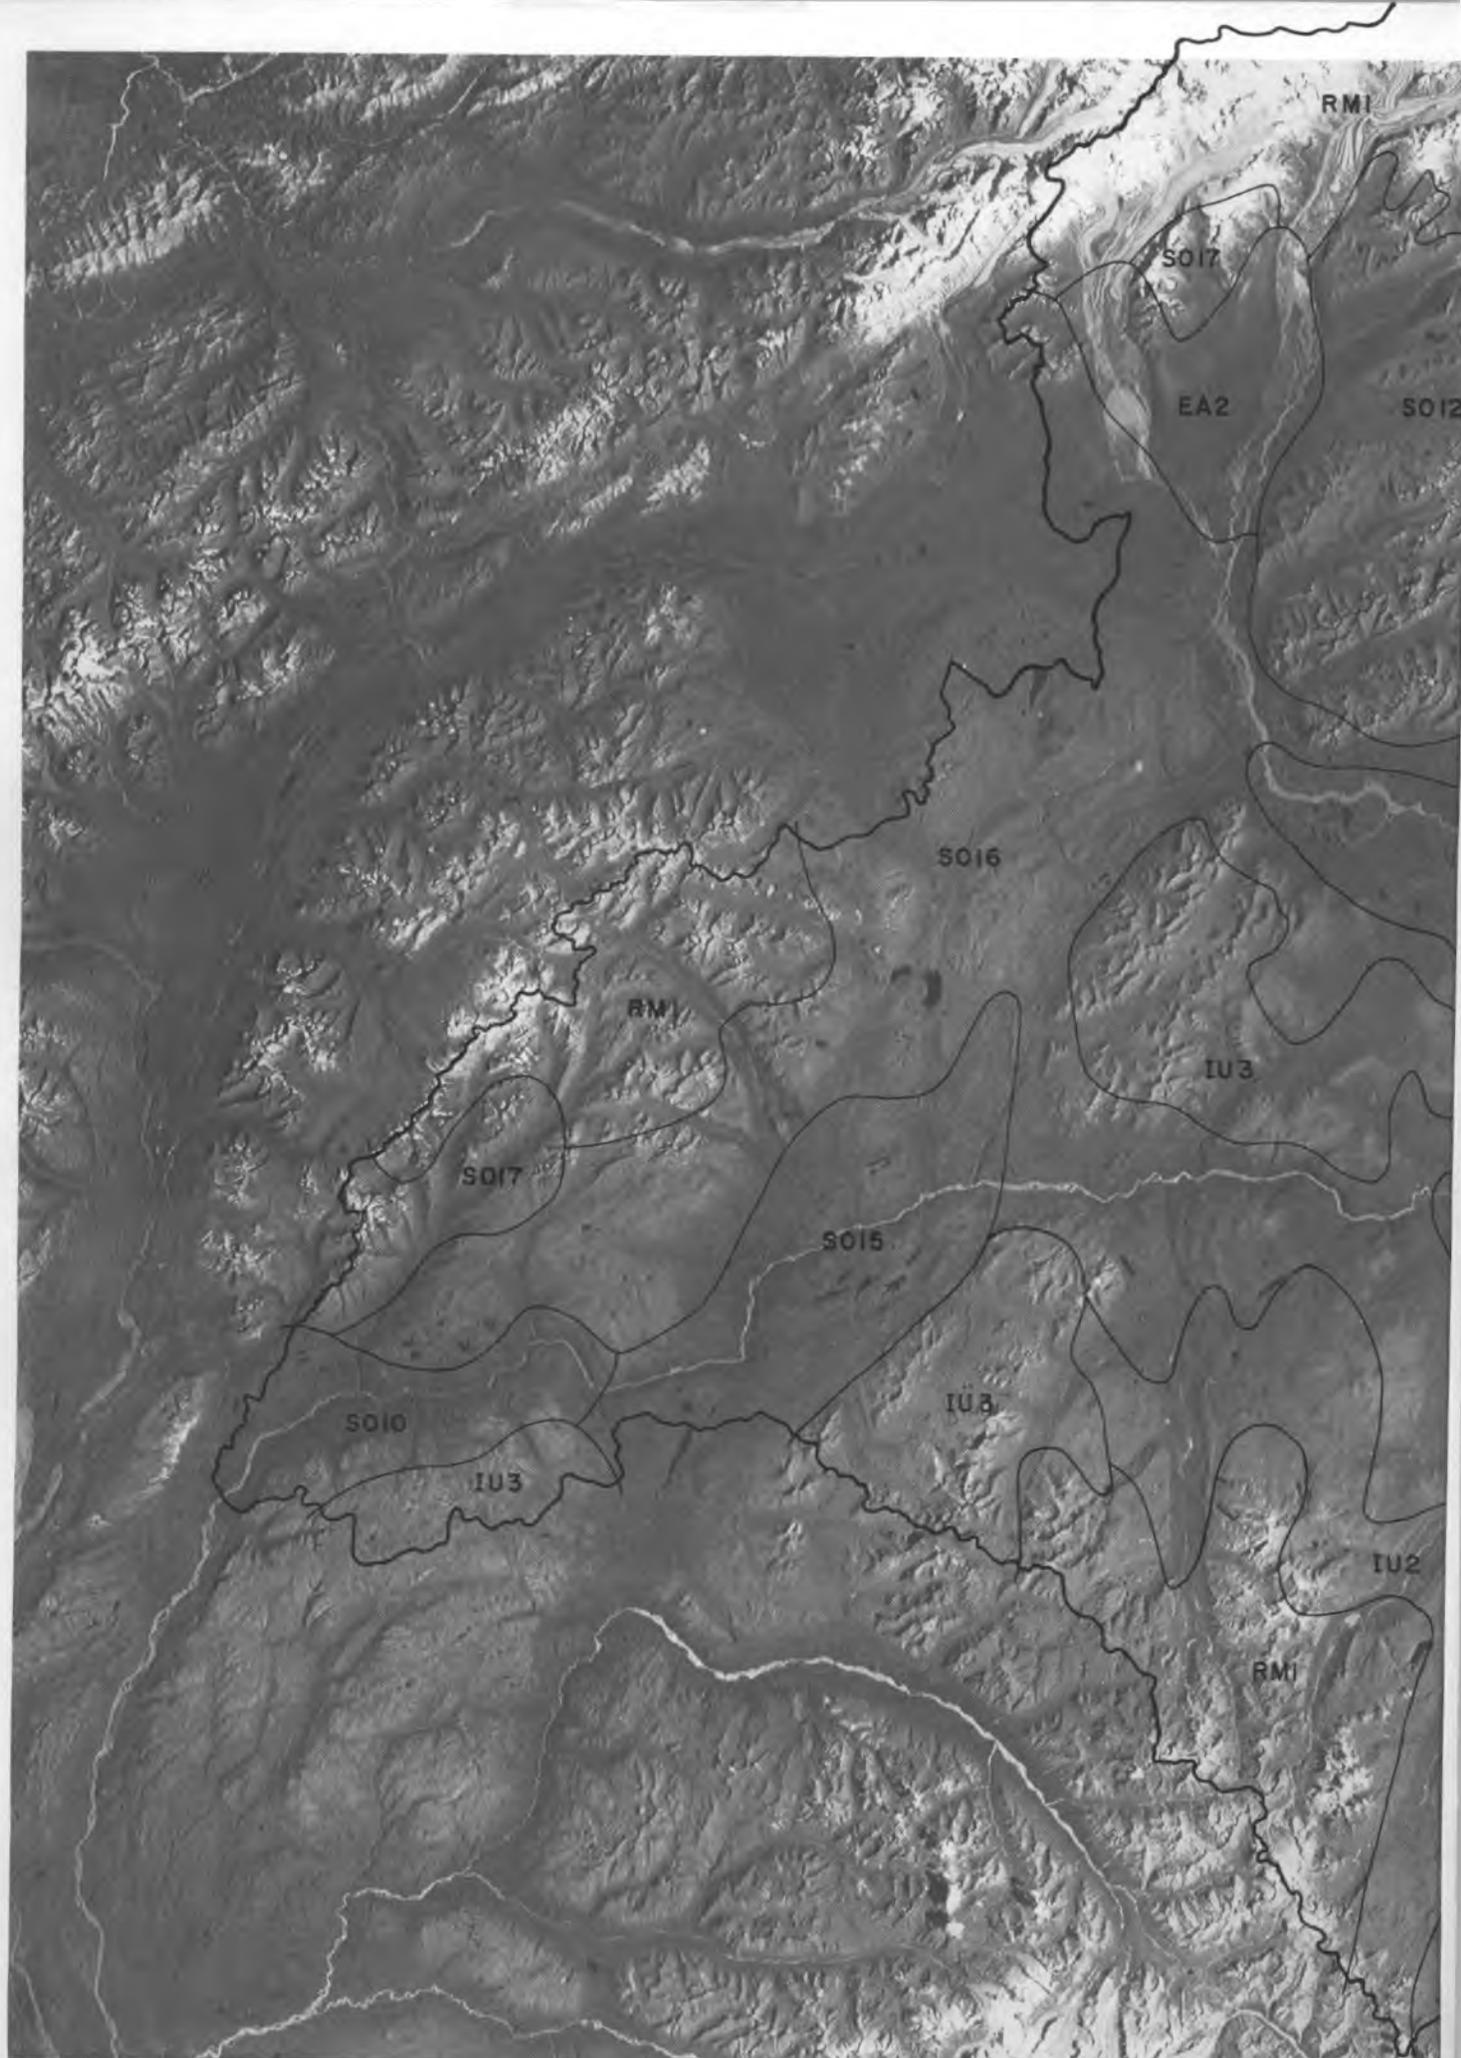
Figure 22. Exploratory soil survey map of the Upper Susitna River Basin, Alaska (from Rieger et al. 1979). (Registration of colored overlay is not accurate everywhere on base photograph because of material shrinkage.)
