Evaluation of Supa-Trac Matting for Expeditionary Roads

Timothy W. Rushing, Jeb S. Tingle, Timothy J. McCaffrey,
and Todd S. Rushing

August 2009

Final report

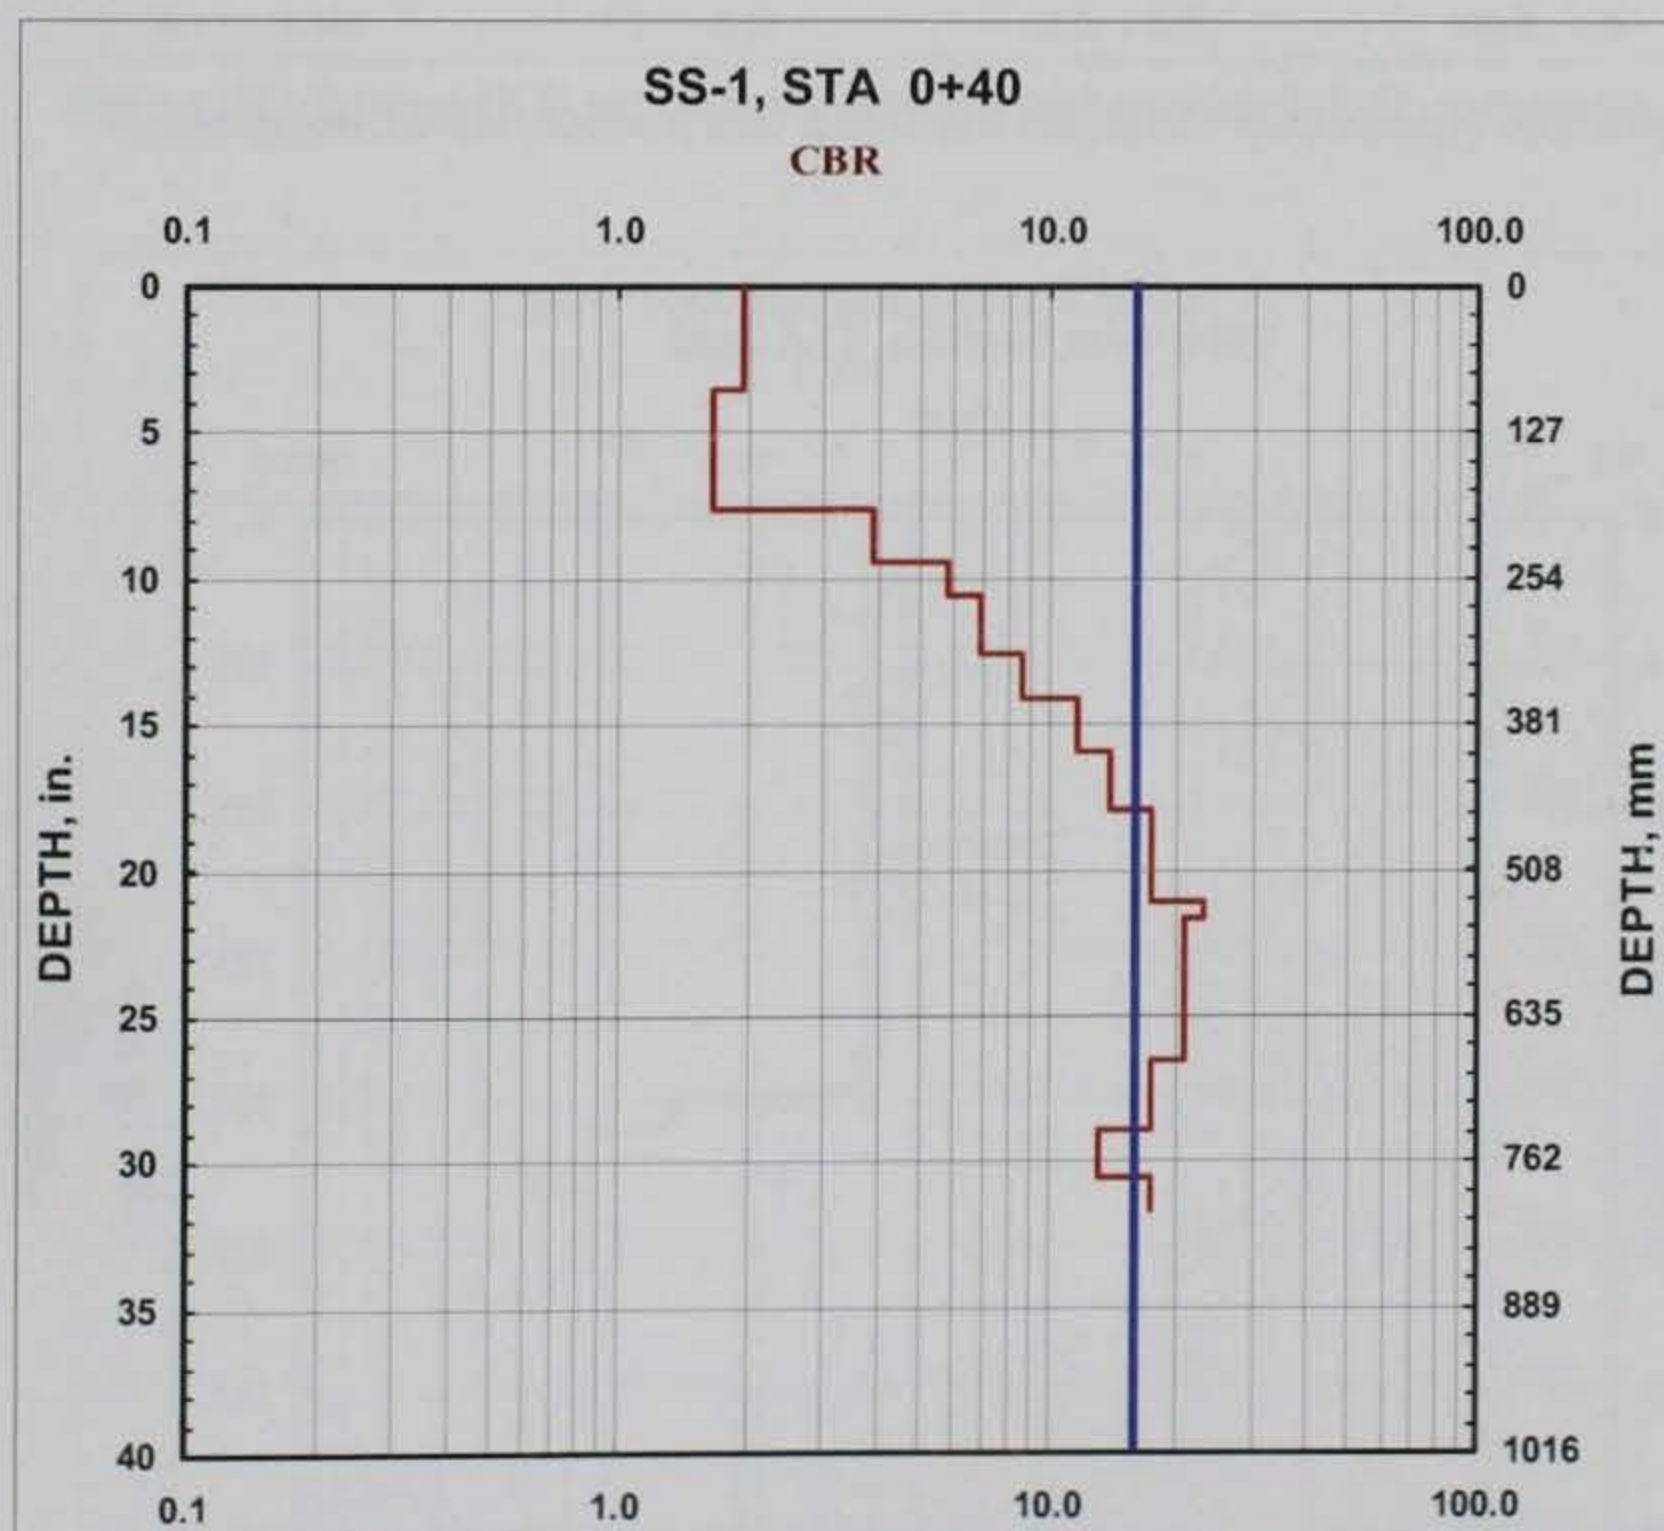
Figure 18. Typical DCP result for the SS-1 test section SP subgrade.

For the SS-1 test section constructed from an SP material, the load bearing capacity varied according to the degree of sand particle confinement. Because surface sand is more poorly confined than subsurface sand, the apparent CBR measured by the DCP increases with depth of penetration. In this study, reasonably constant sand strength was reached only after penetration of approximately 12 to 15 in.

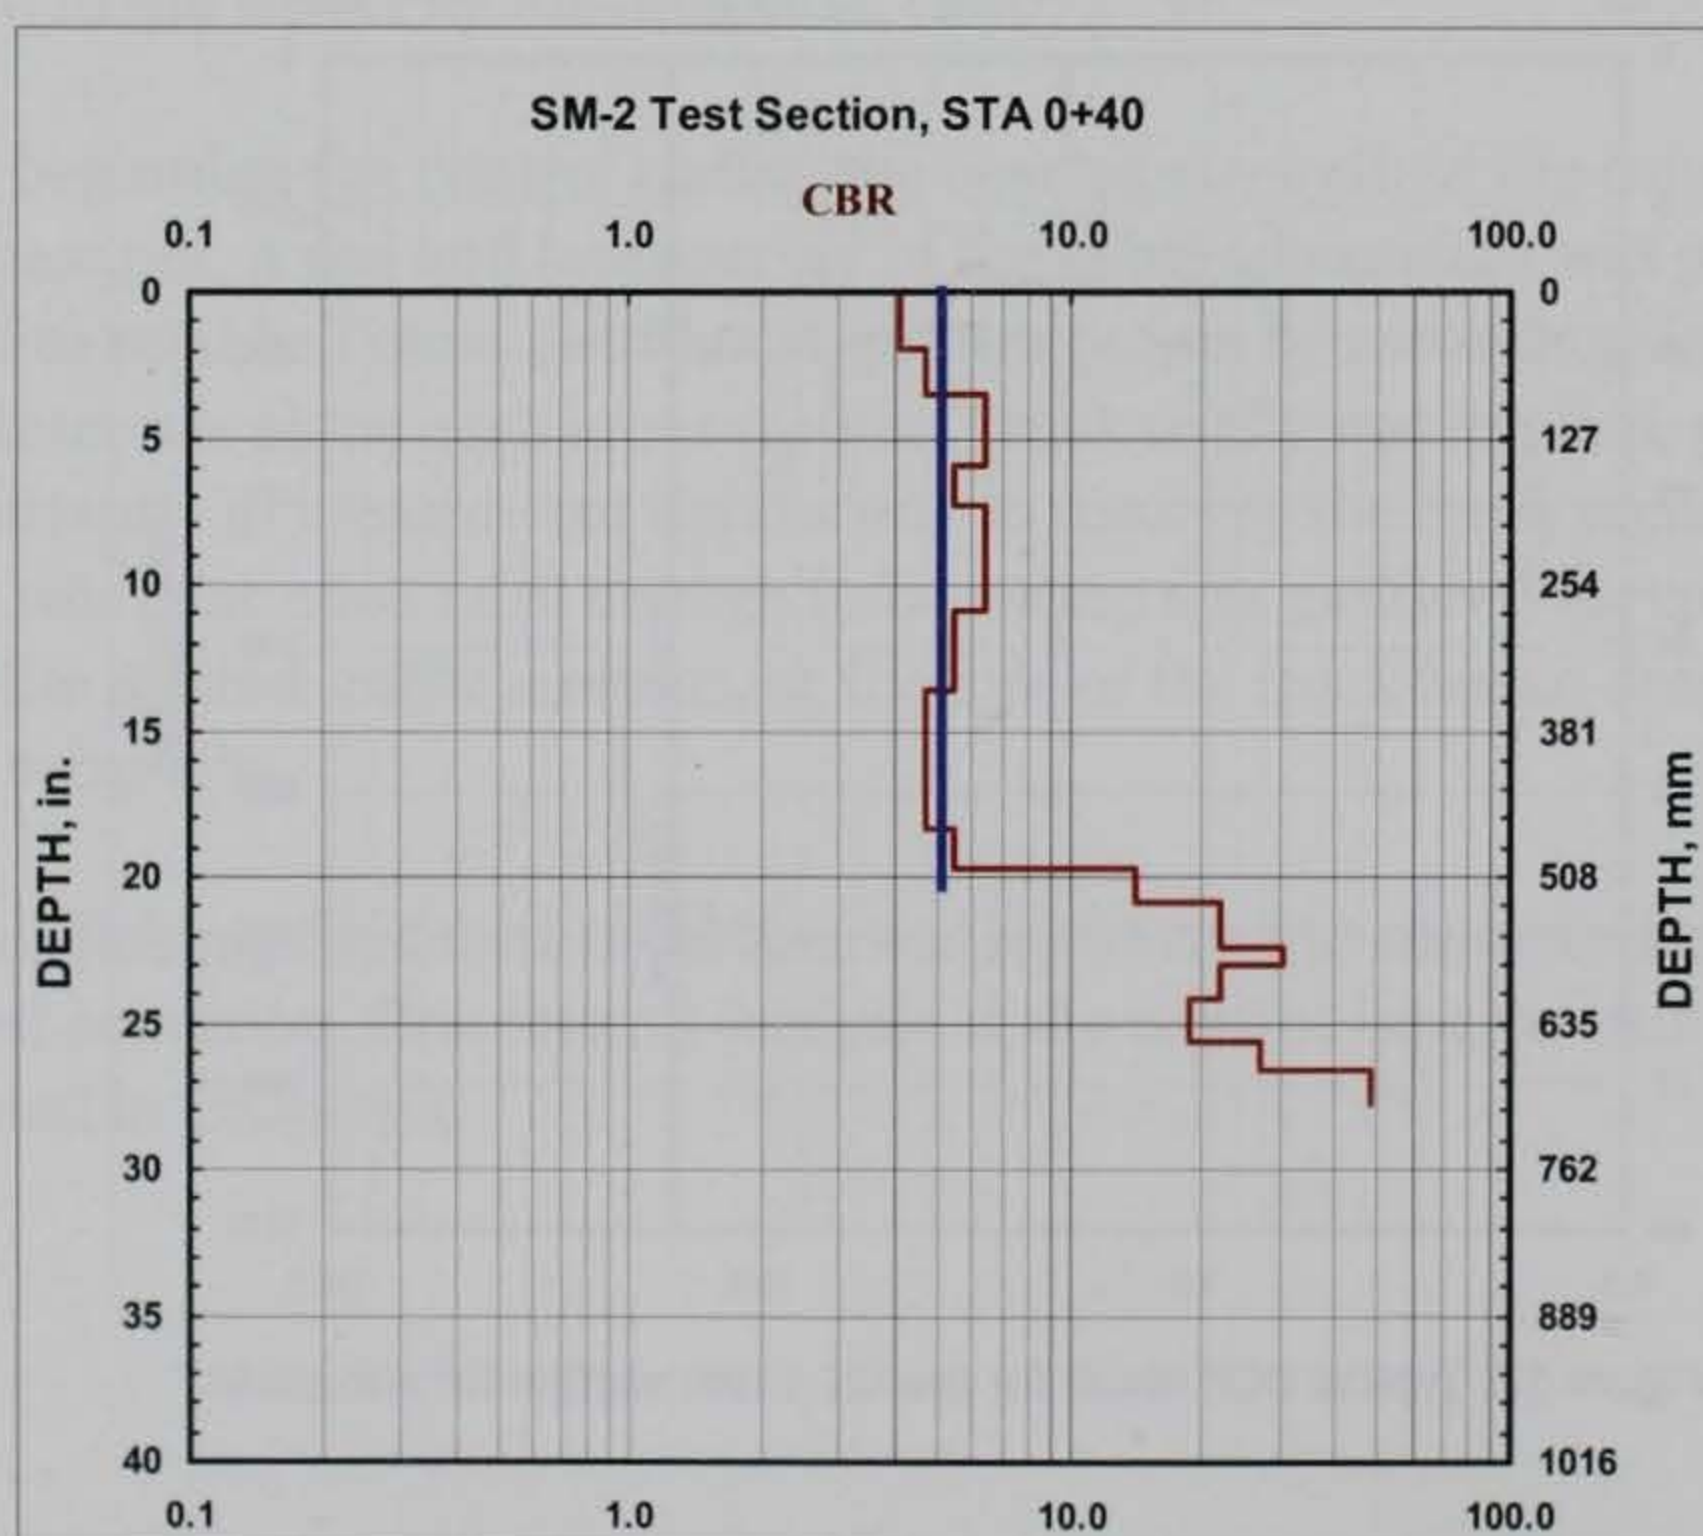
Figure 20. Typical DCP result for the SM-2 test section ML-CL subgrade.

strength. In Figures 19 and 20, the CBRs remained relatively consistent at 1 and 5 CBR for the SM-1 and SM-2 test sections, respectively. After approximately 20 in. deep, the subgrade strength increased to 20 CBR, indicating the bottom of the processed material. Test section SM-3 was conducted on an unprocessed natural subgrade with greater variability in bearing capacity with depth. The data shown in Figure 21 indicated there was a stronger layer from approximately 7 to 14 in. The effective CBR of the test section was determined to be 5 CBR.

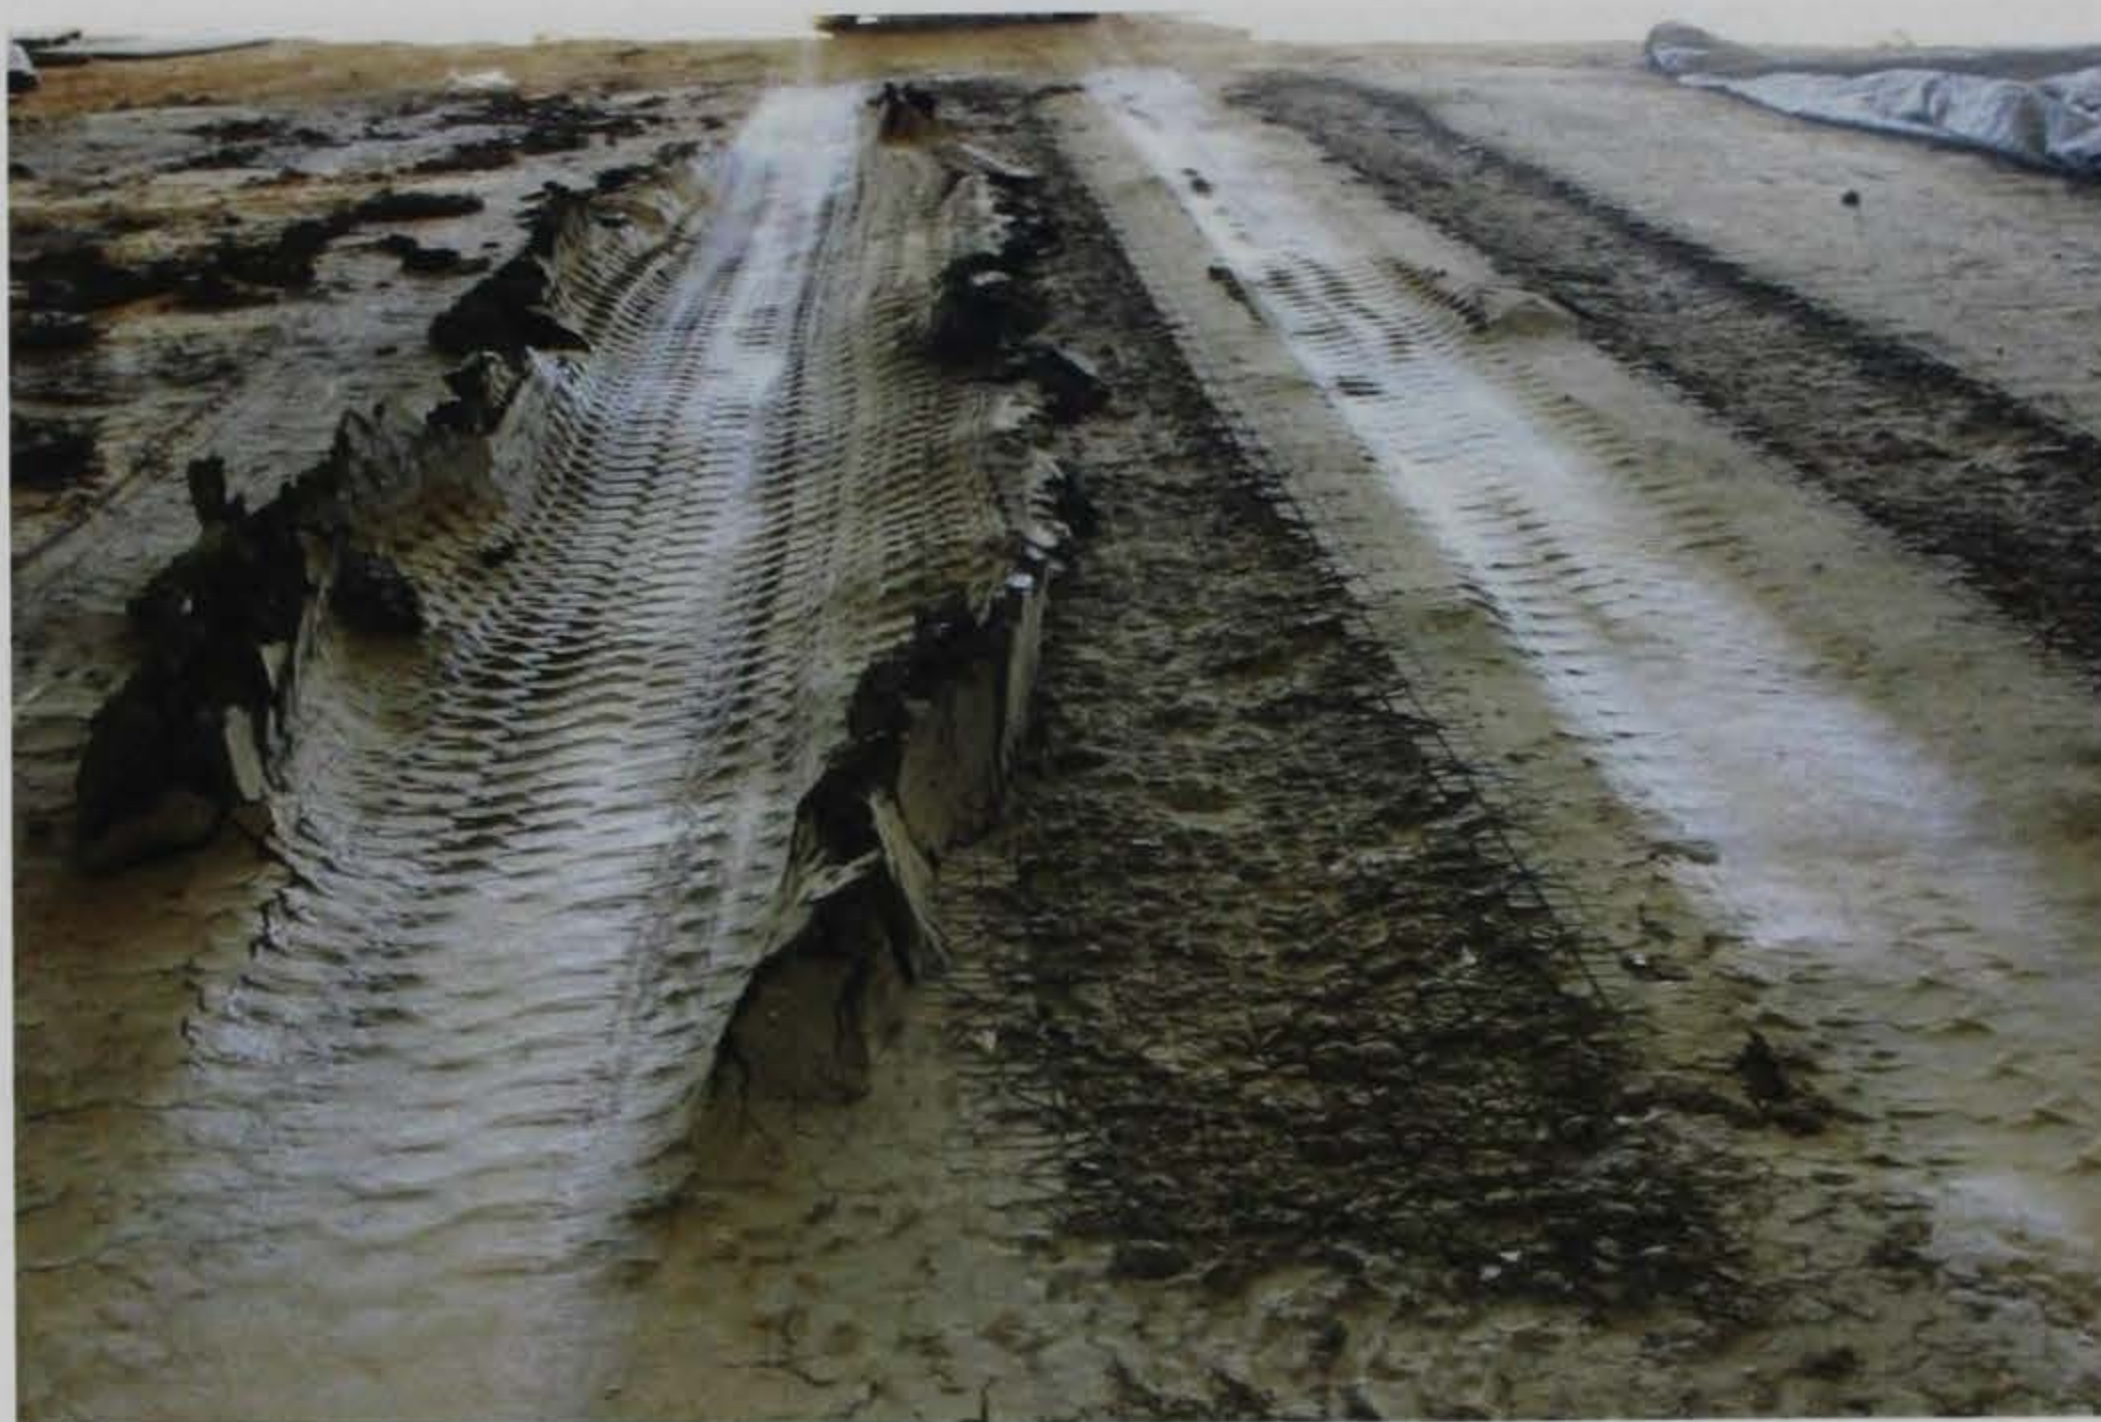
Figure 55. SM-4 control after 1,000 passes.

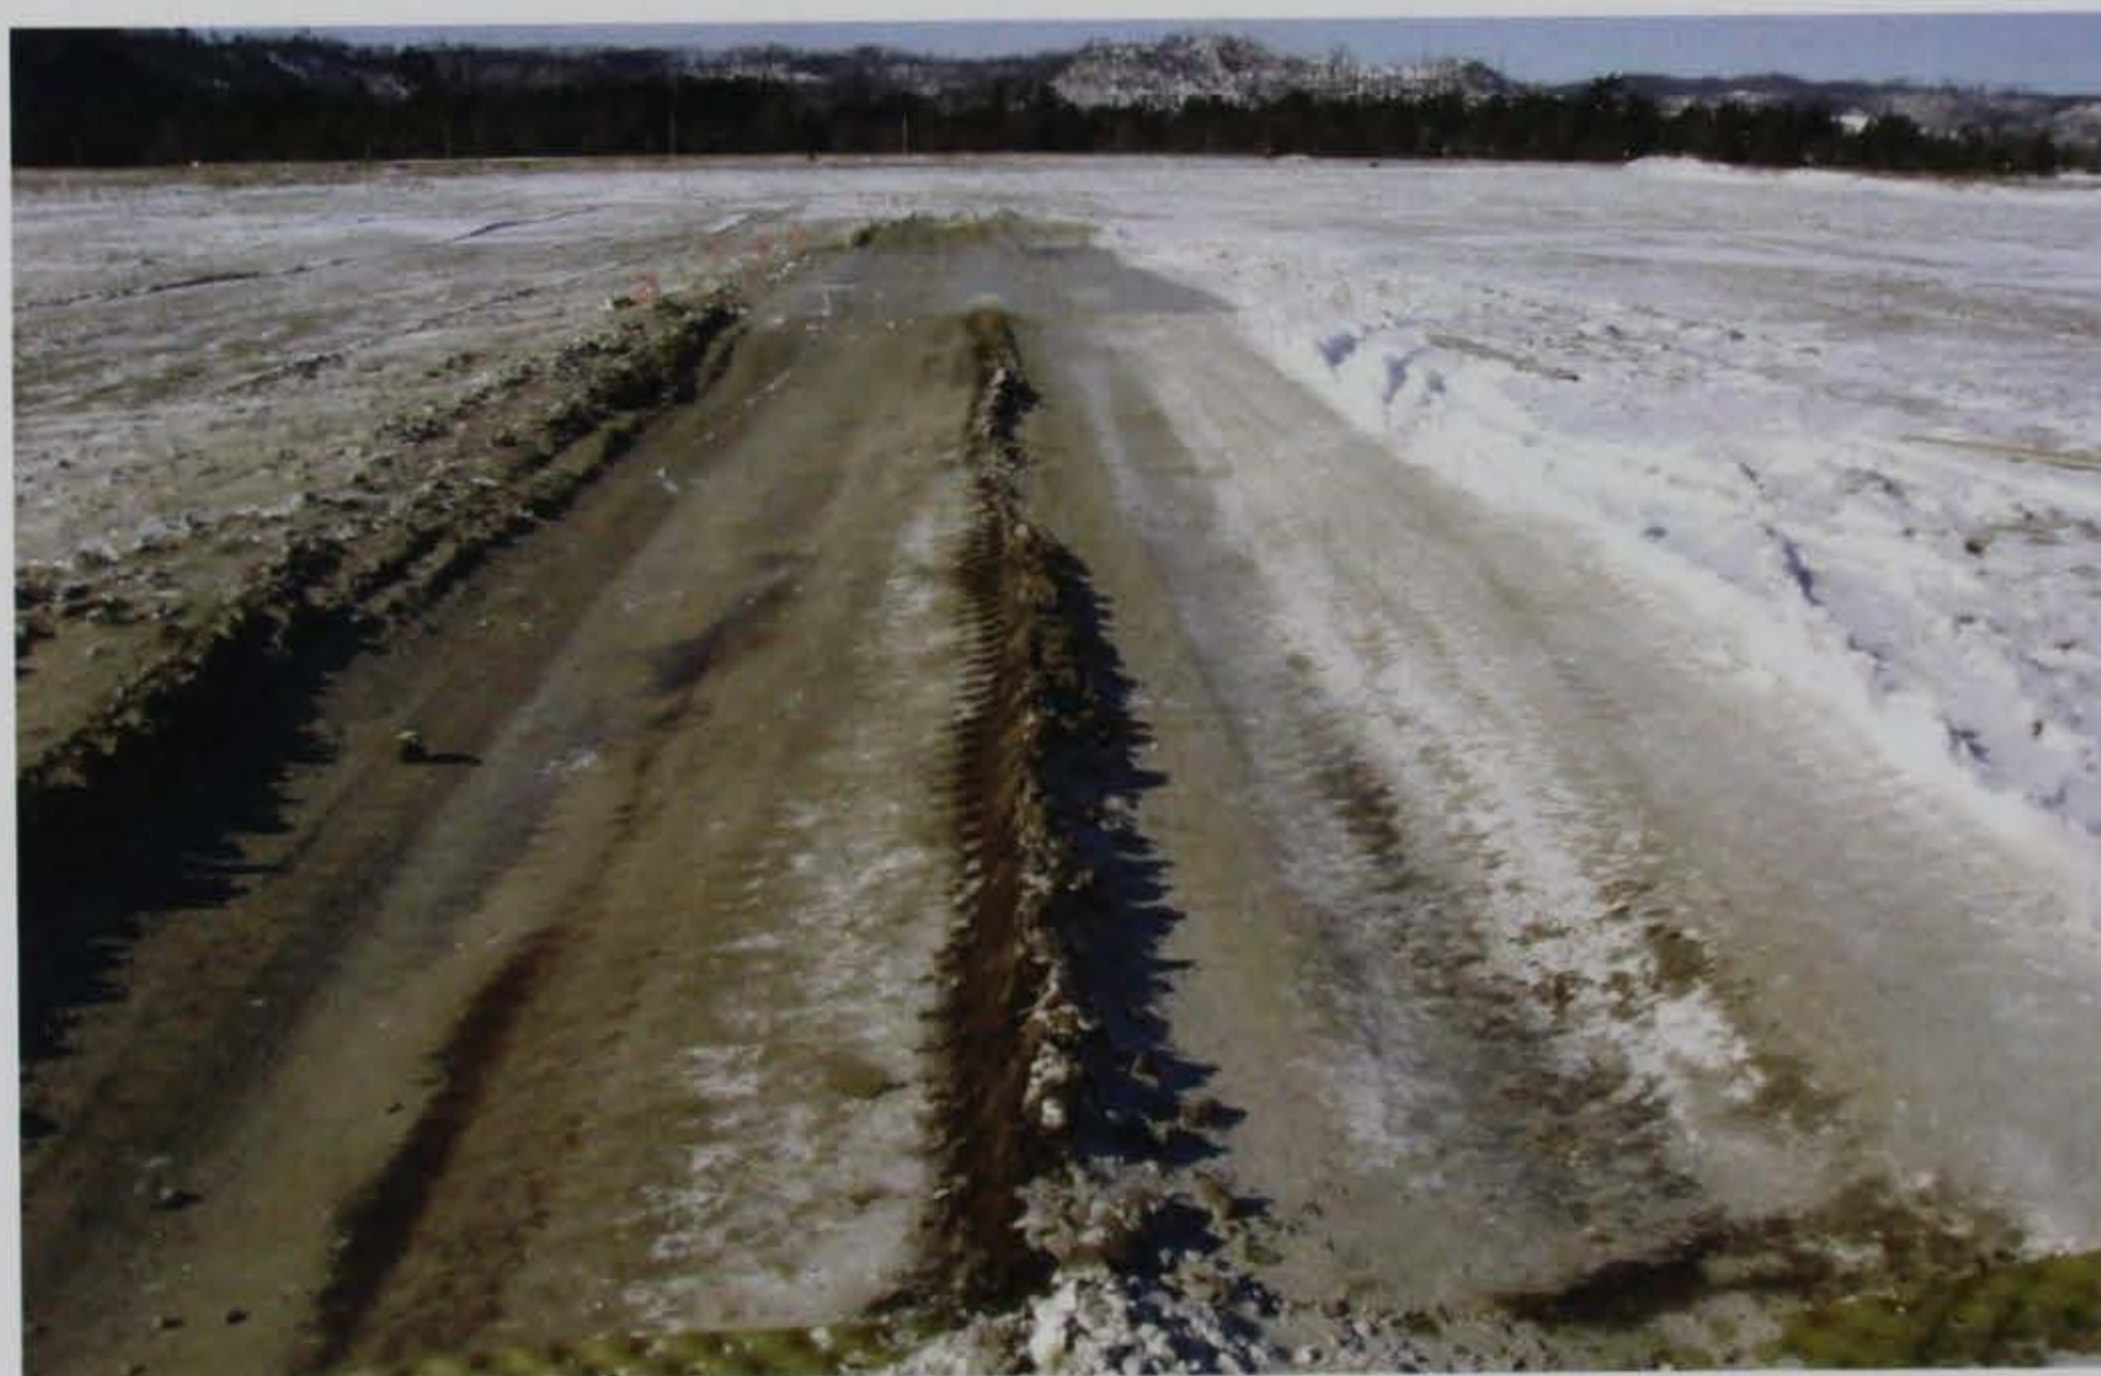
Figure 56. SC-2 control after 2,000 passes.
