Demonstration and Validation of Materials for Corrosion-Resistant Fencing and Guard Railings in Aggressive Climates

Final Report on Project F09-AR02

October 2015

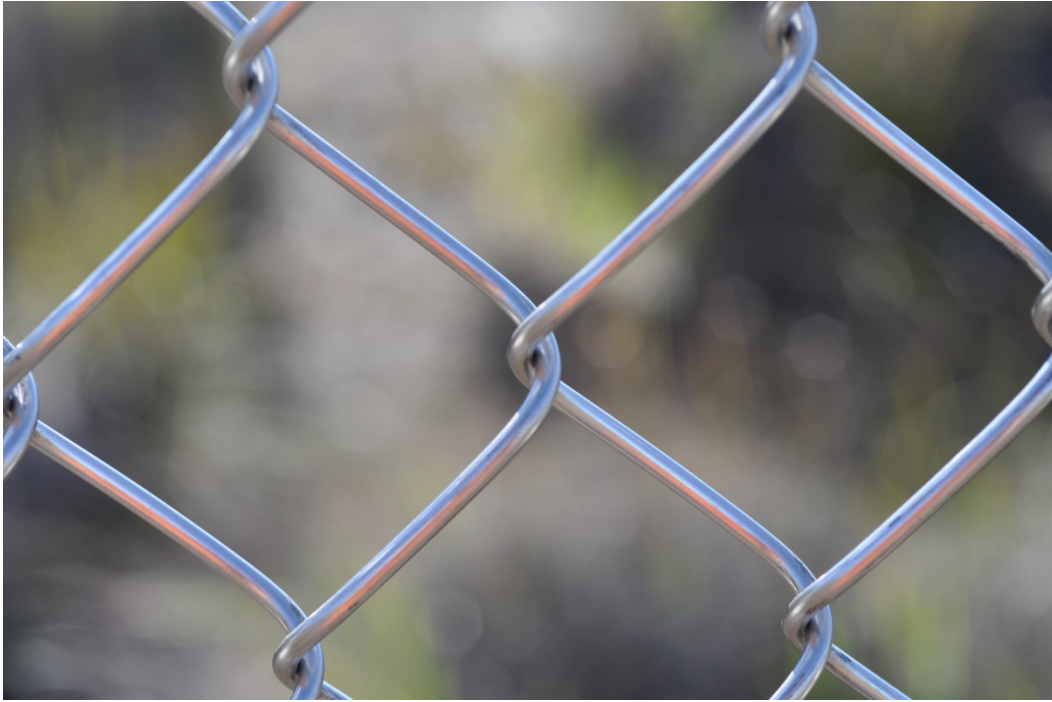
Figure A9. Aluminum after 6 months exposure.

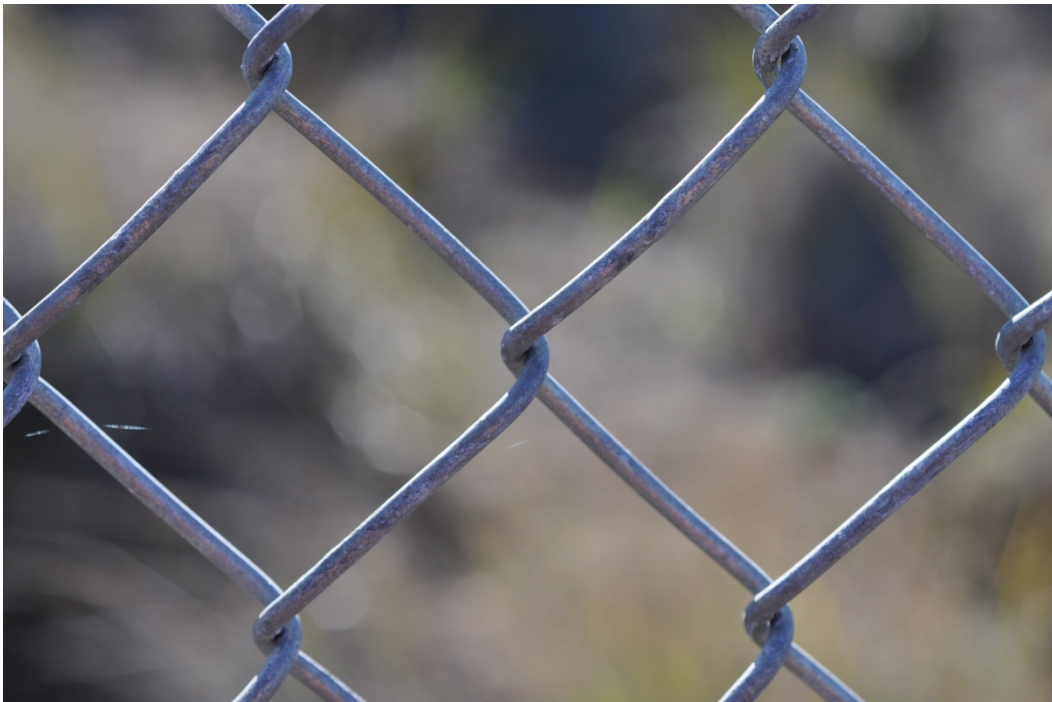
Figure A10. Galvanized steel after 6 months exposure.

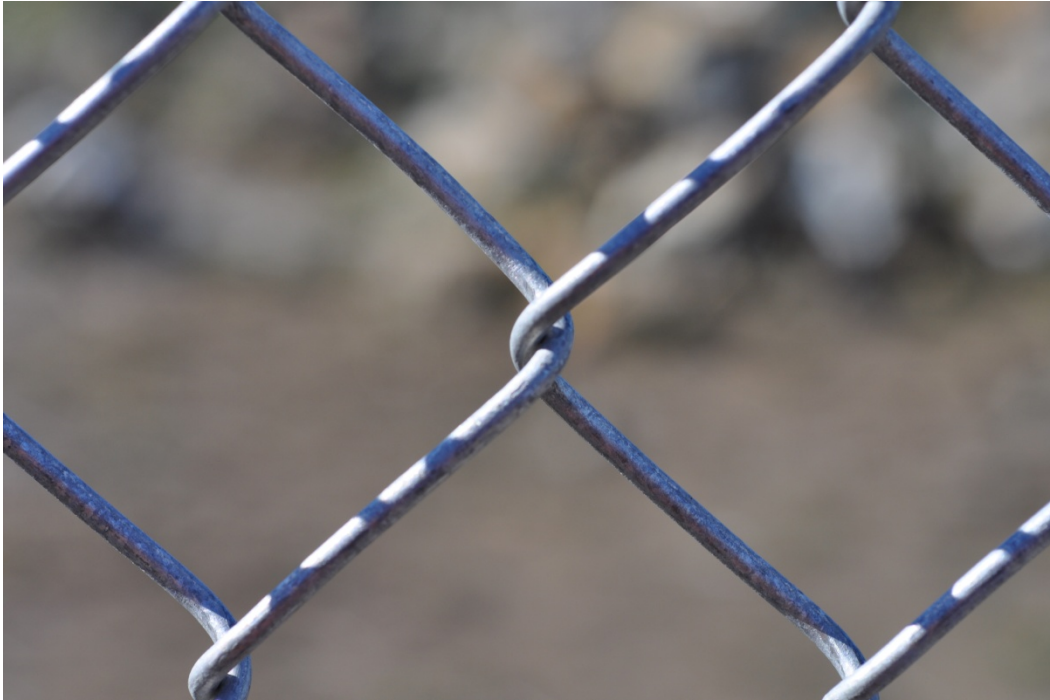
Figure A11. Aluminized after 6 months exposure.

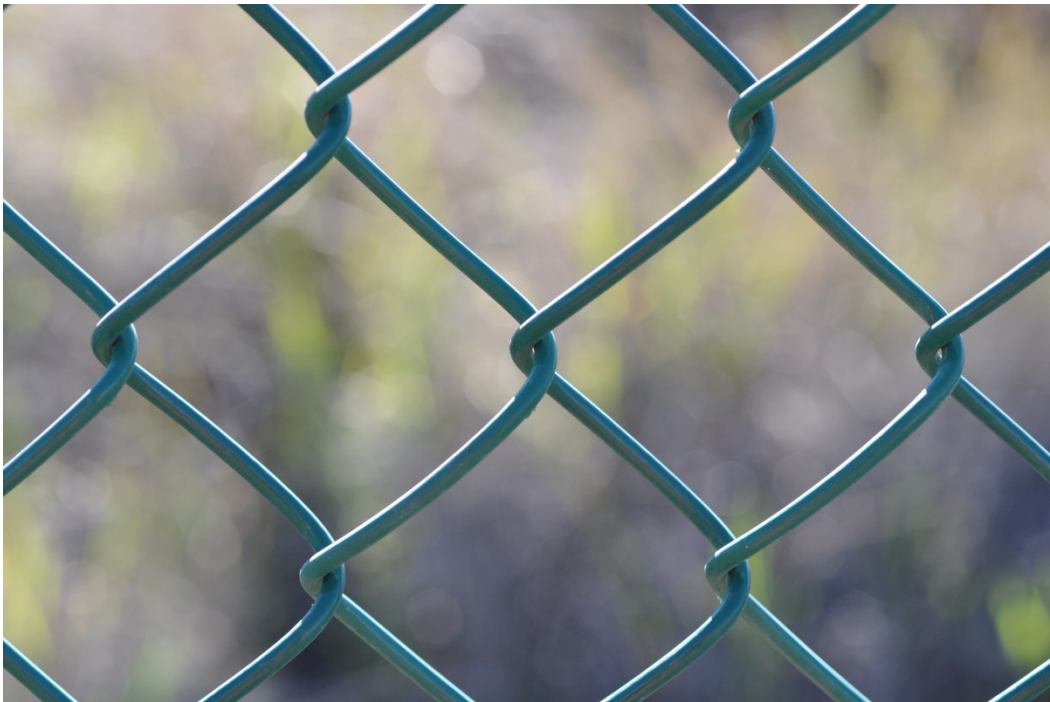
Figure A12. Standard PVC after 6 months exposure.

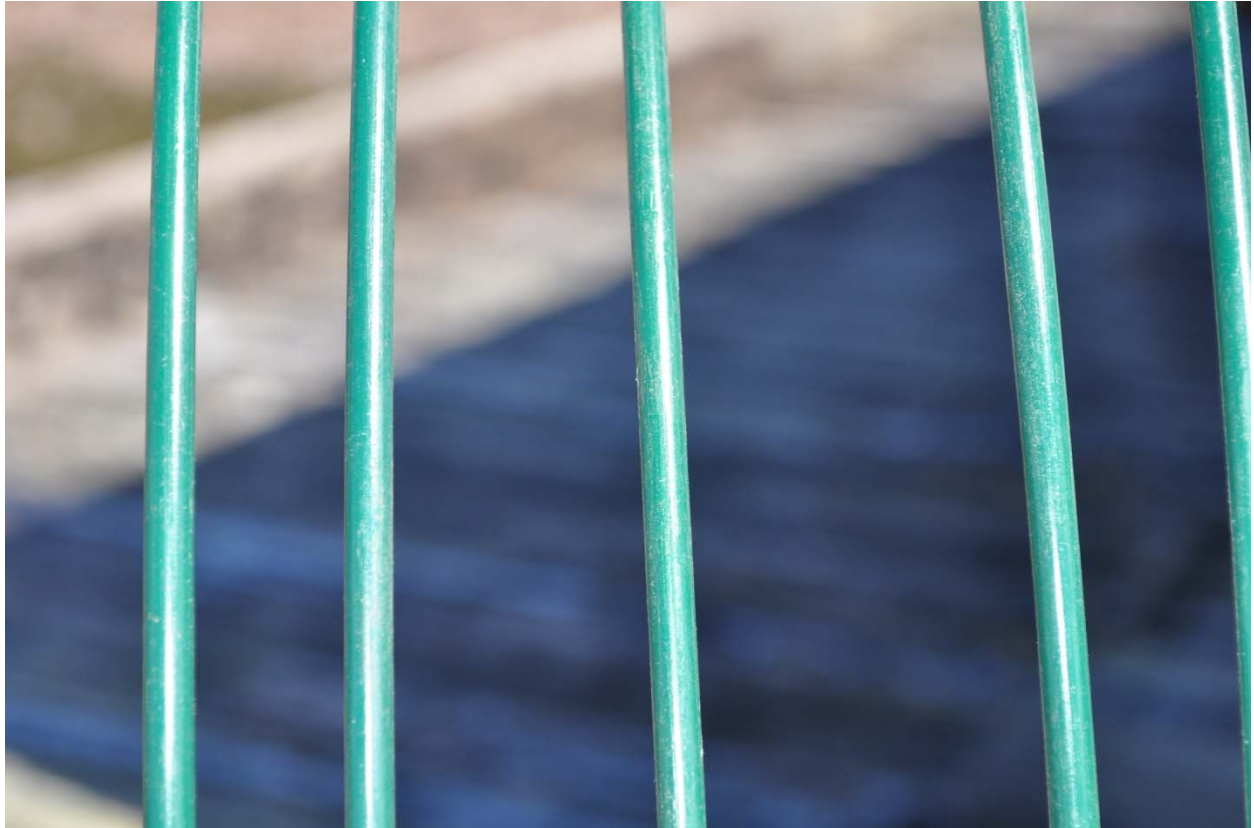
Figure B148. Standard PVC Coated Galvanized Wire Coupon

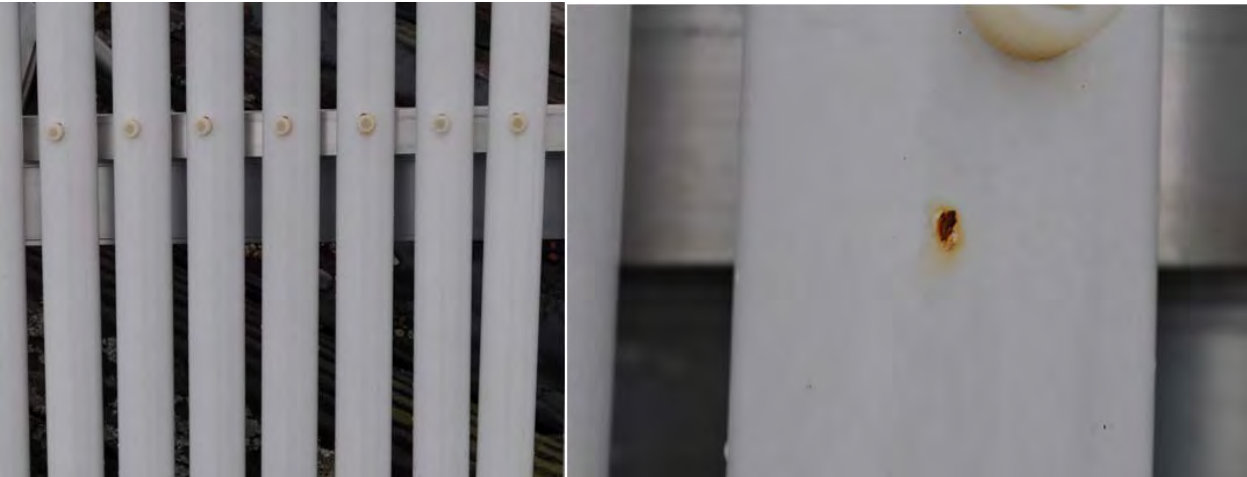
Figure B150. Coated Steel Coupon

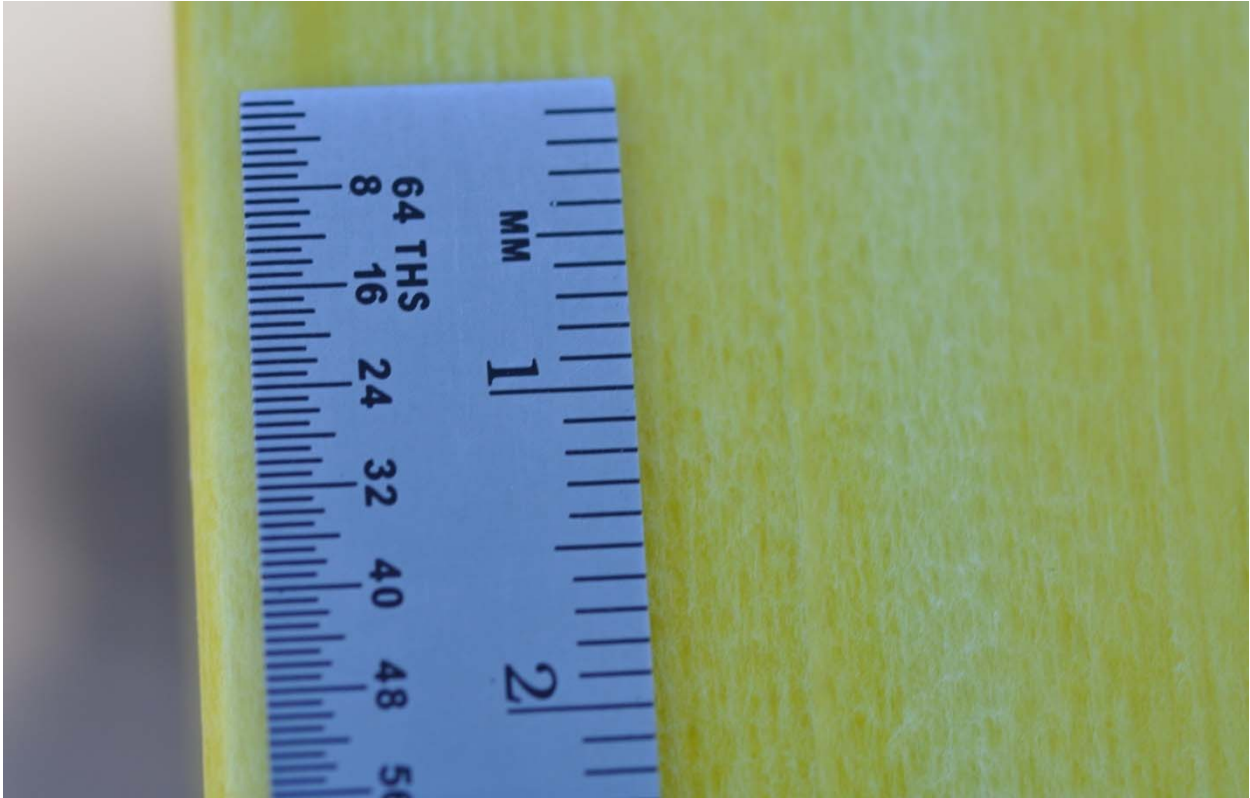
Figure B160. FRP Railing Coupon

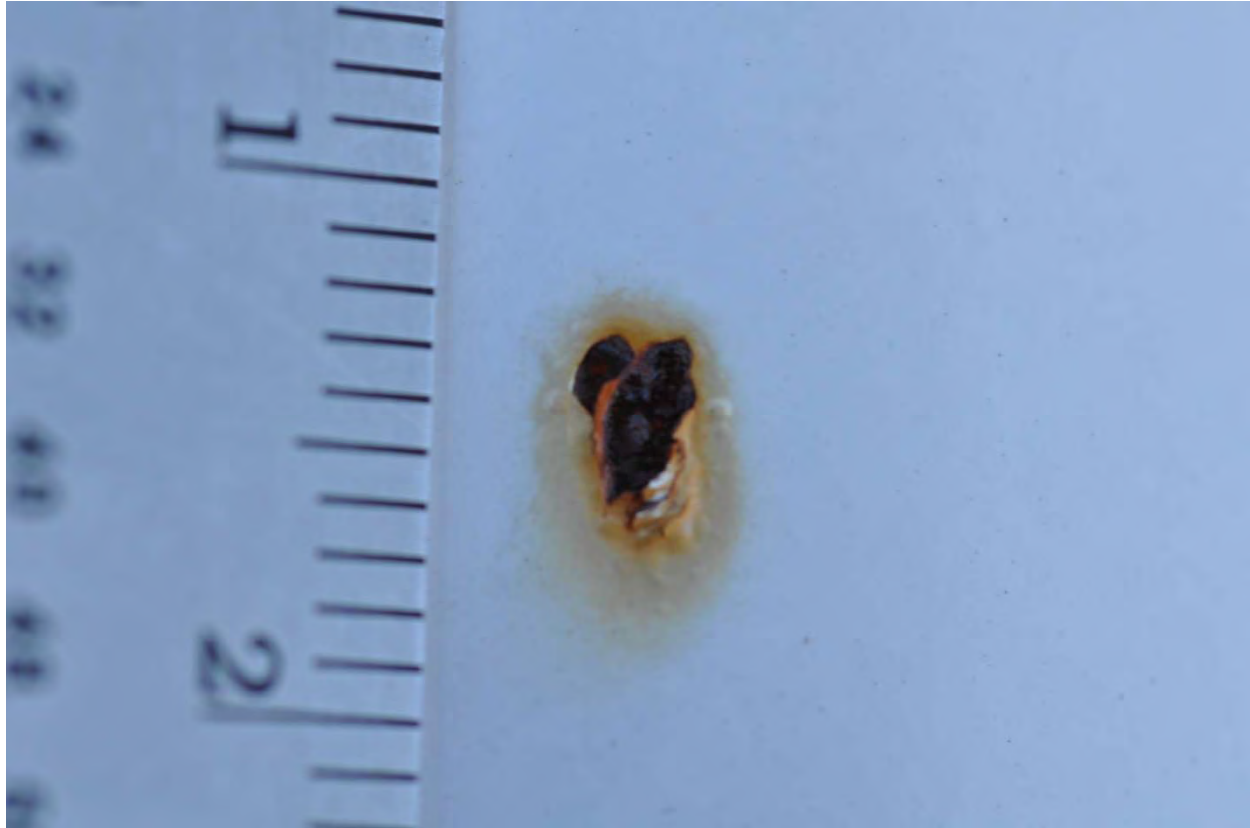
Figure B161. Coated Steel Coupon

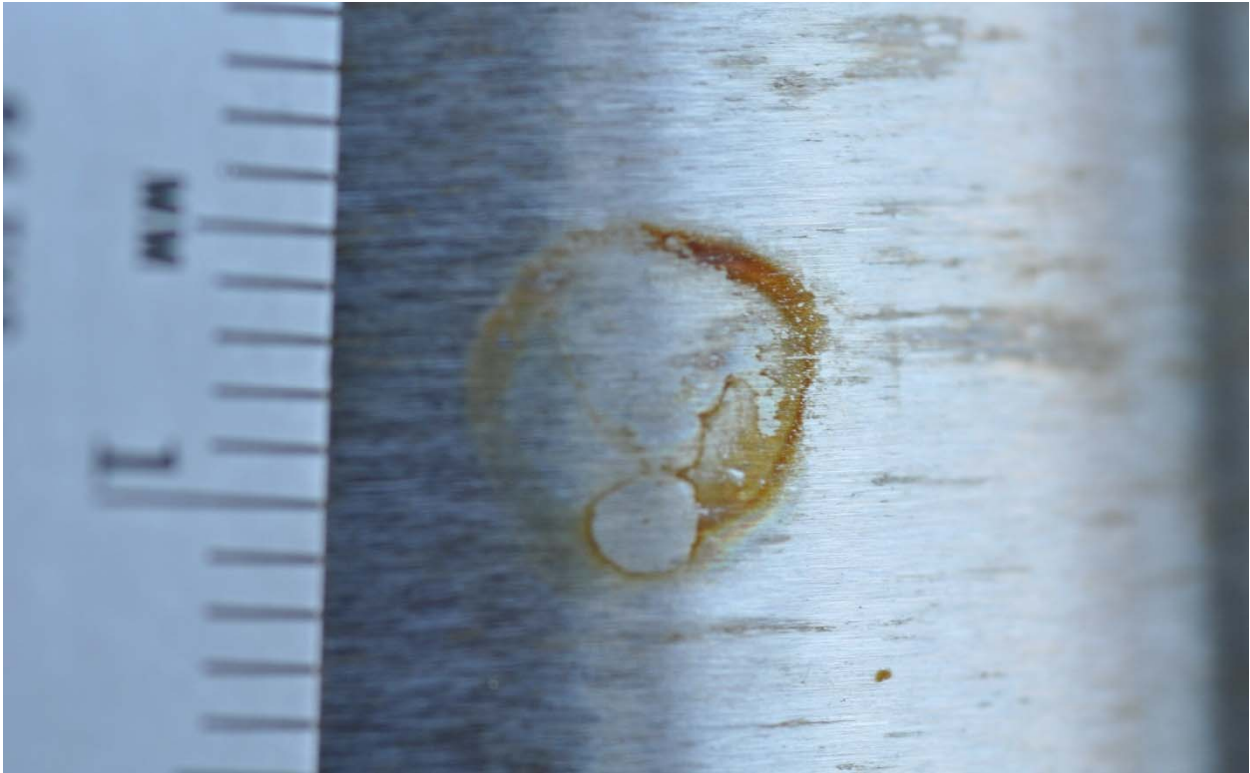
Figure B162. Stainless Steel Coupon

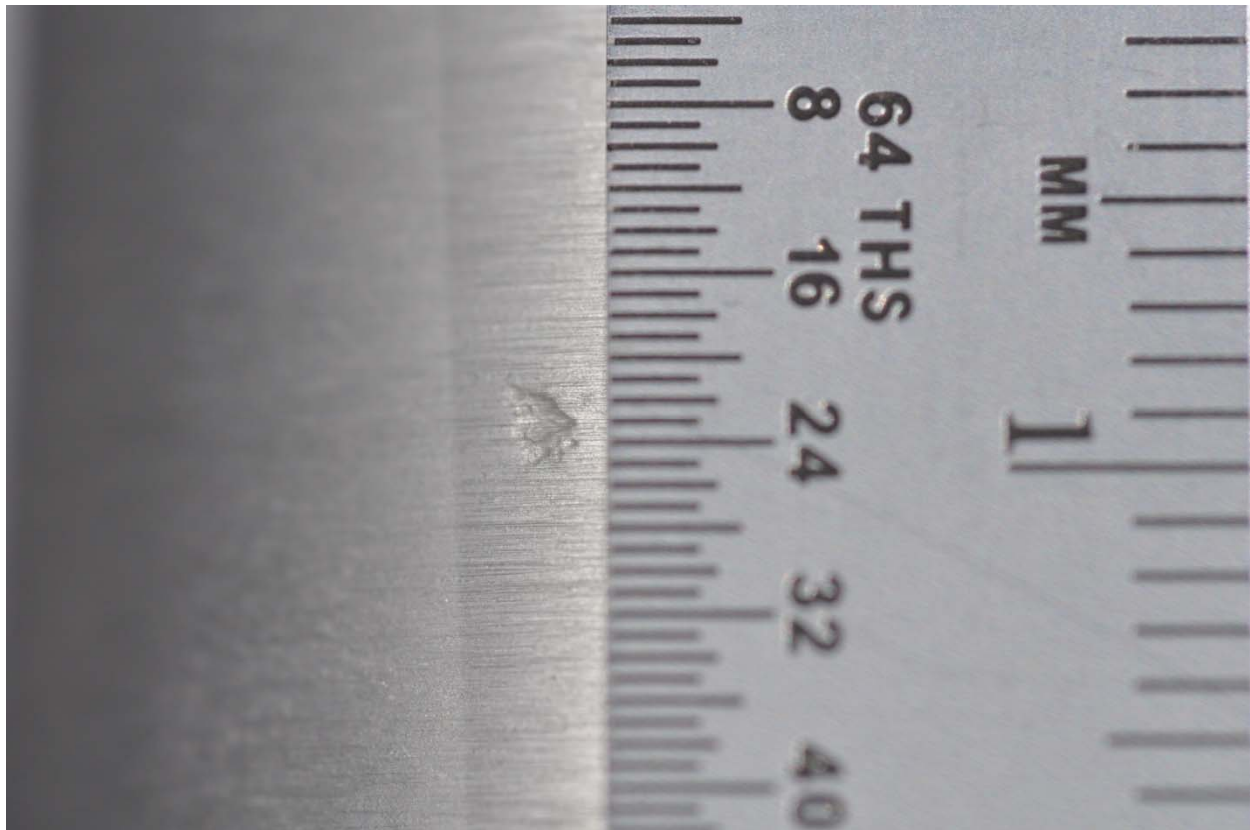
Figure B163. Aluminum Railing Coupon
