TECHNICAL REPORT S-74-8

COMPARATIVE PERFORMANCE OF STRUCTURAL LAYERS IN PAVEMENT SYSTEMS

DESIGN, CONSTRUCTION, AND BEHAVIOR UNDER TRAFFIC OF PAVEMENT TEST SECTIONS

U. S. Army Engineer Waterways Experiment Station

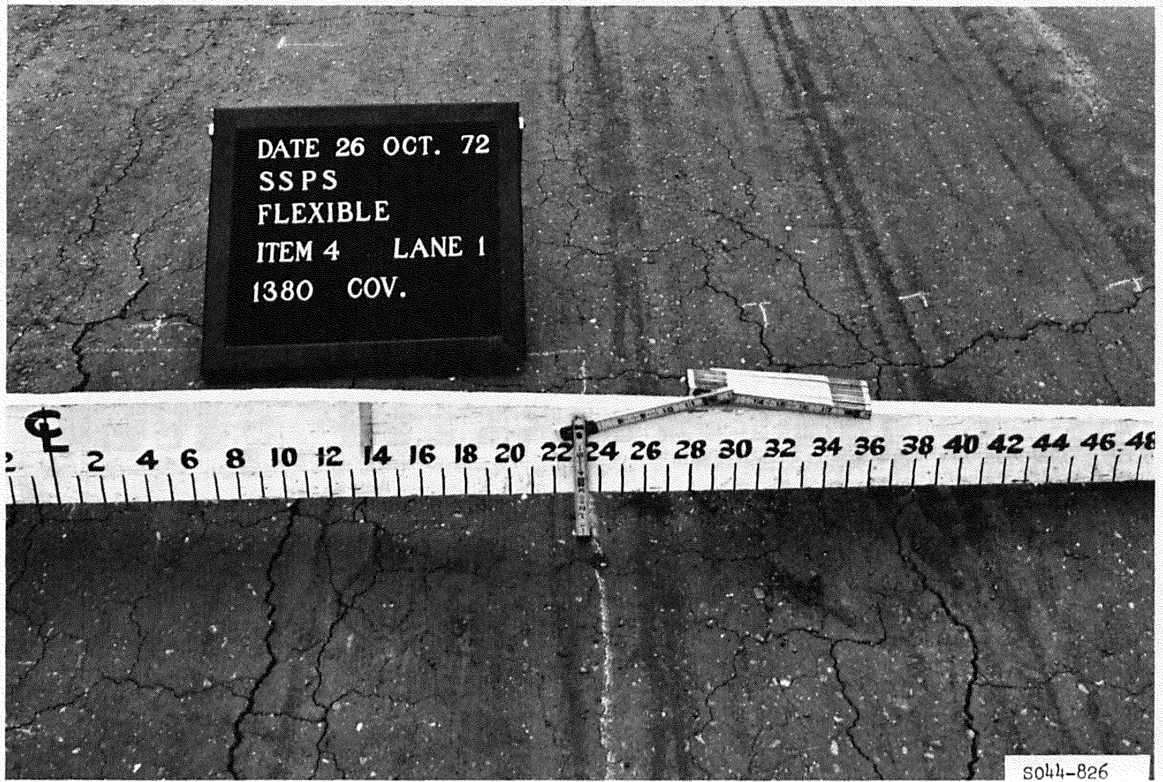
5044-826

A general view of item 4 prior to traffic is shown in Figure B9. Moderate cracking was noted on the west end of the traffic lane at about 760 coverages. At 1200 coverages, severe cracking had occurred over most of the western half of the item (Figure B10). The item was judged failed at 1380 coverages due to cracks penetrating the full depth of the asphaltic concrete. Cracks were about 1/2 in. wide, and some rutting had occurred. Figure B11 shows the condition of the pavement at failure.

Figure B11. Item 4, lane 1, flexible pavement test section, at 1380 coverages of 200-kip twin-tandem assembly
