MISCELLANEOUS PAPER S-69-27

LANDING MAT OVERLAY ON DETERIORATED PAVEMENT

BARE BASE SUPPORT

June 1969

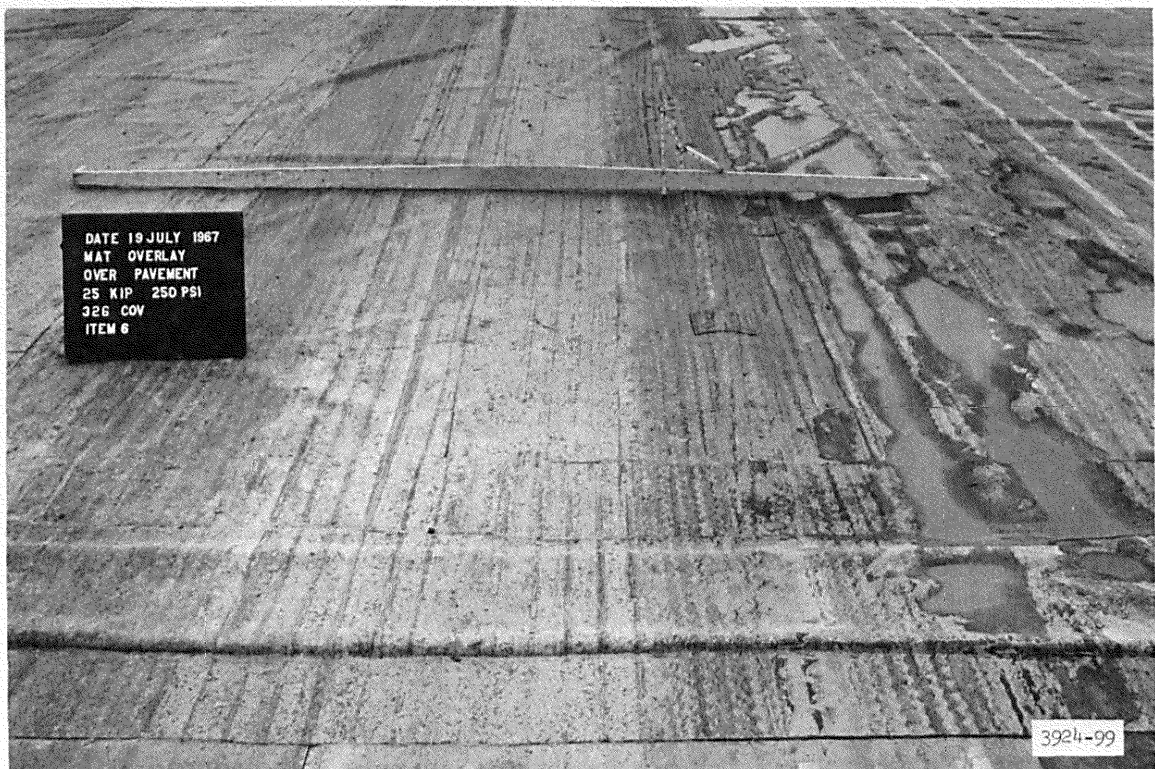
34. From 14 to 18 July, the test section received 100 coverages (total 300) and no difficulties were experienced. On 19 July, 26 coverages were applied during a heavy rainstorm. Severe pumping of the sand in items 1 and 2 and of the clay gravel fines in items 3 and 4 occurred. No soil pumping was observed in items 5 and 6. Views of items 1 through 6 at 326 coverages are shown in photographs 23 to 28, respectively. A close-up of sand pumped through the mat joints between items 1 and 2 is shown in

Photograph 28. Item 6 after 26 coverages applied during heavy rainfall
(326 coverages total)

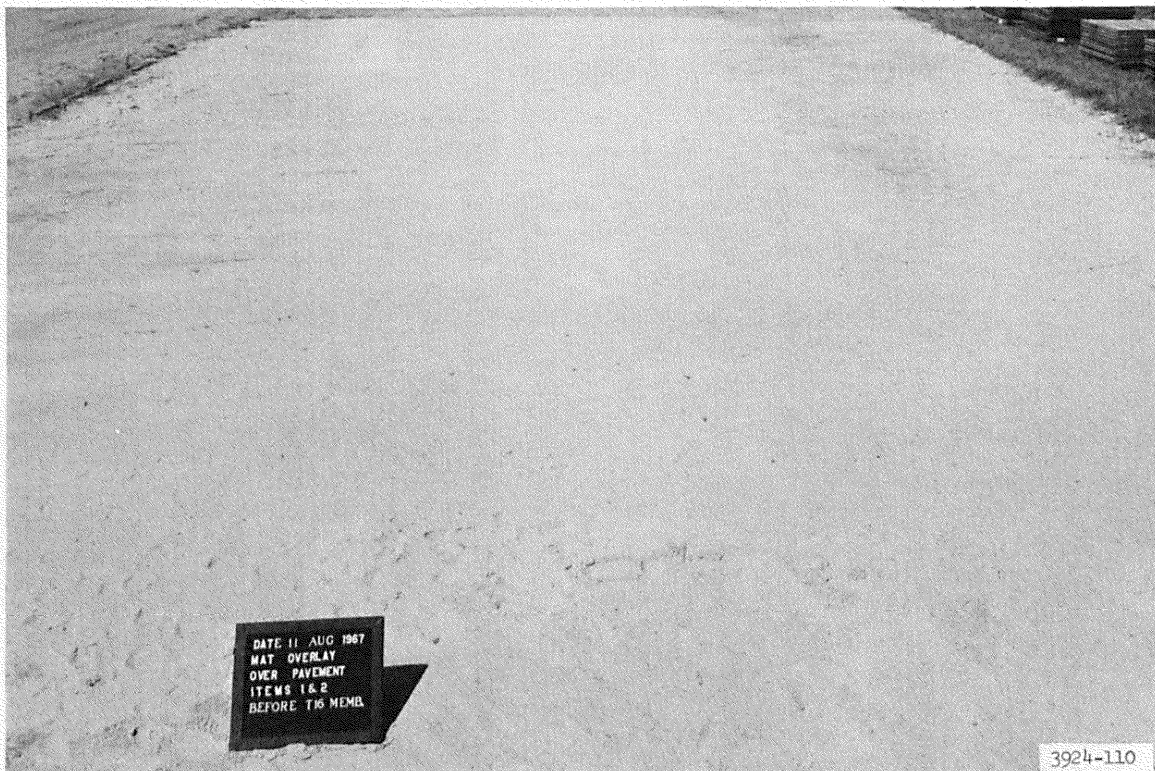
Photograph 31. Sand in items 1 and 2 after secondary construction I

37. Work was begun on 10 August. The average water contents of the sand and clay gravel overlay soils at this time were 4.3 and 5.8 percent, respectively. The sand in items 1 and 2 was smoothed by hand raking, and a continuous sheet of Tl6 membrane was placed over these items and half of item 3 (photographs 31 and 32). The clay gravel overlay in item 4 and the adjacent half of item 3 were stabilized with about 6 percent portland cement by weight of dry soil. Bags of portland cement first were spotted on the clay gravel, as shown in photograph 33. The cement was spread by hand and mixed into the soil with a small, portable rotary tiller (photograph 34). The clay gravel was then compacted with 16 coverages of the 50,000-lb roller. After compaction, the soil was fine bladed with a road grader and smoothed with a steel-wheeled roller. Landing mat was then replaced on the test section, with each panel being replaced into its original position. The Tl6 membrane that was placed on the sand in items 1 and 2 extended 3 to 4 ft beyond the landing mat at the sides of the test section, and, as shown in photograph 35, landing mat was placed on the free edge of the membrane for anchorage. A general view of the test section at this time is shown in photograph 36.

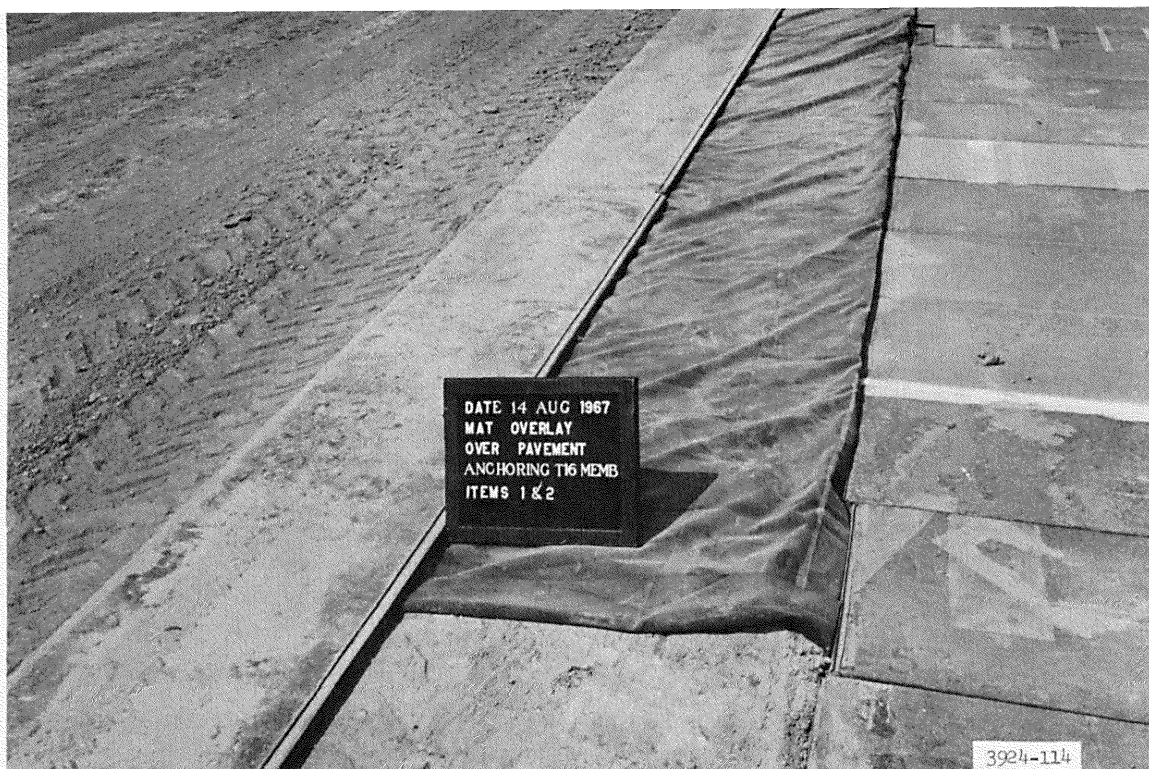
Photograph 35. Free edge of T16 membrane anchored with landing mat

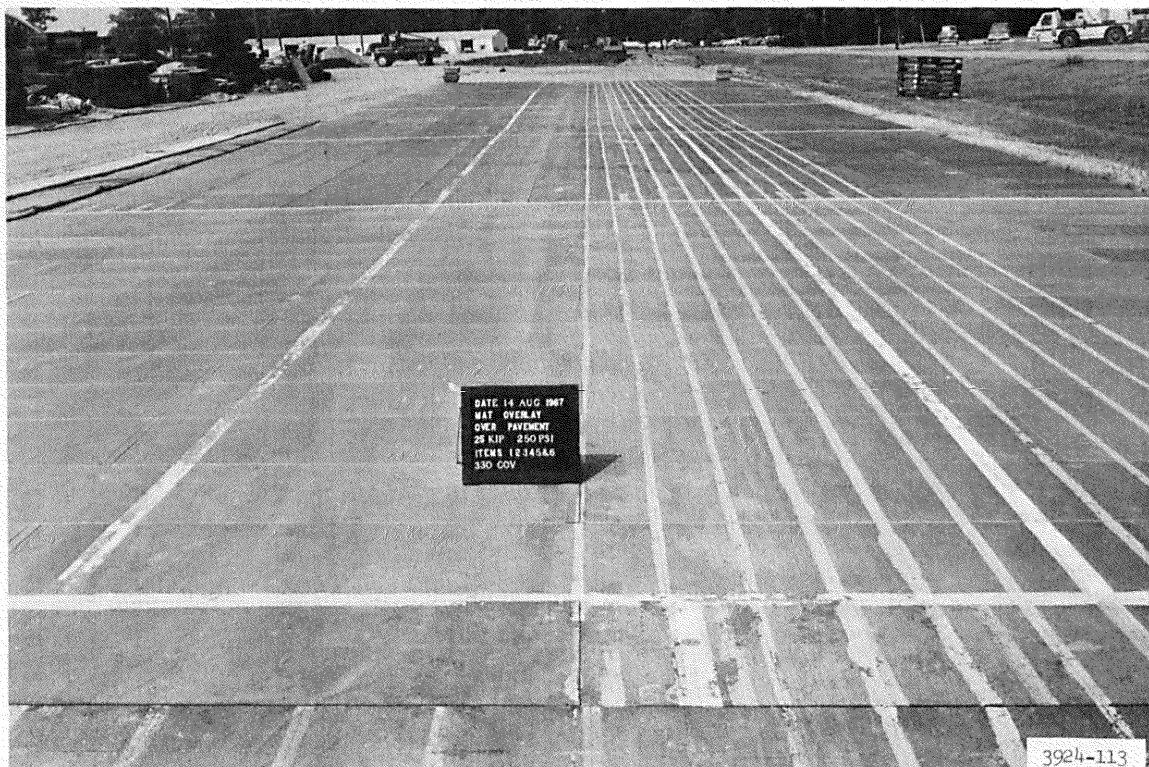
Photograph 36. General view of test section after completion of secondary construction I

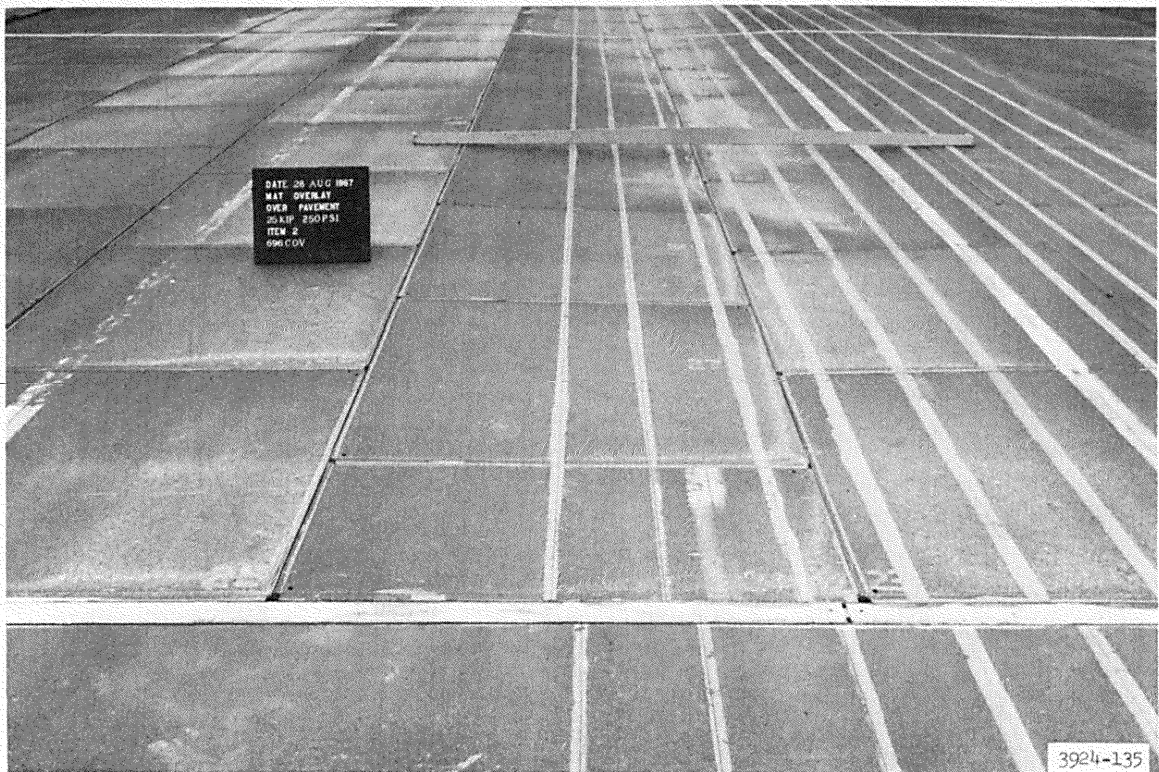
Photograph 38. Item 2 after 696 coverages

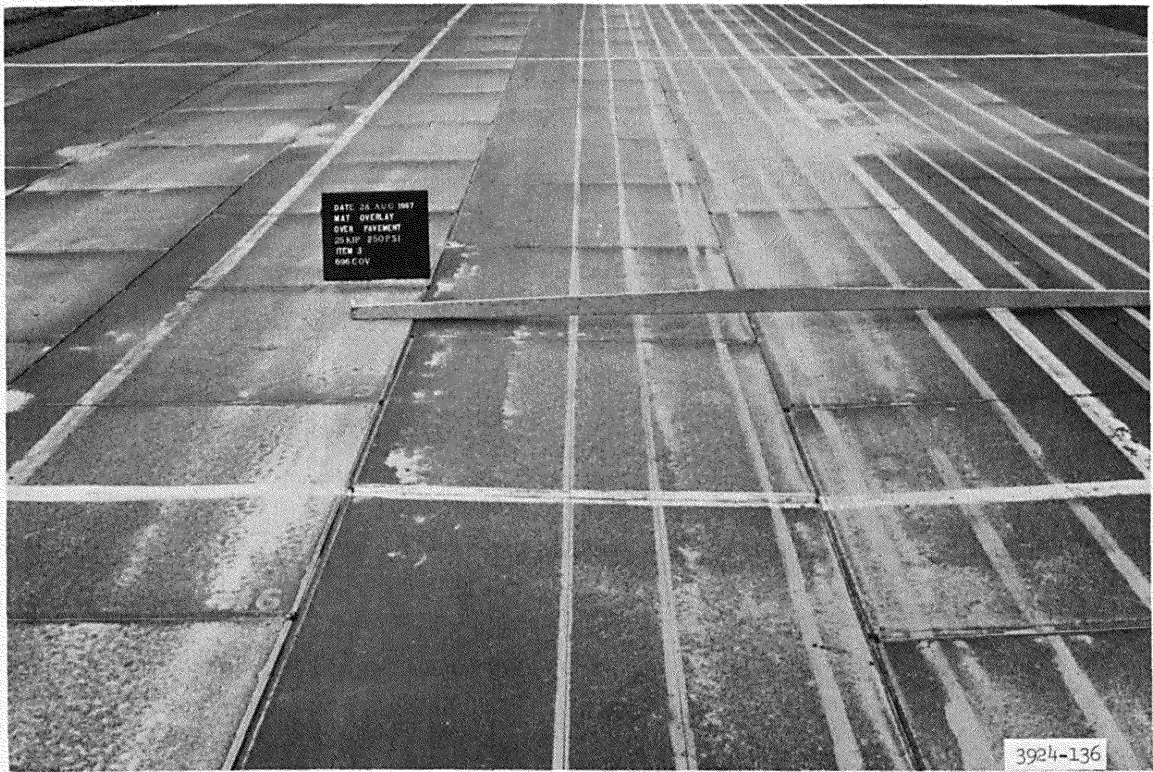
Photograph 39. Item 3 after 696 coverages

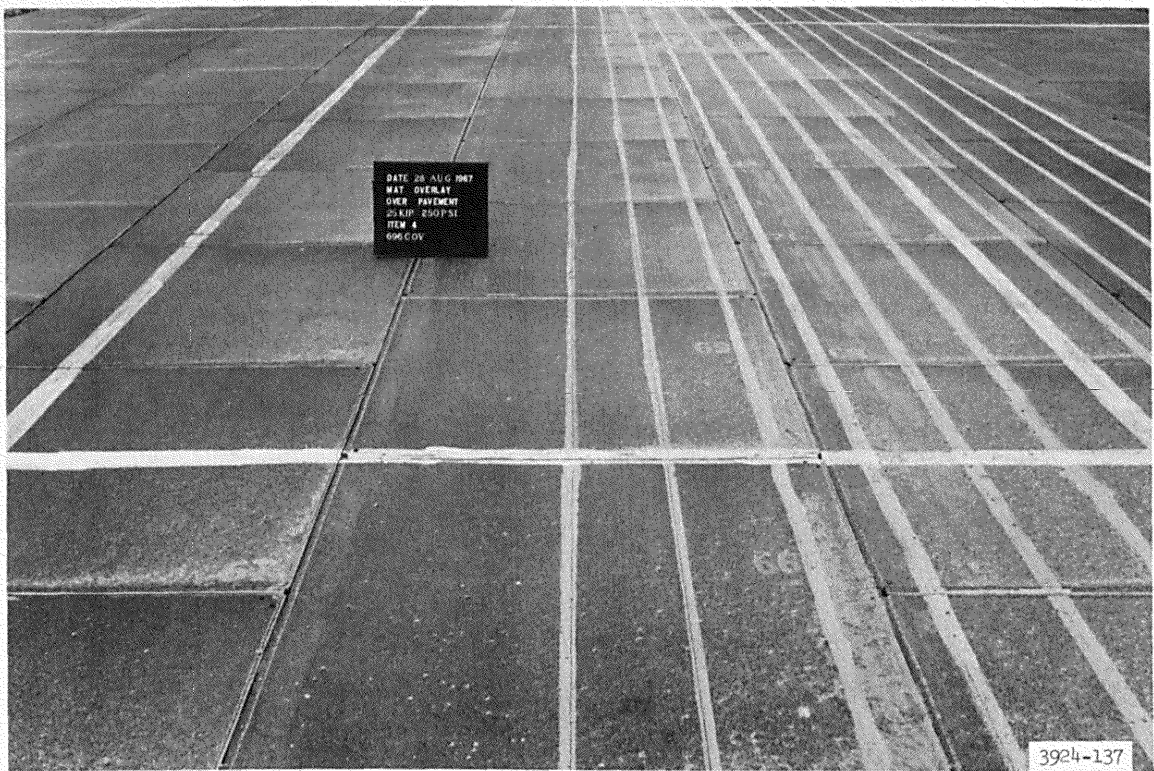
Photograph 40. Item 4 after 696 coverages

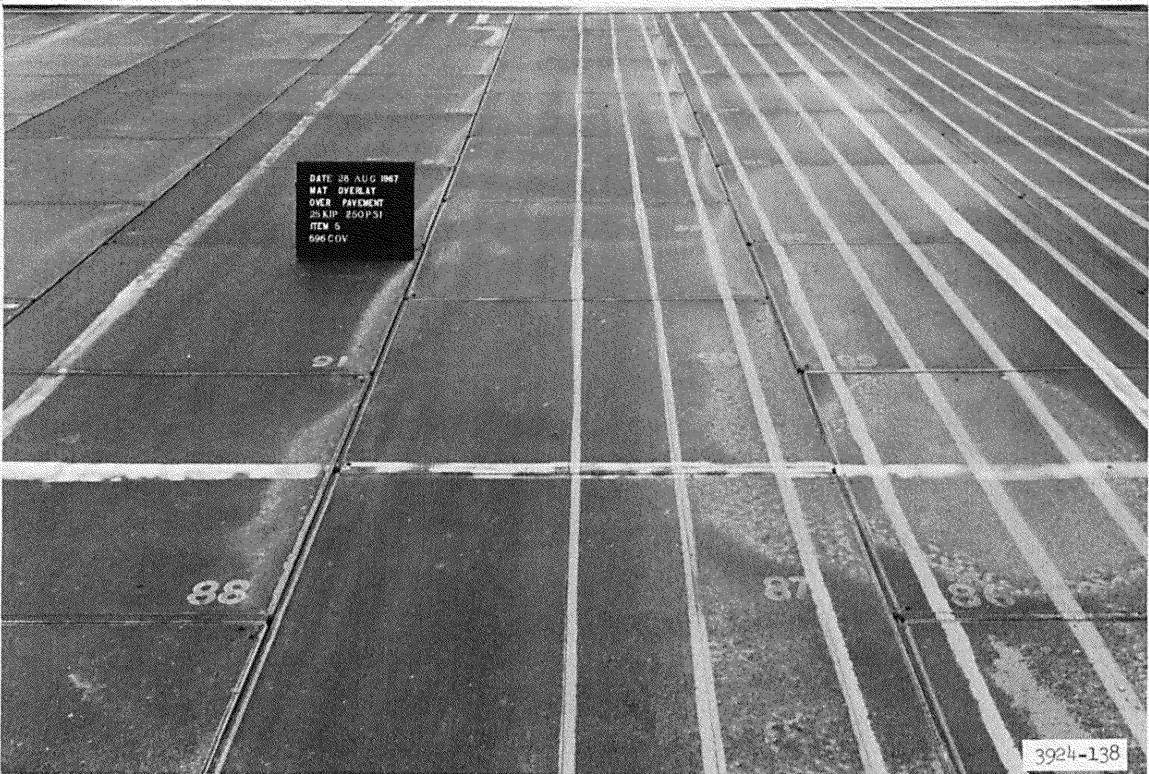
Photograph 41. Item 5 after 696 coverages

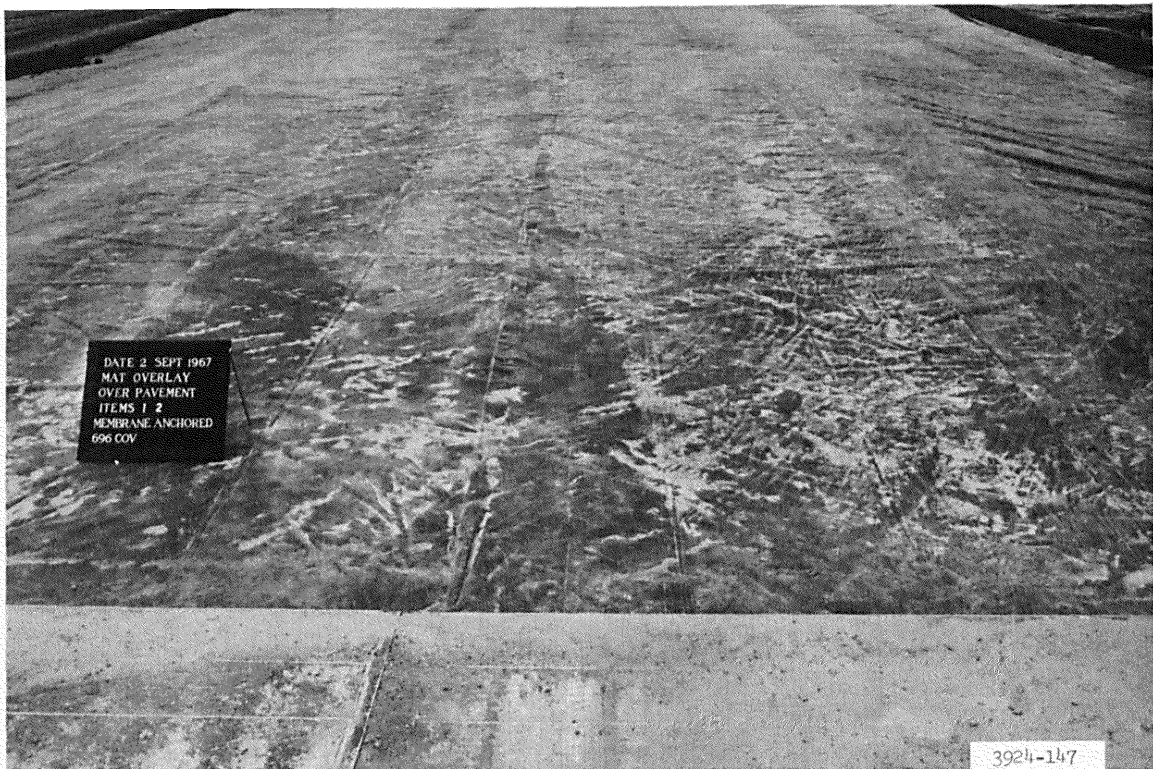
Photograph 47. T16 membrane on items 1 and 2 after secondary construction II

42. Work was begun on 31 August. The sand in items 1 and 2 had been allowed to air-dry for several days and was leveled by hand raking. Anchor trenches, as described in paragraph 41, were cut by hand and the T16 membrane was replaced on items 1 and 2. The south and west edges of the membrane were placed in the trench and secured to the bottom with anchor pins. The clay gravel in the first 15 ft of item 3 was stabilized with portland cement and compacted using the methods described in paragraph 37. A piece of WX18 membrane was placed on this area with one edge of the membrane in the lateral anchor trench between items 2 and 3. Both trenches were then backfilled, and the soil was well compacted. A view of the T16 membrane on items 1 and 2 at this time is shown in photograph 47. A view of the WX18 membrane is shown in photograph 48.

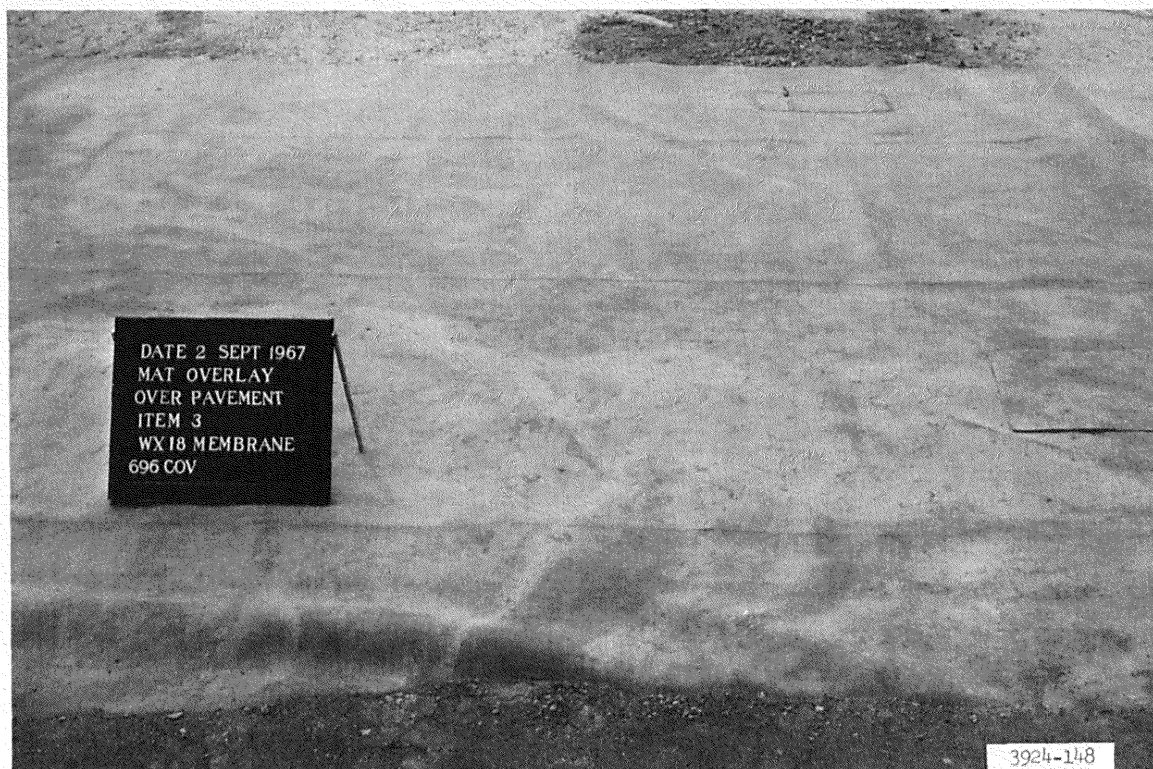
Photograph 48. WX18 membrane on item 3 after secondary construction II

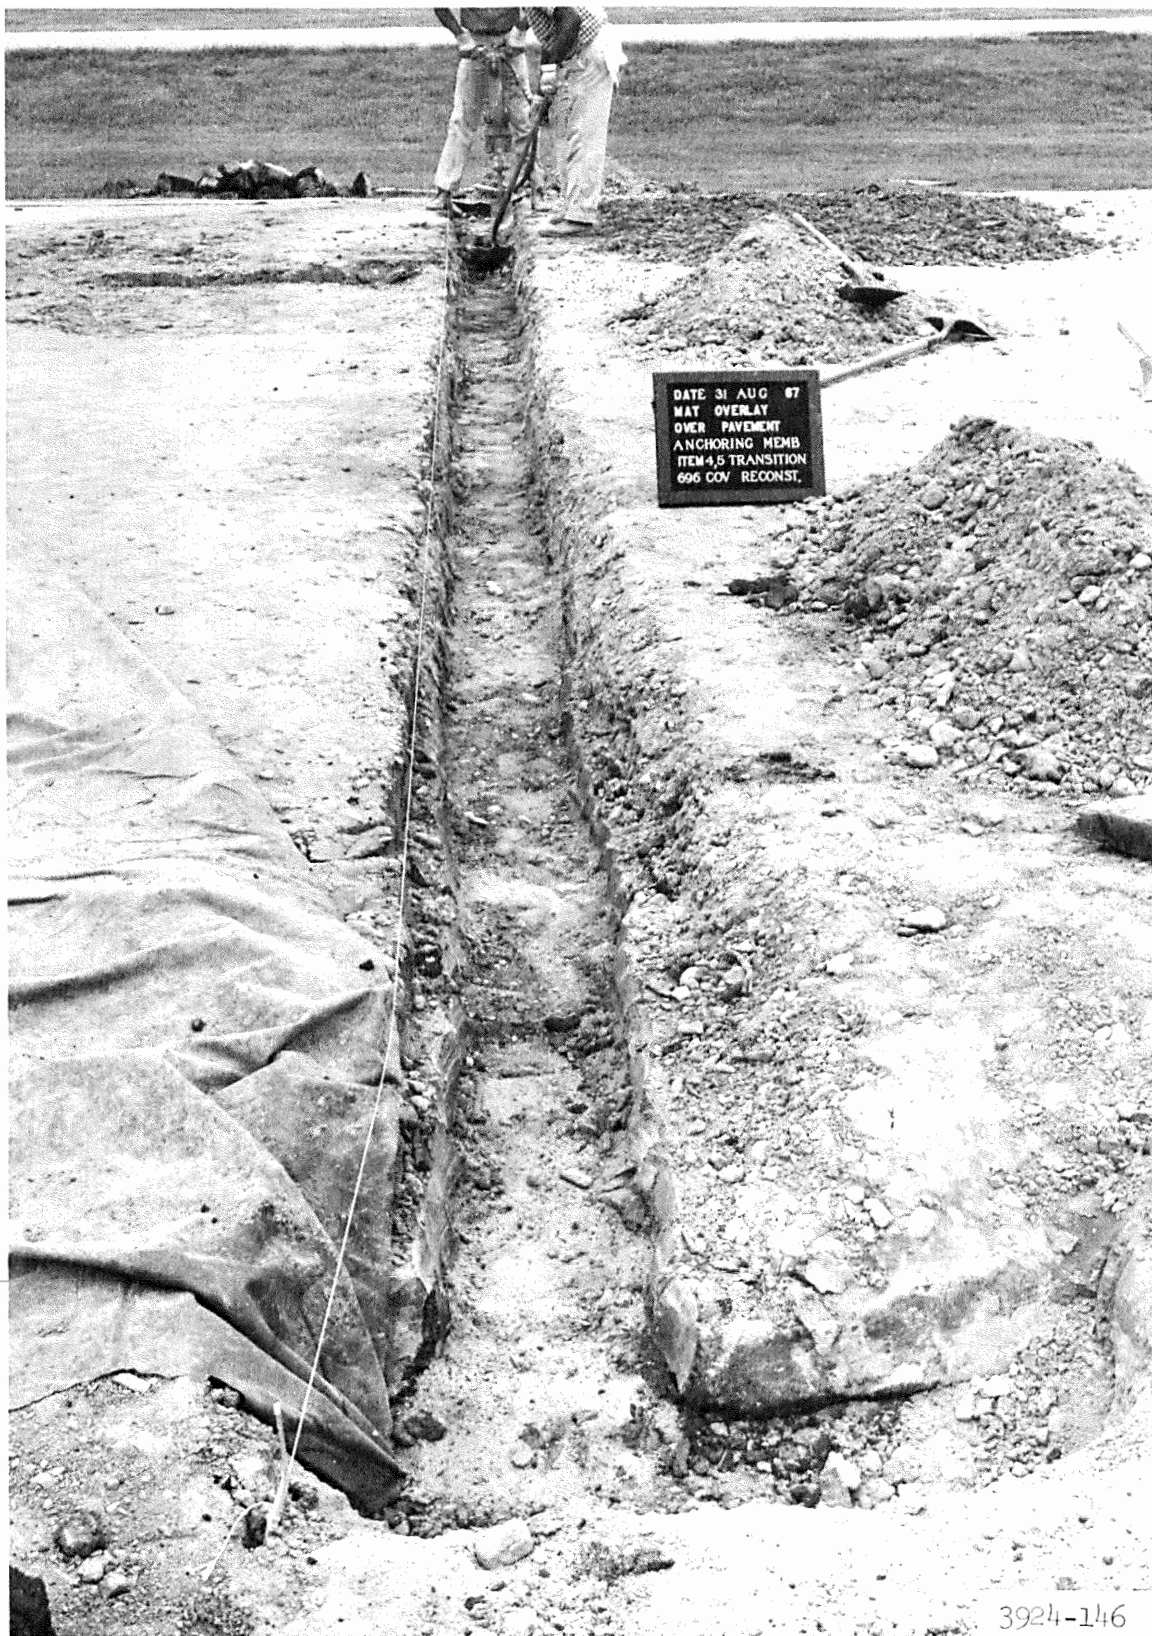
Photograph 49. Anchor trench cut laterally between items 4 and 5
in secondary construction II

43. Repairs were then made in item 5. The wet soil was removed from the area in which leakage had occurred and was replaced with dry lean clay. The replacement soil was well compacted and leveled with hand tools. As described in paragraph 41, a membrane-anchor trench was cut laterally at the transition between items 4 and 5 (see photograph 49). The free edge of the membrane was placed in the trench and secured with anchor pins, the trench was backfilled, and the soil was well compacted. All mat was then replaced on the test section, and again each mat panel was laid in its original position. A view of the test section after replacement of the mat is shown in photograph 50.

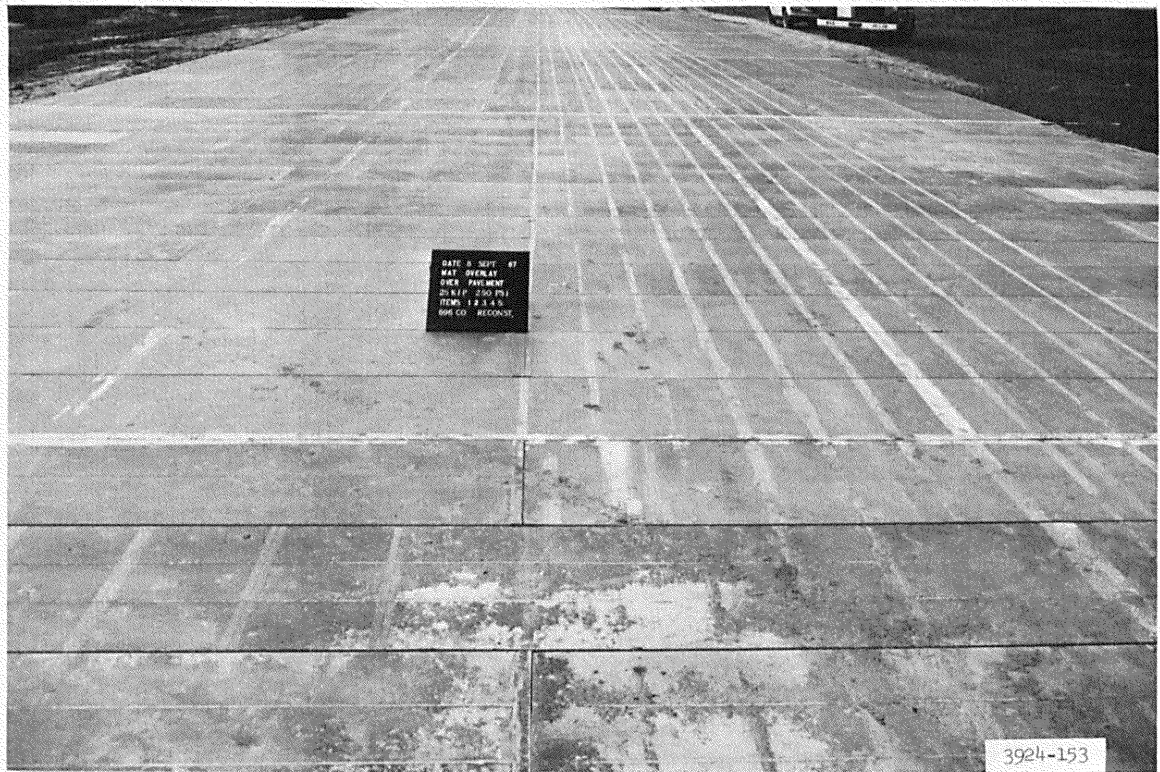
Photograph 50. General view of test section after completion of secondary construction II

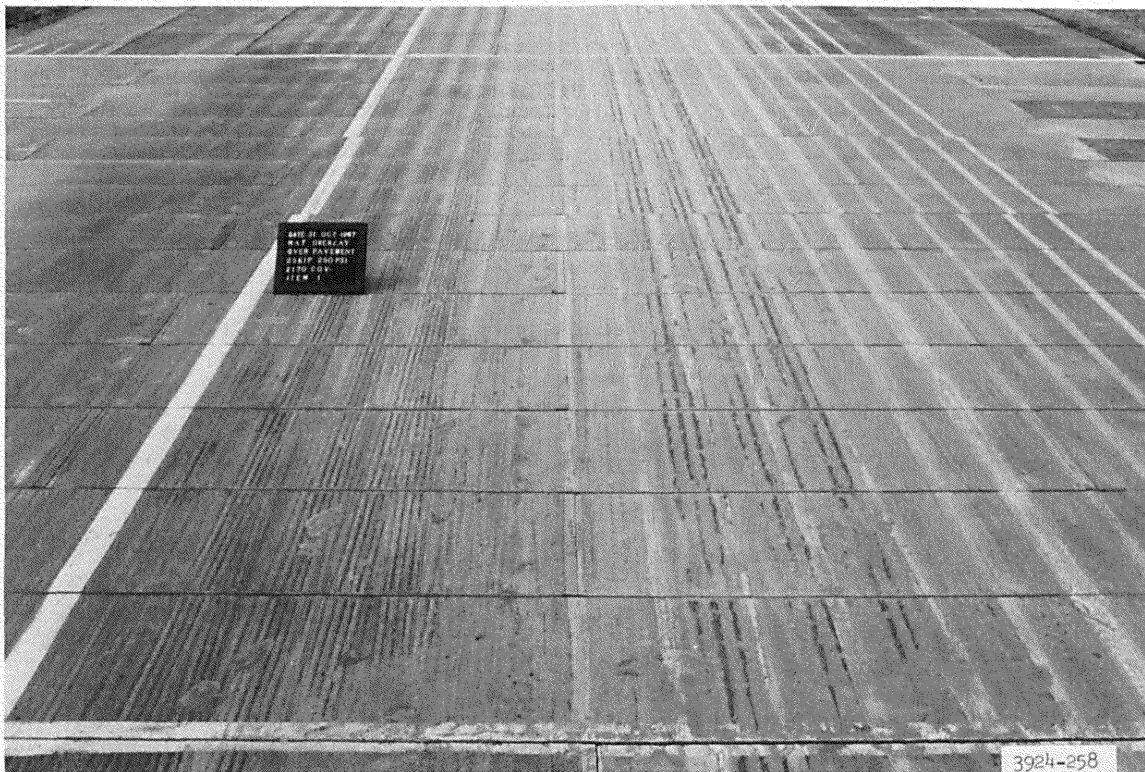
Photograph 52. Item 1 after 2170 coverages

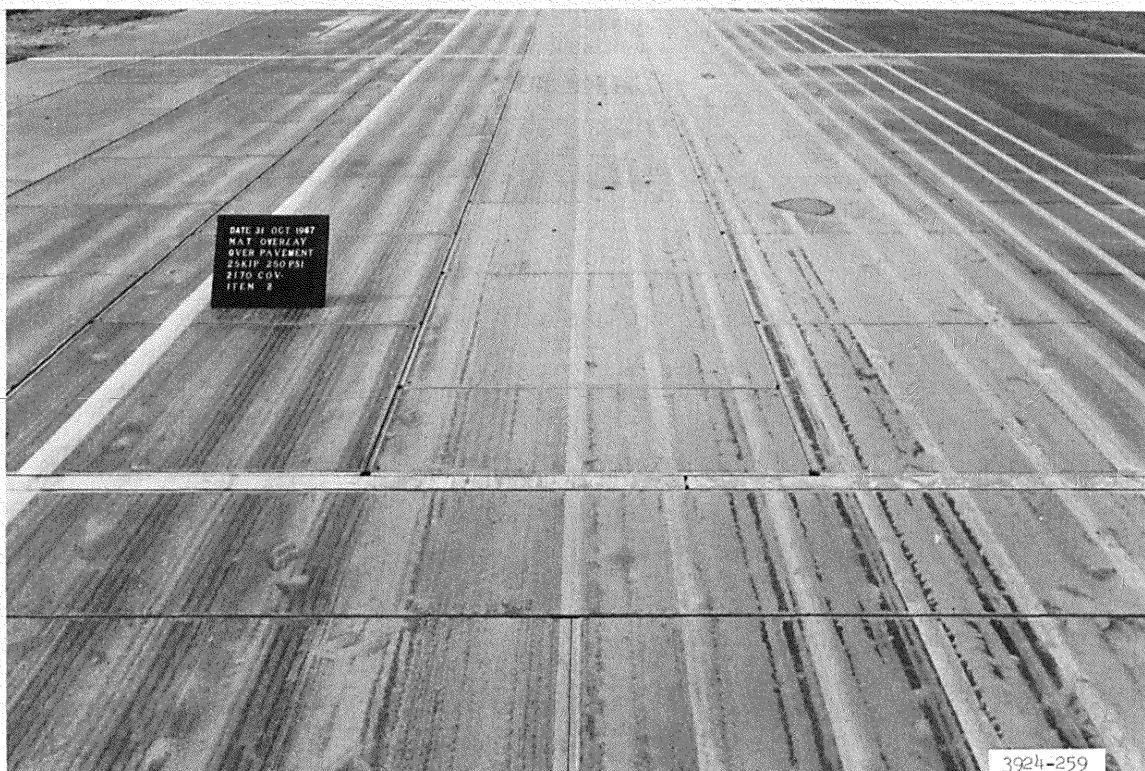
Photograph 53. Item 2 after 2170 coverages

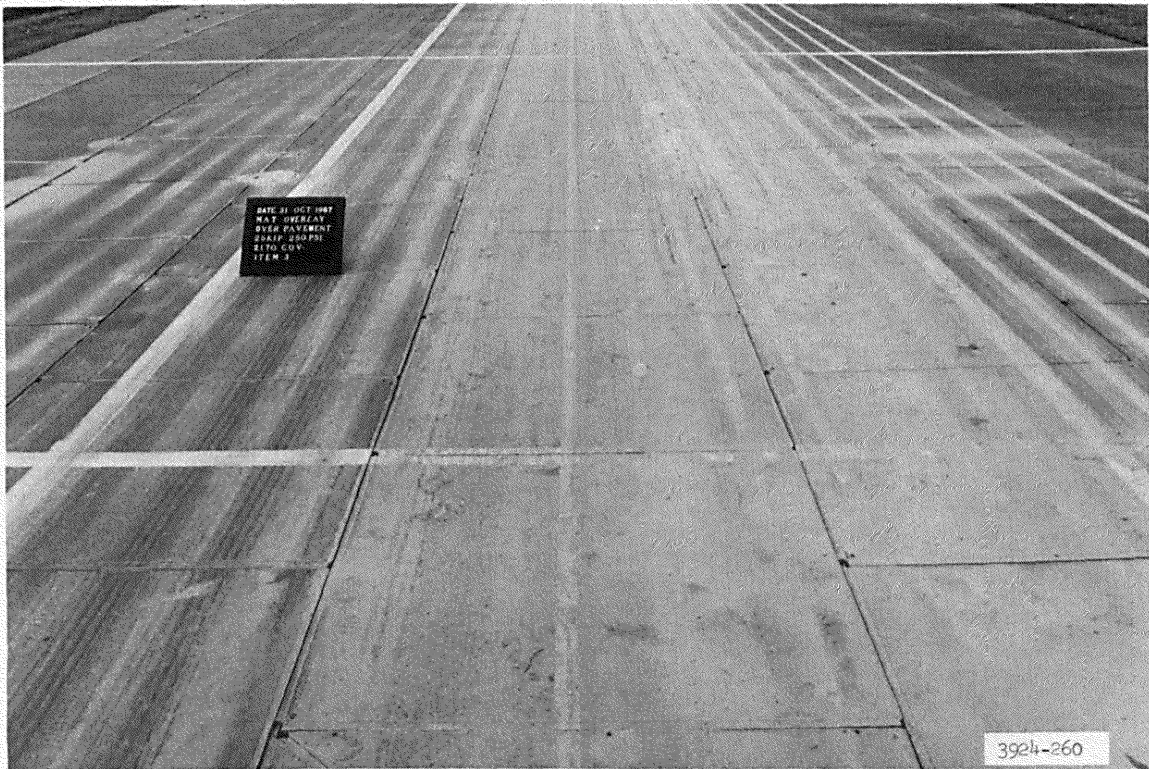
Photograph 54. Item 3 after 2170 coverages

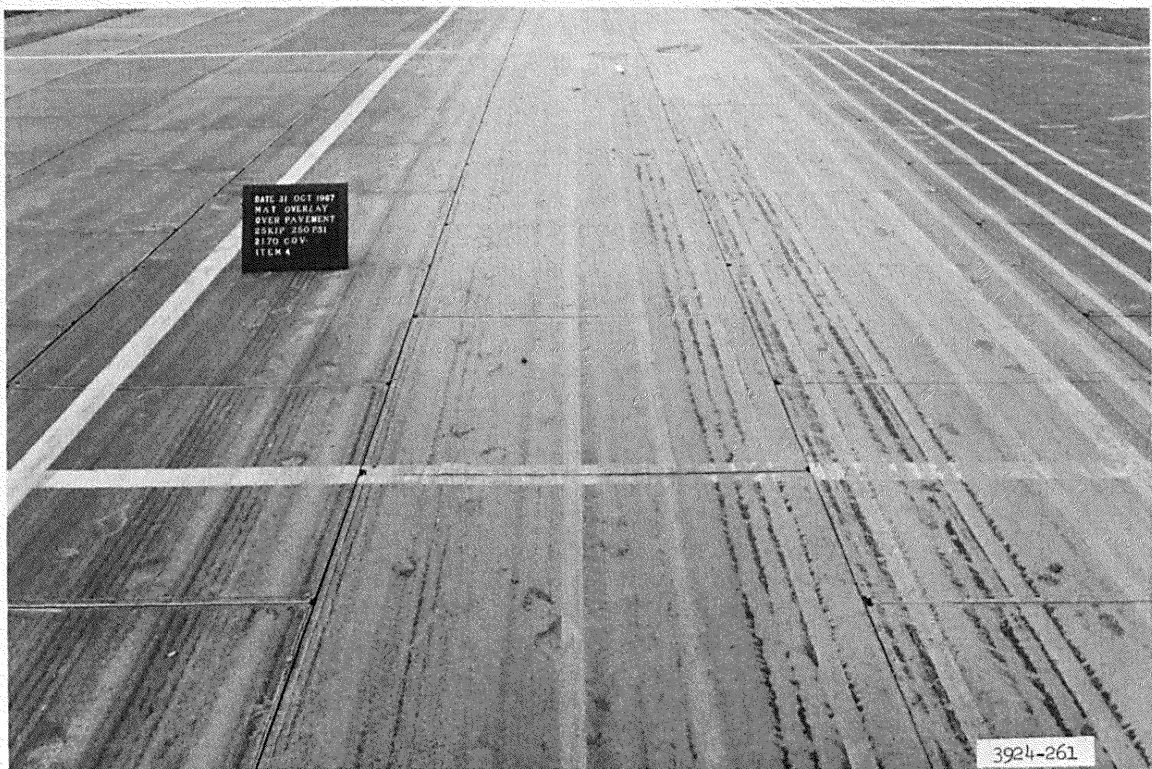
Photograph 55. Item 4 after 2170 coverages

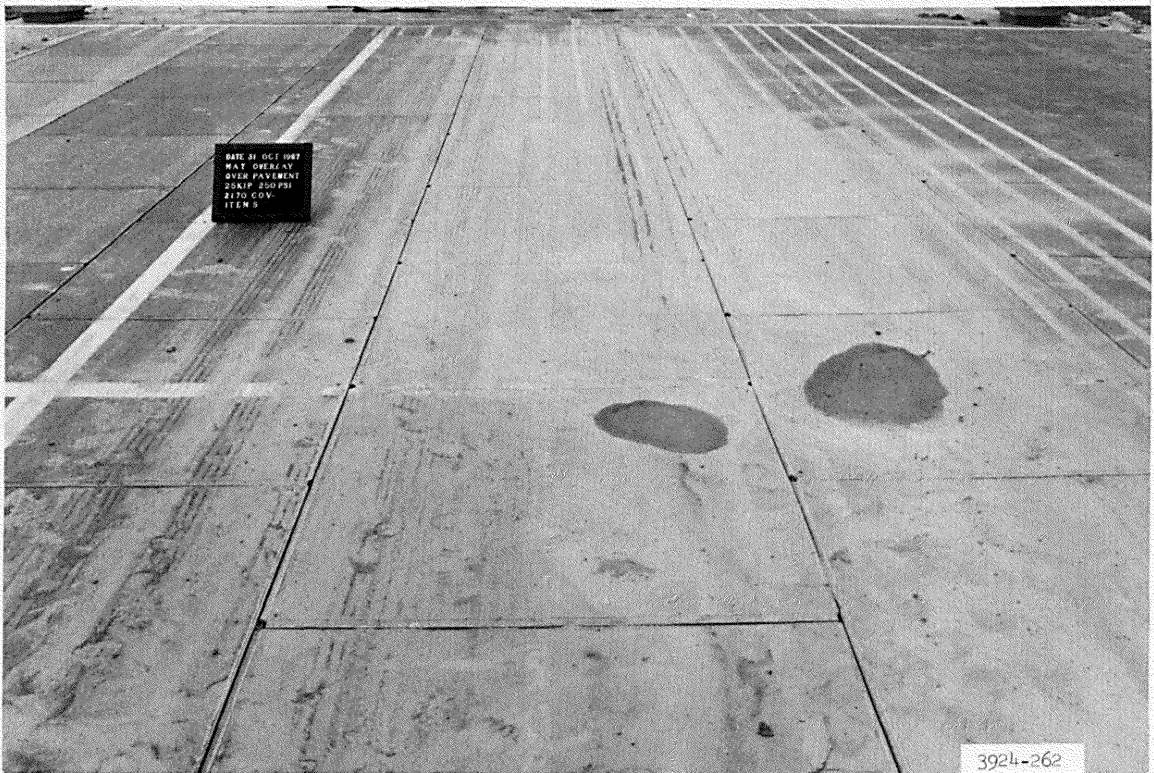
Photograph 56. Item 5 after 2170 coverages

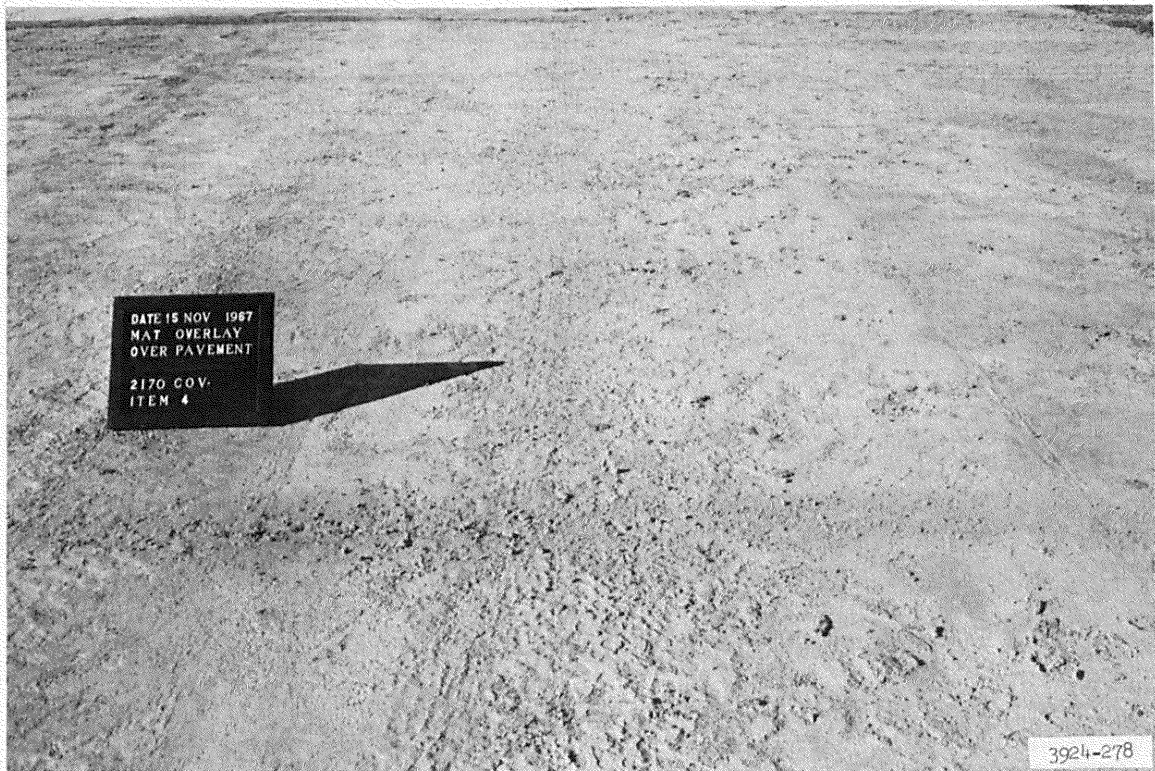
49. The clay gravel in item 4 that had been stabilized with portland cement is shown in photograph 62. The lower part of the photograph actually shows part of the clay gravel leveling course in item 3, which was also stabilized with portland cement. From this photograph, it can be seen that the stabilized clay gravel was still quite stable. Soil tests at this time indicated that the surface strength of the material in item 4 was in excess of 300 CBR.

Photograph 62. Condition of stabilized clay gravel in item 4
after 2170 coverages
