**CAMP CENTURY REVISITED  
A PICTORIAL VIEW-JUNE 1969**

**Austin Kovacs**

**July 1970**

**CORPS OF ENGINEERS, U.S. ARMY  
COLD REGIONS RESEARCH AND ENGINEERING LABORATORY  
HANOVER, NEW HAMPSHIRE**

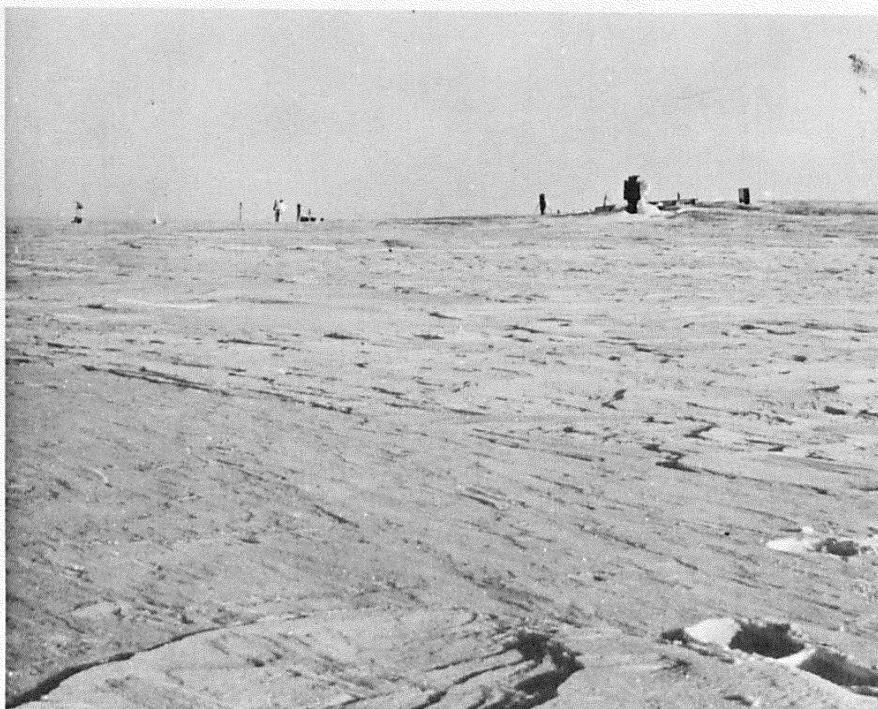
*Figure 7. Area of the 1966 surface camp. This camp consisted of three wanigan trains and a T-5 building.*

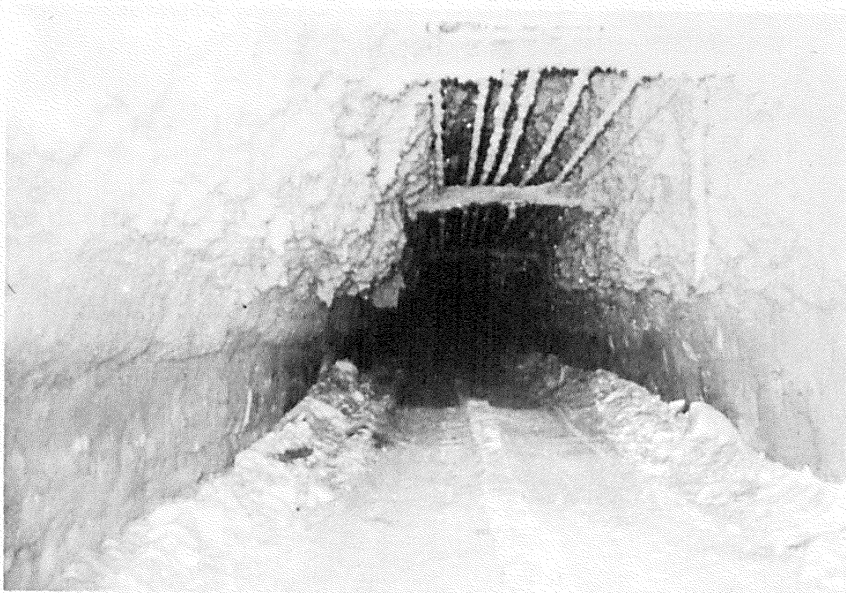
*Figure 10. View of main trench.*

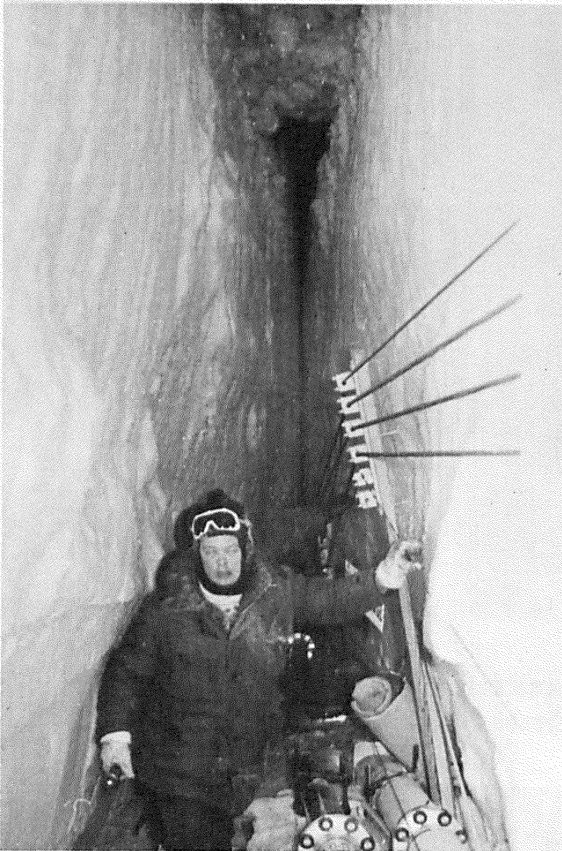
*Figure 11. The glycol trench, once 9 ft wide, has undergone considerable deformation. Heat which once escaped from the glycol pipeline leading from the reactor to the glycol well and residual heat within the well increased the temperature of the surrounding snow. This in turn increased the deformation rate of the snow and accelerated trench closure.*

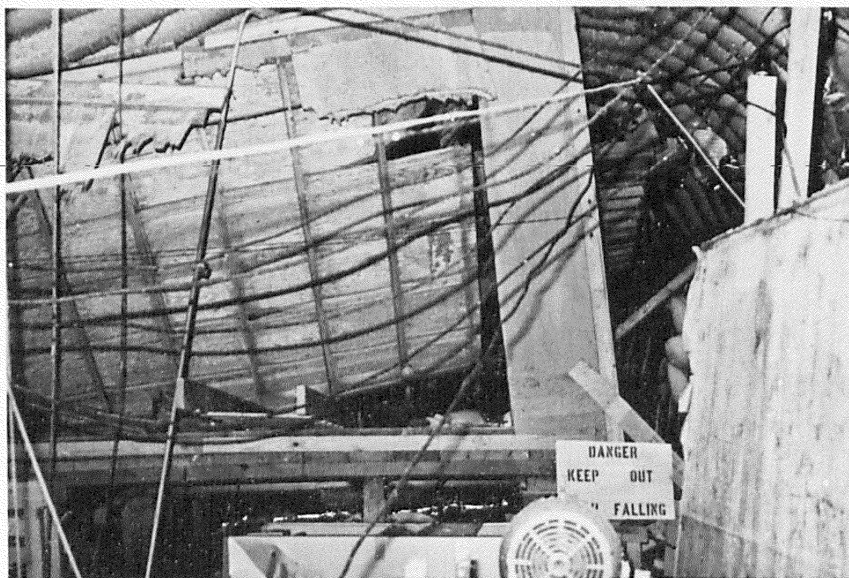
*Figure 13. Snow load from above deforms metal arch, crushing wooden structure in Trench 2.*

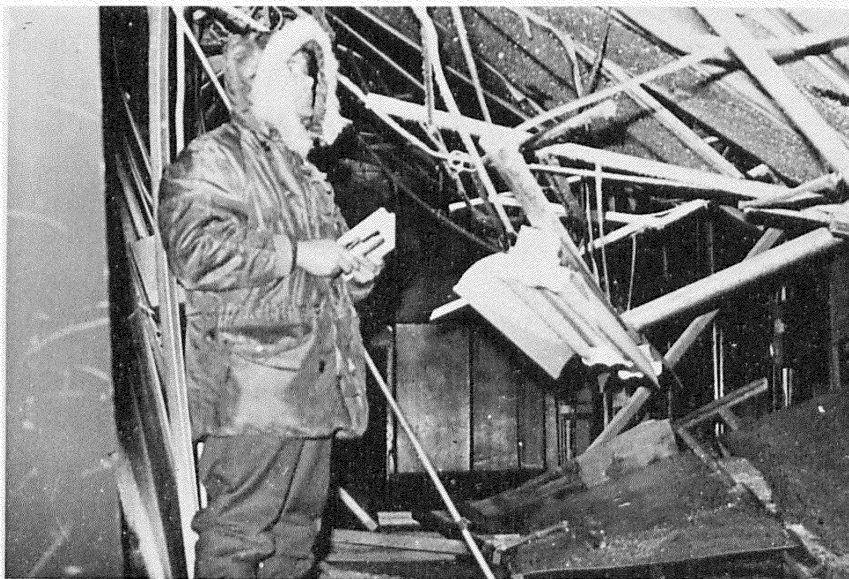
*Figure 14. Crushing of wood and steel reactor building in Trench 3.*

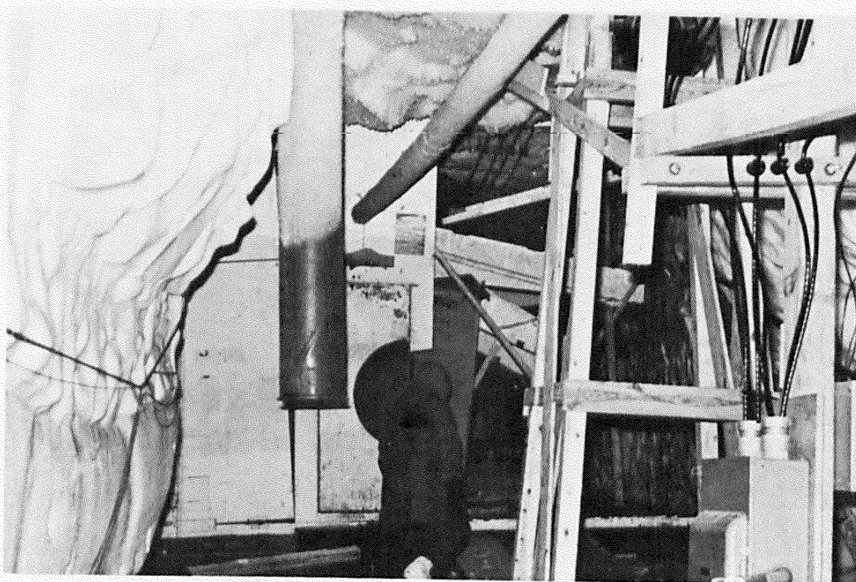
*Figure 23. Entrance to mess hall.*

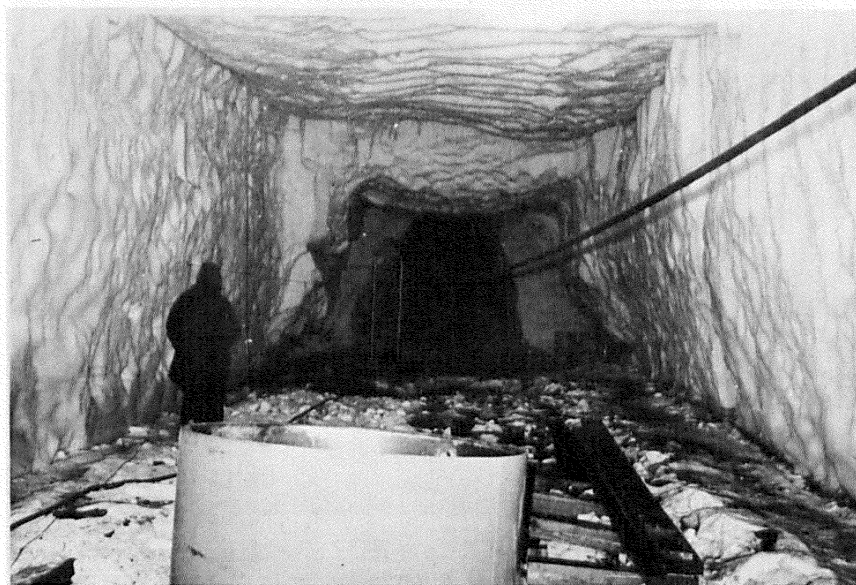
*Figure 27. Area once occupied by water treatment and storage plant.*

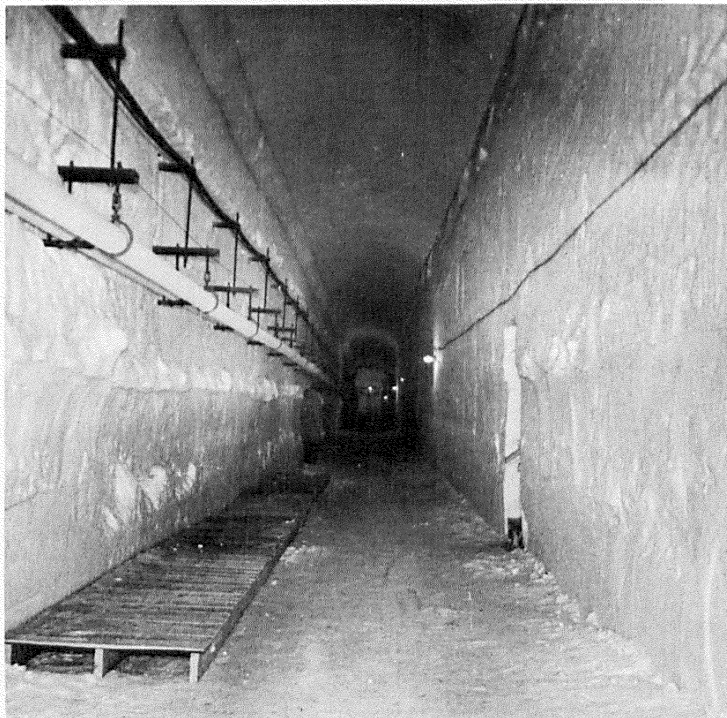
*Figure 28a. Trench 6 passageway in 1960.  
(From Leighty, 1963).*

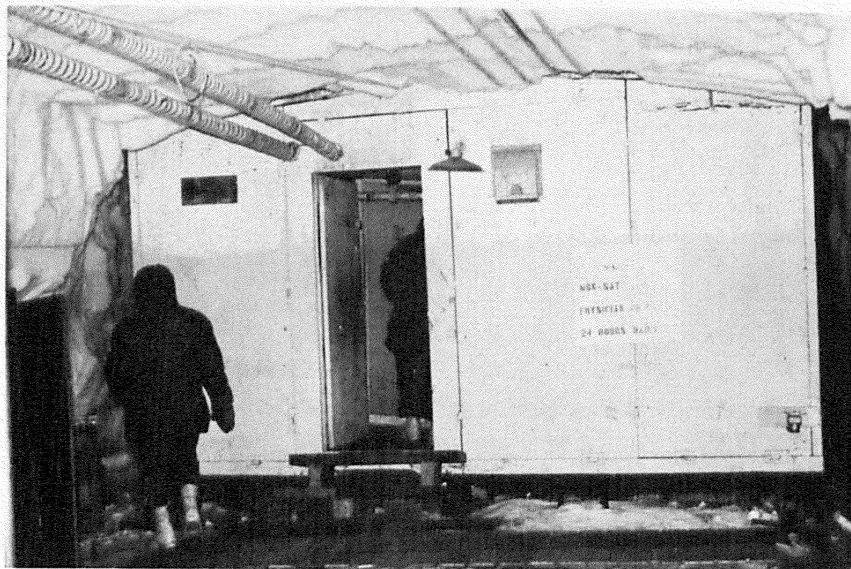
*Figure 36. Entrance to laundry (Trench 7).*

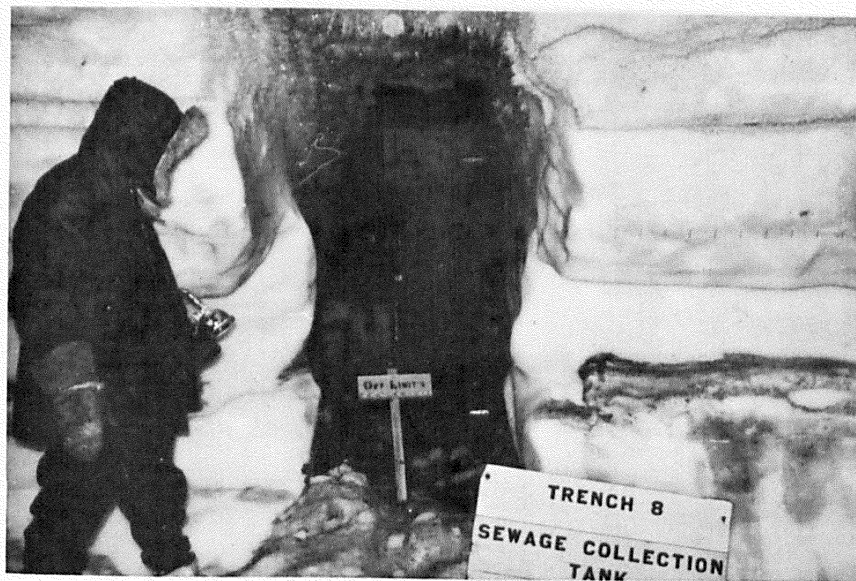
*Figure 38. Entrance to Trench 8.*

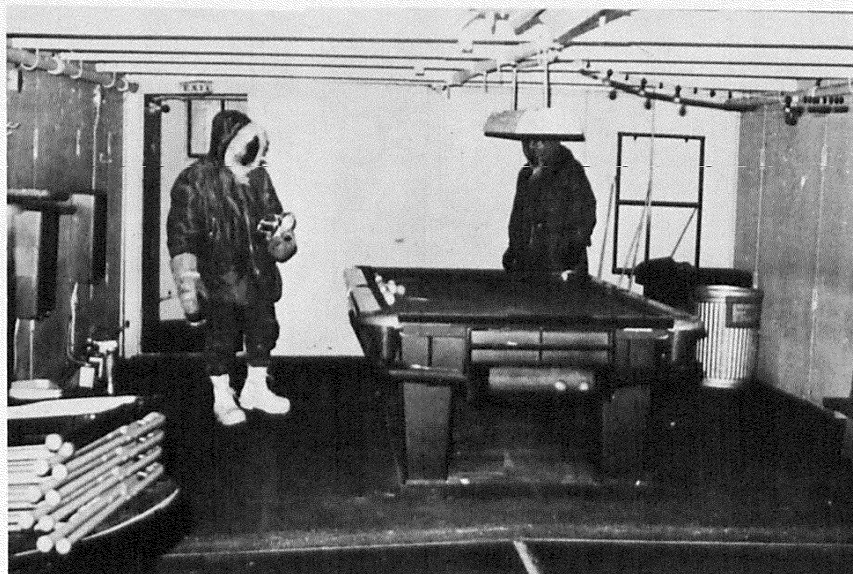
*Figure 46. Floor buckling in EM club.*

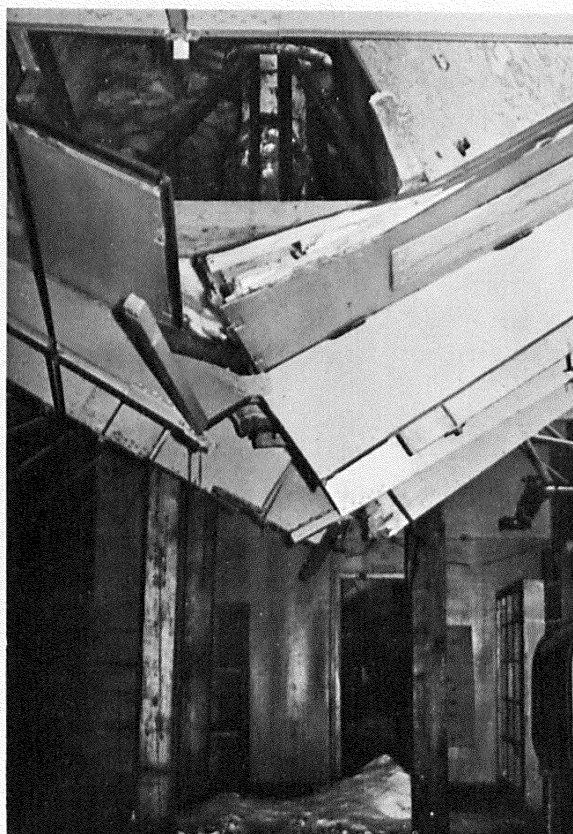
Figure 70. Ceiling cave-in at vent stack, Trench 15.

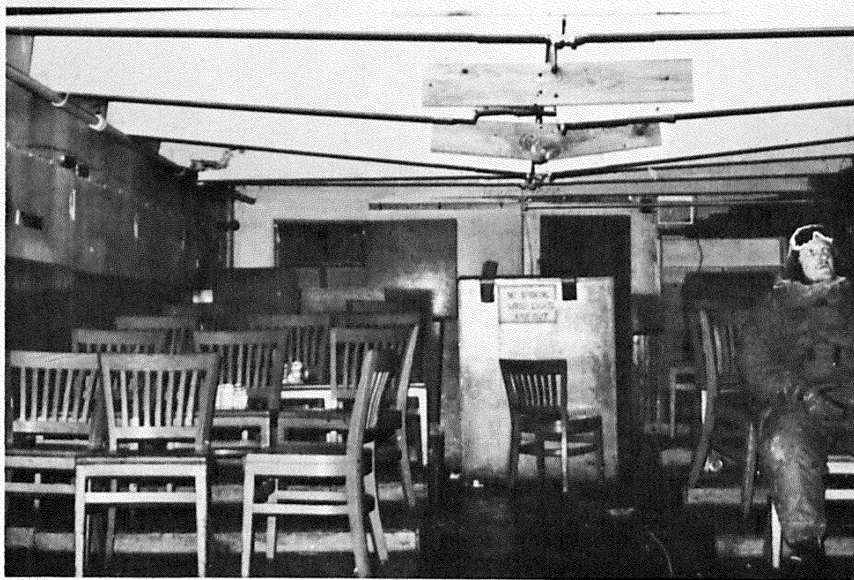
Figure 73. Interior of theater-chapel.

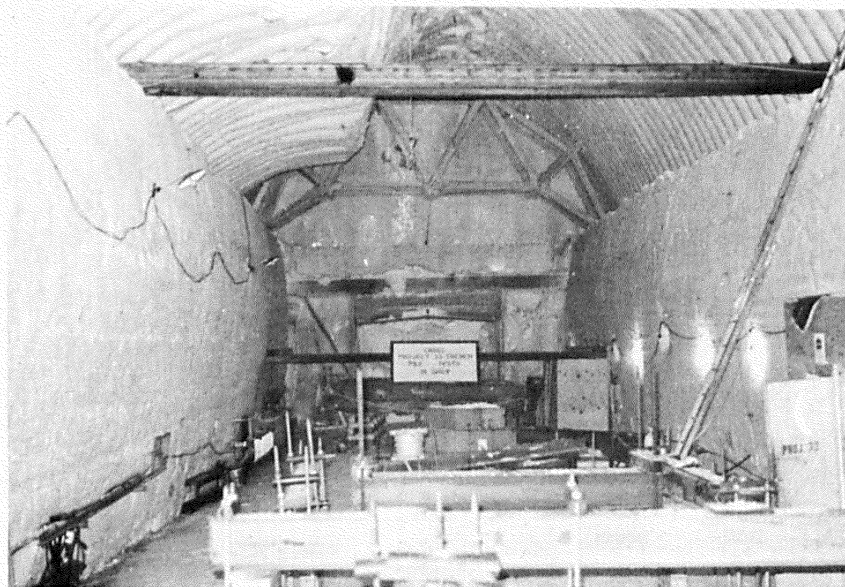
*Figure 96. North end wall, Trench 33.*

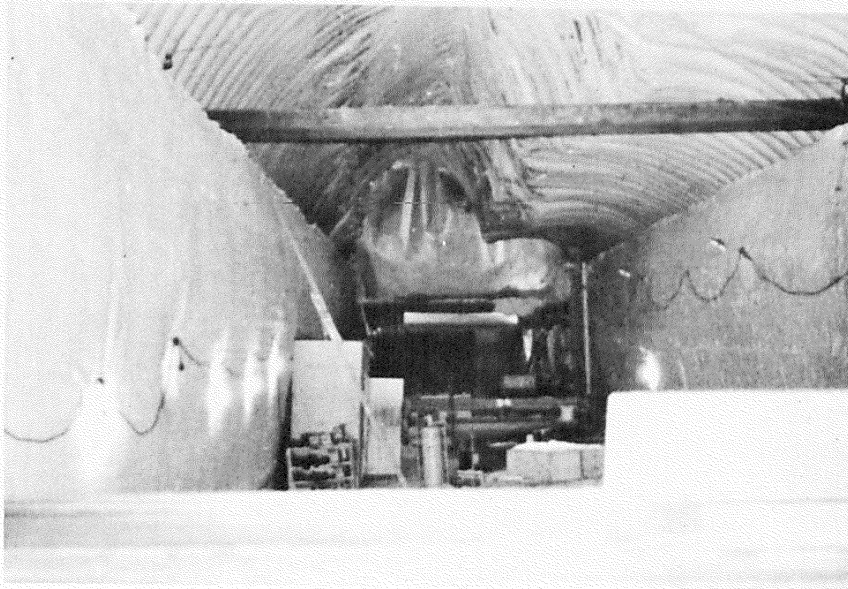
*Figure 97. South end wall, Trench 33.*
